# Comprehensive Analysis and Evaluation of Fukushima Daiichi Nuclear Power Station Unit 2

**Abstract** — Estimation and understanding of the state of the fuel debris and fission products inside the plant comprise an essential step in the decommissioning of Tokyo Electric Power Company Holdings' Fukushima Daiichi nuclear power station (1F). However, because of the plant's high-radiation environment, direct observation of the plant interior is difficult. Therefore, in order to understand the plant's interior conditions, comprehensive analysis and evaluation based on various measurement data from the plant, analysis of plant data during the accident progression phase, and information obtained from computer simulations for this phase are necessary. These evaluations can be used to estimate the conditions of the interior of the reactor pressure vessel (RPV) and the primary containment vessel (PCV). This paper addresses 1F Unit 2 as the subject to produce an estimated map of the fuel debris distribution from data obtained about the RPV and PCV based on comprehensive evaluation of various measurement data and information obtained from the accident progression analysis, which were release

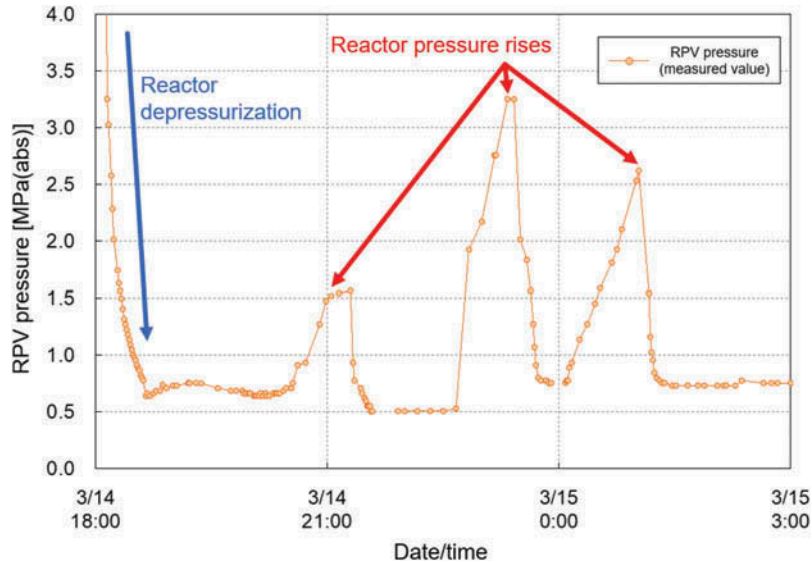
Even though the RPV at Unit 2 was successfully decompressed at 18:00 on March 14, 2011, with the forced opening of the SRV, three increases in the RPV pressure occurred between the evening and the following morning [Fig. 4 (Refs. 1 and 48)]. According to the records, this behavior is considered to have come along with the opening/closing of the SRV (pressure increase = SRV closed; pressure decrease = SRV opened).

Fig. 4. The RPV pressure behavior after manually opening the main SRV (Refs. 1 and 48).

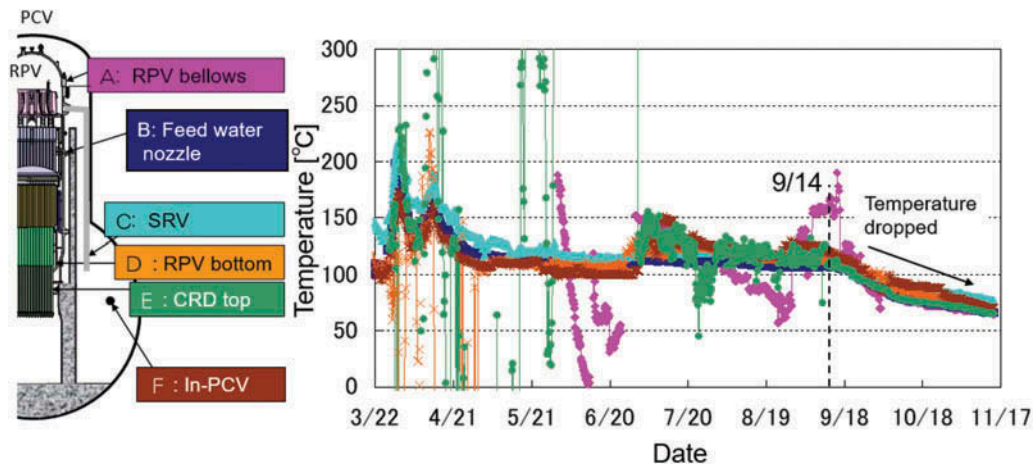
As shown in Fig. 7 (Refs. 1 and 49), the temperature of each section of the containment vessel decreased after the water injection from the core spray (CS) system, which began on September 14, 2011. However, during the period shown in Fig. 7 (Refs. 1 and 49), after water injection from the CS system began, the maximum rate of water injection was 7.2 m<sup>3</sup>/h, which is dramatically less than the designed flow rate of 1141 m<sup>3</sup>/h, implying that the sprayed water is unlikely to have spread very wide with this low flow rate. Therefore, some of the fuel likely reached the sprayed water even with the low flow rate water injection from the CS system, for instance, around the periphery of the reactor core region. However, while this information indicates the possibility that a heat source was present on the outer circumference, it cannot distinguish between heat from the fuel debris that remained on the periphery of the reactor core region and heat from fuel debris that solidified after molten fuel dropped onto the fuel support. Thus, a detailed vertical

Fig. 7. Temperature of each part of the PCV in 2011 (Refs. 1 and 49).

decreased following the water injection from the CS system, which began on September 14, 2011. Note that the flow rate of water injection from the FDW system was approximately the same before and after the CS system was engaged. Moreover, based on this fact, one can infer that heat sources were located such that they could be cooled down by the water injection from the CS system, and it is unlikely that the heat sources had moved outside the shroud because of damage to the shroud. Therefore, the shroud may not be extensively damaged. Note that the integrity of the shroud support was likely affected by the height of fuel debris accumulated at the bottom of the pressure vessel. At Unit 2, approximately 10 m<sup>3</sup> of debris accumulated from the bottom of the pressure vessel to the lower part of the shroud support, excluding the volume of the control rod guide tube (CRGT). Considering the amounts of fuel in the reactor core and the structure at the lower part of the RPV, the accumulation of fuel at the bottom of the RPV may have reached the lower part of the shroud support. Therefore, while the shroud support may be damaged by the fuel debris, not enough information and knowledge are available to make an inference. Note that as the state of the fuel debris while moving to the bottom of the RPV differed from unit to unit owing to the difference in the accident progression, it is possible that the state of the shroud support also differed from unit to unit.

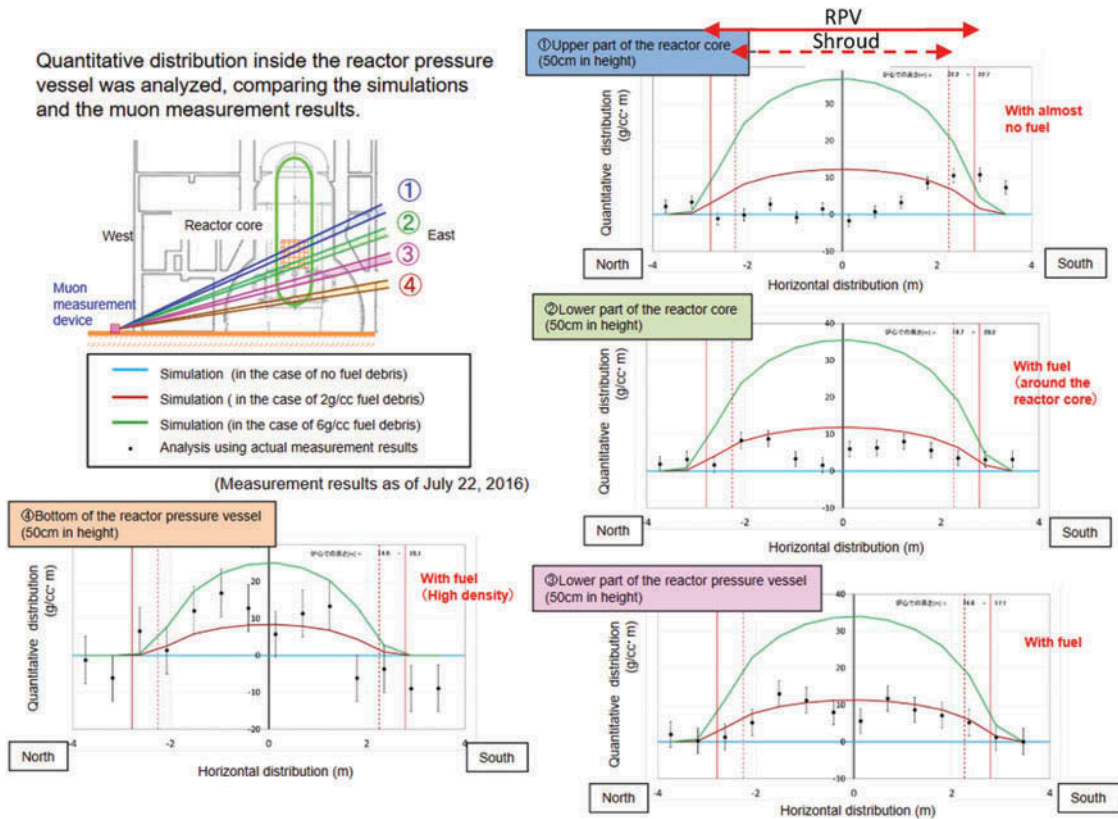
At Unit 2, measurements using the muon-transmission method were conducted between March and July 2016 to analyze and evaluate the position of fuel debris in the RPV. Figure 8 (Ref. 18) shows the results of the evaluation of the amount of substance inside the RPV by comparing the simulation results with muon measurements at “①” the upper part of the reactor core, “②” the lower part of the reactor core, “③” the lower part of the RPV, and “④” the bottom part of the RPV. Comparing the measurement of the lower part of the reactor core (“②”) and the simulated measurement shows that the measurements are closer to the result of the simulation in cases where fuel is present as compared to cases where fuel is not present. Thus, some fuel may remain around the periphery of the reactor core region.

Fig. 8. Comparison of muon measurement results and simulation results.<sup>18</sup>

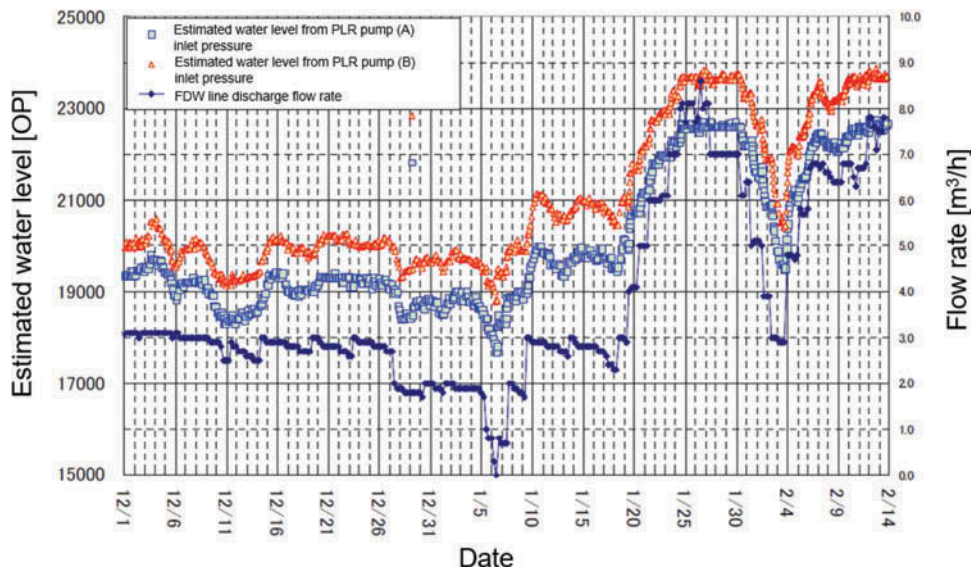
Figure 9 (Refs. 1 and 50) shows the relationship between the amount of the water injection from the feedwater (FDW) system and the annulus water level estimated from the entry pressure of the primary loop recirculation (PLR), as recorded between December 2011 and February 2012. As the amount of water injection from the FDW system changed, the water outside the shroud increased. This relationship suggests the following two possibilities. First, the damage to the shroud may have been small so that water accumulated outside the

Fig. 9. Relationship between the amount of water injection from the FDW system and the annulus water level estimated from the entry pressure of the PLR system from December 2011 to February 2012 (Refs. 1 and 50).

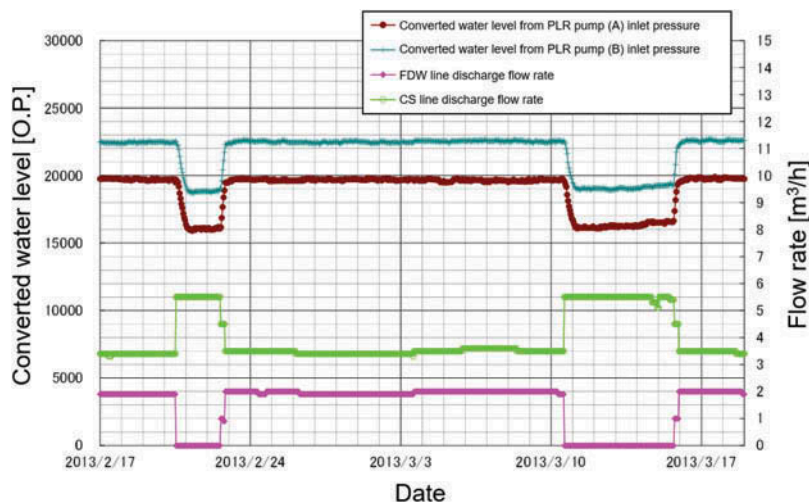
Figure 10 shows a similar relationship between the amount of water injection from the FDW system and the annulus water level estimated from the entry pressure of the PLR as recorded between February 2013 and March 2013. During the period shown in Fig. 10, there were times when the amount of water injection from the FDW system was turned to zero without changing the total amount of water injection amount by combining the amount of water injection from the FDW system and that from the CS system twice. The annulus water level, estimated from the entry pressure of the PLR system, decreased at these two moments. This behavior is likely caused by a certain amount of water accumulated outside the shroud. Therefore, the

Fig. 10. Relationship between the amount of water injection from the FDW system and the annulus water level estimated from the entry pressure of the PLR system from February 2013 to March 2013 (Ref. 1).

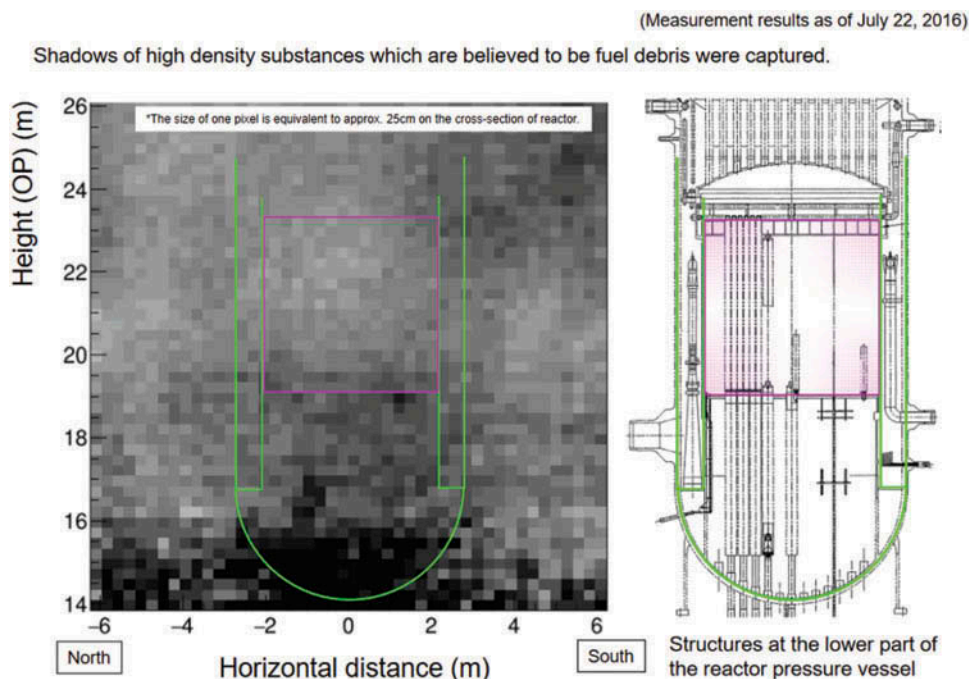
As shown in Fig. 11 (Ref. 18), the results of muon measurement conducted between March and July 2016 verified the existence of a shadow of a high-density matter that is inferred to be fuel debris at the bottom of the RPV. Thus, the fuel debris that dropped to the lower plenum probably remained at the bottom of the RPV.

Thus, the muon measurements verified the existence of a trace of high-density matter that is probably fuel debris at the bottom of the RPV. It is inferred that the fuel that dropped to the lower plenum remained at the bottom of the RPV.

Fig. 11. Muon measurement results.<sup>18</sup>

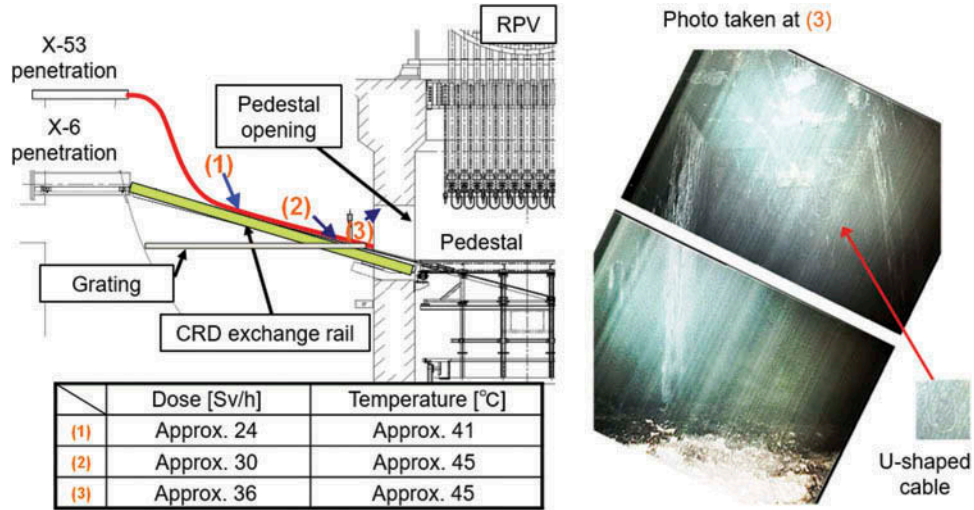
As shown in Fig. 12 (Ref. 30), a research device entered from the X-53 penetration zone in August 2013 to study the exchange rail of the control rod drive mechanism (CRDM) and the area near the opening of the pedestal. A U-shaped cable appears in the photograph captured from the point indicated by “(3)” in Fig. 12 (Ref. 30), while the device was facing the inside of the pedestal. Next, Fig. 13 (Ref. 30) shows the state of the interior of the pedestal of Unit 5. Figure 13(a) was captured from the same angle as the photograph shown in Fig. 12 (Ref. 30), Fig. 13(b) shows a view from below, and the U-shaped cable resembles the one observed in Unit 2.

Fig. 12. Interior of the Unit 2 pedestal (1/4) (Ref. 30).

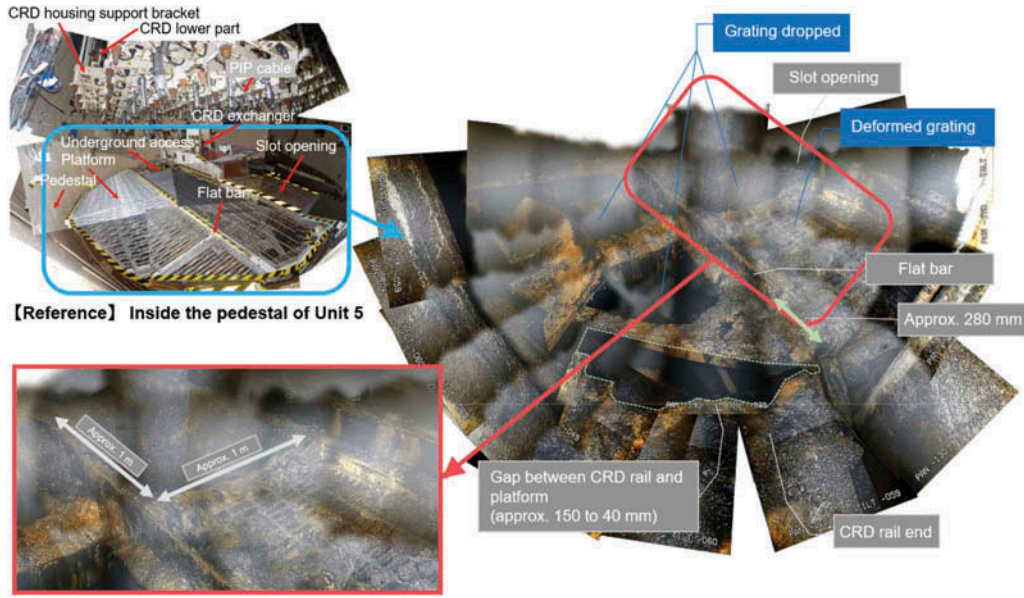
From the images captured in January 2017 during the inspection of the PCV interior using the guide pipe [Fig. 14 (Ref. 40) and Fig. 15 (Ref. 40)], it can be observed that the grating is about to fall along with the accumulated debris at a location closer to the center than the inner circumference of the pedestal but not at the center itself. Moreover, on observation of the upper part, because the coating of the cables maintains its shape, some fuel debris of relatively low temperatures may have fallen on this spot. Furthermore, water drops are seen falling on the entire surface of the pedestal floor in the video obtained during the internal inspection of the

Fig. 14. Interior of the Unit 2 pedestal (2/4) (Ref. 40).

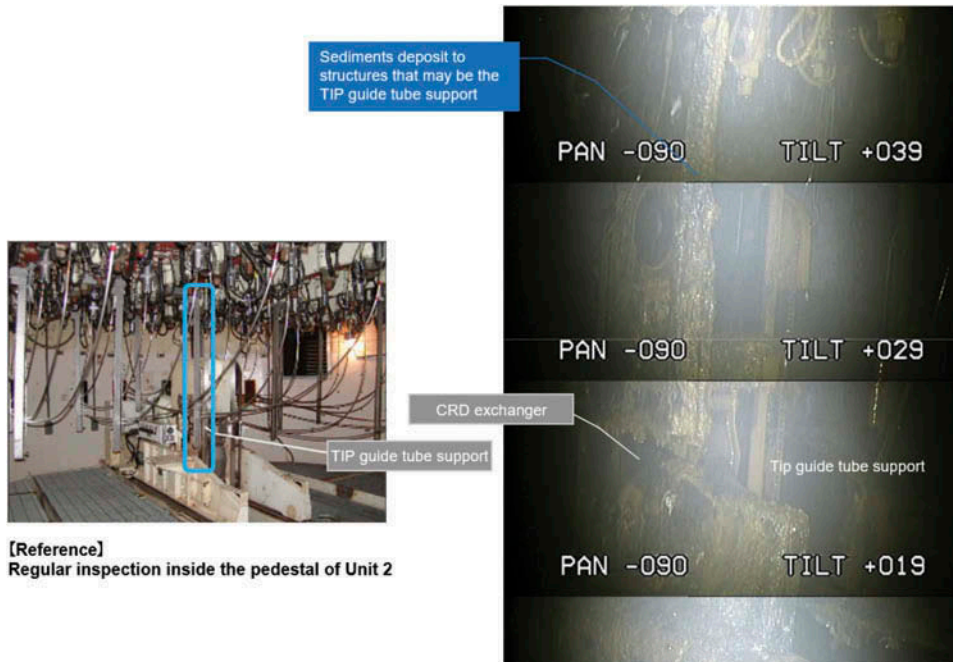
Fig. 15. Interior of the Unit 2 pedestal (3/4) (Ref. 40).

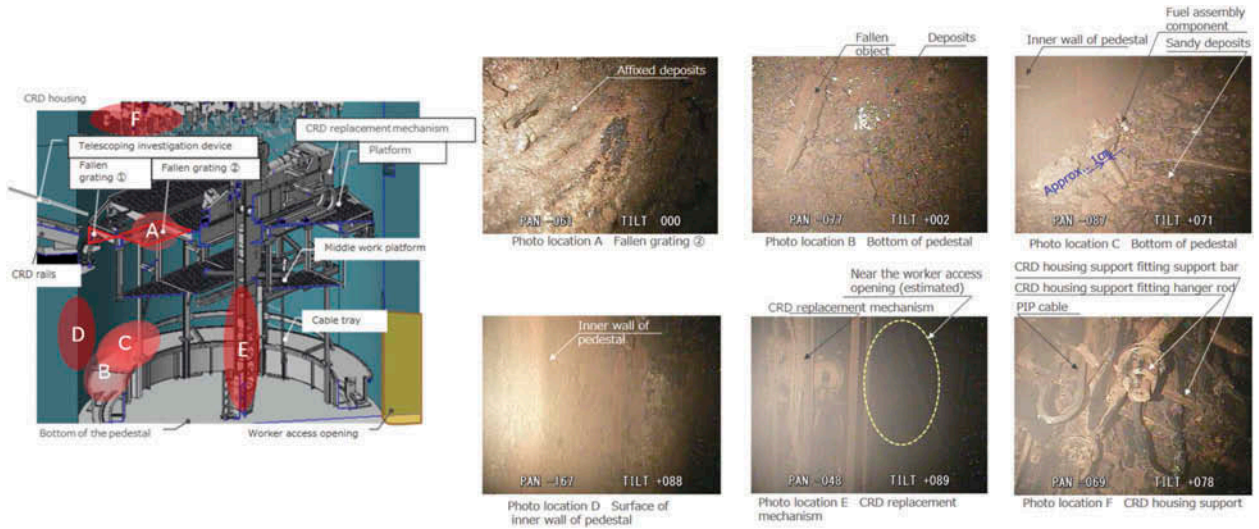
The images captured in January 2018 during an inspection of the PCV interior using the guide pipe and the telescopic research device [Fig. 16 (Ref. 38)] show that the upper tie plate of the fuel assembly fell on the pedestal floor. Because it fell near the inner wall of the pedestal and the CRDs around the outer circumference remain, as shown in Estimation 12, the upper tie plate fell through the openings formed by the damage outside the area at the bottom of the RPV where the CRDs are standing close together.

research device conducted in January 2018 [Fig. 16 (Ref. 38)] show that the upper tie plate of the fuel assembly fell on the pedestal floor. It may be inferred that there is a hole in the RPV that is at least large enough for the upper tie plate to fall through.

Fig. 16. Interior of the Unit 2 pedestal (4/4) (Ref. 38).

The image obtained during the inspection of the PCV interior using the guide pipe and the telescopic research device conducted in January 2018 [Fig. 16 (Ref. 38)] indicates that the upper tie plate of the fuel assembly fell on the pedestal floor. If the fuel debris fell through the same hole that the upper tie plate fell through, it may be inferred that the accumulation near the fallen upper tie plate is fuel debris. Moreover, during the inspection of the PCV interior conducted in January 2018, dose rate and temperature were measured. Figure 17 (Ref. 38) shows the measurement results. The measurement results did not indicate any significant change in either the dose or the temperature from the pedestal floor to the platform, and their numbers were relatively small (dose: 7 to 8 Gy/h; temperature: 21.0°C). Thus, it is inferred that the contribution to the dose or as a heat source from the fuel debris that fell on the pedestal floor was relatively small. There was no conspicuous damage to the lower structure of the pedestal, such as the cable tray, and the accumulation of fuel debris spreads all over the pedestal floor, though there are some local differences in the accumulation height. From these facts, it is inferred that the fuel debris was in a low-temperature state with a certain degree of fluidity when it fell. Moreover, from the fact that most of the fuel debris inside the pedestal had cooled down even though it was exposed, it is inferred that there is a possibility that the fuel debris accumulated on the pedestal is composed of a material comprising a high metal component and low melting point.

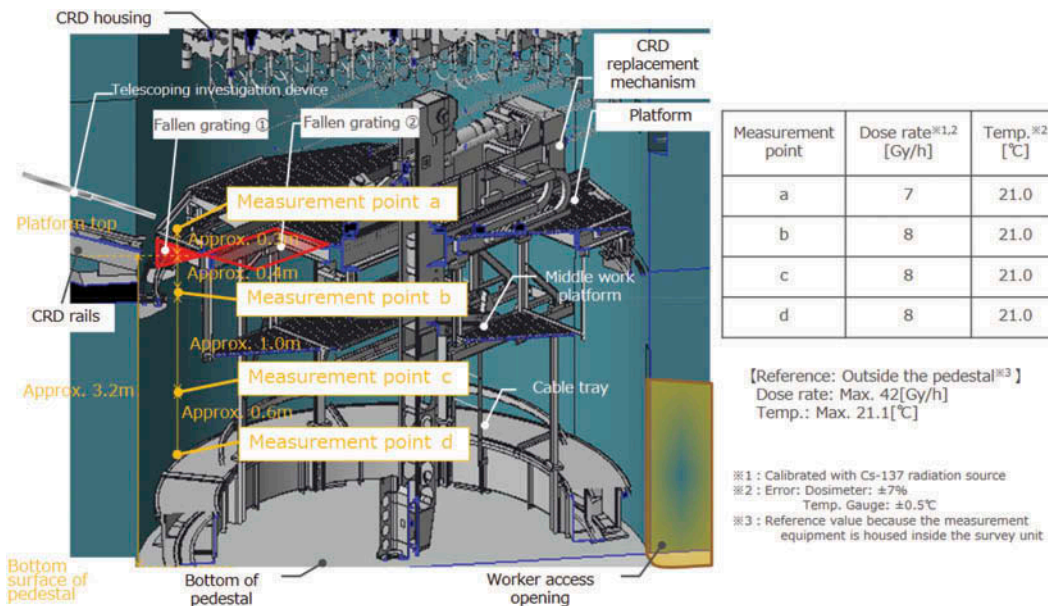
Thus, it is inferred that the fuel debris on the pedestal floor has relatively low dose and decay heat and may contain large amounts of metal because no changes in dose or temperature were detected between the pedestal

Fig. 17. Results of dose rate and temperature measurements inside the pedestal.<sup>38</sup>

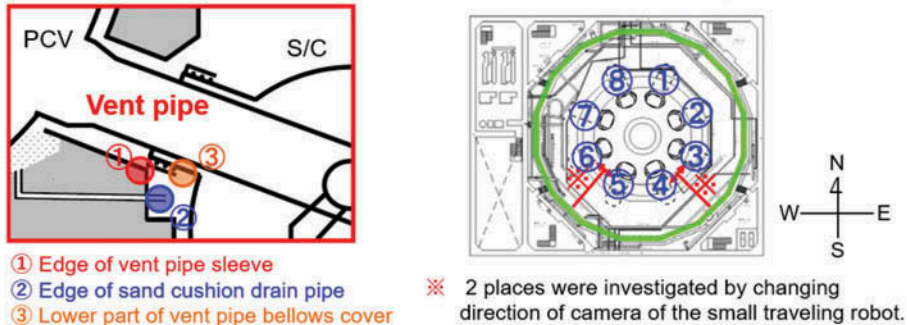
lower parts of the vent pipe bellows that cover the eight vent pipes as shown in Fig. 18 (Ref. 47), and no leakage was found [Fig. 19 (Ref. 47)]. Thus, it is inferred that even if the fuel debris that fell in the pedestal reacted with the concrete, it occurred within a limited area.

Thus, it is inferred that the MCCI was limited as there was no tendency for damage to the PCV shell (no leakage from the sand cushion drain pipe).

Fig. 19. Inspection results of the area around the lower part of the Unit 2 vent pipe.<sup>47</sup>
