Comprehensive Analysis and Evaluation of Fukushima Daiichi Nuclear Power Station Unit 2

Takuya Yamashita, Ikken Sato, Takeshi Honda, Kenichiro Nozaki, Hiroyuki Suzuki, Marco Pellegrini, Takeshi Sakai & Shinya Mizokami

Abstract — Estimation and understanding of the state of the fuel debris and fission products inside the plant comprise an essential step in the decommissioning of Tokyo Electric Power Company Holdings' Fukushima Daiichi nuclear power station (1F). However, because of the plant's high-radiation environment, direct observation of the plant interior is difficult. Therefore, in order to understand the plant's interior conditions, comprehensive analysis and evaluation based on various measurement data from the plant, analysis of plant data during the accident progression phase, and information obtained from computer simulations for this phase are necessary. These evaluations can be used to estimate the conditions of the interior of the reactor pressure vessel (RPV) and the primary containment vessel (PCV). This paper addresses 1F Unit 2 as the subject to produce an estimated map of the fuel debris distribution from data obtained about the RPV and PCV based on comprehensi

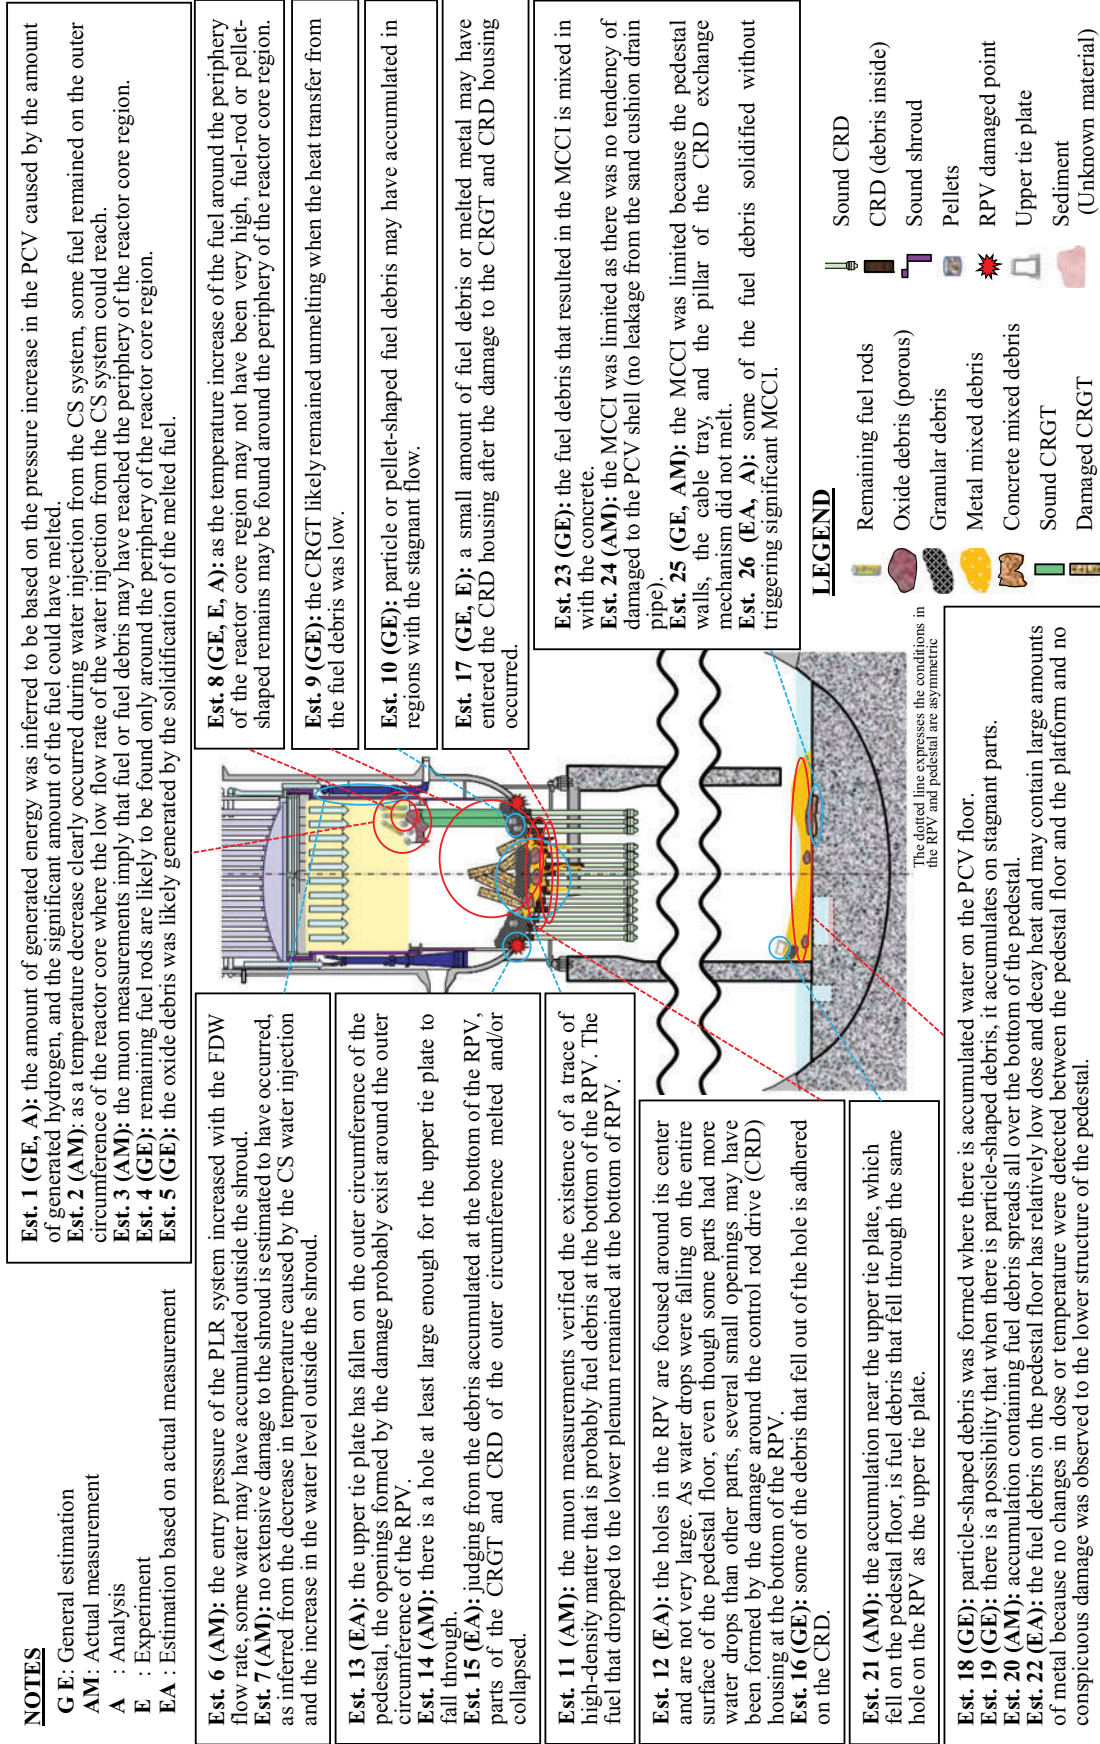
Fig. 3. Estimated distribution of fuel debris in Unit 2 (Ref. 2).

The estimated map of fuel debris distribution in the RPV and PCV, shown in Fig. 3 (Ref. 2), was prepared based on a comprehensive evaluation of the aggregated information (Fig. 2 and Table I), all of which was deemed relevant to the state of the RPV, PCV, and reactor building of each unit. The remainder of this section provides explanations of the basis for the estimation of each part of the main sections in the map of fuel debris distribution shown in Fig. 3 (Ref. 2).

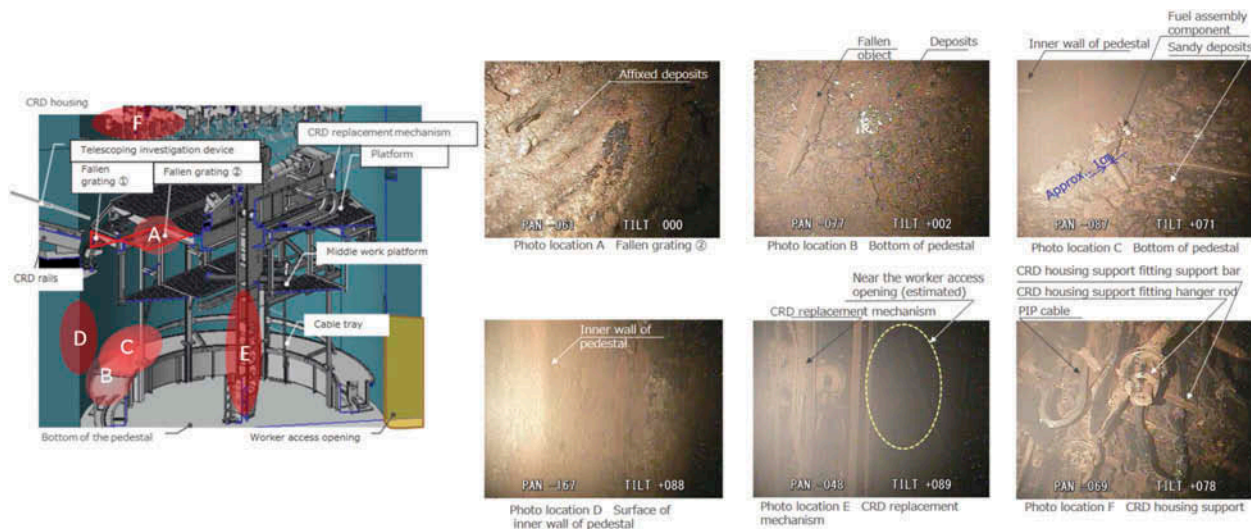
Fig. 16. Interior of the Unit 2 pedestal (4/4) (Ref. 38).

The images captured in January 2018 during an inspection of the PCV interior using the guide pipe and the telescopic research device [Fig. 16 (Ref. 38)] show that the upper tie plate of the fuel assembly fell on the pedestal floor. Because it fell near the inner wall of the pedestal and the CRDs around the outer circumference remain, as shown in Estimation 12, the upper tie plate fell through the openings formed by the damage outside the area at the bottom of the RPV where the CRDs are standing close together.

Thus, because the upper tie plate has fallen on the outer circumference of the pedestal, the openings formed by the damage probably exist around the outer circumference of the RPV.

research device conducted in January 2018 [Fig. 16 (Ref. 38)] show that the upper tie plate of the fuel assembly fell on the pedestal floor. It may be inferred that there is a hole in the RPV that is at least large enough for the upper tie plate to fall through.

Thus, it is inferred that there is a hole at least large enough for the upper tie plate to fall through.

The image obtained during the inspection of the PCV interior using the guide pipe and the telescopic research device conducted in January 2018 [Fig. 16 (Ref. 38)] indicates that the upper tie plate of the fuel assembly fell on the pedestal floor. If the fuel debris fell through the same hole that the upper tie plate fell through, it may be inferred that the accumulation near the fallen upper tie plate is fuel debris. Moreover, during the inspection of the PCV interior conducted in January 2018, dose rate and temperature were measured. Figure 17 (Ref. 38) shows the measurement results. The measurement results did not indicate any significant change in either the dose or the temperature from the pedestal floor to the platform, and their numbers were relatively small (dose: 7 to 8 Gy/h; temperature: 21.0°C). Thus, it is inferred that the contribution to the dose or as a heat source from the fuel debris that fell on the pedestal floor was relatively small. There was no conspicuous damage to the lower structure of the pedestal, such as the cable tray, and the accumulation of fuel debris spreads all over the pedestal floor, though there are some local differences in the accumulation height. From these facts, it is inferred that the fuel debris was in a low-temperature state with a certain degree of fluidity when it fell. Moreover, from the fact that most of the fuel debris inside the pedestal had cooled down even though it was exposed, it is inferred that there is a possibility that the fuel debris accumulated on the pedestal is composed of a material comprising a high metal component and low melting point.

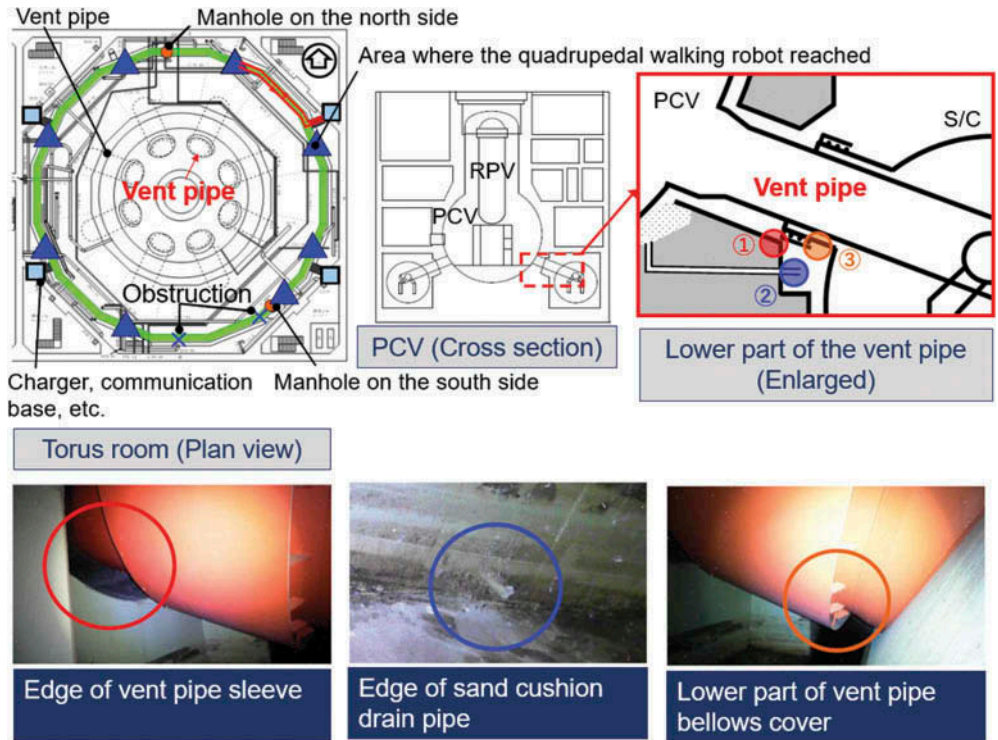
Fig. 18. Sections of the lower part of the vent pipe to be inspected.⁴⁷

The inspection of the torus room interior conducted at Unit 2 showed no evidence of the damage to the containment shell, such as leakage from the sand cushion drain pipe, which was observed in Unit 1. As shown in Fig. 18 (Ref. 47), verification of the leakage from the area around the lower part of the suppression chamber (S/C) vent pipe using a quadruped walking robot was conducted in December 2012 and April 2013. These inspections were conducted at “①” the vent pipe sleeves, “②” the ends of the sand cushion drain pipes, and “③” the

lower parts of the vent pipe bellows that cover the eight vent pipes as shown in Fig. 18 (Ref. 47), and no leakage was found [Fig. 19 (Ref. 47)]. Thus, it is inferred that even if the fuel debris that fell in the pedestal reacted with the concrete, it occurred within a limited area.
