# Environmental Site Assessment and Hydrogeologic Impacts to Groundwater at St. Ignatius, Montana and Hanford, Washington

# ENVIRONMENTAL SITE ASSESSMENT AND HYDROGEOLOGIC IMPACTS TO GROUNDWATER AT ST. IGNATIUS, MONTANA AND HANFORD, WASHINGTON

The first chapter, titled "An Environmental Site Assessment, St, Ignatius, Montana", is a Phase I commercial property environmental site assessment (ESA) report, completed on behalf of Pioneer Technical Services, Missoula, Montana (Carter, 2011). The chapter describes the purpose of the environmental assessment, limiting factors, site conditions, and results of visual observations at the site, findings, and conclusions. The entire report is included in this portfolio paper verbatim with minor edits for clarity. Research was focused on whether the property development had affected the local environment. This report touched on many of my academic interests including policy research, property development, and externalities impacting human and environmental health. This report was the first site assessment and characterization I completed since beginning my professional work in the environmental arena.

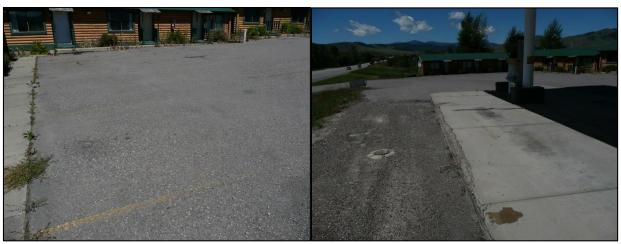
The parking lot appears to be in good condition, without any major cracks or potholes. Approximately 3,000 sq ft is asphalt, 250 sq ft is concrete, and 2,500 sq ft is gravel parking and drive-through. The restaurant parcel's parking area is completely graveled. According to satellite photos elevation records on Google Earth, the elevation on the north end is 2,907 feet asl (above sea level). There is a gentle downslope to the south parking area at the motel, which is at 2,903 feet asl.

The subject property buildings are no longer used as intended. There are no disposed batteries, barrels or buckets visible on the property. There is minor staining at various locations on the asphalt parking lot indicating spills of oil or other products in isolated areas (Figure 4). The stains appear to be typical for the type of activity on the property and does not appear to pose a threat to the environment.

Figure 4. Views of the Paved Asphalt Parking Lot and Concrete Pad with Staining

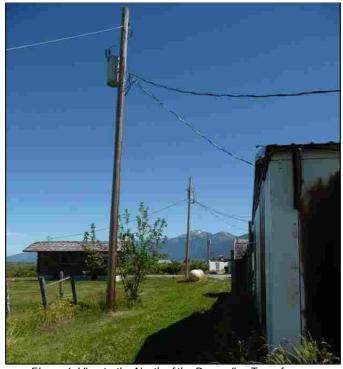
The electrical power to the site is supplied by a power pole located north of the White Buffalo Restaurant. There are six power poles on the subject property, three of which have transformers (Figure 6), and were observed to be modern transformers that Pioneer personnel did not suspect of containing PCBs (post-1977 construction of power lines). Pioneer did not contact Northwestern Energy to verify that the transformers do not contain PCBs.

Figure 6. View to the North of the Power-line Transformers

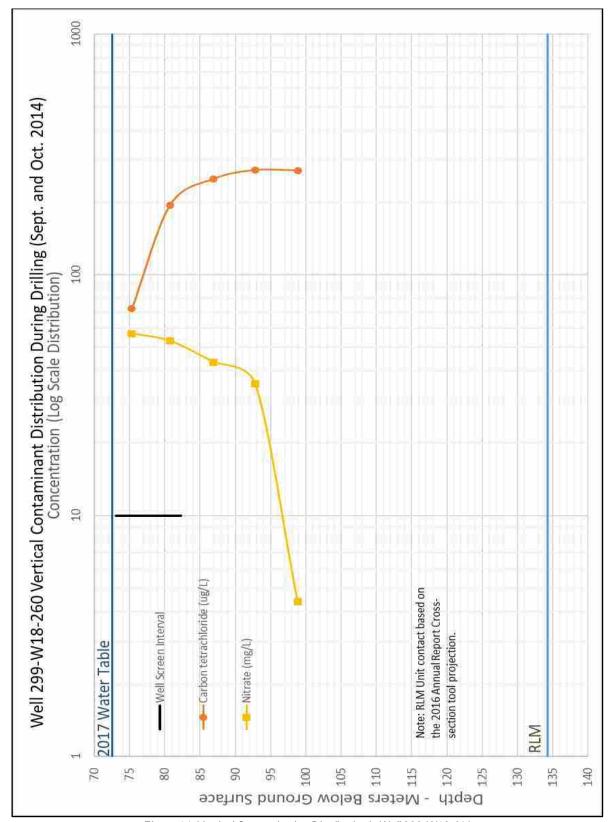
increase in carbon tetrachloride and nitrate concentrations beginning about 2 m (6.6 ft) and 8 m (26.2 ft), extending to 20 m (65.6 ft) and 25 m (82.0 ft), respectively, below the 2017 water table.

In summary, the WMA U is located within the regional 200 West Area plumes and within the local-scale plumes. It is additionally impacted by the current, local 200-UP-1 P&T and 200 West P&T well network operations. Based on the limited data available, the vertical distribution of plume concentrations do not appear to penetrate the entire depth of the aquifer. Available data for the well are not sufficiently representative to evaluate vertical plume migration from a release from WMA U.

Figure 14. Vertical Contamination Distribution in Well 299-W18-260
