Low velocity impact damage assessment in IM7/977-3 cross-ply composites using 3D computed tomography

A thesis submitted in partial fulfillment
of the requirements for the Master of
Science degree in Mechanical Engineering
in the Graduate College of
The University of Iowa

Thesis Supervisor: Associate Professor Olesya I. Zhupanska

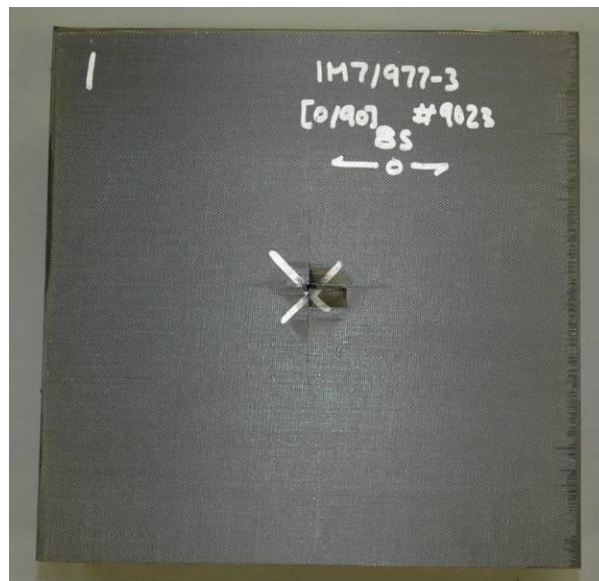
Figure 3.1: Impact Damage on the Top Surface of Specimen 1

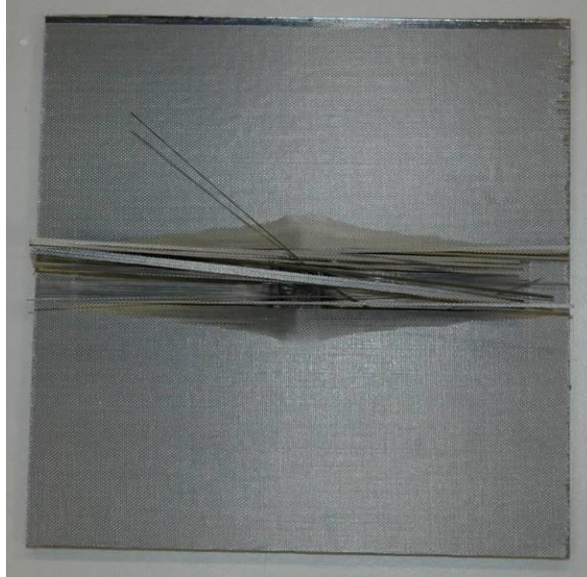
Figure 3.2: Impact Damage on the Bottom Surface of Specimen 1

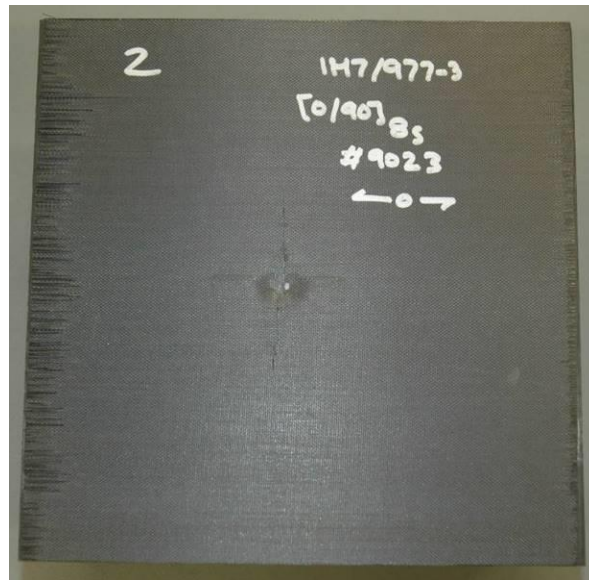
To reduce the amount of damage produced during impact, the impact energy was decreased to half of the initial value, resulting in an impact energy of 37.76 J. To achieve this, the same mass was used (12.831 kg) and the height was decreased to 0.30 m. Specimen 2 was clamped into the impact testing machine and impacted at this energy. The specimen damage, seen in Figure 3.4 through Figure 3.6, was moderate in scope with a large dent on the top surface and raised delamination on the back surface. While the damage was less than that for specimen 1, it was still more severe than desired.

Figure 3.4: Impact Damage on the Top Surface of Specimen 2

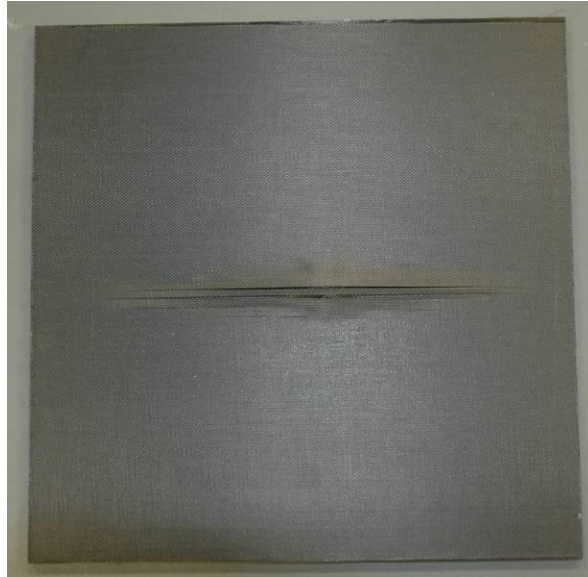
Figure 3.5: Impact Damage on the Bottom Surface of Specimen 2

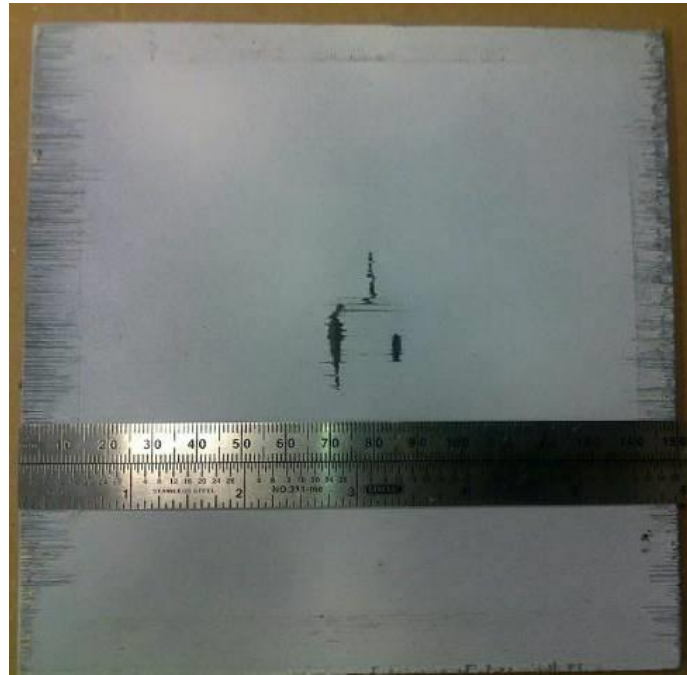
Figure 3.40: Visible Damage on the Back Side of Sample 48 (Hart 2011)

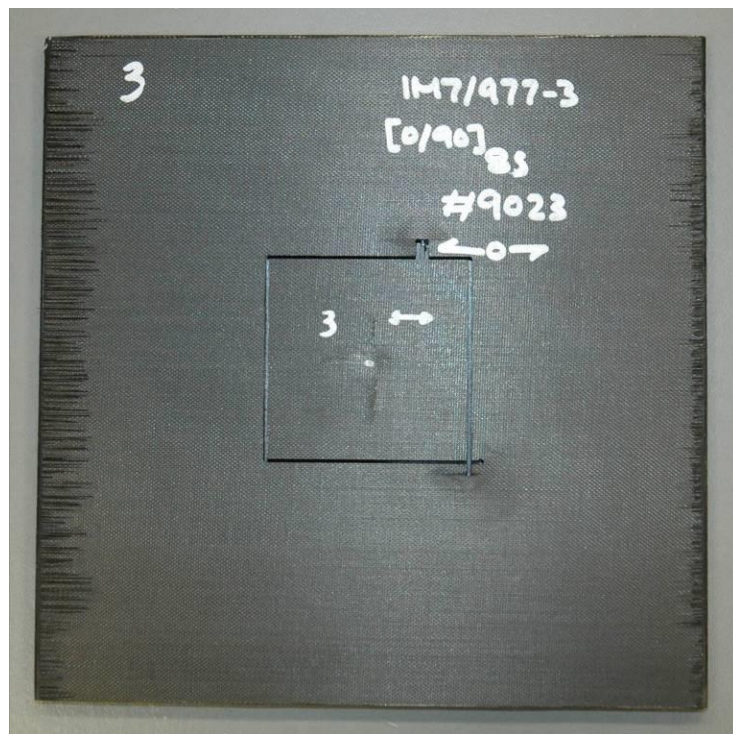
edge-surface quality of the cuts was generally excellent, there was a small amount of delamination induced near the start and stop of the cut path (located at the corner of the cut specimen, on the lower right in Figure 4.3). This delamination was a result of the crossing toolpath, and the induced damage for Specimen 3 is highlighted in the boxed region of Figure 4.4. A more detailed analysis of the cutting-induced damage is provided in a later section.

Figure 4.3: Cut Specimen 3 within Original Plate

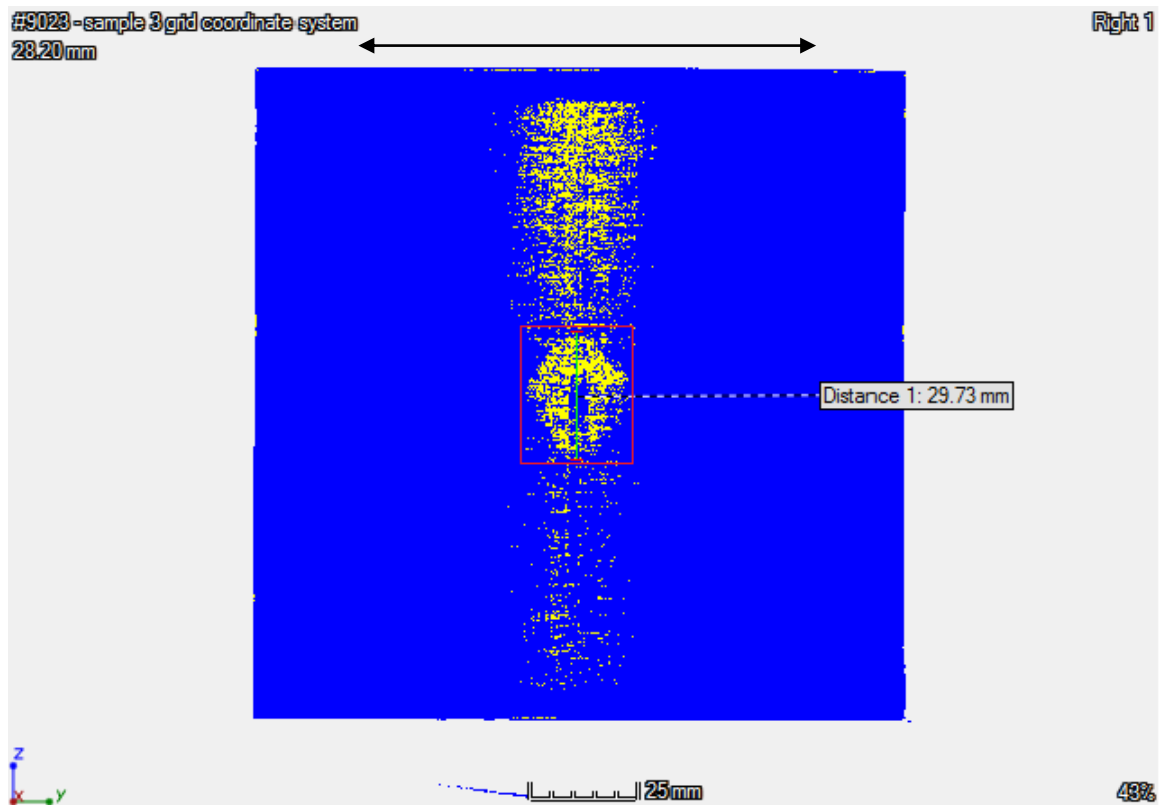
damaged volume for specimen 3 was found to be 2097.0 mm^3 , which was approximately 0.359 % of the total volume of the plate.

Figure 4.5: Length of Largest Internal Damage for Specimen 3 (Depth of 2.58 mm)

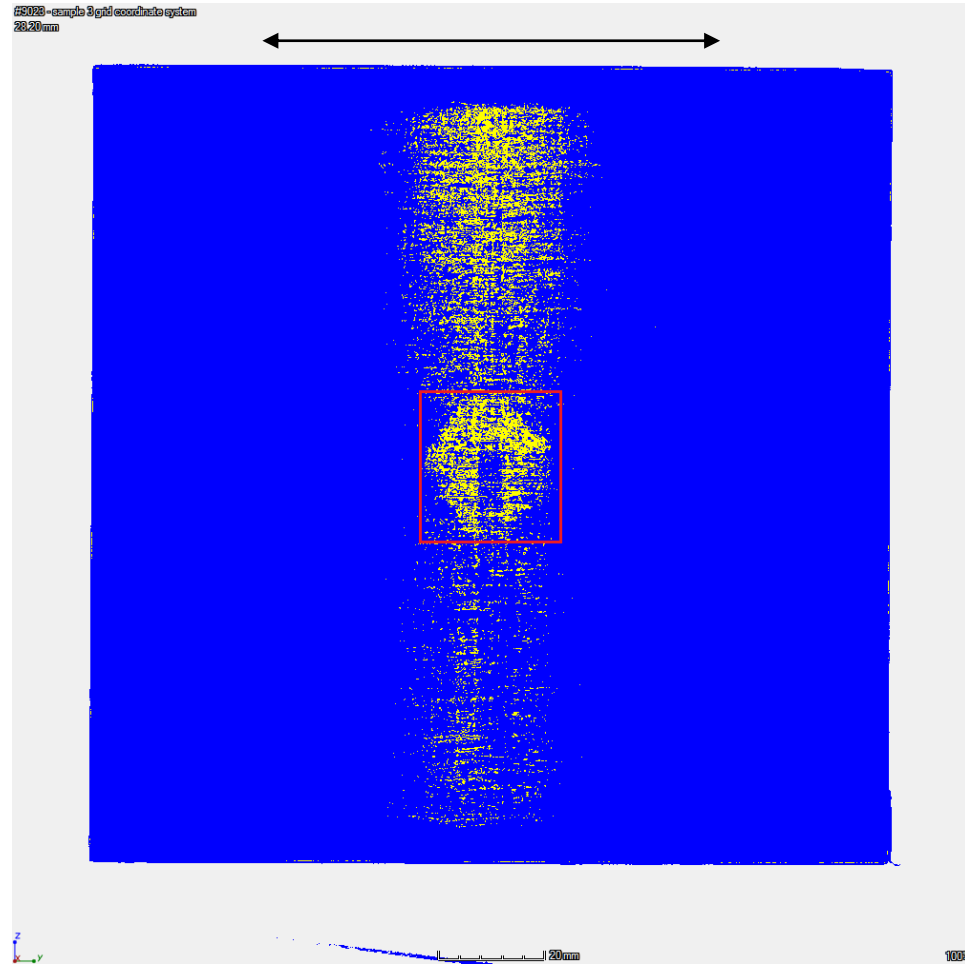
Figure 4.6: Segment with Largest Damaged Area for Specimen 3 (Depth of 2.48 mm)

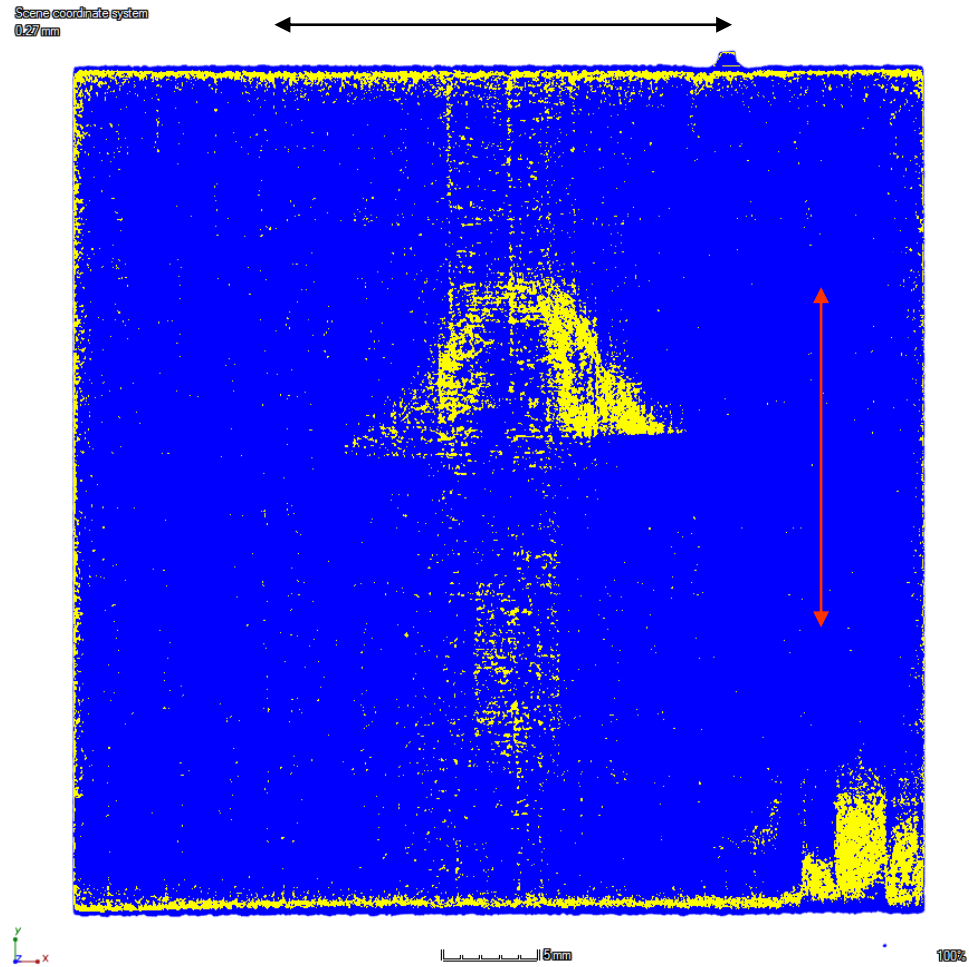
relative depth, within the 28th ply from the top) and the maximum vertical (90° orientation) damage length was found to be 29.85 mm at a depth of 3.43 mm (3.65 mm relative depth, at the interface between the 26th and 27th plies). From image processing of the cut plate, it was found that the maximum internal damaged area occurred at a depth of 1.80 mm (2.24 mm relative depth) from the impacted surface and was measured to be 132.5 mm², shown in Figure 4.7. This CT slice occurred within the 16th ply from the top, which was the first of the two symmetric 90° fiber orientation plies. In the figure, the black arrow above the plate indicates the global 0° fiber direction, while the red arrow indicates the ply orientation. From the damaged area for this slice, the maximum damaged volume per slice was 7.79 mm³. The total damaged volume for cut specimen 3 was found to be 868.5 mm³, which was approximately 0.149 % of the total volume of the original plate. This percent volume for the damaged region was calculated using the total volume originally calculated for the uncut specimen and the damaged volume found from analysis of the cut specimen. This allows for direct numerical comparison of the percent damaged volume from the full-sized and cut specimens (presented in a later section). For this specimen, the cutting process induced additional delamination in the lower right corner as seen in Figure 4.7.

Figure 4.7: Segment with Largest Damaged Area for Cut Specimen 3 (Depth of 1.80 mm, Within Ply 16)

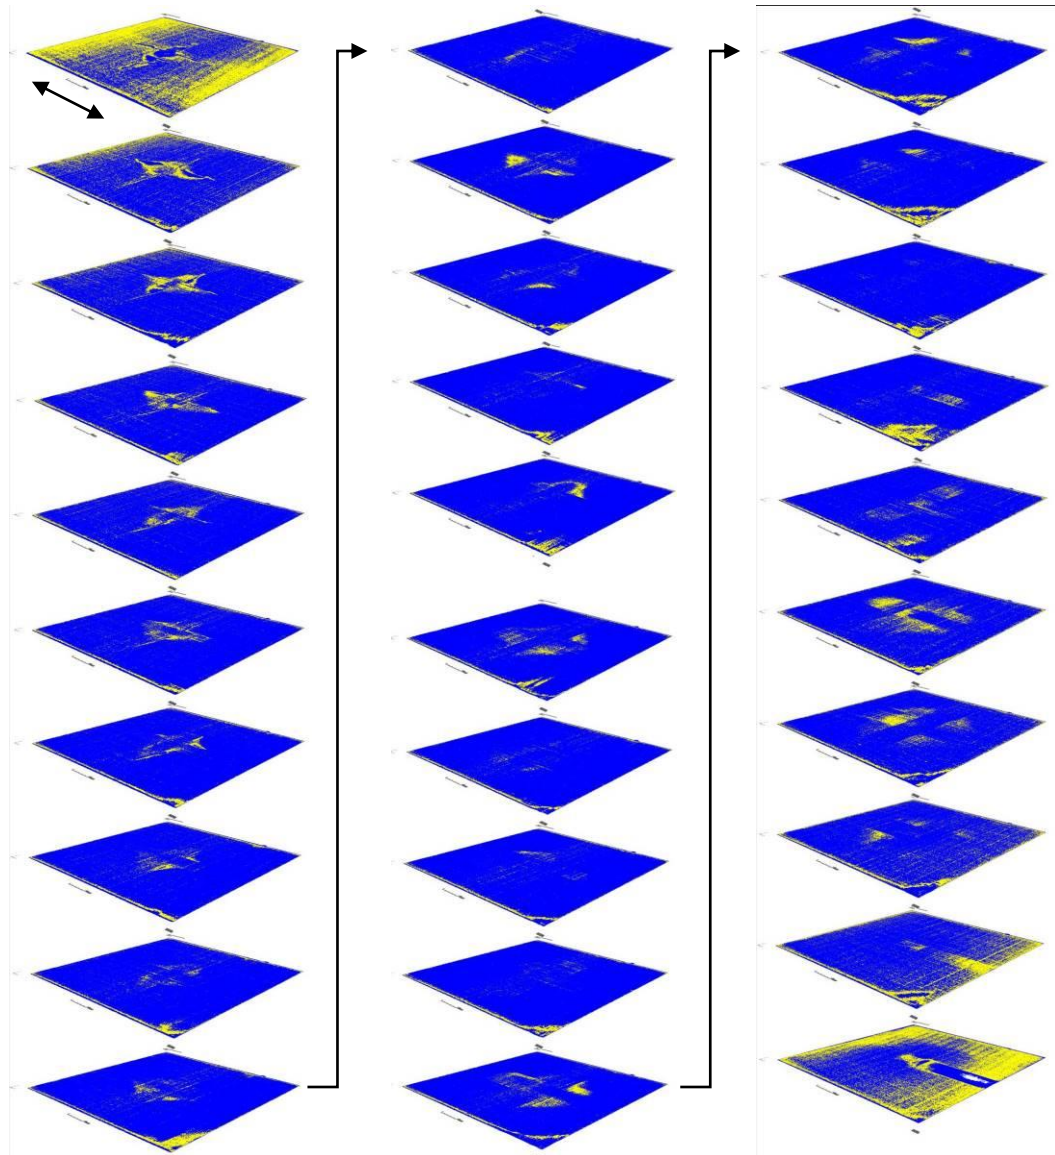
From the images of the cut specimen, it was possible to identify the ply orientation of each slice. Further, as there were approximately 2.5 CT slices per ply, images along the ply interface could usually be selected. The 30 different-direction ply interfaces from specimen 3 can be seen in Figure 4.13. The black arrow near the first image indicates the global 0° fiber direction. The first image is at the interface between the top, 0° orientation ply and the second, 90° orientation ply. The pattern continues from there. No ply interface image was included for the central interface between the middle 90° plies. As can be seen from this figure, the damage at the ply interfaces is typically in the orientation of the lower ply, as is expected for unidirectional angle-ply composites. Note that the significant amount of pixels coded as damage near the front and back surfaces (first and last images in Figure 4.13) are a product of surface effects and the threshold used, and so do not accurately reflect damage on these interfaces.

Figure 4.13: Ply Interfaces from Specimen 3

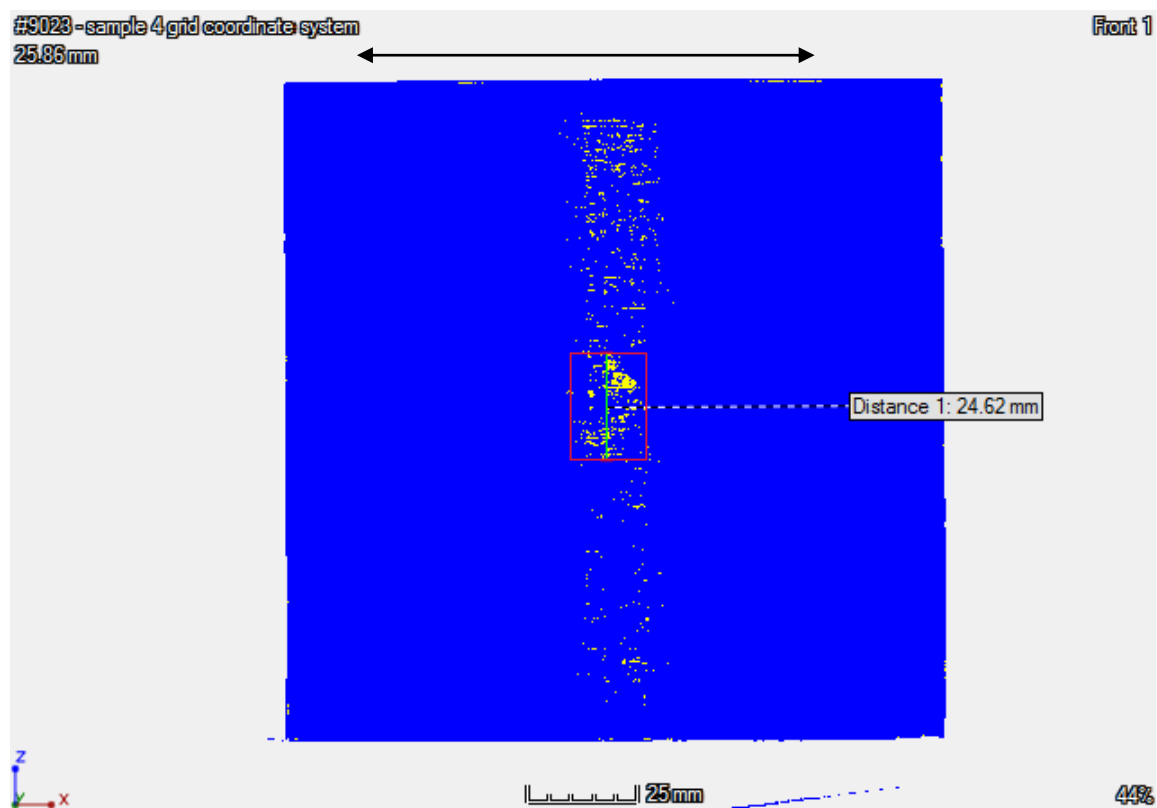
Specimen 4 had also been impacted at an energy of 20.77 J. The CT scan resolution for specimen 4 was 0.1802 mm/px and produced a stack of 38 images through the thickness of the plate. From image processing, it was found that the scan through the thickness had a total unadjusted depth of 6.31 mm. The maximum damaged length was found to be 24.62 mm at a depth of 2.67 mm (relative depth of 3.24 mm), shown in Figure 4.14. The maximum internal damaged area occurred at a depth of 2.40 mm (relative depth of 3.06 mm) from the impacted surface as was measured to be 226.1 mm². The colorized CT scan slice with the largest damaged area can be seen in Figure 4.15. The damaged area is boxed in both figures, and the global 0° fiber orientation is indicated by the black arrow above the specimen. From the damaged area for this slice, the maximum damaged volume per slice was 40.7 mm³. The total damaged volume for specimen 4 was found to be 1331.5 mm³, which was approximately 0.214 % of the total volume.

Figure 4.14: Length of Largest Internal Damage for Specimen 4 (Depth of 2.67 mm)

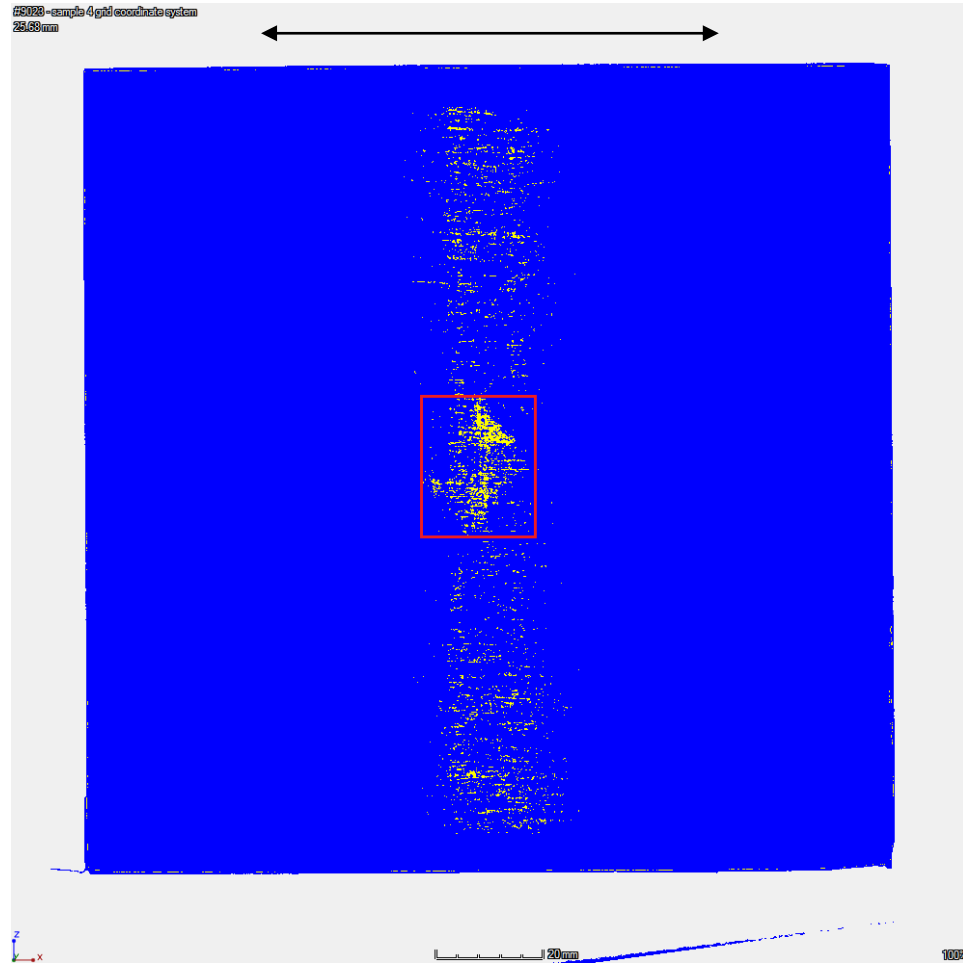
Figure 4.15: Segment with Largest Damaged Area for Specimen 4 (Depth of 2.40 mm)

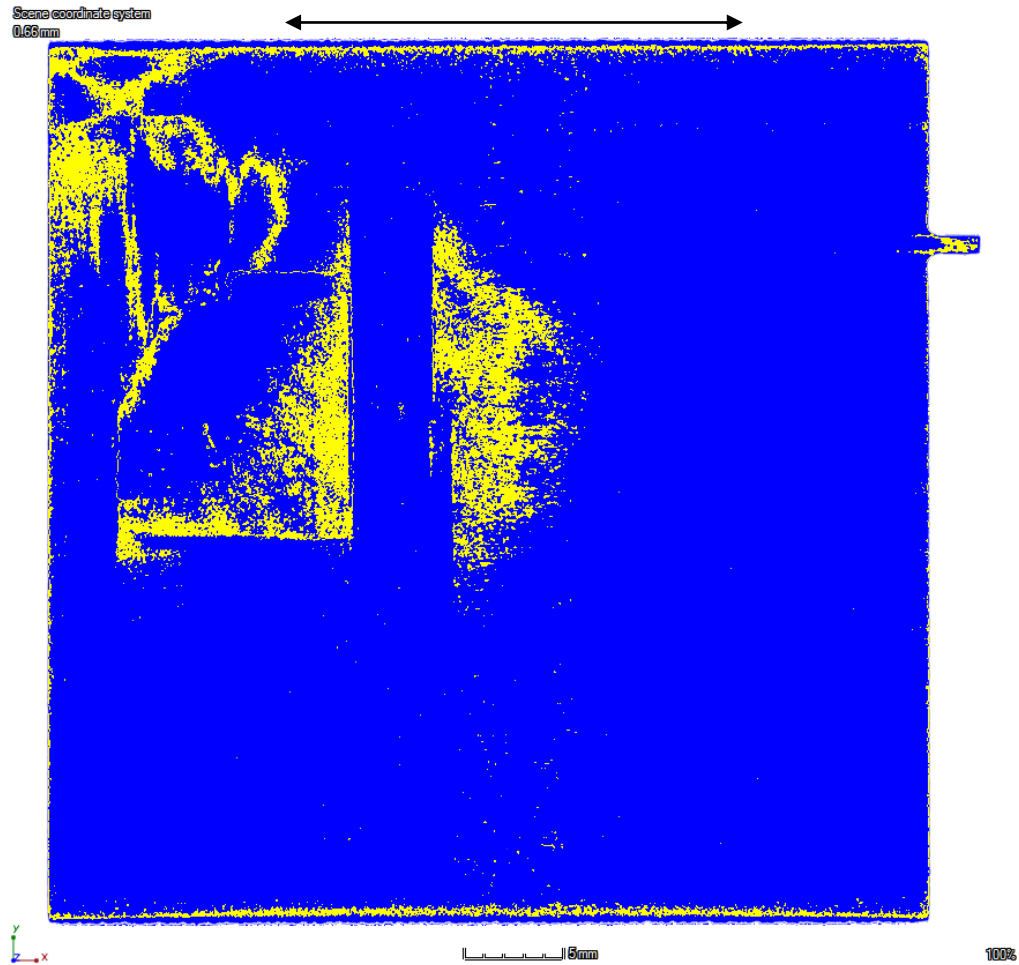
to be 28.03 mm at a depth of 0.13 mm (0.59 mm relative depth). From image processing of the small plate, it was found that the maximum internal damaged area occurred at a depth of 2.29 mm (2.77 mm relative depth) from the impacted surface and was measured to be 174.96 mm², shown in Figure 4.16. In this figure, the black arrow above the plate indicates the global 0° fiber direction. From the damaged area for this slice, the maximum damaged volume per slice was 10.29 mm³. The total damaged volume for cut specimen 4 was found to be 539.2 mm³, which was approximately 0.087 % of the total volume of the original plate. For this specimen, the cutting process induced additional delamination in the upper left corner, as seen in Figure 4.16.

Figure 4.16: Segment with Largest Damaged Area for Cut Specimen 4 (Depth of 2.29 mm)

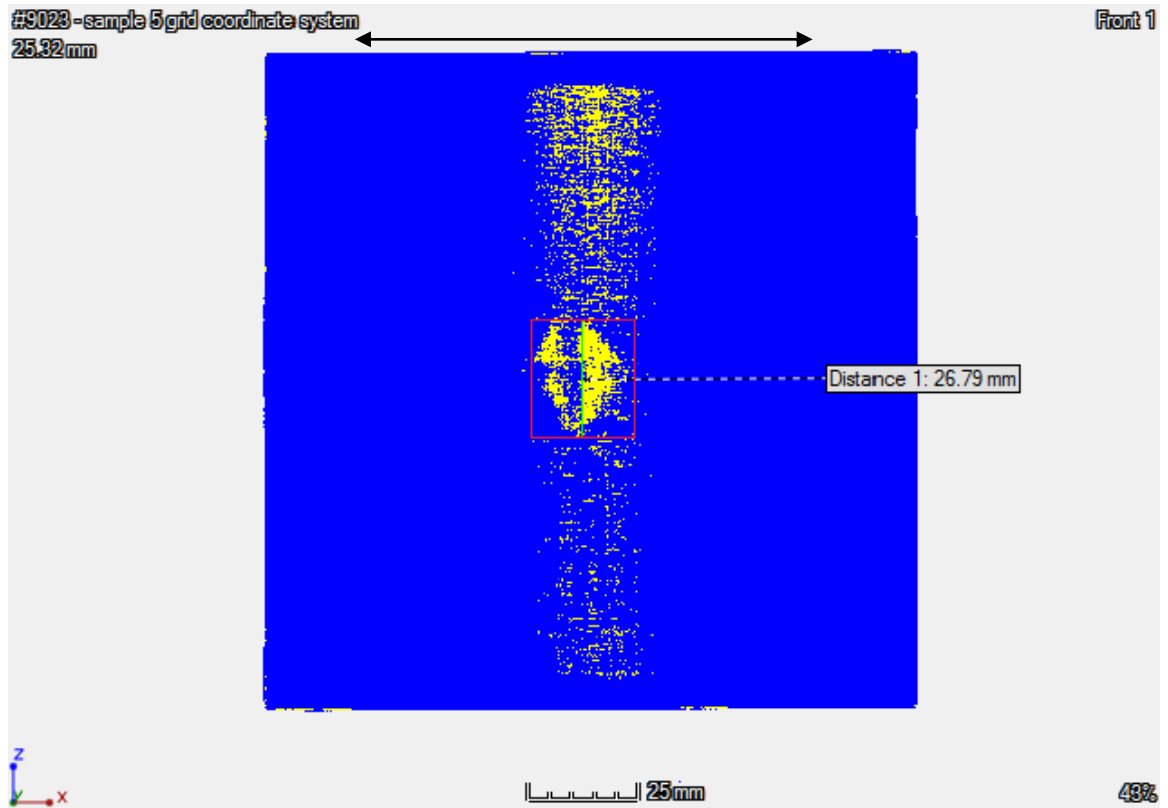
Specimen 5, as with specimens 3 and 4, had been impacted at an energy of 20.77 J. The CT scan for specimen 5 also had a resolution of 0.1802 mm/px and produced a stack of 31 images through the thickness of the plate. From these images it was determined that the scan had an unadjusted plate depth of 5.05 mm. The maximum damage length was found to be 26.79 mm, occurring at a depth of 2.49 mm (relative depth of 2.70 mm). This can be seen in Figure 4.17. From image processing it was found that the maximum internal damaged area occurred at a depth of 2.32 mm (relative depth of 2.52 mm) from the impacted surface. The maximum damaged area was measured to be 887.8 mm² and is shown in Figure 4.18. The black arrow above the figures indicates the global 0° fiber orientation, and the damaged area is boxed in both figures. From the damaged area for this slice, the maximum damaged volume per slice was 160.0 mm³, which was approximately 0.434 % of the total volume.

Figure 4.17: Length of Largest Internal Damage for Specimen 5 (Depth of 2.49 mm)

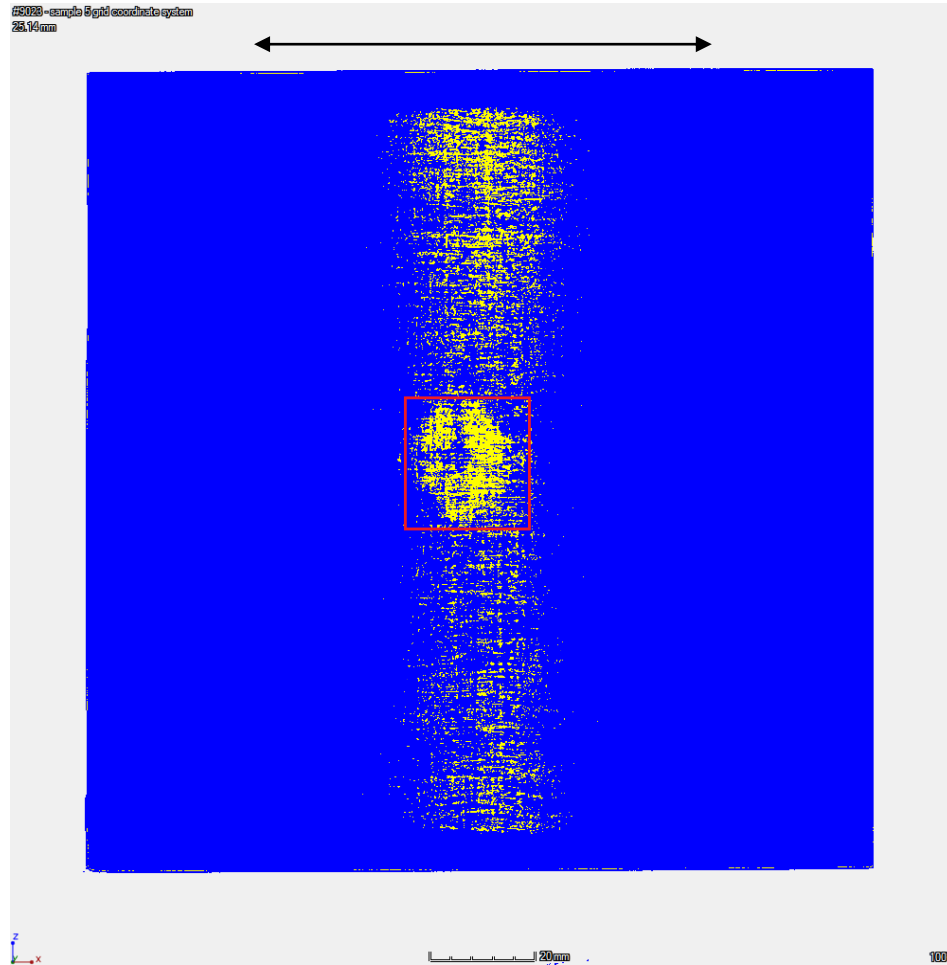
Figure 4.18: Segment with Largest Damaged Area for Specimen 5 (Depth of 2.32 mm)

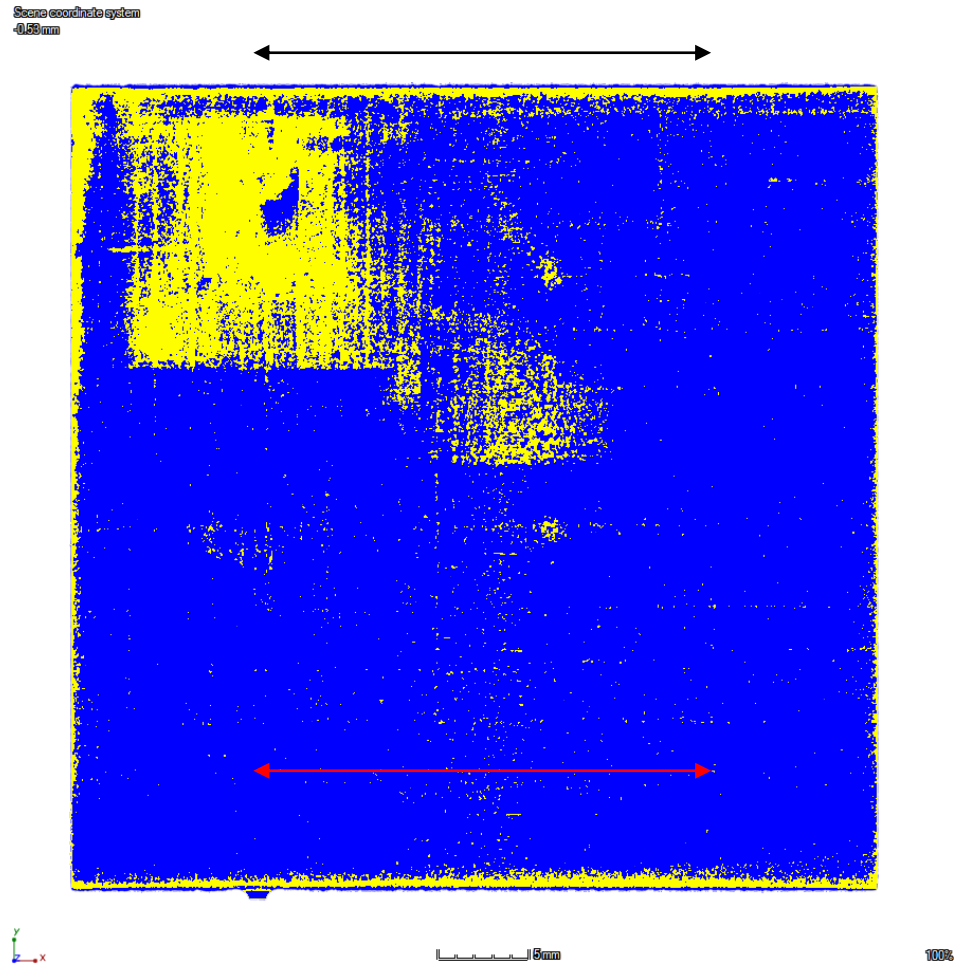
be 28.60 mm at a depth of 3.74 mm (3.94 mm relative depth, within the 28th ply). From image processing of the cut plate, it was found that the maximum internal damaged area occurred at a depth of 3.02 mm (3.24 mm relative depth, within the 29th ply) from the impacted surface and was measured to be 289.31 mm², shown in Figure 4.19. This occurred at the interface between the 24th and 25th plies from the top surface. In this figure, the black arrow above the plate indicates the global 0° fiber direction. As this slice occurred at a ply interface, the red arrow indicates the fiber orientation of the lower ply. From the damaged area for this slice, the maximum damaged volume per slice was 17.01 mm³. The total damaged volume for cut specimen 5 was found to be 1141.1 mm³, which was approximately 0.206 % of the total volume of the original plate. For this specimen, the cutting process induced additional delamination in the upper left corner as seen in Figure 4.19.

Figure 4.19: Segment with Largest Damaged Area for Cut Specimen 5 (Depth of 3.02 mm, Between Plies 24 and 25)

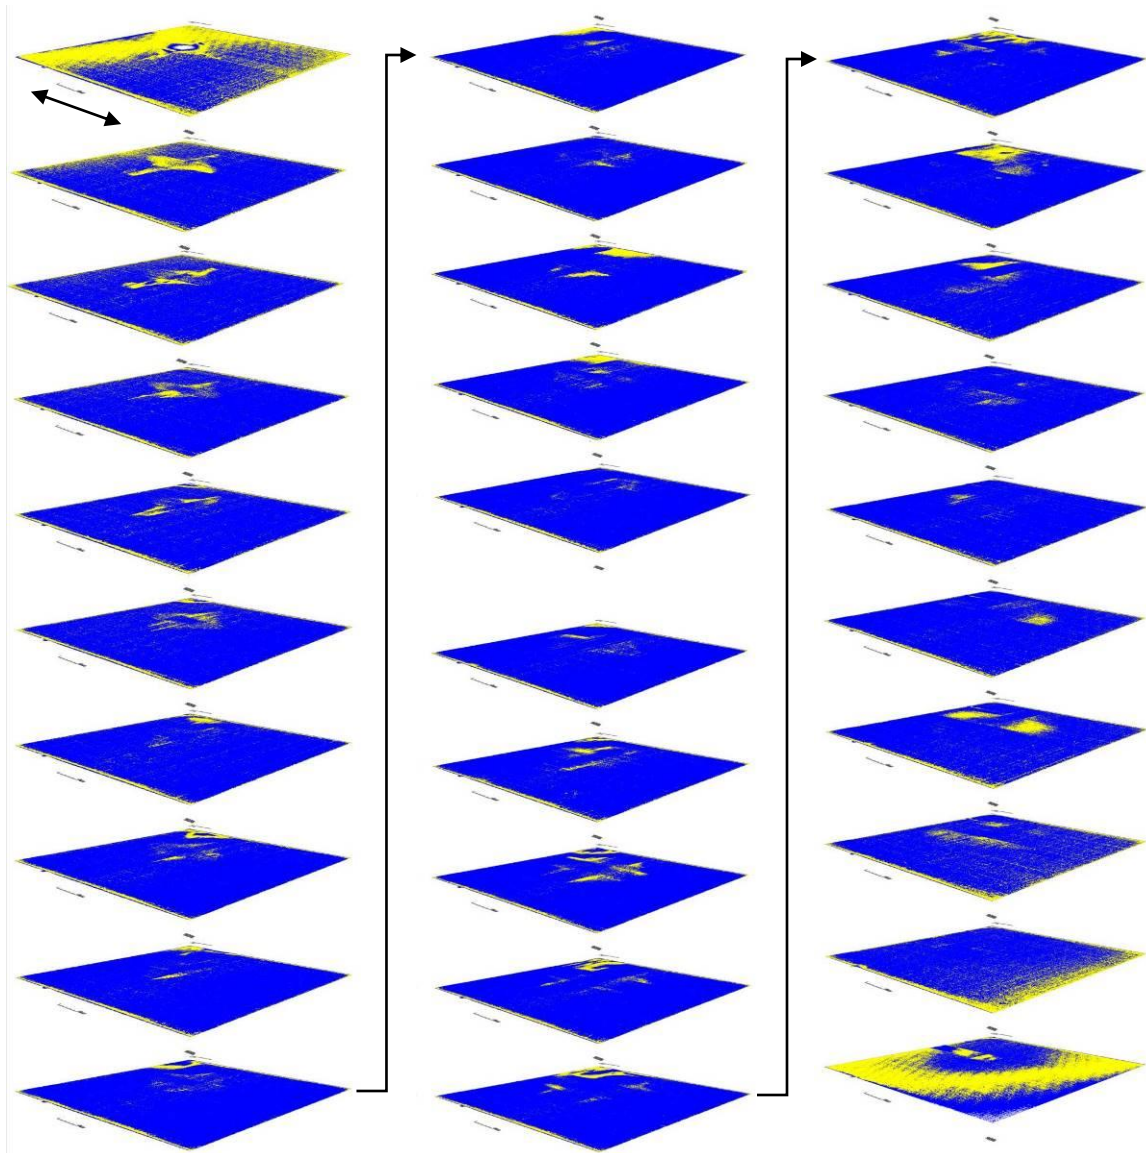
Figure 4.22: Ply Interfaces from Specimen 5

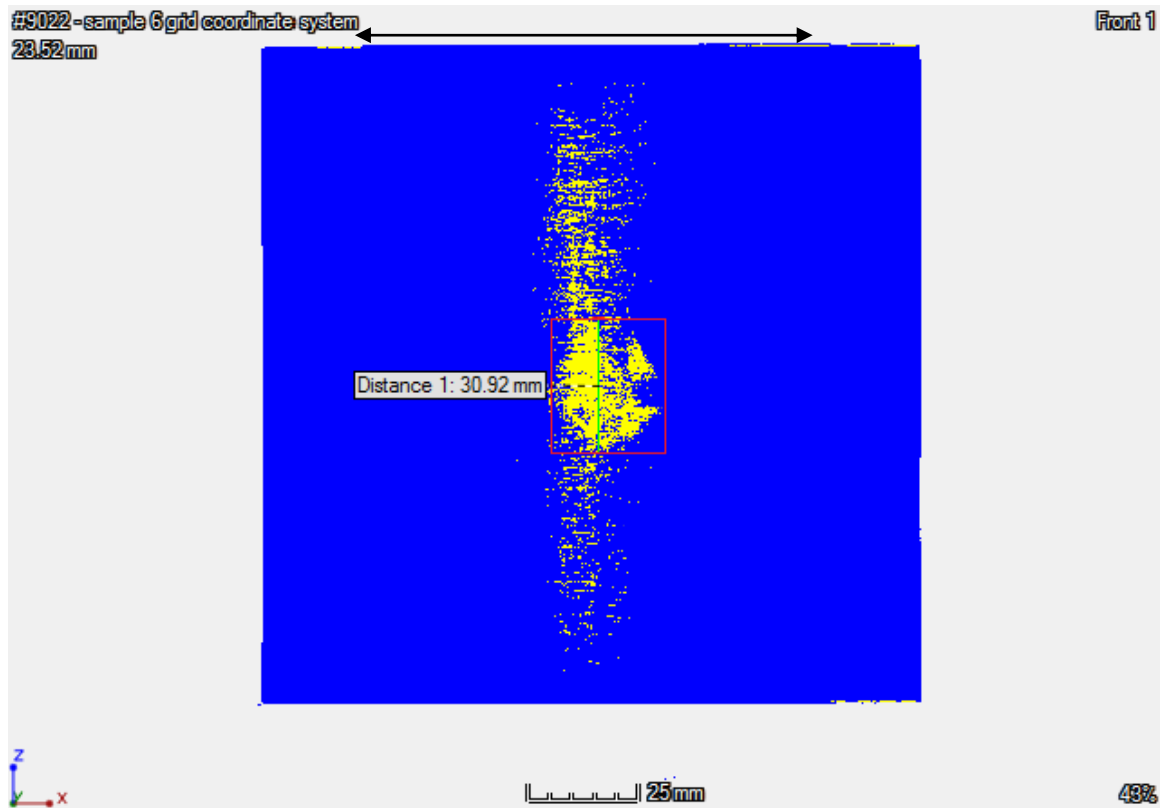
Figure 4.23: Length of Largest Internal Damage for Specimen 6 (Depth of 2.17 mm)

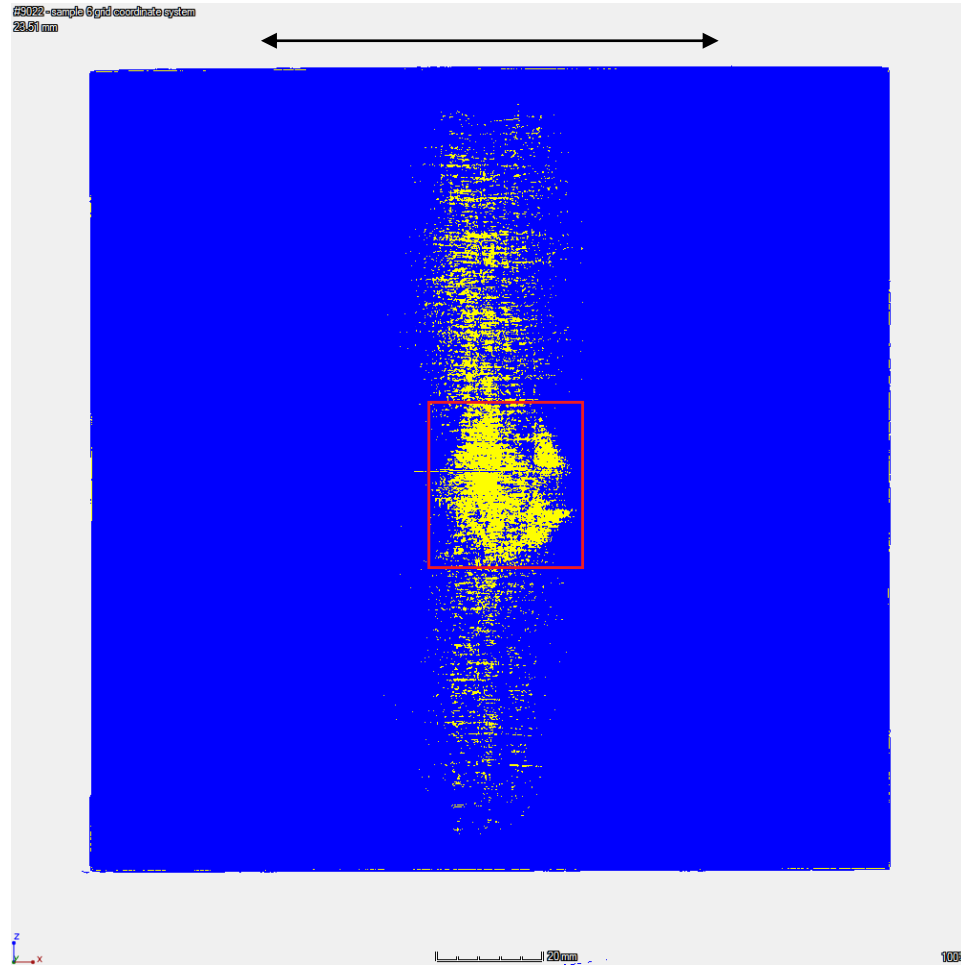
Figure 4.24: Segment with Largest Damaged Area for Specimen 6 (Depth of 2.17 mm)

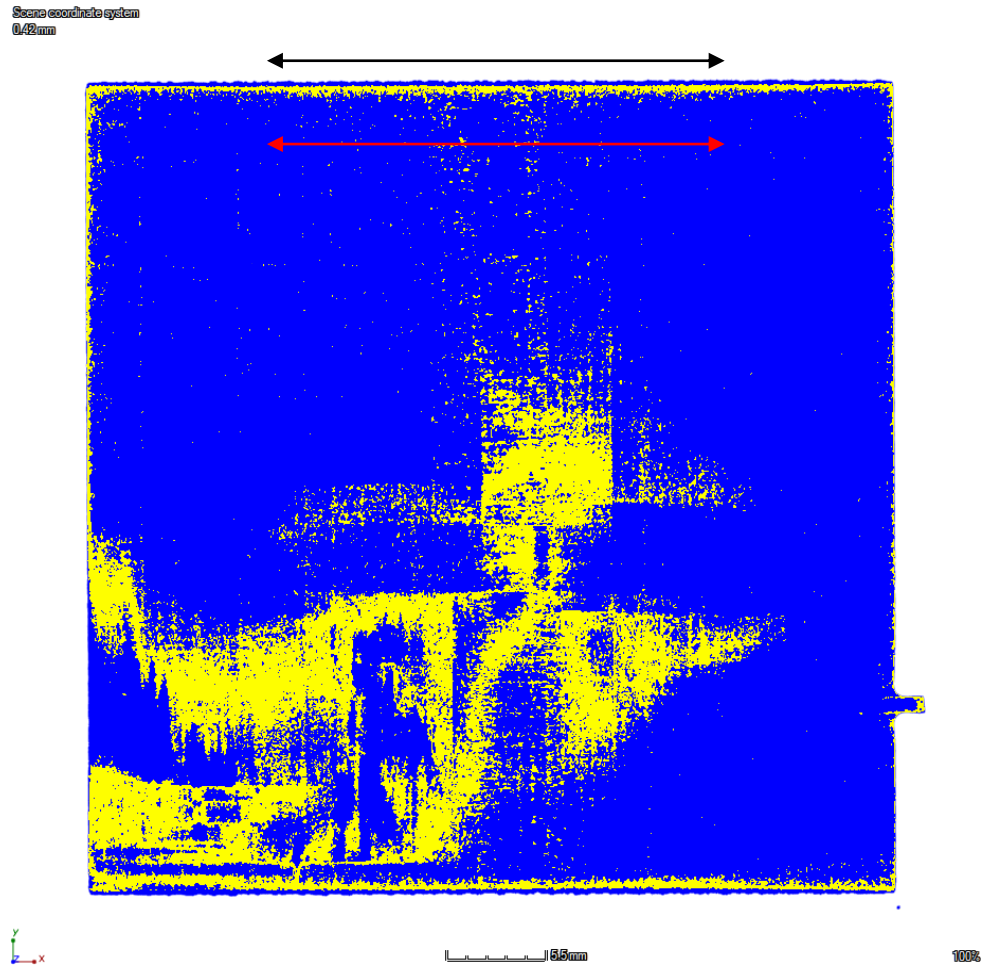
Figure 4.25: Segment with Largest Damaged Area for Cut Specimen 6 (Depth of 1.76 mm, Between Plies 14 and 15)

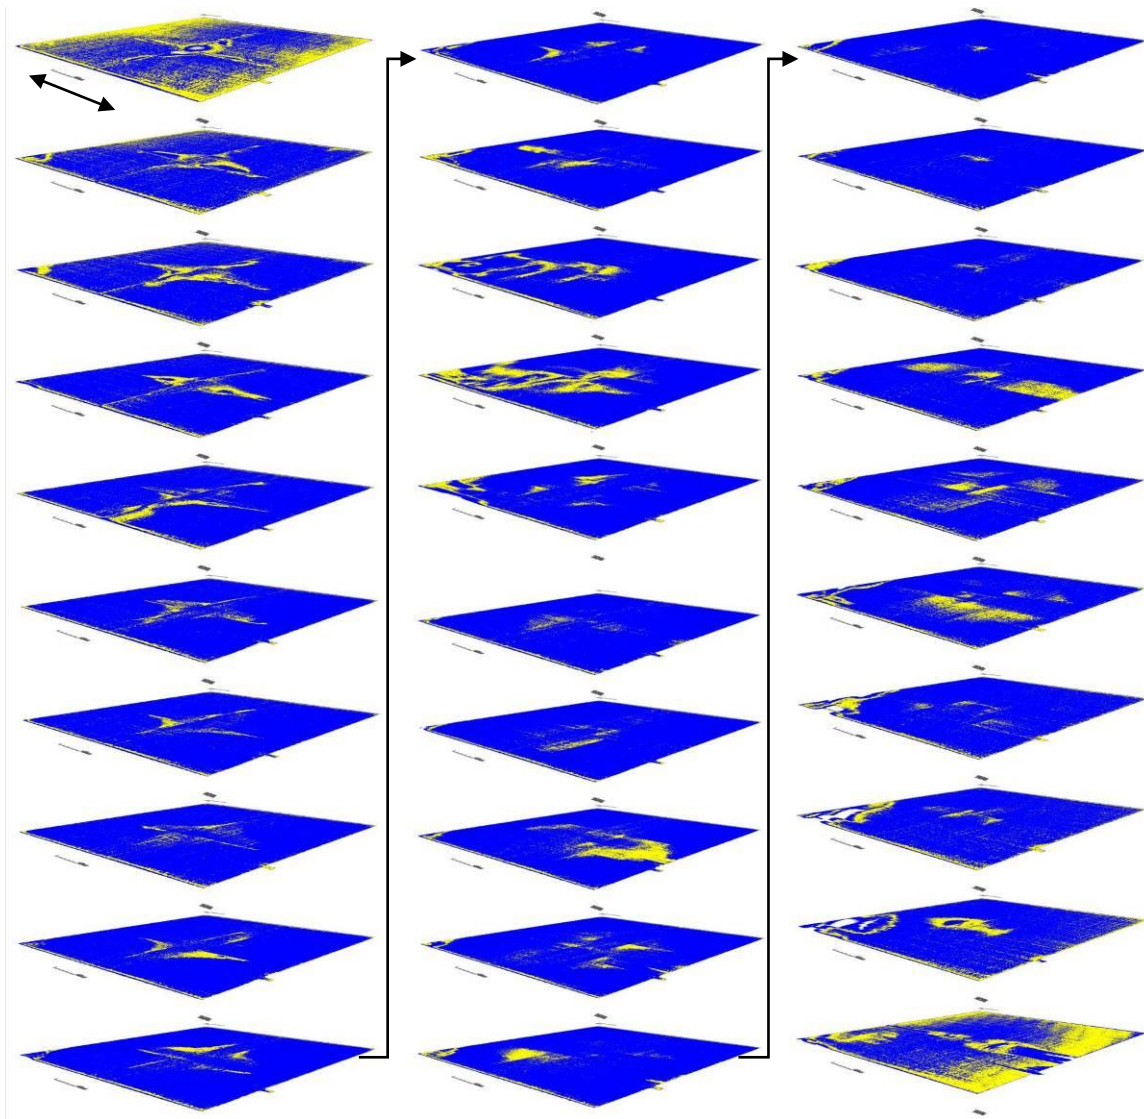
induced by the impact. The middle and lower plies have less coordinated damaged zones produced by delamination, and these regions generally extend in the direction of the lower ply fiber orientation.

Figure 4.28: Ply Interfaces from Specimen 6

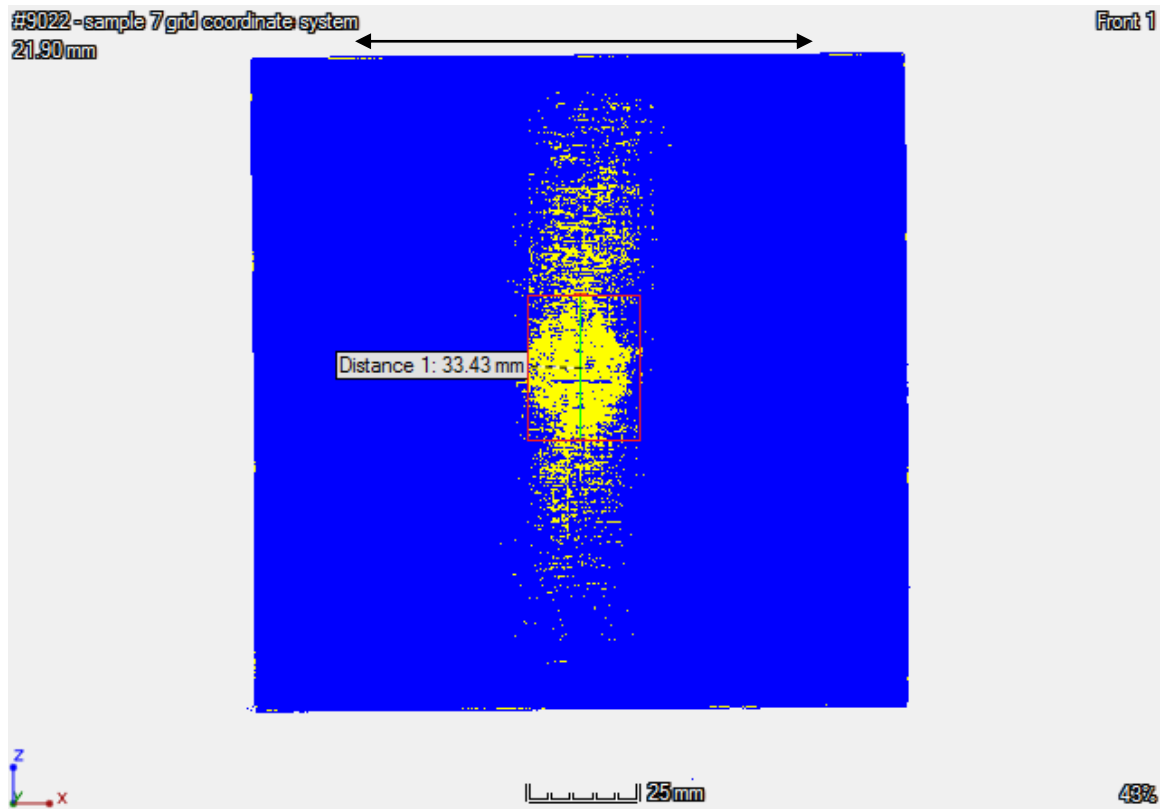
Figure 4.29: Length of Largest Internal Damage for Specimen 7 (Depth of 2.17 mm)

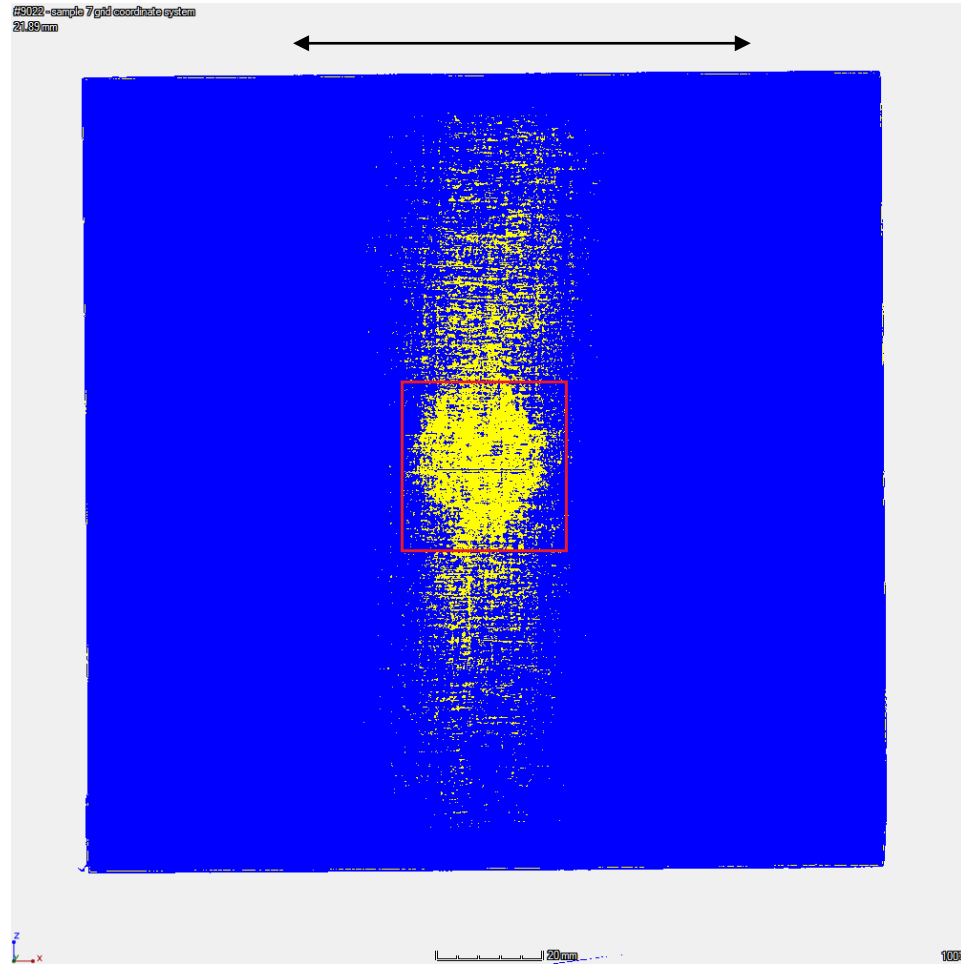
Figure 4.30: Segment with Largest Damaged Area for Specimen 7 (Depth of 2.17 mm)

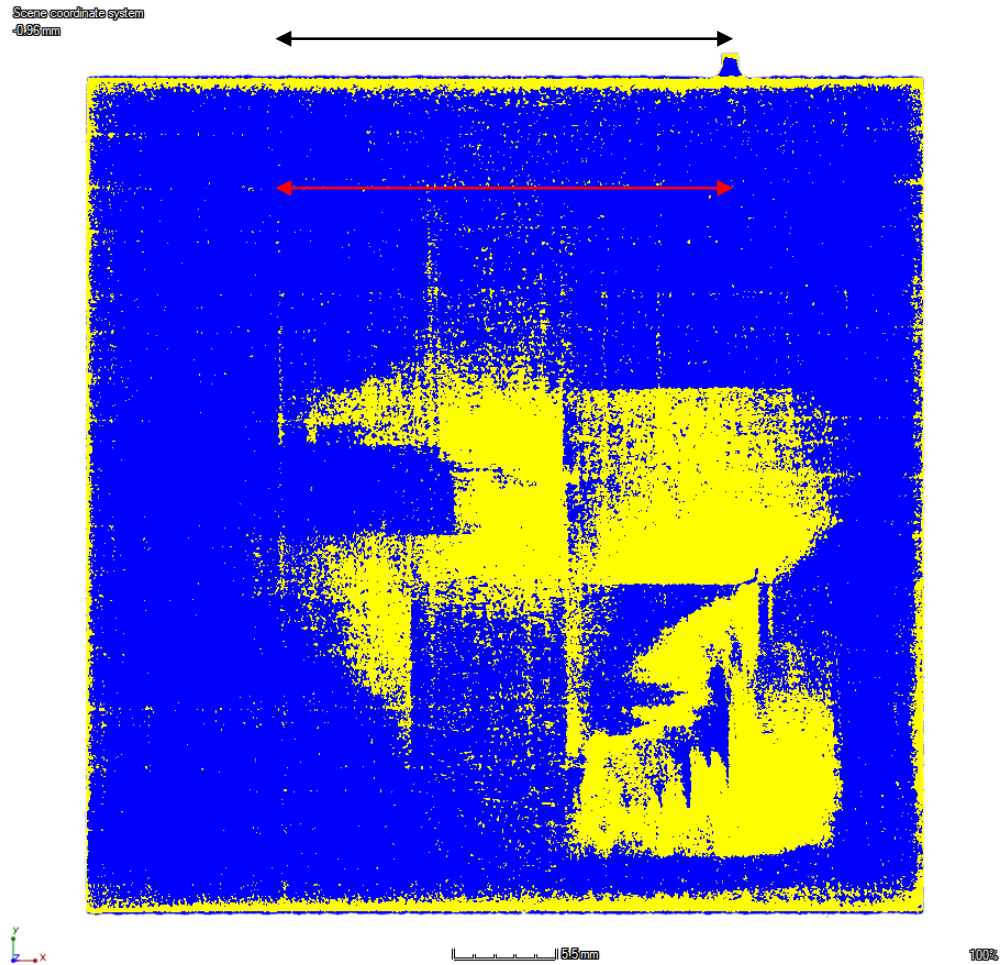
Figure 4.31: Segment with Largest Damaged Area for Cut Specimen 7 (Depth of 3.01 mm, Between Plies 23 and 24)
