Low velocity impact damage assessment in IM7/977-3 cross-ply composites using 3D computed tomography

A thesis submitted in partial fulfillment
of the requirements for the Master of
Science degree in Mechanical Engineering
in the Graduate College of
The University of Iowa

Thesis Supervisor: Associate Professor Olesya I. Zhupanska

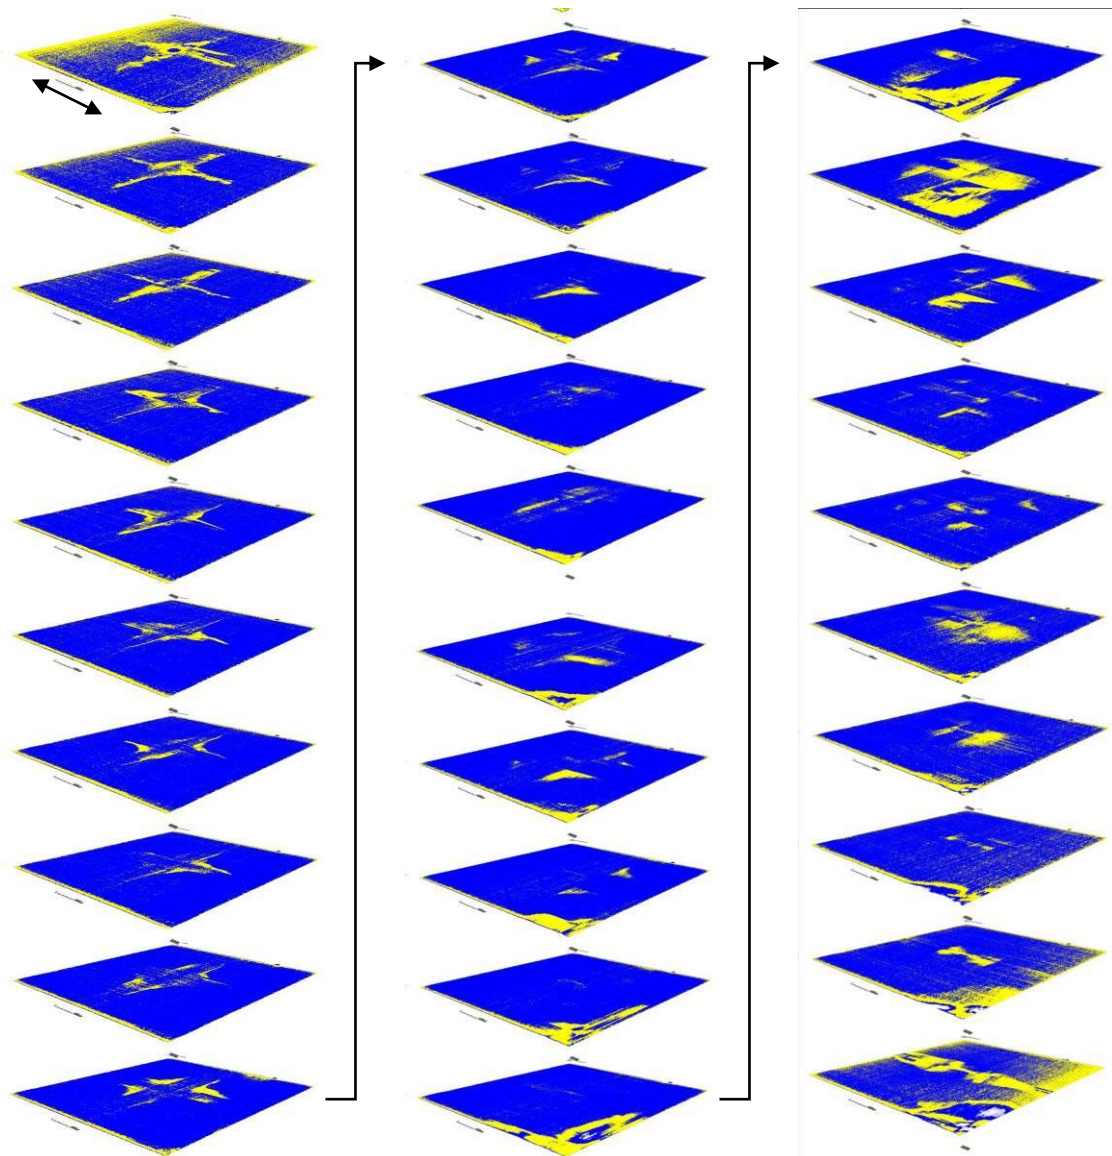
Figure 4.34: Ply Interfaces from Specimen 7

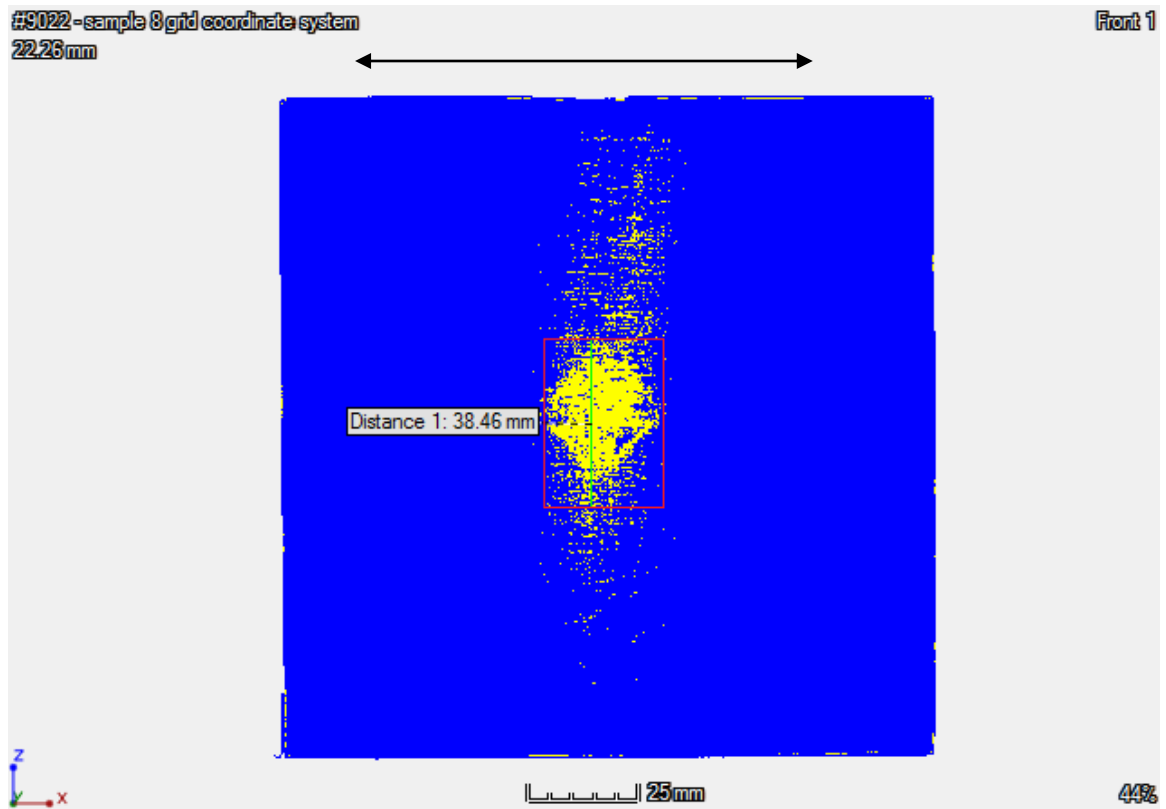
Figure 4.35: Length of Largest Internal Damage for Specimen 8 (Depth of 2.32 mm)

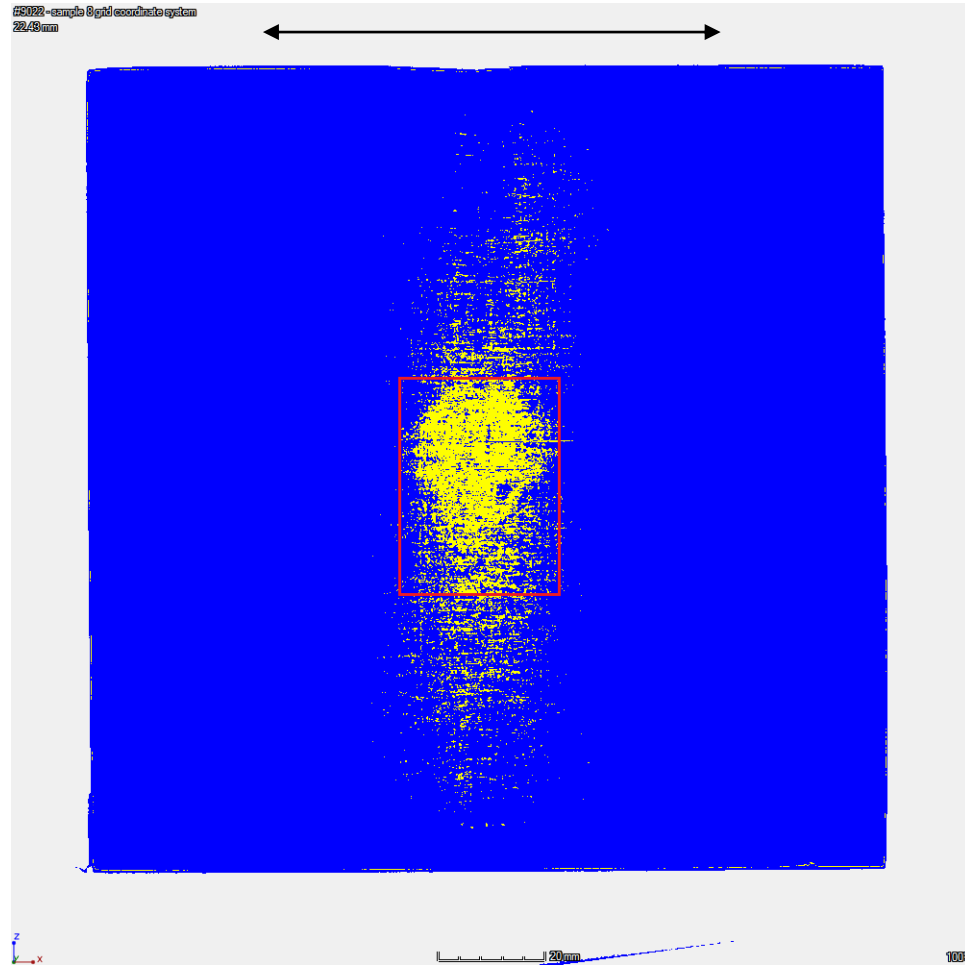
Figure 4.36: Segment with Largest Damaged Area for Specimen 8 (Depth of 2.55 mm)

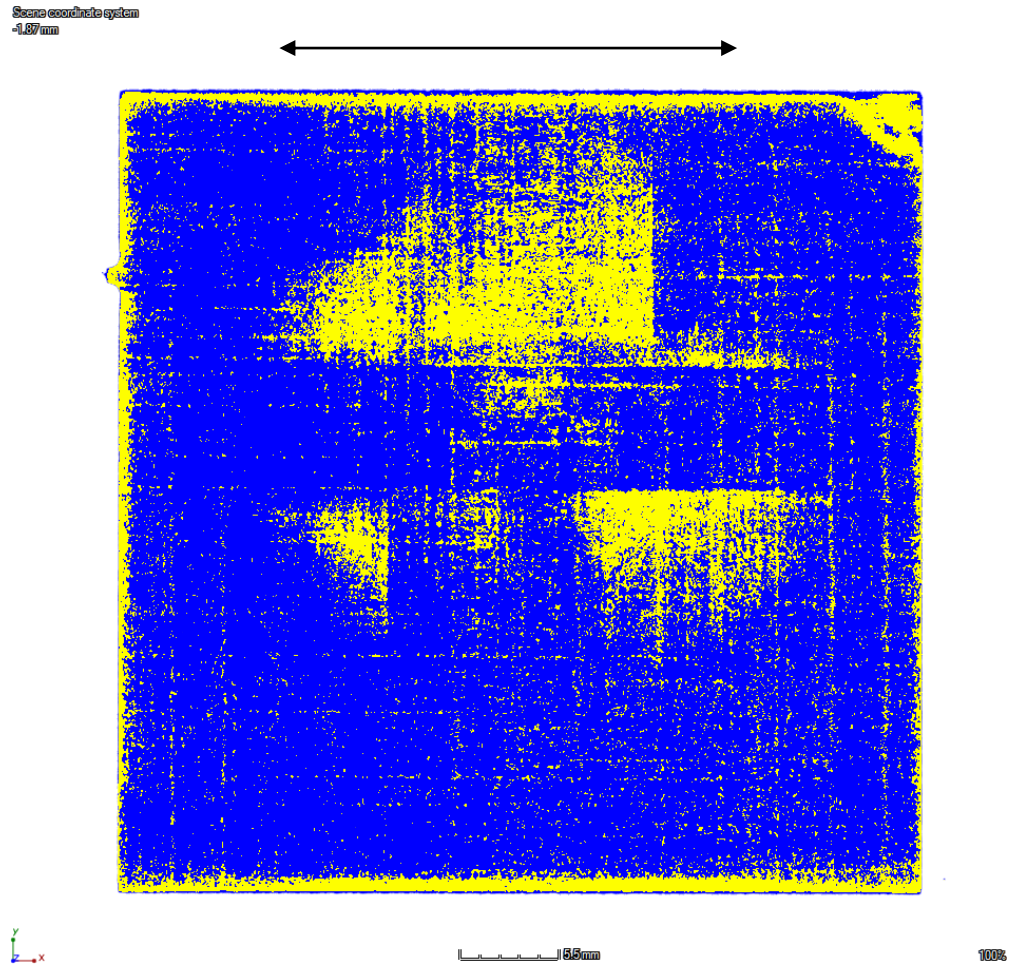
Figure 4.37: Segment with Largest Damaged Area for Cut Specimen 8 (Depth of 3.57 mm)

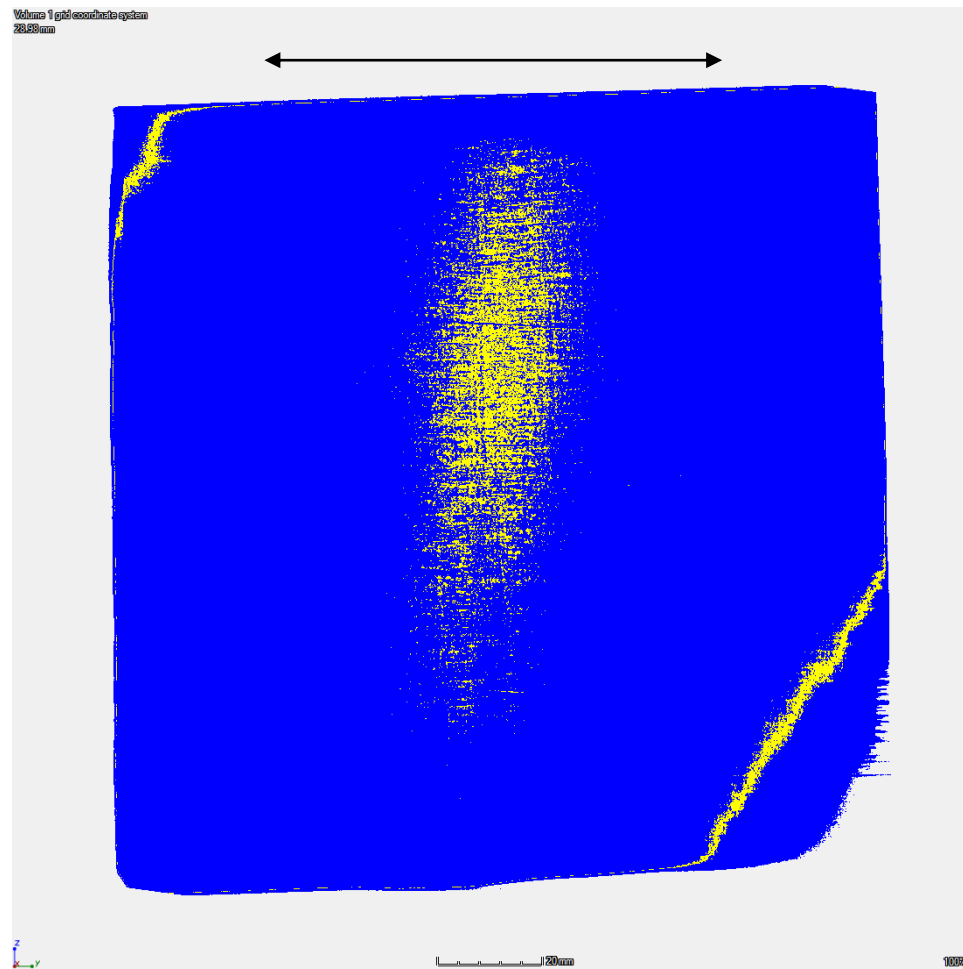
Figure 4.38: Internal Segment from Specimen 9 (Depth of 4.17 mm)

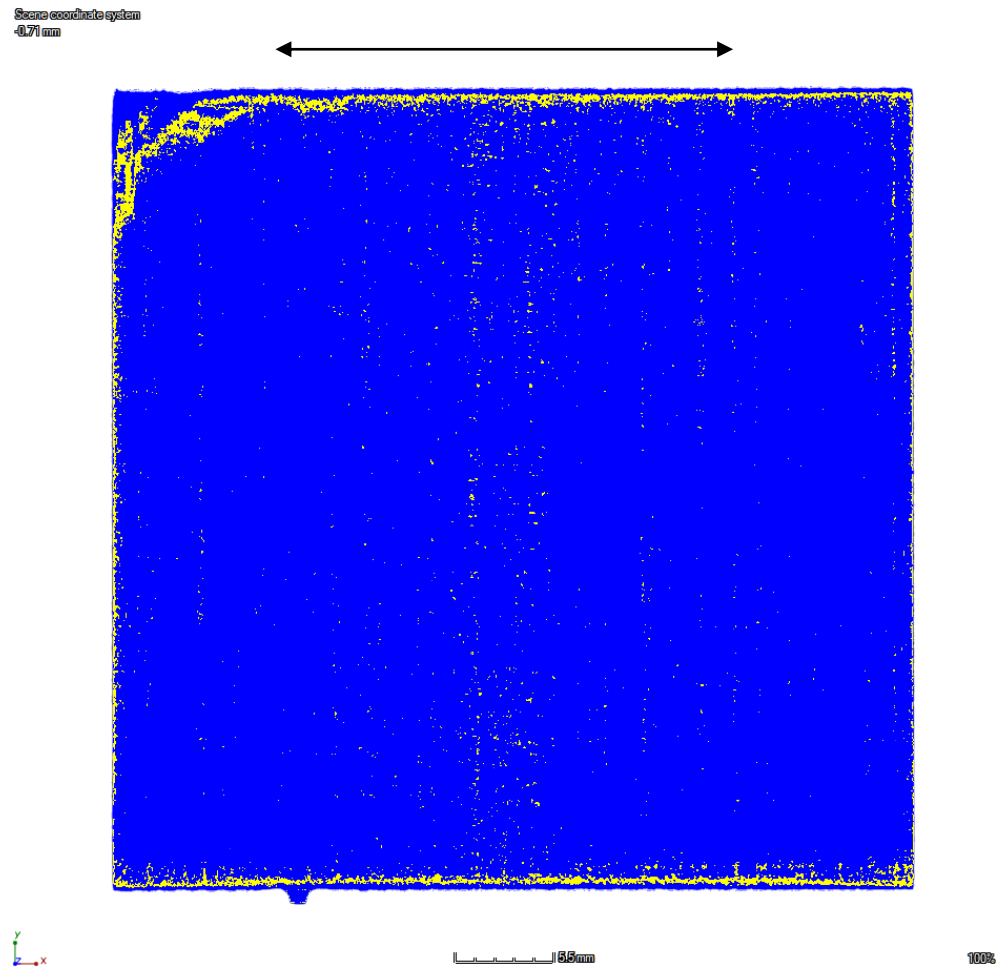
Figure 4.39: Internal Segment from Cut Specimen 9

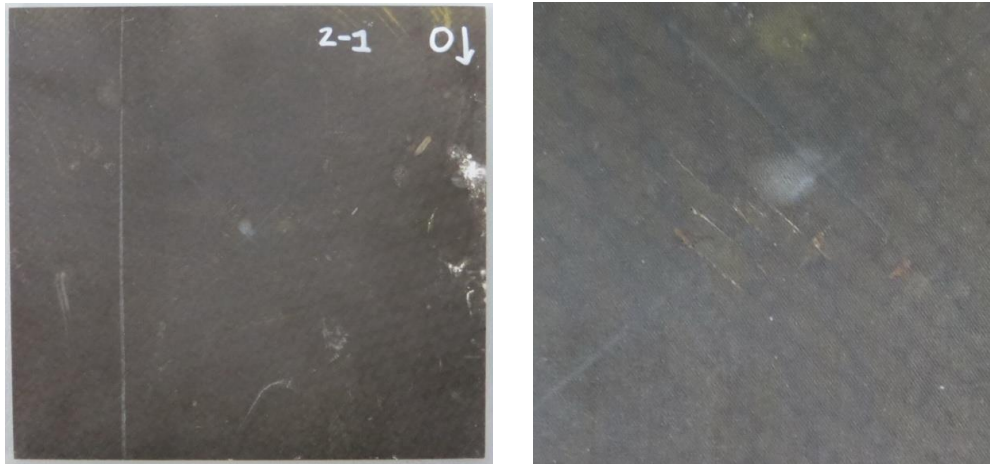
Figure 4.50: Front (Left) and Back (Right) Damage to Specimen 2-1, Impacted at 16 J (Song 2014)

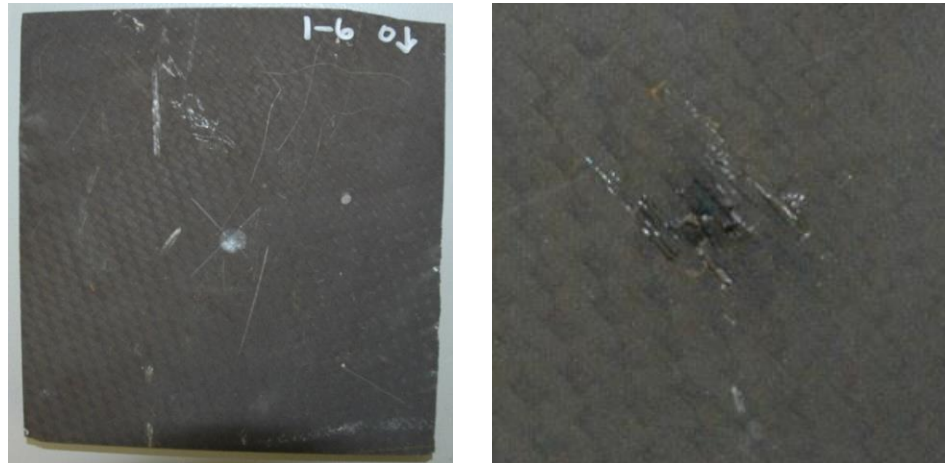
Figure 4.51: Front (Left) and Back (Right) Damage to Specimen 1-6, Impacted at 22.5 J (Song 2014)

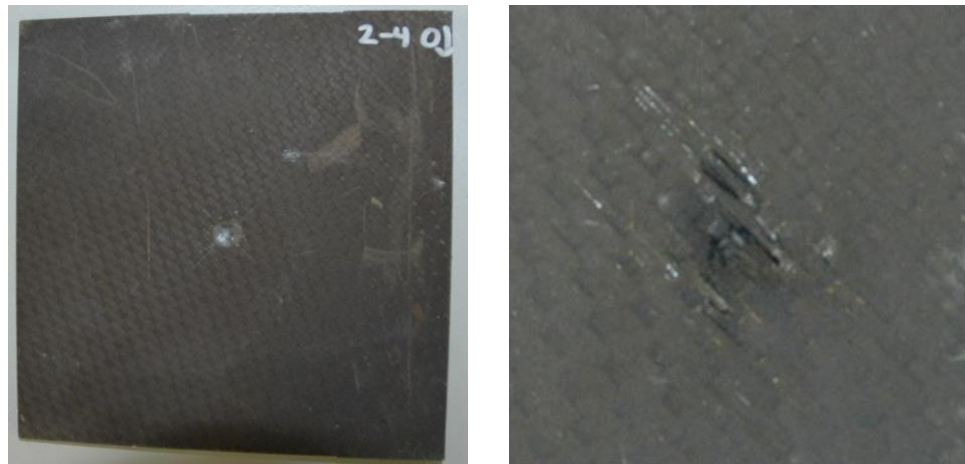
Figure 4.52: Front (Left) and Back (Right) Damage to Specimen 2-4, Impacted at 26 J (Song 2014)

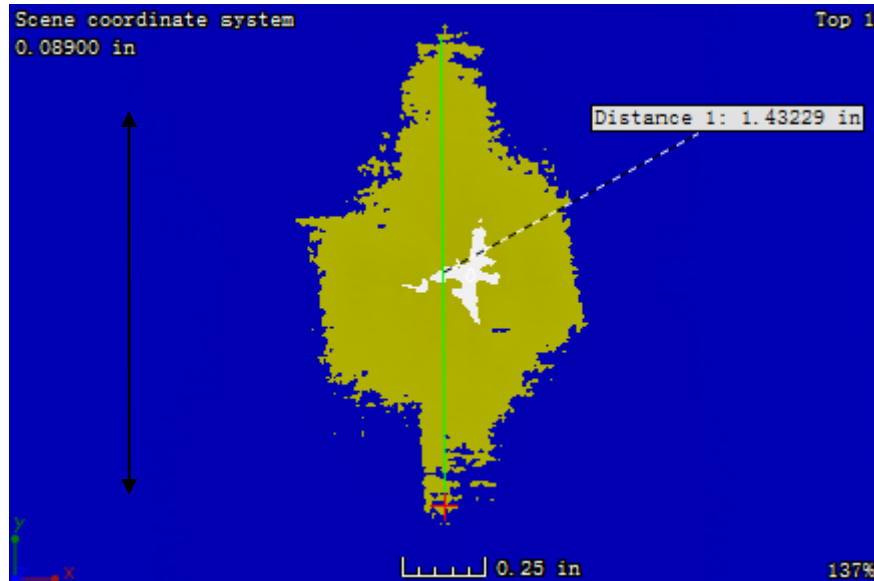
Figure 4.53: Length of Largest Internal Damage Measured by Song for Specimen 1-6 (Depth of 2.22 mm) (Song 2014)

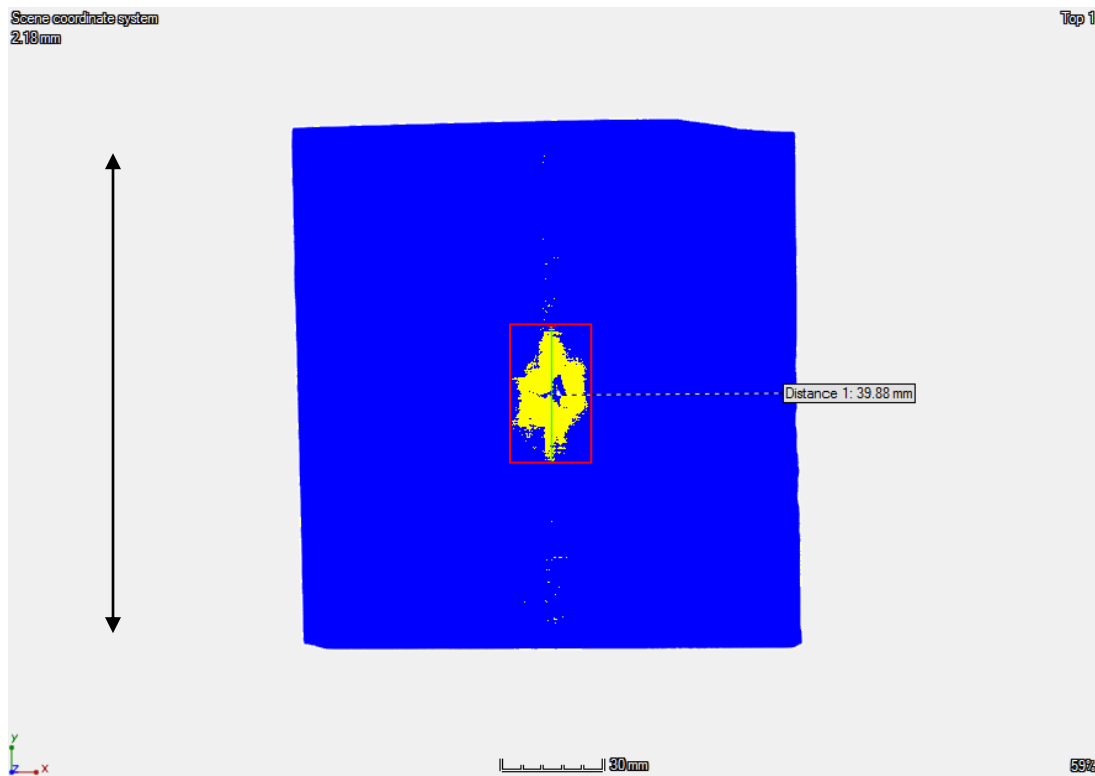
Figure 4.54: Length of Largest Internal Damage for Specimen 1-6 (Depth of 2.64 mm)
