# Nondestructive evaluation of a carbon fiber wing spar using air-coupled ultrasound

Adam Howard Kite  
*Iowa State University*

A thesis submitted to the graduate faculty  
in partial fulfillment of the requirements for the degree of  
MASTER OF SCIENCE

Major: Aerospace Engineering

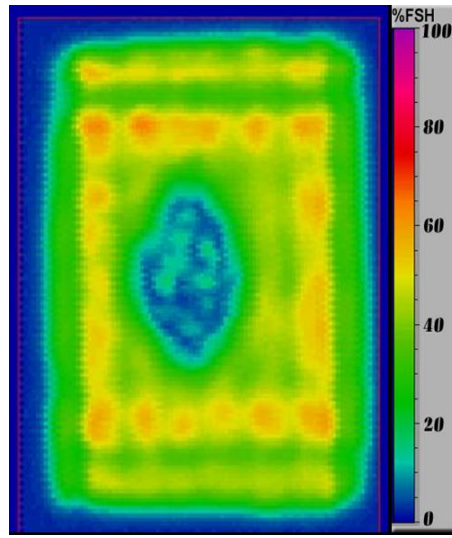
The amplitude C-scan made with the 120 kHz transducers depicted the impact damaged area as a low intensity region as shown in Fig. 5.2, meaning the damage was attenuating the ultrasound passing through the test panel. The amplitude C-scan colors represent the intensity of the sound reaching the receiver. The cause of the high amplitude square box that surrounds the impact damage is unknown. The scan results using 400 kHz transducers, Fig. 5.3, depicted the impact damaged area as a low intensity region as well.

Figure 5.2 The 4.5" by 6.5", 120 kHz scan image of the A-20 impact panel.

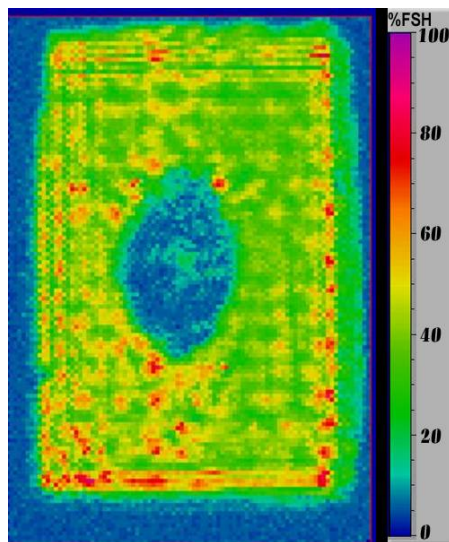
Figure 5.3 The 4.5" by 6.5", 400 kHz scan image of the A-20 impact panel.

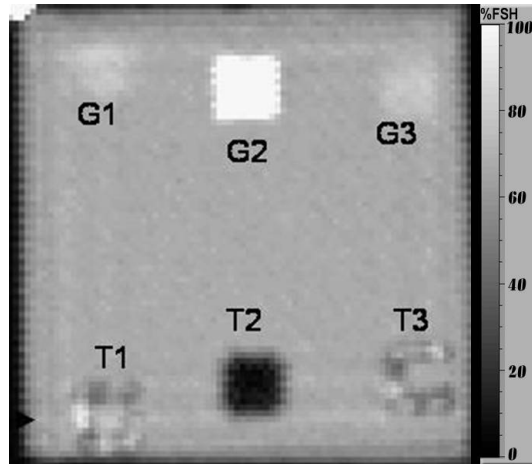
The images produced with both the 120 kHz and the 400 kHz frequencies were very similar. They both show the Grafoil inserts as higher intensity regions than the Teflon inserts. The 400 kHz scan does show more detail of the ply orientation or weave of the fabric as seen in Fig. 5.6. This is common when using a higher frequency since the shorter wave length increases the spatial resolution of the scan.

Figure 5.5 8.0" by 8.0" amplitude C-scan image from QMI 120 kHz transducers showing Grafoil(G) and Teflon(T) one inch square embedded defects.

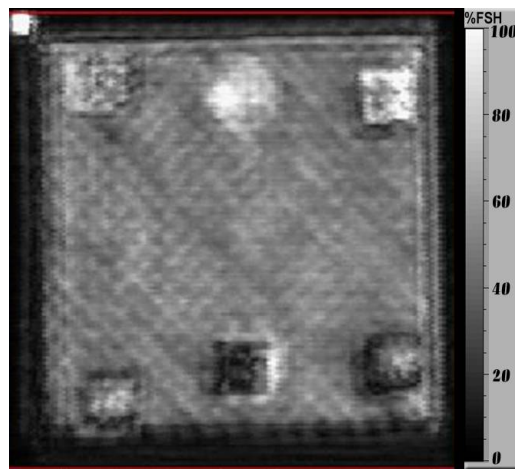
Figure 5.6 Amplitude C-scan image of GT panel with 400 kHz transducers.

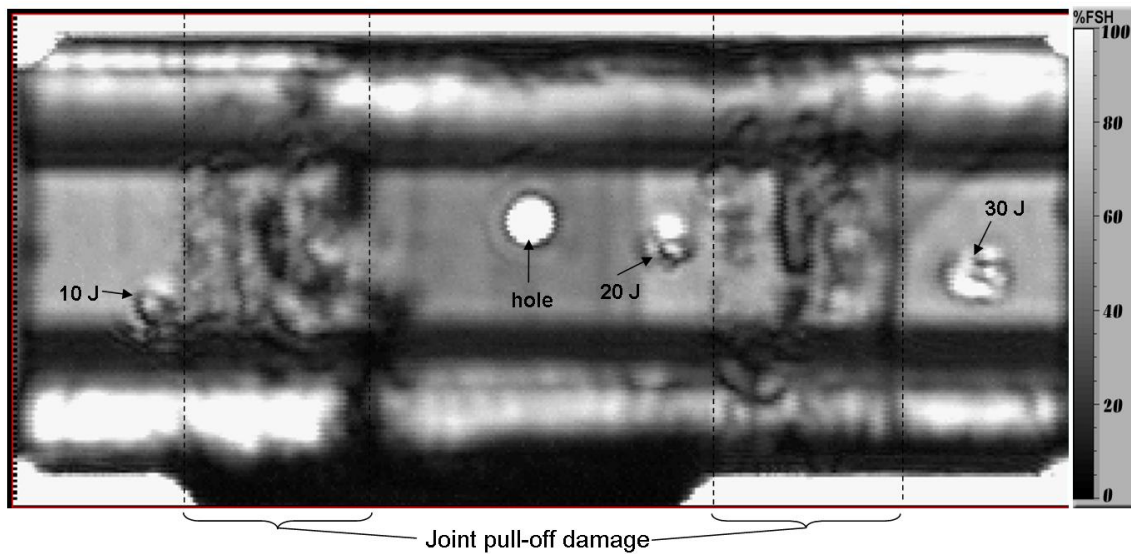
The SONIX scanning system was utilized with the QMI system to make the first air UT images of the web area as shown in Fig. 5.14. The image produced showed the three impact damages and some of the damage caused by the joint pull-off testing. Interestingly, these defects again appeared as an area of higher transmission, note Fig. 5.15. This is similar to the results on the Grafoil inserts described previously in section 5.2.

Figure 5.15 The 18" x 8.5" amplitude C-scan image produced from the web of CS1 with the QMI 120 kHz focused transducers.

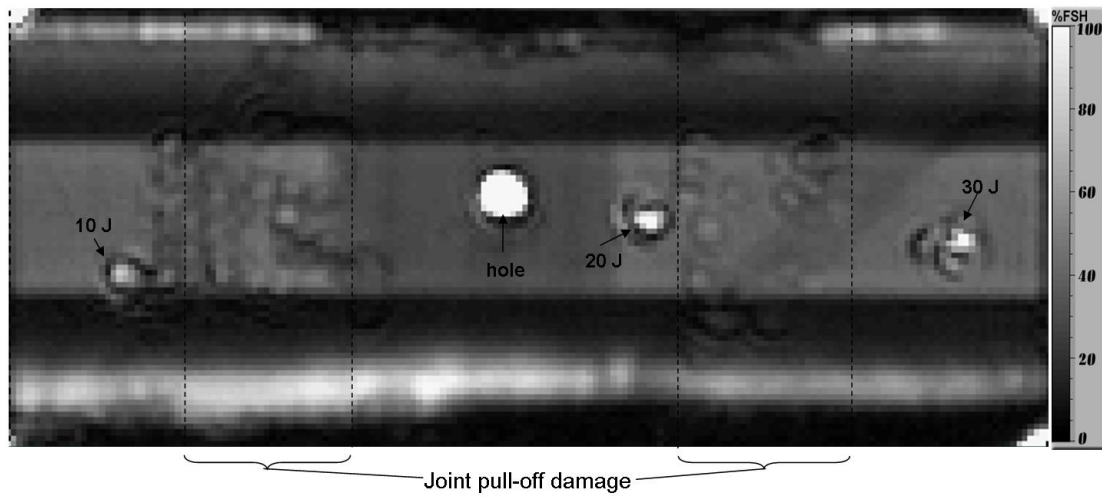
After the preliminary scans of CS1 in the condition received were complete, the loose layers in the pull-off damage region were cleaned up to reduce their effects on the C-scan images. The central portion of the web surrounding the hole was virtually undamaged, but in both directions extending toward the ends of the spar, there was considerable damage in the web as many plies were pulled away as a result of the joint testing performed by Cirrus. The inside web surface of the spar was sanded extensively to remove the damage caused by the destructive joint testing. After the clean up process the spar was scanned again using the same setup as before shown in Fig. 5.14 . This setup was used to create the C-scan images for 120 kHz (Fig. 5.16), 225 kHz (Fig. 5.17), and 400 kHz (Fig. 5.18). Note that the pull-off damage is less visible in Fig. 5.16. Figure 5.18 depicts the impact damage areas in the thin web as a lower intensity region but the overall lower amplitude appearance of the C-scan indicates that the 400 kHz transducers are too high of a frequency for good penetration of the CS1 spar. The flat web surface of the spar is relatively easy to scan except for the ply-drop off area. This area presents a challenge due to the angled geometry.

Figure 5.16 The 18" x 8.5" C-scan of CS1 after the web cleaning using the QMI 120 kHz focused transducers.

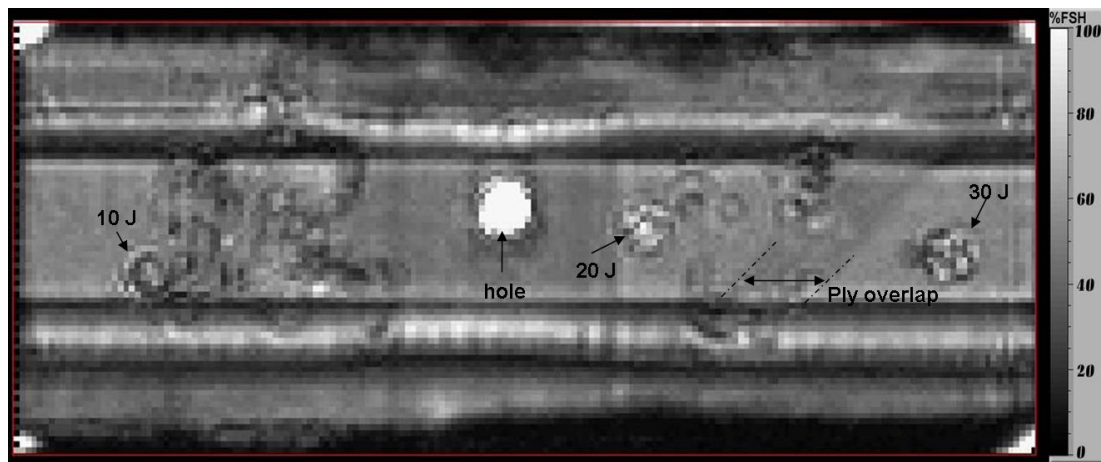
Figure 5.17 The 18" x 8.5" C-scan of CS1 after cleaning using the QMI 225 kHz focused transducers.

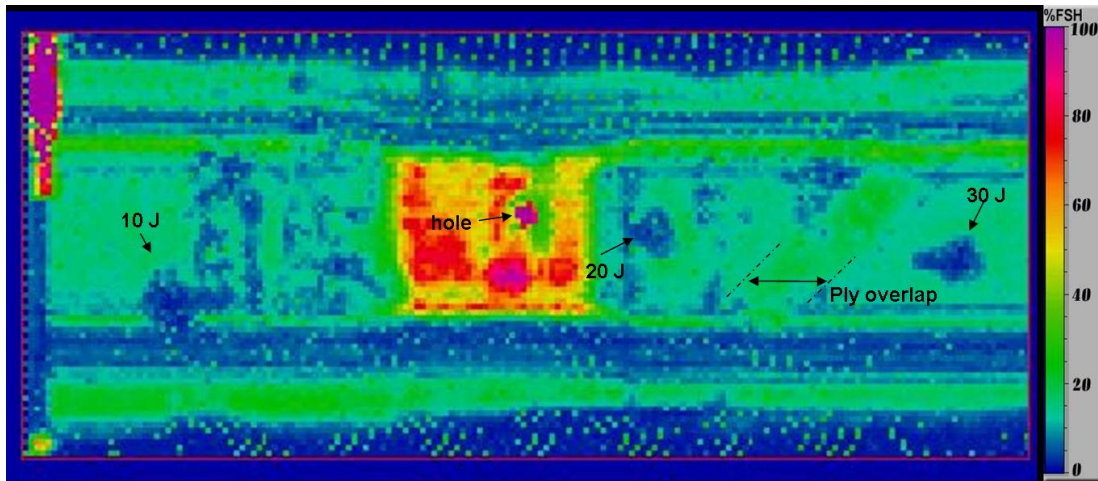
Figure 5.18 The 18" x 8.5" C-scan of CS1 after cleaning using the QMI 400 kHz focused transducers. The high amplitude central portion could be a result of resonance.

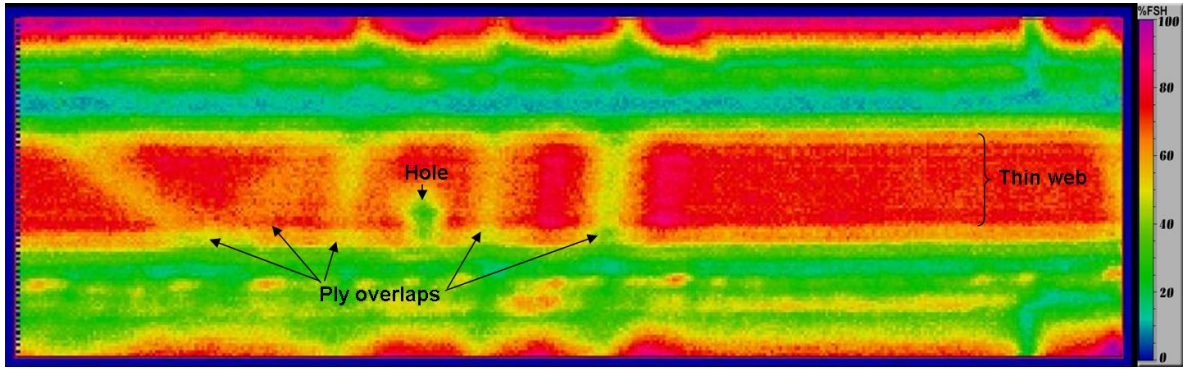
Figure 5.19 is an amplitude C-scan of the undamaged CS2 spar section. The green spot in the center of the web is a hole plugged with foam. The web is much more uniform than the CS1 sample that had ply pull-off damage. The edge effects along the axial edges seem to be a reflection disturbance as the transducers approach the cap. This scan was made with the 200 kHz Ultrason GMP transducers powered with the 5058 Panametrics pulser-receiver. Notice that this sample is quite uniform which is good for detecting induced impacts. Some ply overlaps are also visible in the C-scan.

Figure 5.19 The 18" by 5.5" C-scan image of the undamaged CS2 carbon spar. Notice all of the ply overlaps in the thin web.

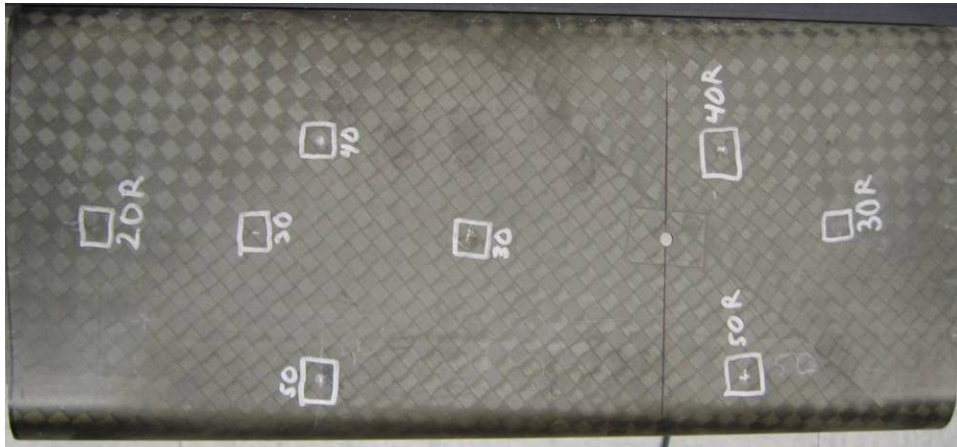
Once the preliminary scans were produced, CS2 was damaged by the same method as CS1. The impactor was dropped in a transparent acrylic tube with distance graduations and the rebound of the impactor was recorded with video equipment. The rebound height of the impactor was obtained from video footage and used to more accurately measure the amount of energy induced into the spar. The information on each impact site is shown in Table 5.1. All impacts were done in the supported state except for the 30U impact. The impacts labeled with R had their rebound height documented by video. The location of each impact is listed as being in either the thin web(Tnweb), thick web(Tkweb), or the ply drop-off(PDO). The drop(D) and rebound(R) heights and energies are listed.

Figure 5.20 The impact damaged CS2 carbon spar.

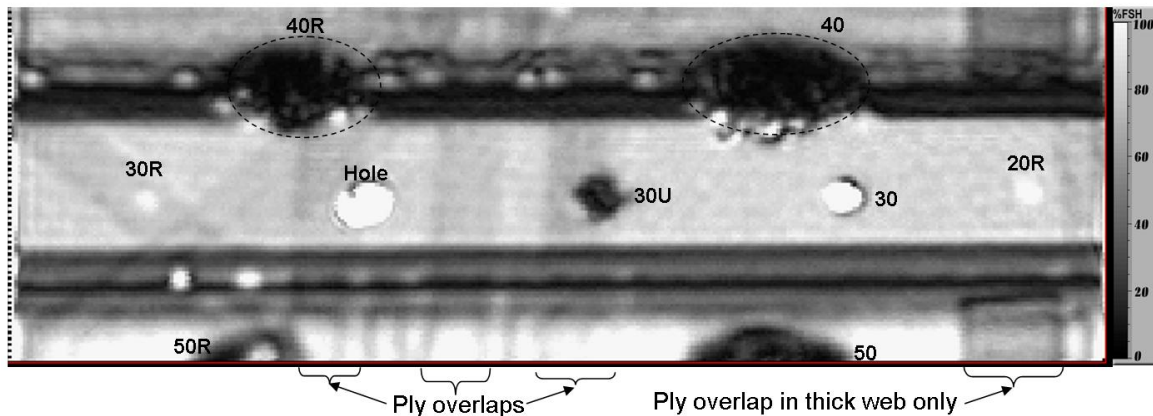
The damage layout can be seen in Fig. 5.20. After damage, amplitude C-scan images of the CS2 spar were produced with the QMI coupled with the SONIX automated scanner and the Epoch 4 coupled with the GenScan manual scan system. The QMI scans were produced at three different frequencies of 120, 225, and 400 kHz. The 120 kHz (Fig. 5.21) and the 225 kHz (Fig. 5.22) amplitude C-scans were very informative and easy to interpret. All eight of the impact damages were visible along with the ply overlaps in the thick and thin webs. These features are labeled in both figures for easy identification.

Figure 5.21 The 18" by 5.5" C-scan image of the damaged CS2 carbon spar with the QMI 120 kHz transducers.

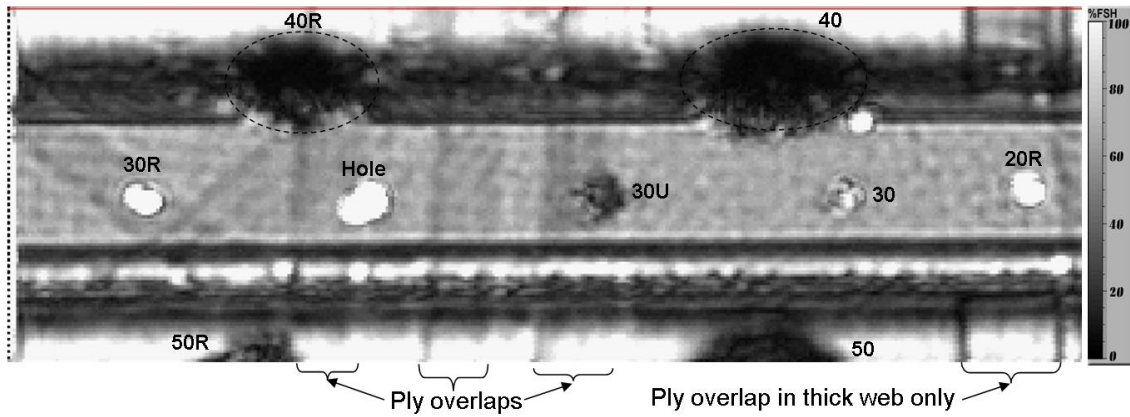
Figure 5.22 The 18" by 5.5" C-scan image of the damaged CS2 carbon spar with the QMI 225 kHz transducers.

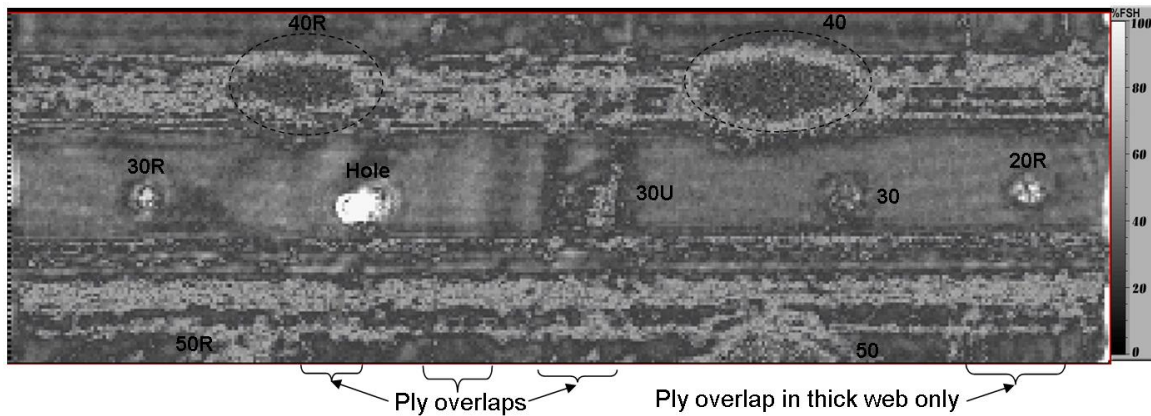
Figure 5.23 The 18" by 5.5" C-scan image of the damaged CS2 carbon spar with the QMI 400 kHz transducers.

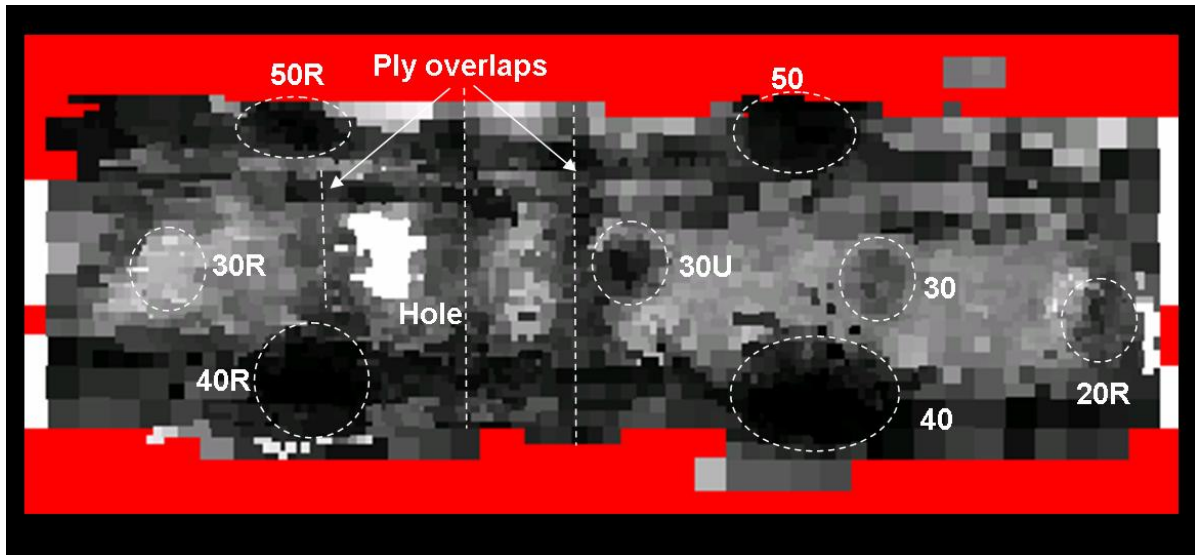
The C-scan in Fig. 5.25 from the 200 kHz GMP transducers shows many of the same features as the earlier scans. All of the impact damages are visible except for one in the thin web. Also seen are the damages in the ply drop-off and the thick web as well as the ply overlaps. The features have been labeled as before to help identify their location. The GenScan image is harder to interpret than the QMI C-scan images at this time. The GenScan is still under development and there are continuous advancements in the image quality that the GenScan is capable of producing.

Figure 5.25 The 18" by 5.5" C-scan image of the damaged CS2 carbon spar with the Epoch 4 and the 200 kHz Ultrason GMP transducers using the GenScan system.

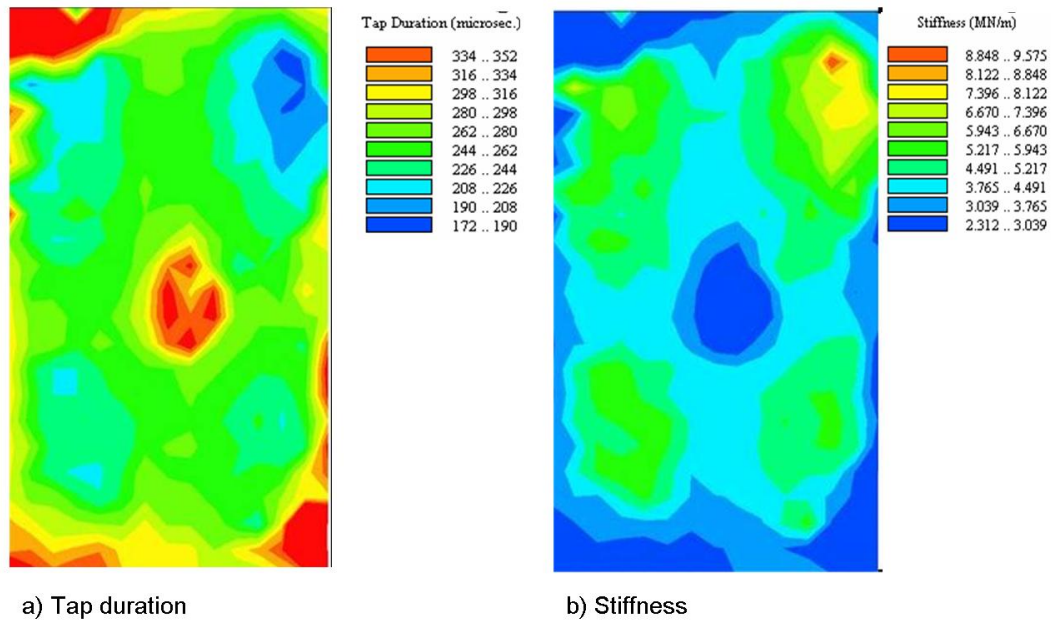
The computer aided tap tester was first applied to the A-20 impact panel. The data is collected using the supplied software with the CATT. The contact time and the stiffness are shown in Fig. 6.1. The damaged area in the center of each image is depicted as an area of longer contact time and lower stiffness. The tap duration or contact time are shown in microseconds and the stiffness in MegaNewton per meter.

Figure 6.1 CATT images of the A-20 panel with a) tap duration and b) stiffness.

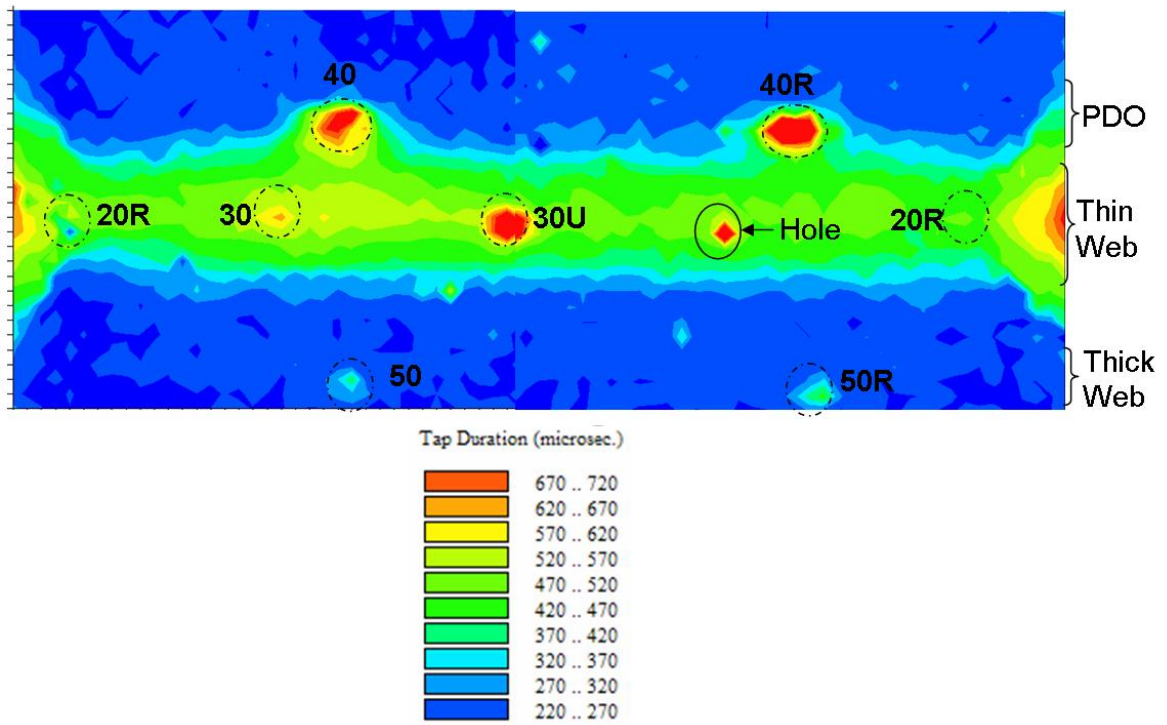
Figure 6.3 The image produced from the web of CS2 depicting tap duration.

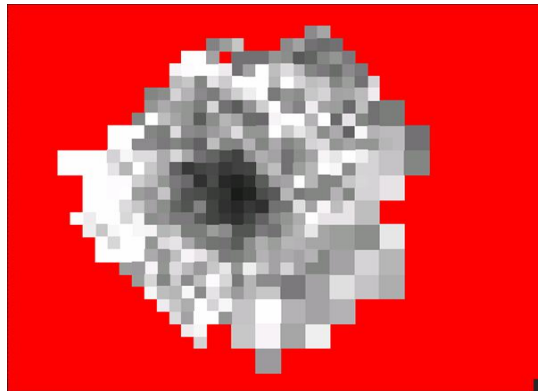
Amplitude C-scans using the pitch-catch method were made on the CS1 carbon spar. Figure 7.4 shows the 20 Joule impact damage area in the thin web of the CS1 spar. This was made using the Rayleigh wave, 2.25 MHz, transducers with the Epoch 4 flaw detector. The transducers were orientated at -45 degrees. The image produced with the same setup of the 30 Joule impact site can be seen in Fig. 7.5. Amplitude C-scans of the supported and unsupported impact sites on the cap of the carbon spar as well as the 10 Joule impact damage in the thin web were undistinguishable in the pitch-catch C-scan images.

Figure 7.4 Amplitude image produced with Epoch 4 and GenScan of 20 Joule impact area in web of CS1.

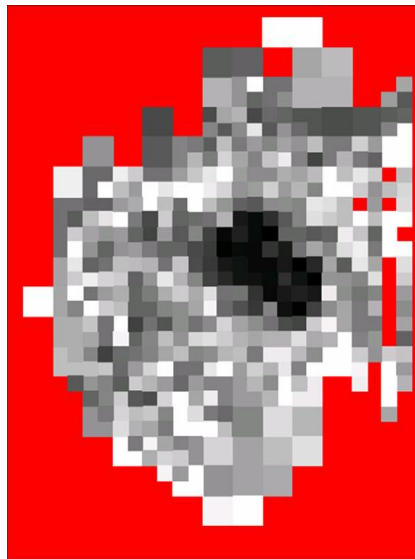
Figure 7.5 Amplitude image produced with Epoch 4 and GenScan of 30 Joule impact area in web of CS1.
