April 2018

Investigations on FRP-Concrete Bond

A dissertation submitted in partial fulfillment
of the requirements for the degree of
Doctor of Philosophy
Department of Civil and Environmental Engineering
College of Engineering
University of South Florida

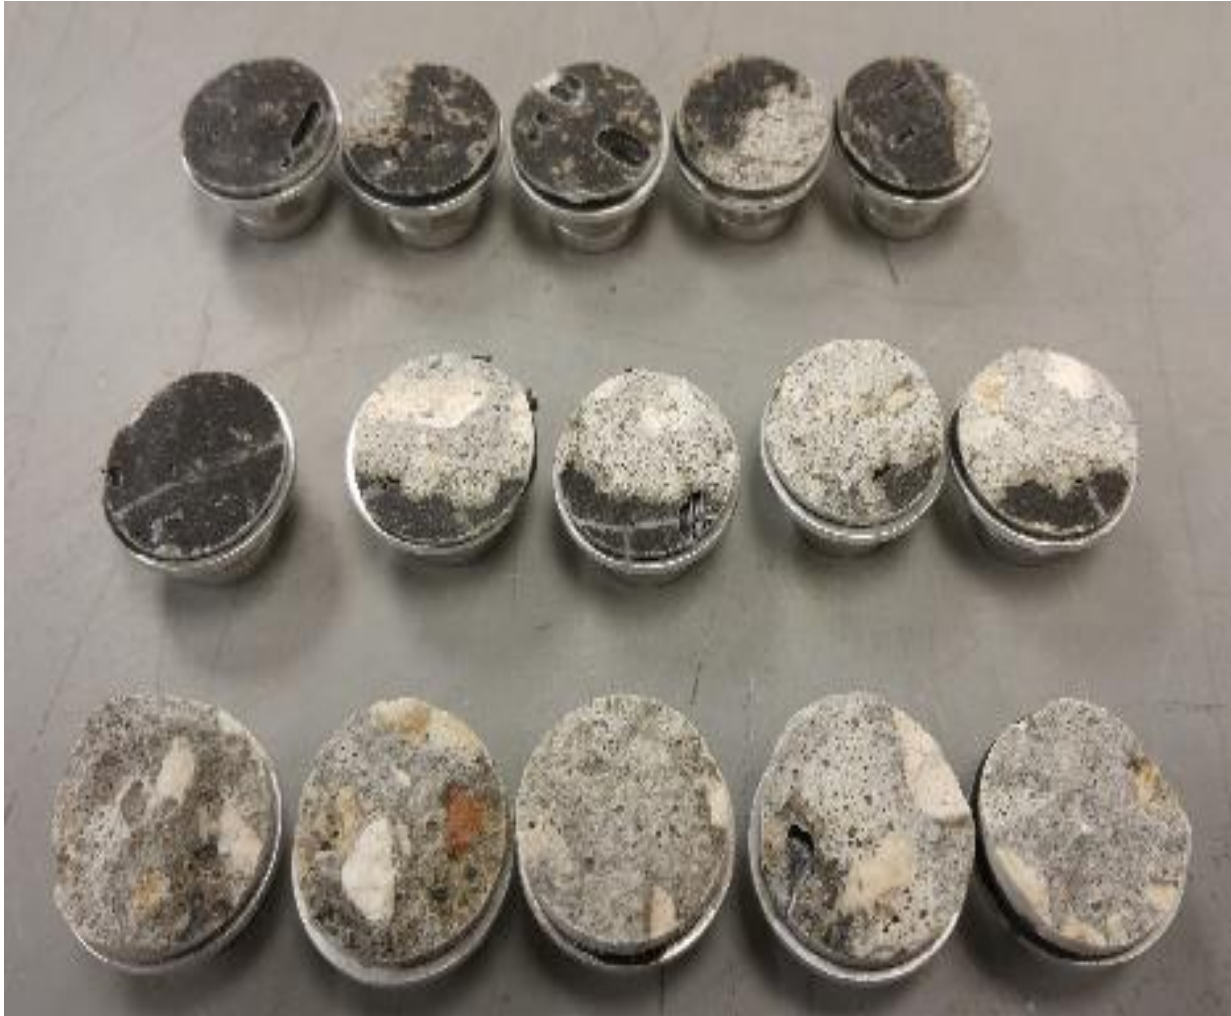
Figure 8.2 Failure mode after moisture exposure.
Failure Mode: G (Concrete Substrate failure), E (FRP/concrete interface), F (mixed mode G and mode E)

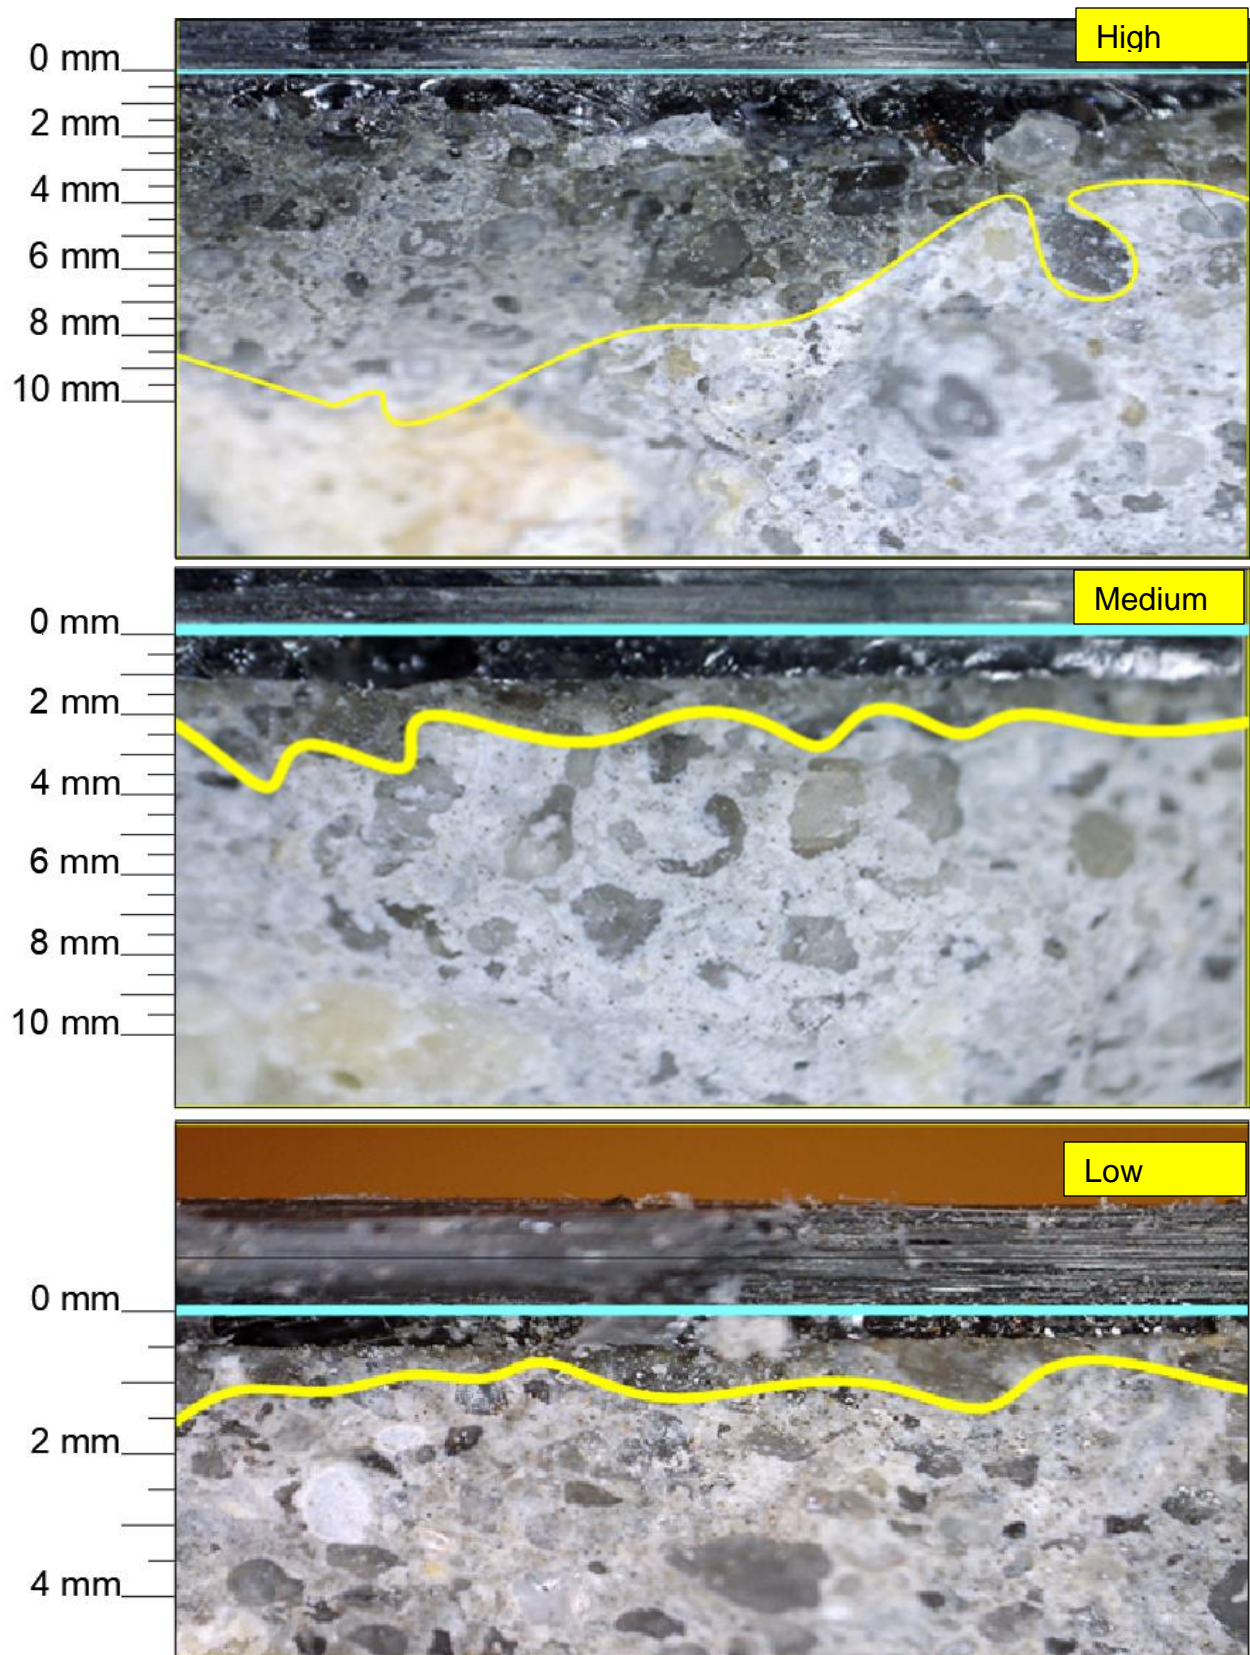
A total of nine images were taken – three of these corresponding to high, medium and low porosity are shown in Figure 8.12. Each picture is accompanied by its own local scale. The FRP material is clearly visible at the top.

Figure 8.12 Relative depth of epoxy penetration

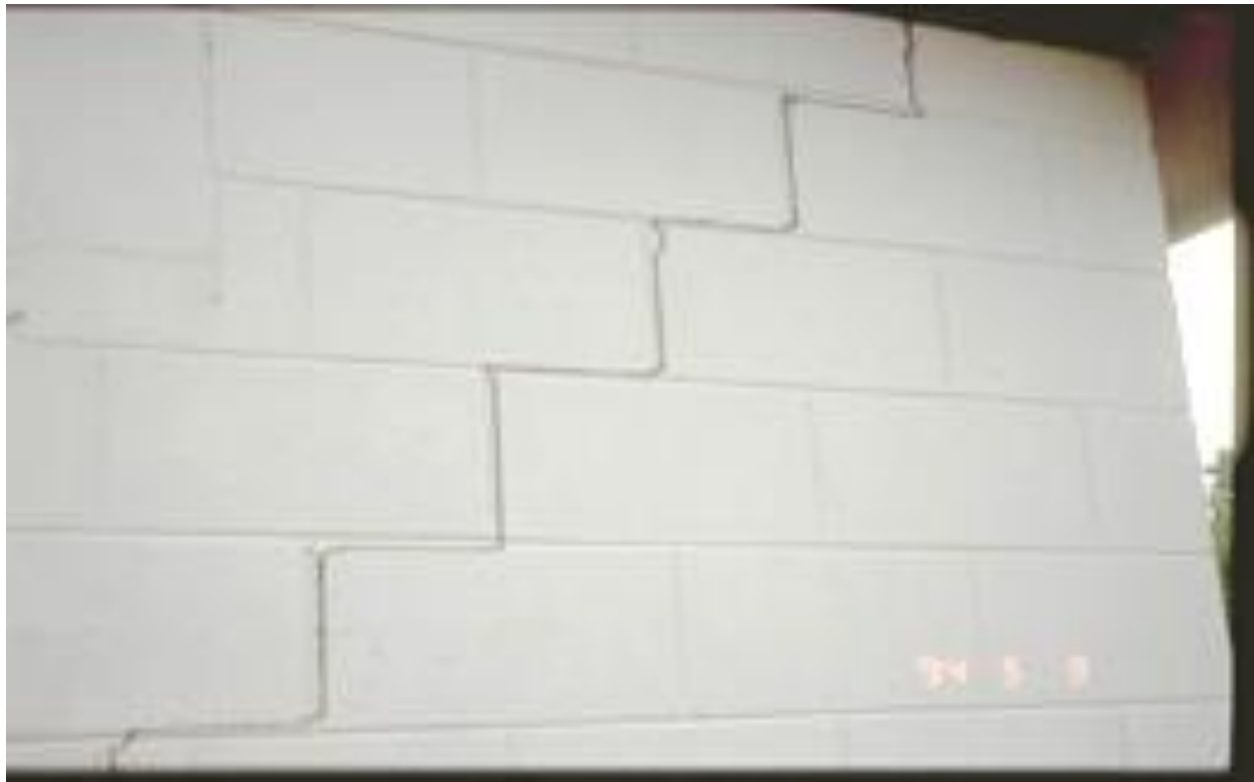
Figure 9.1 Characteristic stair-step cracking in CMU wall.

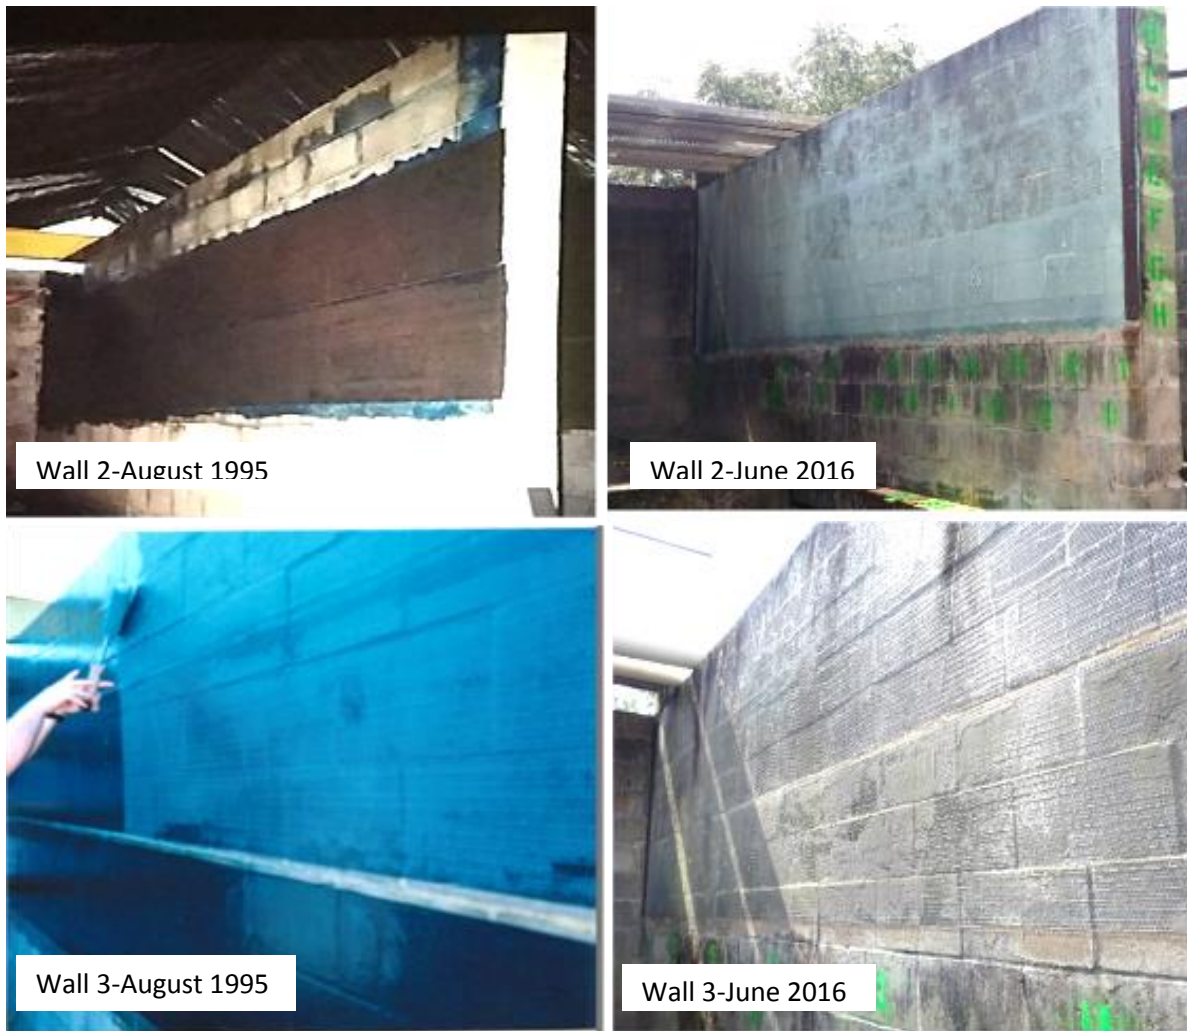
Discoloration of the CFRP was noticeable though there was minimal deterioration at the mortar joints. Sunlight was believed to be the likely cause of the discoloration. Close-up photos of these regions at 60 and 160 magnifications provided conclusive evidence of a disintegrating top epoxy coating that revealed the underlying carbon fiber (Figure 9.7). These locations correlated well with the spatial temperature variation shown in Figure 9.6 As a result, the destructive pull-off tests were targeted for shaded and sunny regions on the CFRP surface to allow quantification of the difference, if any, in residual bond.

Figure 9.7 Comparison of images for wall 2 and wall 3.
At installation and after exposure

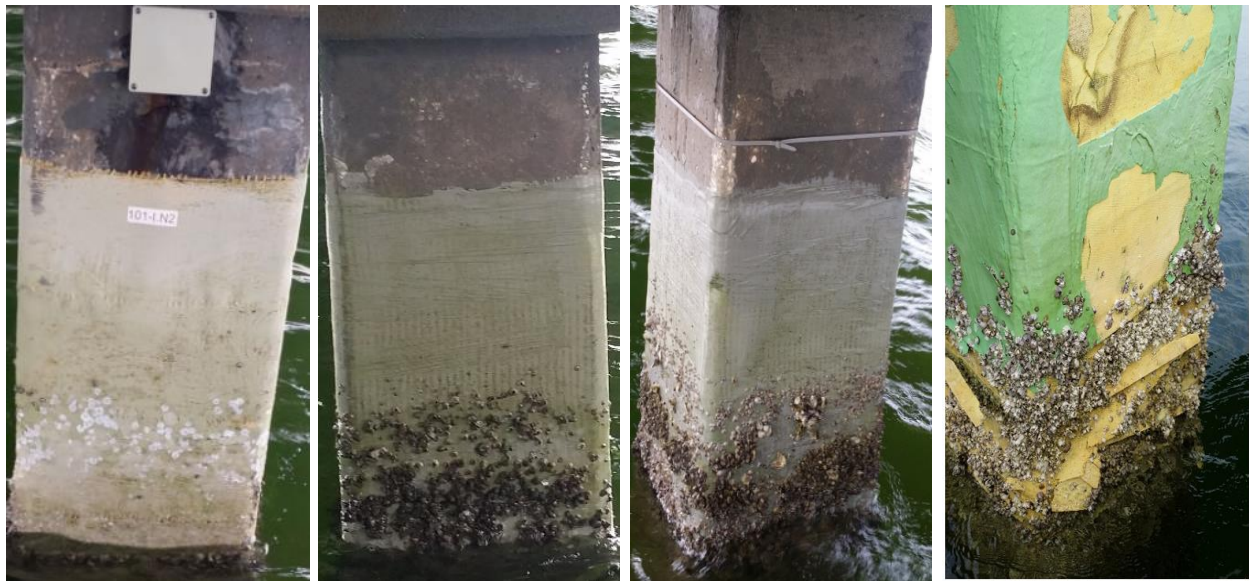
Figure 10.4 Photos of FRP repairs in piles.
(left to right) 101 B, 101C, 103C and 104B

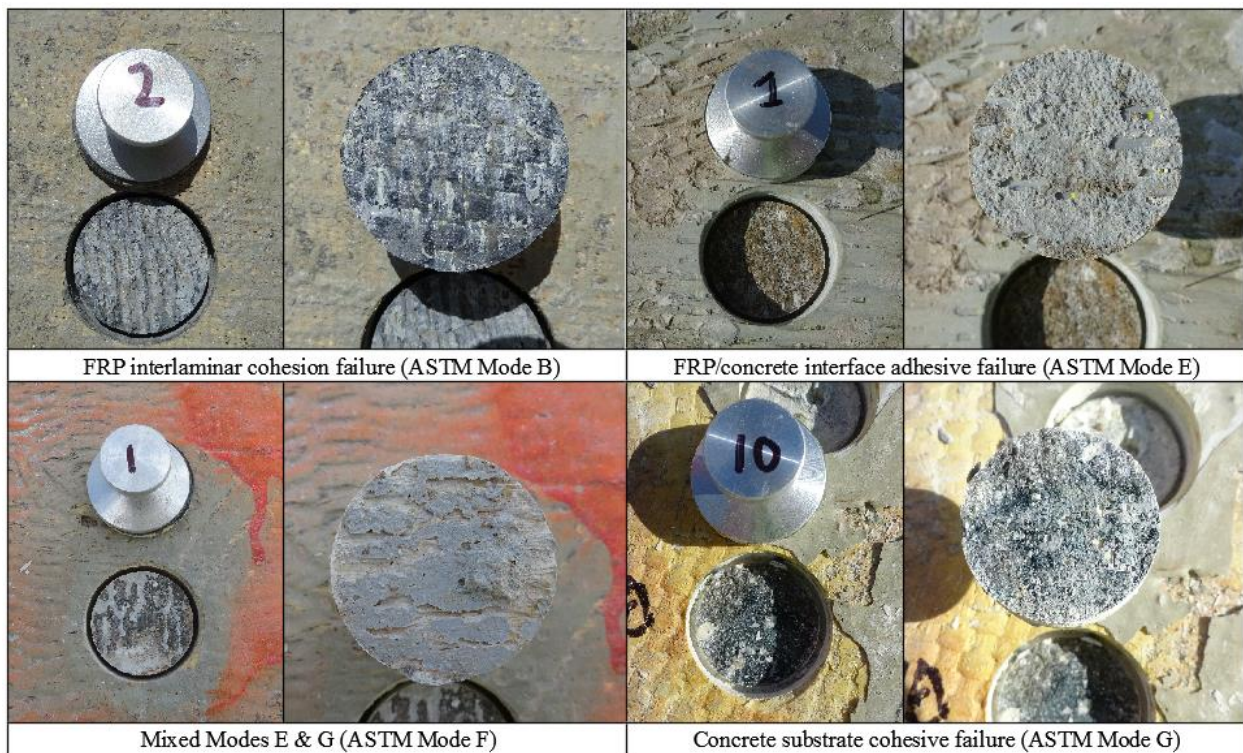
The failure modes observed in the 120 tests were cohesive, mixed mode, adhesive and inter-layer failures. Cohesive failure in the substrate concrete during pull-off testing corresponds to Mode G in ASTM D7522 (ASTM 2009). Within the recorded data set, one specimen (0.85% of total points) exhibited a Mode G failure. A total of 13 specimens (10.7% of total points) exhibited Mode F, which is a mixed mode condition. The remaining 107 specimens exhibited Mode B (cohesive in laminate) or Mode E (adhesive at bond plane) failure modes. Figure 10.12 illustrates the failure modes encountered during testing.

Figure 10.12 Representative failure modes

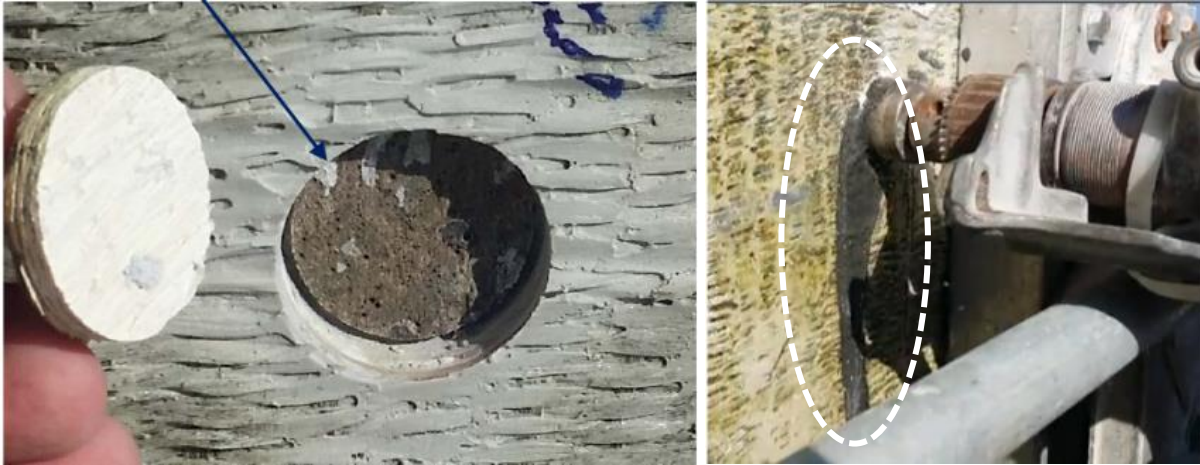
Voids provide a direct pathway for moisture to reach the concrete substrate or accumulate between FRP layers.

(a) Moisture in bond plane and between FRP layers

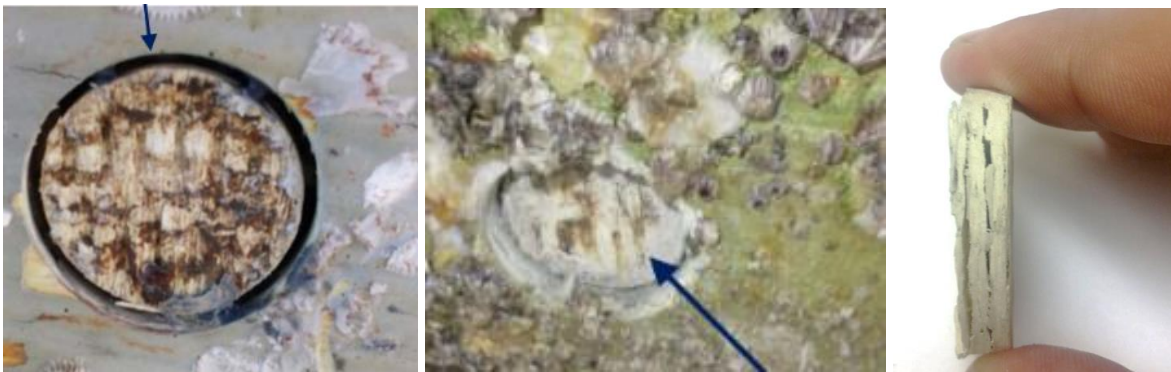
(b) Marine growth between FRP layers and voids between FRP layers
