Investigation of an alternative gravel roads rejuvenation method

Ziliang Zhang

Major: Civil Engineering (Construction Engineering and Management)

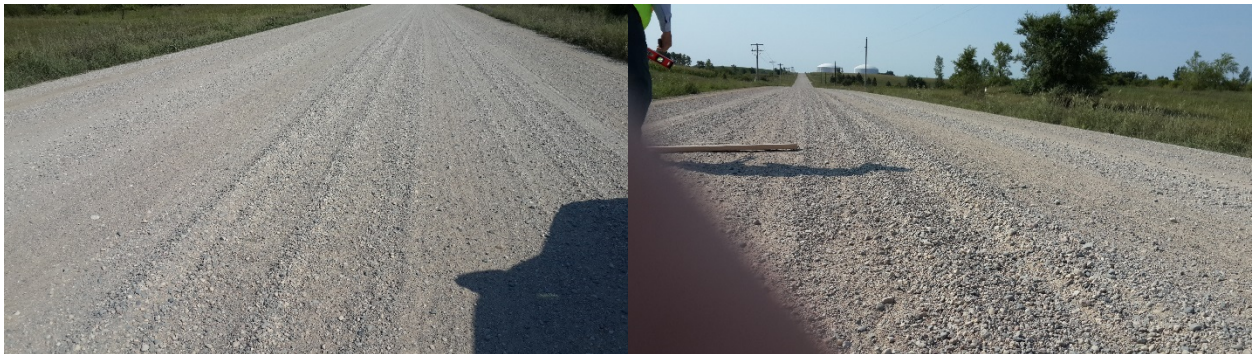
Figure 3 Loose Aggregate on CR 35, Pope County, July, 2013 (Photo by the Author)

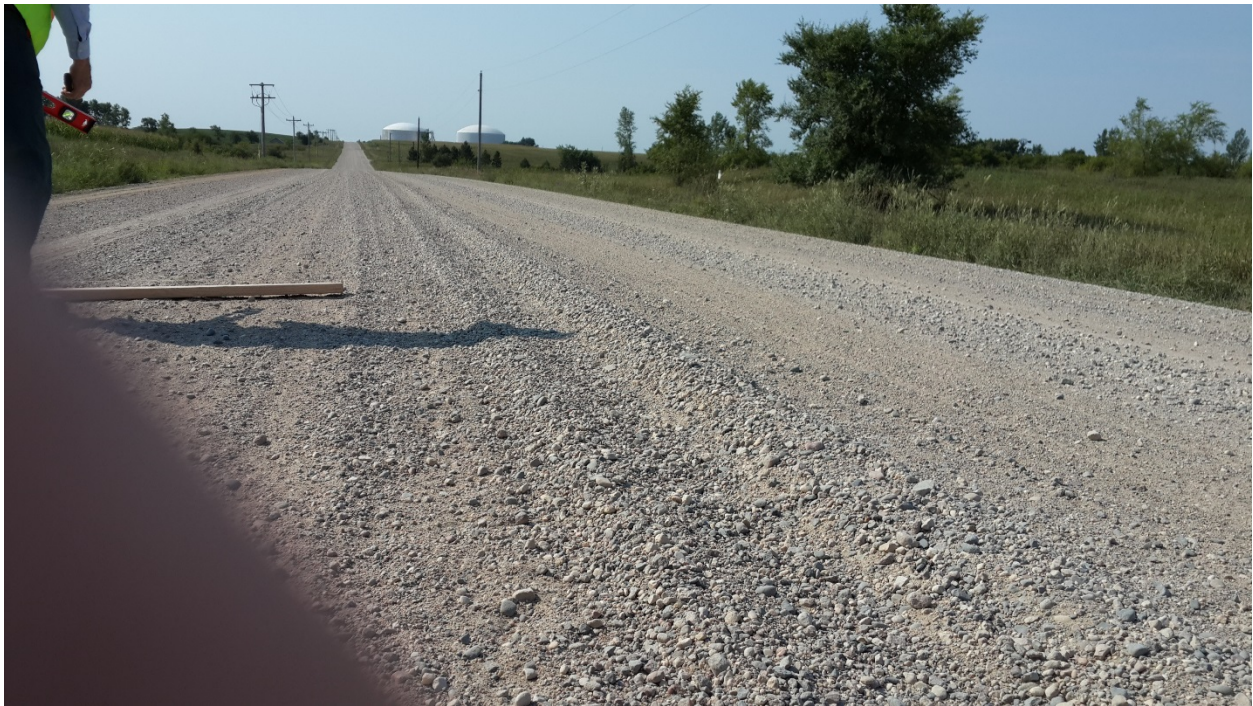
The research team visited Pope County in July, 2013. CR 35 was considered a typical road section that has a considerable amount of loose aggregate, see Figure 20. The volume of loose aggregate was estimated to be 307.24 tons/mi based on an estimate involving the scrape test.

Figure 20 Loose Aggregate on CR 35, Pope County (Photo by the Author)

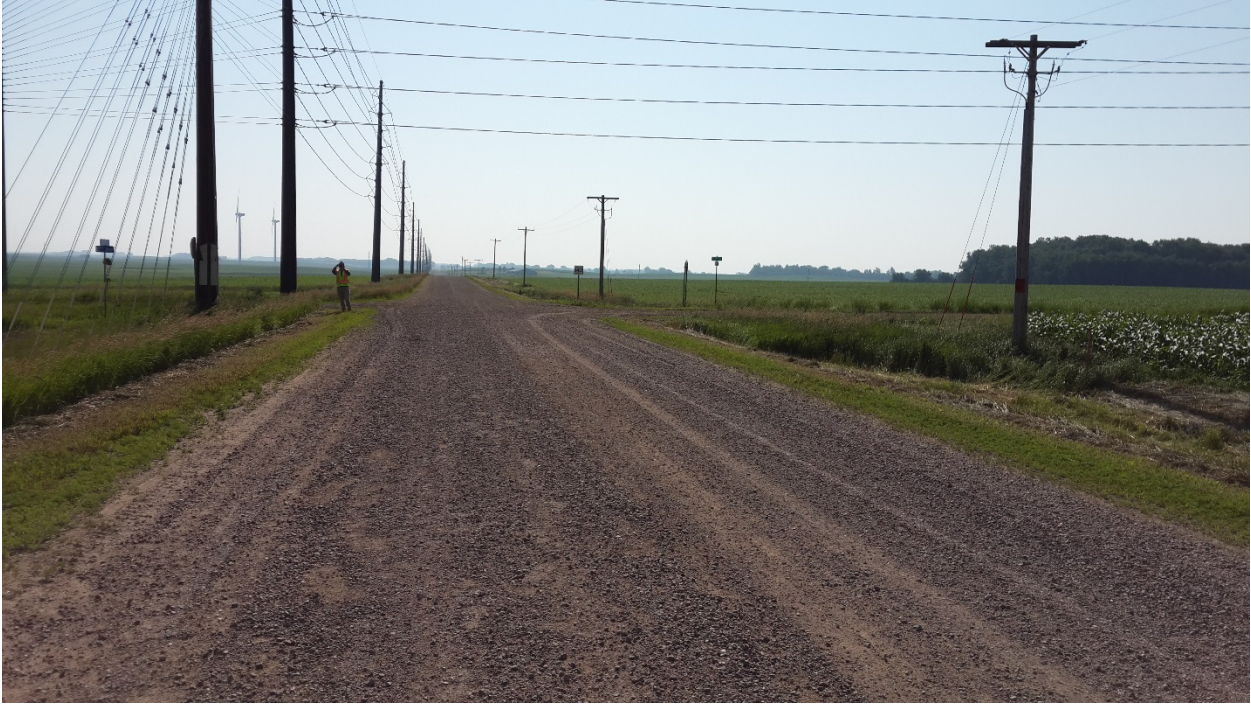
Figure 21 Jackson County Road 76 Surface Conditions in July, 2013 (Photo by the Author)

Scattered loose aggregate was seen along the road but was not considered serious. Loose aggregate accumulated away from the wheel path. Whipped-off coarse aggregate was seen along the shoulder. Loose aggregate volume was estimated to be 186 tons/mile according to the estimates based on scrape test results.

The road did not comply with typical recommendation for crown slope which is 4%-6% (Ken Skorseth and Ali Selim 2000; Center for Dirt & Gravel Roads Studies 2005). Our measurements show the eastbound cross slope was 2.9% and the westbound side was 3.3%. The road, from the perspective of the research team, is moderately dusty during dry season.

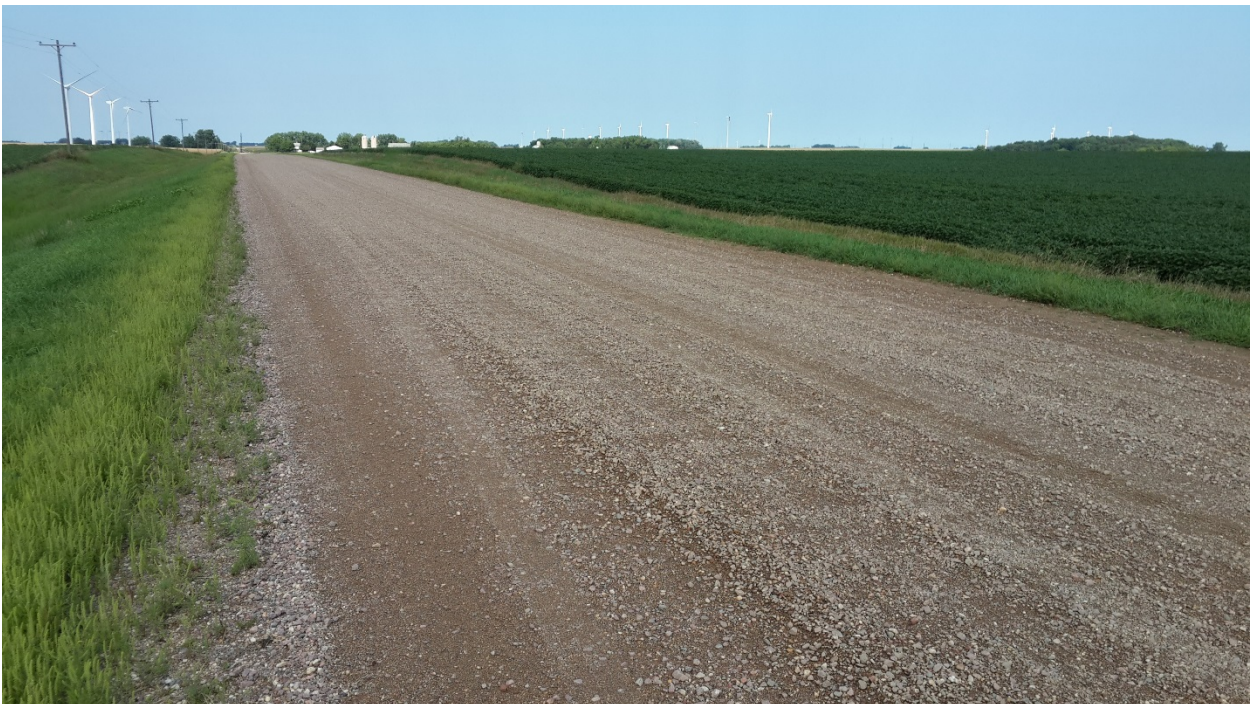
Figure 22 Jackson County Road 76 Surface Conditions in August, 2013 (Photo by the Author)

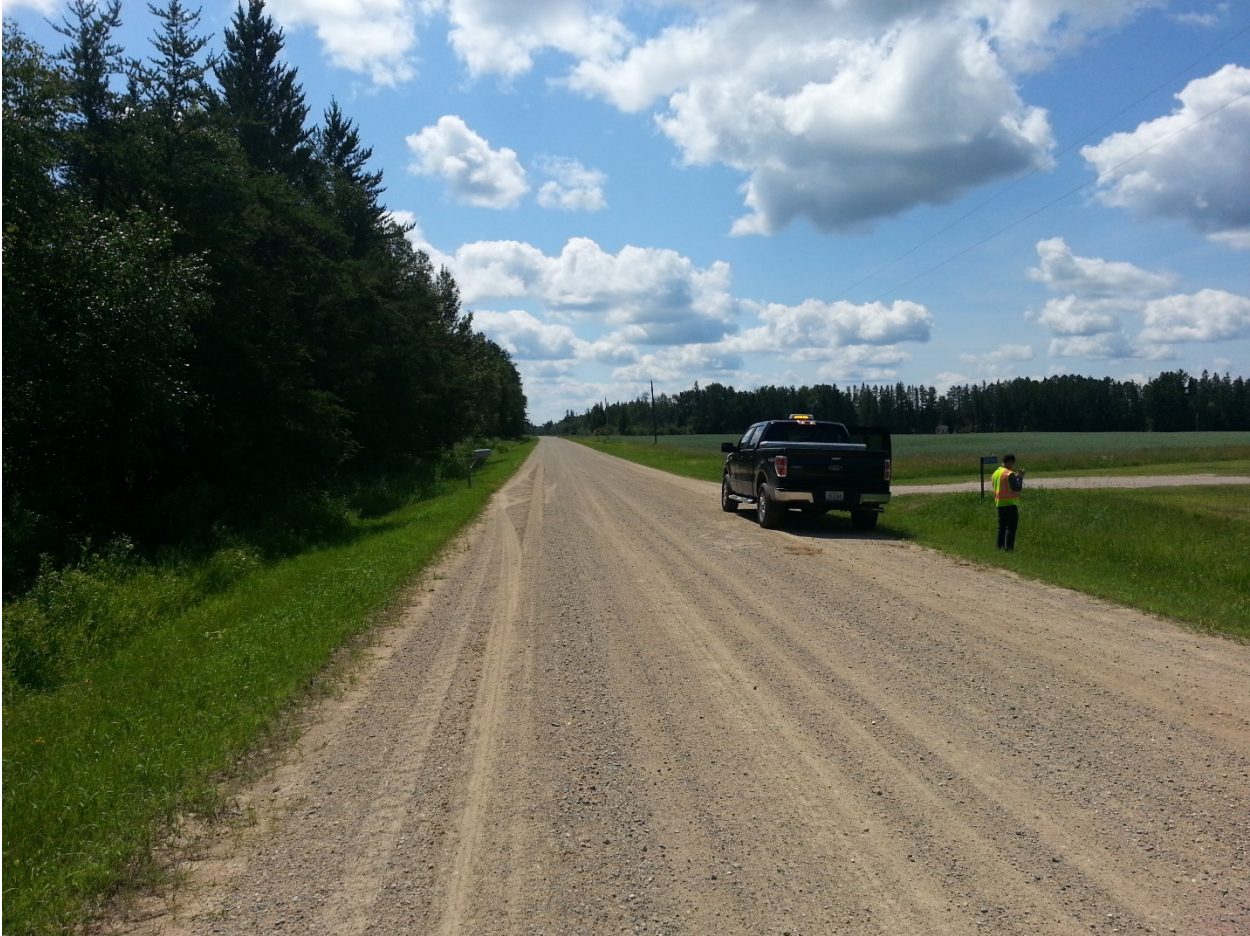
The research team visited the Beltrami County CR 23 test site once in July, 2013, before construction. The loose aggregate problem was not pronounced, as shown in Figure 23, although there was scattered loose aggregate.

Figure 23 Beltrami County Road 23 Surface Conditions in July (Photo by the Author)

Loose aggregate tonnage was estimated to be 91.3 tons/mile according to estimates based on scrape test results. The road did not comply with typical recommendation for crown slope. Measurement showed that the northbound cross slope was 1.2% and the southbound side was 1.9%.

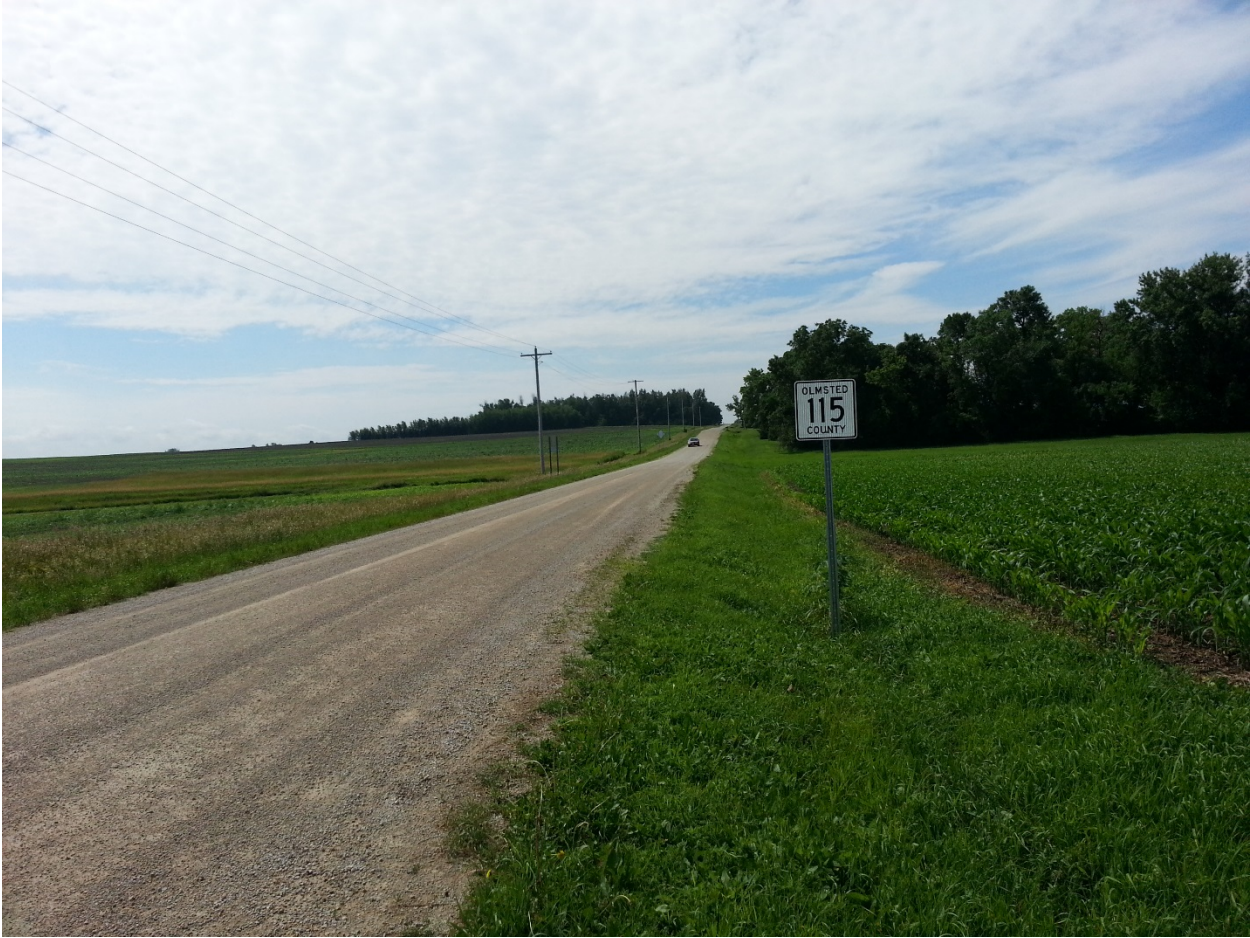
The research team visited the Olmsted County CR-115 test site once in July before construction. A small amount of loose aggregate was present on the road. Wheel paths were clearly seen in Figure 24. The wheel paths were highly compacted and had the appearance of an aged pavement.

Figure 24 Olmsted County Road 115 Surface Conditions in July (Photo by the Author)

Loose aggregate tonnage was estimated to be 71.49 tons/mile. The road has an effective crown slope. Our measurement shows that the northbound cross slope is 6.7% and the southbound side is 6%.

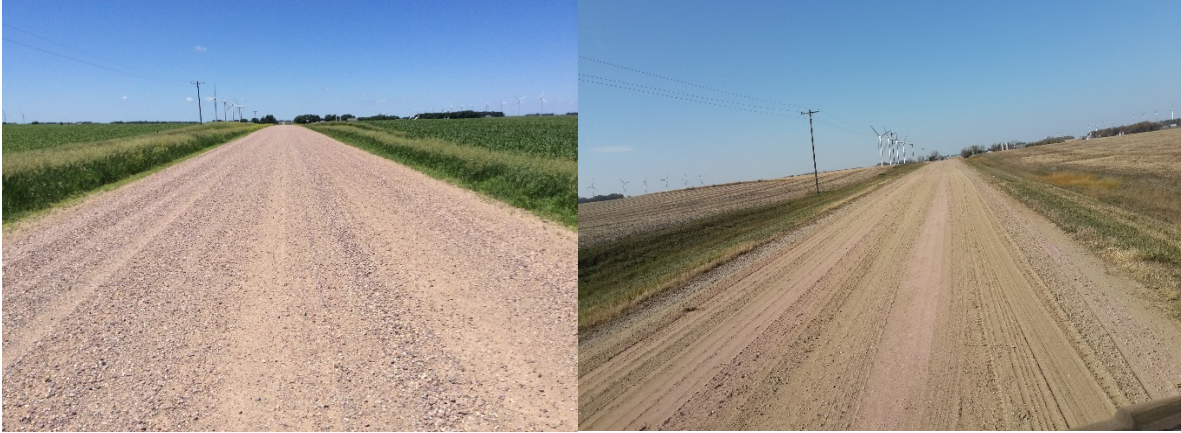
Second follow-up visit was made in June, 2014. No more follow-up visits were made to Jackson County since the crusher dust mixture under these conditions did not appear to be providing the desired result.

Figure 49 Seven Months after Construction-Jackson County

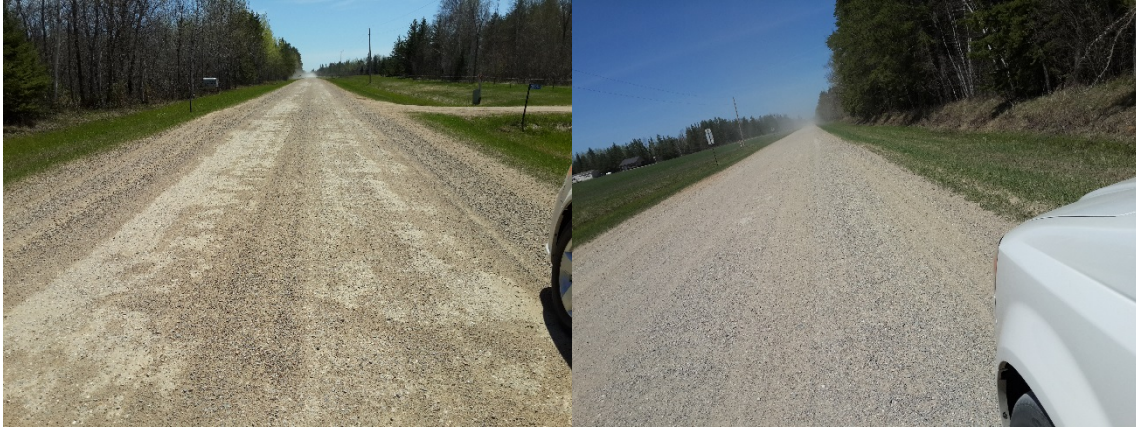
Figure 60 North Section (Left) and Middle Section (Right) (Photo by the Author)

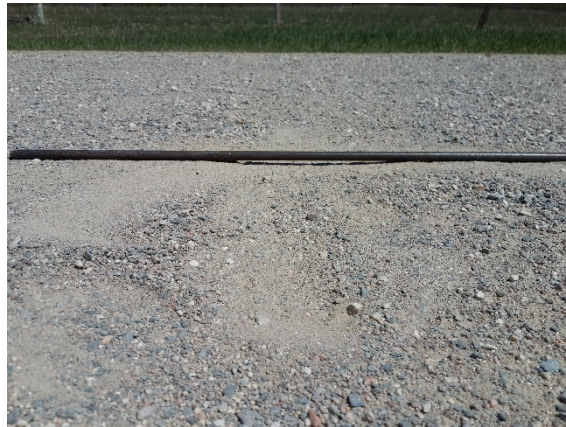
The South Section/3rd Section was rated “Fair” for the distress of washboarding, which reflects the lasting distress observed in this section. Fair level of washboarding suggests that 10%-25% of roadway appears to suffer from corrugations that are generally 1”-2” deep and vehicle control is compromised. The Middle Section/2nd Section particularly performed well by having few pothole distress. See Figure 54 below.

Figure 61 Typical Corrugation in the South Section/3rd Section (Photo by the Author)

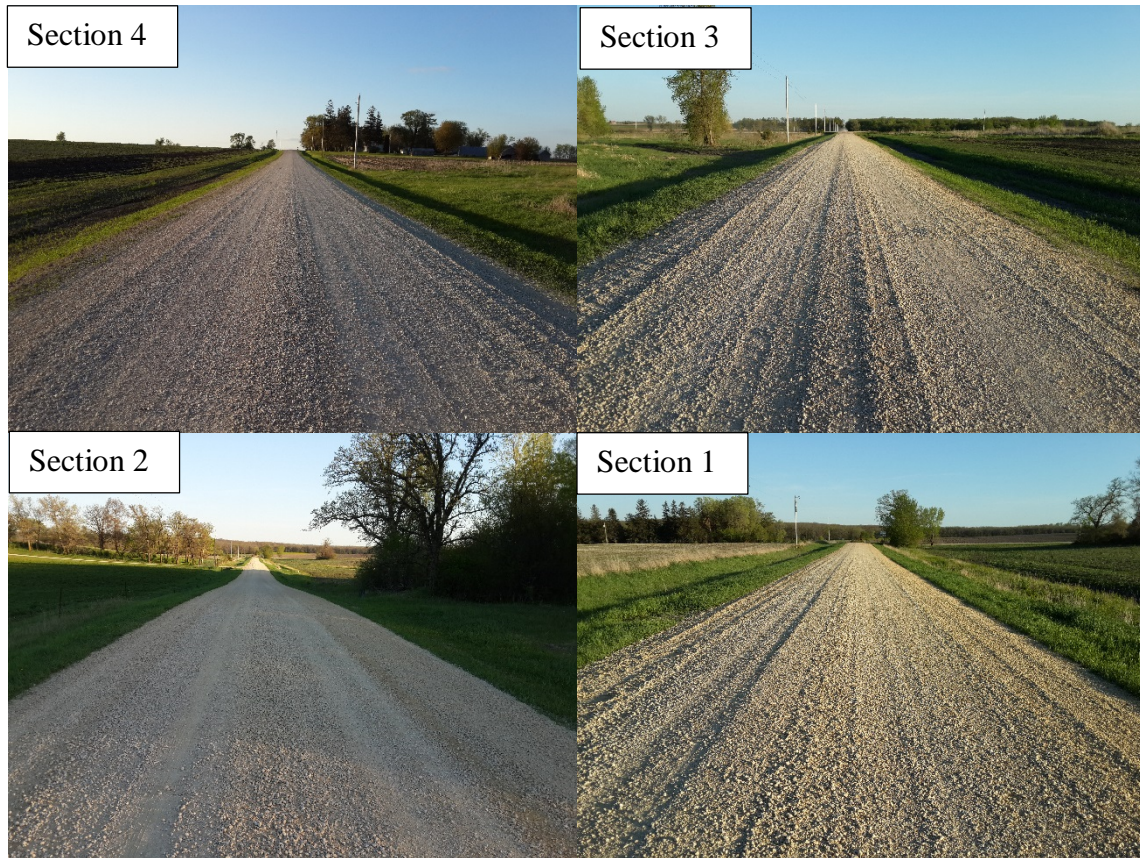
Figure 70 Four Test Sections Surface-Olmsted County CR 115 (Photo by the Author)
