Using Soybean Oil Soapstock for Stabilizing Granular Shoulders

Using soybean oil soapstock for stabilizing granular shoulders

Major: Civil Engineering (Construction Engineering and Management)

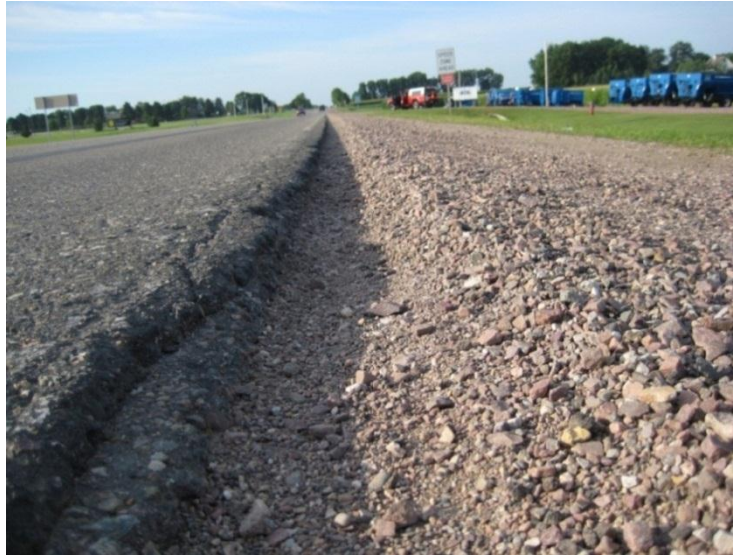
Edge rutting on granular shoulders is a traffic safety concern because it poses a safety hazard for vehicles. The possible bad results include crossing to an adjacent lane, encroaching on the far side of roadway, or skidding on shoulders or roadways, which would cause potential collision or rollover (Hallmark et al. 2006). Figure 1 shows an example of edge rutting that has developed along the interface between a pavement and a granular shoulder. Edge rutting is caused by three factors, wind and air currents, vehicle off-tracking, and drainage. Over time, wind and air currents from large vehicles blow fine material away from the shoulder and large particles are exposed on the shoulder surface that are more easily removed by vehicle off-tracking. Off-tracking refers to the situation where rear tires run a different path from front tires during vehicle's turning movement. Water from pavement drainage accumulates along the pavement edge, softens the granular material and makes shoulder materials unstable.

Figure 1. Edge rutting on granular shoulders (by Thang Phan)

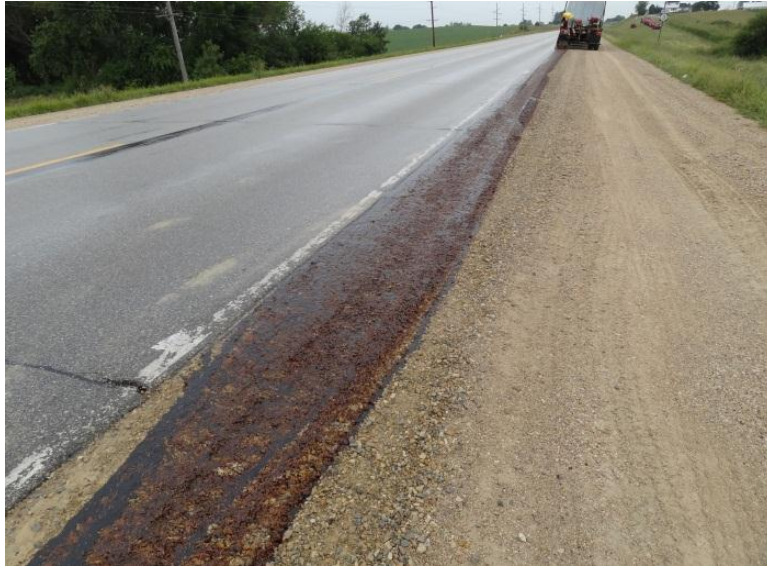
On August 18, 2011, a rain was encountered during the construction activities executed around Allison and Shell Rock. Figure 12 shows the result of the soapstock application on the westbound shoulder of IA 3 nearby and east of Alison when it was raining. The rain became heavy in the afternoon, thus work was suspended until the next day. Apparently the rain did have some negative effect on the treatment, because many of the locations where soapstock was applied during the rain performed poorly in comparison to other work locations in post observations.

Figure 12. Spraying in the rain on IA 3 near Allison

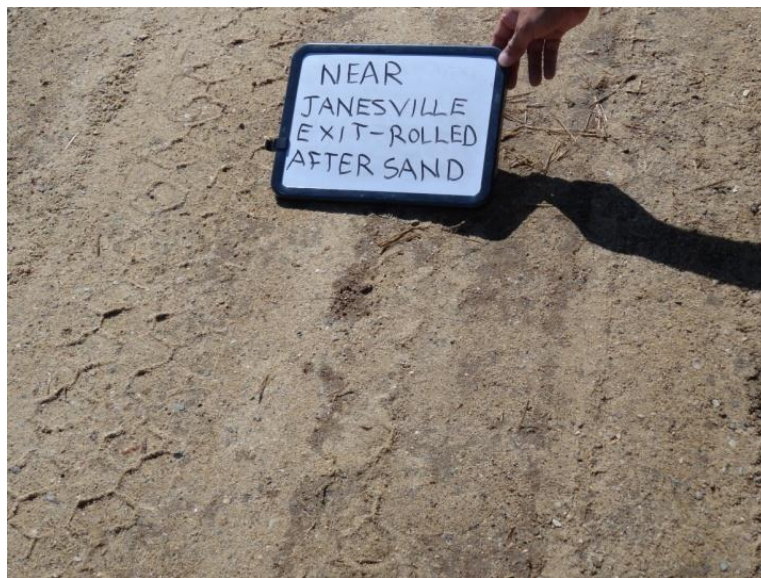
In the same location 2.02, one action observed by researchers might be meaningful for a successful application. Near Janesville exit on US 63 near Denver, the treated surface was rolled after the sand application. The result of this was shown in figure 14.

Figure 14. Surface rolled after sand application for the shoulder of US 63 near Denver

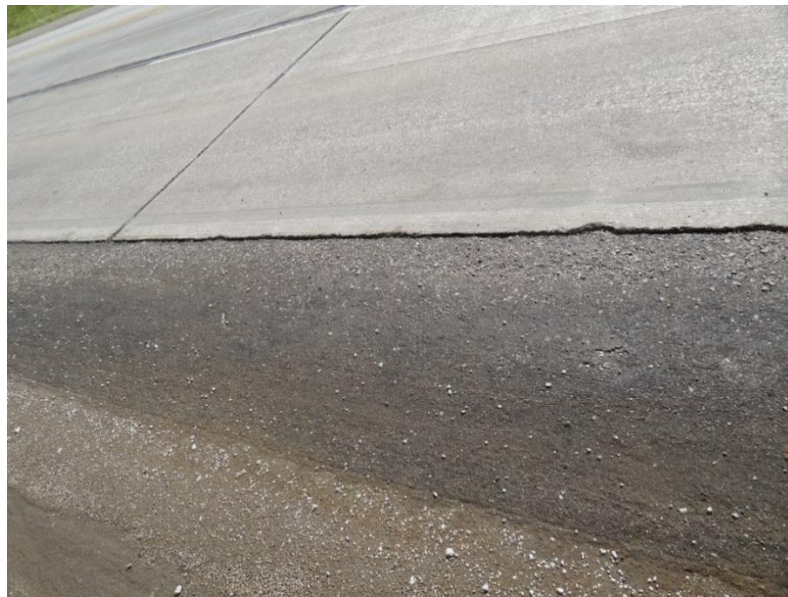
**Figure 20. Southbound shoulder of US 169 south of Algona**

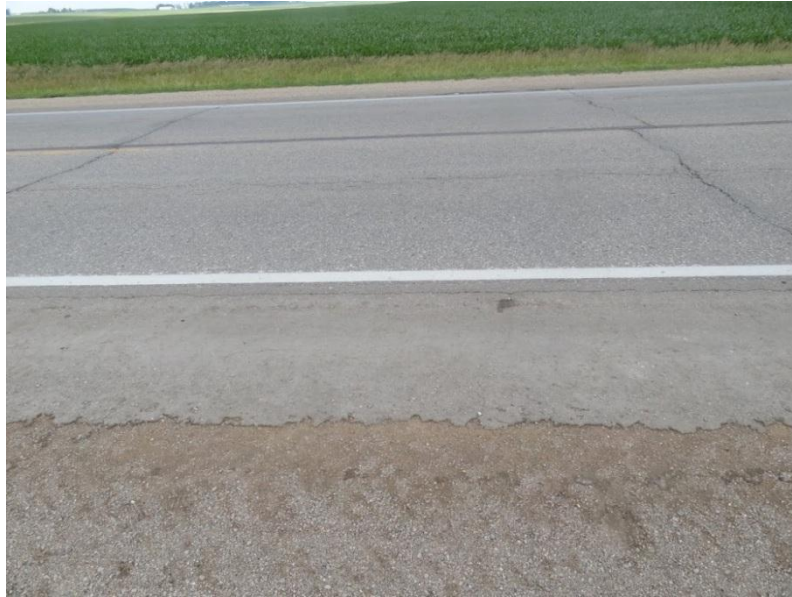
Figure 21 provides an example of good shoulder performance for this area. This shows a section of the US 169 shoulder adjacent to the southbound lane just south of Algona, where a thin layer of soapstock remained firmly on the shoulder. Another example is shown in figure 22. The shoulder section was on US 18 near Garner with a thicker layer of soapstock on surface.

Figure 21. Eastbound shoulder of US 18 near Garner

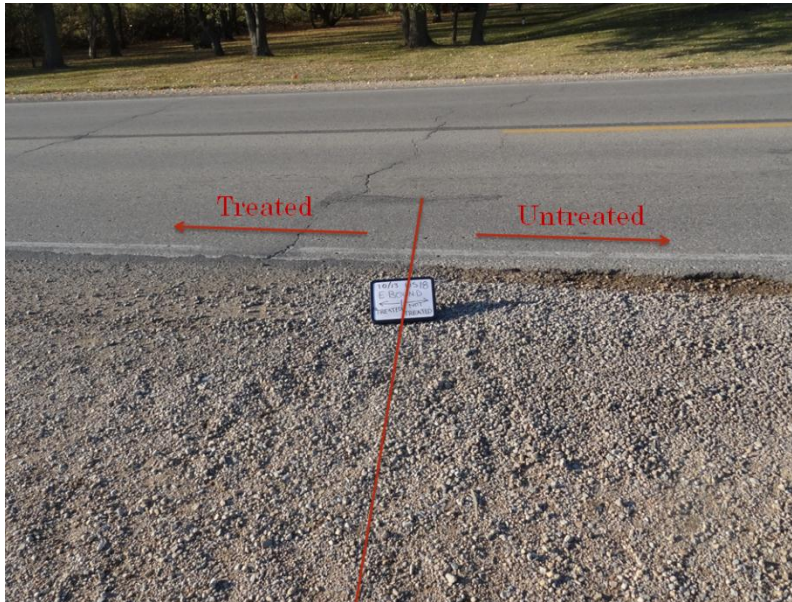
Figure 24 shows an example of a comparison of an untreated shoulder edge and the untreated one. The photo was taken on October 13, 2011 about 2 months after application at US 18 near Garner. On the right side of the red dividing line, a small amount edge rutting could be observed where soapstock was not sprayed. On the left side of the red dividing line, the original edge rut was more severe than the one on the right, but it had been filled with granular material and covered with soapstock.

Figure 23. Compared results of treated and untreated shoulder edge

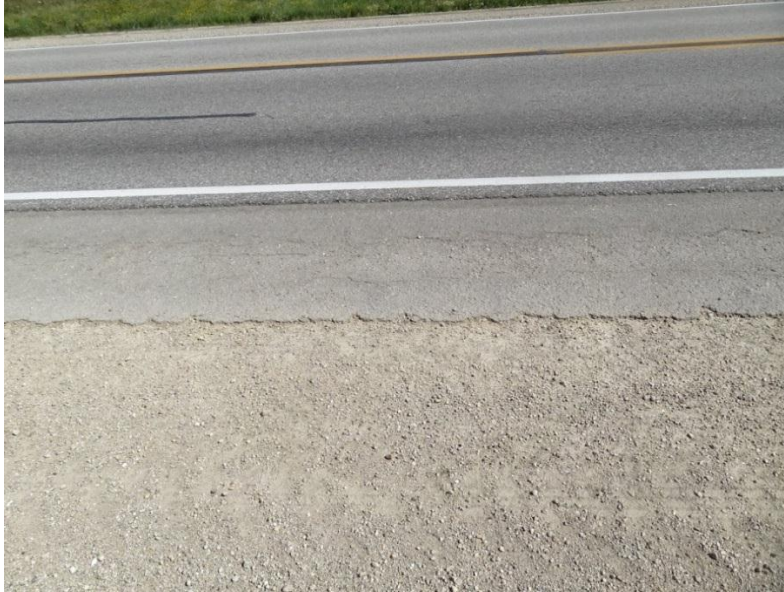
Figure 25 provides an example of good shoulder performance for this area. This shows a shoulder section of IA 3 on adjacent to the eastbound lanes just east of Waverly, where a thick layer of soapstock remained firmly on the shoulder. Another example was shown in figure 26. The shoulder section was on US 63 near Denver, where soapstock had penetrated into the shoulder and could not be easily seen.

Figure 24. Eastbound shoulder of IA 3 east of Waverly

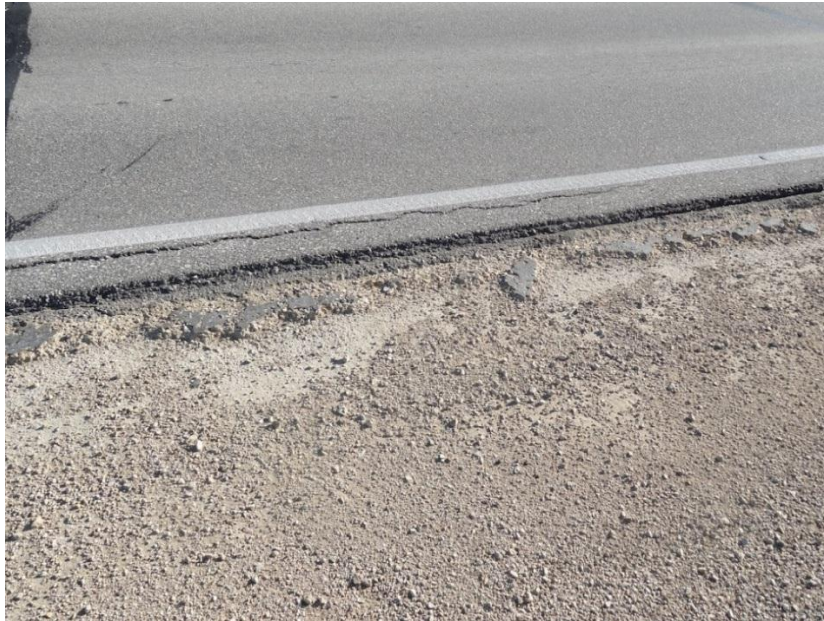
Figure 27 shows one example of an undesired situation where most soapstock was abraded away by the traffic although neither edge ruts nor pot holes developed. This was part of the shoulder of IA 3 on eastbound near east of Allison. However, an edge drop off did exist because as asphalt overlay created an elevation difference between the pavement and the shoulder this elevation difference had not been addressed by adding shoulder aggregate after construction or the new aggregate was added had been removed since construction.

Figure 26. Soapstock missing near east of Allison

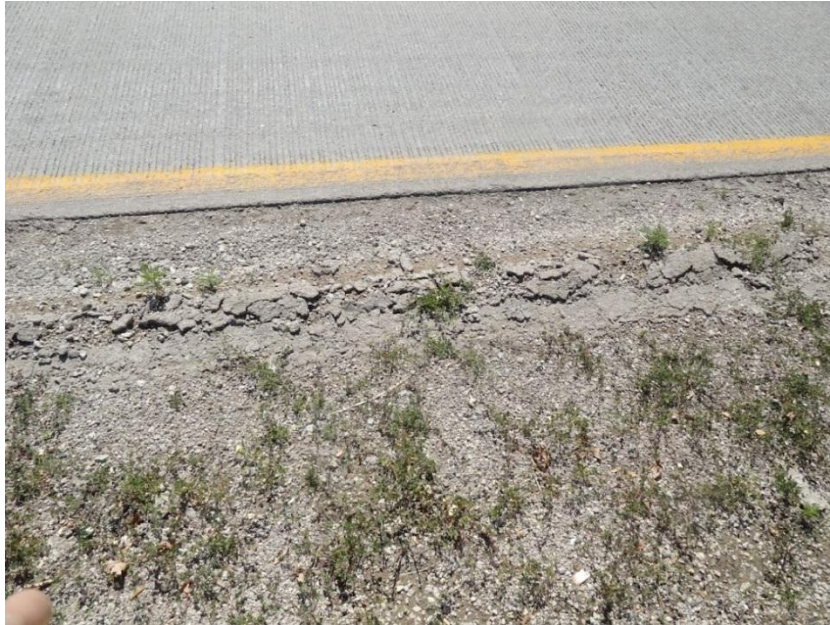
Figure 28 shows another undesired situation where the soapstock was not remaining on the inside shoulder of US 63 on northbound near Denver. Part of shoulder materials had been displaced by the traffic.

Figure 27. Northbound inside shoulder of US 63 near Denver

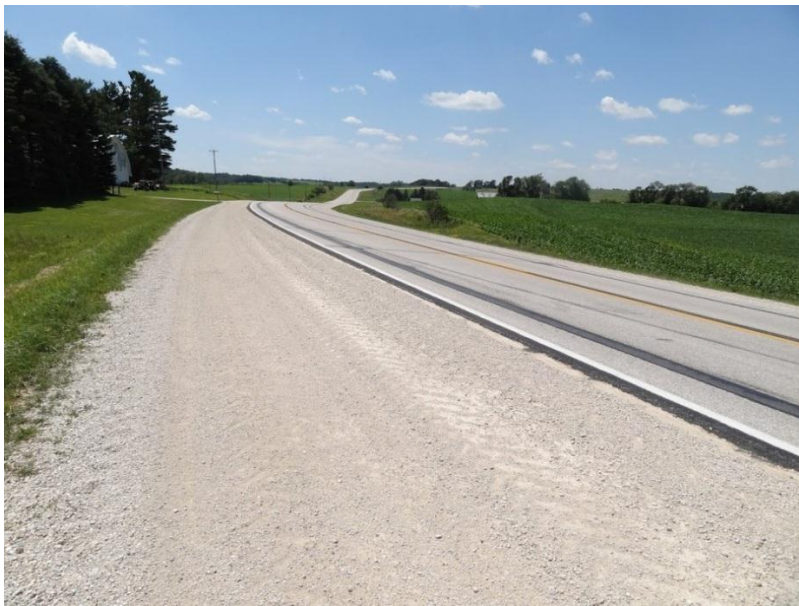
Figure 29. Shoulder of US 18 on eastbound near west of Clermont
