Rehabilitation of Precast Deck Panel Bridges

Atiq H. Alvi
University of South Florida

A thesis submitted in partial fulfillment
of the requirements for the degree of
Master of Science in Civil Engineering
Department of Civil and Environmental Engineering
College of Engineering
University of South Florida

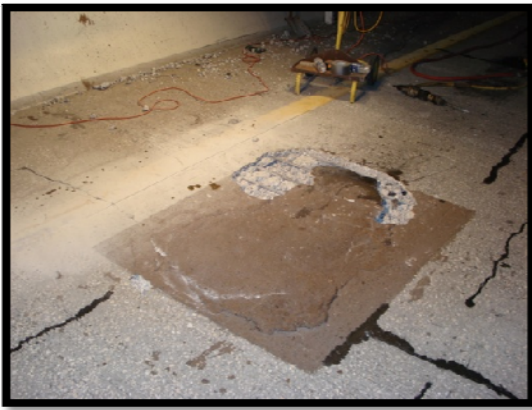
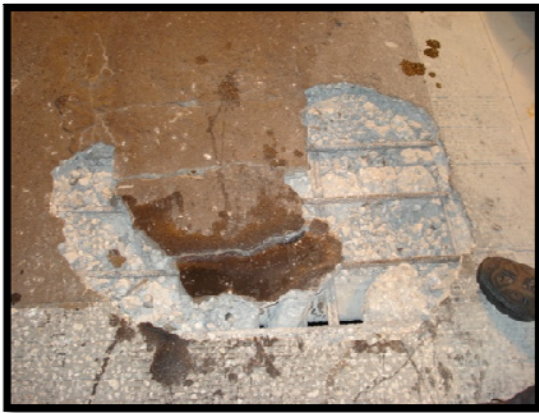
The first failure occurred on March 5, 2007, on Bridge No. 100332, The Crosstown Expressway (Westbound) Viaduct, Span 39, Lane 2 (see Figures 3.1 and 3.2), The failure size was approximately 18 in. x 8 in. hole through the deck and it occurred within the outside edges of a nearly 5 ft. x 7 ft. existing repair patch. It was located on the edge of the panel and the edge of the beam.

Figure 3.1 Bridge No. 100332, Span 39 Failure (Deck Top)

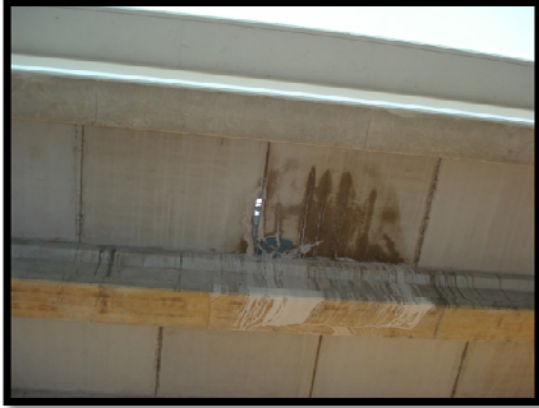
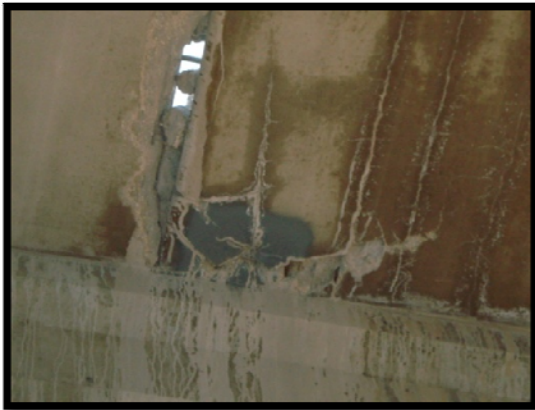
Figure 3.2 Bridge No. 100332, Span 39 Failure (Deck Underside)

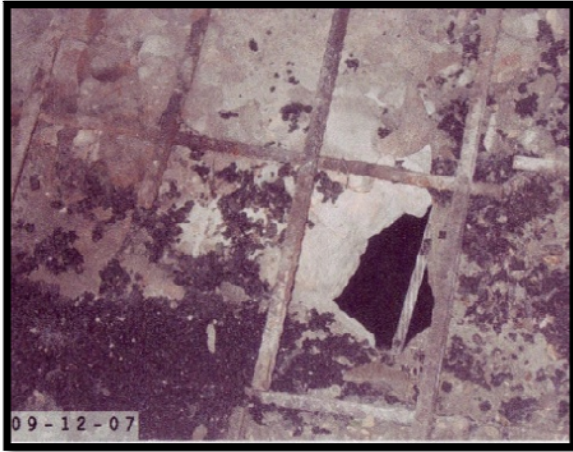
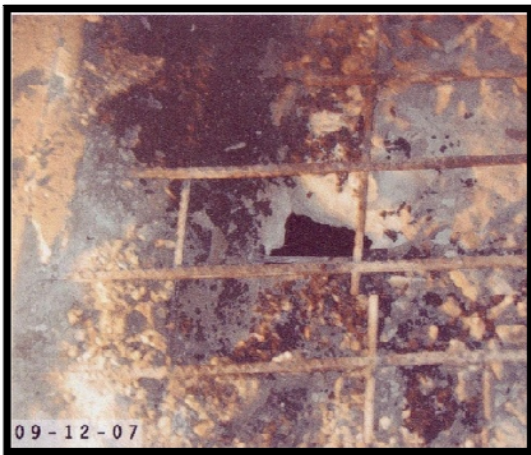
The next failure took place on September 11, 2007, on Br. 100436, I-75 (Northbound) over E. Broadway Ave., CR 574 and CSX Railroad, in Span 4, Lane 3 (See Figures 3.4 and 3.5). The failure was approximately 12 in. x 24 in. and was located inside an existing repair patch, on the edge of the panel as indicated in the emergency inspection report in Figure 3.6 [10]. Like its predecessor, the failure was also located on the edge of the panel and the edge of the beam.

Figure 3.4 Bridge No. 100436, Span 4 Failure (Deck Top)

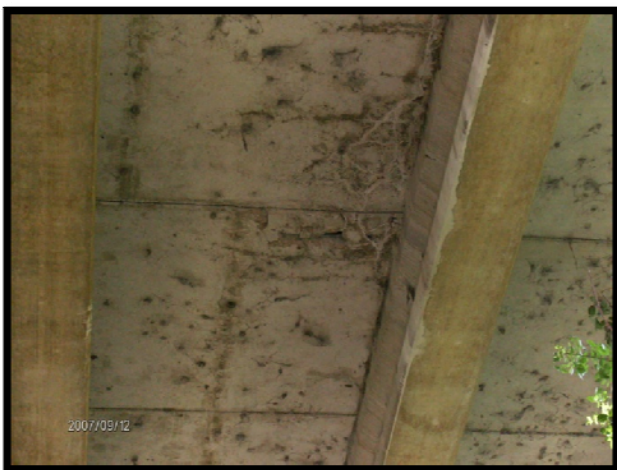
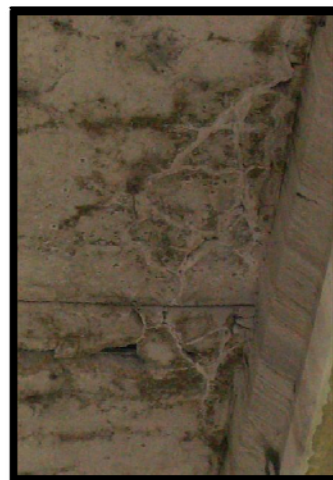
Figure 3.5 Bridge No. 100436, Span 4 Failure (Deck Underside)

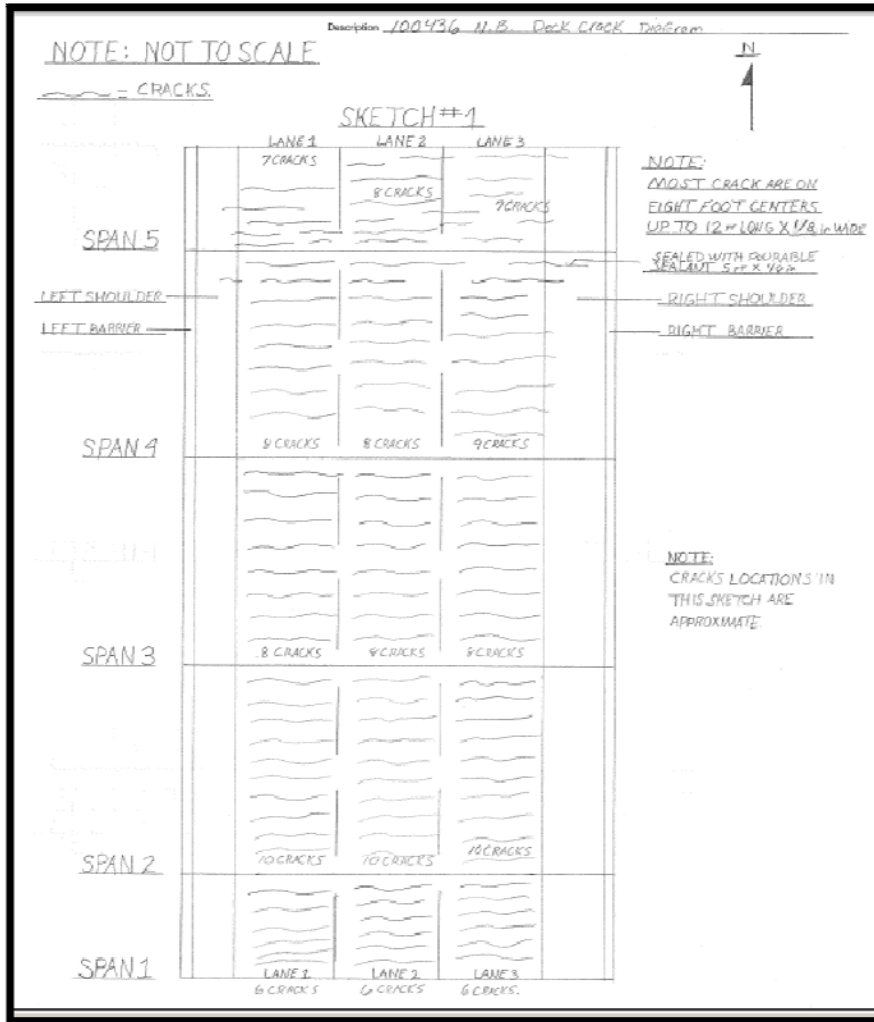
The last biennial inspection report prior to the failure was finalized October 27, 2005, 685 days before failure, which assigned the deck an NBI Rating of 5 (fair) [11]. The report documented that there are numerous patches made with “epoxy type” material in the deck top, longitudinal cracking with maximum widths of 1/16 in. over the edge of beam lines and transverse cracks up to 12 ft. long x 1/8 in. wide over the precast deck panel joints in all spans. It stated that most transverse cracks are spaced 8 ft. apart, which is the approximate length of a deck panel on this bridge. Due to the problem with

Figure 3.7 Bridge No. 100436, Transverse Cracking Pattern

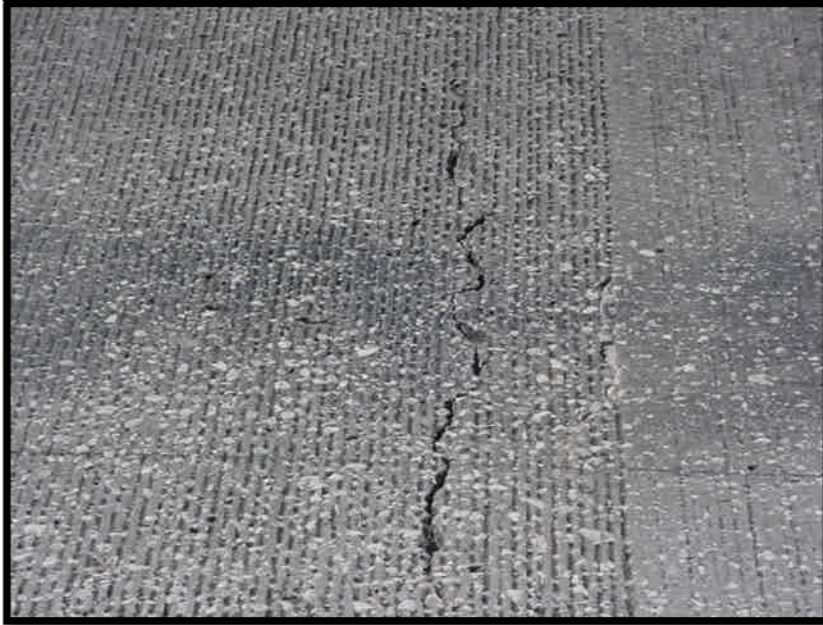
The monthly inspection reports indicate that localized repairs were made in Span 4 in April, July and September of 2005 and in February of 2007. The reports also indicate that there is a problem with transverse cracking throughout the bridge. Most of the cracking is 1/8 in. wide but three cracks in particular were identified with an approximate

width of ¼ in. [13]. The reports indicate that the three ¼ in. cracks have been present since August of 2006 as shown in Figure 3.8.

Figure 3.8 Bridge No. 100436, Span 4 Failure (3/4 in. Transverse Crack)

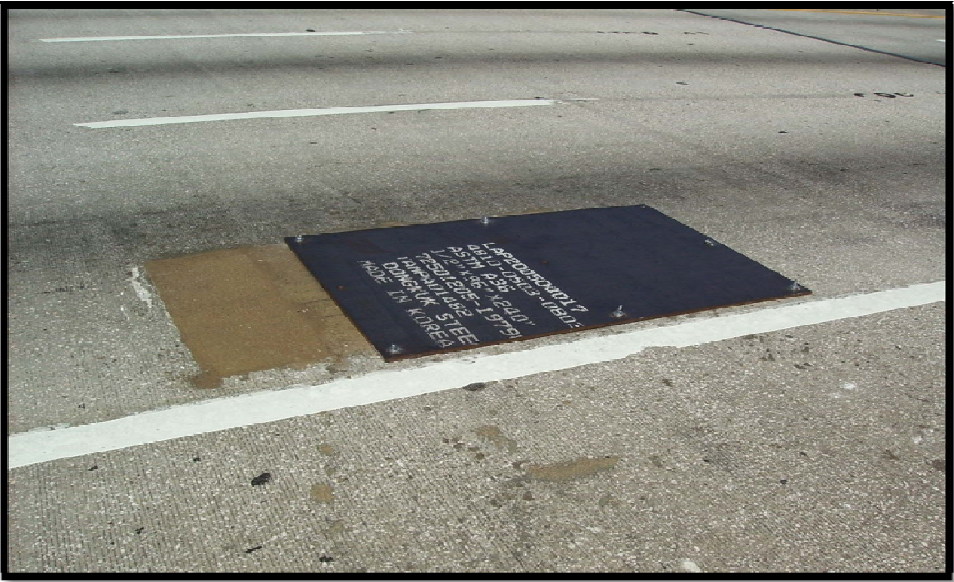
Figure 4.1 Bridge No. 100436, Span 4 Failure (Temporary Steel Plate)

ADT on I-75, the lanes could not be closed to traffic to allow the concrete to cure as required. Instead, the DSMO instructed their asset maintenance contractor to temporarily fasten a 3/4 in. thick steel plate with anchor bolts on the deck top over the failure as shown in Figure 4.1. Then timber bracing was installed in the bays underneath to prevent beams from torsion (see Figure 4.2). A few days later, the steel plate was removed and replaced with high strength, fast setting concrete repair material. This repair was performed within a few hours during a night time lane closure [17].

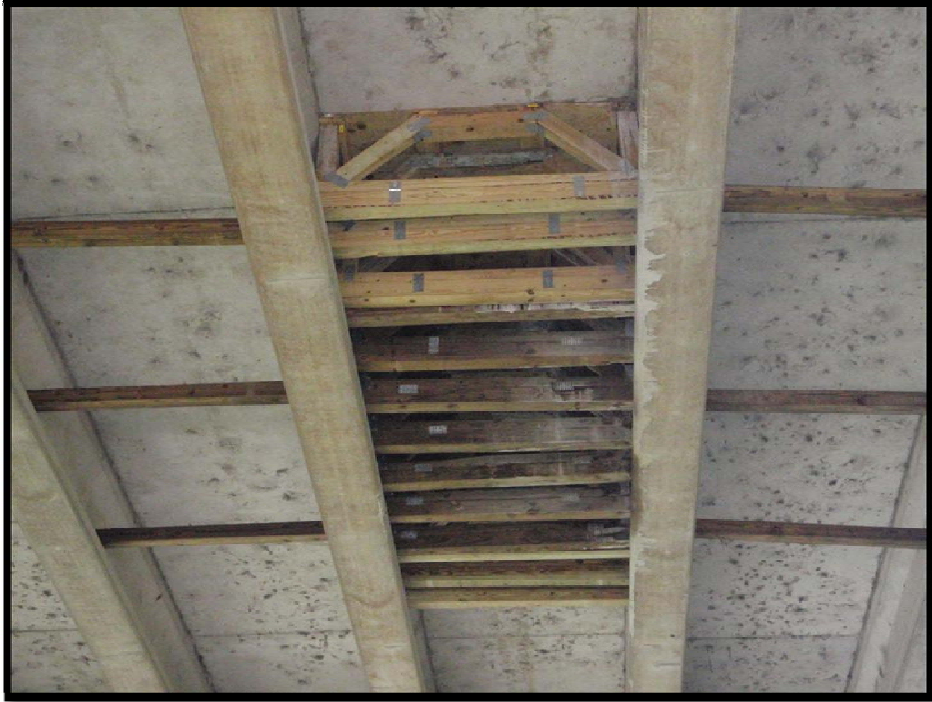
Figure 4.2 Bridge No. 100436, Span 4 Failure (Timber Bracing)

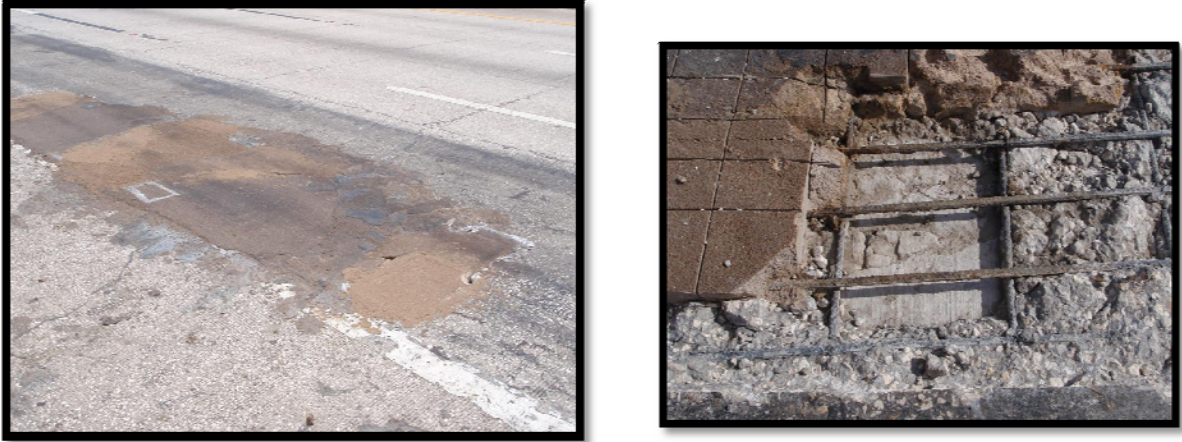
Approximately eleven months after the failure, on August 19, 2009, DSMO's monthly inspection of deck panel bridges cited significant deflection and deterioration in the repair patch material (see Figure 4.3). Asset maintenance personnel were summoned onsite, and it was agreed by all parties that an immediate repair was required. The lane once again had to be temporarily closed to traffic for a few hours. The deteriorated patch was removed and replaced with sound material and additional timber bracing was installed in both north and south directions of the existing shoring between the beams [18].

Figure 4.3 Bridge No. 100436, Span 4 (Failure in Patch Repair Material)

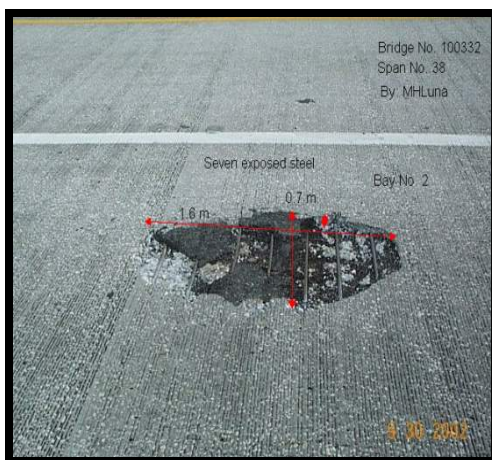
Figure B.1 Bridge No. 100332, Span 38- Asphalt Patch (2 Days Before Failure)

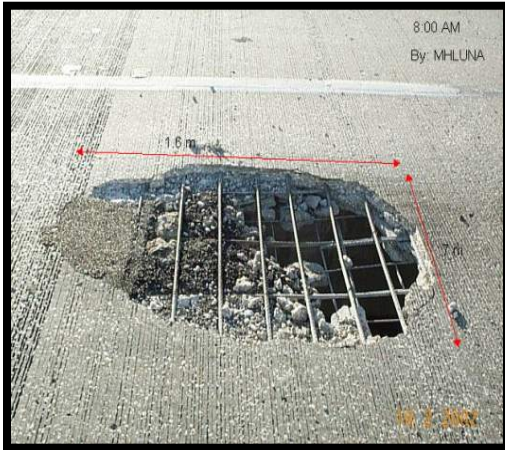
patch causes pumping action between the asphalt and the precast panel until failure. Although there is no solid proof, it is strongly believed that this is a major cause of punch through failure in the deck. Six of the seven failures in Tables 1 and 5 occurred after rainfall.

Figure B.2 Bridge No. 100332, Span 38- Asphalt Patch (Failure)

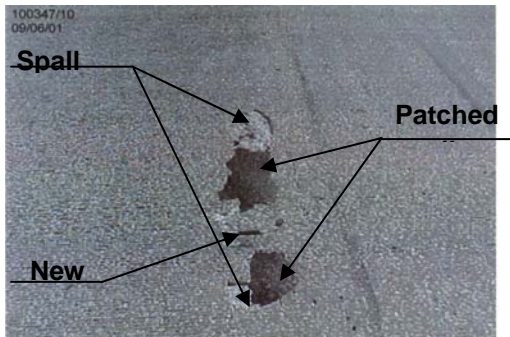
Although this is a permanent repair, the FDOT has not had much success with the longevity of these repairs. Due to the nature of the deck panel system not acting compositely, the localized repairs start separating at the edges and new spalls described as “walking spalls” start appearing in front of these repairs (see Figure B.3).

Figure B.3 Patched Spalls and Walking Spalls

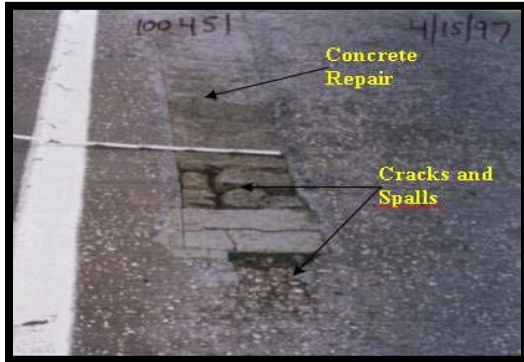
the spall. This creates additional stresses in that region, and accelerates its deterioration generating new spalls, which are also generally treated with flexible repair material (see Figure B.4).

Figure B.4 Localized Spall Repair Starting to Spall at the Edge
