# Evaluating CFRP-Masonry Bond Using Thermal Imaging

Joseph Christopher Ross

A thesis submitted in partial fulfillment  
of the requirements for the degree of  
Master of Science in Civil Engineering  
Department of Civil and Environmental Engineering  
College of Engineering  
University of South Florida

Date of Approval:  
October 18, 2013

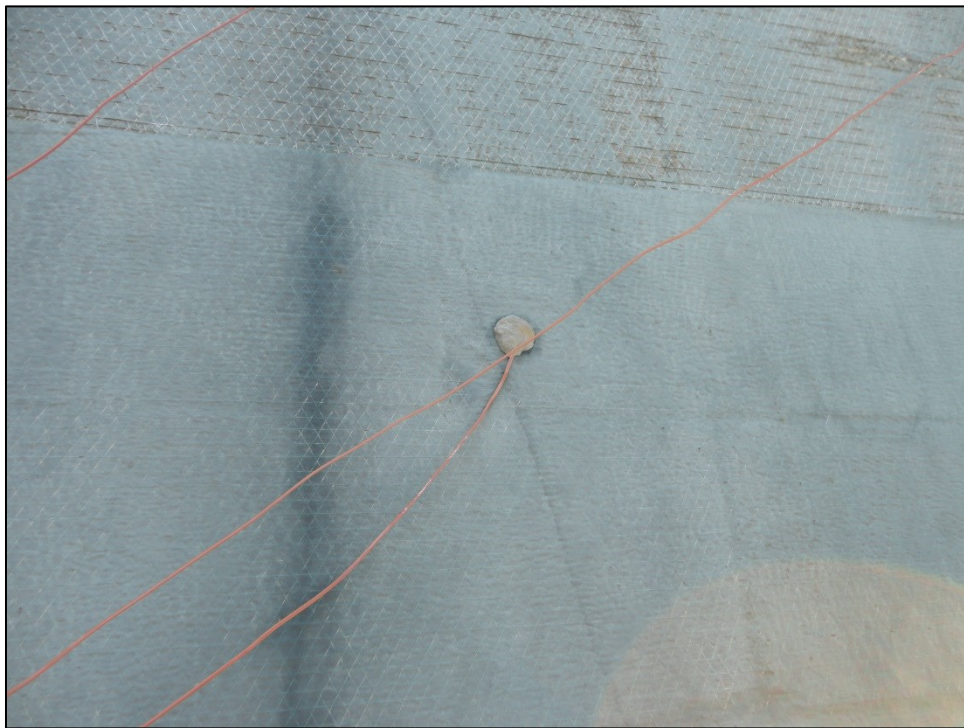
**Figure 43: Wall 2 at Location 15 near Where Hot Spots 1 and 2 were Found**

Figure 41 also shows a hot spot not far from the first. This de-bonded area was found by sounding the FRP and confirmed with infrared thermography. This area was also approximately 1" in diameter. It was located 6" above thermocouple location 15 and 2" to the left of this position. Figure 43 shows a photograph of location 15 and its surroundings. The de-bonded areas are visible and appear as the puffy areas of CFRP.

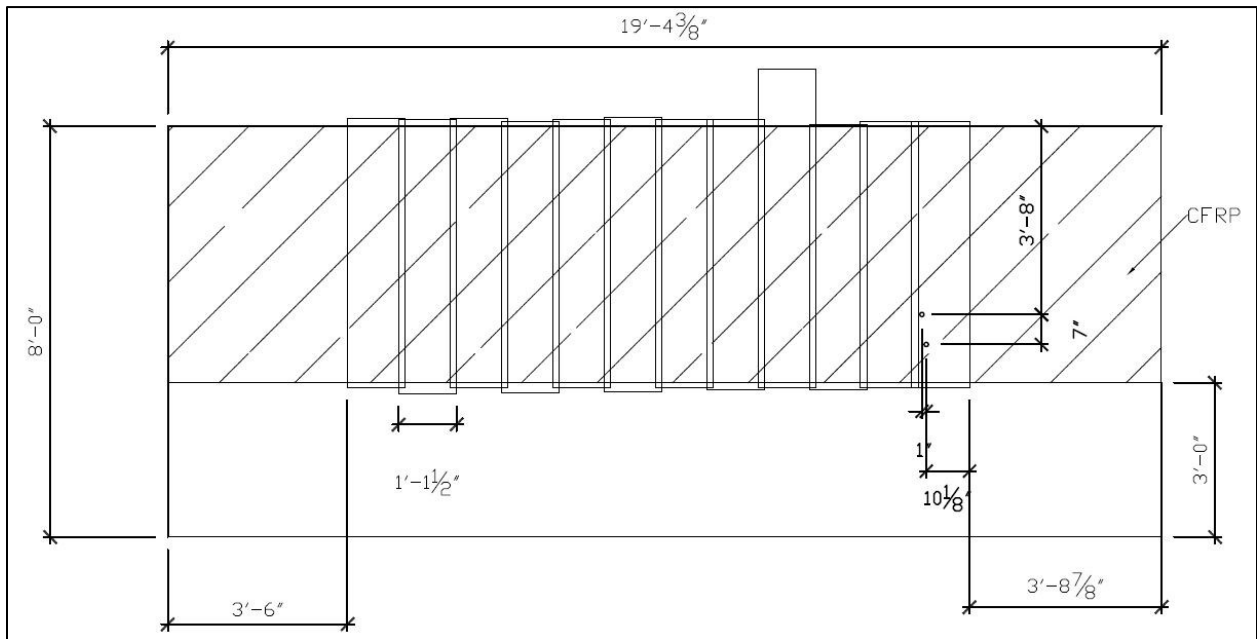
**Figure 55: Hot Spots from Thermal Camera on Wall 2 (North Side of Wall)**

<b>Anomaly #</b>	<b>Coordinates (X, Y)</b>	<b>Comments</b>
4	10'-11", ALL	False reading. Corrupted scan.
5	12'-3", 7'-10"	Defect
6	12'-9", 7'-10"	False reading, scanner stopped.
7	12'-3", 7'-5 1/2"	Defect
8	13'-0", 6'-7"	Defect
9	12'-4 1/2", 6'-1"	Defect
10	14'-1 1/2", 5'-9 1/2"	Defect
11	14'-9", 7'-11"	False reading, scanner stopped.
12	15'-0", 6'-4"	Defect
13	15'-0", 5'-10"	Defect
14	15'-0", 5'-0 1/2"	Defect
15	14'-0 1/2", 3'-2"	Defect
16	15'-0", 4'-5"	Defect. Hot spot 2 detected with thermal camera.

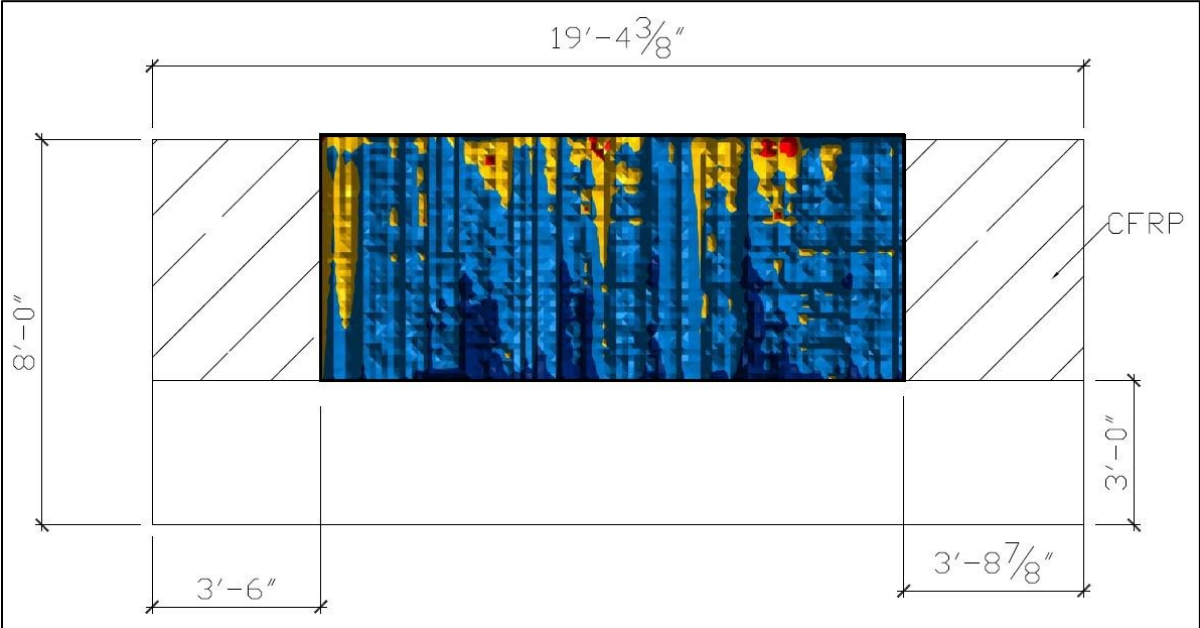
**Figure 60: Results on Wall 3**

Anomaly #	Coordinates (X, Y)	Comments
5	13'-0", 6'-5"	Defect
6	13'-0", 7'-10"	False Reading, scanner stopped.
-	Global warm regions	Caused by passive heat sources.

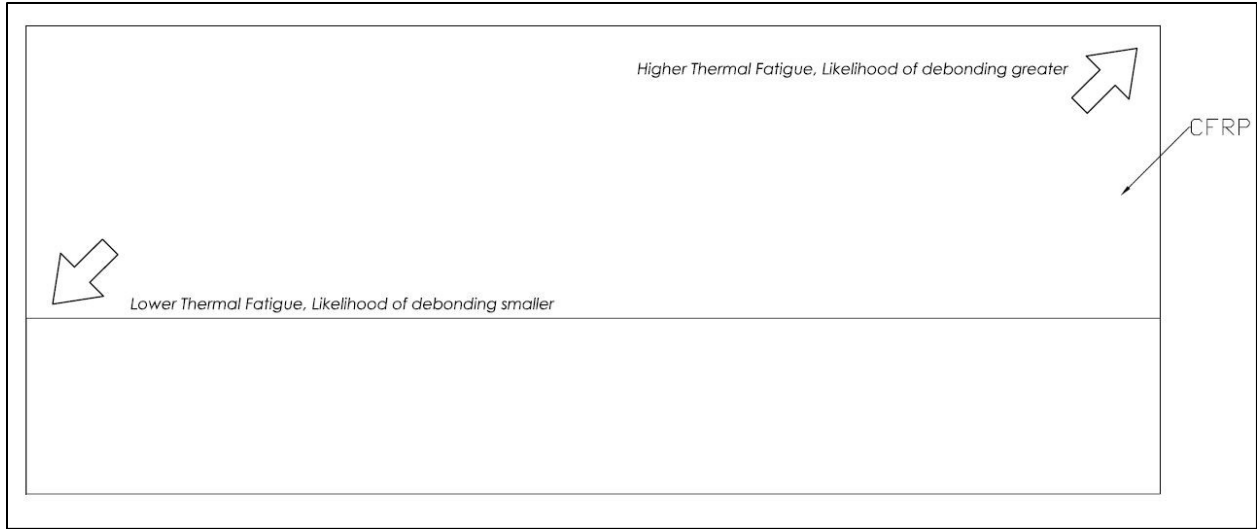
**Figure 61: General Predictions on CFRP Bond on Walls 2 and 3**

Based on the number of hot spots found using both active and passive thermography the Toner epoxy is performing better than the Henkel epoxy. In general, the bond has endured; however, there are a few localized areas that have de-bonded. Pull-off tests are recommended on walls 2 and 3. Five locations in regions suspected to have poor bond and five locations in regions suspected to have good bond are identified for each wall.
