INVESTIGATION OF WHEELCHAIR INGRESS/EGRESS ACTIVITIES IN LARGE
ACCESSIBLE TRANSIT VEHICLES AND EVALUATION OF ADA RAMP
GUIDELINES FOR IMPROVED RAMP SAFETY AND USABILITY

Sheryll Sison
B.S., University of Louisville, 2007

A Thesis
Submitted to the Faculty of the
University of Louisville
J.B. Speed School of Engineering
in Partial Fulfillment of the Requirements
for the Professional Degree

Department of Mechanical Engineering

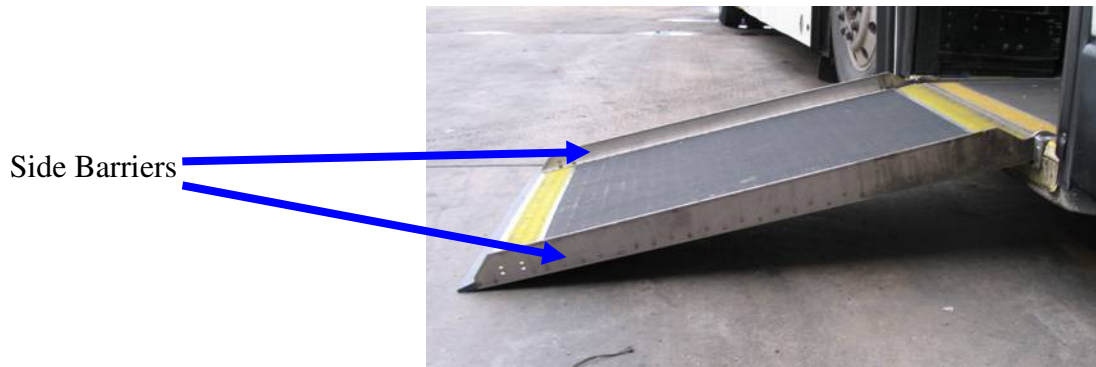
FIGURE 8 – TARC LATV Ramp Side Barriers

The main purpose of side barriers is to prevent wheelchairs from falling from the ramp. The ADA guidelines specify a side barrier height of 2 inches as measured from the surface of the ramp. TARC LATV side barriers as shown in Figure 8 are 2 inches in height from the ramp surface to the top of the barriers, and thus meet ADA guidelines. In this study, ramp side barriers performed sufficiently in containing the wheelchair within the ramp area in all events except during one egress incident. This incident involved a power wheelchair user who drove his/her front right wheelchair caster over the right side barrier during egress. The LATV operator assisted in placing the caster back onto the ramp and guided the wheelchair and wheelchair passenger down the ramp. With the improvements in wheelchair maneuverability and power output (especially in power wheelchairs), a raised barrier may be necessary to prevent future incidents (LaPlante, 2003).

Lastly, the height of the side barriers in relation to power wheelchair and scooter propulsion should be further investigated. The power required to overcome obstacles such as side barriers is proportional to weight of the wheelchair, wheelchair user, and personal items. Based on the only incident that occurred in this study, the side barriers failed to contain the wheelchair within the ramp surface area. An increase in the height of the side barriers may have prevented the wheelchair and/or any wheelchair components from traversing over the ramp side barrier.

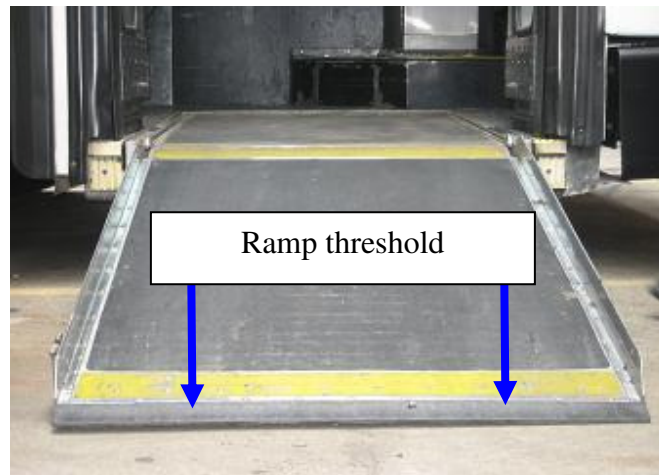
Figure 9 – TARC LATV Ramp Threshold

Ramp thresholds on TARC LATVs are beveled with a rubber wedge and meet the ADA specifications of a slope of 1:2 as shown in Figure 9. However, when the ramp is extended onto uneven terrain surface, the ramp may not be completely flush with the surface. This may be a result of uneven surface terrain or degradation of rubber material. Regardless of the underlying cause, vertical gaps between the outer terrain surface and the ramp surface may result in ramp deformation from wear and tear. In this study, the wheelchair passenger experienced minor bumps and stops when the wheelchair initiated contact with the ramp.

designed for loads up to 600 lbs. Several TARC LATV ramps showed deformation when the ramp was extended, which was evident by uneven vertical gaps between the ramp threshold and the terrain surface. During video analysis, we also observed both ambulatory passengers and a wheelchair passenger occupying the ramp at the same time. With the increase in heavier wheelchairs and common occurrences of ambulatory passengers occupying the ramp simultaneously with wheelchair passengers, current ramp design specifications may not be sufficient and must be reconsidered for higher ramp loads.

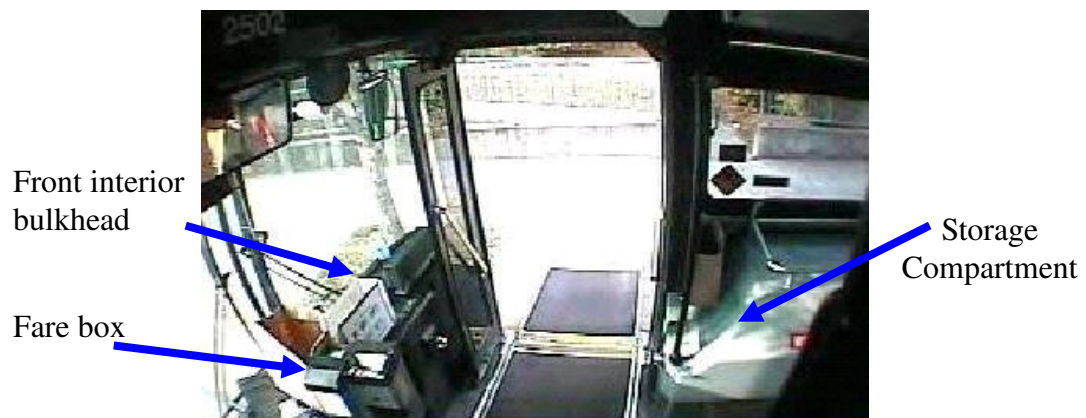
FIGURE 10 – Interior TARC LATV Components in Access Path

shown in Figure 10. Integration of the fare box into the LATV front interior dashboard will eliminate the surface footprint of the fare box post which may reduce occurrences of LATV obstruction. Furthermore, reduction of front storage compartments to accommodate larger access path widths may also decrease wheelchair passenger difficulty and/or incident. Current ADA requirements only address surface widths in terms of allowable floor space for wheelchair passengers and are based on common wheelchair widths. Additional research is needed to accommodate not only large wheelchairs, but also allowable space required above the floor surface for bags and other personal items attached on the wheelchair.

Additionally, TARC LATVs are equipped with mounted interior lights that protrude into both sides of the aisle and are adjacent to the LATV door. These mounted lights protrude approximately 18 inches above the LATV floor. Although the review of video data was unable to conclusively determine whether or not these interior lights obstructed passengers observed in this study, these lights may be an additional source of LATV component obstruction. Replacing these interior light fixtures with LED floor strips may provide more room for wheelchair passengers to maneuver.

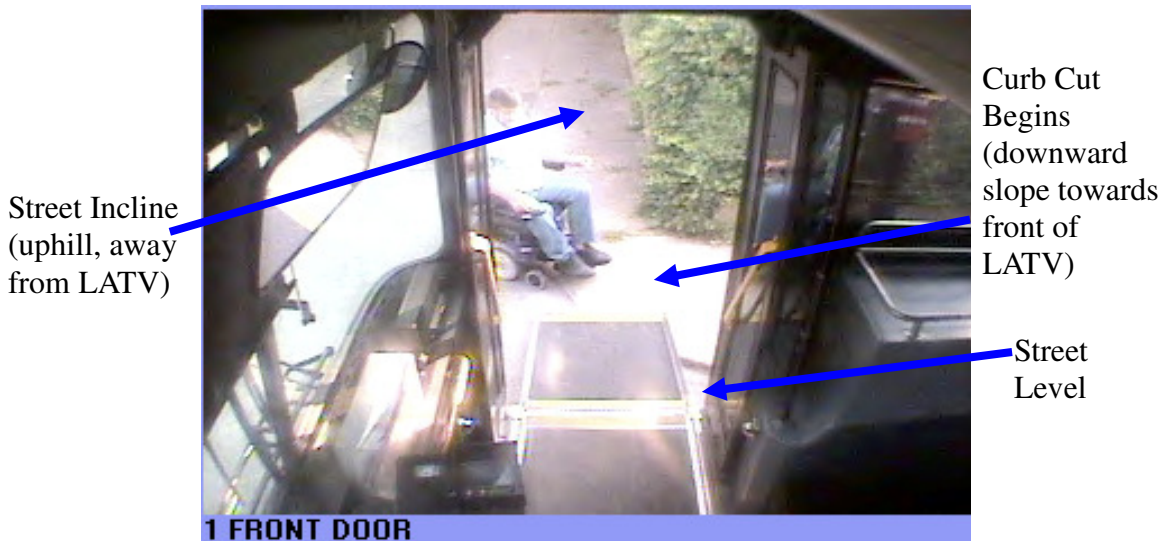
FIGURE 11 – Example of ramp deployment onto uneven surfaces

LATV operator factors contributing to adverse events involved ramp extension onto uneven surfaces (i.e. deploying the ramp across a curb cut and sidewalk) and ramp extension near sidewalk curbs (when ramp is deployed onto street). Figure 11 shows an example of the ramp being halfway extended onto the street and the other half onto curb

cut. In this study, ramp deployment onto uneven terrain and/or inadequate clearance beyond the ramp contributed in 5 of 22 adverse ingress events (see Appendix II). These factors may contribute to frustration for wheelchair passengers who have to perform multiple back and forth maneuvers to overcome the uneven terrain or limited clearance. Consequently, these factors may also increase ingress time, which may delay the fixed-route schedule to which LATV operators must adhere to for other passengers who rely on their services. There were no ramp extension issues that contributed to adverse egress events. Additional LATV operator training is recommended to ensure the ramp is deployed with sufficient clearance for wheelchair passenger ingress/egress. In addition, public obstructions such as bike racks, LATV stop shelters, fire hydrants, and trashcans should be avoided.
