Detection and characterization of impact damage in carbon fiber aircraft fuselage structure

**DETECTION AND CHARACTERIZATION OF IMPACT
DAMAGE IN CARBON FIBER AIRCRAFT FUSELAGE
STRUCTURE**

THESIS

**Master of Science
Civil Engineering**

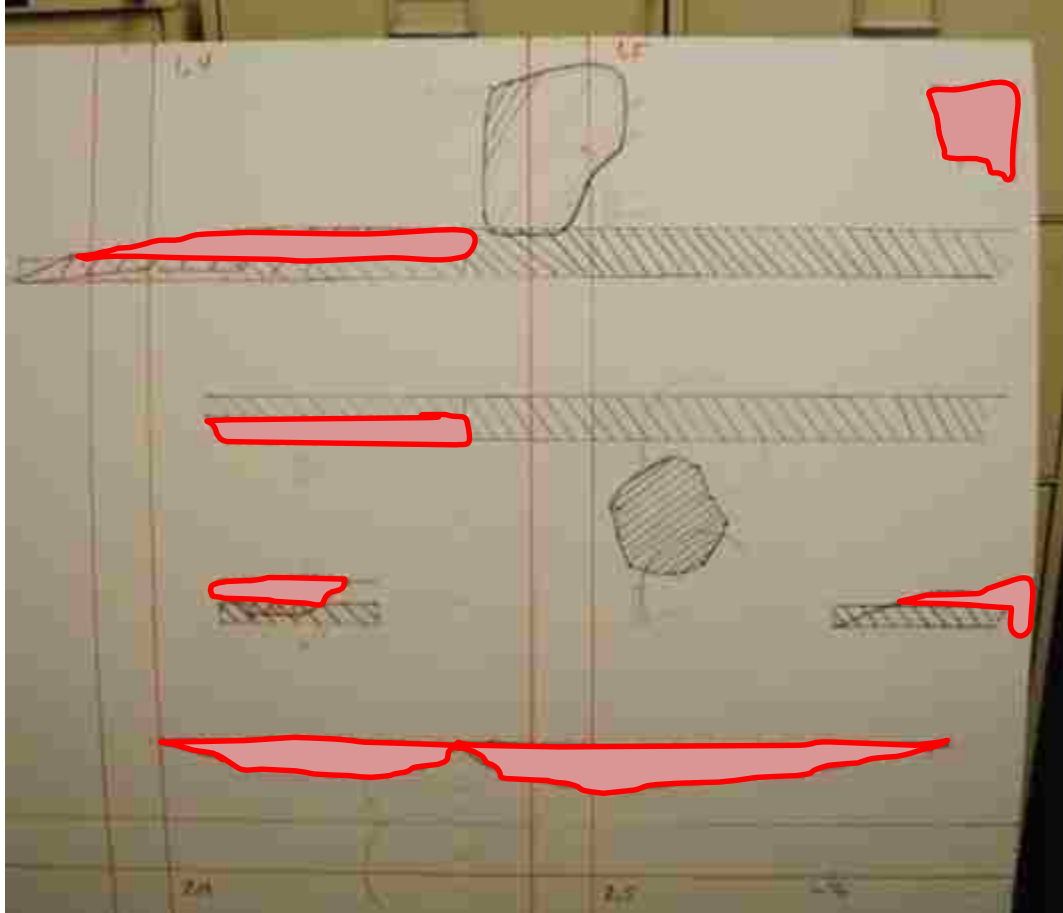
The C-scan inspections revealed significantly more information than the hand held pulse-echo inspections performed during impact testing. Flaws that were difficult to size using hand deployed UT were easily sized and mapped using a combination of amplitude and time of flight C-scan images. The difference in damaged mapping is illustrated on the top left side of panel B in Figure 4-3. The black mapped regions of damage were sized using hand held UT and the red mapped regions were mapped using a combination of UT amplitude, TOF and resonance.

Figure 4-3: Top Right Side of Panel B - Black Mapped Damage Was Detected After Impact With Hand-Held UT and Red Mapped Damage was Additional Damage Detected and Sized Using the MAUS V Scanning System

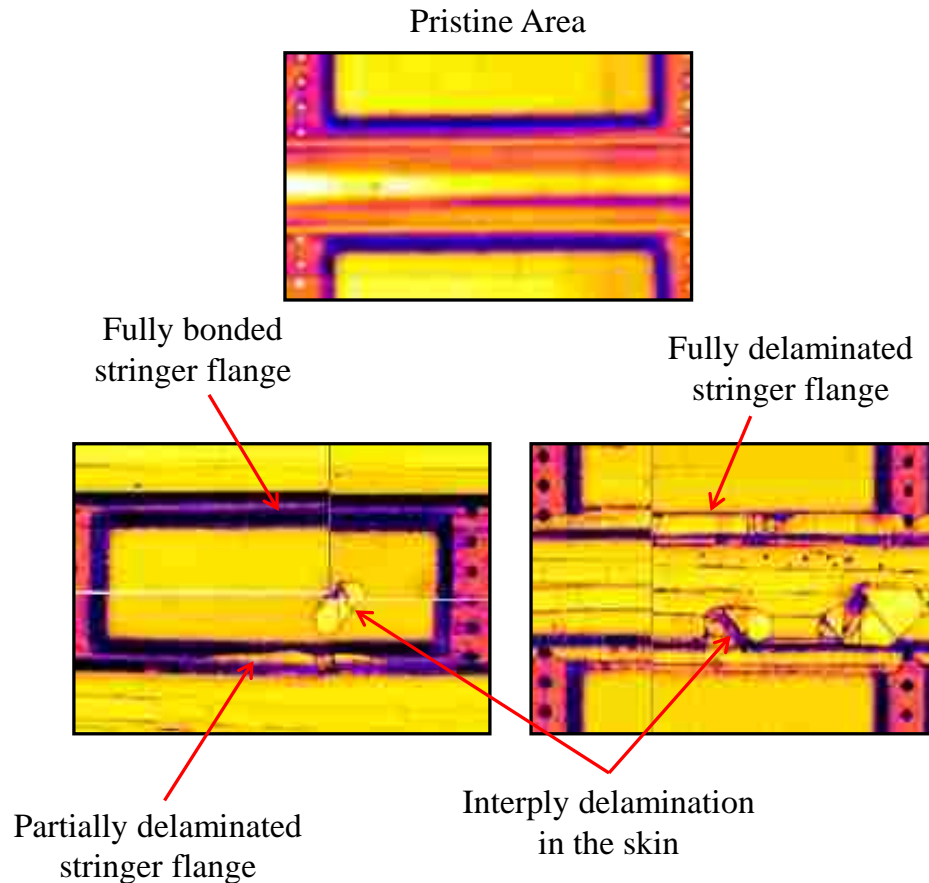
figure has one fully bonded stringer flange, and one partially disbonded flange. The image on the right has two fully bonded flanges. These two images can be compared to the pristine area shown at the top of the figure.

Figure 4-4: Impact Damage Induced on Panel A Showing the Difference Between Interply Delamination and Stringer Flange Delamination

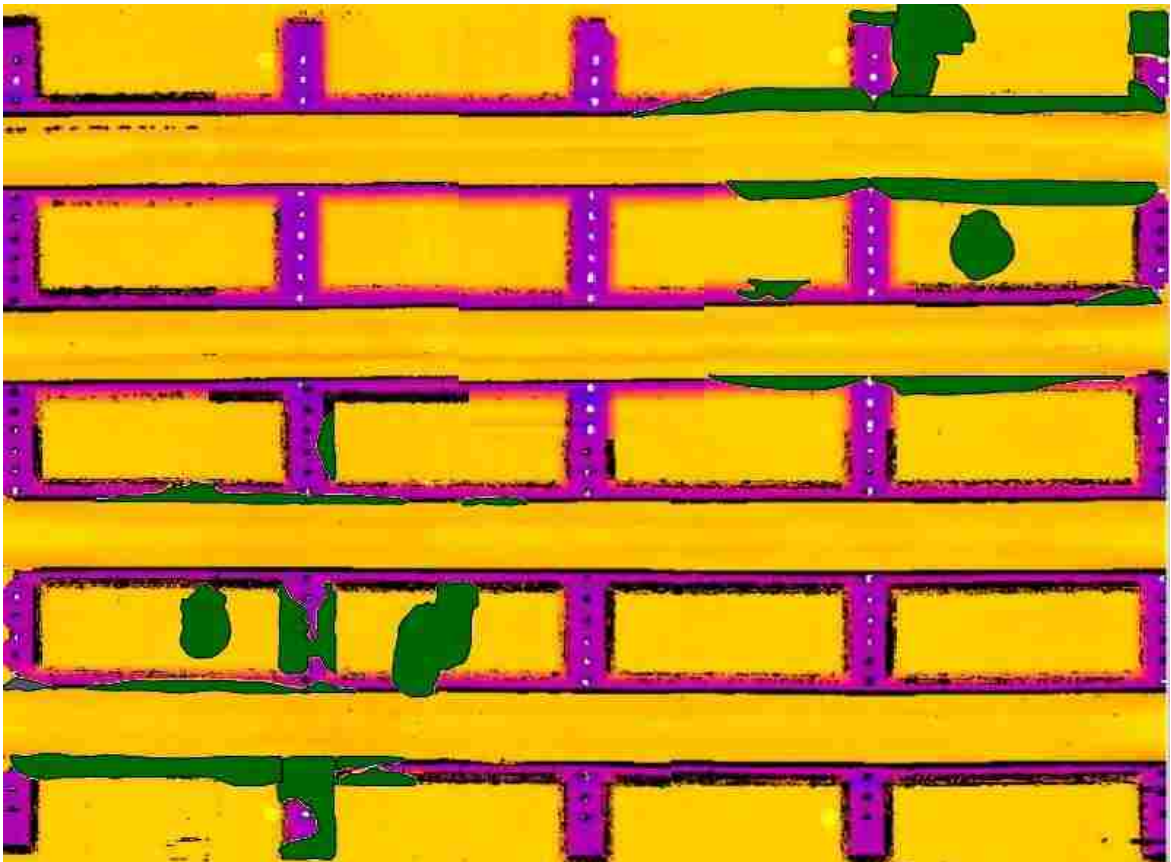
The area of damage induced by simulated hail impact damage was determined using time of flight C-scan images generate during pulse-echo UT inspections. The TOF C-scans were imported into SolidWorks and scaled to the physical dimensions of the panel. The damage was traced and the area was calculated using a Solid Works surface area calculation feature. The traced areas used to calculate the damage area on panel B are shown in Figure 4-14.

Figure 4-14: Green Tracings Used to Determine Damage Area on Panel B

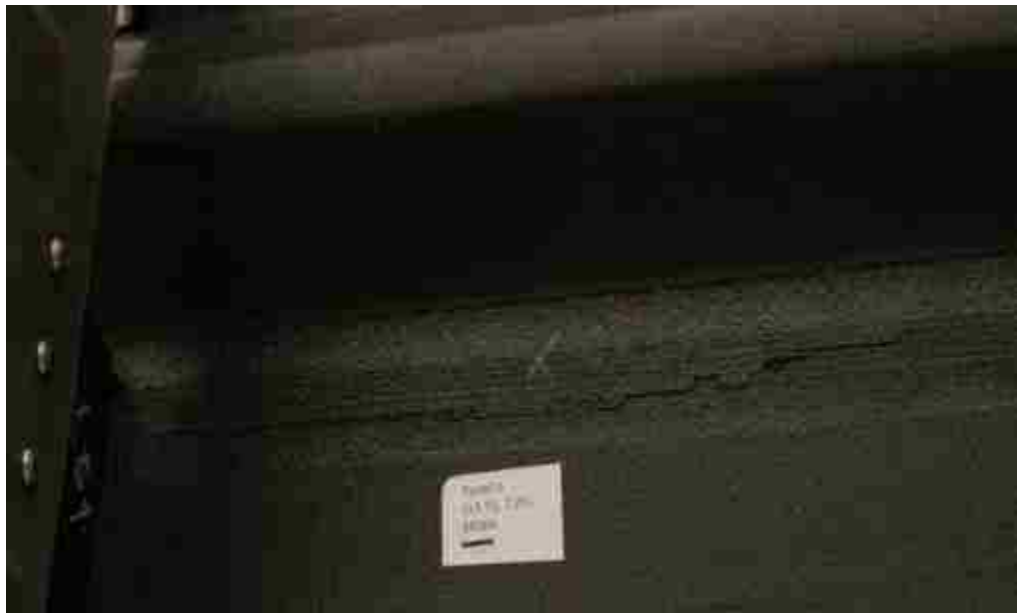
Figure 4-15: Stringer Flange Delamination Detectable from Backside of Panel A

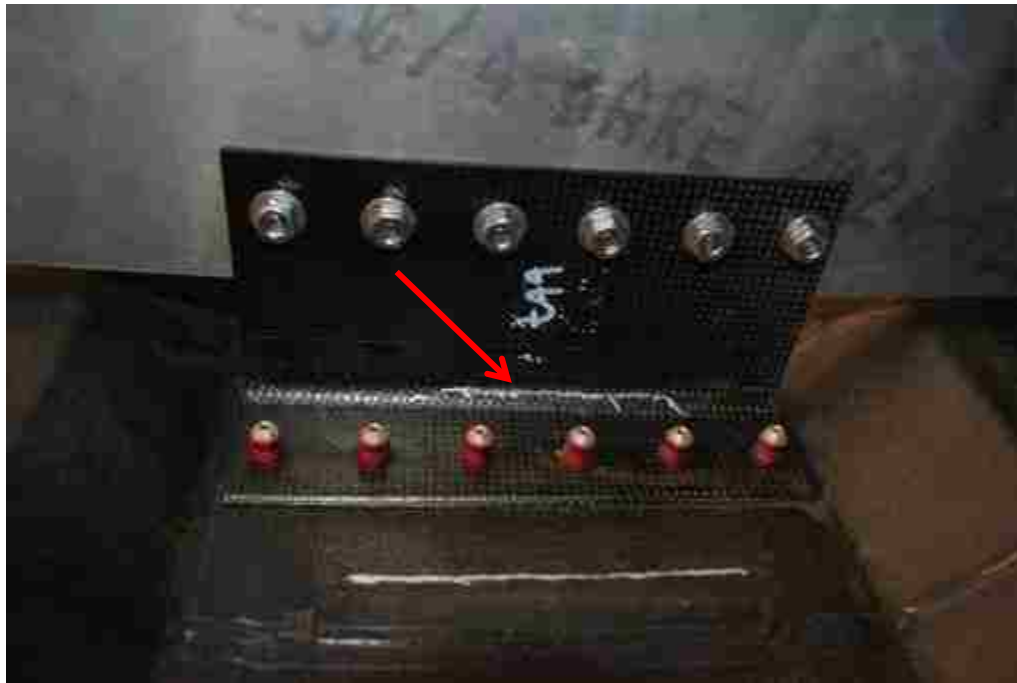
Figure 4-16: Crack on Shear Tie Bend Radius Not Detectable Using NDI from Front Side of Panel

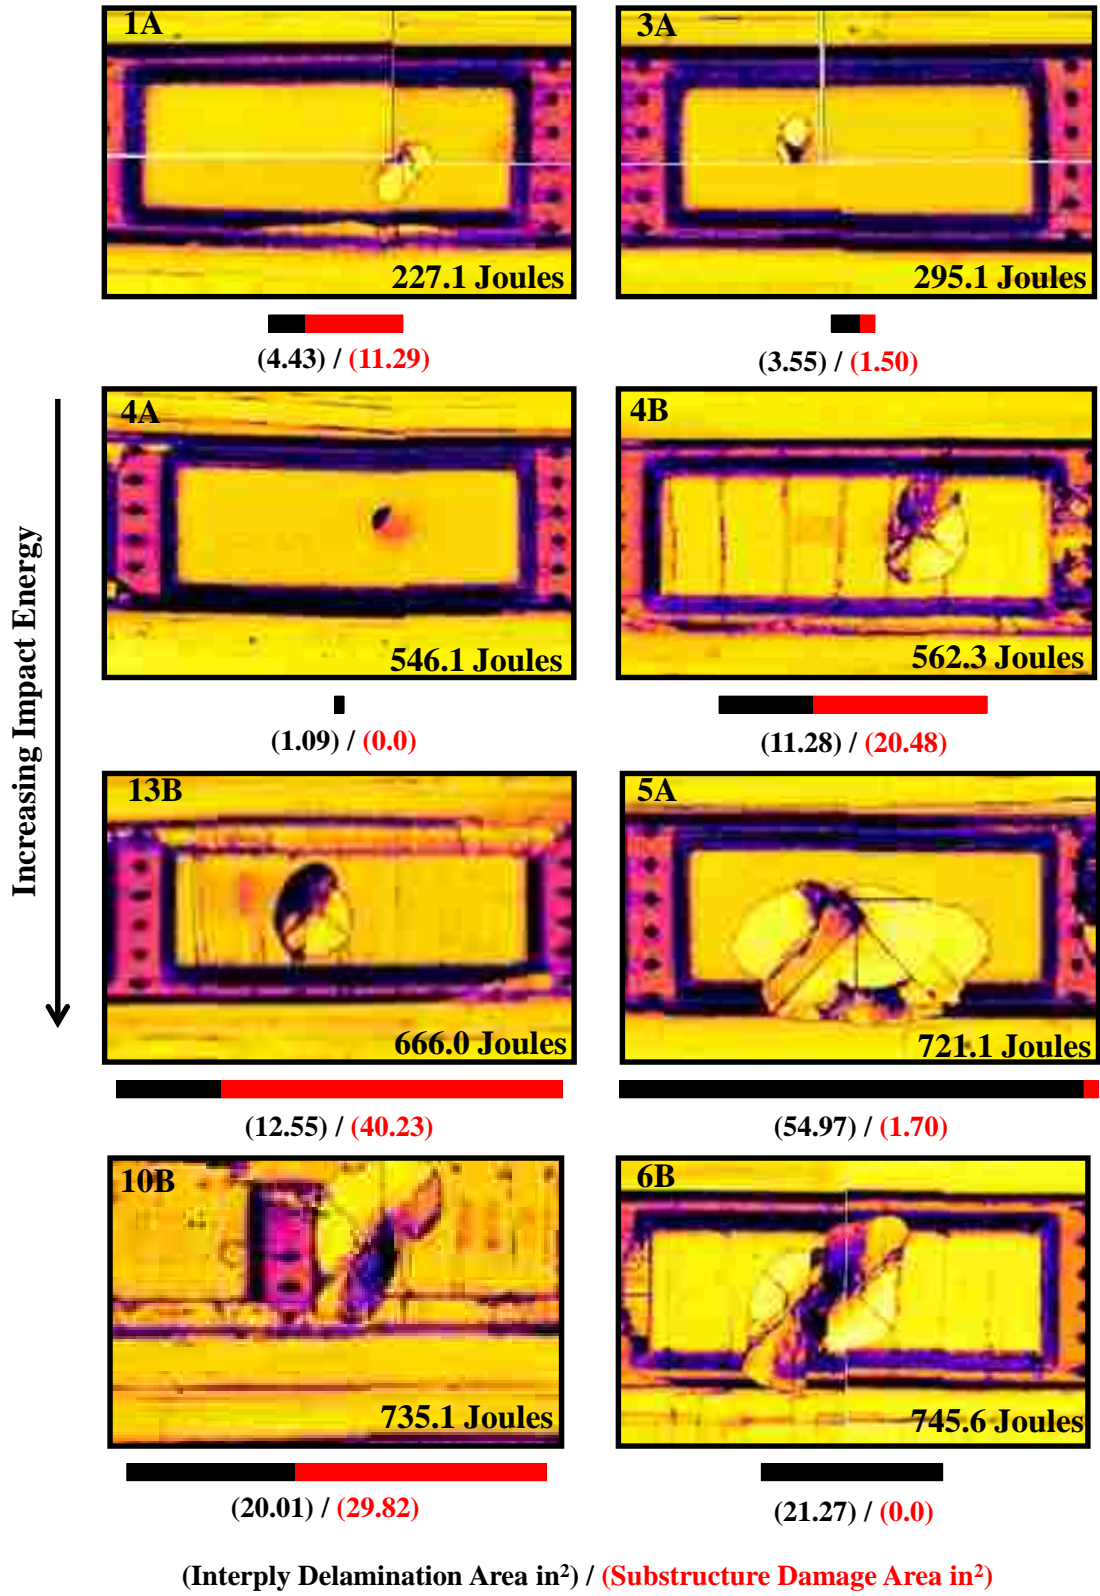
To illustrate the damage produced from mid-bay skin impacts, inspection results along with associated damage area and the associated impact energy levels are shown in Figure 4-19. The minimum energy level to achieve damage was (1A) 227.1 Joules.

Figure 4-19: Amplitude C-Scan Results for Simulated Hail Mid-Bay Impacts (Type I1)

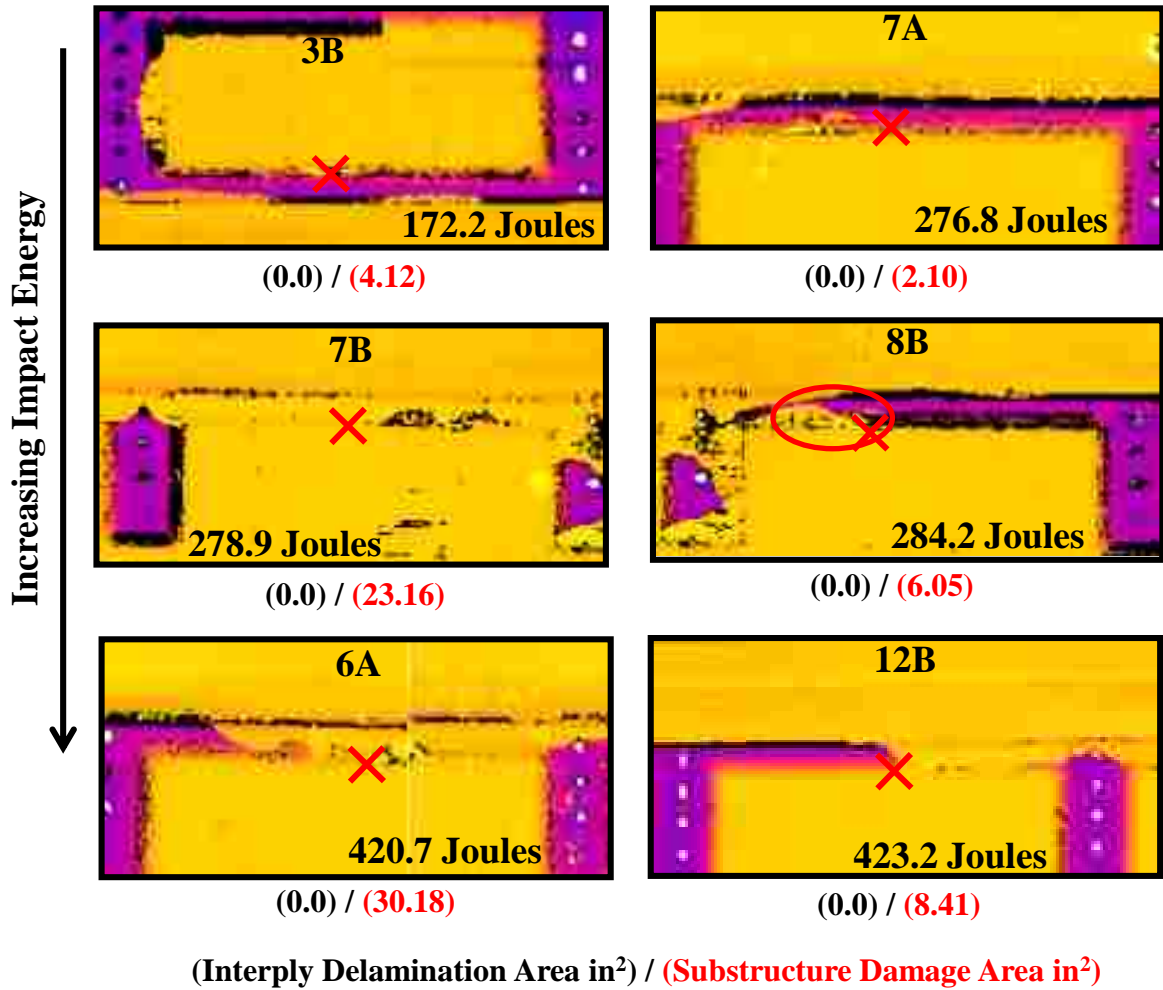
substructure delamination area. This could potentially be due to the proximity of 7B to the edge of the panel, but this was not observed in other edge bay impacts.

Figure 4-21: Ultrasonic TOF C-Scans of Stringer Flange Edge Impact Damage Produced by Impact at X (Type I2a)

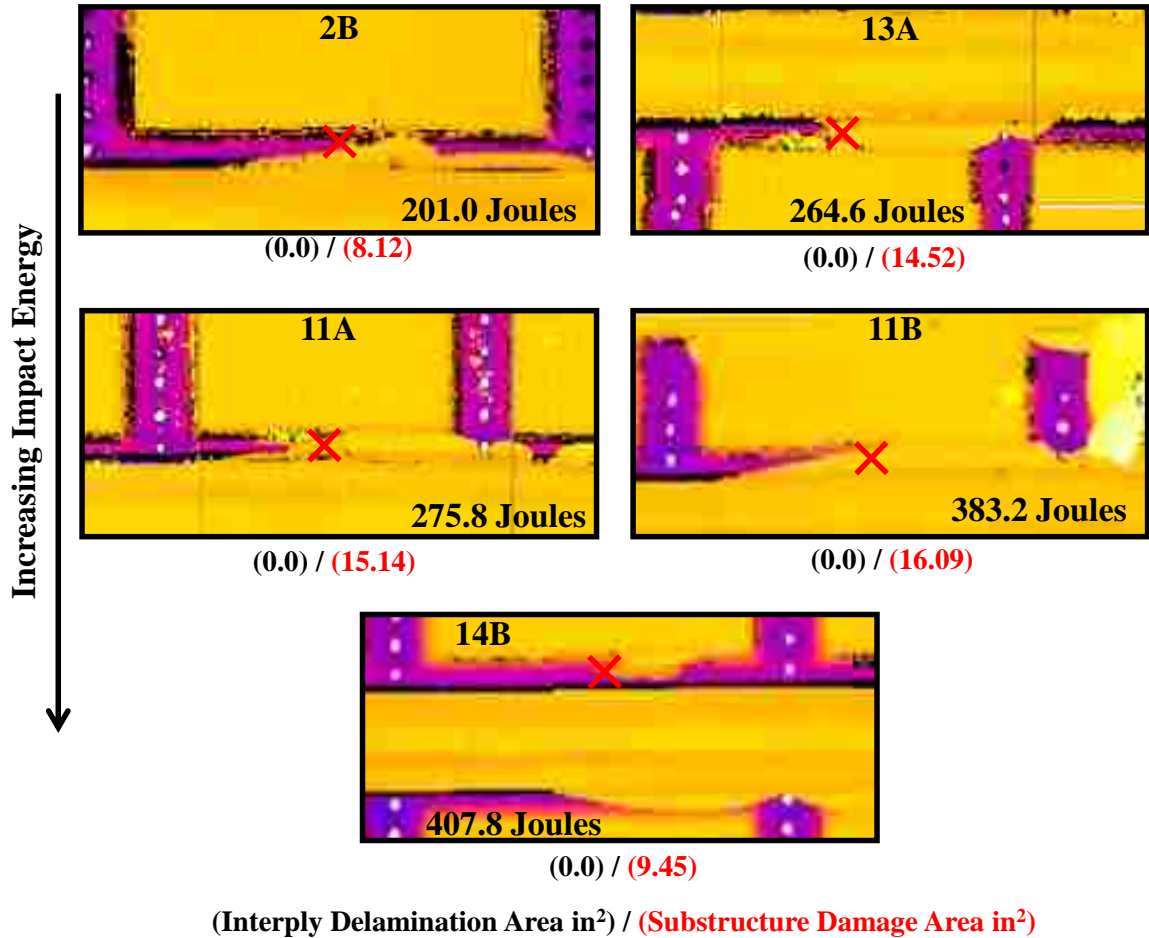
Damage associated with center of flange impacts (type 2b) are shown in the TOF images in Figure 4-22. Interestingly, impact 14B was the highest energy impact of this type and showed fairly little delamination at the impact site, but did cause delamination of the adjacent stringer flange.

Figure 4-22: Ultrasonic TOF C-Scans of Center Stringer Flange Impact Damage Produced by Impact at X (Type I2b)

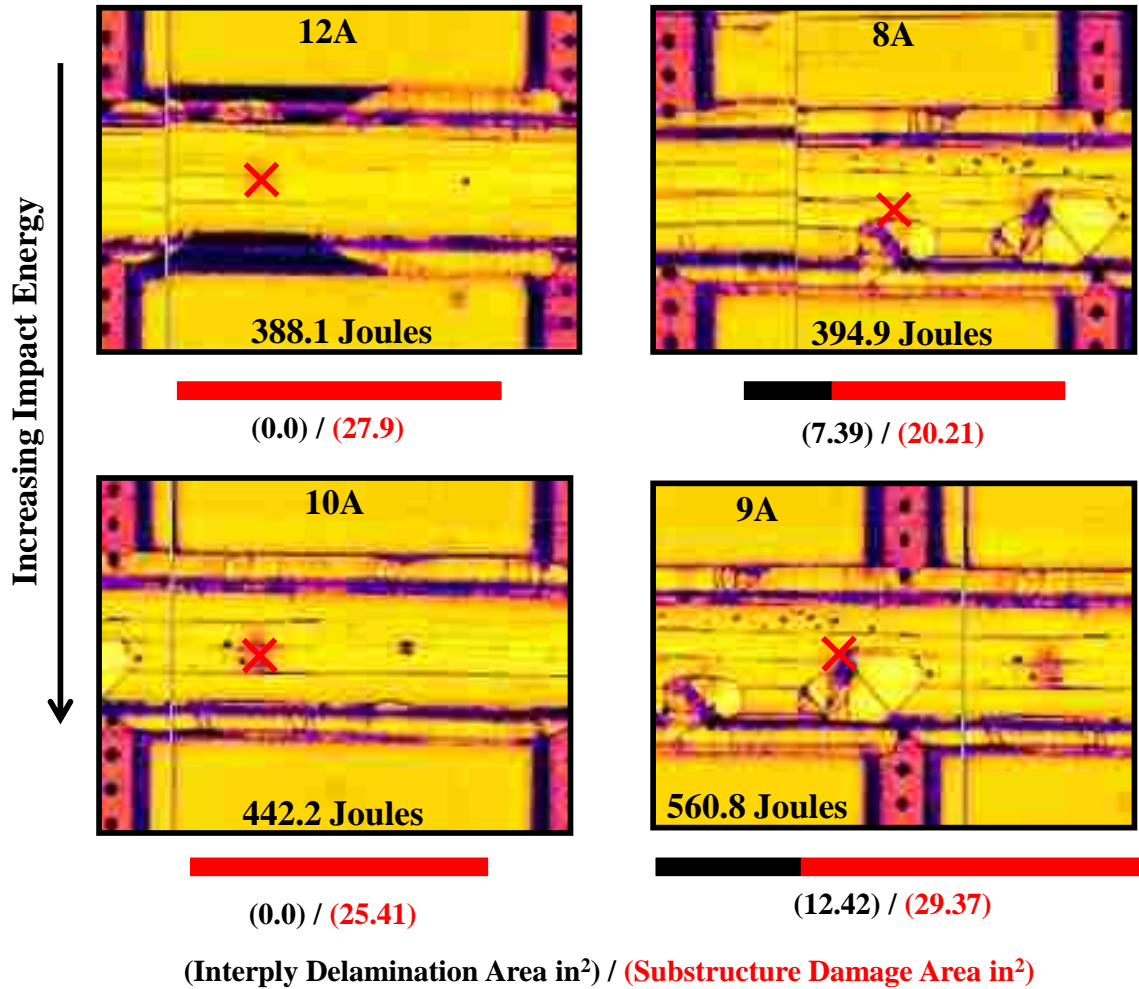
Figure 4-25: Ultrasonic Amplitude C-Scans of Mid-Stringer Impact Damage (Type I3)

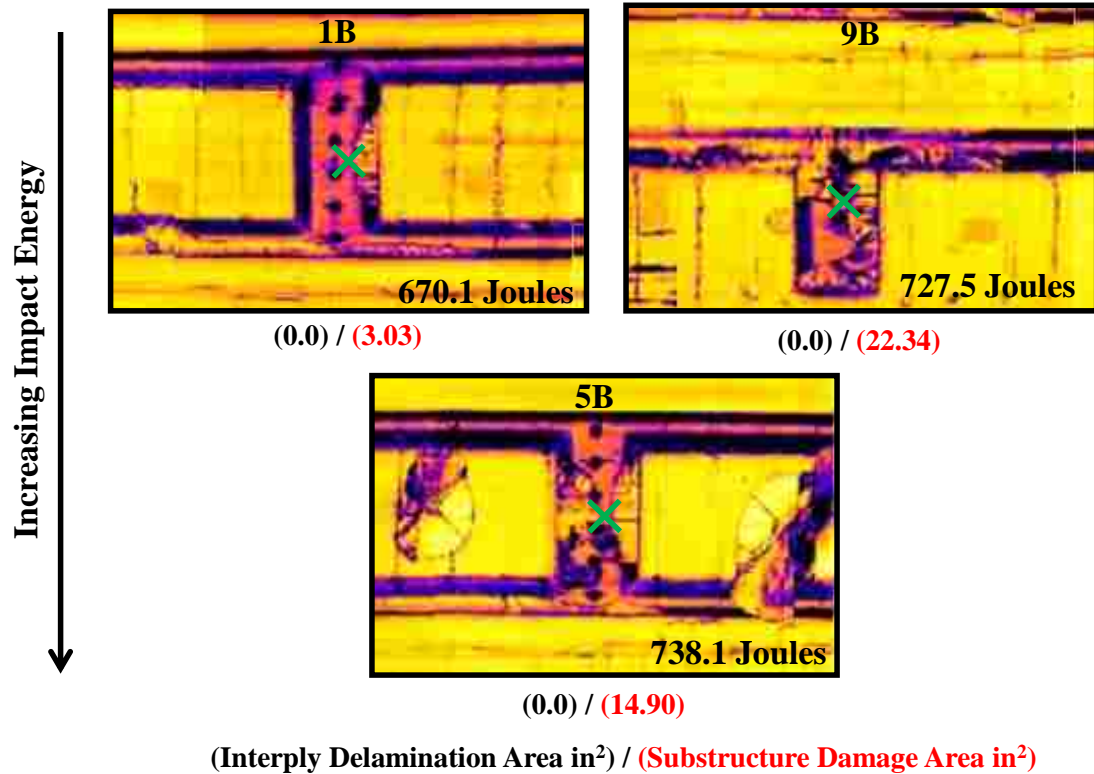
Figure 4-27: Ultrasonic Amplitude C-Scans of Shear Tie Impact Damage (Type I4)

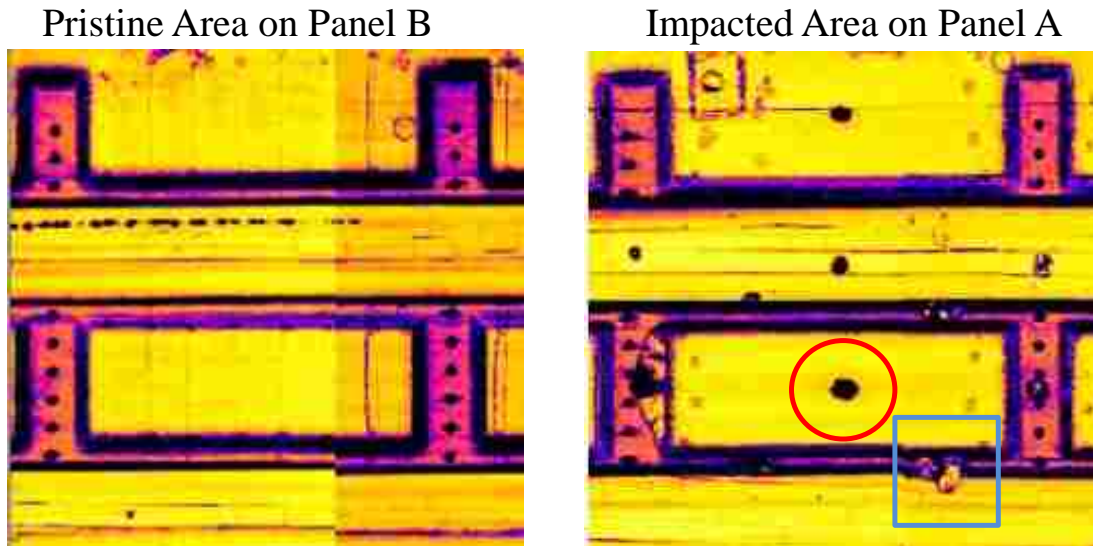
Figure 4-32: Example of Spherical Tip Impact Damage On Panel A

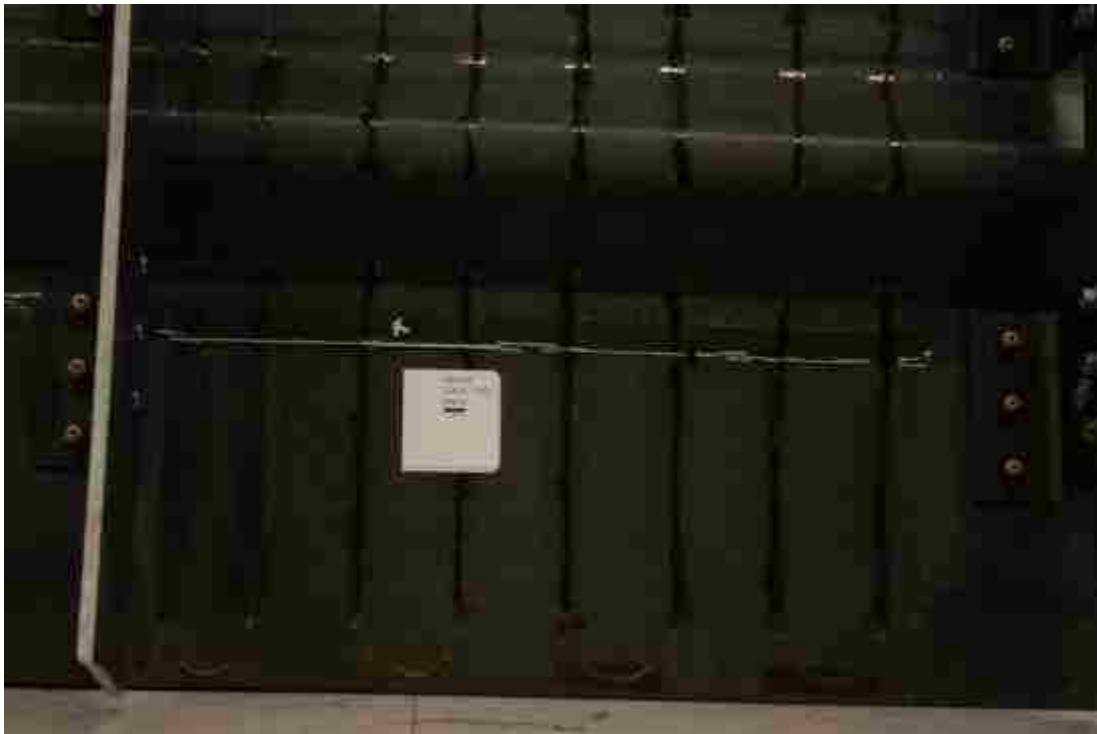
Figure 4-35: Broken Fiber Optic Due to Stringer Flange Delamination
