Fatigue Failure Evaluation of Tie Plates due to Secondary Deformations on Steel Plate Girder Bridges

Xiang Li
Lehigh University

A Thesis

In Candidacy for the Degree of
Master of Science
In
Civil Engineering

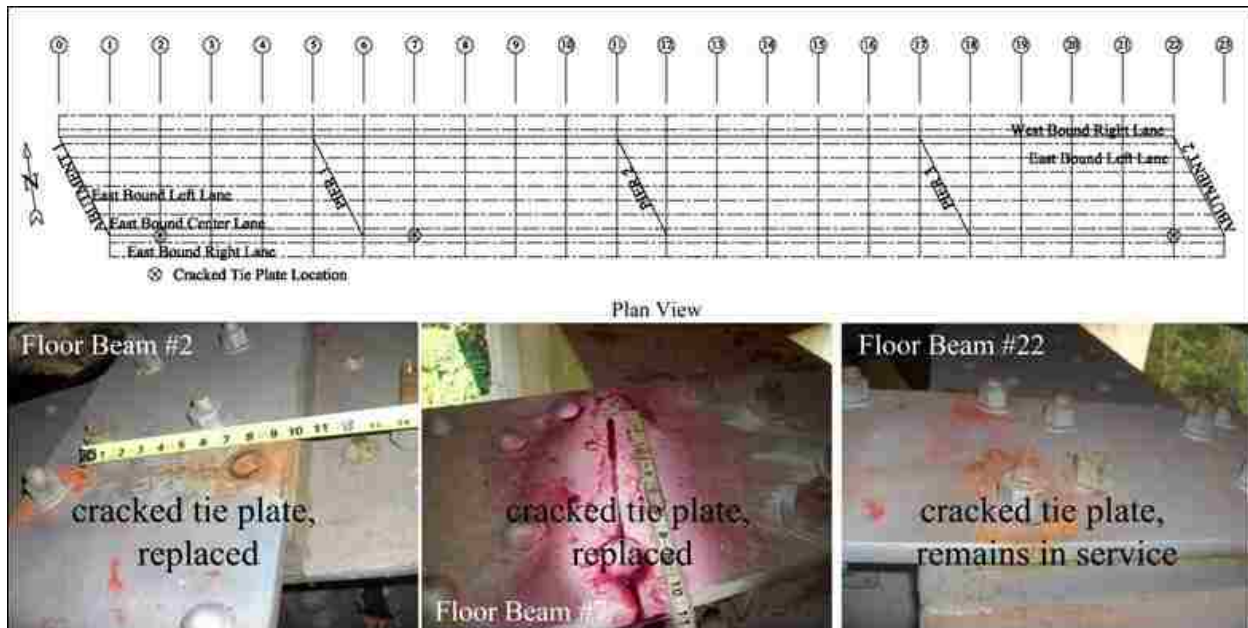
Figure 2-5: Location of the three cracked tie plates discovered on the bridge

A 2009 inspection of the bridge revealed a crack of a tie plate connecting the main floor beam to the cantilever bracket over the top flange of the girder (see Figure 2-4). The crack was discovered in the tie plate at floor beams 2, 7 and 22 at the south girder (see Figure 2-5). The crack at floor beam 2 was approximately 5.5 in. long and was removed from the bridge and replaced with a similar tie plate by PennDOT. This new tie plate with identical dimensions as the one it replaced is not connected to the girder and the beveled fill plate has been removed. The cracked tie plate at floor beam 7 was removed from service and replaced using the same procedures as floor beam 2. The crack at floor beam 22 was located at the inside tie plate to girder bolt hole and propagated only to the edge of the plate. This tie plate remains in service.

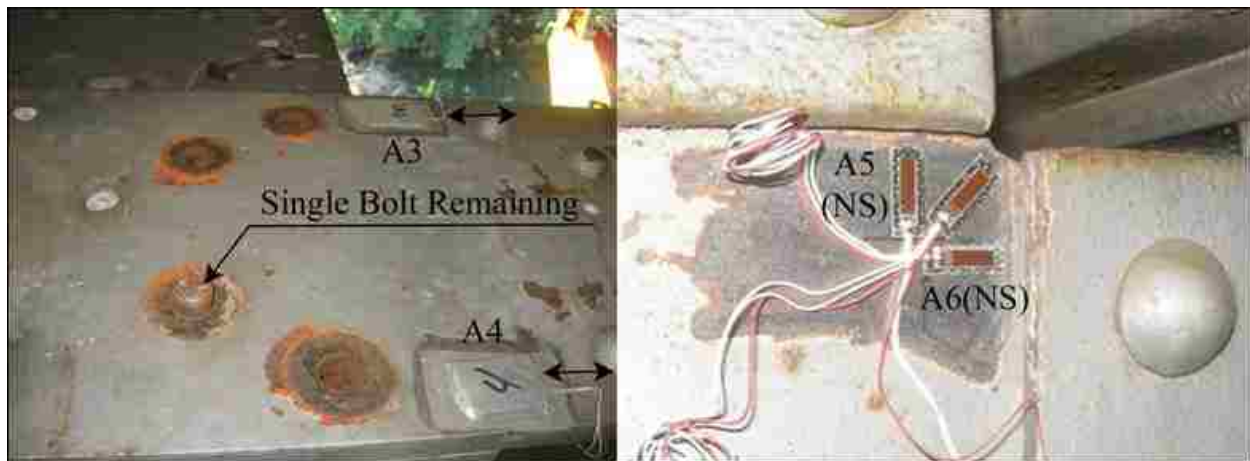
Figure 2-8: Strain gages installed on the tie plate (A3, A4) after 7 of the 8 bolts removed and on the cantilever bracket web (A5, A6)

However, it should be noted that the PennDOT bridge crew was not able to remove all eight bolts connecting the tie plate to the girder. One bolt remained in place (without the nut). A

photograph of this tie plate with the single bolt in place is shown in Figure 2-8. The expected lateral deformation of the plate was expected to be less than 0.05 in., which is less than the distance between the remaining bolt and the bolt hole. Consequently, the remaining un-tensioned bolt was deemed to be acceptable for the evaluation. Horizontally- and vertically-oriented strain gages were installed on both sides of the cantilever bracket web (back-to-back). In addition, back-to-back diagonally-oriented strain gages were installed. The three strain gages installed on one side of the bracket web at Location A was also shown in Figure 2-8.

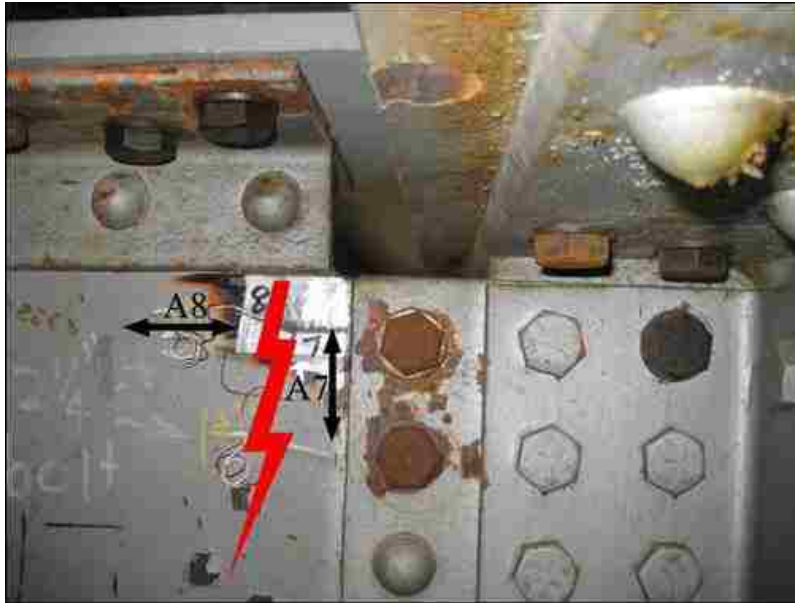
Figure 3-6: Potential web cracking (in red) locations in web of cantilever bracket

Estimates for the remaining fatigue life for A8 and B8 in **Error! Reference source not found.** and Table 3-2 reveal that removal of the tie plate-to-girder connection removes the restraint between the tie plate and the girder. This results in longitudinal displacement on the floor beam and cantilever bracket webs causing the region to bend out of plane. This additional demand can result in fatigue cracking of the web region (sketched in Figure 3-6). The strain gages measurements indicate that a vertical crack along the connection angle would occur before a horizontal crack (higher stresses in the horizontally oriented gages).
