Rapid repair of severely damaged RC columns under combined loading of flexure, shear, and torsion with externally bonded CFRP

RAPID REPAIR OF SEVERELY DAMAGED RC COLUMNS UNDER
COMBINED LOADING OF FLEXURE, SHEAR, AND TORSION
WITH EXTERNALLY BONDED CFRP

A DISSERTATION

CIVIL ENGINEERING

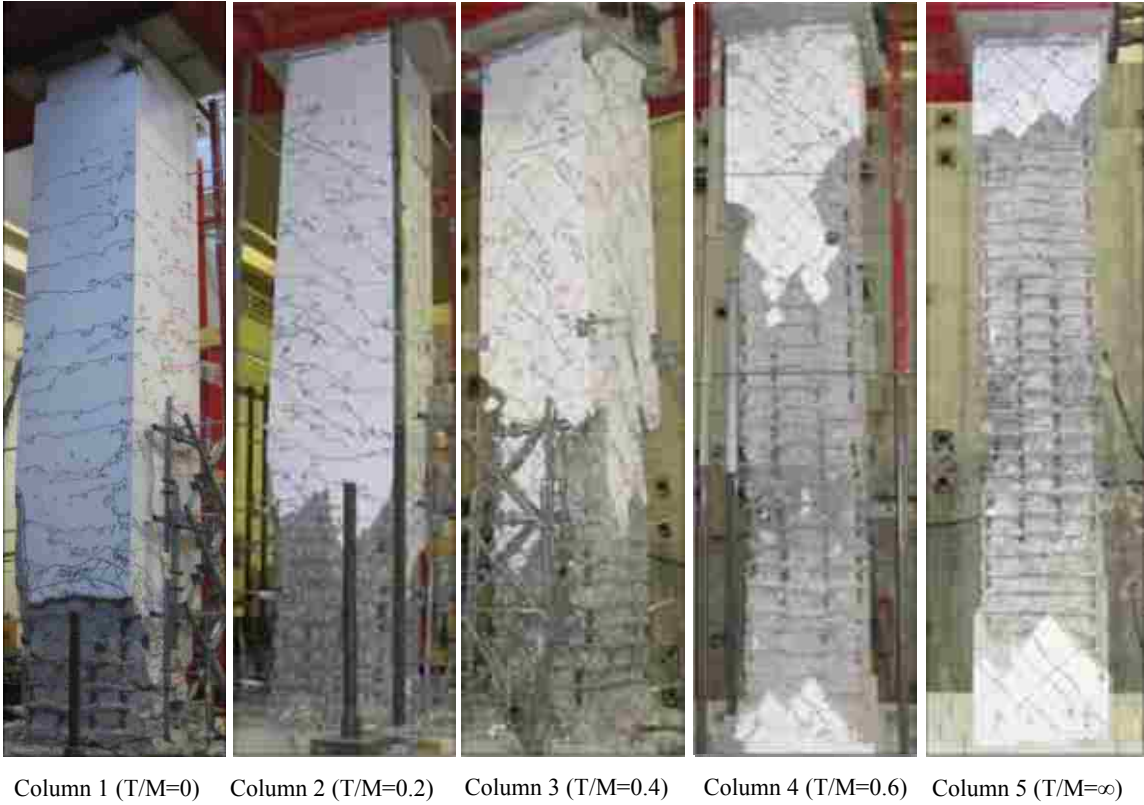
Fig. 2 Damage conditions of the original columns after previous tests.

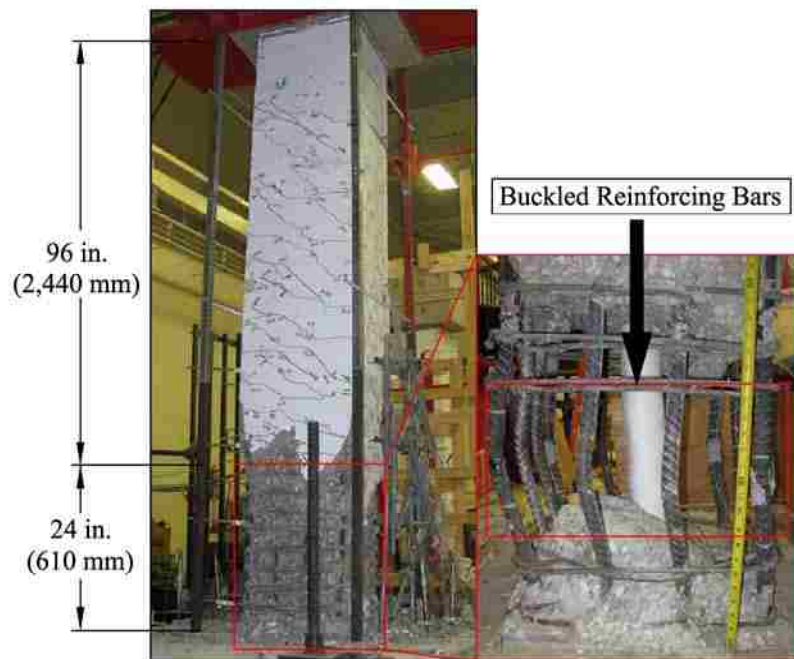
Fig. 3. Damage to Column 2 ($T/M=0.2$).

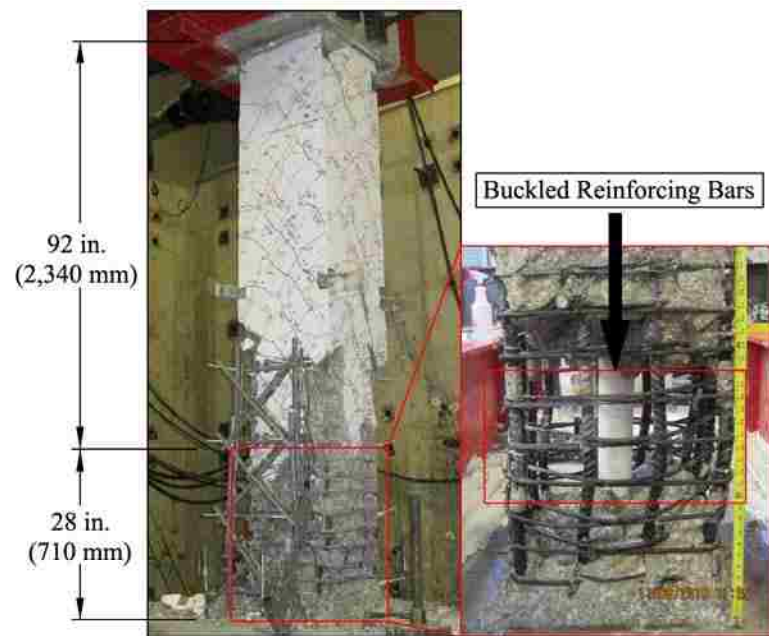
Fig. 4. Damage to Column 3 ($T/M=0.4$).

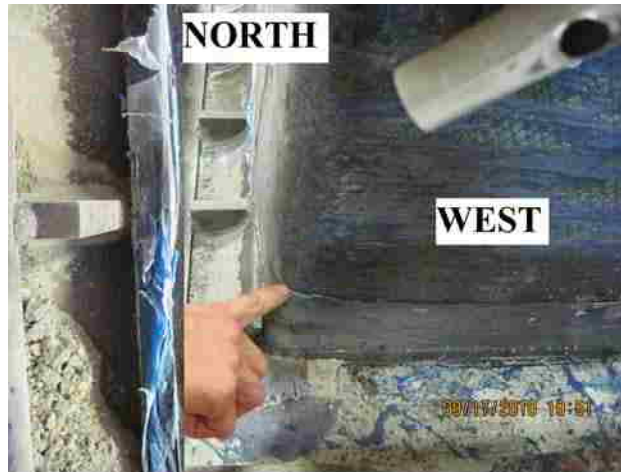
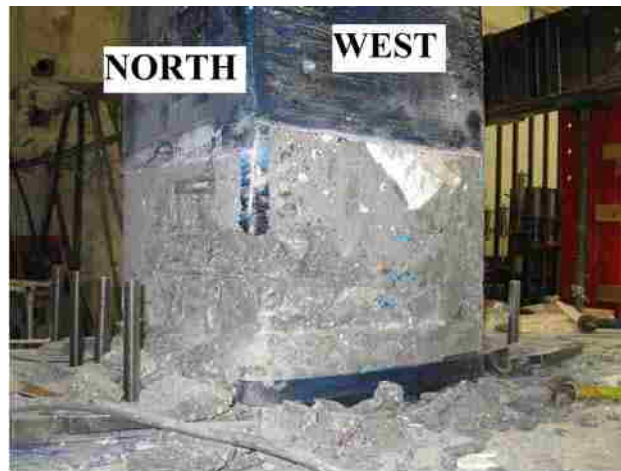
Fig. 14. Failure of repaired Column 1-R ($T/M=0$) - northwest corner.

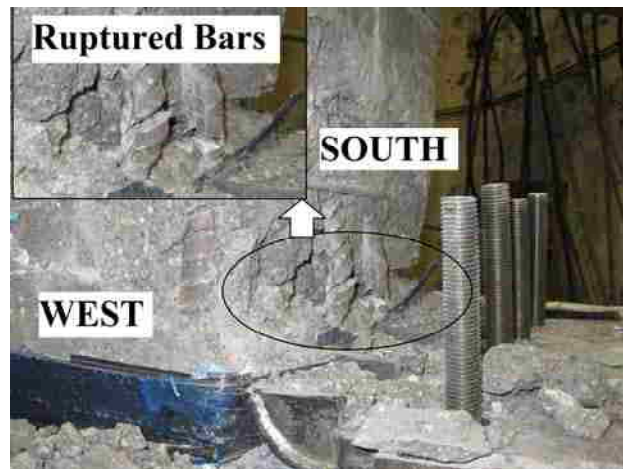
Fig. 15. Failure of repaired Column 1-R ($T/M=0$) - south side.

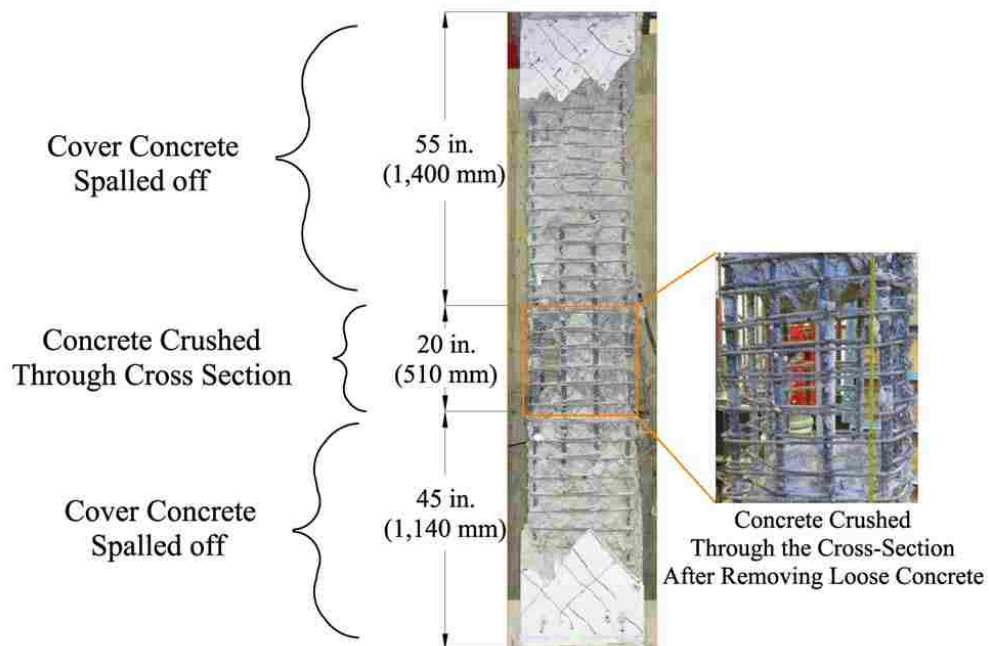
Fig. 2 - Damage condition of concrete in original column.

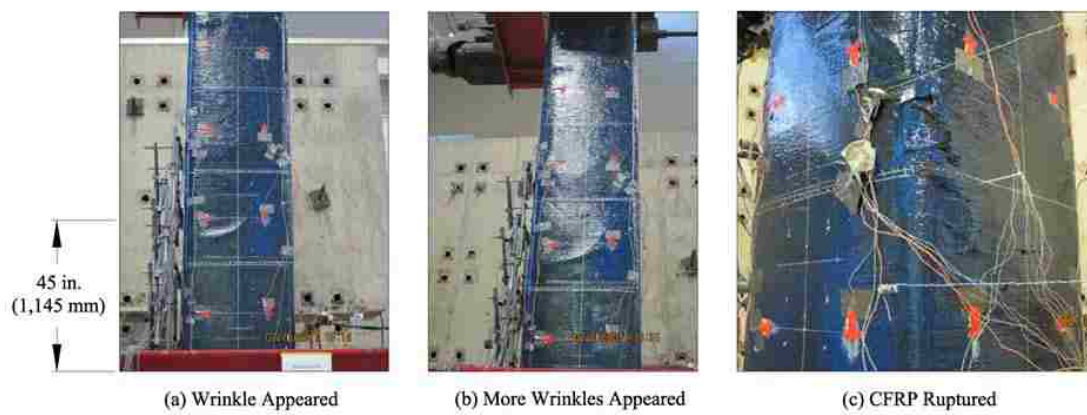
Fig. 5 - Failure of repaired column.

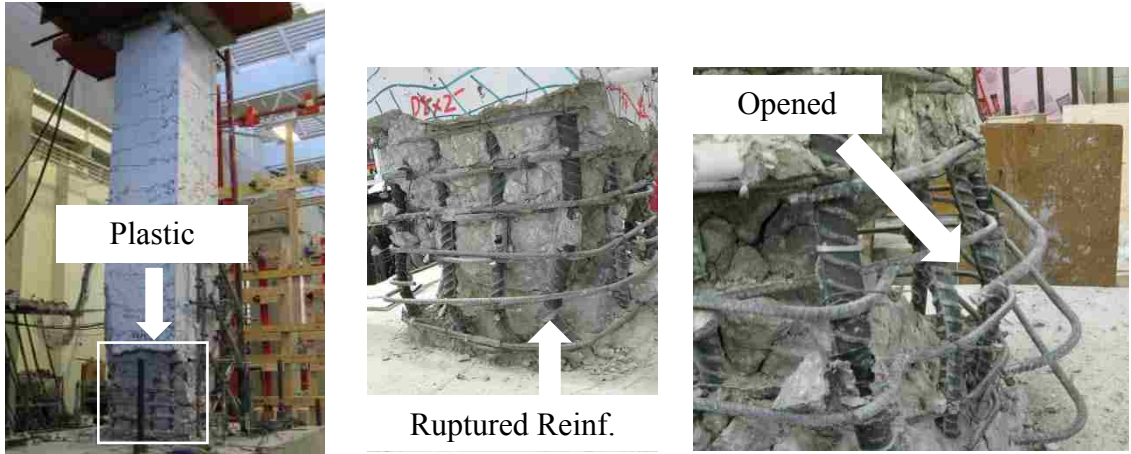
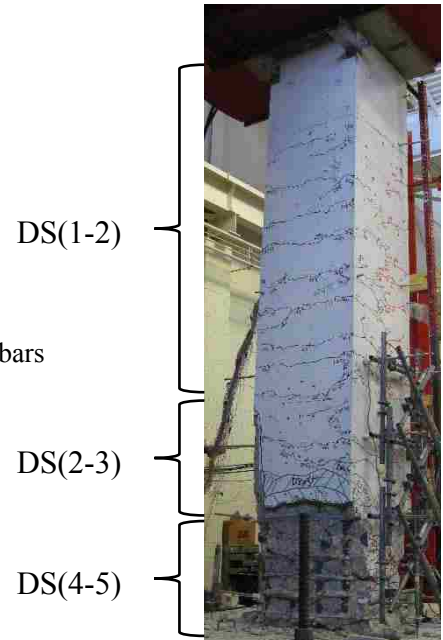
(a) Damaged column (b) Longitudinal reinforcement rupture (c) Failure of ties

- DS1: Flexural cracks
- DS2: First spalling and shear cracks
- DS3: Extensive cracks and spalling
- DS4: Visible lateral and longitudinal bars
- DS5: Imminent failure

Fig. 6. Damage to original column prior to repair
