Bridge deck condition assessment using destructive and nondestructive methods

BRIDGE DECK CONDITION ASSESSMENT USING DESTRUCTIVE AND
NONDESTRUCTIVE METHODS

BRANDON TYLER GOODWIN

MASTER OF SCIENCE IN CIVIL ENGINEERING

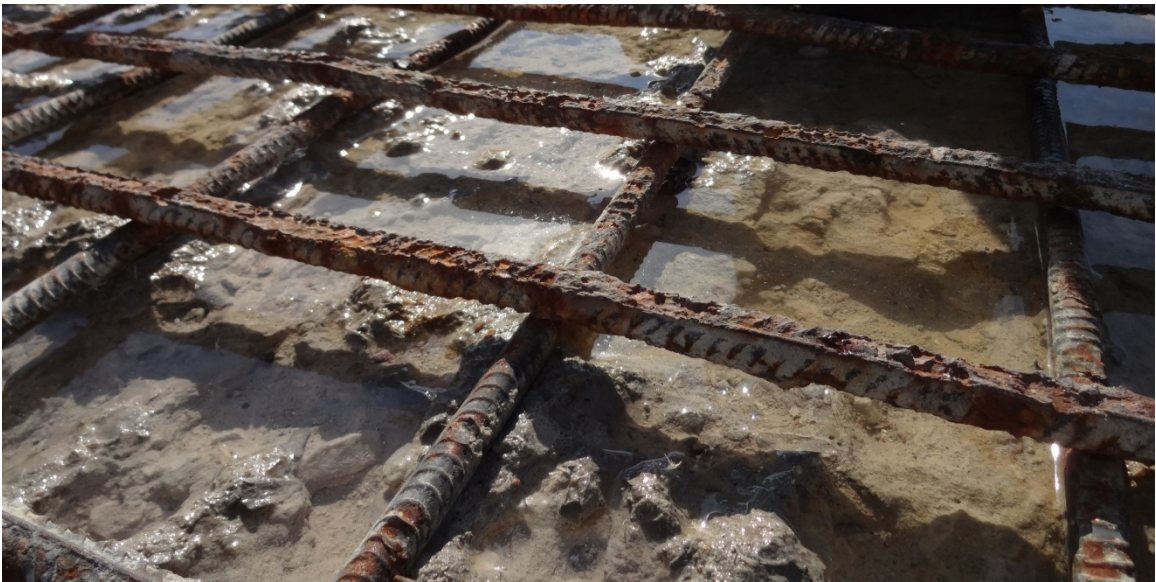
Figure 3.10. Corroded Rebar Exposed After Removal of Loose and Deteriorated Concrete by Hydrodemolition

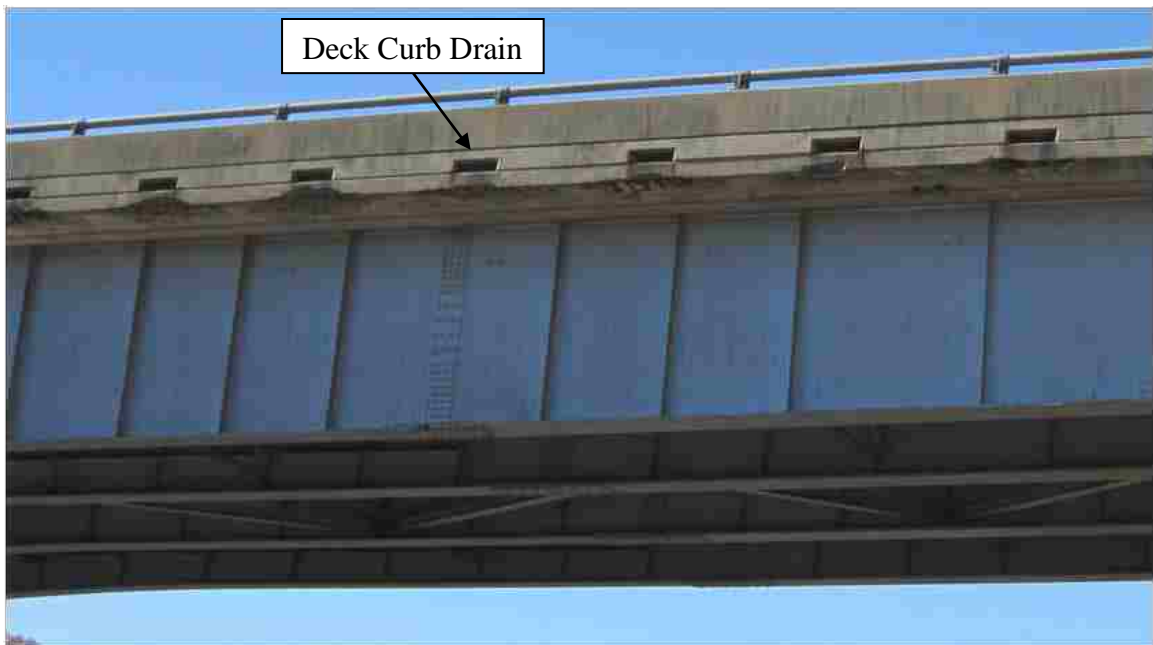
During the investigation, it was noted by researchers that the bridge experienced a large amount of deflection or vibration during heavy traffic loading. The bridge also contained deck drains within the curb. These drains were spaced along both curbs of the bridge. Heavy deterioration was noted around these drains, especially on the side and bottom of the deck as shown in Figure 3.17 below. More detailed findings were noticed with the visual inspection, GPR, cores, and the survey of the post-hydrodemolition deck. See Appendix A for bridge drawings, which include visual inspection findings and GPR results, along with the lidar survey of material removal during the rehabilitation. A complete digital version of the A1479 Bridge Investigation Drawing is included in the Digital Appendix which is further discussed in Appendix F.

Figure 3.17. Bridge A1479 Deterioration of the Deck Soffit Around Curb Drains

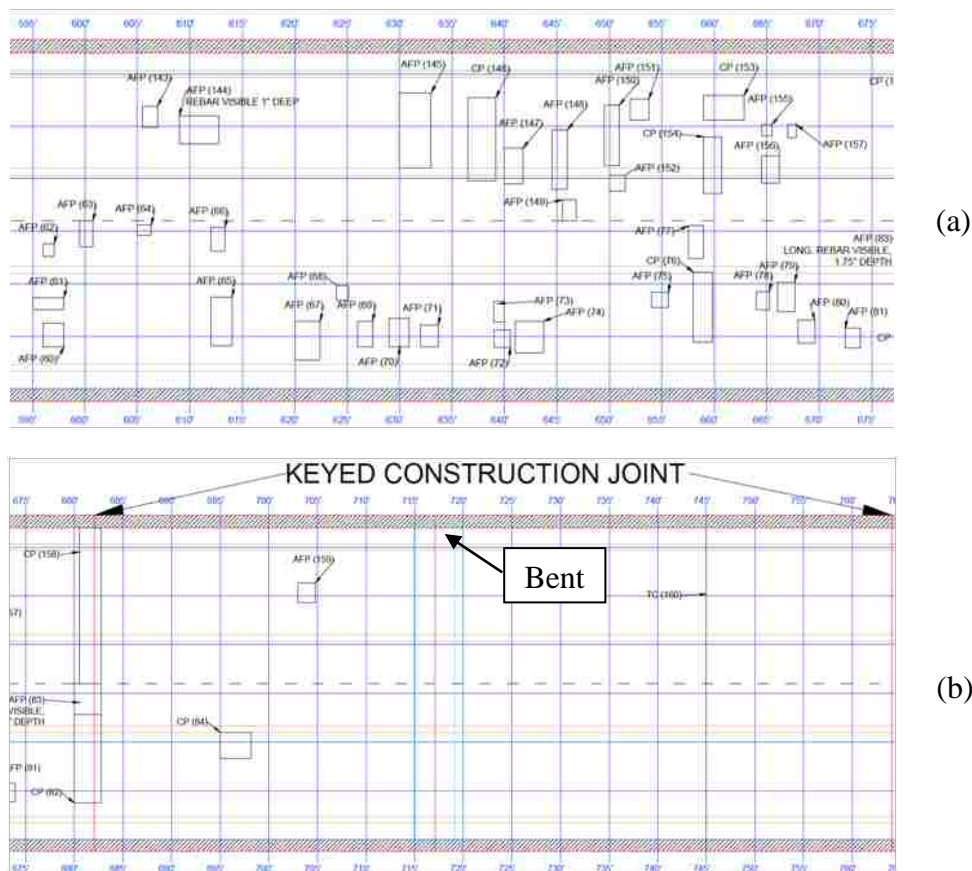
reinforcing bars visible. The majority of the documented defects were located mid-span of the girders (i.e., between the bents). Few defects were noted near the bents as illustrated in Figure 3.18 below.

Figure 3.18. Bridge A1479 Visual Inspection Results Near Mid-Span (a) and Bent (b)

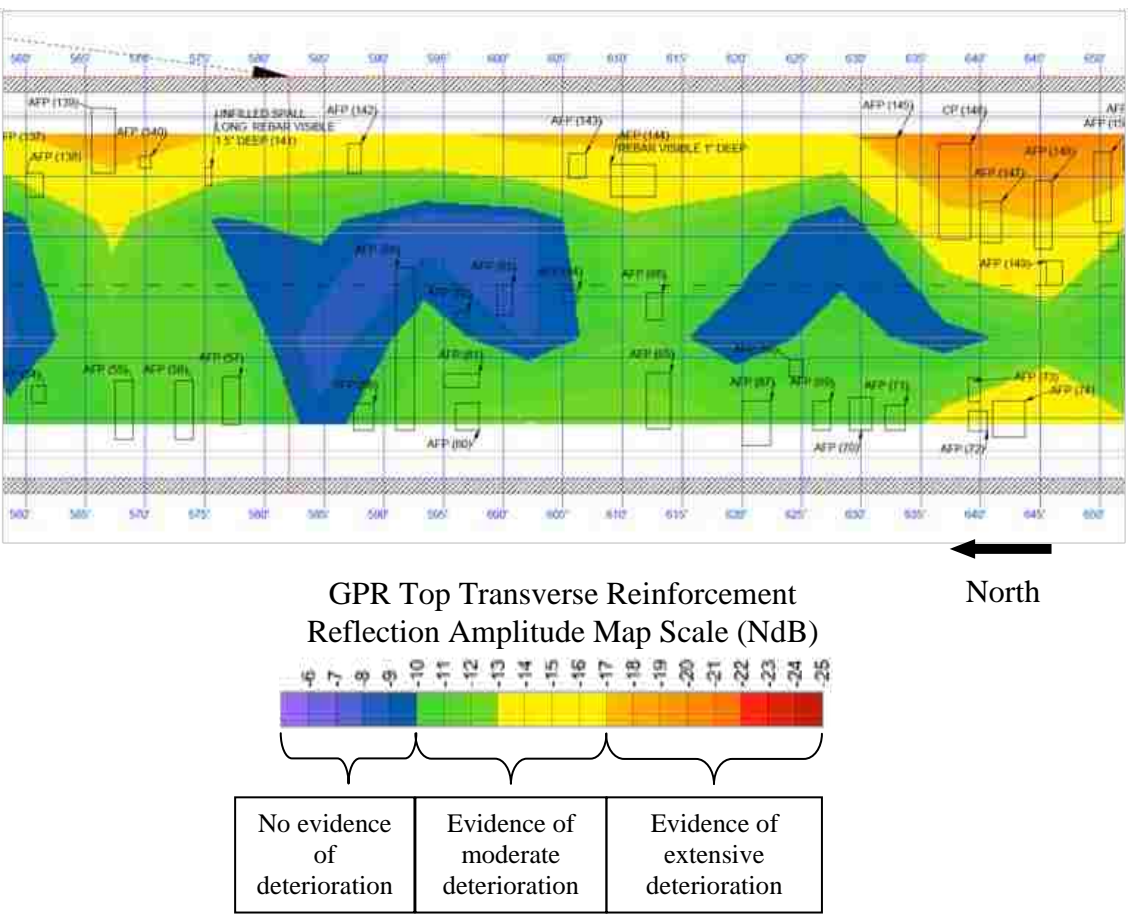
reinforcement. Figure 3.19 below illustrates the GPR results included in the bridge drawing. Increased evidence of deterioration based on the GPR results is more prevalent on the East side of the bridge deck than the West side.

Figure 3.19. Section of Bridge A1479 GPR Results

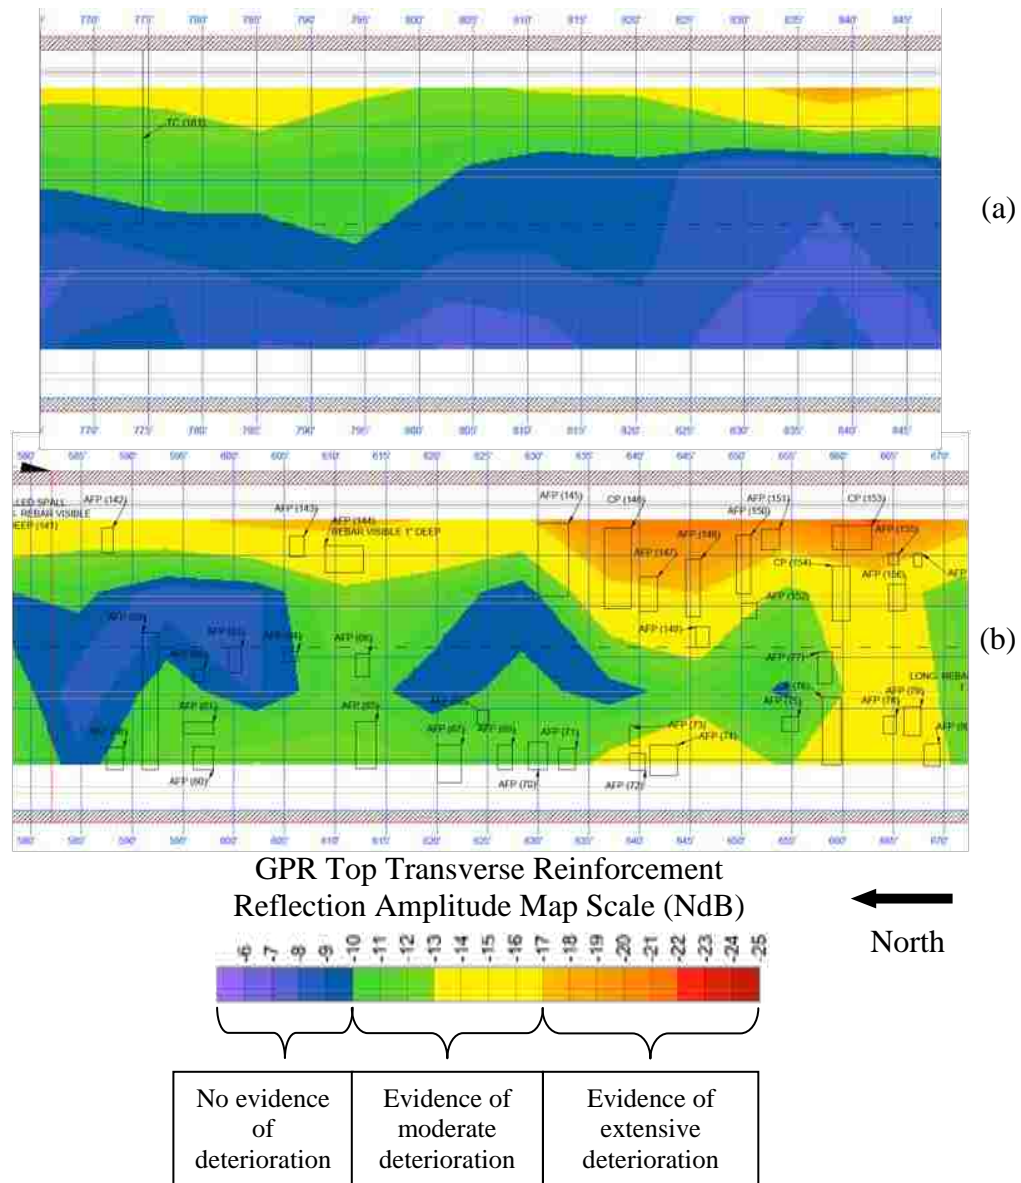
Most sections of the bridge deck that showed no evidence of deterioration based on the GPR results also had few documented visual defects. Figure 3.20 (a) below shows a section of the bridge deck that has very few visual defects and also shows no evidence of deterioration based on the GPR results. In areas where many visual defects were documented, the GPR results indicate higher levels of deterioration as indicated in Figure 3.20 (b).

Figure 3.20. Bridge A1479 GPR and Visual Inspection Results with Low Levels of Deterioration (a), and with High Levels of Deterioration (b)

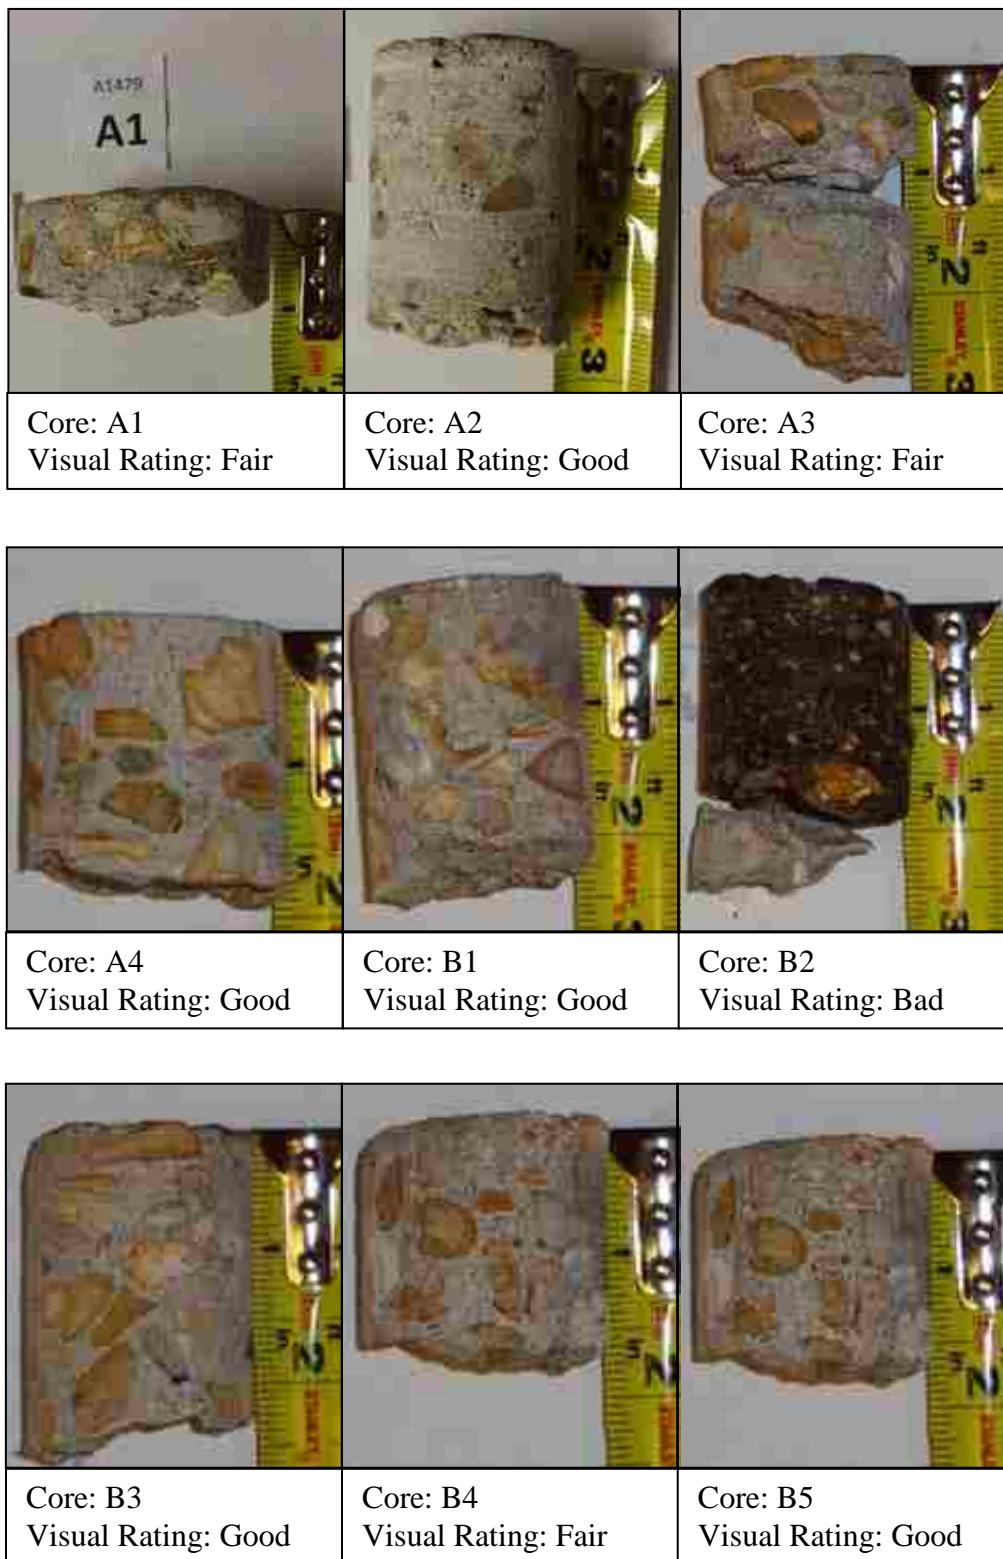
Figure 3.23. Bridge A1479 Cores and Visual Core Ratings

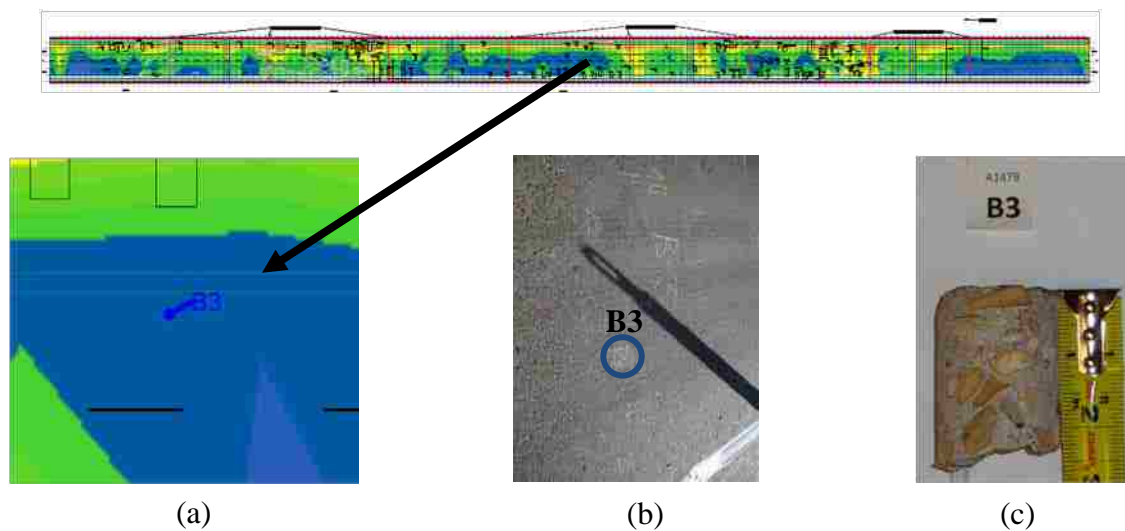
Figure 3.24. Bridge A1479 Core B3, (a) On Bridge Drawing, (b) Deck Image at Core Location, (c) Extracted Core

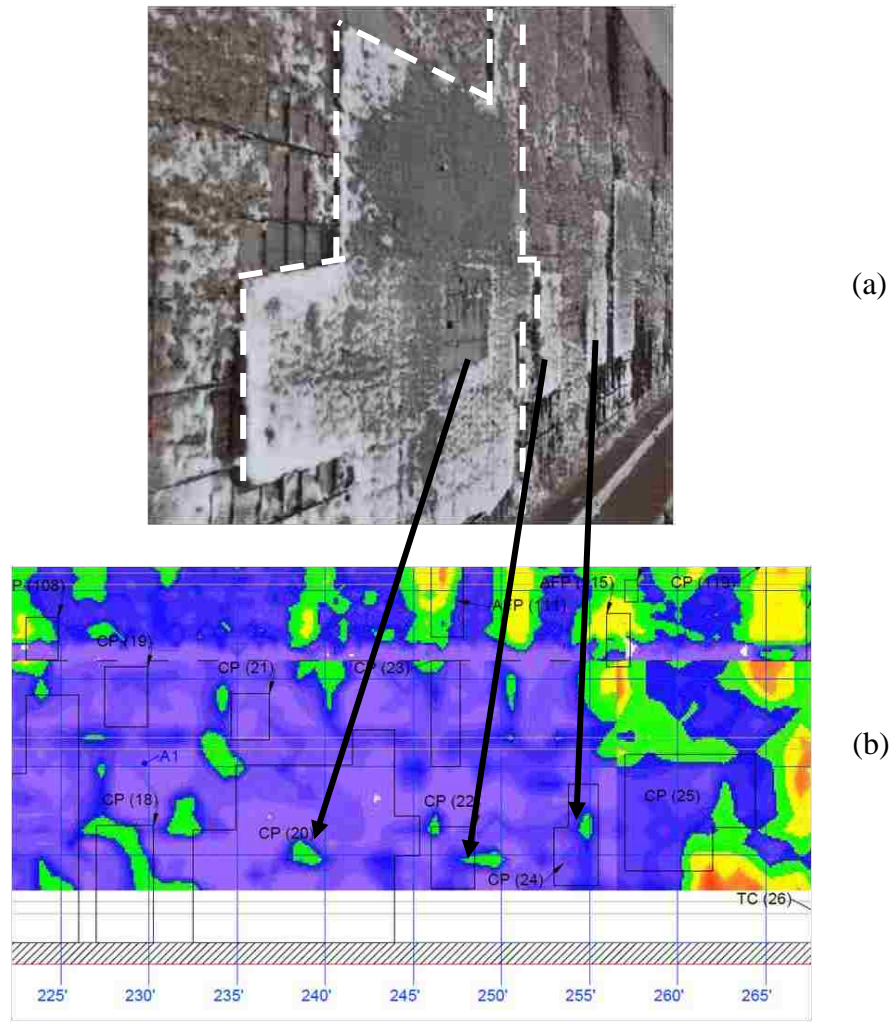
Figure 3.29. Image of Bridge A1479 Deck Surface After Hydrodemolition (a) Compared to Lidar Rehabilitation Survey and Visual Investigation Results (b)

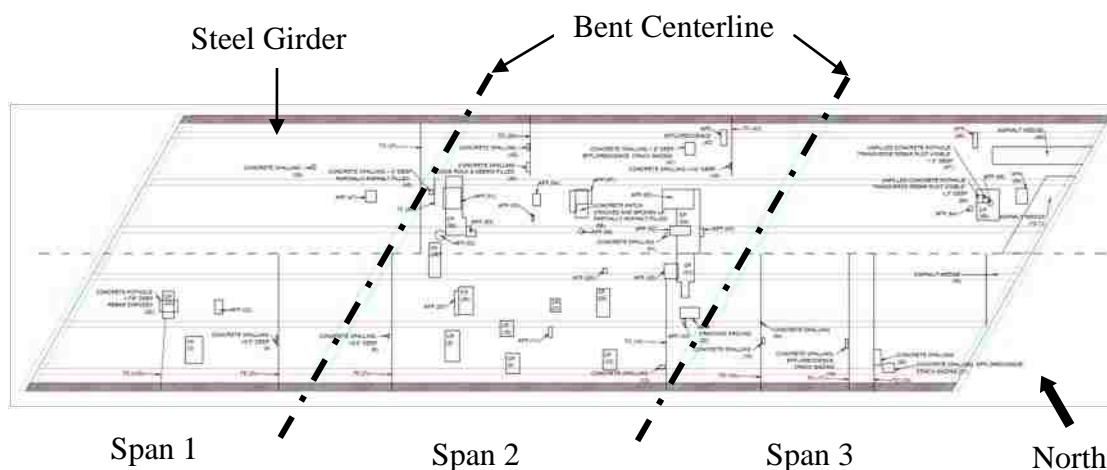
Figure 3.36. Bridge A1297 Visual Inspection Results

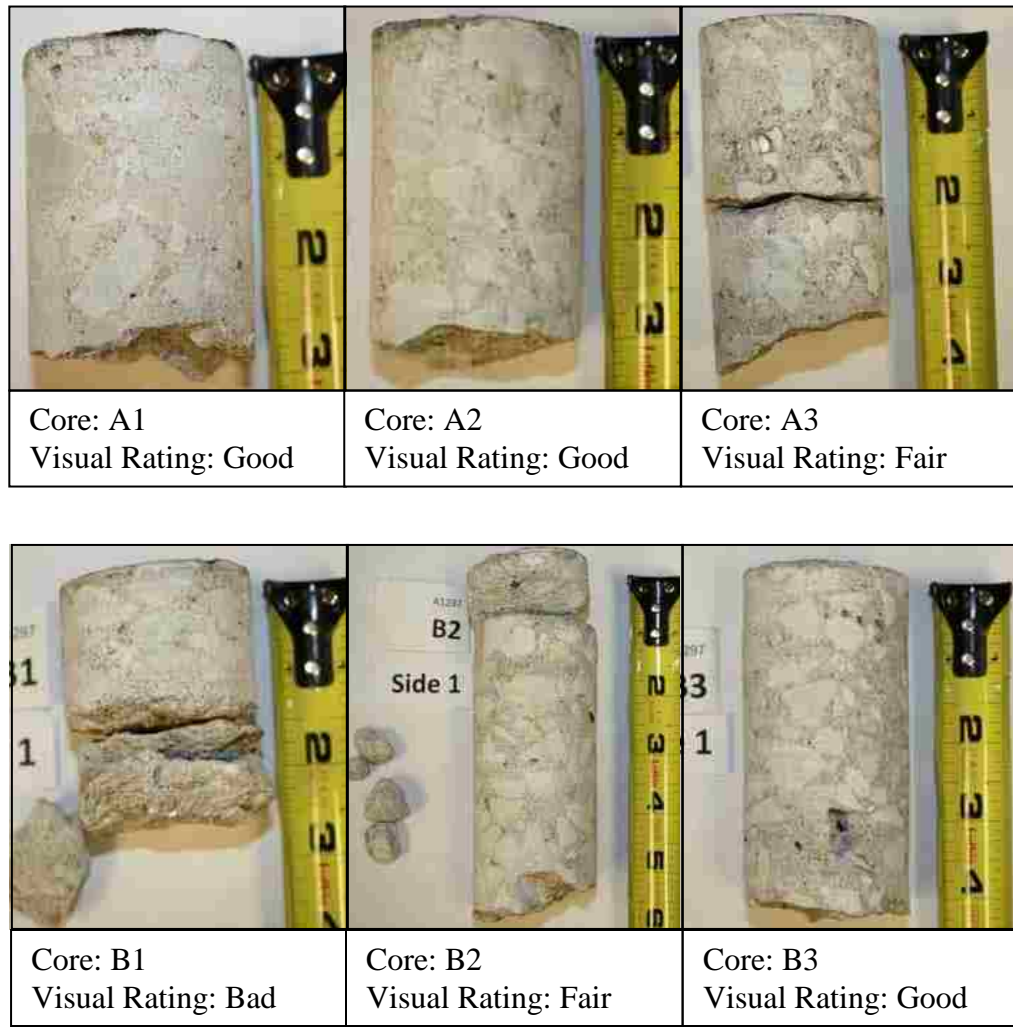
Figure 3.39. Bridge A1297 Cores and Visual Core Ratings

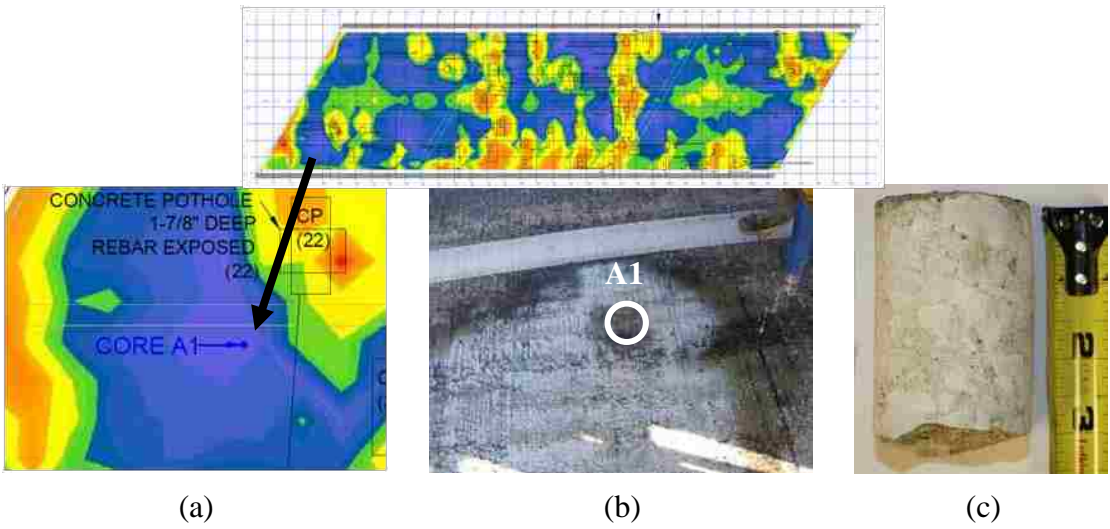
Figure 3.40. Bridge A1297 Core A1, (a) On Bridge Drawing, (b) Deck Image at Core Location, (c) Extracted Core

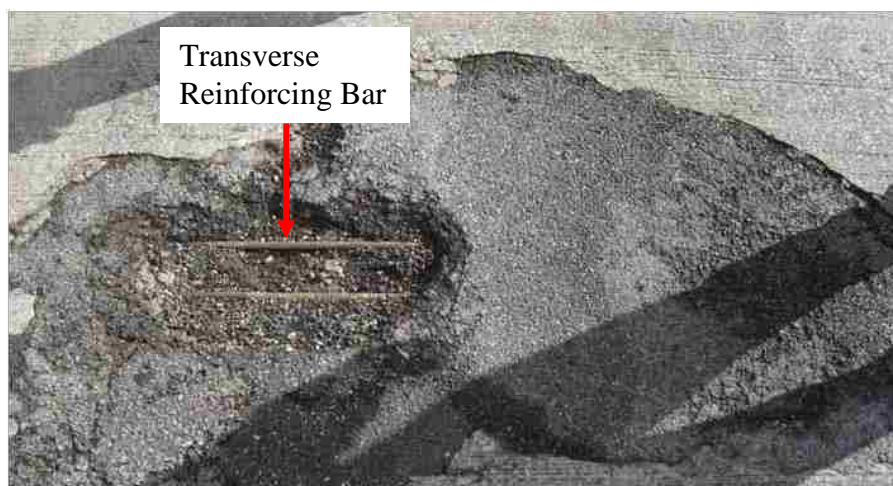
Figure 4.1. Reinforcing Bars Visible in Asphalt Filled Pothole
