Constructability Testing of Folded Plate Girders

CONSTRUCTABILITY TESTING OF

FOLDED PLATE GIRDERS

CONSTRUCTABILITY TESTING OF COMPOSITE FOLDED PLATE GIRDERS

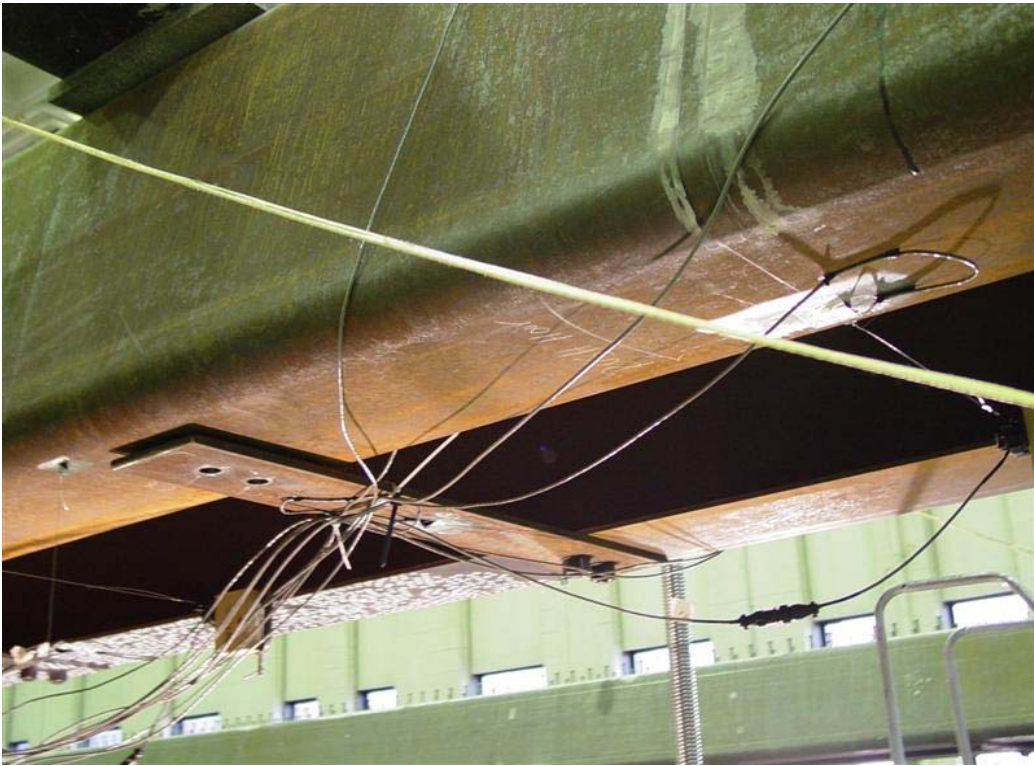
Figure 2-13 Disconnected tie plate at section H

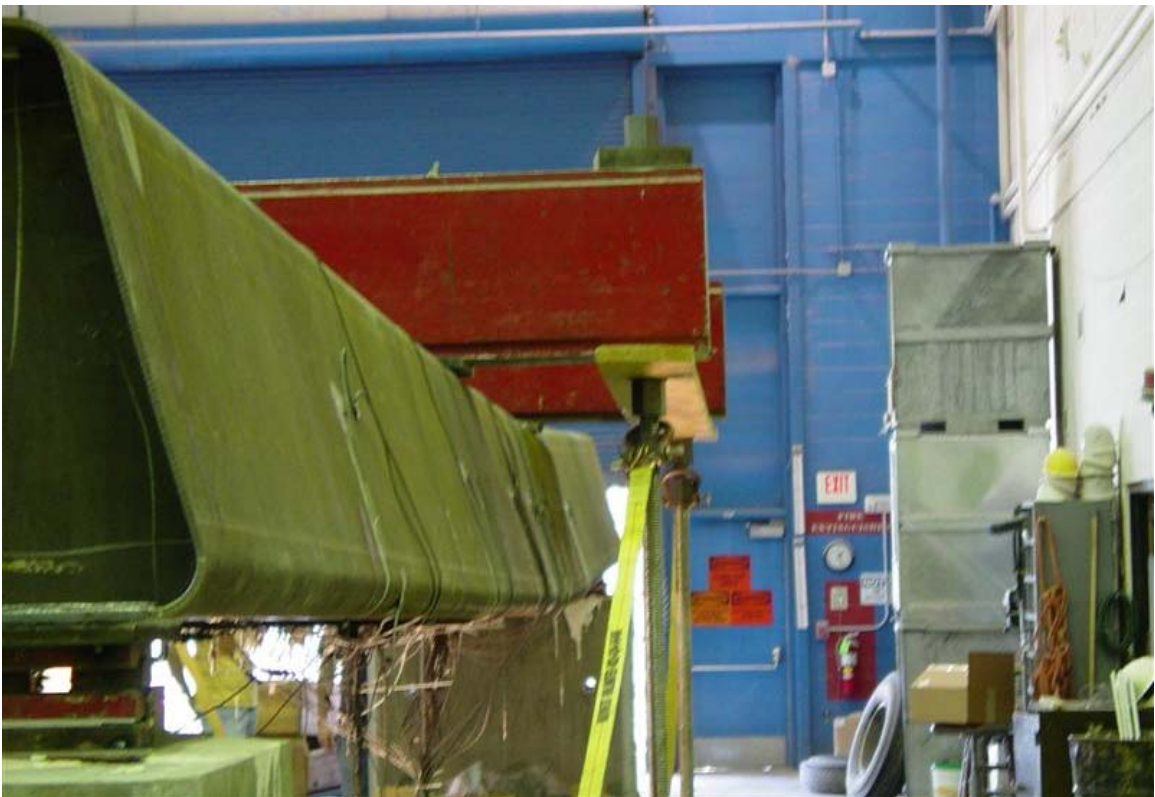
Figure 3-5 Specimen A during testing

Figure 3-4 through Figure 3-9 show the girder before and after the top flange and web buckle. Figure 3-10 shows the buckling of the top flange and web from inside the girder.

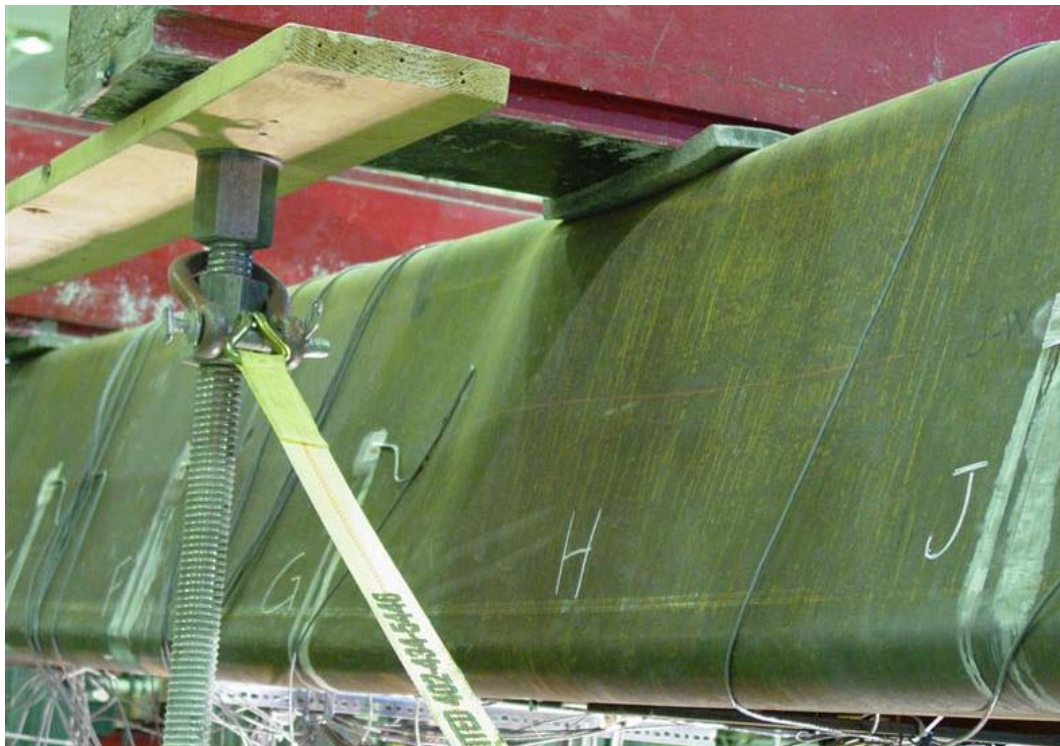
Figure 3-9 Web deformation from loading.

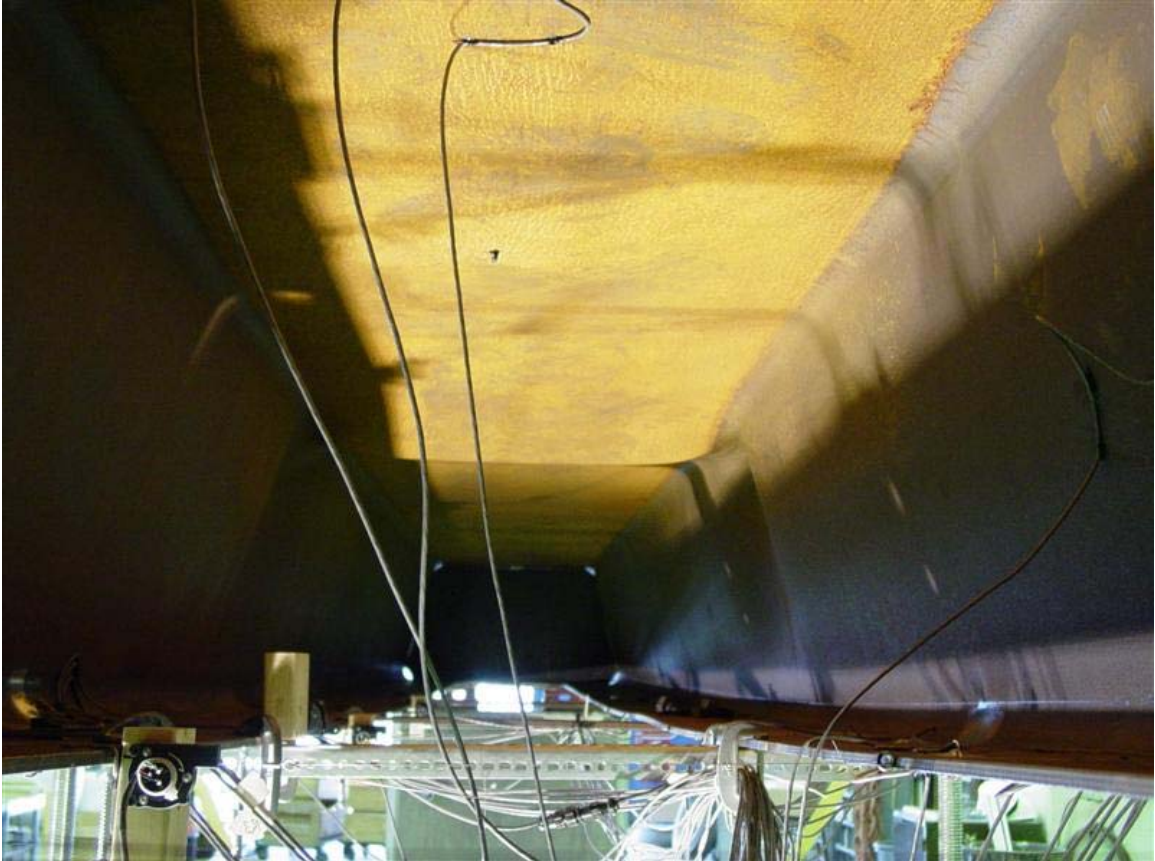
Figure 3-10 Inside of folded plate girder after failure

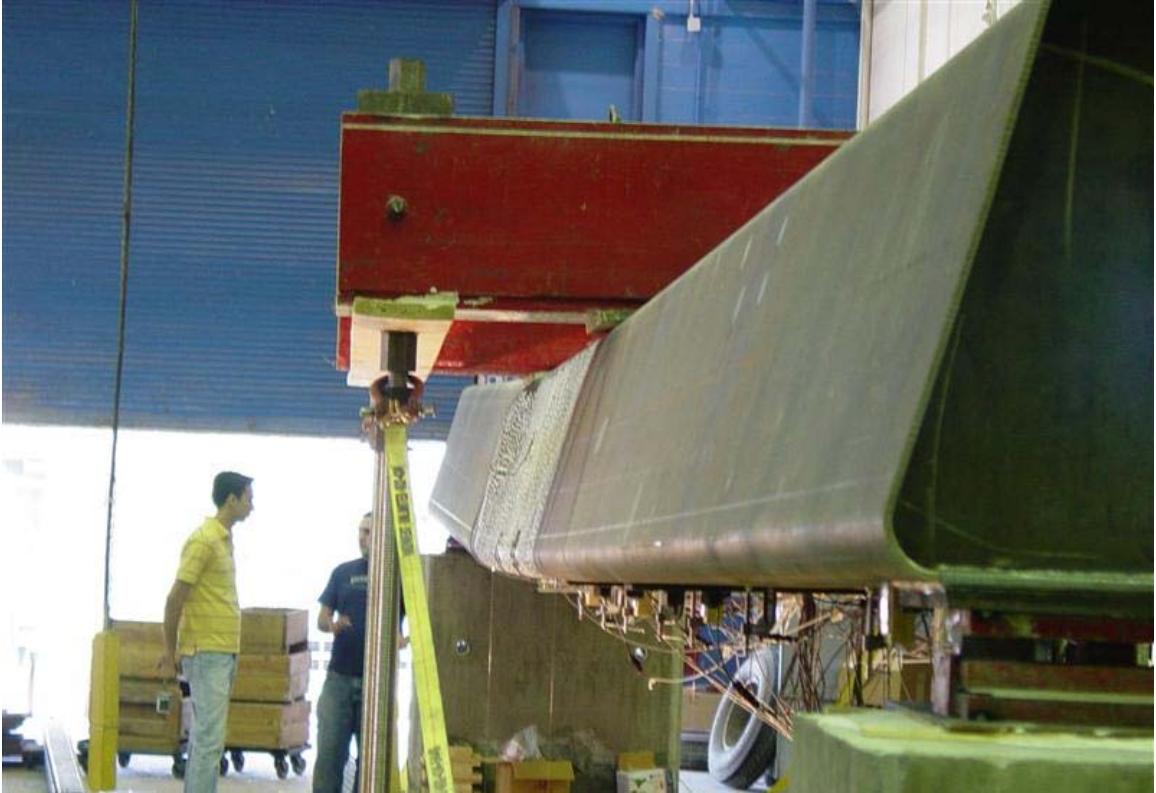
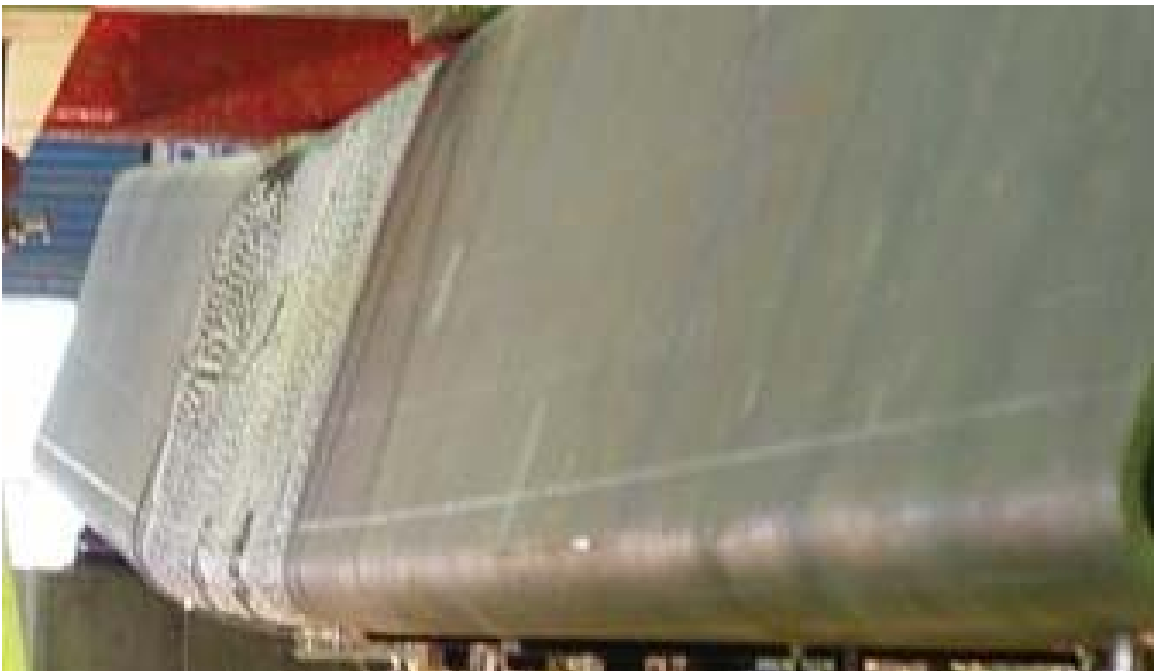
Figure 3-11 shows the north side of the girder after loading with the close spreader beam being the west load point. These two figures do a good job of showing the web buckling and the fact the girder has buckled under the east load point more than the west load point. This can also be seen in the moment deflection graph, Figure 3-2, and is the reason that the pots P12 and P13 show higher deflections than P9 and P10 after the peak load.

Figure 3-11 North side of girder facing east showing girder deflection and web buckling

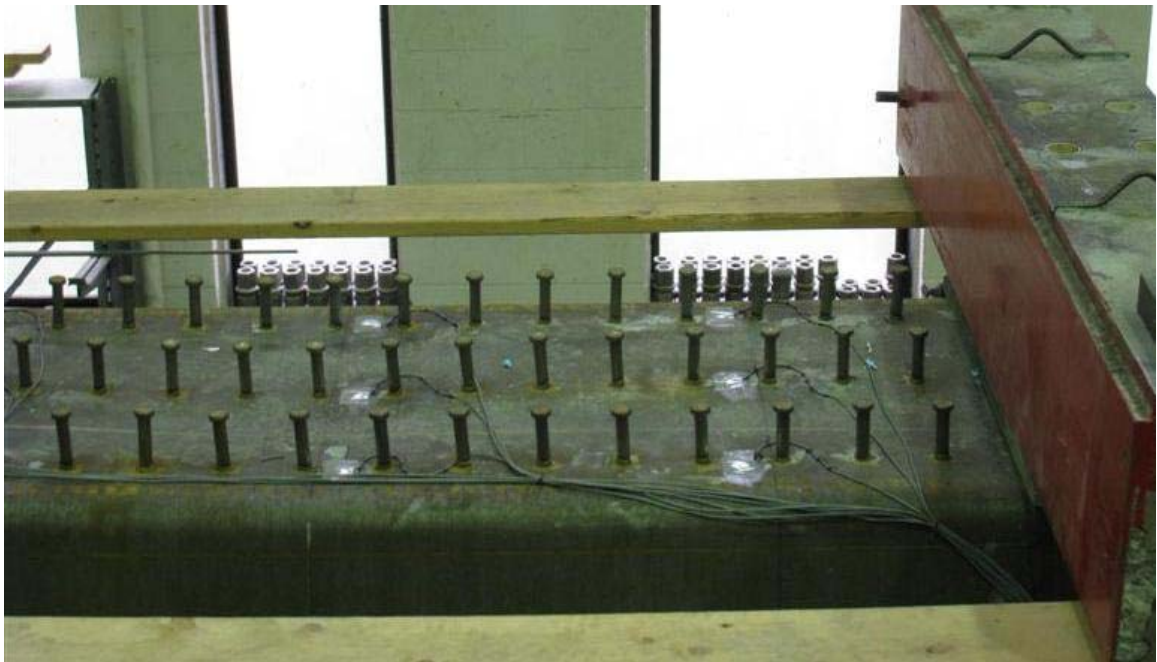
Figure 3-37 Top flange at twice the construction moment

The top flange is beginning to buckle slightly. The leaning shear studs are the best indicator of the top flange deformation.

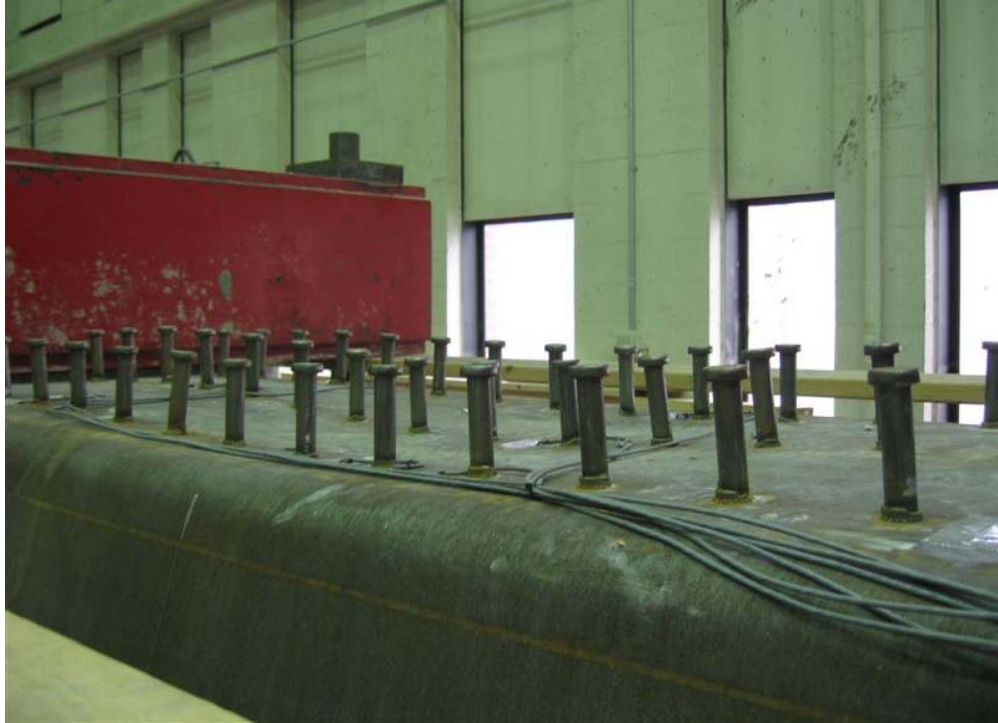
Figure 3-39 Test B1 top flange at 120kip

Figure 3-39 shows the top flange at 120kips; the deformation of the top flange is becoming more apparent. Figure 3-40 through Figure 3-43 show different parts of the beam at 140kips of load. This is within five kips of the ultimate load, when the girder begins to fail. Figure 3-41 shows that the deformation of the girder is actually bending the tie plate. Figure 3-42 is a picture taken from the west end of the girder looking down the top flange towards the spreader beam. Near that spreader beam, the top flange is buckling downwards. Figure 3-43 shows the deformation of the top flange between the load points.

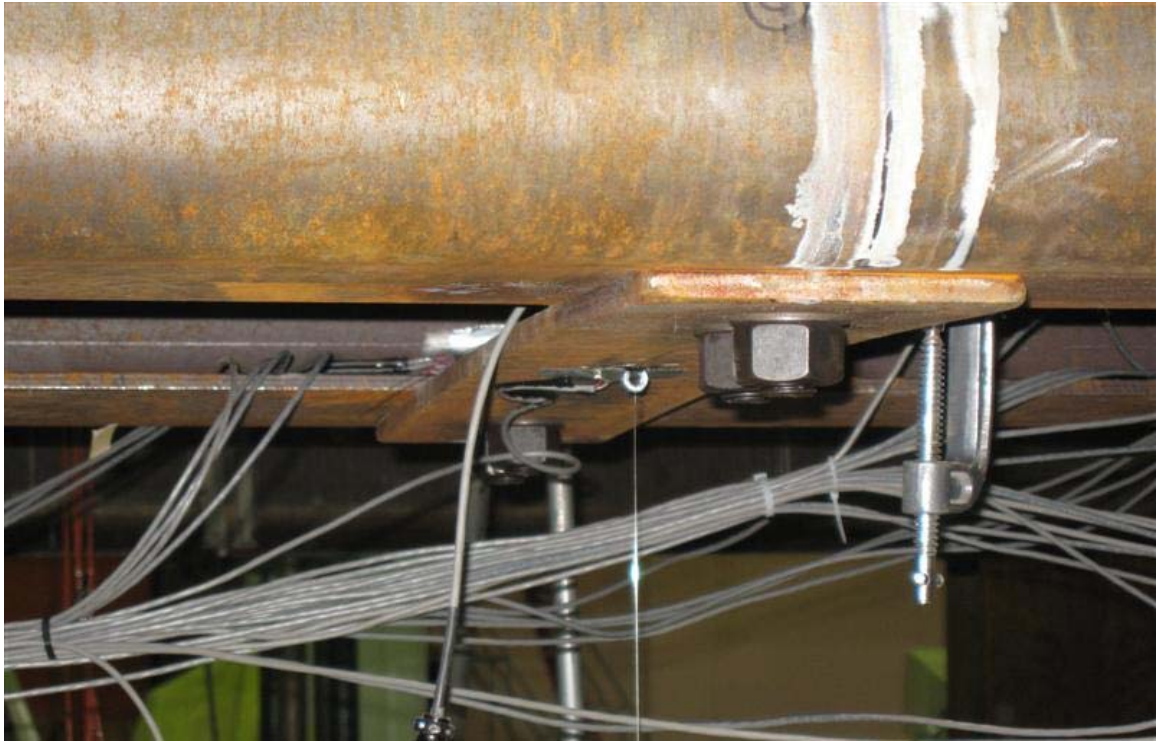
Figure 3-41 Test B1 tie plate at 140kip

affect the force resisted by the tie plates. Figure 3-41 showed the tie plate at section F bending because of the girder deformation. This flexure creates secondary strains in the tie plate which can dominate the strain at the bottom of the tie plate. If a second gage was located on the top of the tie plate, the combined strain from flexure and tension would create total strain that would be much larger than what is shown in the curve for F-P.

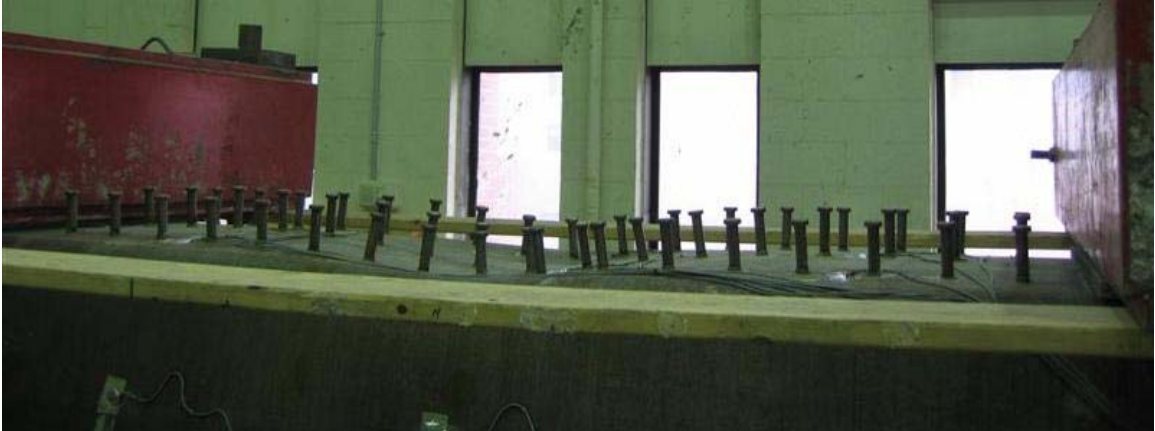
Shortly after these pictures were taken the girder reached its ultimate capacity and began to fail. Figure 3-44 shows the top flange when loading is at 137kips as the girder continues to fail. Figure 3-45 shows the girder outside of the load points also at 137kips. These two figures show a difference in the amount of buckling taking place in between the load points compared to outside of the load points.

Figure 3-44 Top flange at 137 kip after failure

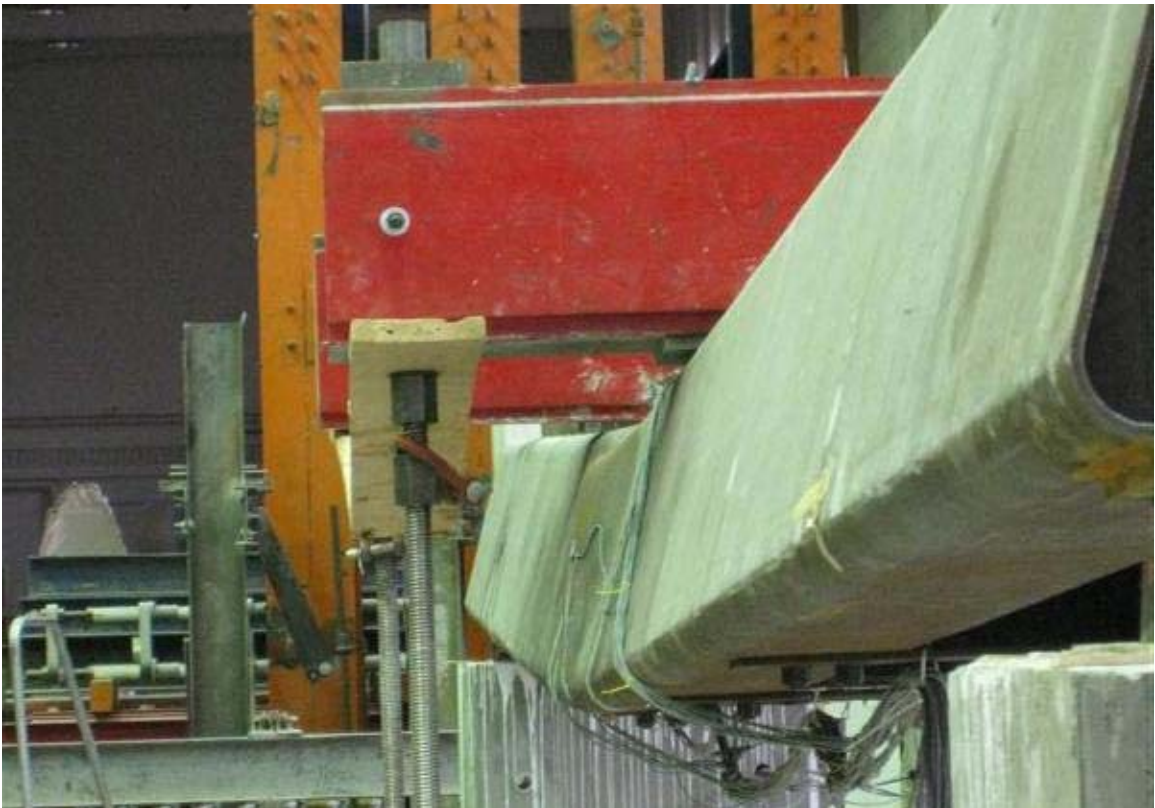
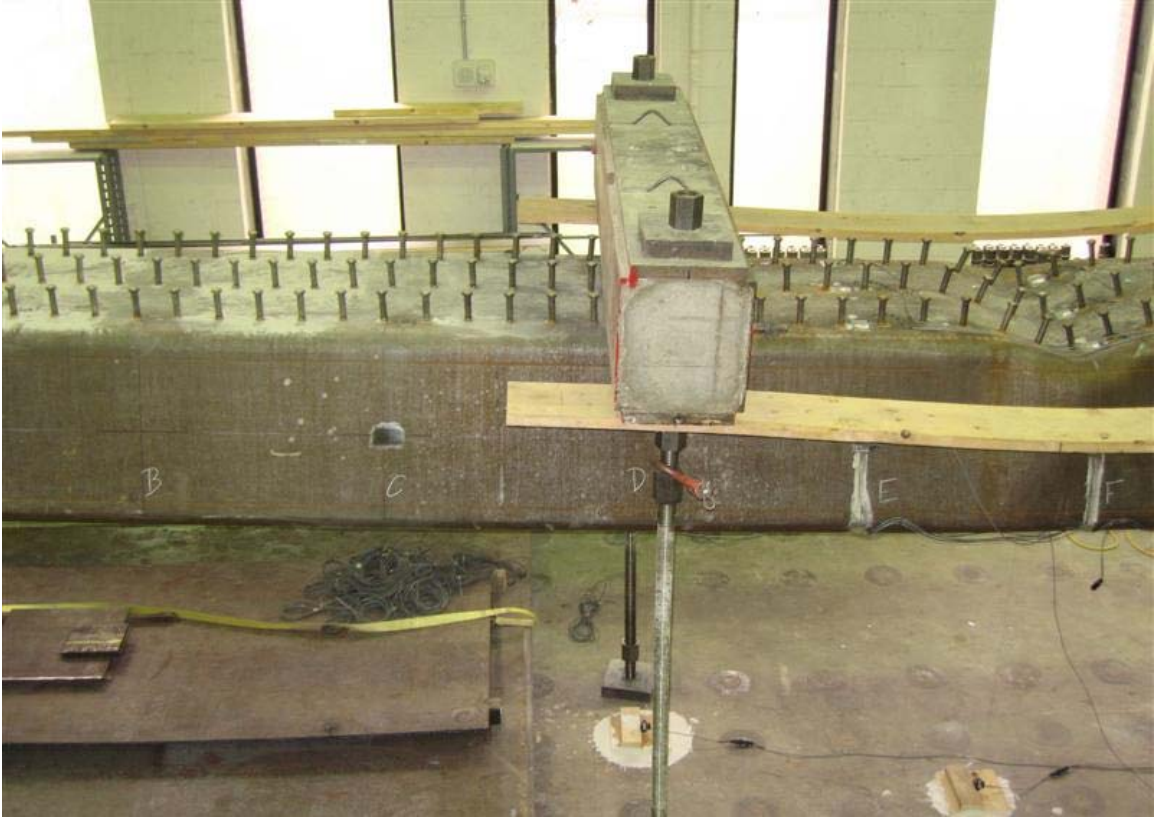
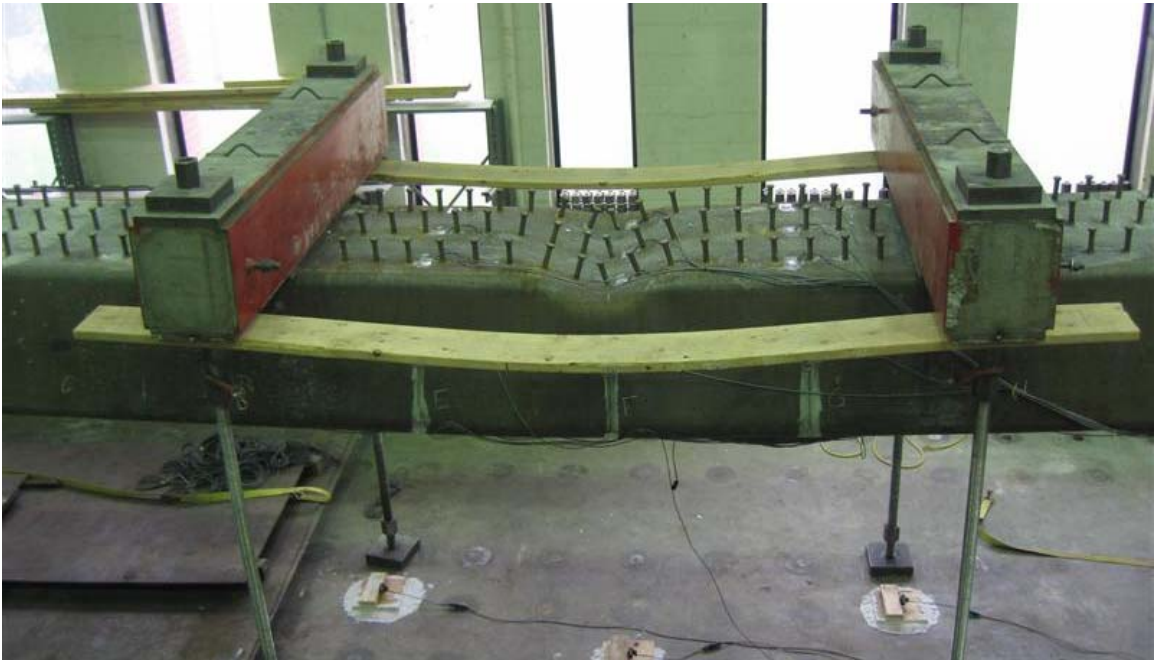
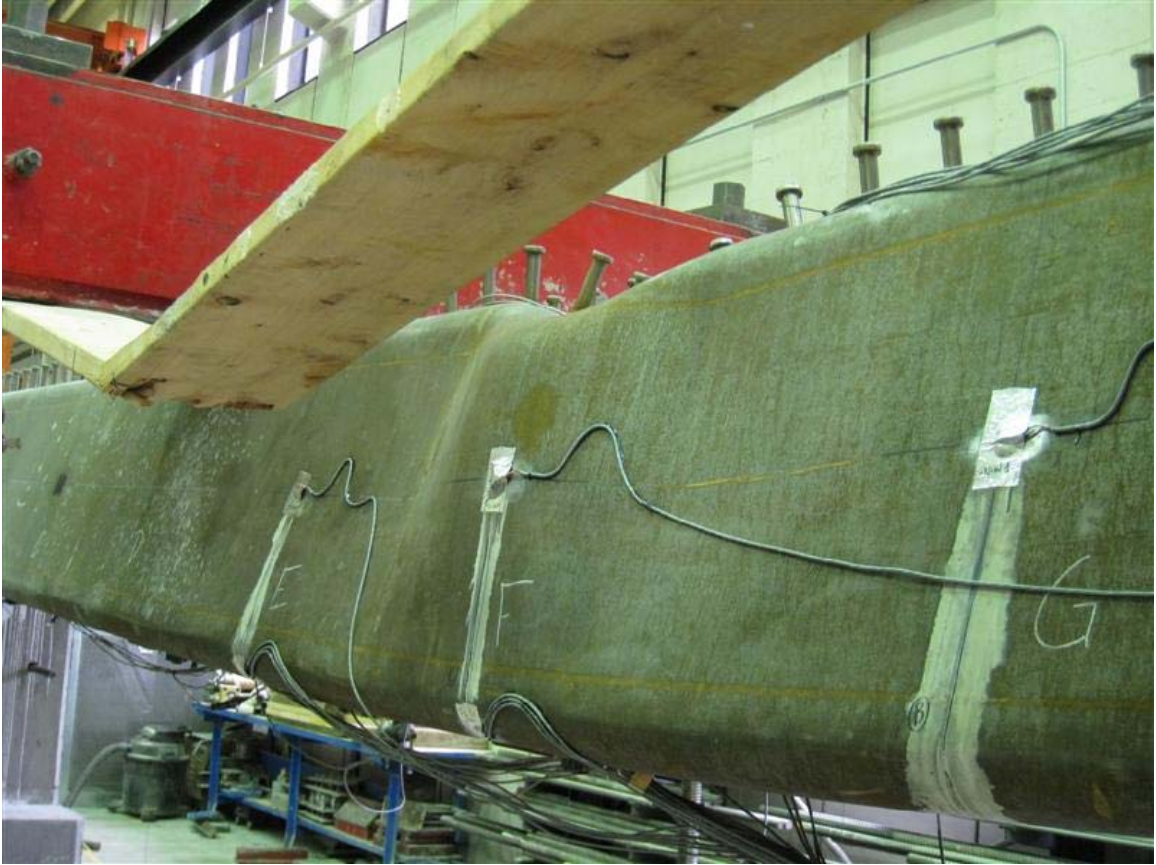
extreme buckling at midspan resulted in what was almost a hinge. The midspan area contained most of the permanent deformation; the rest of the girder returned to its original state. Figure 3-47 shows the girder on both sides of the west load point. This picture also shows that the majority of the failure occurred at midspan. Figure 3-48 shows the section of the girder between load points and Figure 3-49 provides a closer view of the web buckling.

Figure 3-46 Girder deflection after unloading

Figure 3-47 Permanent deformation after unloading

Figure 3-48 Girder deformation at midspan of girder after unloading

Figure 3-49 Girder permanent deformation after unloading. Web buckling
