# EFFECTIVENESS OF STRAW BALE CHECK DAMS AT REDUCING POST-FIRE SEDIMENT YIELDS FROM EPHEMERAL CHANNEL CATCHMENTS

EFFECTIVENESS OF STRAW BALE CHECK DAMS AT REDUCING POST-FIRE  
SEDIMENT YIELDS FROM EPHEMERAL CHANNEL CATCHMENTS

Thesis

Master of Science  
in Resource Conservation

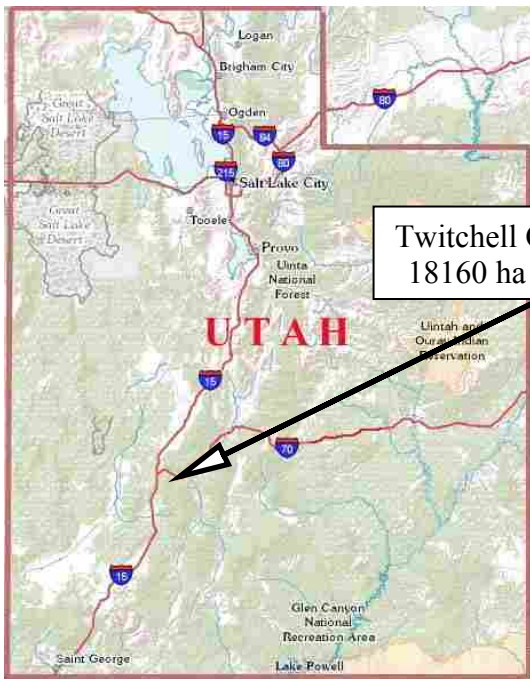
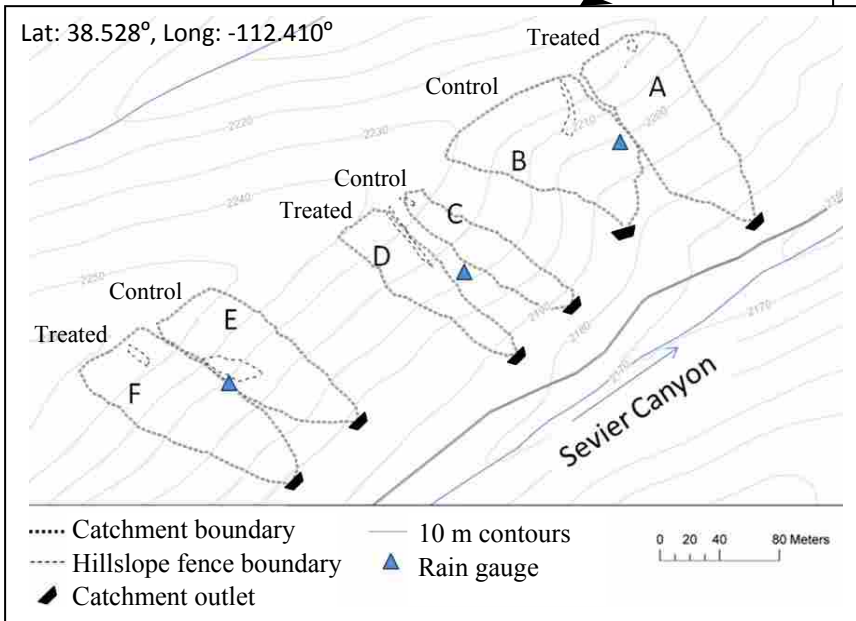
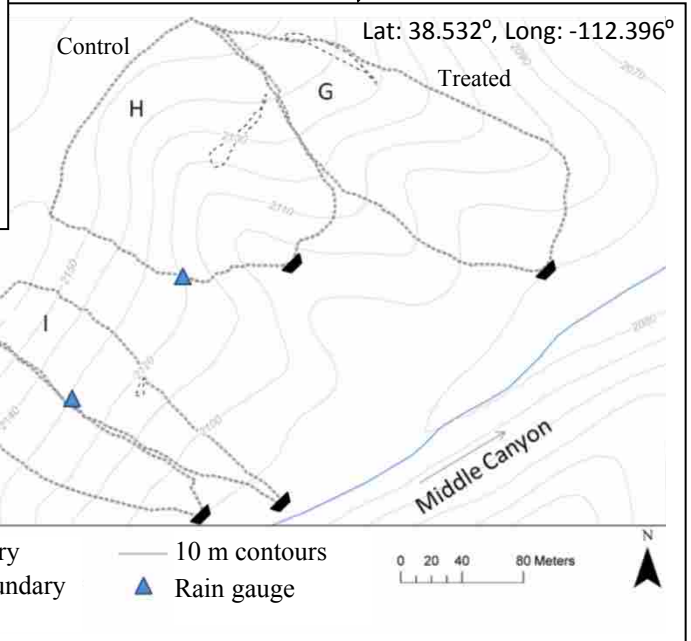
**BARC Image / Color Scheme**  
 Natural Green ... Unburned Areas (13 %)  
 Teal ... Low Severity Burns (20 %)  
 Yellow ... Moderate Severity Burns (14 %)  
 Red ... High Severity Burns (33 %)

**Figure 2.** (Starting in top left of page with figure descriptions moving clockwise) 1. Twitchell Canyon Fire in south-central Utah. 2. Burned Area Reflectance Classification (BARC) map indicating burn severity, the study paired catchments are colored white and outlined in black. 3. Treated and control catchments within pair and the locations of hillslope plot boundaries, rain gauges, and catchment outlets.

We conducted our study in small ephemeral channel catchments. Ten ephemeral channel study catchments were paired, with each pair consisting of one treated and one untreated or control catchment. Catchments ranged in size from 0.2 to 1.6 ha (0.5 to 4.0 ac) (Figure 2).

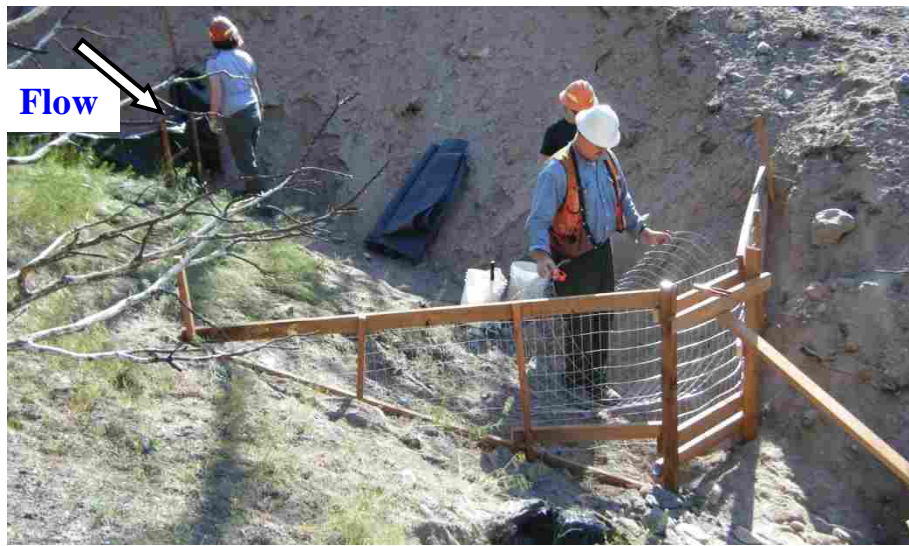
**Figure 7.** Lumber framing of sediment retention structure secured into the channel bed and banks with the added strength of wire mesh attached to the up-channel face. Spillway wall is located in the center of the structure with side walls opening up-channel. Photo looks up-channel.

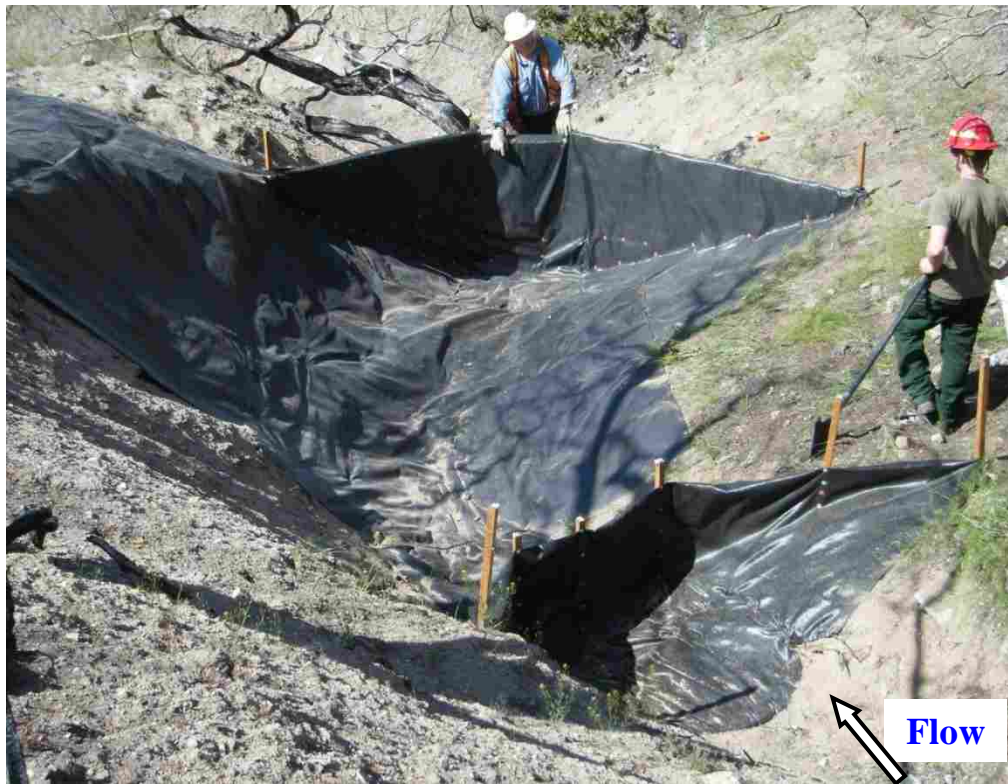
**Figure 8.** Tandem sediment retention structures in the channel. Geotextile woven fabric was secured to the up-channel face of the framed structures and extends up-channel attached with sod staples to the bed and banks. Tandem structures increased the maximum sediment storage capacity of sediment retention structures. Photo looks down-channel.

This reduced the chance of flow undercutting the structure and provided a base reference to help distinguish between captured eroded sediment and the original channel bed. Two sediment retention structures were built in tandem in each catchment's channel to capture total bedload sediment yield during a rain event, and in two channels an additional third structure was added halfway into the 2011 season after sediment yields overtopped the original two structures (Figure 8).

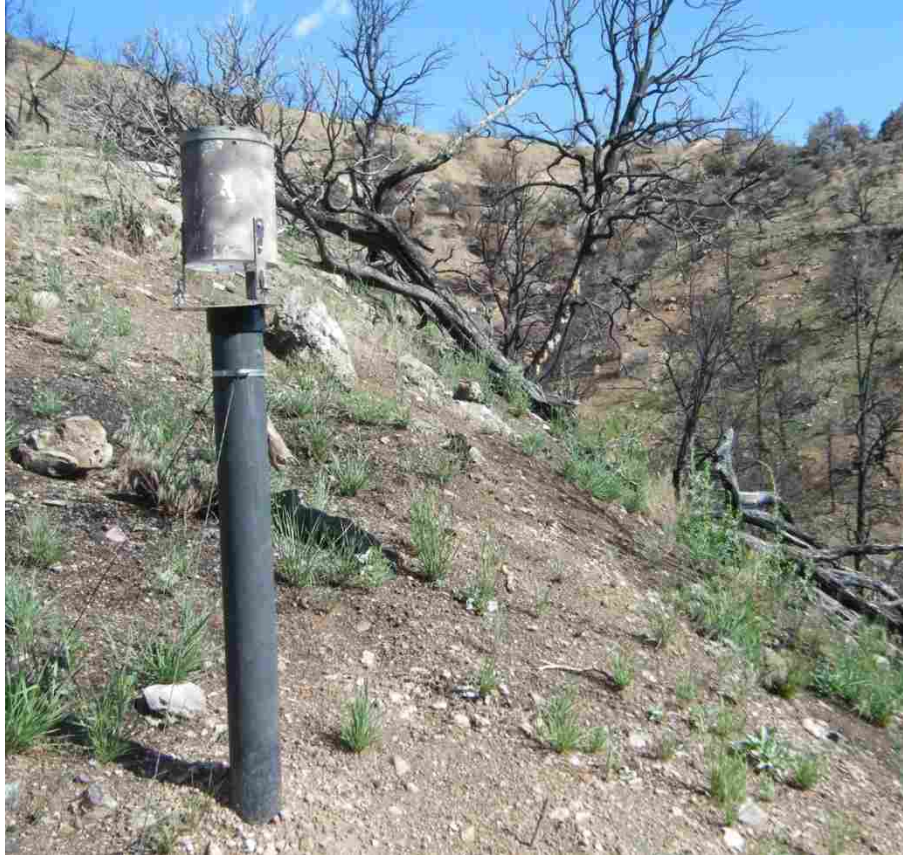
**Figure 9.** Tipping bucket rain gauge (~20 cm [8 in] opening) set level to the ground and located roughly half way up catchment ridge (monitored catchment in background). The rain gauge was mounted to a plate of sheet metal attached to the top of a 10 cm (4 in) diameter PVC post. The hollow PVC post was buried 45 cm (~18 in) into the ground, filled to the brim with soil, and secured with three guy-wires spaced at 120° that were attached to the post 140 cm (~55 in) from the ground surface and anchored at the ground with rebar to reduce systematic error of wind disturbance tipping the recording bucket.

We measured spring, summer, and fall rainfall events. Five tipping bucket rain gauges recorded rain event duration, intensity, and total precipitation monitored continuously for the duration of the monsoon seasons for both the first and second post-fire years, from 10 Jun 2011 to 8 Oct 2011 and 7 May 2012 to 26 Sep 2012. Four rain gauges are located on the adjoining ridge between paired catchments, and one rain gauge is located on the far western ridge of a paired catchment (Figure 9). Tipping-bucket rain gauges (8" Tipping Bucket Rain Gauge, RainWise, Bar Harbor, ME; HOBO Event Logger, Onset Computer Corporation, Bourne, MA) record volume (0.254 mm [1/100 in]) per time with a resolution of 0.5 seconds (Ciach, 2003). Rain data was standardized to tips per minute, and events were separated by the passing of a six hour time interval between consecutive tips. Total precipitation (mm) [in], duration (min), and 10-minute ( $I_{10}$ ) and 30-minute ( $I_{30}$ ) rainfall intensities were determined for each event and categorized according to their 10 minute intensities for 1, 2, and 5-year recurrence intervals (Bonnen *et al.* 2006).

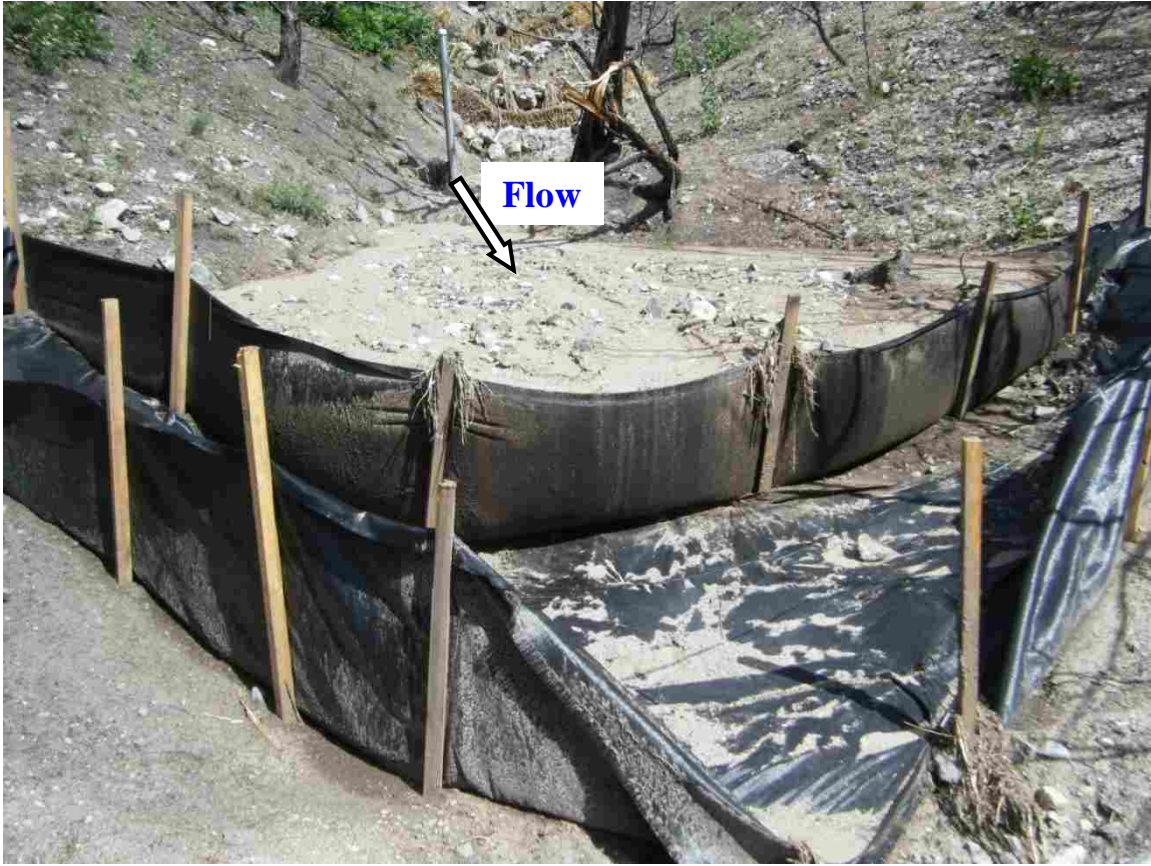
**Figure 12.** Sediment overwhelmed the upper sediment retention structure and caused the lower sediment retention structure to fail in catchment F from a high sediment yielding 16 mm (0.6 in) 1-year  $I_{30}$  21 mm hr<sup>-1</sup> (0.8 in hr<sup>-1</sup>) return period event on 8 Jul 2011. Overwhelmed and failed fences occurred only in Sevier Canyon due to the high sediment erosion rates during 2011. The reliable sediment yield is the measurement of sediment in the upper fence shown here, and is a conservative estimate of the true sediment yield from the catchment during the rain event.

Large sediment yields from catchments were typical for 2011. The sediment retention structures were cleaned out five times during 2011 (Table 6 [a,b]). The cleanout in pair A-B on 26 Jul 2011 was the sum of two sediment yield events produced from a 2-year  $I_{30}$  return period event on 15 Jun and a 5-year  $I_{30}$  return period event on 8 Jul 2011. The  $I_{30}$  rainfall intensity was found to be the best predictor of sediment yields and I will refer to this intensity when addressing sediment yields. The rain event on 8 Jul 2011 caused sediment retention structures to be overwhelmed in 5 of the 10 catchments (all located in Sevier Canyon) causing sediment retention structures to fail or fill to the maximum storage capacity and be overtopped by sediment mobilized in the channel (Figure 12).

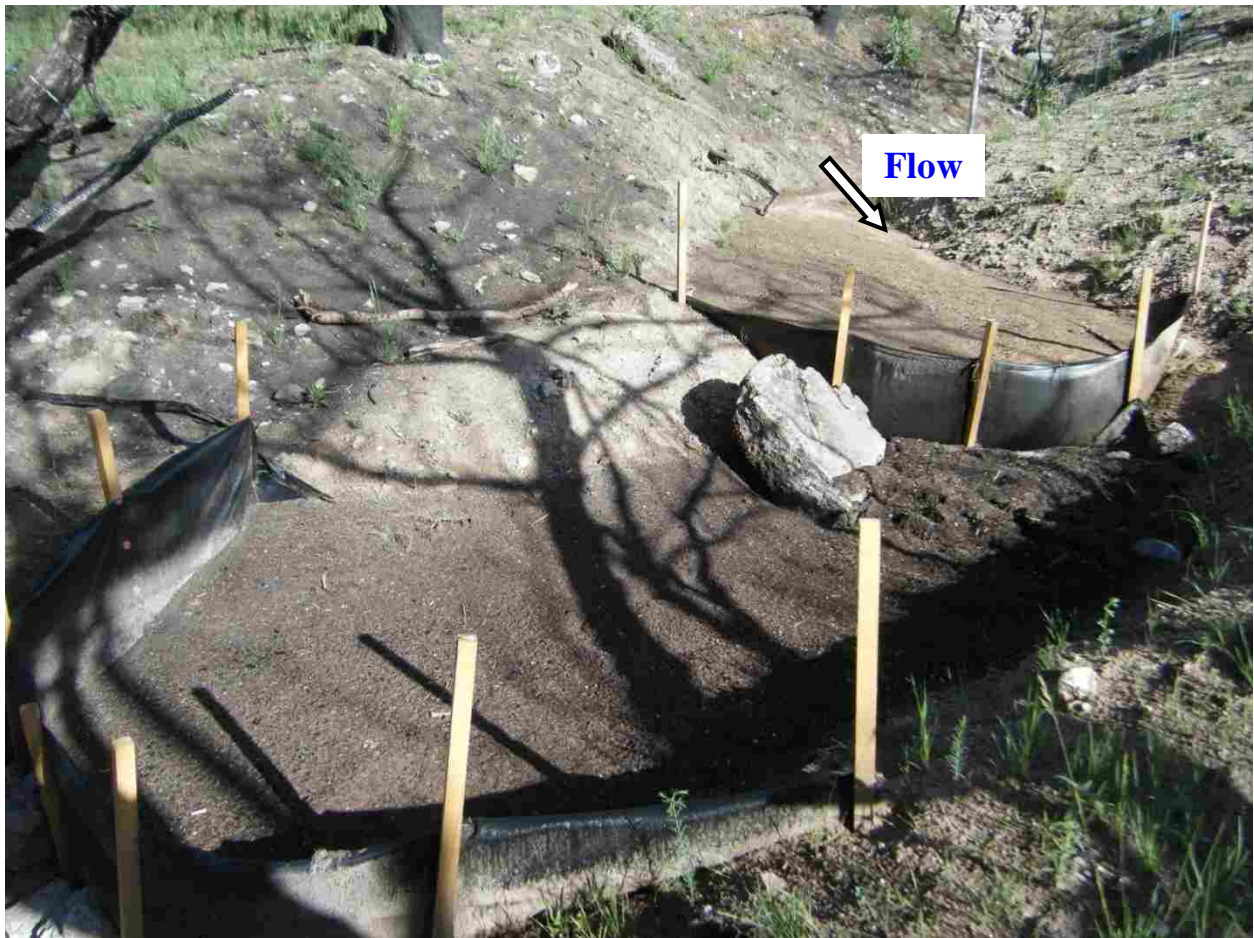
**Figure 13.** Total sediment yield captured by sediment retention structures in catchment I.5 from an event on 8 July 2011. Lower sediment yields in Middle Canyon allowed total annual sediment yields to be captured during the 2011 monitored period.

The 2011 sediment yields in Middle Canyon's paired catchments G-H and I-J were much less than those in Sevier Canyon, allowing the sediment retention structures to capture the total annual sediment yield (Figure 13). In Middle Canyon the mean annual sediment yield from catchments treated with 4 straw bale check dams  $\text{ha}^{-1}$  (2 SCDs  $\text{ac}^{-1}$ ) was  $3.93 (\pm 0.1) \text{ Mg ha}^{-1}$  [ $1.75 \text{ t ac}^{-1} \text{ yr}^{-1}$ ] and  $16.10 (\pm 0.5) \text{ Mg ha}^{-1}$  [ $7.18 (\pm 0.2) \text{ t ac}^{-1} \text{ yr}^{-1}$ ] from control catchments or a 76 ( $\pm 4$ ) % reduction in sediment yield rates. Middle Canyon pairs G-H and I-J had a mean treated:control paired catchment ratio of  $0.51 (\pm 0.02): 1$  (Table 9).

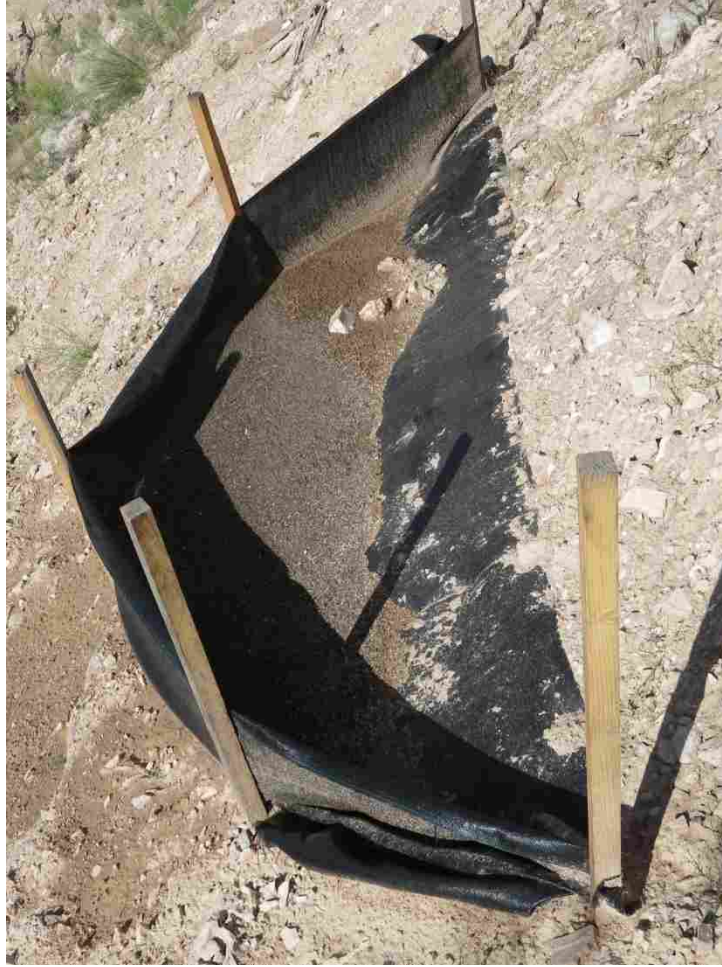
**Figure 14.** Hillslope fence G captured total sediment yield from an 11 mm (0.4 in)  $27 \text{ mm hr}^{-1}$  ( $1.1 \text{ in hr}^{-1}$ ) rain event on 8 Jul 2011 that was less than a 1-year  $I_{10}$  recurrence interval event.

In Middle Canyon the 2011 annual hillslope erosion rates were much less than in Sevier Canyon, allowing hillslope fences to capture the total erosion during each event (Figure 14). In Middle Canyon the erosion rates varied widely for upslope fences of 7.2 and 35.8 Mg ha<sup>-1</sup> [3.2 and 16.0 t ac<sup>-1</sup>] and for base of hillslope fences of 0.1 and 24.7 Mg ha<sup>-1</sup> [0.1 and 11.0 t ac<sup>-1</sup>]. The first cleanout on 26 Jul 2011 accounted for 65 % of annual erosion in upslope fences and 49 % of annual erosion for base of hillslope fences. Mean hillslope erosion rates were higher than catchment sediment yields in Middle Canyon. The representative mean annual hillslope erosion rate of the combined four upslope and base of hillslope fences was 17.0 Mg ha<sup>-1</sup> [7.6 t ac<sup>-1</sup>], or 5 % higher than the representative mean annual sediment yields from control catchments H and I of 16.1 Mg ha<sup>-1</sup> [7.2 t ac<sup>-1</sup>].

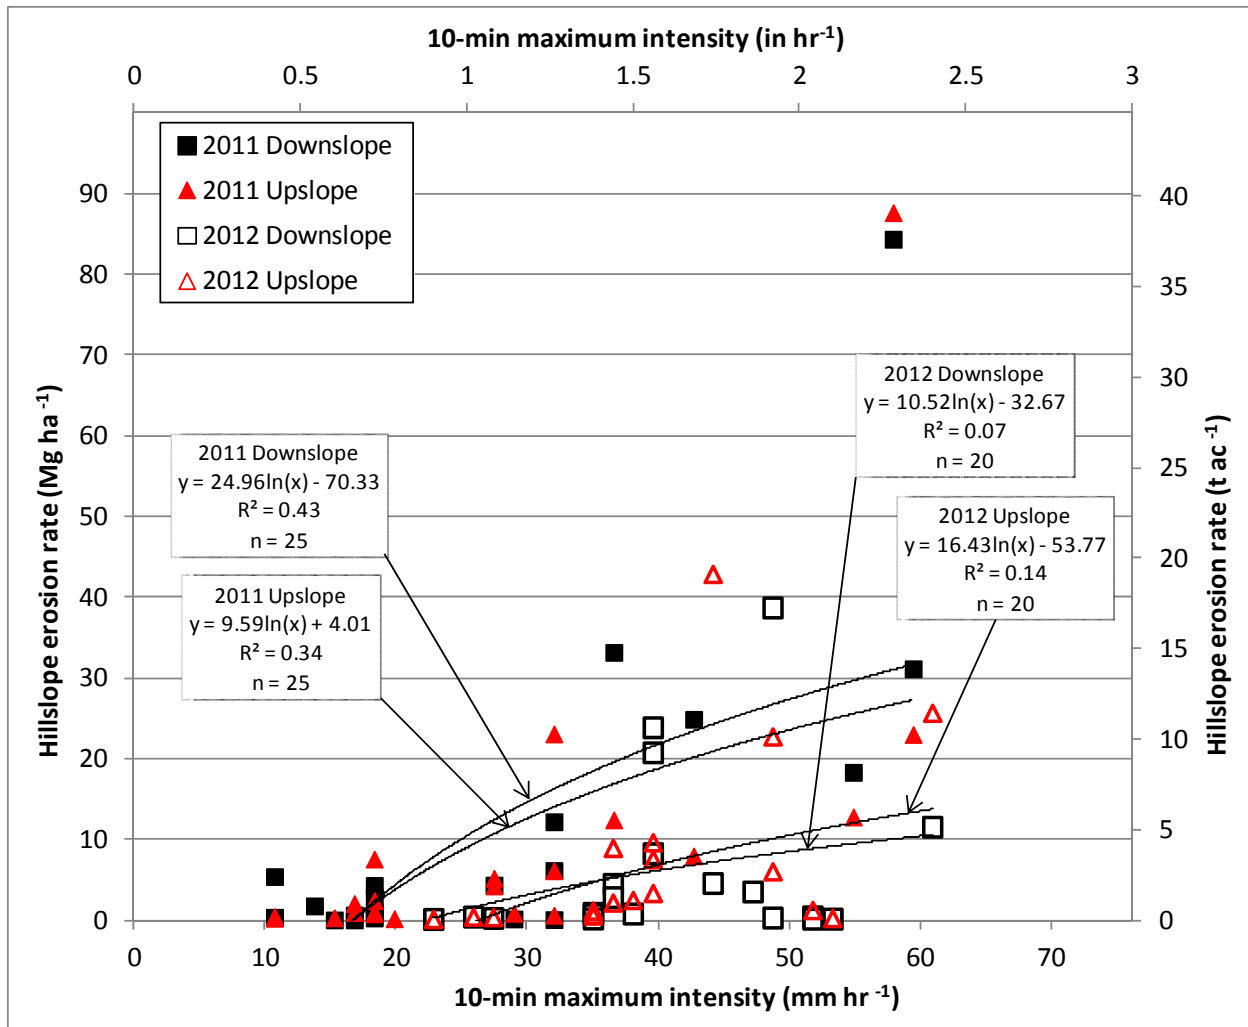
**Figure 15.** The relationship between 10-min maximum rainfall intensity ( $\text{mm hr}^{-1}$ , in  $\text{hr}^{-1}$ ) and base of hillslope (downslope; squares) and upslope (triangles) erosion rates by year (2011 closed symbols, 2012 open symbols).

In 2012 Middle Canyon had a large range for annual upslope fence erosion rates. The two upslope fences measured 6.8 and 77.6 Mg ha<sup>-1</sup> [3.0 to 34.6 t ac<sup>-1</sup>] of sediment erosion, while the range for base of hillslope fences was 0.5 to 19.1 Mg ha<sup>-1</sup> [0.2 to 8.5 t ac<sup>-1</sup>]. The 16 Jul 2012 and 1 Aug 2012 events contributed 66 to 90 % to the annual sediment erosion rates. 2011 and 2012 hillslope sediment erosion rates vs. I<sub>10</sub> rainfall intensities shows erosion rates increase with higher intensity events (Figure 15).

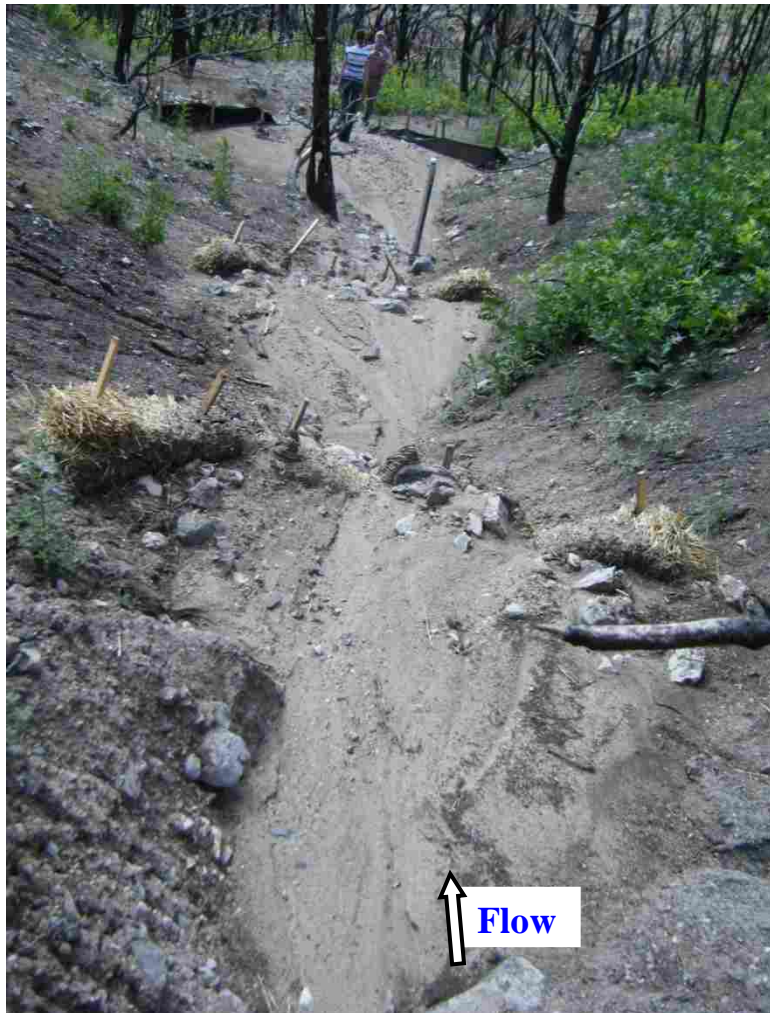
**Figure 16.** Channel F treated with 2 straw bale check dams that filled to capacity and were overwhelmed by a 16 mm (0.6 in), 21 mm hr<sup>-1</sup> (0.8 in hr<sup>-1</sup>)  $I_{30}$  intensity 1-year return period event. The majority of sediment trapped by straw bale check dams was a sandy loam, but large woody debris and cobble mobilized by overland flow were also trapped. Photo looks down channel.

on 15 Jun 2011 and 8 Jul 2011 in catchment A respectively. The SCDs filled to capacity during the 1-year  $I_{30}$  intensity return period event on 8 Jul 2011 in catchments D and F (Figure 16).

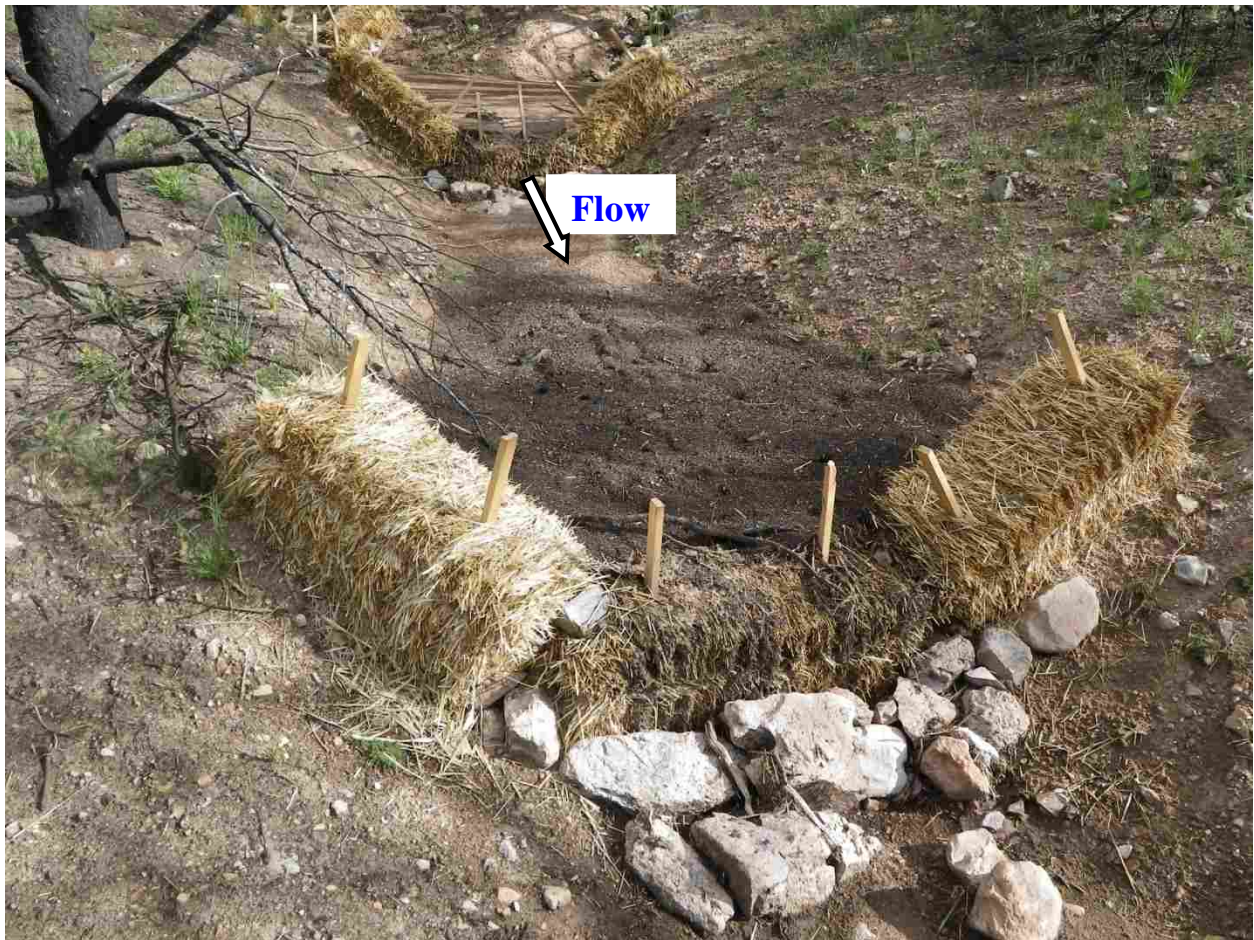
**Figure 17.** Straw bale check dam in catchment G filled to capacity during a 11 mm (0.4 in), 13 mm hr<sup>-1</sup> (0.5 in hr<sup>-1</sup>) I<sub>30</sub> intensity rain event on 8 Jul 2011, which is less than a 1-year return period I<sub>30</sub> intensity event. Spillway rocks to reduce scour were undisturbed by flow. Photo looks up-channel.

capacity (Figure 17), and in catchment J the event filled two of the three straw bale check dams to maximum sediment holding capacity.

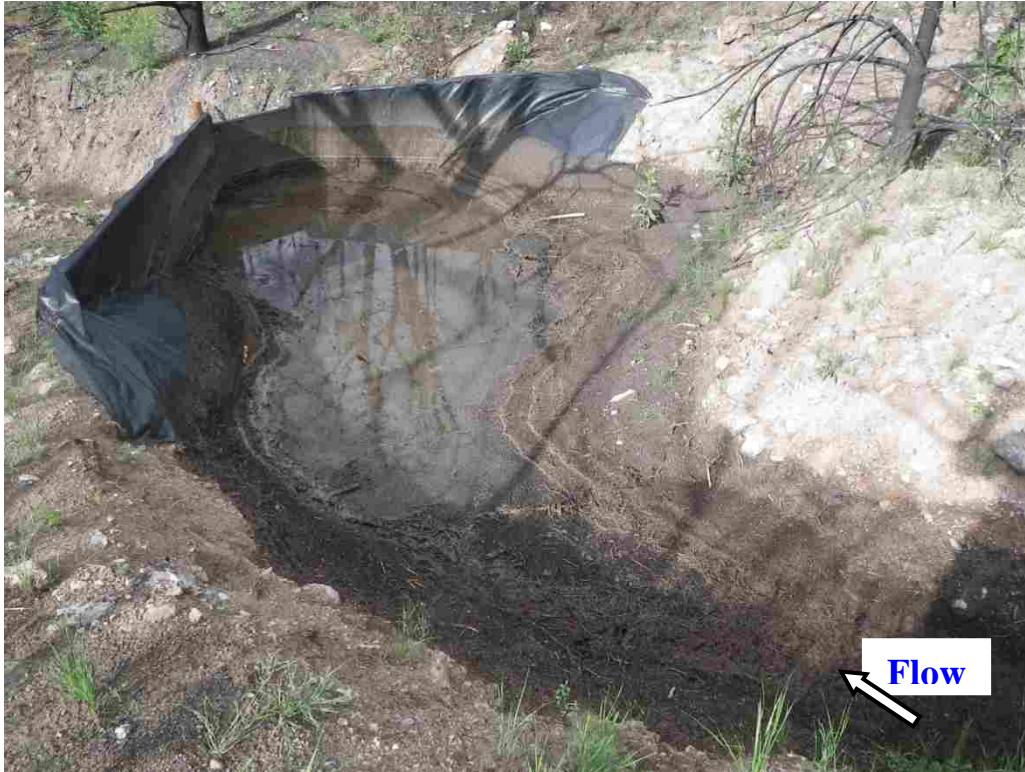
**Figure 18.** In treated catchment G, this sediment retention structure captured 2.55 Mg of sediment that was transported past three empty or partially full straw bale check dams that sat lowest in the channel closest to the catchment outlet, during the 8 Jul 2011 storm.

channel and closest to the catchment outlet. These remaining partially full structures in treated catchments G and J were filled to their maximum sediment holding capacity during the 3 Aug 2011 event that had less than a 1-year  $I_{30}$  return period intensity.

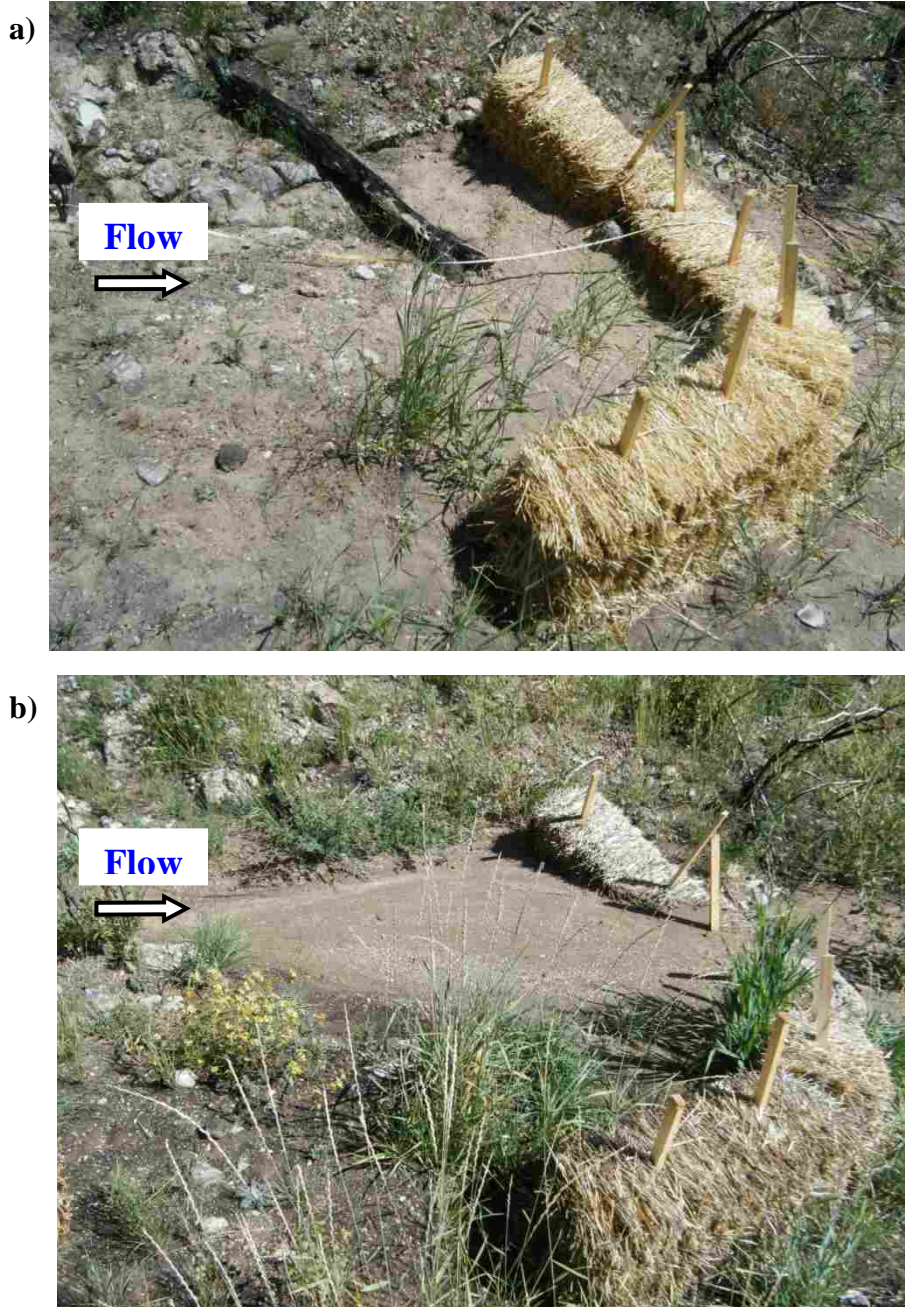
**Figure 19.** a) empty straw bale check dam at time of installation. b) same straw bale check dam filled to maximum sediment holding capacity with the height of trapped sediment equal to the spillway height. The volume of sediment trapped by this straw bale check dam was  $0.64 \text{ m}^3$  ( $22.7 \text{ ft}^3$ ) or a trapped mass of  $0.79 \text{ Mg}$  ( $0.87 \text{ t}$ ). Below the spillway  $0.04 \text{ m}^3$  ( $1.4 \text{ ft}^3$ ) of sediment was scoured by flow or  $0.05 \text{ Mg}$  ( $0.05 \text{ t}$ ) of scoured mass.

All straw bale check dams trapped a net positive amount of sediment because no structures failed or were displaced from where they were installed. The mean volume of sediment trapped by straw bale check dams was  $1.00 \text{ m}^3$  ( $35.2 \text{ ft}^3$ ) with a range of 0.29 to  $2.22 \text{ m}^3$  ( $10.4$  to  $78.5 \text{ ft}^3$ ) (Table 9). The mean mass of sediment trapped by the straw bale check dams was 1.27 Mg (1.40 t) per structure with a range of 0.35 to 3.16 Mg (0.38 to 3.48 t) with an average bulk density of  $9.86 \text{ Mg m}^{-3}$  ( $616 \text{ lbs ft}^3$ ) (Figure 19). The mean mass of sediment trapped per catchment-area at a treatment rate of four straw bale check dams  $\text{ha}^{-1}$  (2 SCDs  $\text{ac}^{-1}$ ) was  $5.87 \text{ Mg ha}^{-1}$  ( $2.62 \text{ t ac}^{-1}$ ) with a range of 3.40 to  $10.48 \text{ Mg ha}^{-1}$  ( $1.52$  to  $4.68 \text{ t ac}^{-1}$ ).

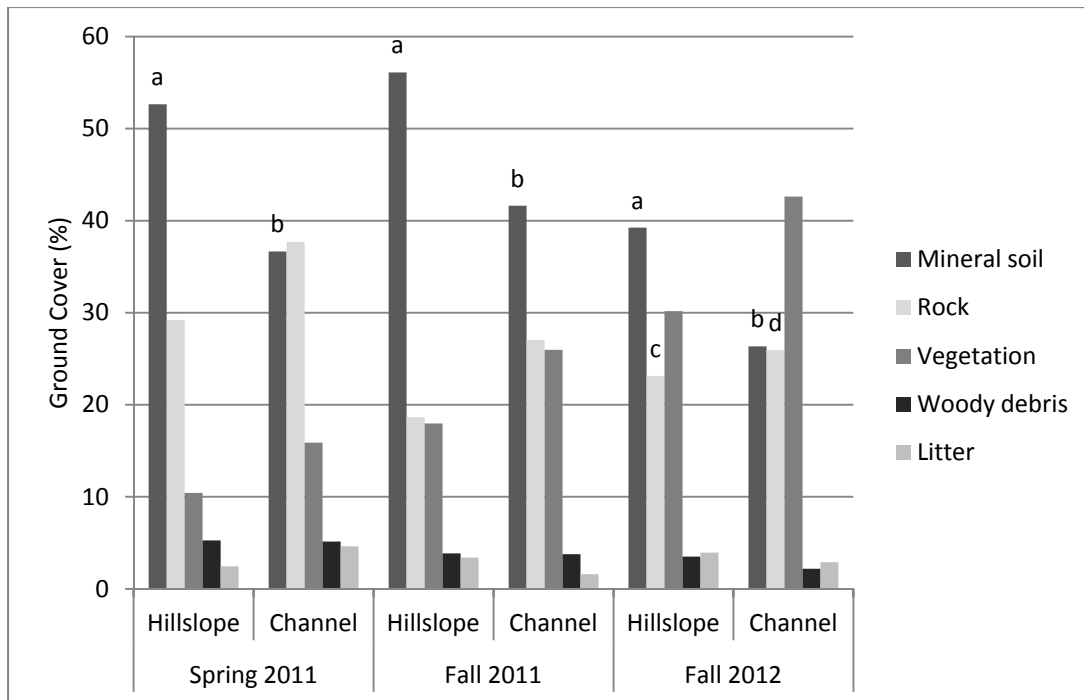
**Figure 23.** Percent ground cover of the five variables: mineral soil, rock, vegetation, woody debris and litter, shown for spring and fall of 2011 and fall of 2012. Labels a and b indicate mineral soil exposure on hillslopes is significantly than channels. Labels c and d indicate a significant difference in vegetation soil cover between hillslope and channel when.

Vegetation is considered the most important ground cover variable with regard to erosion rates because litter was not present in the first post-fire year and had minimal effect on erosion during the second post-fire year. The significance of exposed mineral soil and vegetation cover is reported here, for additional inquiry of significance of the three other cover variables see Table 10. In the spring of 2011 there is a significant difference ( $t = 2.92$ ,  $p = 0.007$ ) between mineral soil cover on the hillslope and in the channel, this was also true in the fall of 2011 ( $t = 3.09$ ,  $p = 0.006$ ) (Table 10). There is a significant difference ( $t = -3.81$ ,  $p = 0.001$ ) in vegetation cover between the spring and fall of 2011.

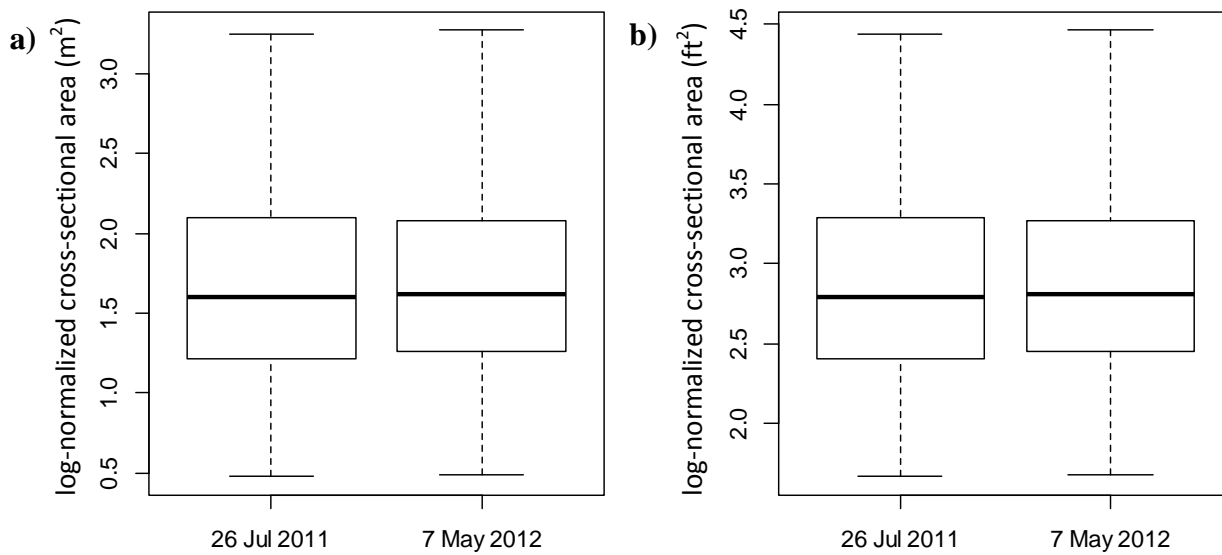
**Figure 25.** Box plot of log-normalized channel cross-section areas **(a)** m<sup>2</sup> **b)** ft<sup>2</sup> for the two survey dates.

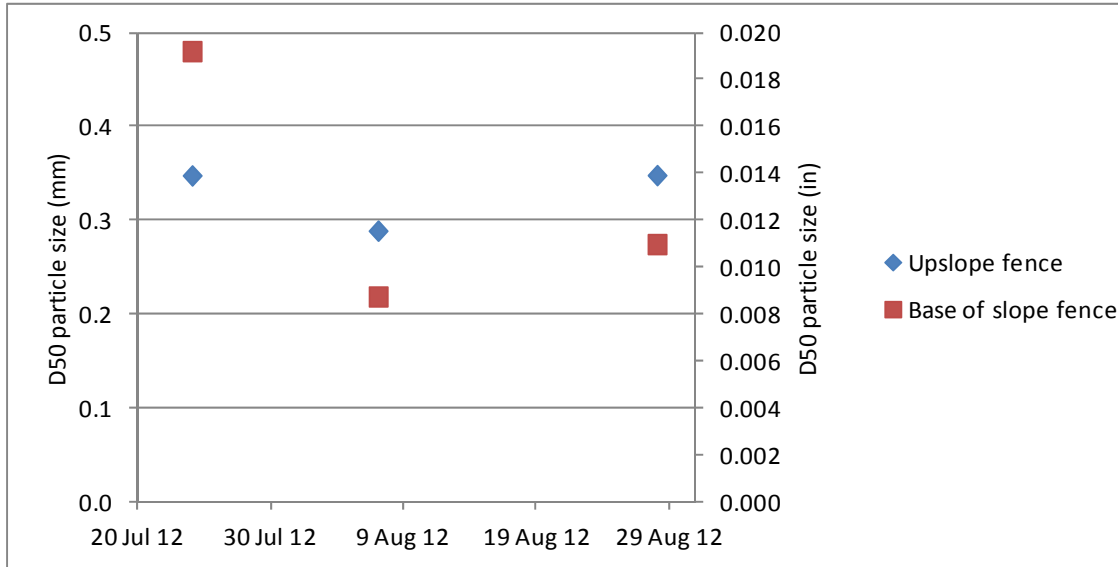
**Figure 27.** Mean  $D_{50}$  particle size for upslope and base of hillslope fence sediment erosion for the first three rain events during 2012.

0.2 to 0.5 mm (0.009 to 0.019 in) (Figure 27), having a similar range to the mean  $D_{50}$  hillslope particle sizes in 2011. There is no consistent trend in particle size between the two fence locations.
