Assessment of water quality of lakes used for recreational purposes in abandoned mines of Linden, Guyana

Marisa Sonya Williams, Temitope D. Timothy Oyedotun & Denise Adrienne Simmons

The open pit method is often the easiest and the most inexpensive form of mining. Bauxite mining, which commenced in 1916 in Linden, Guyana, has left many abandoned pits upon closure of mining activities; subsequently pit lakes have been formed. Globally, Acid Mine Drainage (AMD) is a common water quality problem for pit lakes. However, the pit lakes in Linden are used for recreational activities. In this study, the water quality of three lakes in Linden (NE Kara Kara, Kara Kara and Lucky Spot) were analysed for their physico-chemical characteristics. The morphological and aesthetic features were also examined. The study showed that all three lakes are acidic, with mean pH values of 3.4, 3.1 and 4.7, which are not within the allowable range for recreational waters. Mean concentrations of Al (23.06 mg/l), Fe (10.56 mg/l) and Mn (2.4 mg/l) exceeded acceptable limits; nevertheless, TDS levels measured were within the acceptable limits. In terms of aesthetic quality, NE Kara Kara and Kara Kara pit lakes

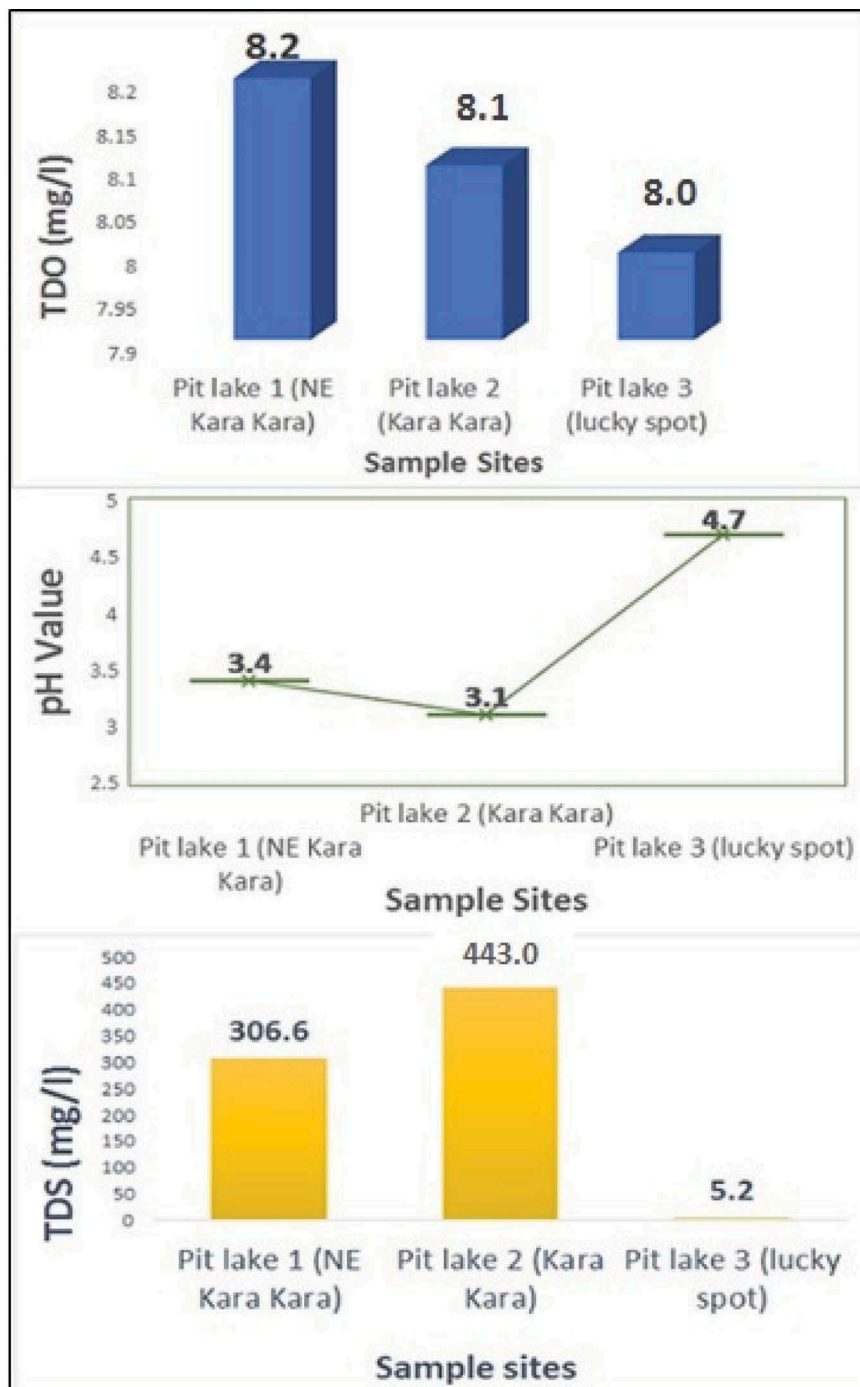
Figure 2. Mean pH, TDS and TDO for the three Pit Lake sample sites.

The mean pH of all the samples collected was 3.7. Specifically, the mean pH values for NE Kara Kara, Kara Kara and Lucky Spot were 3.4, 3.1 and 4.7, respectively (Figure 2). The results were not within the ANZECC & ARMCANZ (2000) and Health Canada (2012) range of 5.0–9.0. The results for TDS indicated that all the samples collected were within the acceptable limit of 1,000 mg/l specified by ANZECC & ARMCANZ (2000). In this study, Pit Lake 2 had the highest TDS concentration (Figure 2). The mean TDS values were as follows: NE Kara Kara 306.6 mg/l, Kara Kara 443.0 mg/l and Lucky Spot 5.2 mg/l. Total Dissolved Oxygen (TDO) is considered as one of the best indicators of the health of any aquatic ecosystem (Muigai, Shiundu, Mwaura, & Kamau, 2010). The mean TDO for the samples was 8.1 mg/l, which is in accordance with the standard of > 6.5 mg/l stipulated by ANZECC & ARMCANZ (2000). NE Kara Kara had the highest concentration of 8.2 mg/l, followed by Kara Kara with a TDO of 8.1 mg/l and Lucky Spot with a TDO of 8.0 mg/l.

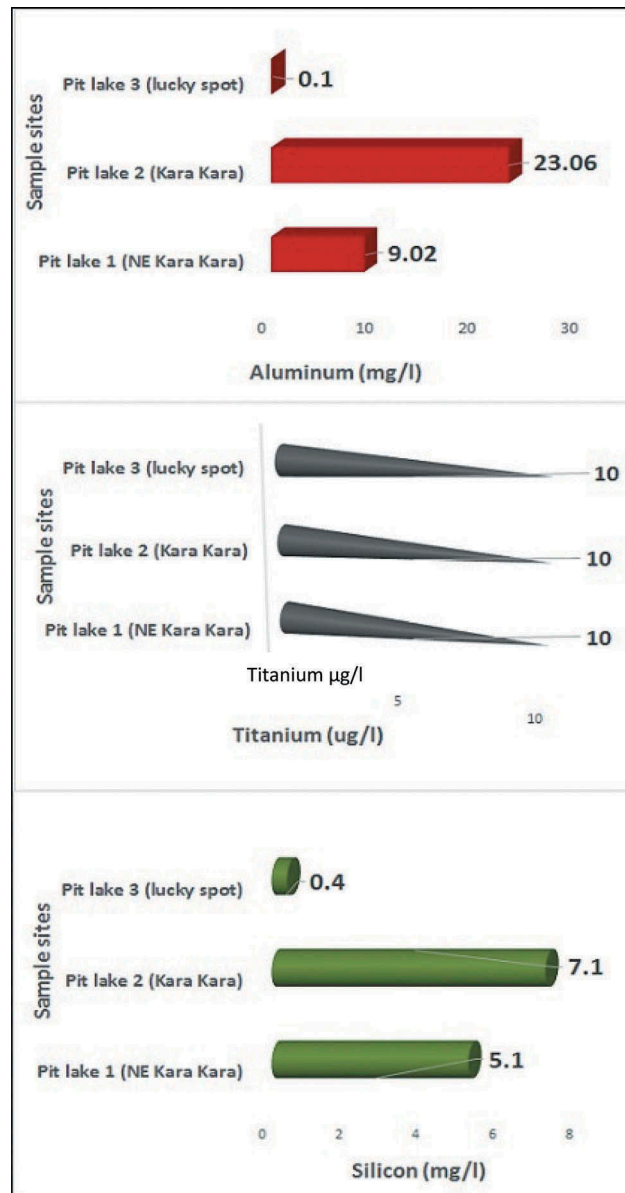
Figure 3. Mean concentrations of aluminium, titanium and silicon in the lakes.

Aluminium, titanium and silicon were analysed because of the high-quality composition of these chemicals in bauxite ore, which was the main material previously being mined in the study area. The extremely high levels of the composition of these materials can be dangerous (Eccarius, 1998; Fabri et al., 2013), therefore the need for their consideration in the analyses. The results for aluminium indicated that the samples collected from Pit Lakes 1 and 2 were not within the acceptable limit of 0.2 mg/l as specified by ANZECC & ARMICANZ (2000); the recorded values were 9.02 mg/l and 23.06 mg/l respectively. Pit Lake

3, on the other hand, had the lowest concentration of aluminium and it was within the ANZECC & ARMICANZ (2000) guideline (Figure 3). The mean titanium concentration for NE Kara Kara, Kara Kara and Lucky Spot sample sites was 10 µg/l. Results for silicon revealed that the mean was 4.2 mg/l. Specifically to the sites, Kara Kara had the highest concentration of 7.1 mg/l, followed by NE Kara Kara with a value of 5.1 mg/l, and Lucky Spot with a concentration of 0.4 mg/l (Figure 3). However, neither titanium nor silicon are included in the two recreation water quality guidelines as elements of concern.

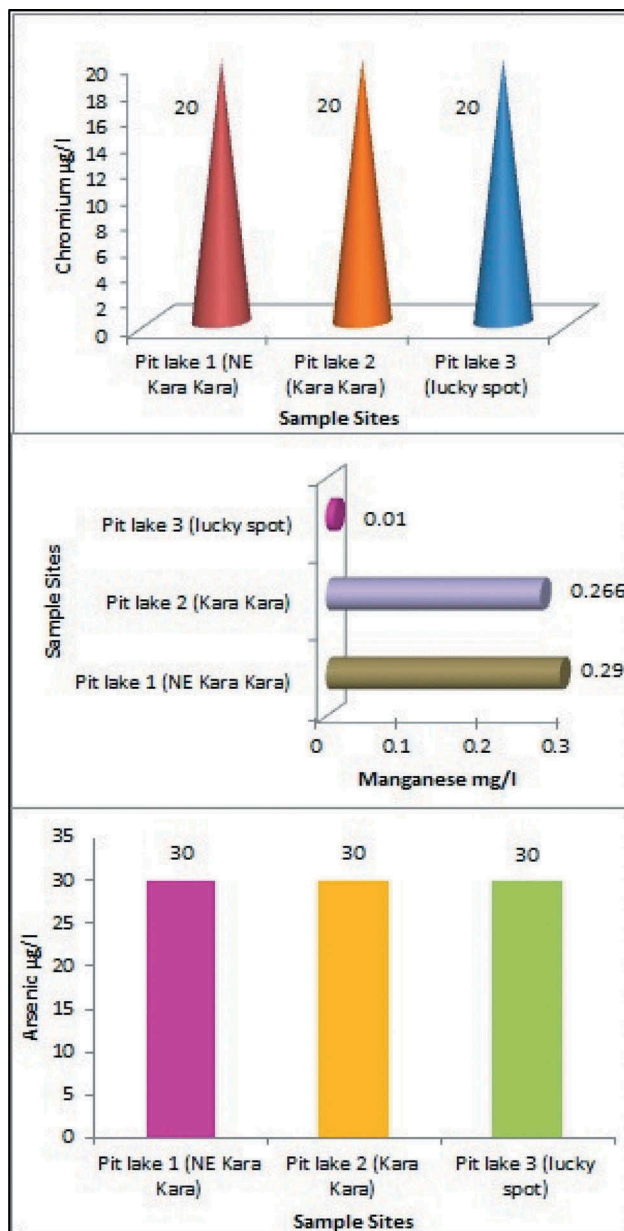
Figure 4. Mean concentrations of manganese, chromium and arsenic in the sampled pit lakes.

The mean concentration of chromium for Pit Lakes 1, 2 and 3 was 20 $\mu\text{g/l}$. All results obtained were within the limit of 50 $\mu\text{g/l}$ (ANZECC & ARMCANZ, 2000). The mean concentration of manganese was 1.58 mg/l. The mean manganese concentration for NE Kara Kara was 2.40 mg/l, for Kara Kara it was 2.14 mg/l, and for Lucky Spot, it was the lowest at 0.20 mg/l (Figure 4). These values exceeded the ANZECC & ARMCANZ (2000) acceptable limit of 0.1 mg/l. However, the mean arsenic concentration was within the acceptable limit of 50 $\mu\text{g/l}$ (ANZECC & ARMCANZ, 2000). The mean concentration of arsenic at all three sites was 30 $\mu\text{g/l}$ (Figure 4).

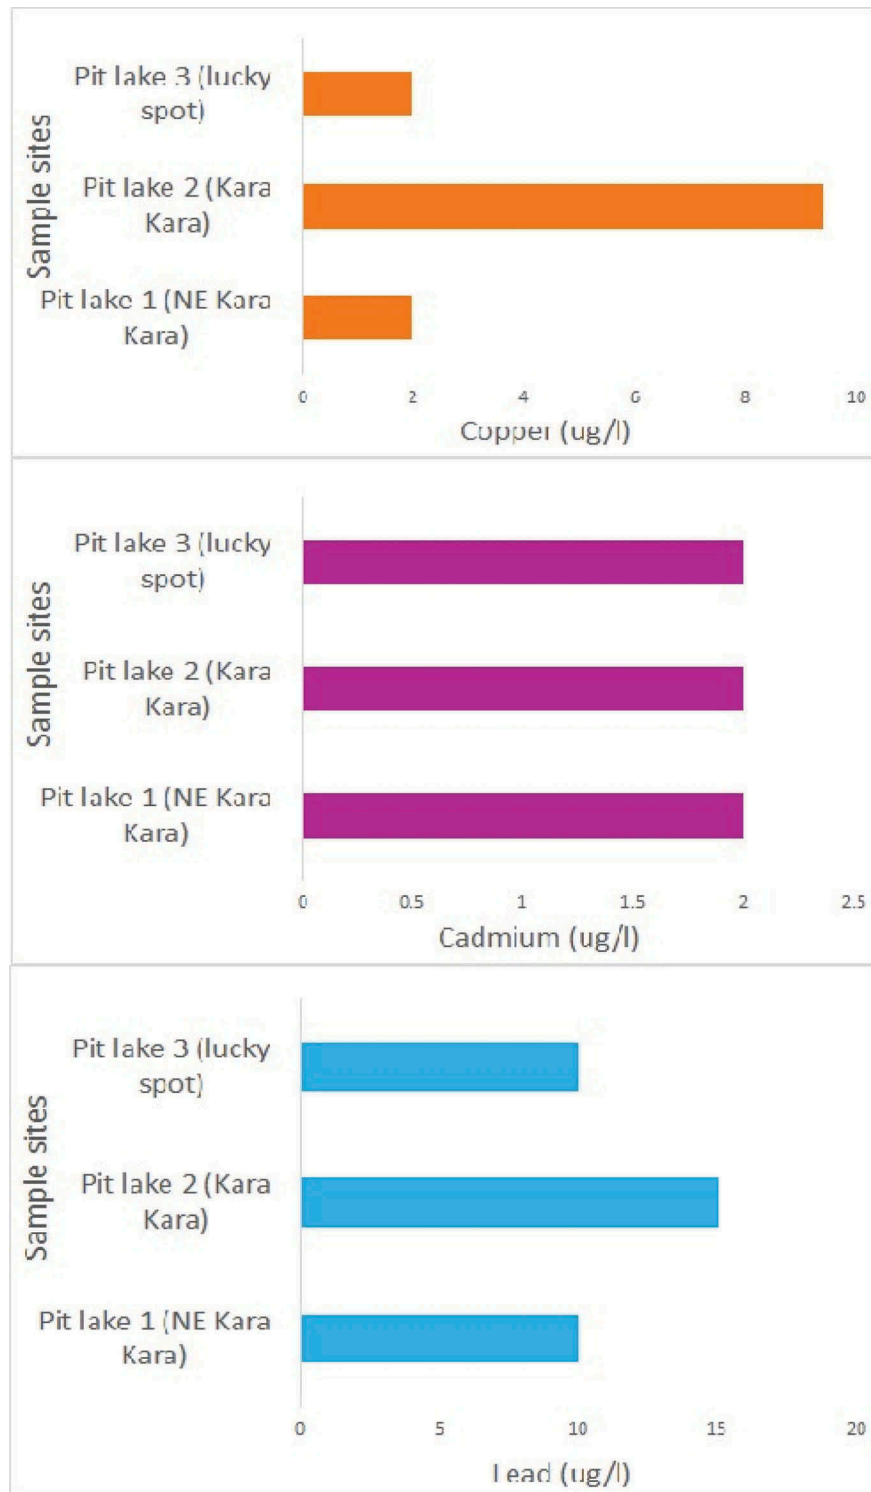
Figure 5. Mean concentrations of lead, copper and cadmium in pit lakes' waters.

15 $\mu\text{g/l}$ and Lucky Spot was 10 $\mu\text{g/l}$. Regarding the copper levels, Pit Lake 2 (Kara Kara) had the highest concentration (Figure 5), while Pit Lakes NE Kara Kara and Lucky Spot had a value of 2 $\mu\text{g/l}$ each. All values obtained were below or within the recommended limit of 1000 $\mu\text{g/l}$. Additionally, the mean concentration of cadmium for the three pit lakes was 2 $\mu\text{g/l}$ (Figure 5), which was within the limit of 5 $\mu\text{g/l}$ (ANZECC & ARMCANZ, 2000).

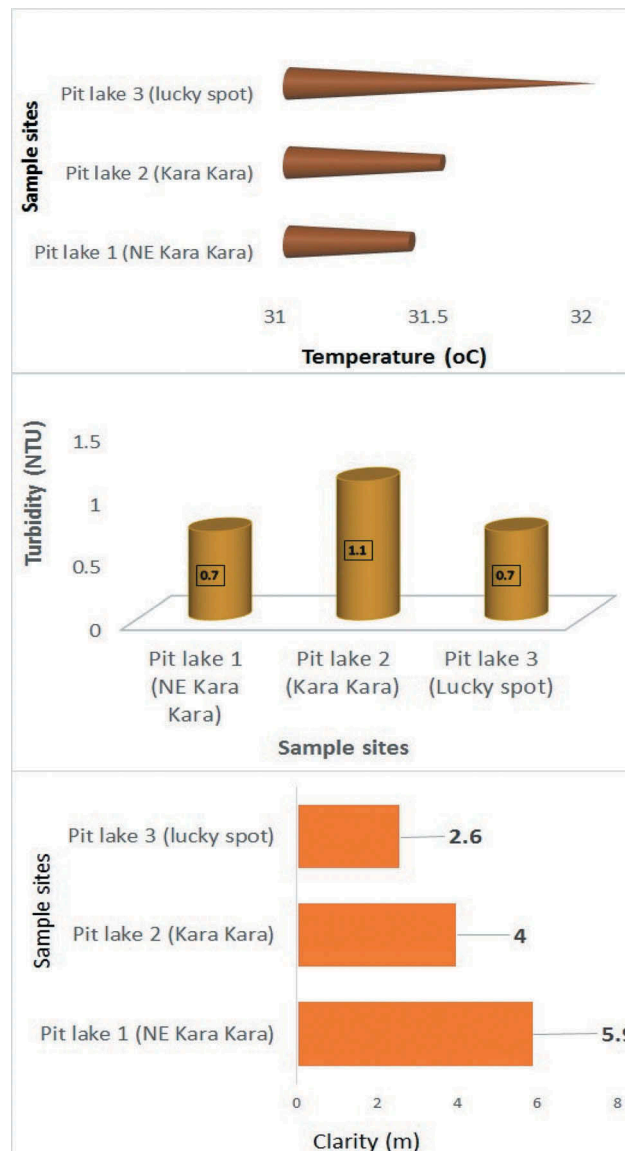
**Figure 6.** Mean clarity, turbidity and temperature of water in sampled pit lakes.

turbidity levels of all pit lakes were below the acceptable limit of 50 NTU (ANZECC & ARMCANZ, 2000). The results for clarity indicate that all the pit lakes were within the limit of 1.6 m specified by ANZECC & ARMCANZ (2000) and 1.2 m specified by Health Canada (2012). Pit Lake 1 had a clarity reading of 5.9 m, Pit Lake 2 had a value of 4 m and Pit Lake 3 a reading of 2.6 m (Figure 6).

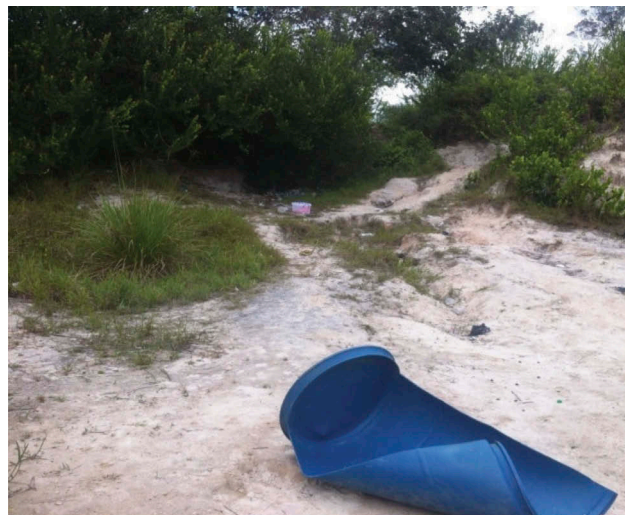
Figure 7. Example of litter observed at Pit Lake 3 (Lucky Spot lake).

Waters used for recreational purposes should be free from substances or objects that impair its aesthetic quality (ANZECC & ARMICANZ, 2000). An evaluation of the pit lakes studied indicated that they were generally free from unpleasant substances and objects. The exception, however, was Pit Lake 3 which had a small amount of litter on the shore (e.g. Figure 7). This is an indication that the lake is frequently visited and used for recreational and other purposes by the public. The lakes were, however, free from other dangerous and hazardous materials such as broken glasses, sharp objects, medical wastes and algae. The accessibility to the lakes is restricted due to the left-over heaps of sediments which were left around the lakes because of the previous mining excavation and activities. The only access to Pit Lakes 2 and 3 is via foot, while Pit Lake 1 can be accessed both on foot and by use of automobiles.
