Flood-induced ground effects and flood-water dynamics for hydro-geomorphic hazard assessment: the 21–22 October 2019 extreme flood along the lower Orba River (Alessandria, NW Italy)

Andrea Mandarino , Fabio Luino & Francesco Faccini

To cite this article: Andrea Mandarino , Fabio Luino & Francesco Faccini (2021): Flood-induced ground effects and flood-water dynamics for hydro-geomorphic hazard assessment: the 21–22 October 2019 extreme flood along the lower Orba River (Alessandria, NW Italy), Journal of Maps

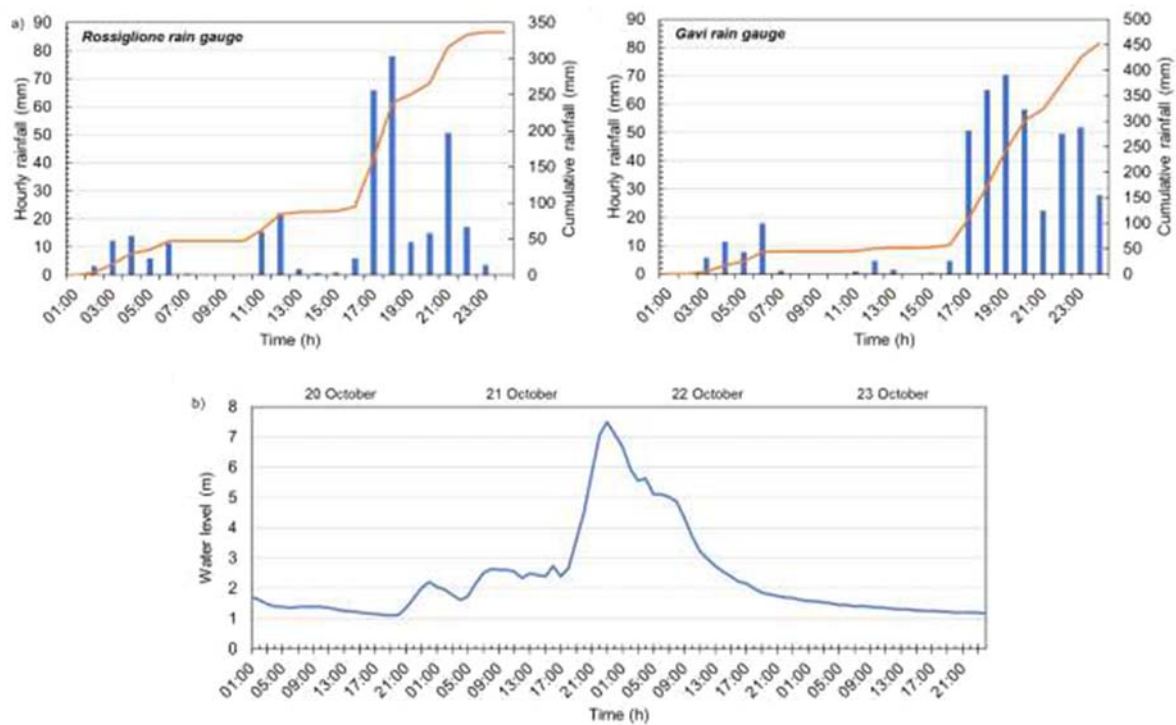
Figure 2. (a) 21 October rainfall values measured by the Rossiglione and Gavi rain gauges (time is referred to CEST). They are the rain gauges that registered the maximum daily rainfall during the event (Table 2). (b) Hydrometric level recorded by the Casalcermelli gauging station (see Figure 1 for location; time is referred to CEST).

From 18 to 24 October 2019 intense and prolonged rainfalls affected large parts of the north-western Italy. The Orba River catchment was mainly hit from 18 to 21 October (ARPA Liguria, 2019; ARPA Piemonte, 2019b), when significant rainfall episodes repetitively affected both the uplands and the lowland areas. The Orba floodplain was largely flooded by the minor hydrographic network in the night and early morning of 21 October. However, the most critical phase of the event occurred in the afternoon and evening of the same day, and it was associated with a thunderstorm cell formed on the Ligurian Sea and then extended northward particularly on the southern part of Piemonte, where it remained stationary for some 12 h (ARPA Piemonte, 2019b). This dynamic resulted in exceptional rainfalls in terms of both cumulative values and intensity (Table 2, Figure 2(a)).

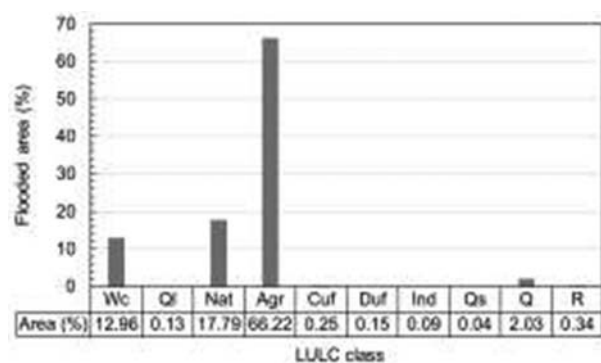
Figure 3. Percentage area of distinct LULC classes affected by the Orba River flood. Wc: water course, Ql: quarry lake, Nat: natural and semi-natural area, Agr: agricultural area, Cuf: continuous urban fabric, Duf: discontinuous urban fabric, Ind: industrial area, Qs: quarried sediment processing site, Q: quarry, R: road infrastructure

approximately 2–3 m above the main ground level were documented. Figure 3 illustrates the percentage area of LULC classes affected by the Orba River flood. The flood spread over 95% of the 200-year flood flow area (the so-called ‘A belt’ according to the river management regulation), 34.4% of the 200-year flooded area (‘B belt’), and 4% of the >200-year flooded area (‘C belt’). Furthermore, 70.9% of the overall flooded area corresponds to the A belt, 20.3% to the B, and 8.8% to the C.

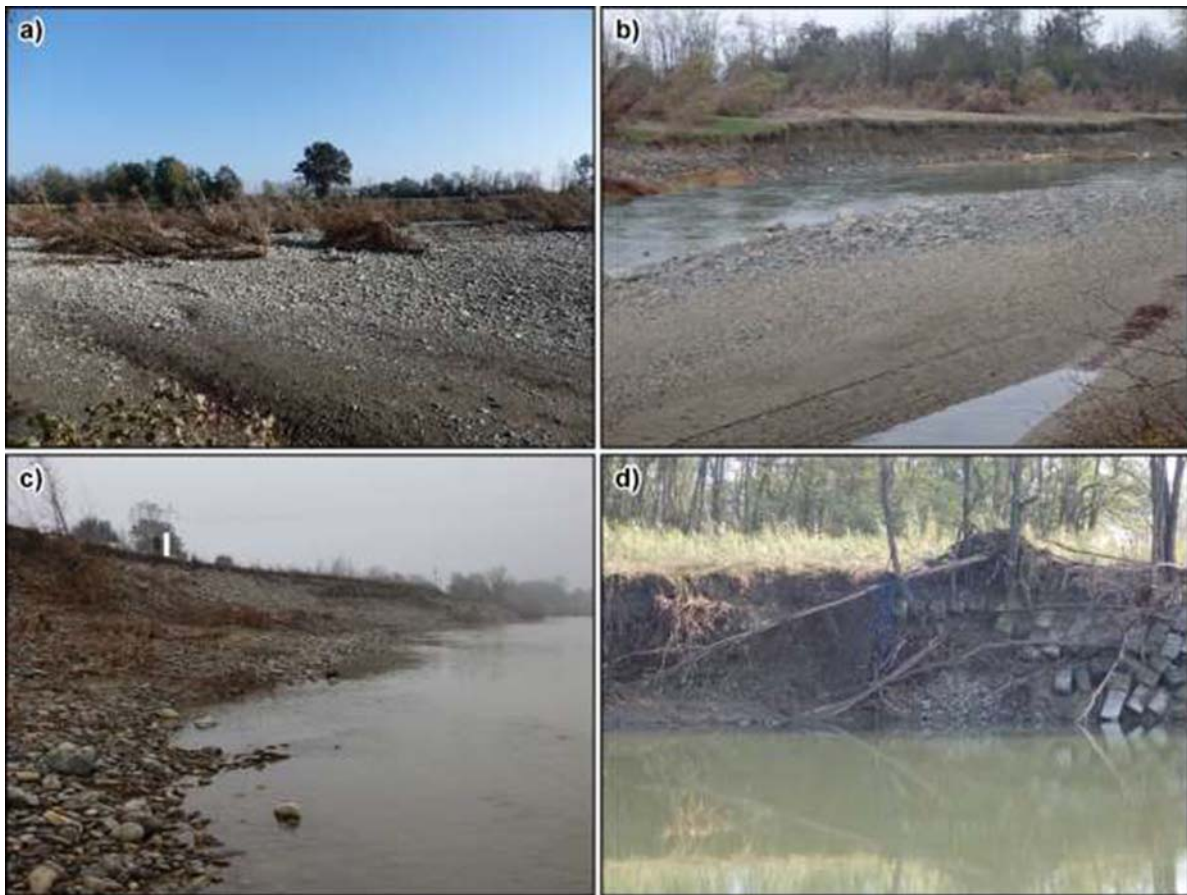
Figure 4. The Orba River active channel after the 21–22 October 2019 flood. (a) Bar affected by intense sediment mobilization and vegetation cover reduction. (b) Bank retreat process involving the modern floodplain. (c) Bank retreat process involving the recent terrace that was already ongoing before the flood. The white line represents a real height of 1.8 m. (d) Collapsed bank protection; most of these structures were already partly or totally collapsed before the flood.

The flood triggered erosional and depositional processes that affected both the riverbed and the floodplain. Within the active channel a generalized intense sediment mobilization was noticed, vegetated bars became largely bare, but no channel pattern changes occurred (Figure 4(a)). The active channel area increased by 6.9%, from 223 ha to 238.5 ha. This newly-formed active channel area belonged to agricultural and natural/semi-natural areas by 1.3% and 98.7%, respectively. A generalized slight channel widening involved the modern floodplain strips, generally included within the river corridor defined by ancient (approximately dated back to the twentieth century, before the 1980s) and recent (after the 1980s) bank protections, in terms of both BE retreat and overbank deposition (Figure 4(b)). Furthermore, intense bank erosion processes locally affected the recent terrace downstream of the downstream-most abstraction weir, mostly fostering processes that were already ongoing before the flood under discussion (Mandarino, 2018) (Figure 4(c)).

At the present day, 21.7% of banks is affected by retreating process. Moreover, bank protection structures cover 45.5% of banks, of which 12.3% are partly or totally collapsed (Figure 4(d)). These percentages changes into 62.3% and 10.9%, respectively, considering the total channelization, that is the overall structures within the river corridor. Most of bank instability processes were already ongoing before the flood.

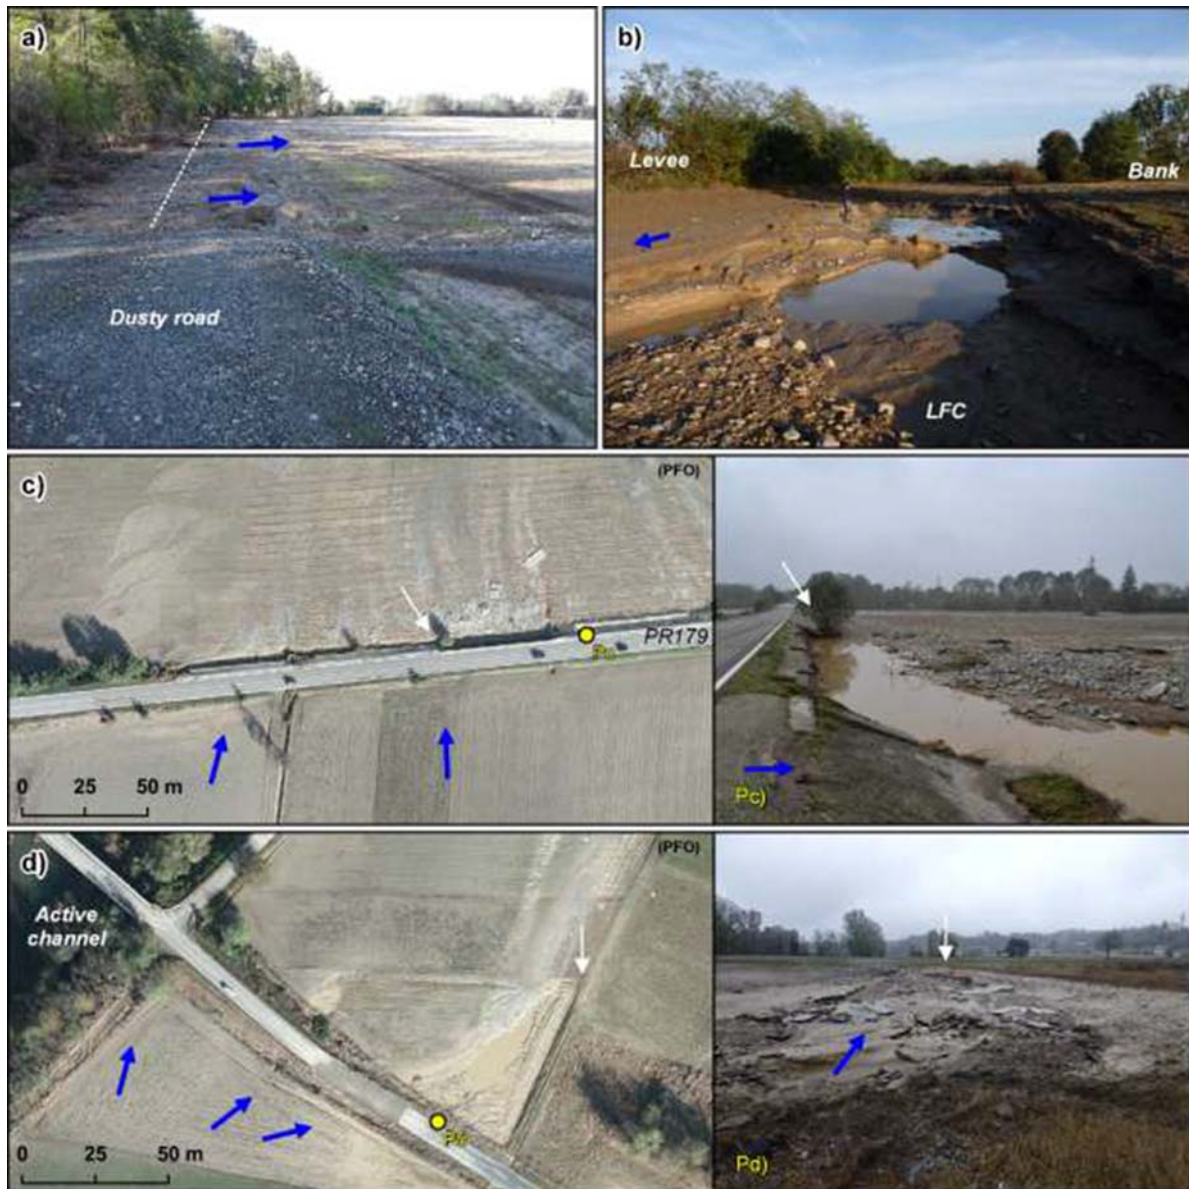
Figure 5. Effects of erosion and deposition processes over the floodplain. (a) Dusty road removed by the flood (white dotted line) and sediment lobes formed downstream. (b) Evidences (worked-soil removal and elongated scour hole formation) of intense superficial erosion that affected agricultural areas within the LFC. (c) Damage to the 179 Provincial Road embankment. (d) Damage to the road between Capriata and Bruno/Ospedale and elongated scour hole downstream of the road itself. These linear infrastructures (c, d) were overtopped and eroded. Downstream intense erosion and deposition processes occurred. It is noteworthy the draining-pipes-induced erosion downstream of the embankment (d). The white arrows (c, d) indicate the same point on the post-flood orthophotograph (PFO) (ADBDPO, 2019) and the field photograph (Pc, Pd); the yellow dot represents the location of photographs (Pc) and (Pd). The blue arrows indicate the main flood-water direction.

along the PR179. In these last cases, the road embankment overtopping together with the flood-water passage into drainage pipes resulted in severe surficial erosion downstream of the infrastructure and in its damage and partial collapse (Figure 5(c,d)).

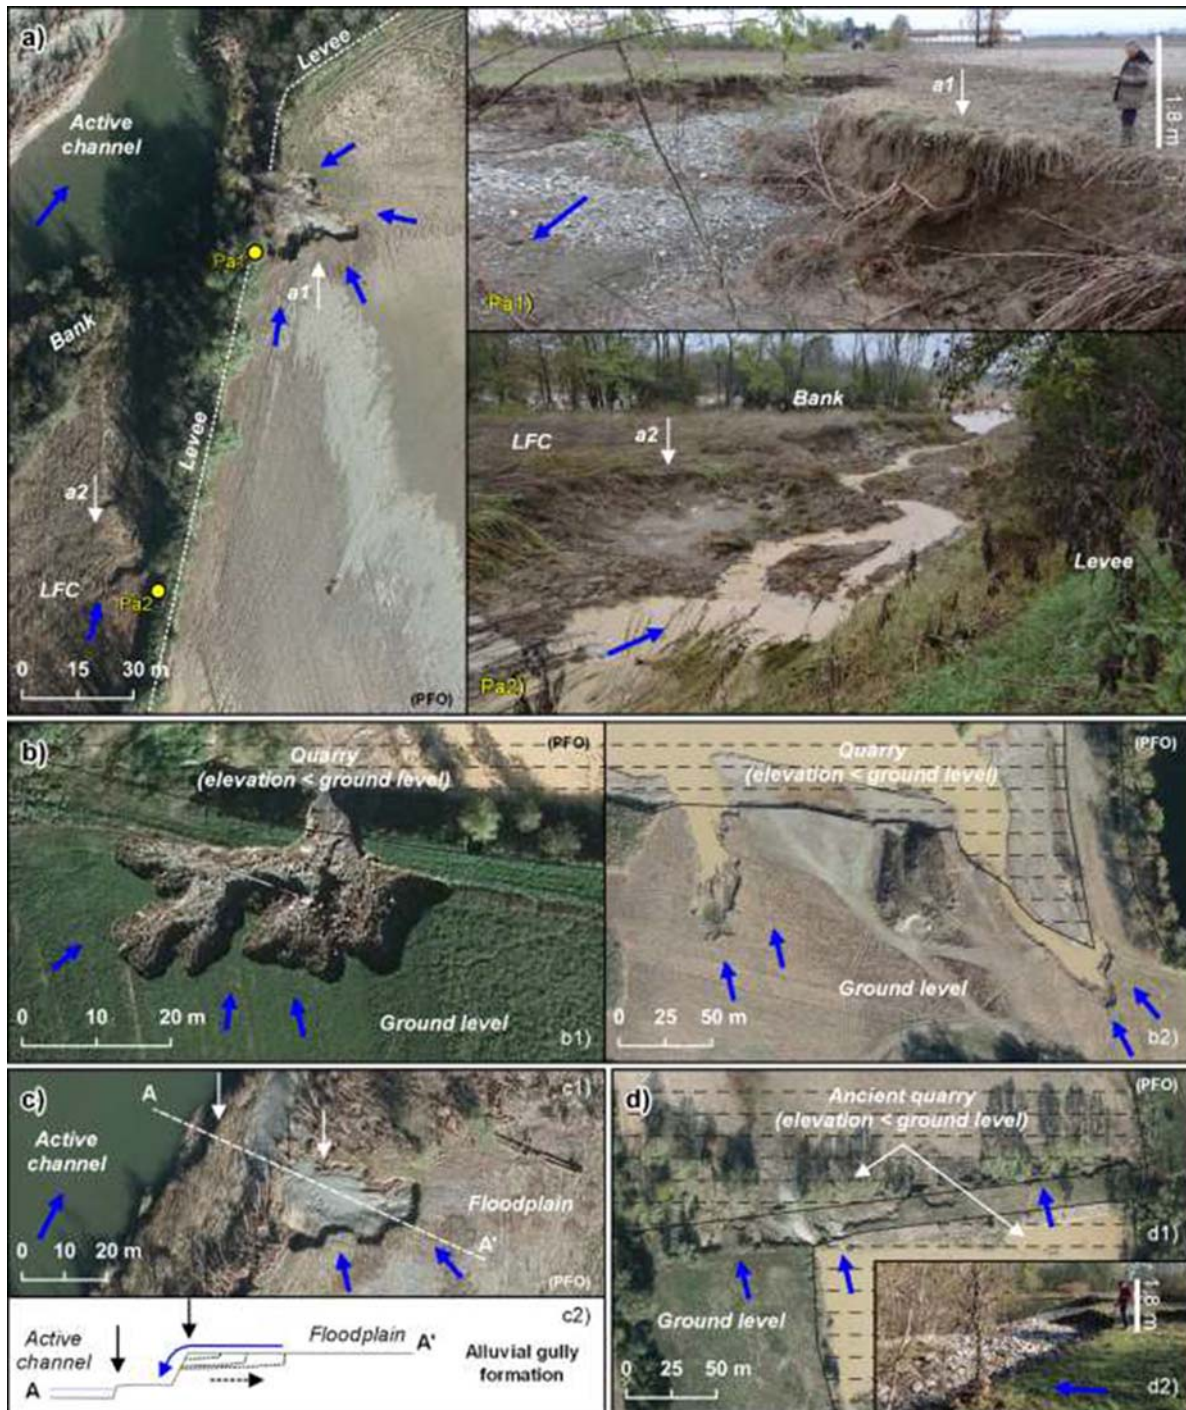
Figure 6. AGs formed or reactivated over the flooded area. (a) Example of AGs reactivated during the 21–22 October 2019 flood downstream of Garzaia, located outside (Pa1) and within (Pa2) the LFC. The white arrows a1 and a2 indicate the same point on the PFO (ADBDPO, 2019) and the field photograph (Pa1) and (Pa2), taken at the yellow dot. (b) AGs developed along steep anthropogenic scarps shaped by quarrying activity at Orbetta-Pitocca (b1) and Bruno (b2). (c) AG formation scheme. Newly-formed AG upstream of Garzaia (c1). The schematic not-to-scale cross section AA' (c2), dashed line in (c1), highlights the AG (c1) formation scheme: the concentrated flood-water from floodplain entering the active channel (blue arrow) triggered a scarp regressive erosion process (dashed arrow) that resulted in the AG formation and enlargement by the AG headcut progressive retreat (series of dotted lines). Vertical arrows in (c1) and (c2) indicate the same scarps, respectively. (d) Continuous scarp front AG developed along a quarry scarp downstream of Pennaceto. In (d1) the eroded scarp is between two ancient quarries; the eroded scarp in (d2) is upstream of the (d1) site. The black dashed pattern indicates the anthropogenic depression (b, d); the blue arrows indicate the main flood-water direction.

A number of alluvial gullies (AGs) (Brooks et al., 2009) reactivated or originated along steep scarps and eroded into the adjacent floodplain, where a concentrated runoff from floodplain entered the active channel (Figure 6(a)) or depressed areas due to quarrying activity (Figure 6(b)), following the Carey et al. (2015) development scheme (Figure 6(c)). The AGs mapped as punctual elements generally presented roundish depletion zone delimited by a jagged, semi-circular or bracket-like headcut (Figure 6(a–c)). Linear and continuous scarp front AGs (Shellberg & Brooks, 2012) were also mapped (Figure 6(a,d)). Some AGs developed or reactivated at the GNSS bank monitoring sites. In the site 1 a new AG formed and in the site 3

the existing one substantially remained stable. In the site 2 increases of 49.3% (from 630 to 941 m²) and 19.3% (from 305 to 364 m²) of the AG area were measured for the AGs included and not-included within the LFC, respectively.

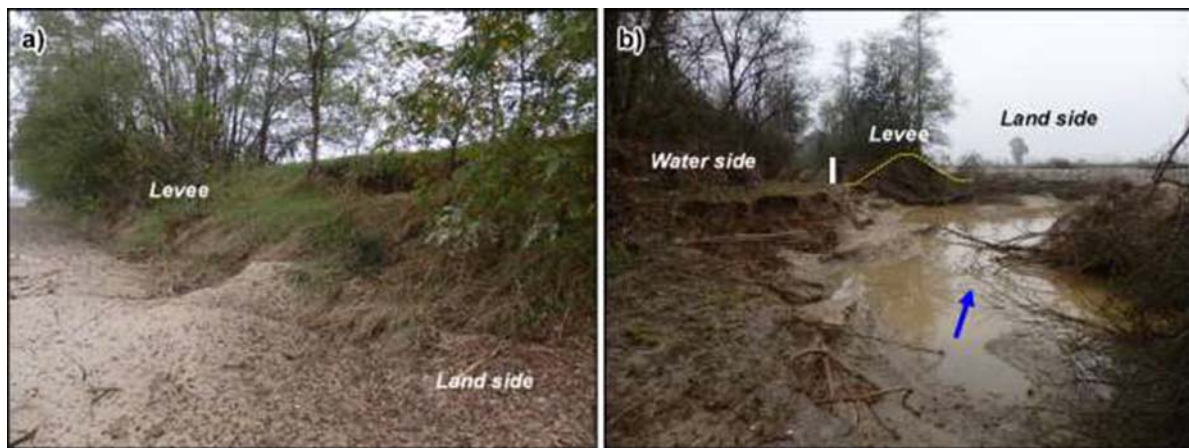
Figure 7. Damage to the levee system at Garzaia. (a) Structural damage to the levee embankment. (b) Levee breach and scour hole; the dotted line represents the levee cross section and the blue arrow indicate the main flood-water direction. The vertical white line represents a real height of 2.2 m.

At some places the flood overflowed the LFC because of levee overtopping, newly-formed or reactivated breaches, burrows, and unmanaged pipes. These dynamics resulted in serious damage to the levee system (Figure 7(a,b)). Most of breaches present a scour hole a few meters deep (Figure 7(b)). Furthermore, levee breaches shaped large crevasse splays principally involving agricultural areas. Something like the levee failure consequences was registered upstream of Garzaia where the flood-water reactivated a scour hole resulting from the dusty-road embankment overtopping by the most recent extreme floods, triggering severe erosion and deposition processes downstream.
