Evaluation of the mechanical strength and protective properties of polycarbonate toecaps subjected to repeated impacts simulating workplace conditions

^aCentral Institute for Labour Protection – National Research Institute (CIOP-PIB), Poland; ^bFaculty of Mechanical Engineering, Technical University of Lodz, Poland; ^cInstitute of Materials Science and Engineering, Lodz University of Technology, Poland

Keywords: toecaps; footwear; impact testing; three-dimensional scanning; reverse engineering; occupational safety

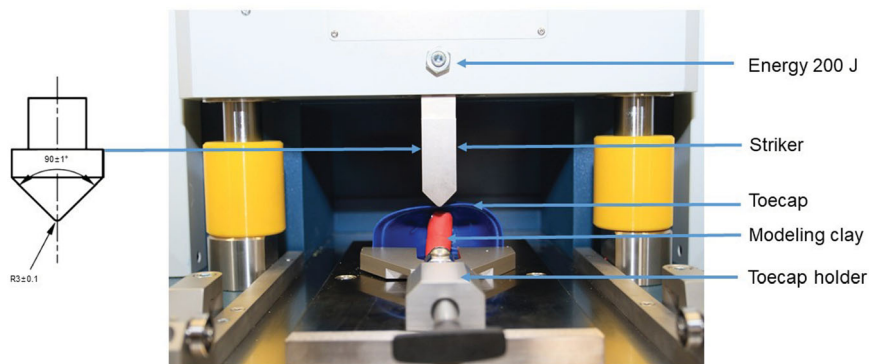
Figure 1. Shape and parameters of the striker used for repeated impact testing of toecaps.
Note: Set-up based on Standard No. EN ISO 22568-2:2019 [14].

Studies were conducted according to a novel methodology developed on the basis of Standard No. EN ISO 22568-2:2019. The applied impact tester (Pegazil by Zipor, Portugal) was equipped with a mechanism that caught the striker following the first impact to prevent secondary rebound impacts. The striker was 60 mm long. The two 40-mm-long rectangular facets of the impact head were at an angle of $90 \pm 1^\circ$. The tip was rounded with a radius of 3 ± 0.1 mm, as shown in Figure 1. The striker was made of steel with

a Rockwell hardness of 60 HRC, and positioned parallel to the toecap holder (perpendicular to the toecap).

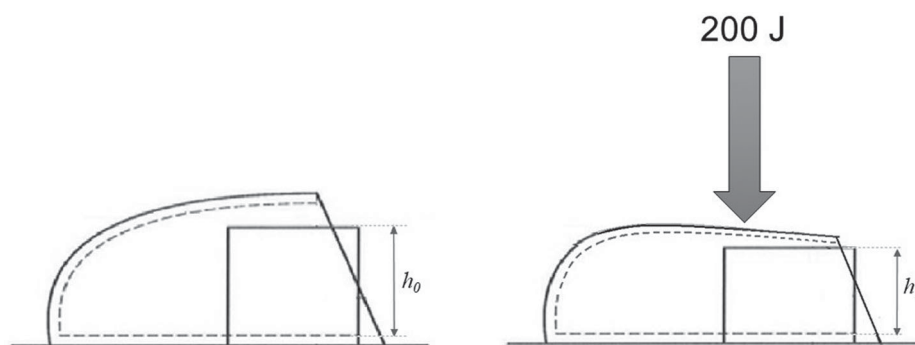
Figure 2. Method of measuring the change in the height of the modeling clay cylinder positioned inside the toecap based on Standard No. EN ISO 22568-2:2019 [14].

Note: h_0 = height of hand-made modeling clay cylinder; h_1 = change in the height of the cylinder.

The hand-made modeling clay cylinder, prepared in accordance with Standard No. EN ISO 22568-2:2019, was 30 mm high (h_0) and 25 mm in diameter. The midline of the polycarbonate toecap was determined using a ruler (Format Professional Quality, Germany). The cylinder was placed on the midline (test axis), with a third of its diameter remaining outside the rear edge of the toecap. The change in the height of the cylinder (h_1) was measured after each of five impacts, as shown in Figure 2. Based on statistical analysis, the cylinder height measurement error was estimated at ± 0.03 mm.

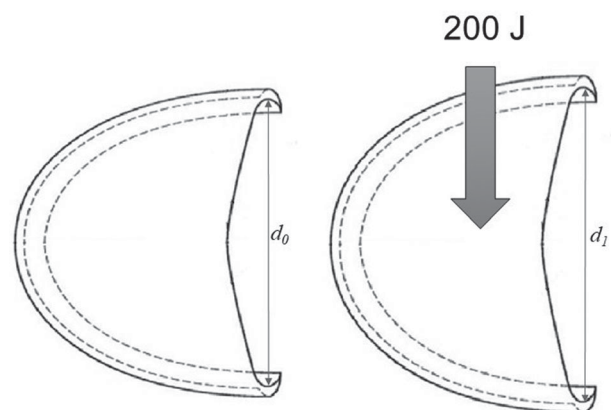
Figure 3. Method of measuring the internal toecap width.
Note: d_1 = initial internal toecap width; d_0 = post-impact internal toecap width.

The initial (d_0) and post-impact (d_1) internal toecap widths were determined using a digital caliper (Vis Sp. z o.o., Poland), as shown in Figure 3.

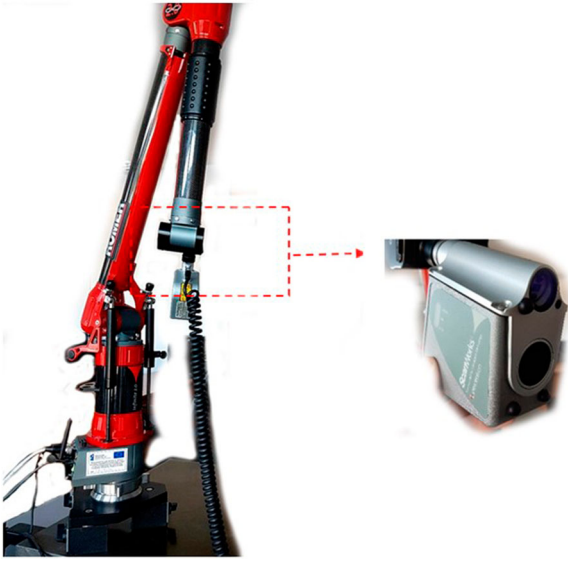
Figure 4. Three-dimensional toecap scanning set-up, including the probe.

Computer-aided design (CAD) models, used as reference files for further end-of-service life assessment, were generated using a Perceptron V4i laser scanning probe and an Infinite 2.0 articulating arm (CimCore, USA), as shown in Figure 4, with the technical parameters presented in Table 2.

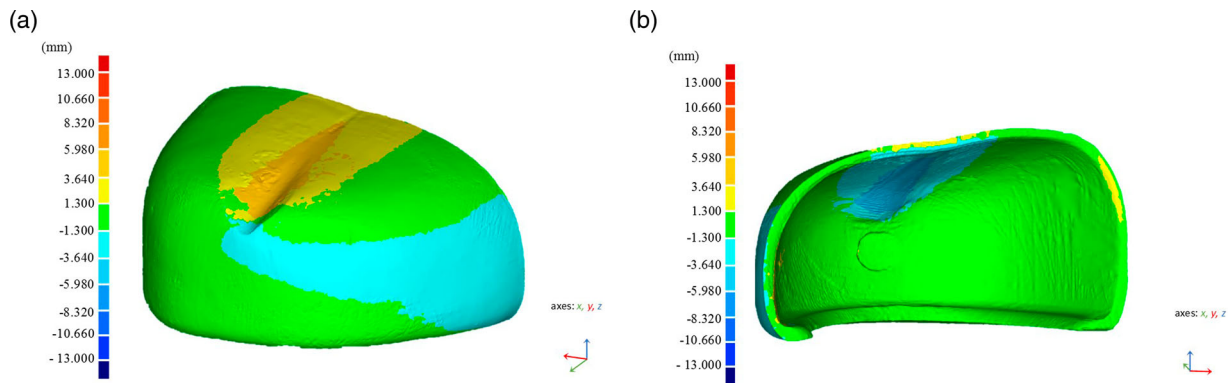
Figure 5. Three-dimensional analysis of toecap deformation after the first impact: (a) outer side; (b) inner side. Note: The full color version of this figure is available online.

In the first step, impact-induced shape deviations were compared to intact toecaps. Figures 5–8 present geometry analyses in which various degrees of plastic deformation are visualized by means of a color scale.

(the distance between the footwear sole and the maximum inward deformation of the upper surface of the toecap) was convergent with the statistical analysis of experimental data. Repeated impacts weakened the toecap material, leading to mechanical failure already after the fifth impact (Figures 5–8, Table 4).

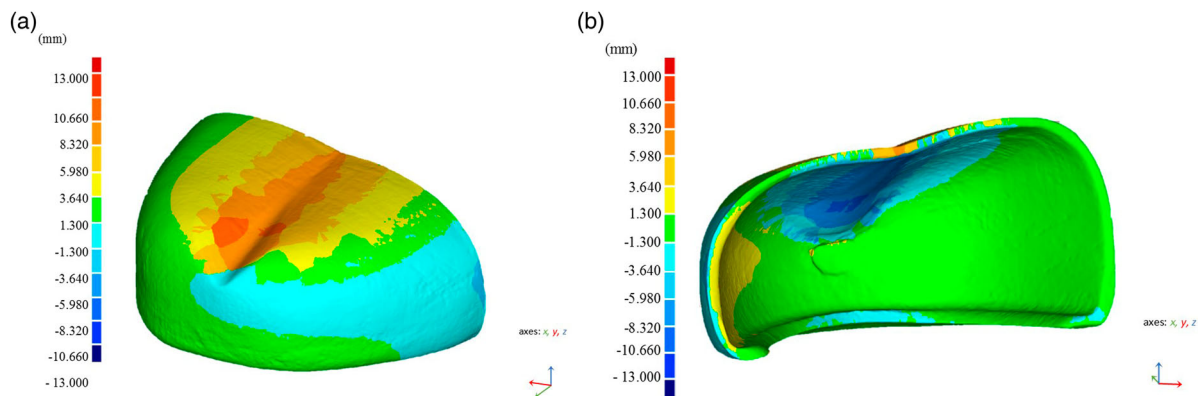
Figure 6. Three-dimensional analysis of toecap deformation after the second impact: (a) outer side; (b) inner side. Note: The full color version of this figure is available online.

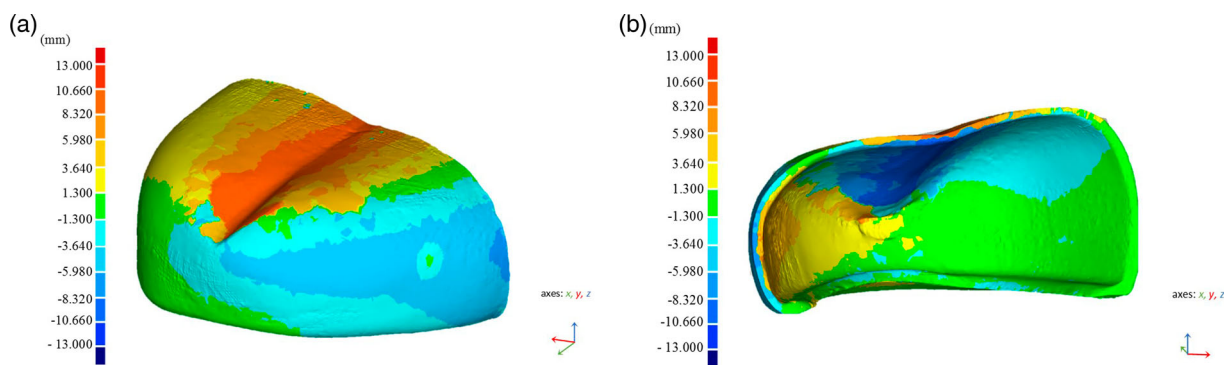
Figure 7. Three-dimensional analysis of toecap deformation after the third impact: (a) outer side; (b) inner side. Note: The full color version of this figure is available online.

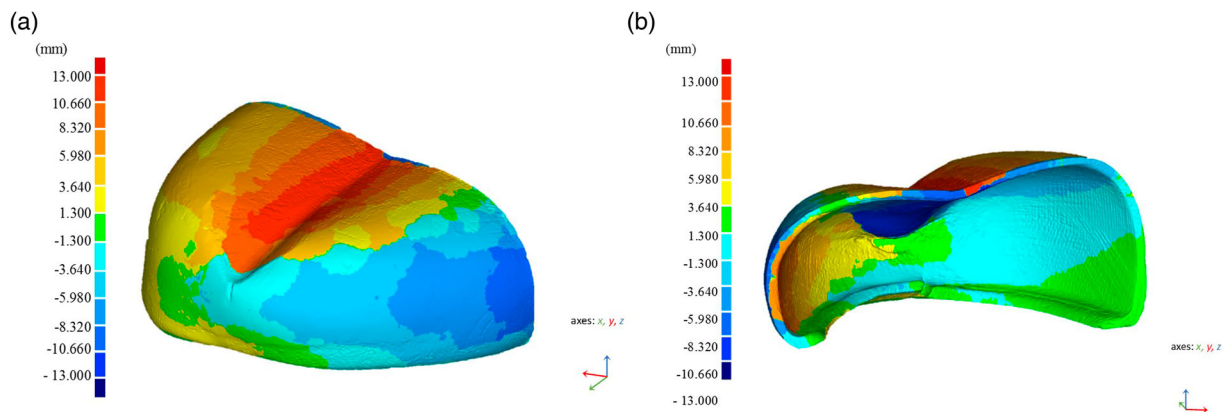
Figure 8. Three-dimensional analysis of toecap deformation after the fourth impact: (a) outer side; (b) inner side. Note: The full color version of this figure is available online.

The fact that toecap deformation after impacts four and five was significantly greater than after impacts one to three shows that the mechanical strength of the toecaps was substantially compromised already by the third impact. As a result, the protective properties of the impacted toecaps deteriorated considerably, which was confirmed by 3D analysis and by their vertical and sideways deformation (Figure 7) as compared to intact toecaps, which increased the risk of toe injury. Moreover, the fourth impact cracked the toecap base (Figure 8), while the fifth caused complete mechanical failure.

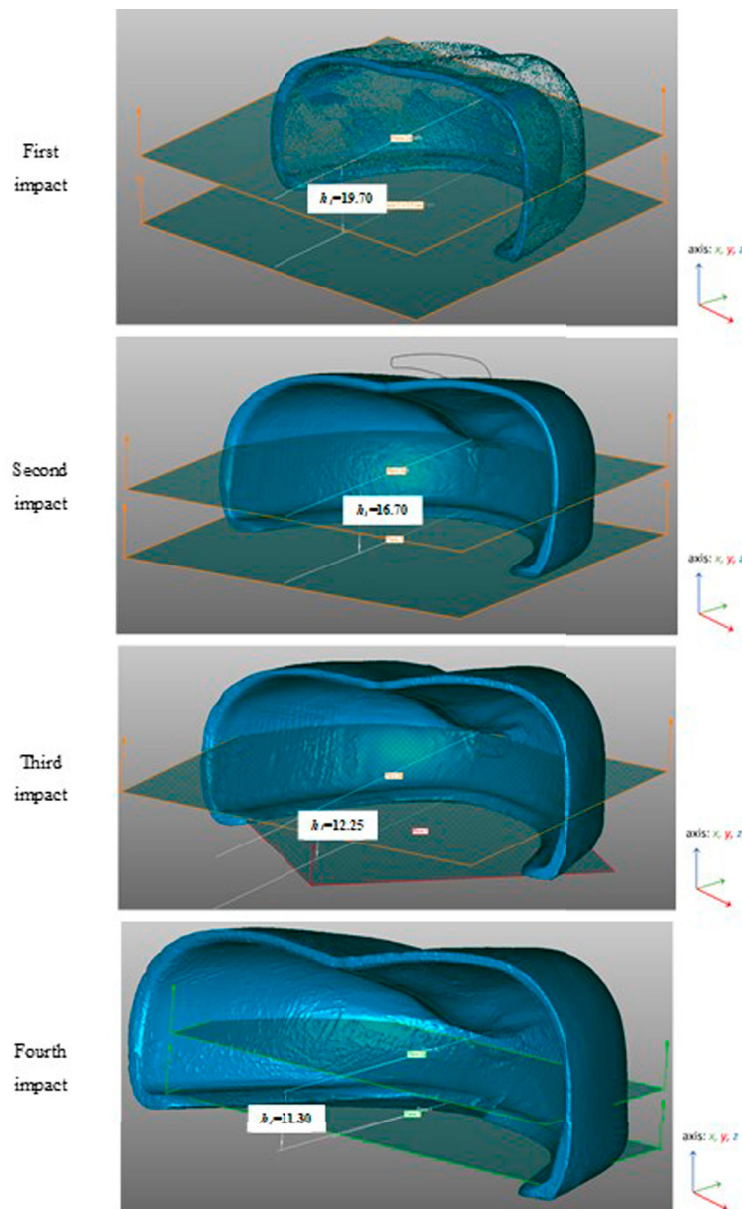
Figure 9. Three-dimensional dimensioning analysis after repeated impacts. Note: The full color version of this figure is available online. h_1 = change in the height of the cylinder.

adopted as the upper limit of the area unaffected by toecap deformation (safe clearance). Finally, measurements were performed using the '3D Dimensioning' function. The results of 3D analyses of toecaps subjected to repeated impacts are shown in Figure 9.

The exact position of Plane 2 was determined by analyzing cross-sections every 0.01 mm in order to precisely delimit the safe area free of any vertical toecap deformation. Figure 9 presents graphical representations of deformations following four consecutive impacts based on analysis of 3D images. The *Z* value represents the safe distance (mm) between Planes 1 and 2 (see Figure 10).

the importance of mechanical strength evaluation of toecaps subjected to repeated impacts simulating workplace conditions. As can be seen from Table 3, while the tested toecaps met the requirements of the relevant standard [23], in the long term they may fail to protect the wearer from injury, as indicated by 3D scans made following repeated impacts (Figures 9–11).

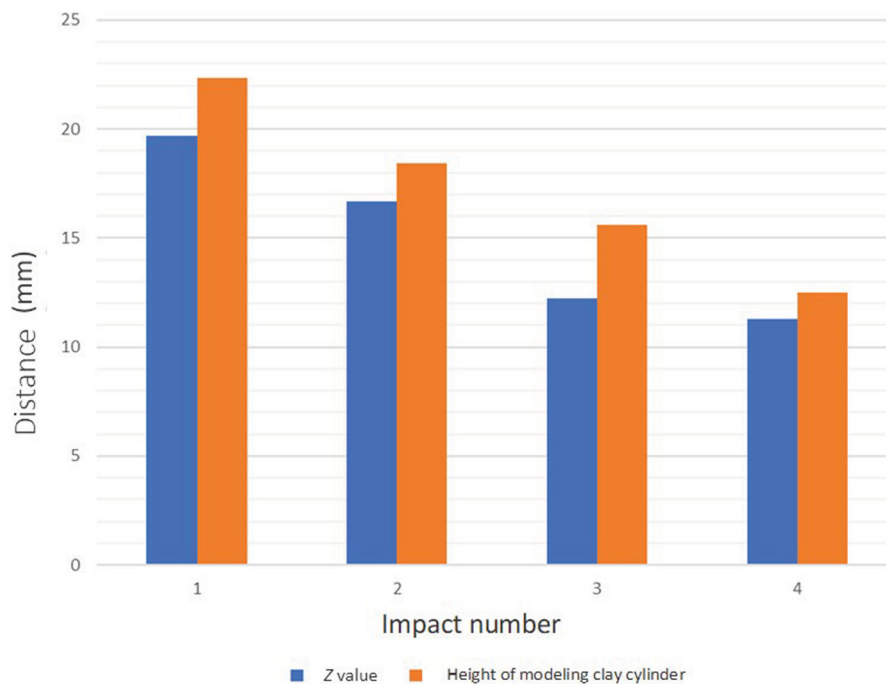
Figure 10. Decreasing clearance between the footwear sole and the upper part of toecaps due to increasing toecap deformations after consecutive impacts.

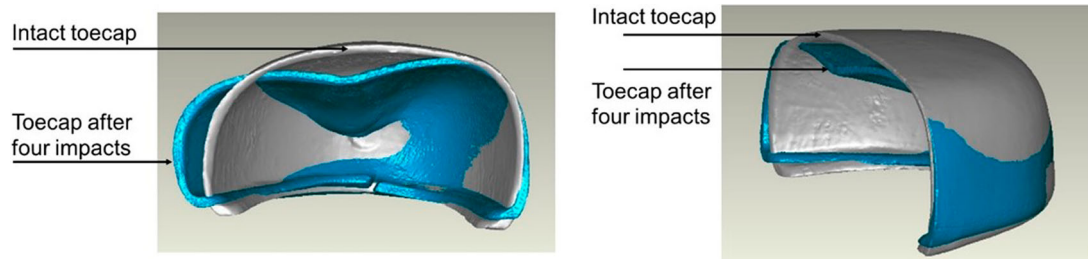
Figure 11. Model showing the shape of an intact toecap and the same toecap after four impacts.

Note: The full color version of this figure is available online. gray = reference shape of the intact toecap; blue = toecap subjected to four impacts.

Three-dimensional models illustrating changes in toecap geometry resulting from repeated impacts are shown in Figure 11. The reference shape of the intact toecap is gray, while the toecap subjected to four impacts is blue. After the fifth impact, the upper toecap surface broke in half.
