Correlating Microstructural Development And Failure Mechanisms To Photo Stimulated Luminescence Spectroscopy And Electrochemical Impedance Spectroscopy In Thermal Barrier Coatings

**CORRELATING MICROSTRUCTURAL DEVELOPMENT AND
FAILURE MECHANISMS TO PHOTO STIMULATED
LUMINESCENCE SPECTROSCOPY & ELECTROCHEMICAL
IMPEDANCE SPECTROSCOPY IN THERMAL BARRIER
COATINGS**

A dissertation submitted in partial fulfillment of the requirements
for the degree of Doctor of Philosophy
in the Department of Mechanical, Materials and Aerospace Engineering
in the College of Engineering and Computer Science
at the University of Central Florida
Orlando, Florida.

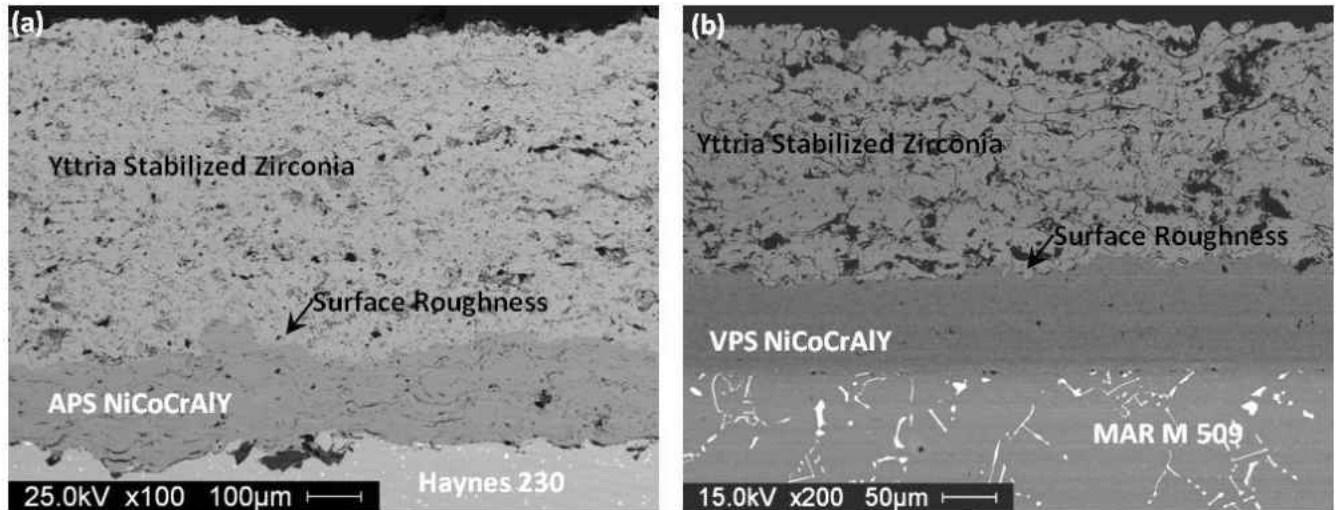
Figure 9. Cross-sectional microstructure and bondcoat surface roughness comparison (a) APS bondcoat on APS topcoat (b) LPPS bondcoat on APS topcoat.

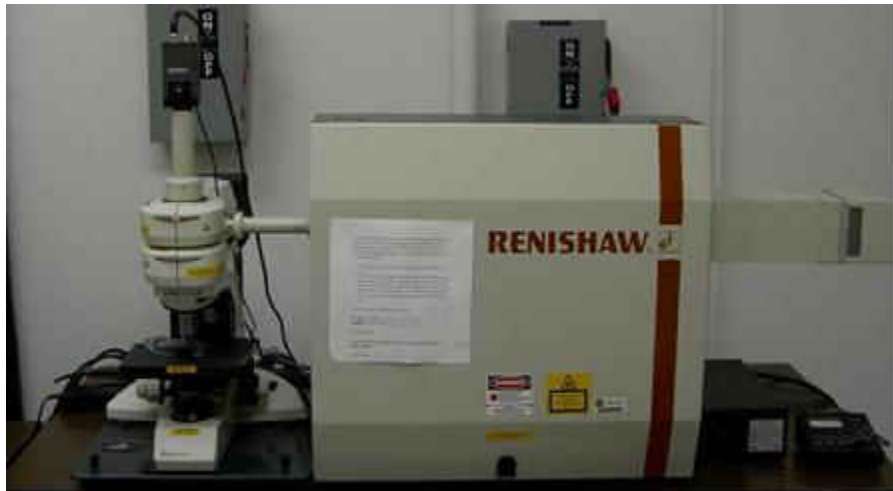
Figure 42. Renishaw TM 1000B Raman Microscope used for performing PLS measurements in this study.

For performing the NDE inspection using PSLS, a RenishawTM, System 1000B RamanscopeTM (RenishawTM, Gloucestershire, UK) equipped with a LeicaTM DM/LM optical microscope shown in Figure 42 was used. The luminescence data acquisition points for two types of EB-PVD samples are shown in Figure 43. A non-linear least-square curve-fitting routine for a mix of Lorentzian and Gaussian functions was employed for curve fitting routine on collected luminescence from α -Al₂O₃, based on the parameters set by Clarke *et al.* [90] The

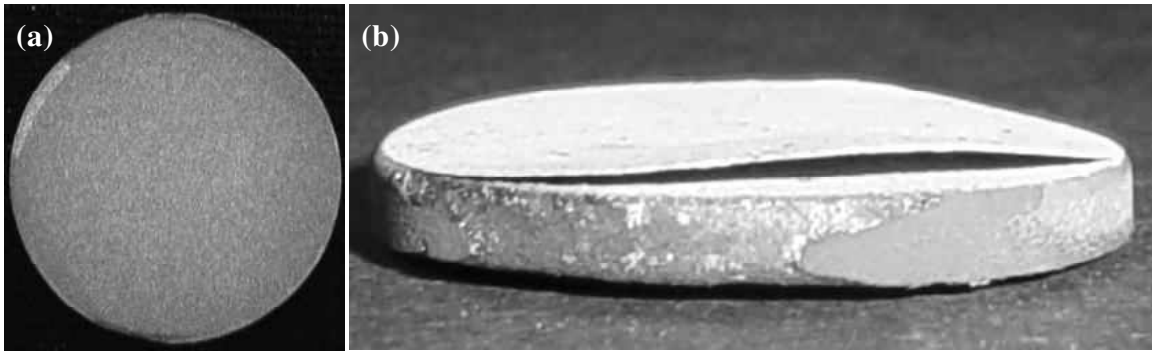
A similar observation and explanation can be given to the type-II APS TBCs examined in this study with LPPS NiCoCrAlY bondcoat shown in Figure 58. Initial fracture occurred by edge delamination shown in Figure 58(b). A detailed analysis was carried out in later section 4.8.1 .

Figure 58. Macro photographs illustrating failure mode of type II APS TBCs with NiCoCrAlY bondcoat with average lifetime of 286 cycles: (a) top surface of bondcoat after YSZ spallation that (b) occurred with initial damage at the edge of the button.

Figure 58. Macro photographs illustrating failure mode of type II APS TBCs with NiCoCrAlY bondcoat with average lifetime of 286 cycles: (a) top surface of bondcoat after YSZ spallation that (b) occurred with initial damage at the edge of the button..... 88

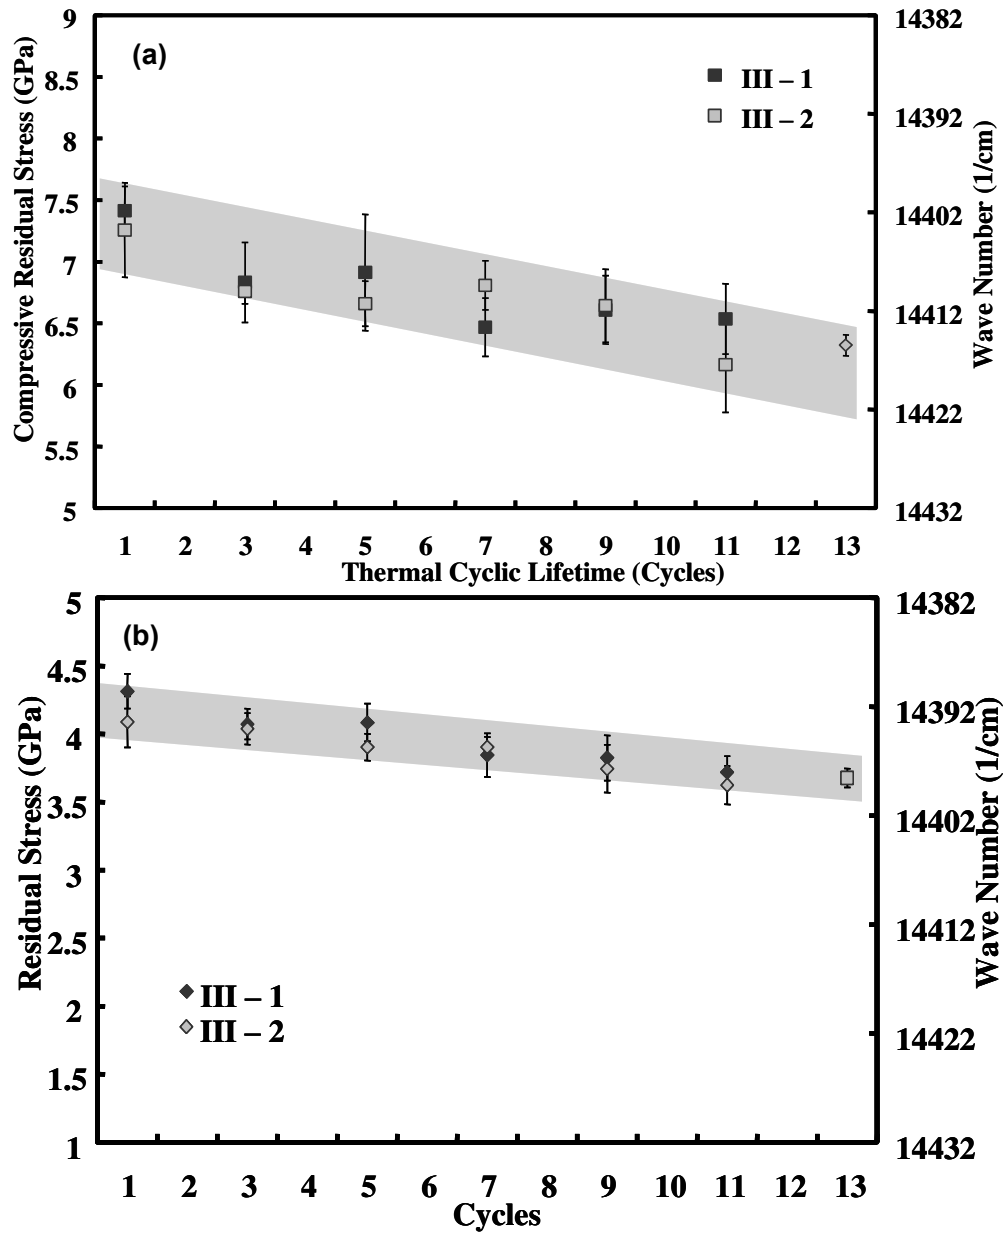
Figure 89. Compressive residual stress within TGO as a function of 50-hour thermal cycling for type-III TBCs with as-coated (Ni,Pt)Al bondcoat. Values of compressive residual stress were calculated from bimodal luminescence corresponding to (a) high and (b) low compressive stress.
