Control of Metal-Release and Tuberculation in a Silica-Laden Groundwater Distribution System on the Volcanic Island of Lana'i

CONTROL OF METAL-RELEASE AND TUBERCULATION IN A SILICA-LADEN
GROUNDWATER DISTRIBUTION SYSTEM ON THE VOLCANIC ISLAND OF LANA'I

A thesis submitted in partial fulfillment of the requirements
for the degree of Master of Science
in the Department of Civil, Environmental, and Construction Engineering
in the College of Engineering and Computer Science
at the University of Central Florida
Orlando, Florida

Spring Term
2016

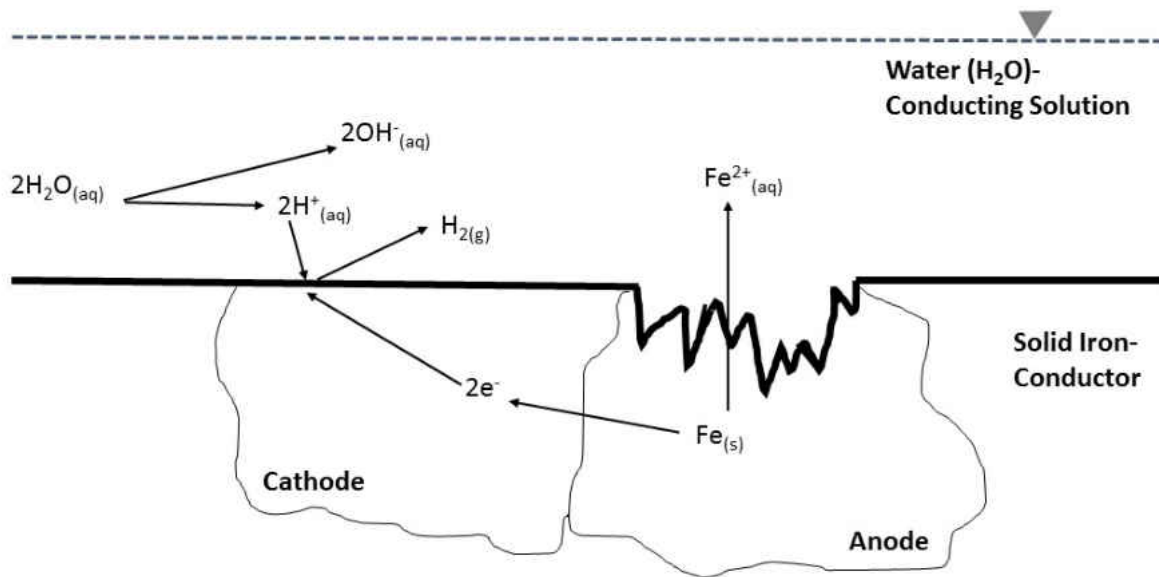
For corrosion to occur, four components which compose a corrosion cell are necessary: (1) the anode, (2) the cathode, (3) a conductor, and (4) a conducting electrolyte. Figure 2-1 depicts a corrosion cell on an iron metal surface and the reactions that occur at each interface. Anodes and cathodes can develop on the surface of a metal pipe for a variety of reasons including: characteristics of the metal, characteristics of the water, sediment accumulation, impurities in the metal, and accumulation of the products of corrosion (AWWA, 2011b).

Figure 2-1: A Simple Diagram of a Corrosion Cell in an Iron Pipe

Corrosion is an oxidation reaction and occurs at the anode where electrons from the metal are generated and metal cations are released to the conducting solution. In Figure 2-1, the iron pipe releases ferrous iron (Fe^{2+}) into the surrounding water solution. Electrons generated at the anode travel through the metal conductor to the cathode. At the cathode, these electrons react with water and hydrogen to form hydroxide ions (OH^-) and hydrogen gas (H_2). In this example, the reaction occurs in an acidic solution and hydrogen ions are the electron acceptor, thus H_2 is formed. If the reaction were to occur in a basic solution, electrons accepted by the cathode react with oxygen in the surrounding water to form hydroxide ions. Furthermore, metal cations released at the anode can react with hydroxide ions to create rust, or iron hydroxide ($\text{Fe}(\text{OH})_2$). Cations produced at the anodic site tend to attract negative particles in the water; the opposite is true of the cathodic site where anions produced attract positively charged particles. Ion movement is a result of changing concentration gradients which retains electro-neutrality in the solution (AWWA, 2011b).

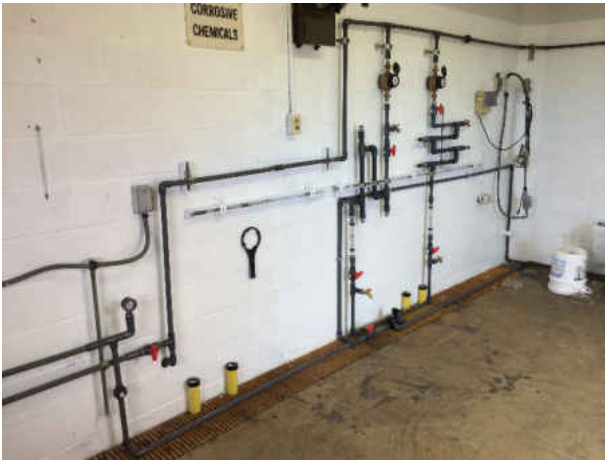
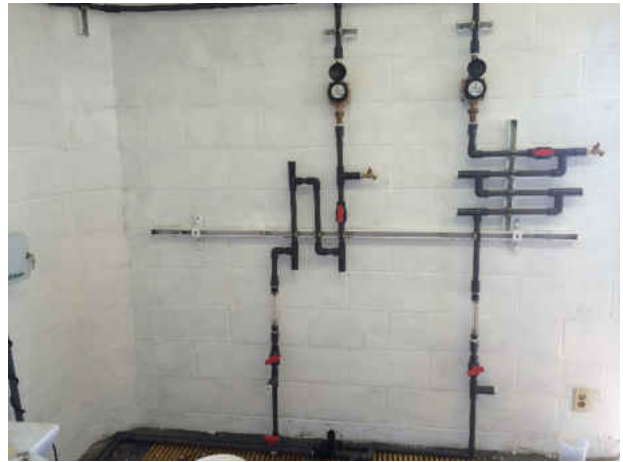
Figure 4-2: Manele Bay WWTF Corrosion Control Skid (a) Control rack (b) Test rack

One rack was consistently used as a control where finished water with no corrosion inhibitor was added for the entirety of the study. The second rack was used to test alternative inhibitors in the finished water for specified time periods within each experiment. Having two racks per skid allowed for the direct comparison between control and test corrosion rates. Each rack consisted of two loops; one loop contained three different metal corrosion coupons and one loop contained three different linear polarization resistance probes. Based on common materials of construction in the existing distribution system, three metals were chosen to be tested in the corrosion study, and included mild steel, lead, and copper coupon alloys; these metals are summarized in Table 4-1. Metals Samples Corrosion Monitoring Systems (Metals Samples; Munford AL), a division of Alabama Specialty Products, Inc. (ALSPI), supplied the corrosion coupons and probes. In addition, Metals Samples also supplied the corrosion monitoring equipment which included the coupon holders, linear polarization resistance (LPR) wands, and portable corrosion data logger.

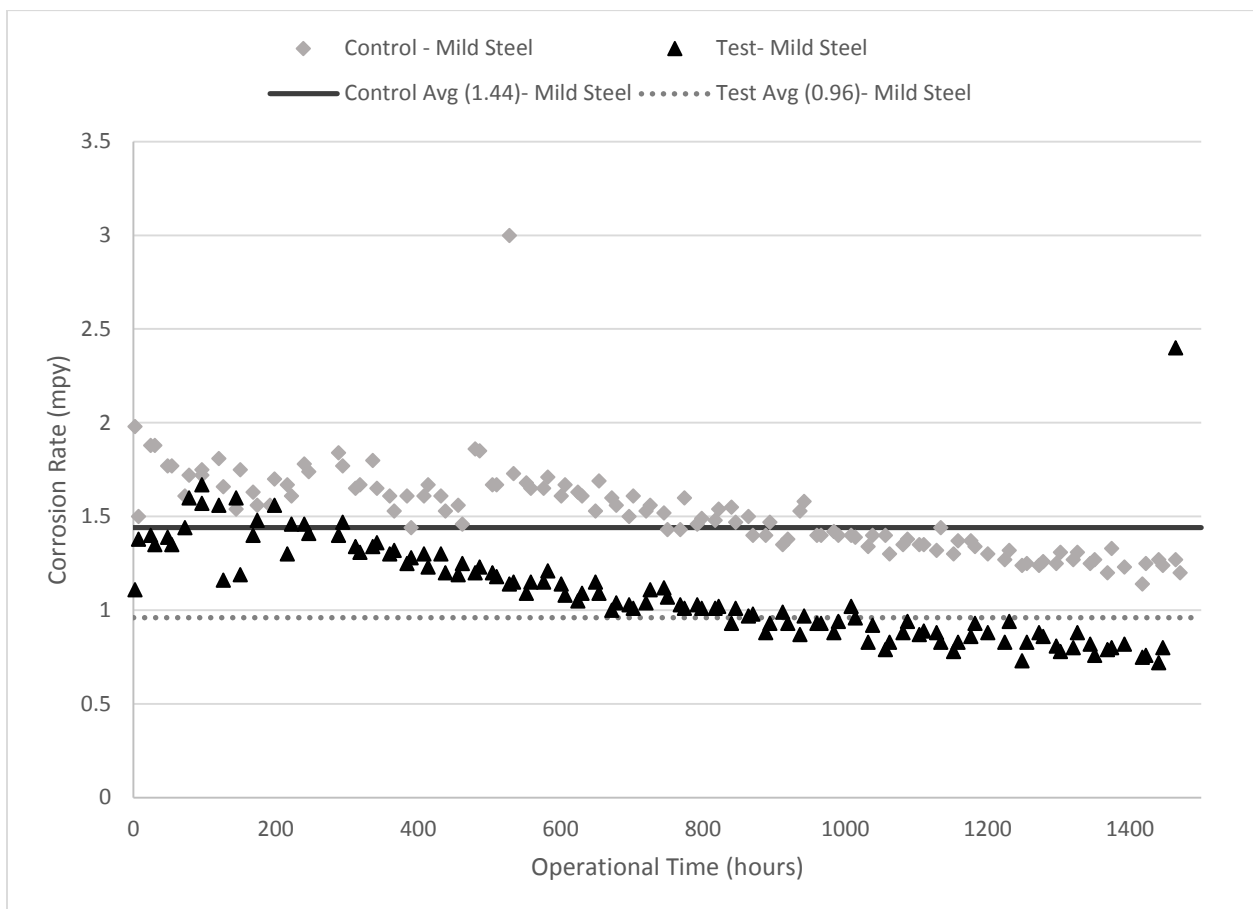
Figure 5-1 illustrates mild steel corrosion rates as a function of time for the initial screening for test and control conditions. The corrosion rates continue to decrease until there is a baseline corrosion rate around hour 1,200 for both test and control conditions. The control condition corrosion rate appears to be corroding at a higher rate than the test condition. The average corrosion rate for the control condition (1.44 mpy) is higher than that of the test condition (0.96 mpy).

Figure 5-1: Mild Steel Corrosion Rates for Manele Bay Initial Screening

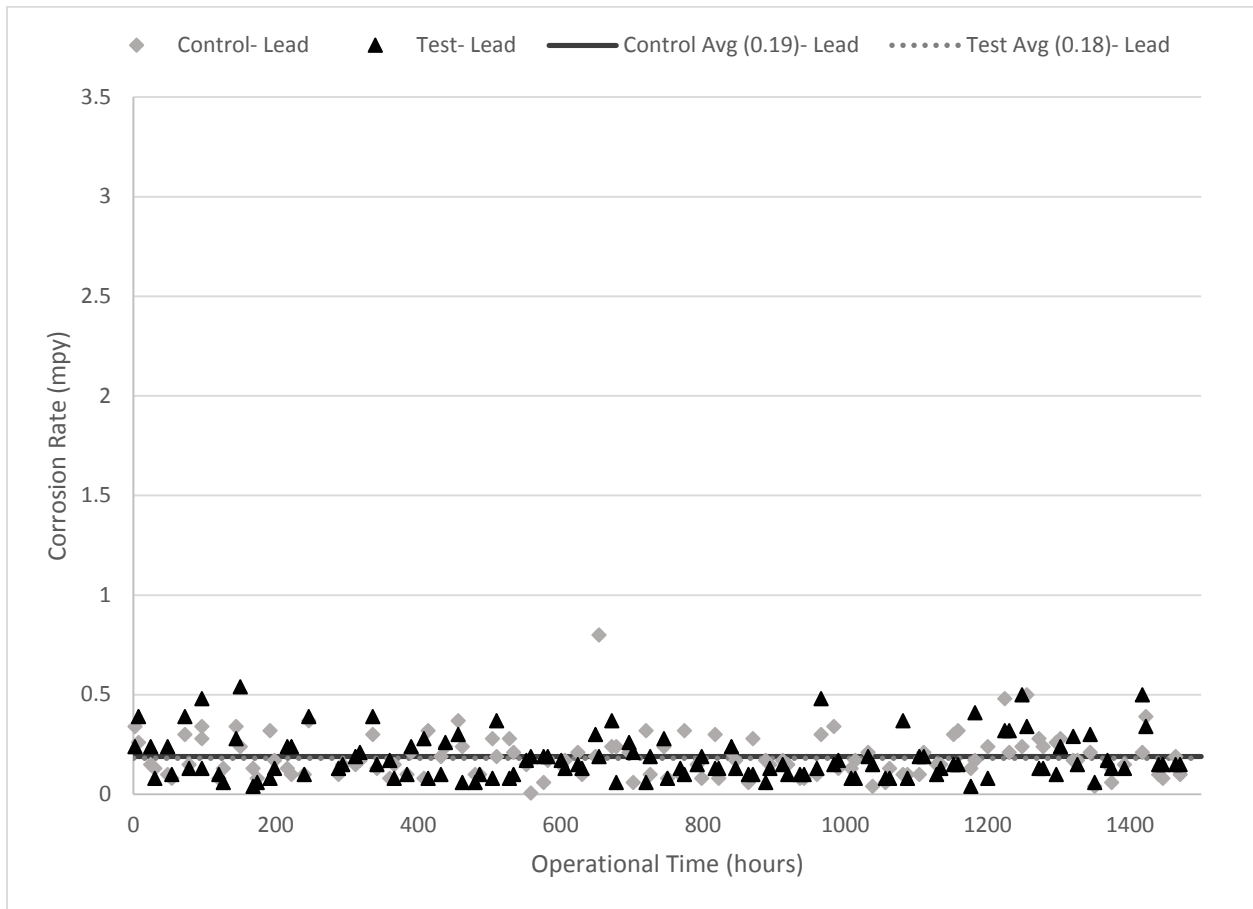
Figure 5-2 shows lead corrosion rates as a function of time for the initial screening test and control conditions. The corrosion rates for lead are very low ($> 0.5\text{ mpy}$) throughout the initial screening data collection. There does not appear to be a difference between the test and control condition corrosion rates. The average corrosion rates for the test and control conditions are barely distinguishable at corrosion rates of 0.18 mpy and 0.19 mpy , respectively. Consequently, it will be difficult to improve the corrosion rates.

Figure 5-2: Lead Corrosion Rates for Manele Bay Initial Screening

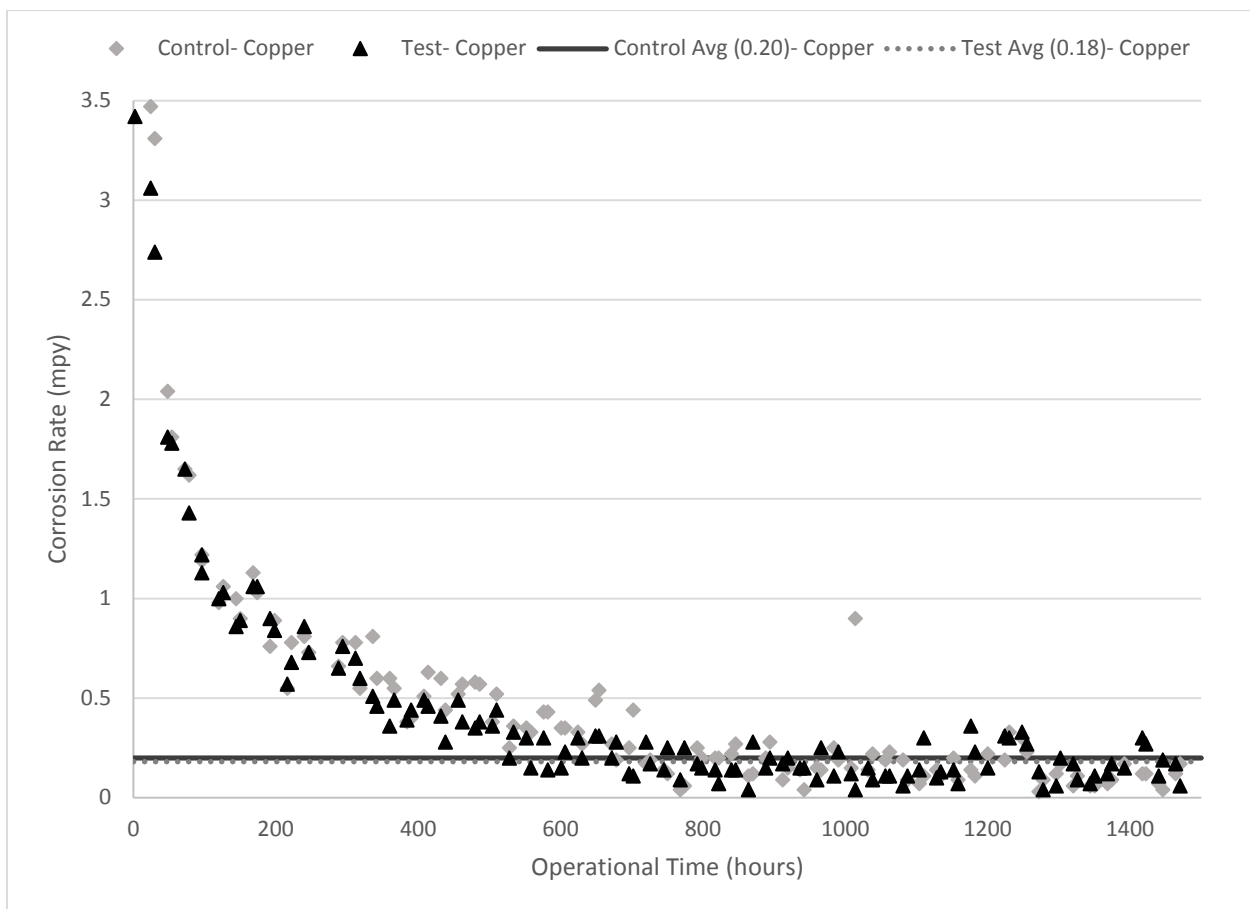
Figure 5-3 shows copper corrosion rates as a function of time for the initial screening test and control conditions. The corrosion rates continue to decrease until there is a baseline corrosion rate around hour 600 for both test and control conditions. Test and control corrosion rates appear to be corroding at the same rate. Similar to the lead corrosion rates, the average corrosion rates between the control and test conditions are indistinguishable at 0.20 mpy and 0.18 mpy, respectively.

Figure 5-3: Copper Corrosion Rates for Manele Bay Initial Screening

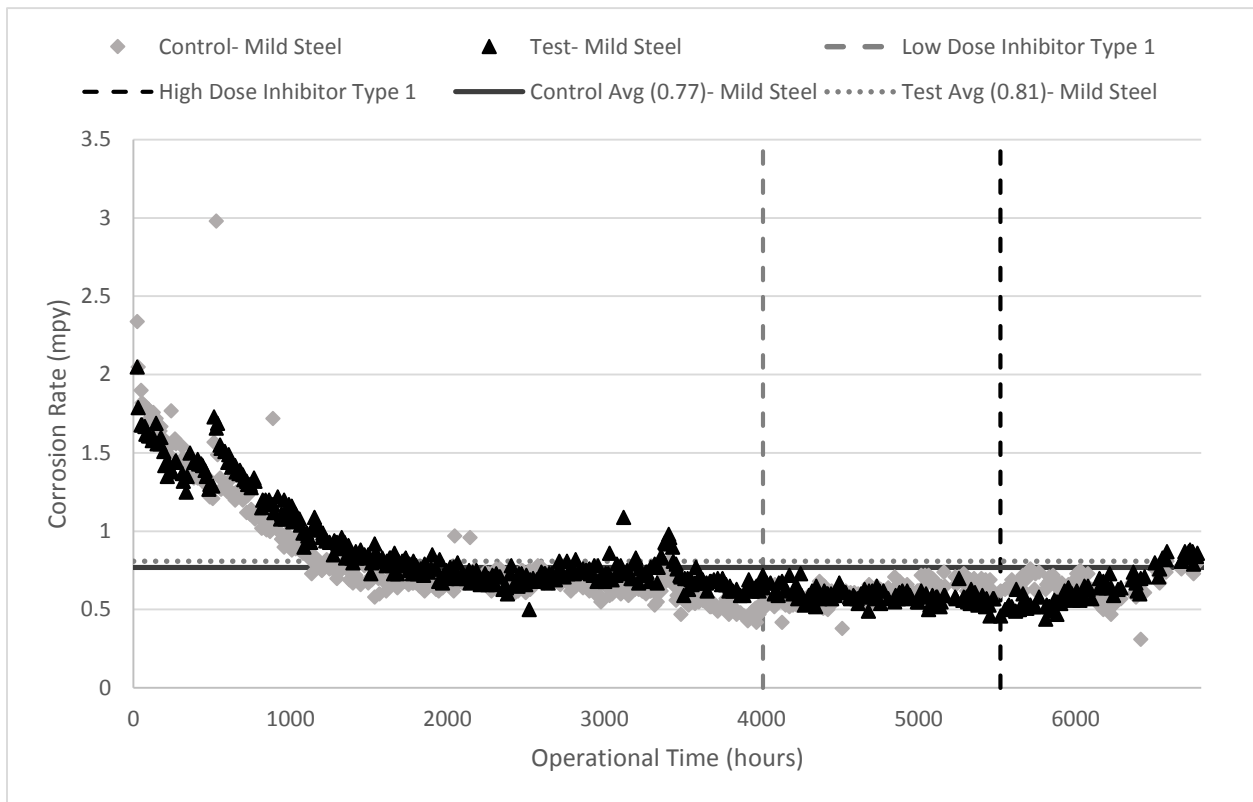
Figure 5-4 illustrates mild steel corrosion rates as a function of time for the inhibitor type 1 experiment for test and control conditions. The corrosion rates continue to decrease until there is a baseline corrosion rate around hour 1,800 for both test and control conditions. The control and test conditions appear to be corroding at similar rates throughout the experiment. The average corrosion rate for the test condition is higher than that of the control condition at 0.81 mpy and 0.77 mpy, respectively. Inhibitor was added continuously starting at hour 4,008, however the dosage changed from a low dose of 0.005 mg/L to a high dose of 1.0 mg/L at hour 5,520. Consequently, it appears that the addition of inhibitor type 1 does not improve the corrosion rate of the test rack and is therefore not a viable option for corrosion control in Manele Bay.

Figure 5-4: Mild Steel Corrosion Rates for Manele Bay Inhibitor Type 1

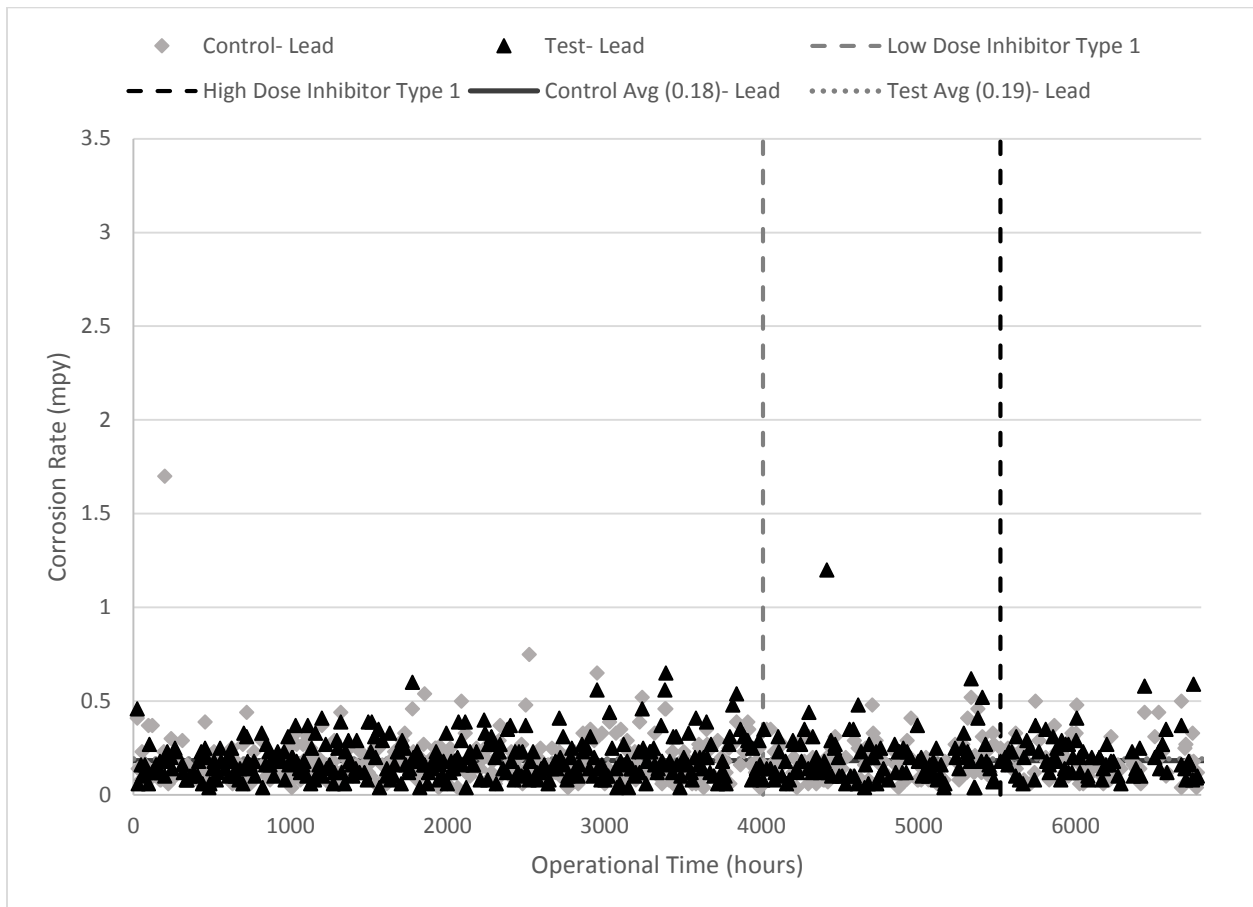
Figure 5-5 shows lead corrosion rates as a function of time for the inhibitor type 1 experiment control and test conditions. The corrosion rates for lead are fluctuating, but are also very low (< 0.5mpy) throughout data collection. There does not appear to be a difference between the test and control condition corrosion rates. The average corrosion rates for the test and control conditions are indistinguishable at 0.19 and 0.18, respectively. Consequently, there was not a discernable difference between the test and corrosion rates after inhibitor was added. It appears that addition of inhibitor type 1 does not benefit in reducing lead corrosion rates.

Figure 5-5: Lead Corrosion Rates for Manele Bay Inhibitor Type 1

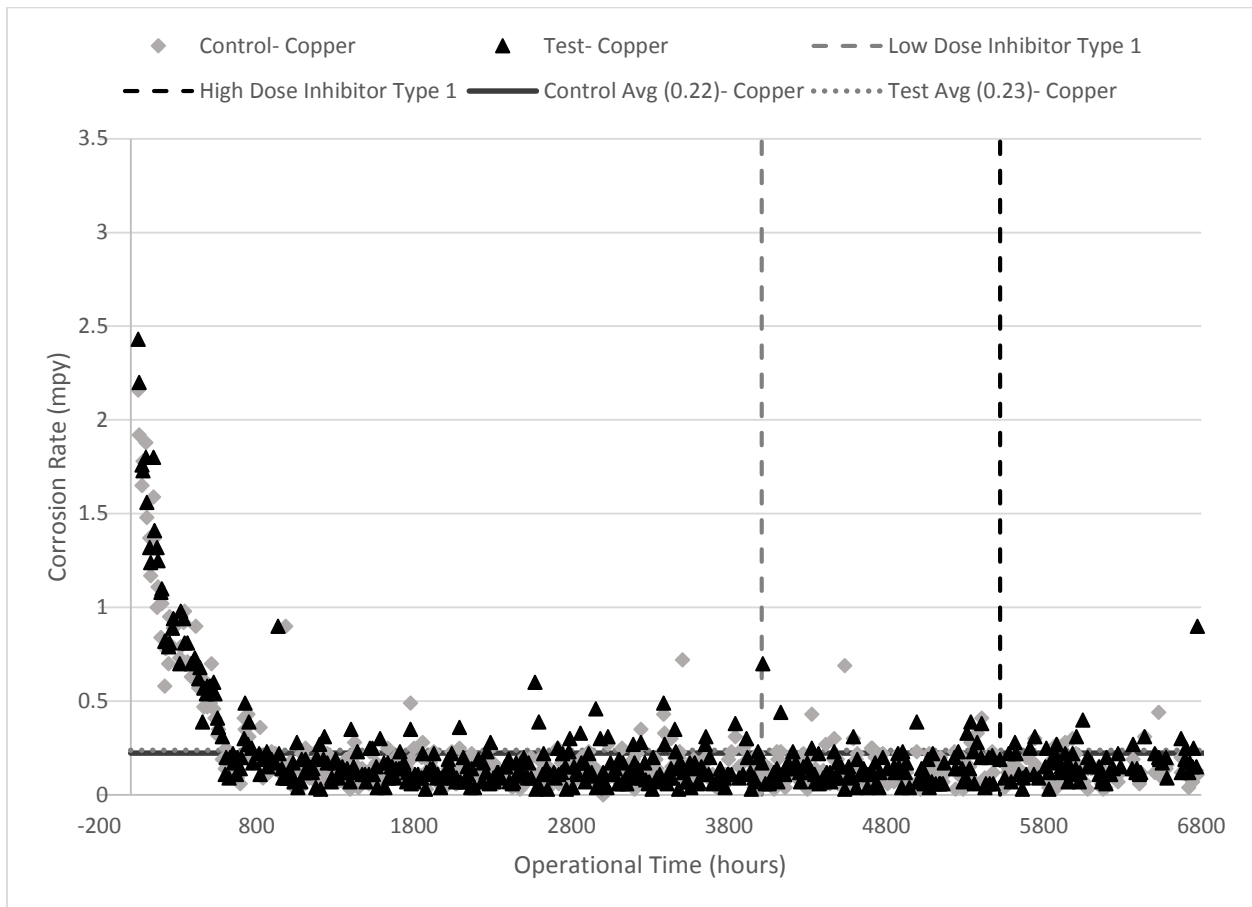
Figure 5-6 shows copper corrosion rates as a function of time for the inhibitor type 1 experiment control and test conditions. The corrosion rates continue to decrease until there is a baseline corrosion rate around hour 800 for both test and control conditions. Test and control corrosion rates appear to be corroding at the similar rate. The average corrosion rates between the control and test conditions are comparable at 0.22 and 0.23 mpy, respectively. Similar to that of mild steel and lead, the corrosion rates do not appear to improve and the use of inhibitor type 1 is not a viable option for corrosion control in Manele Bay.

Figure 5-6: Copper Corrosion Rates for Manele Bay Inhibitor Type 1

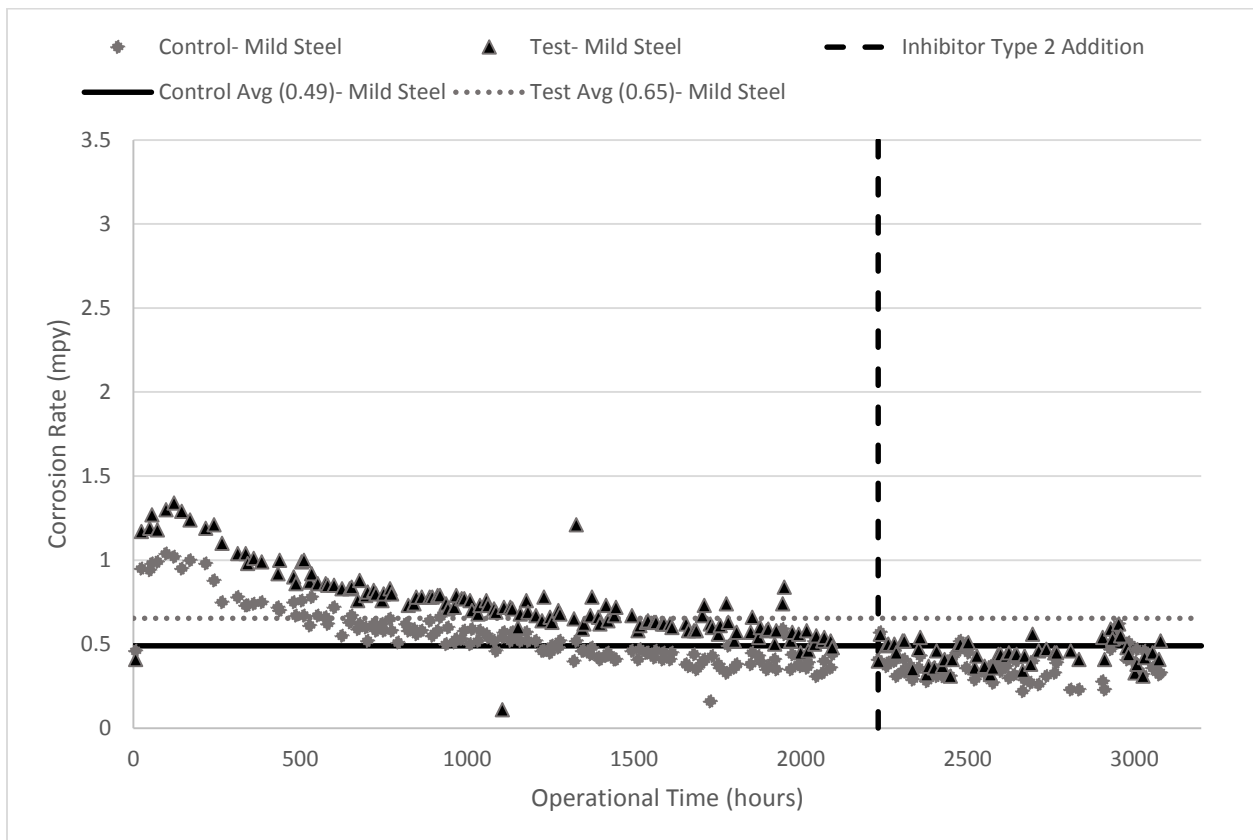
Figure 5-8 illustrates mild steel corrosion rates as a function of time for the inhibitor type 2 experiment for test and control conditions. The corrosion rates continue to decrease until there is a baseline corrosion rate around hour 1,400 for both test and control conditions. While the average corrosion rate for the test condition (0.65 mpy) is higher than that of the control condition (0.49 mpy), the two conditions corrode in a similar way. Inhibitor was added continuously starting at hour 2,232 at a dose of approximately 1.0 mg/L. Inhibitor addition and the experiment was concluded at operational hour 3,072. Consequently, it appears that the addition of inhibitor type 2 does not improve the corrosion rate of the test rack and is therefore not a viable option for corrosion control in Manele Bay.

Figure 5-8: Mild Steel Corrosion Rates for Manele Bay Inhibitor Type 2

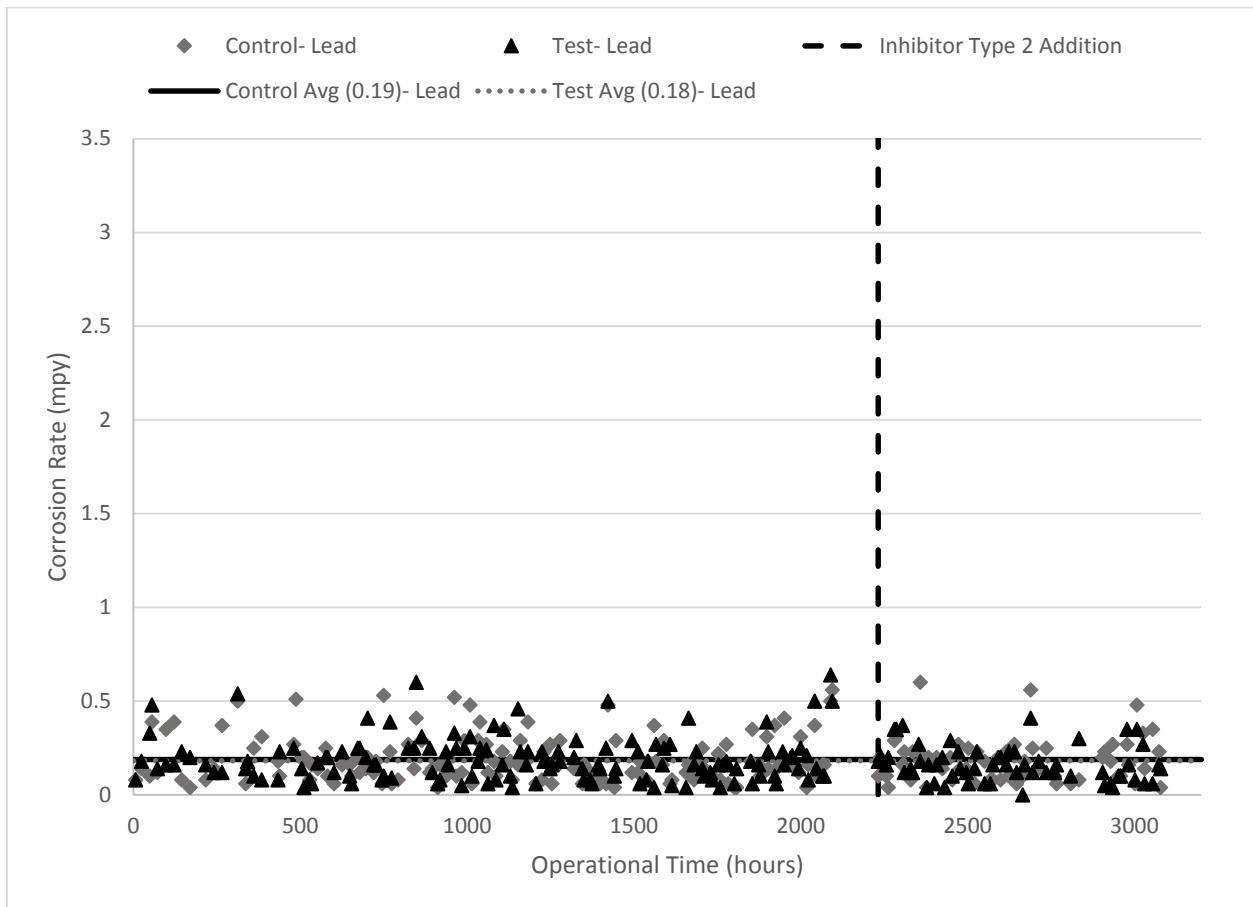
Figure 5-9 shows lead corrosion rates as a function of time for the inhibitor type 2 experiment control and test conditions. The corrosion rates for lead are fluctuating, but are also low (< 0.6 mpy) throughout data collection. There does not appear to be a difference between the test and control condition corrosion rates. The average corrosion rates for the test and control conditions are barely distinguishable. Consequently, there was not a discernable difference between the test and corrosion rates after inhibitor was added. It appears that addition of inhibitor type 2 does not benefit in reducing lead corrosion rates.

Figure 5-9: Lead Corrosion Rates for Manele Bay Inhibitor Type 2

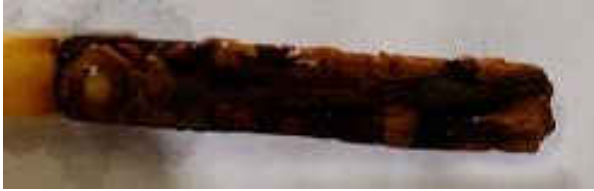
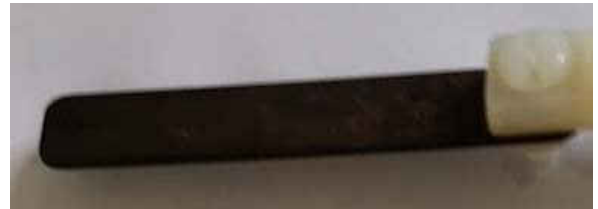
Figure 5-11: Manele Bay Coupon Photographs- Inhibitor Type 2

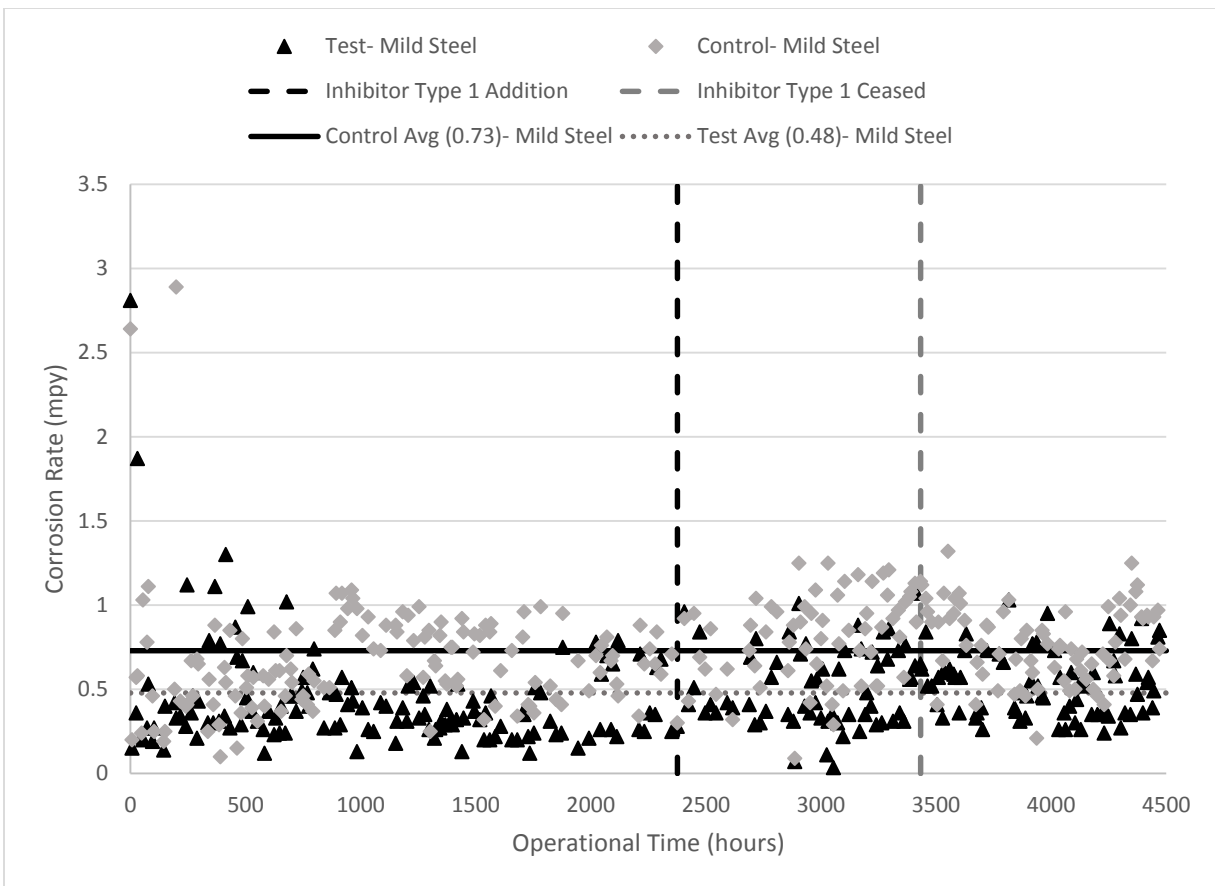
Figure 5-14 illustrates mild steel corrosion rates as a function of time for the inhibitor type 1 experiment for test and control conditions in Lana'i City. There is no distinct curve, however, the corrosion rates appear to reach baseline at hour 1,500. While the average corrosion rate for the control condition (0.73 mpy) is higher than that of the test condition (0.48 mpy), the two conditions corrode in a similar way. Inhibitor was added continuously starting at hour 2,376 at a dose of approximately 1.0 mg/L. Inhibitor feed was ceased at operational hour 3,432 and the corrosion rates continued to be monitored until the experiment was concluded at operational hour 4,464. The addition of inhibitor type 1 does not improve the corrosion rate of the mild steel test rack for and is therefore not a viable option for mild steel corrosion control in Lana'i City.

Figure 5-14: Mild Steel Corrosion Rates for Lana'i City Inhibitor Type 1

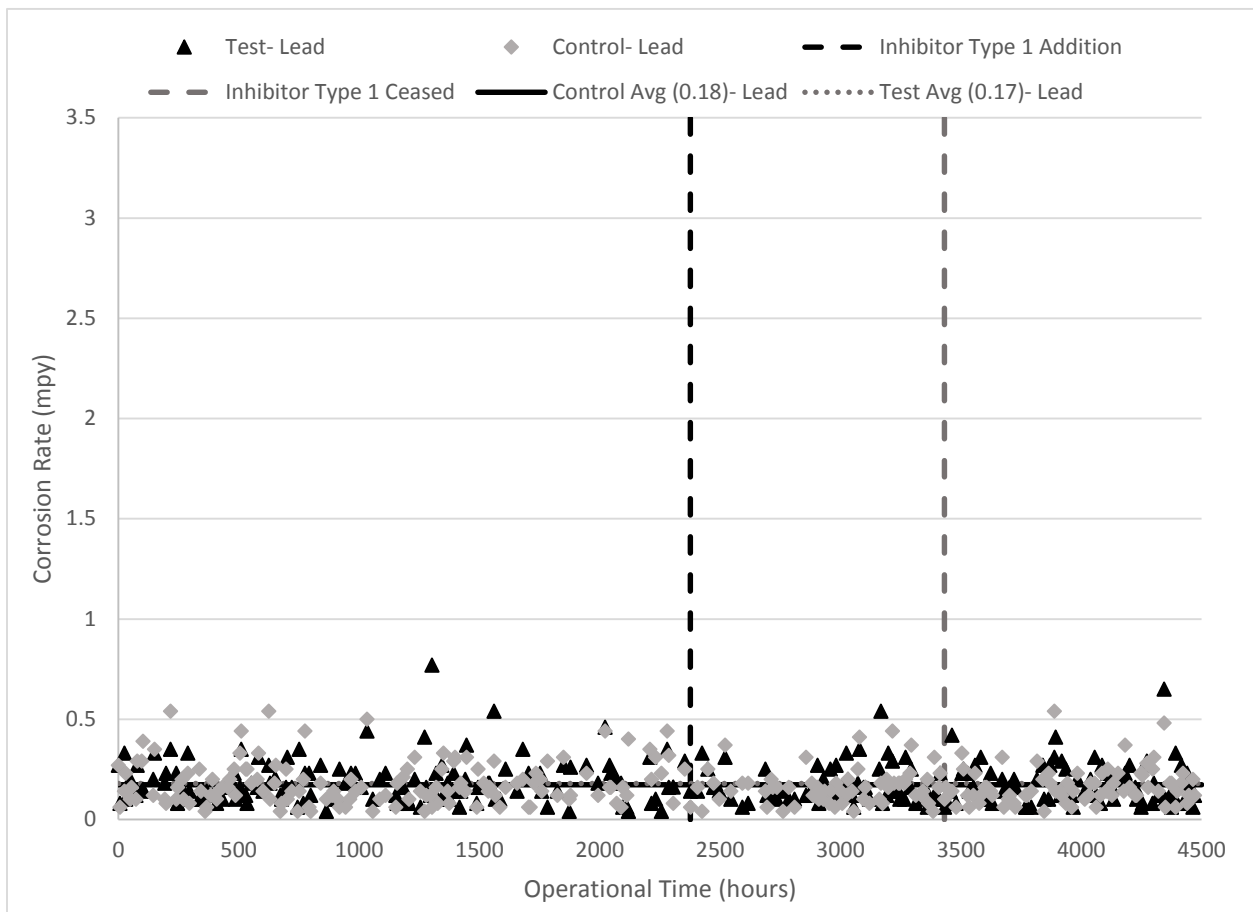
Figure 5-15 shows lead corrosion rates as a function of time for the inhibitor type 2 experiment control and test conditions. The corrosion rates for lead are fluctuating, but are also low (< 0.6 mpy) throughout data collection. There does not appear to be a difference between the test and control condition corrosion rates. The average corrosion rates for the test and control conditions are barely distinguishable (0.17 mpy and 0.18 mpy). In addition, there was not a discernable difference between the test and corrosion rates after inhibitor was added. It appears that addition of inhibitor type 2 does not benefit the distribution system in reducing lead corrosion rates in Lana'i City.

Figure 5-15: Lead Corrosion Rates for Lana'i City Inhibitor Type 1

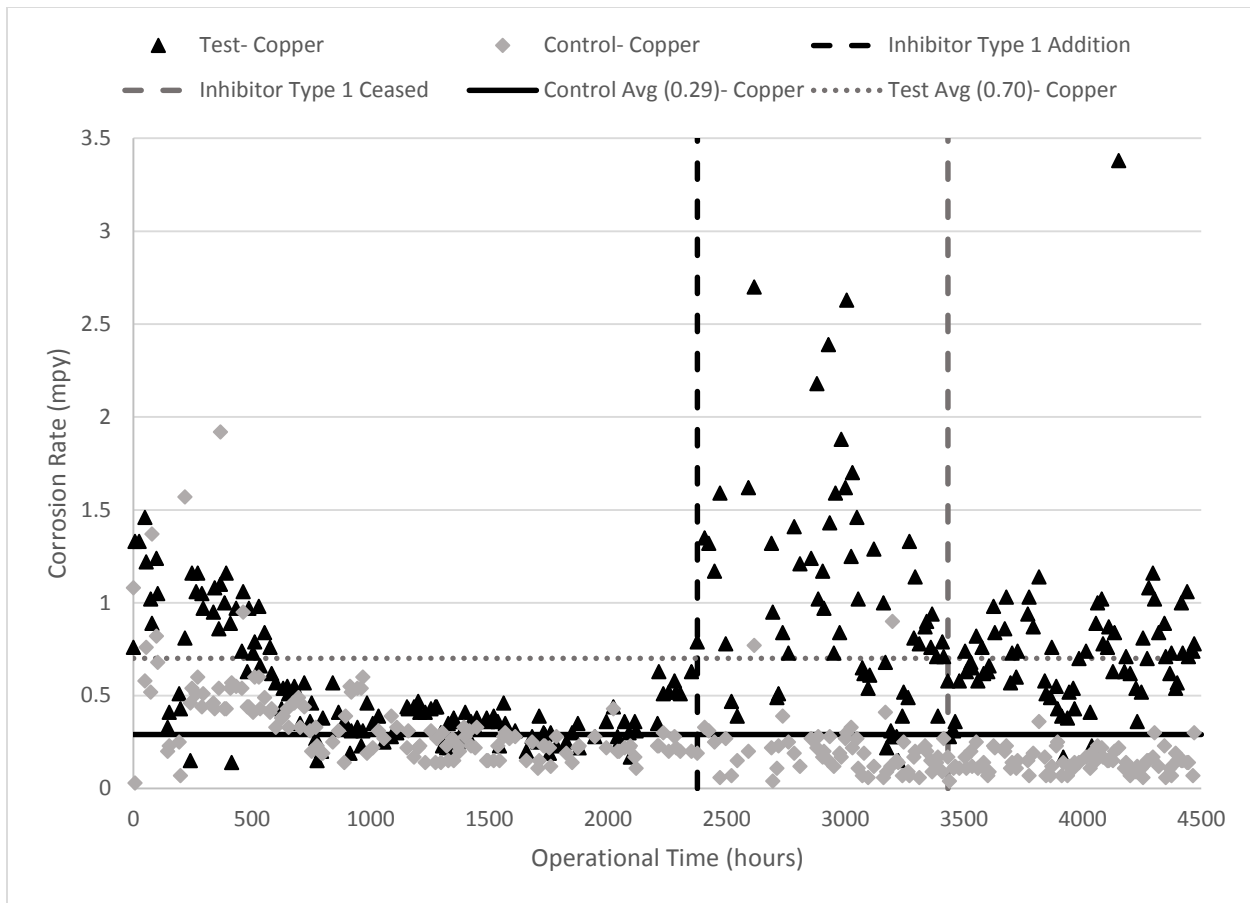
Interactions between silica and phosphate could explain the copper corrosion rate increase when corrosion inhibitor was added. It has been noted that silica addition can affect the properties of phosphate coatings on iron surfaces (Stoch & Stoch, 1989). In addition, silica surfaces with a negative charge have enhanced silica-phosphate complexes in the presence of cations (Muashov & Leszczynski, 1999). While the pipe is not a silica surface, solid silica formations present in the copper corrosion scale may interact with phosphates in such a way that the scale could be compromised and degraded.

Figure 5-16: Copper Corrosion Rates for Lana'i City Inhibitor Type 1

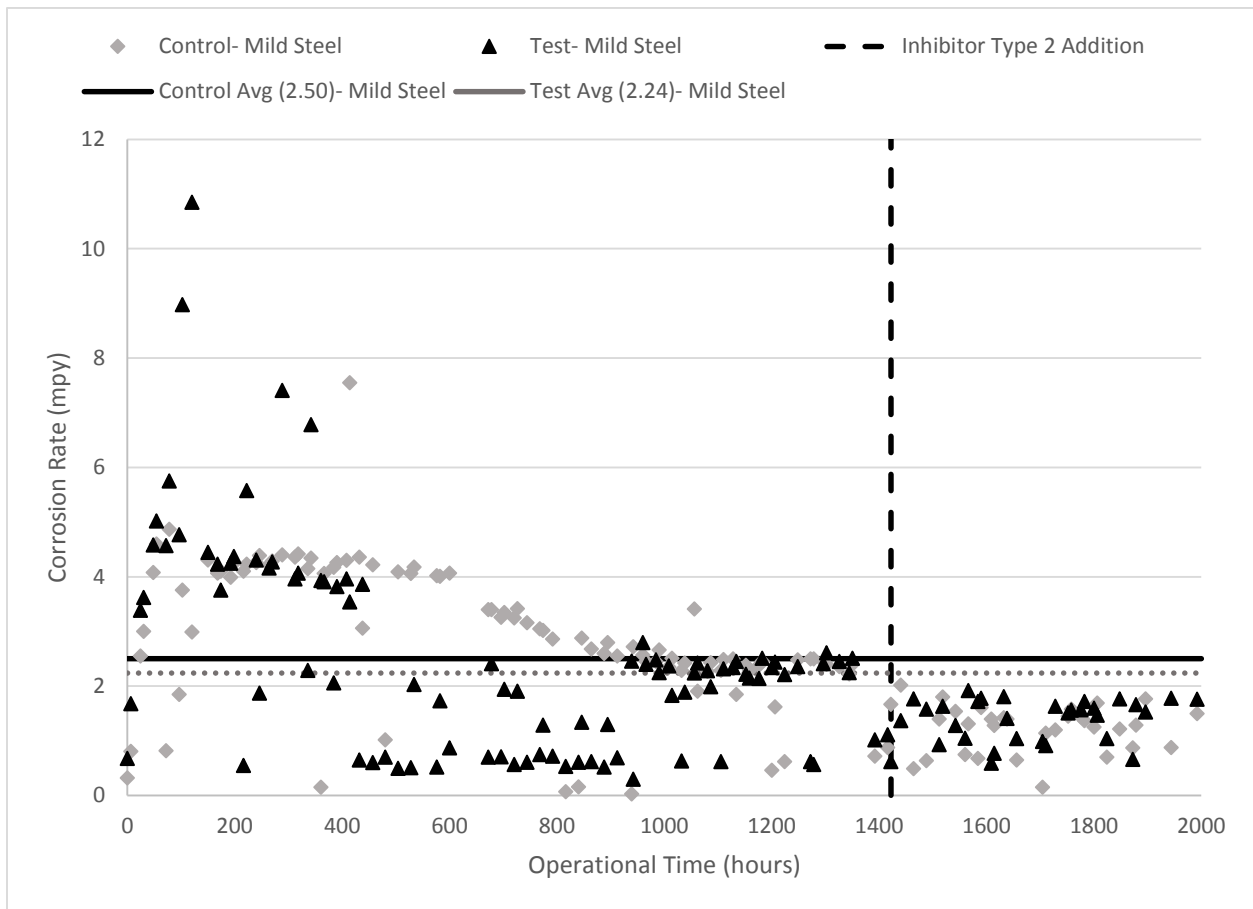
Figure 5-20 illustrates mild steel corrosion rates as a function of time for the inhibitor type 2 experiment for test and control conditions in Lana'i City. There is no distinct curve, however, the corrosion rates appear to reach baseline at hour 1,000. While the average corrosion rate for the control condition (2.5 mpy) is higher than that of the test condition (2.2 mpy), the two conditions corrode in a similar way. Inhibitor was added continuously starting at hour 1,416 at a dose of approximately 1.0 mg/L. Inhibitor feed was ceased at operational hour 2,016. The addition of inhibitor type 2 does not appear to improve the corrosion rate of the mild steel test rack and is therefore not a viable option for mild steel corrosion control in Lana'i City.

Figure 5-20: Mild Steel Corrosion Rates for Lana'i City Inhibitor Type 2

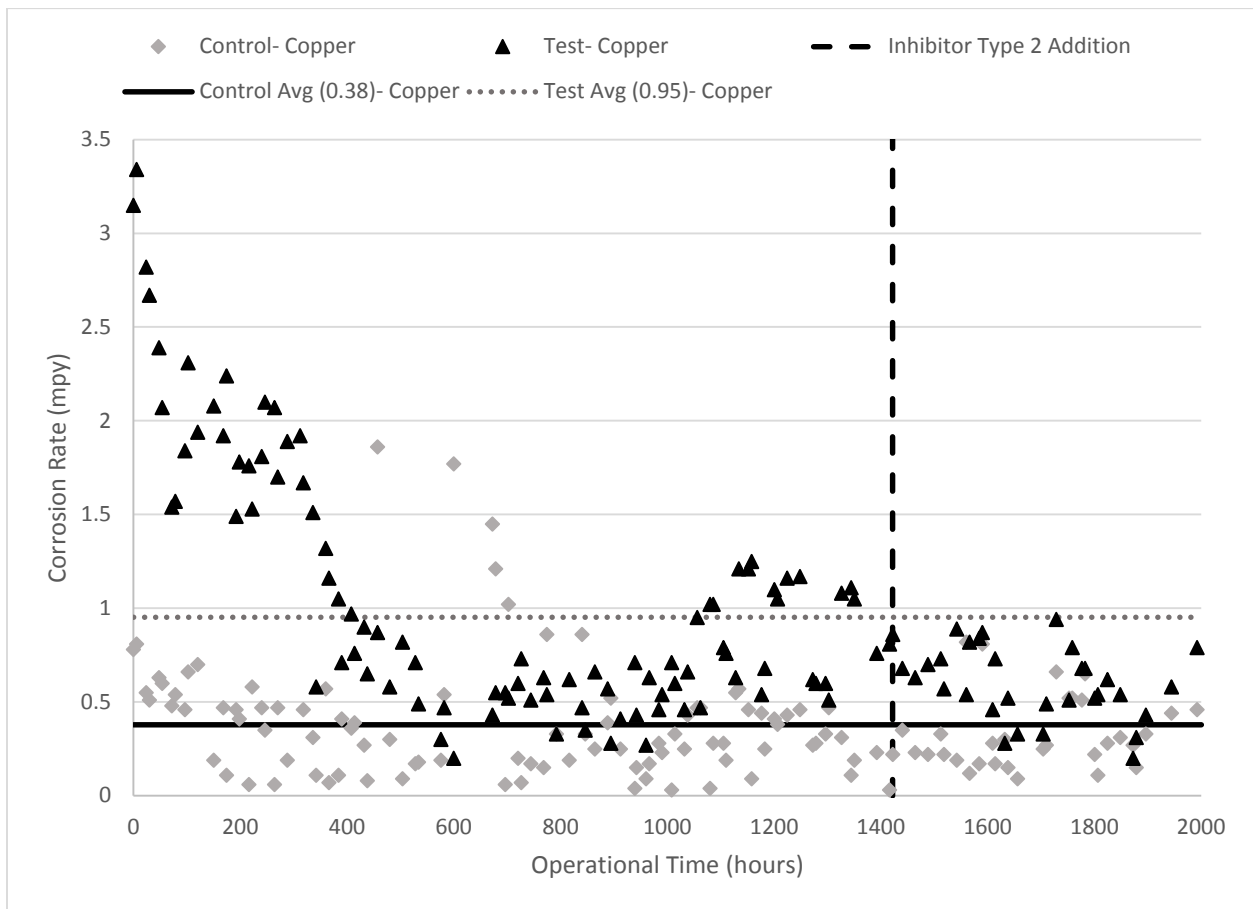
Figure 5-22 shows copper corrosion rates as a function of time for the inhibitor type 2 experiment control and test conditions. The corrosion rates are a bit sporadic at the beginning but appear to level at hour 1,100. Test and control average corrosion rates are not corroding at the same rate. The test condition average is 86% higher than the control condition. The test and control corrosion rates are 0.95 mpy and 0.38 mpy respectively.

Figure 5-22: Copper Corrosion Rates for Lana'i City Inhibitor Type 2

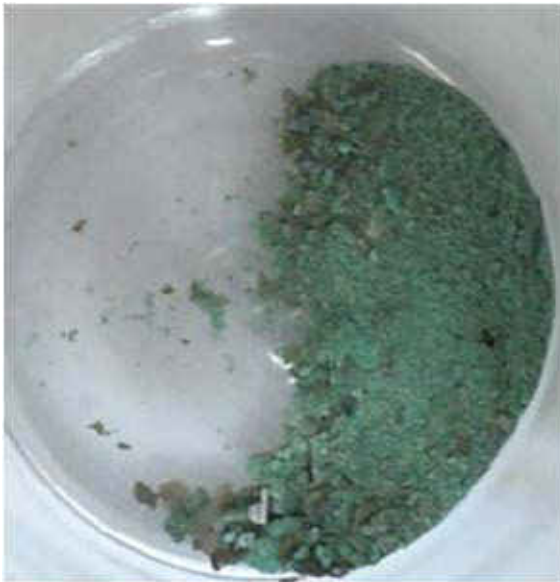
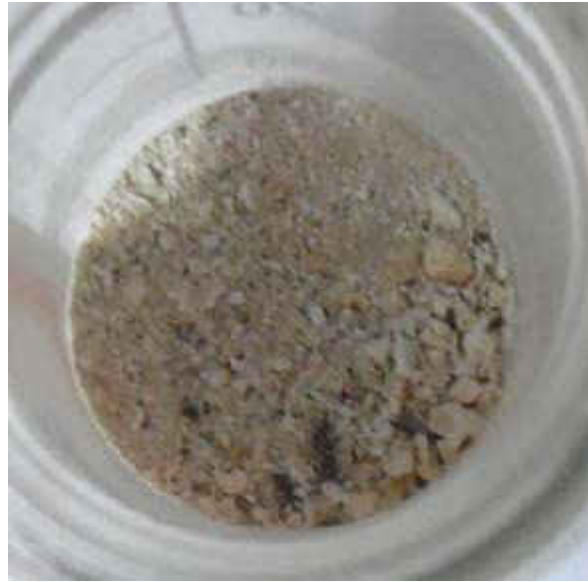
Figure 5-26: Internal Pipe Scale from Copper and Galvanized Iron Pipes in Lana'i City Residence

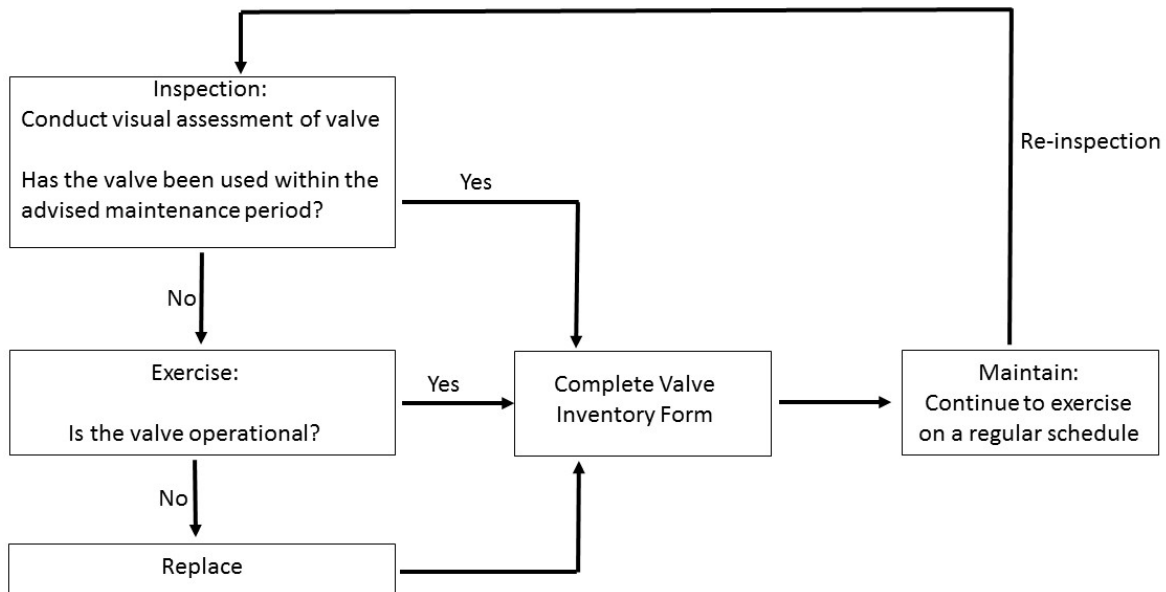
Figure 5-29: Valve Decision Flow Chart

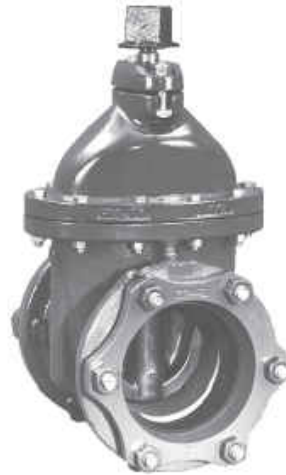
A-USP0-20

- 2" square wrench nut (optional handwheel available) – open left or open right
 - Stainless steel type 304 standard material for bonnet and stuffing box bolts and nuts, and wrench nut cap screw.

- 250 psig (1723 kPa) maximum working pressure, 500 psig (3447 kPa) static test pressure
 - 3"-12" sizes – UL Listed, FM Approved: 200 psig (1379 kPa)
- ††Dirt seal on 4"-12" valves
