Environmental Degradation Of Oxidation Resistant And Thermal Barrier Coatings For Fuel-flexible Gas Turbine Applications

ENVIRONMENTAL DEGRADATION OF OXIDATION RESISTANT AND
THERMAL BARRIER COATINGS FOR FUEL-FLEXIBLE GAS TURBINE
APPLICATIONS

A dissertation submitted in partial fulfillment of the requirements
for the degree of Doctor of Philosophy
in the Department of Mechanical, Materials and Aerospace Engineering
in the College of Engineering and Computer Science
at the University of Central Florida
Orlando, Florida

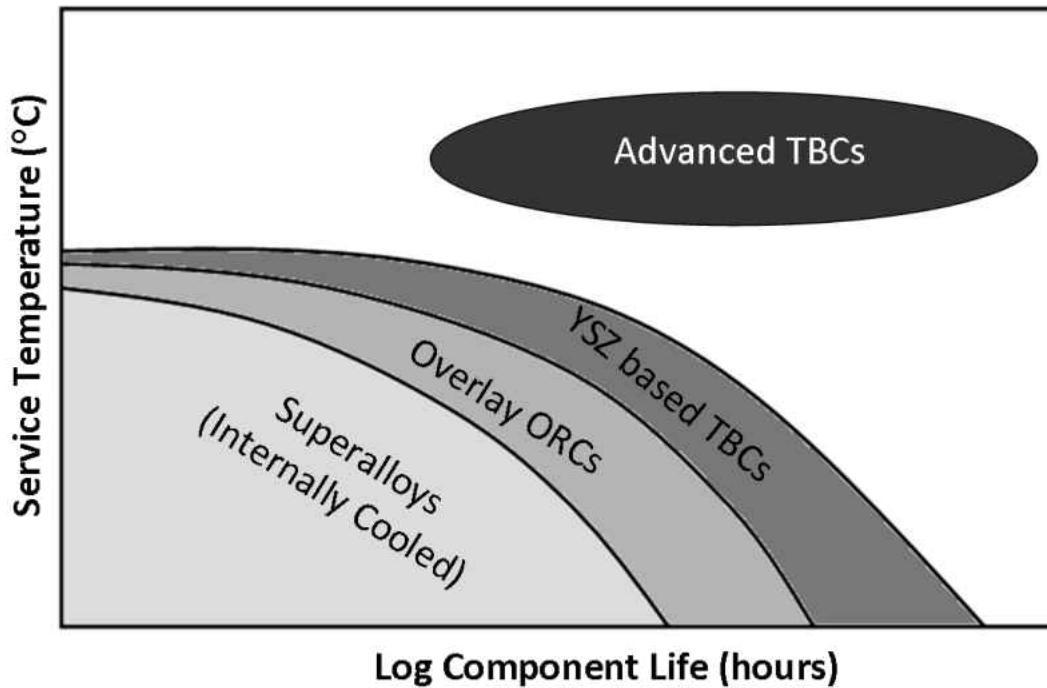
Figure 1.: A schematic plot illustrating the temperature capability of high-temperature protective coatings for gas turbine applications. ORC stands for oxidation resistant coatings.

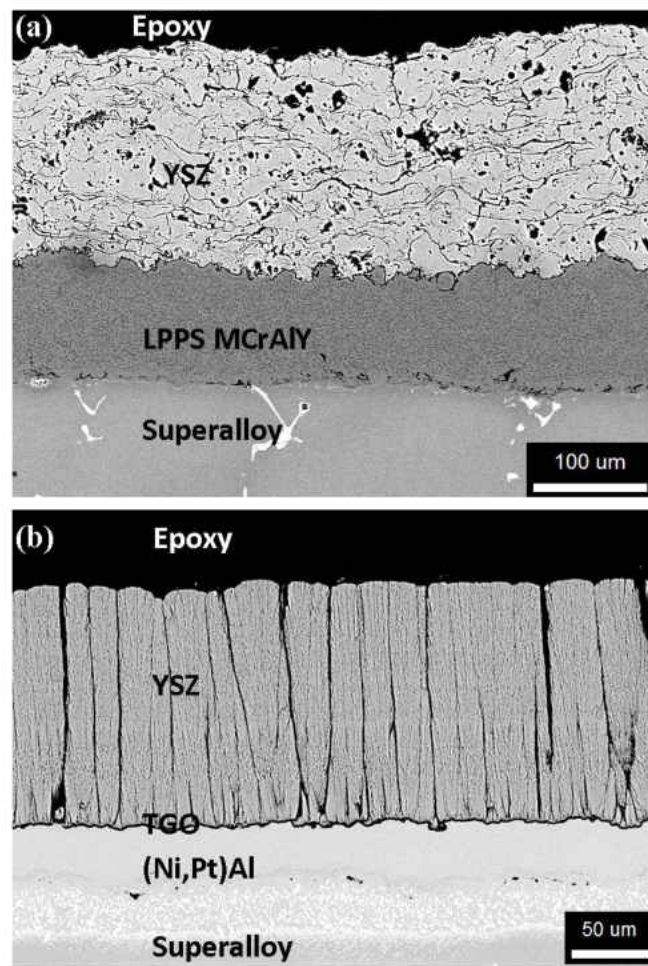
Figure 2.: Cross-sectional backscattered electron micrographs showing typical microstructures of (a) APS TBC (APS YSZ/LPPS MCrAlY/Superalloy) and (b) EB-PVD TBC (EB-PVD YSZ/(Ni,Pt)Al/Superalloy).

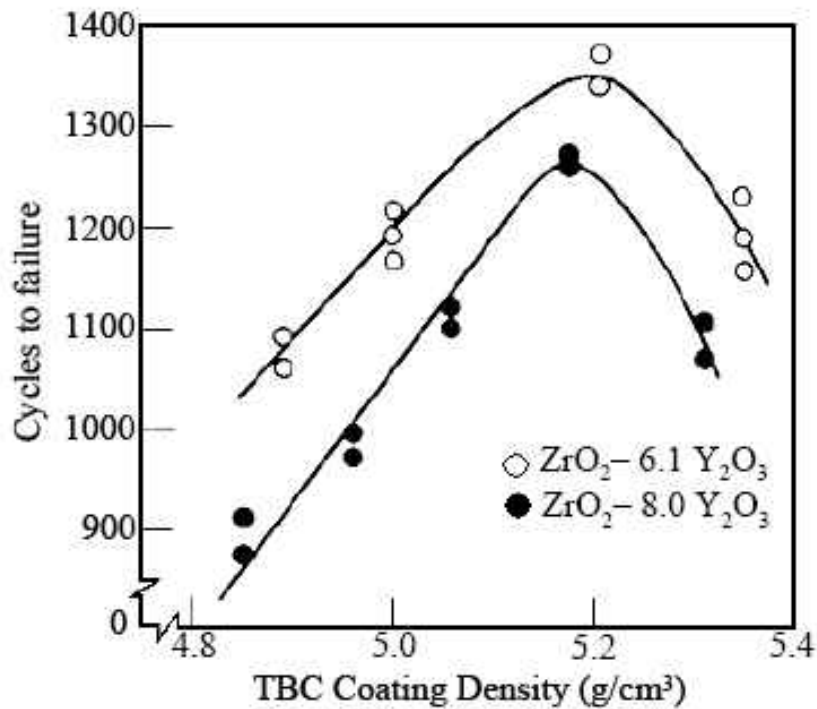
Figure 2.: Effect of the YSZ topcoat density on the thermal cyclic lifetime of YSZ TBCs [68].

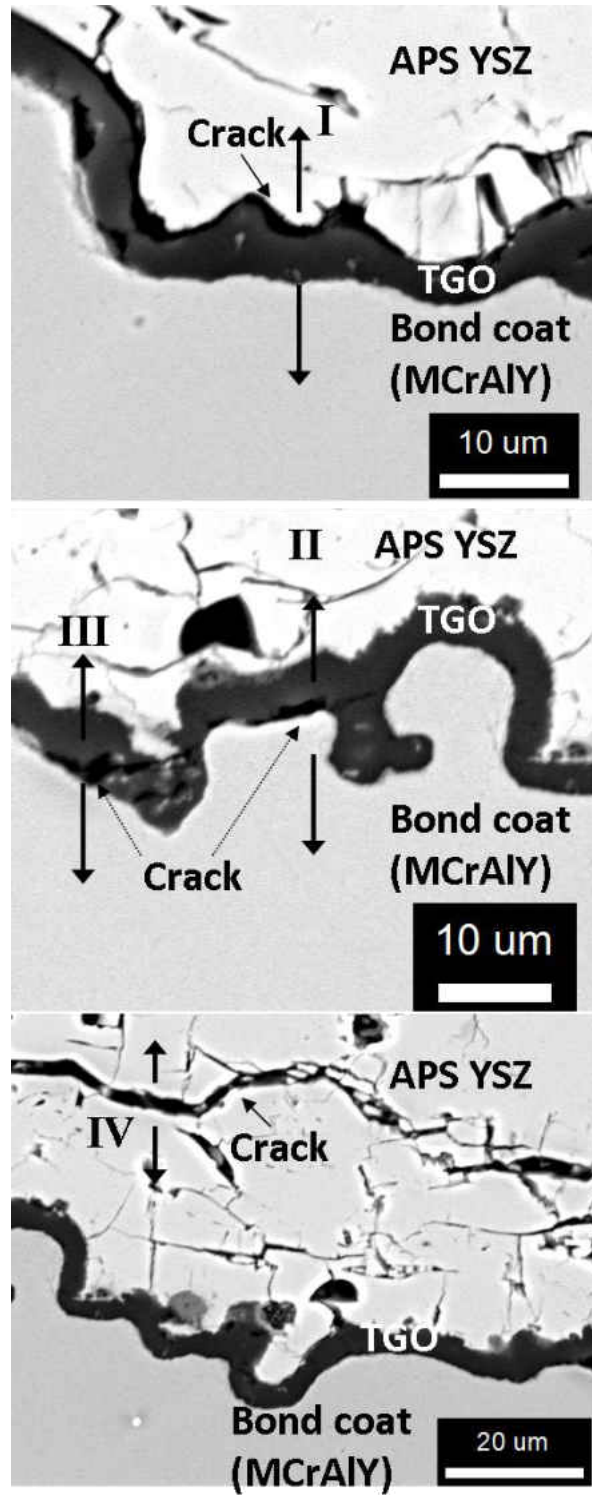
Figure 2.: Cross-sectional microstructures of nearly failed APS TBCs showing different failure mechanisms.

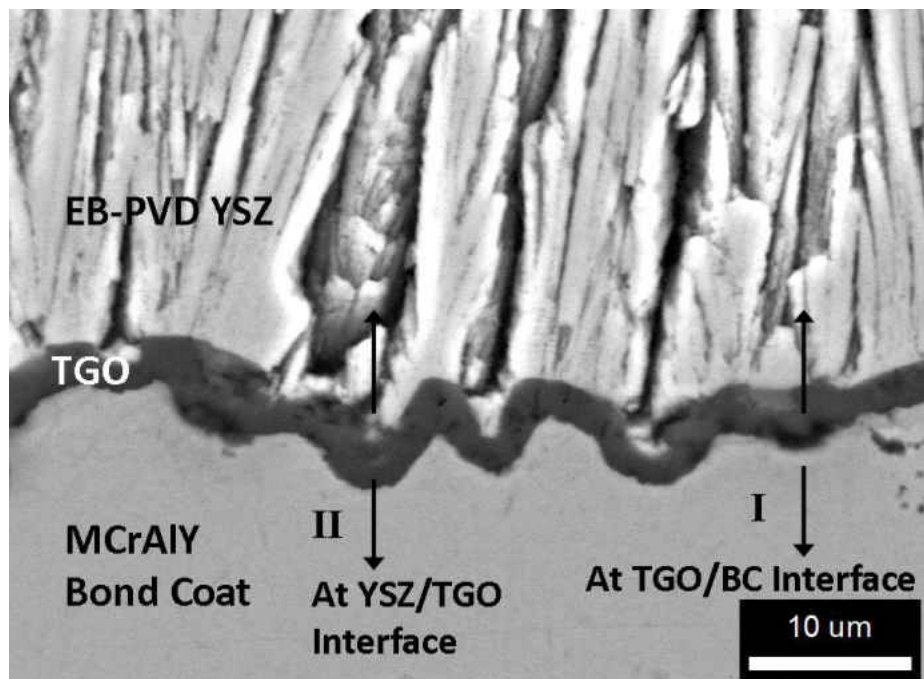
Figure 2.: A cross-sectional micrograph of an EB-PVD TBC hypothetically illustrating the two common failure mechanisms.

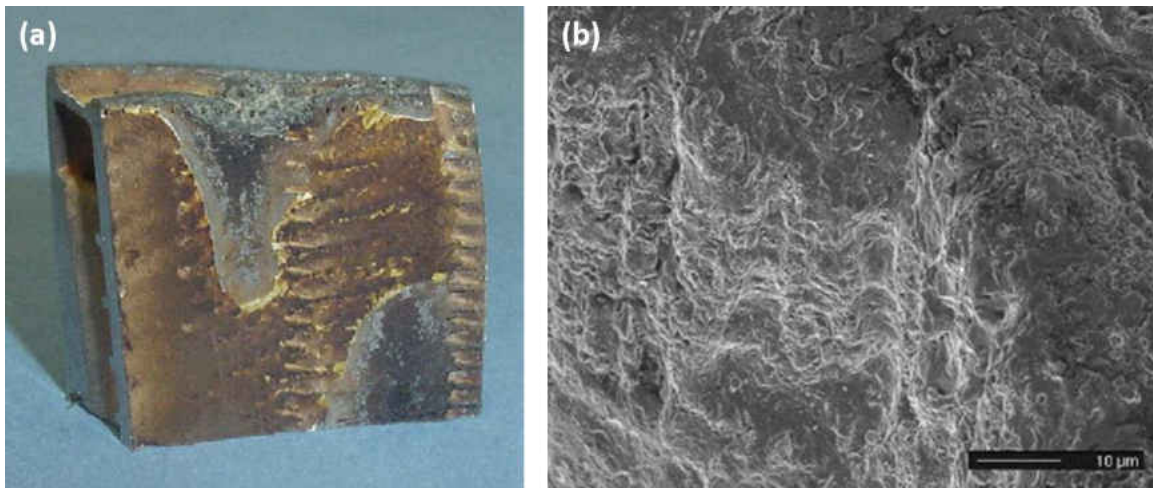
Figure 2.: EBPVD TBC failure on a turbine airfoil due to air-ingested CMAS deposit: (a) Macrograph showing significant TBC spallation, (b) SEM micrograph showing surface morphology of spalled surface revealing amorphous CMAS deposit [103].

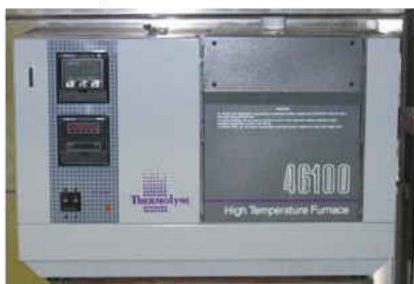
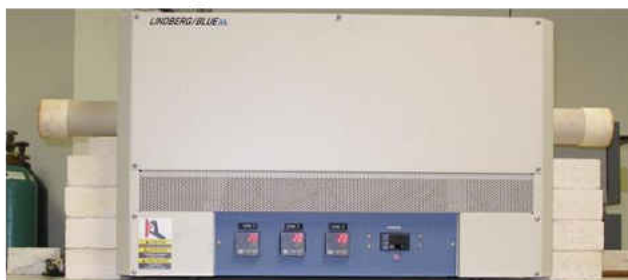
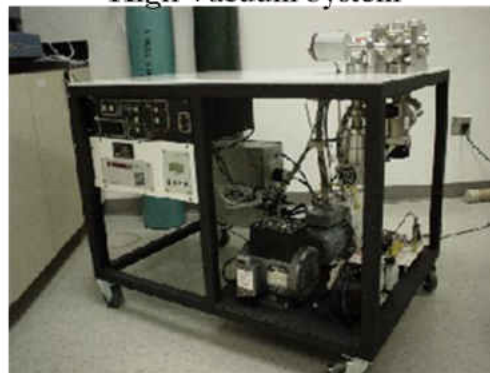
Thermolyne 46100 Muffle Furnace

Lindberg/Blue 3-zone Tube Furnace

High Vacuum System

Figure 3.: Experimental tools used for high temperature molten deposit testing of the free-standing YSZ and CoNiCrAlY.

using a Thermolyne 46100 muffle furnace (1700°C max) shown in Fig. 3.2. Details of molten deposit testing and the potential source of corrosive compounds are listed in Table 3.2. Emphasis was given to test temperatures close to the melting point of the contaminant in order to thoroughly investigate the thermochemical interactions with YSZ and CoNiCrAlY without vaporizing the corrosive species.

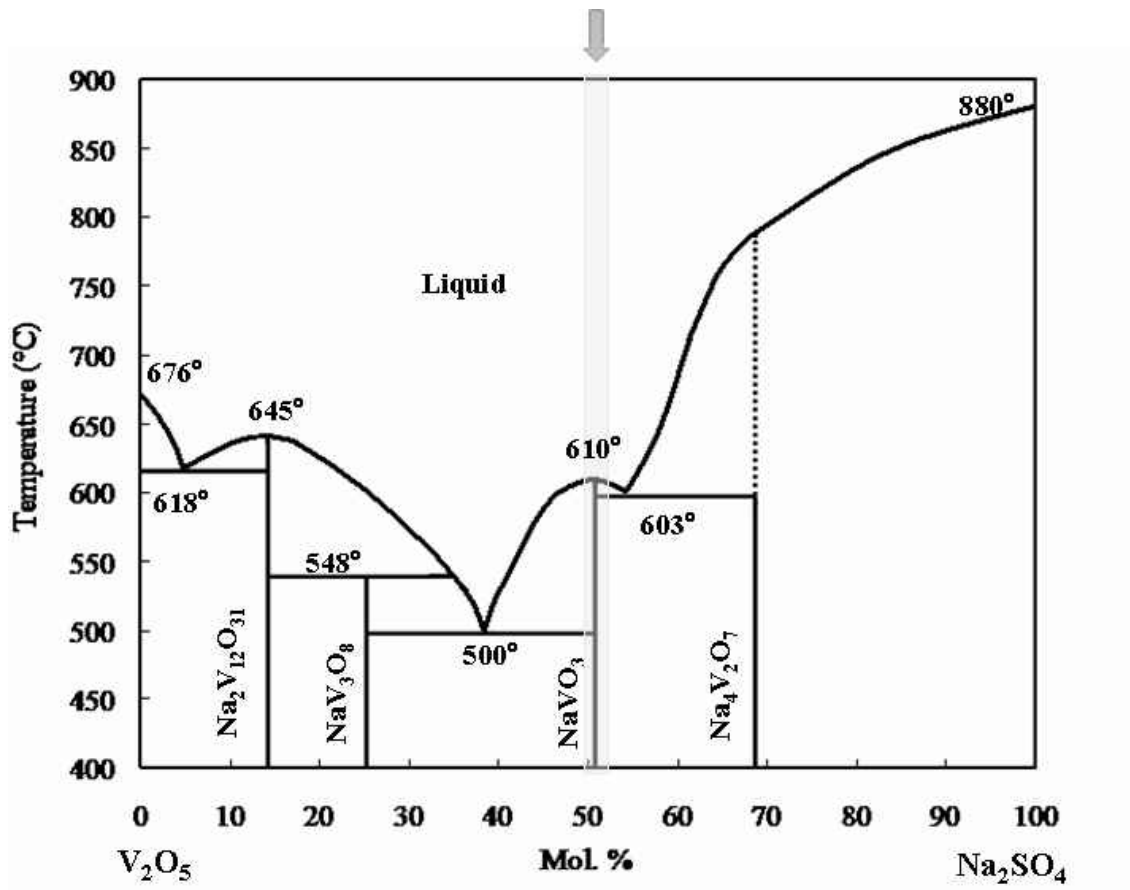
Figure 3.: Equilibrium phase diagram of the V_2O_5 - Na_2SO_4 system and the selected composition of mixture for this study (shaded) [127].

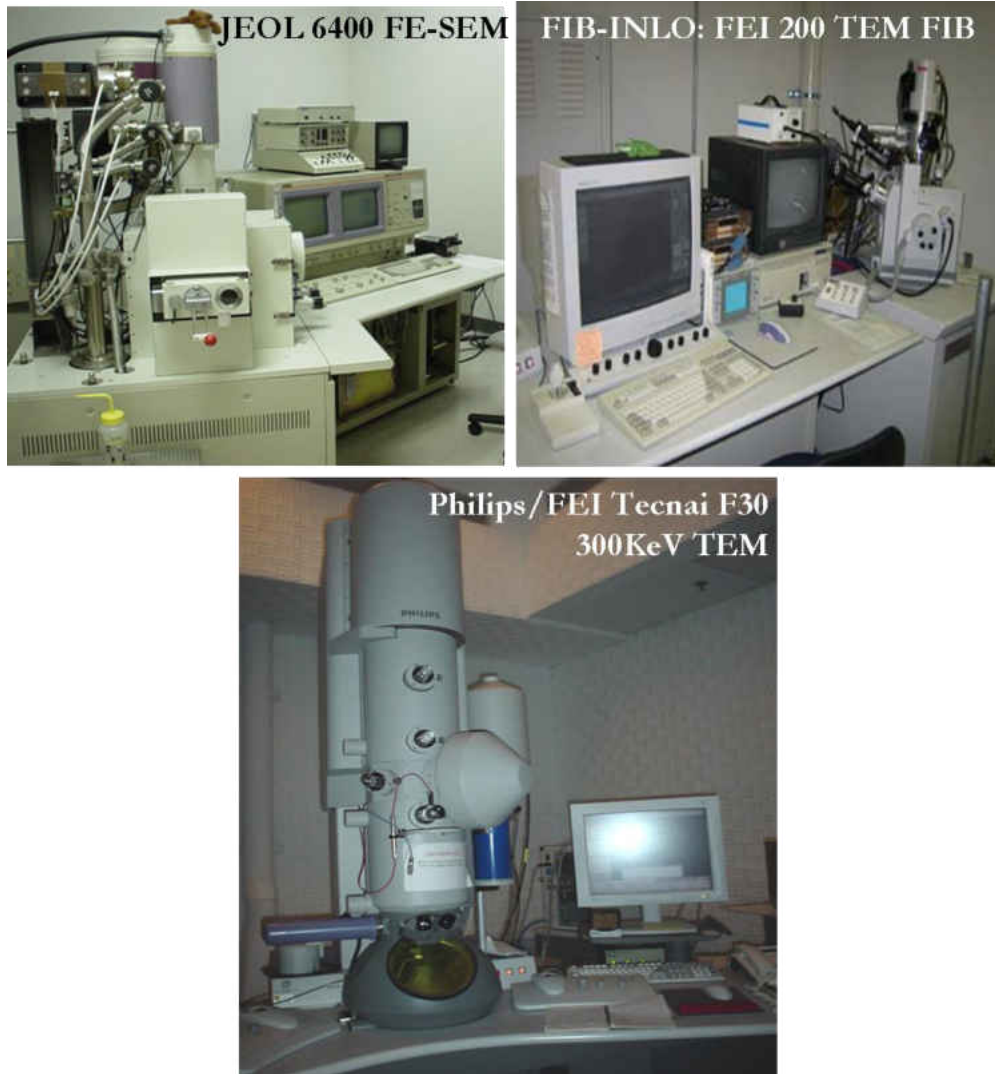
Figure 3.: Materials characterization tools employed in this study.

After a careful visual inspection, tested specimens were thoroughly examined by materials characterization tools (at Materials Characterization Facility (MCF), UCF) for microstructural analysis and phase identification. Characterization tools at UCF MCF that were extensively employed in this study are shown in Fig. 3.5. X-ray diffraction (XRD) studies were performed on the hot corrosion and CMAS tested samples to examine the development of constituent phases. This was performed by using a Rigaku D-Max B Diffractometer (Tokyo, Japan) with Cu K α radiation. XRD patterns after appropriate background correction were indexed based on the available JCPDS resources using MDI Jade software. Surface and cross-

sectional microstructural analysis were carried out to examine the deposit penetration, reaction products and degradation mechanisms by using JEOL 6400F field-emission scanning electron microscope (FE-SEM) (Tokyo, Japan) and Hitachi S3500N scanning electron microscope (SEM) (Tokyo, Japan), both equipped with an X-ray energy dispersive spectrometer (XEDS). For cross-sectional microstructural characterization, specimens were embedded in epoxy resin and metallographically prepared down to 0.25 μm using diamond paste. For microstructural analysis, specimens tested for hot corrosion using sulfate deposits were prepared with organic solvent to minimize the water exposure and preserve the soluble corrosion products for further analysis. For SEM characterization, epoxy mounted cross-sectional specimens and as-tested surfaces were coated with a thin Au-Pd (10 nm) film using an EMITECH K550 D.C. sputter coating system. Backscattered and secondary electron imaging modes were extensively employed for microstructural analysis by SEM. The FE-SEM utilized a cold cathode field emission electron gun and has a resolution of 1.5 nm. Images were collected with a voltage ranging from 15 to 30 kV at a constant emission current of 8 μA . EDS spectra were also collected at regions of interest for a qualitative/quantitative compositional analysis. Detailed microstructural investigation using a Philips/FEI Tecnai F30 300KeV transmission electron microscope (TEM) (Hillsboro, OR, USA), equipped with high angle annular dark field (HAADF) and XEDS was also performed to examine the detailed reaction mechanisms and the phase constituents (e.g. phase transformations and reactions) of the YSZ and CoNiCrAlY due to infiltration and degradation by molten deposits.

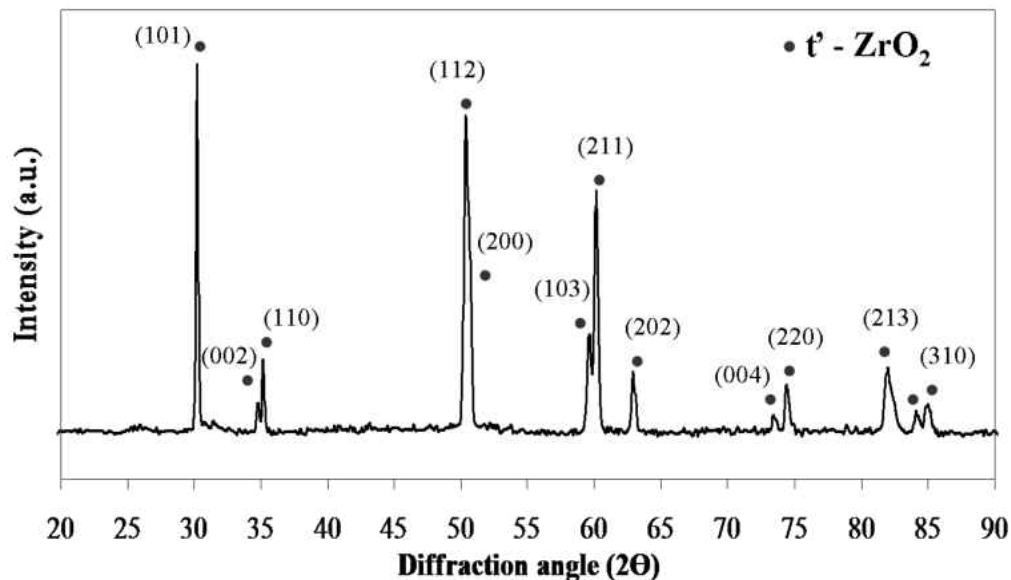
Figure 4.: XRD pattern obtained from the as-sprayed free standing YSZ topcoat surface confirming the phase constituent of YSZ as the t' - ZrO_2 .

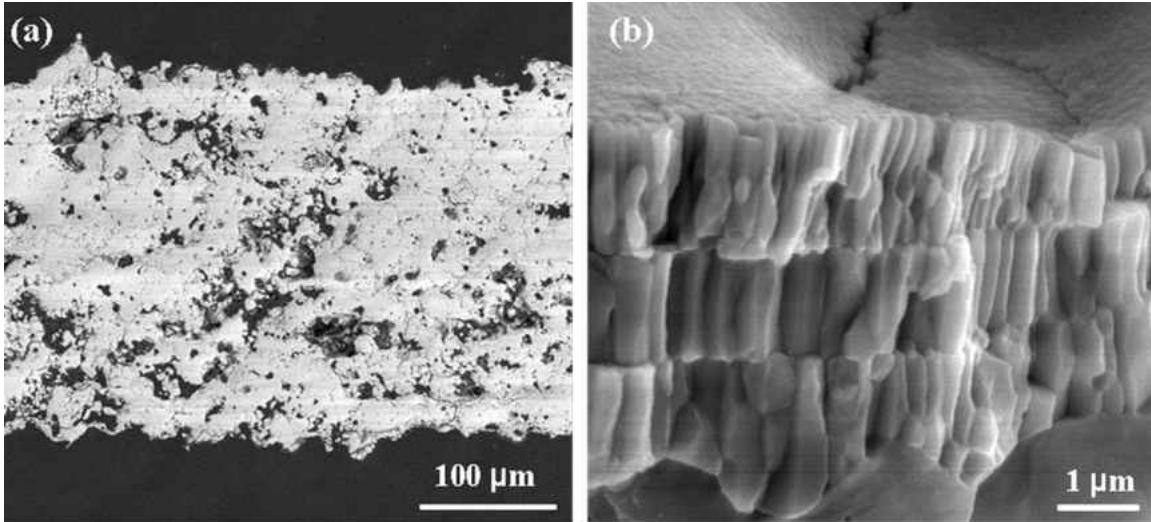
Figure 4.: Cross-sectional (a) backscattered electron micrograph showing the typical microstructure of as-sprayed free standing YSZ topcoat with uniformly thick YSZ topcoat that consists of (b) splat-quenched microstructure observed by secondary electron micrograph.

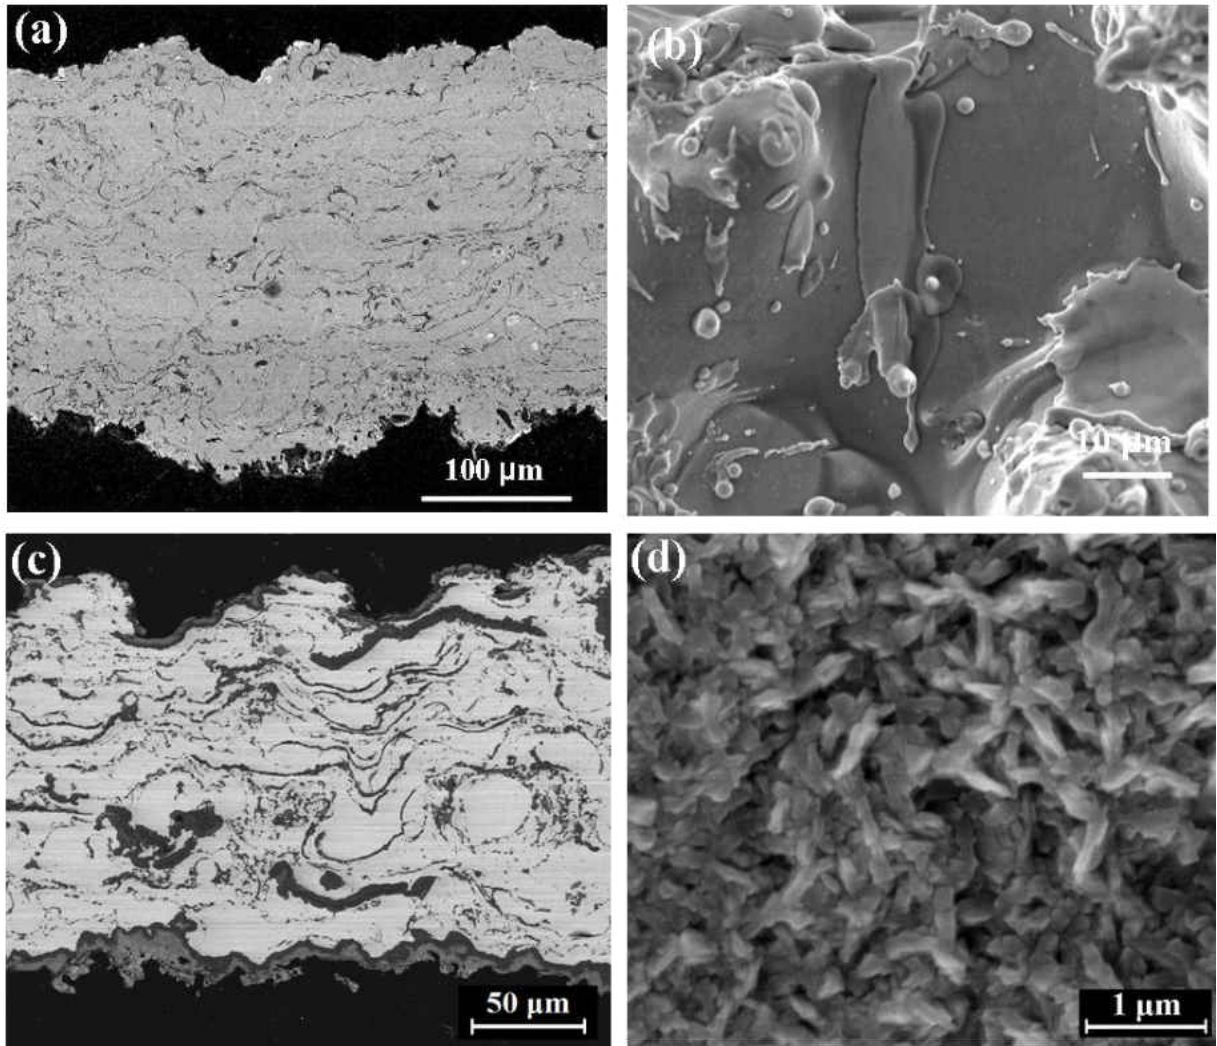
Figure 4.: (a) and (b) Secondary electron micrographs of free standing APS CoNiCrAlY coating showing the uniform cross-section and the typical surface splat microstructure; (c) cross-sectional backscattered electron micrograph presenting the microstructure of heat-treated free standing CoNiCrAlY after 20 h isothermal treatment at 1100°C and (d) secondary electron micrograph revealing the respective surface morphology of TGO scale evolved from isothermal heat-treatment.

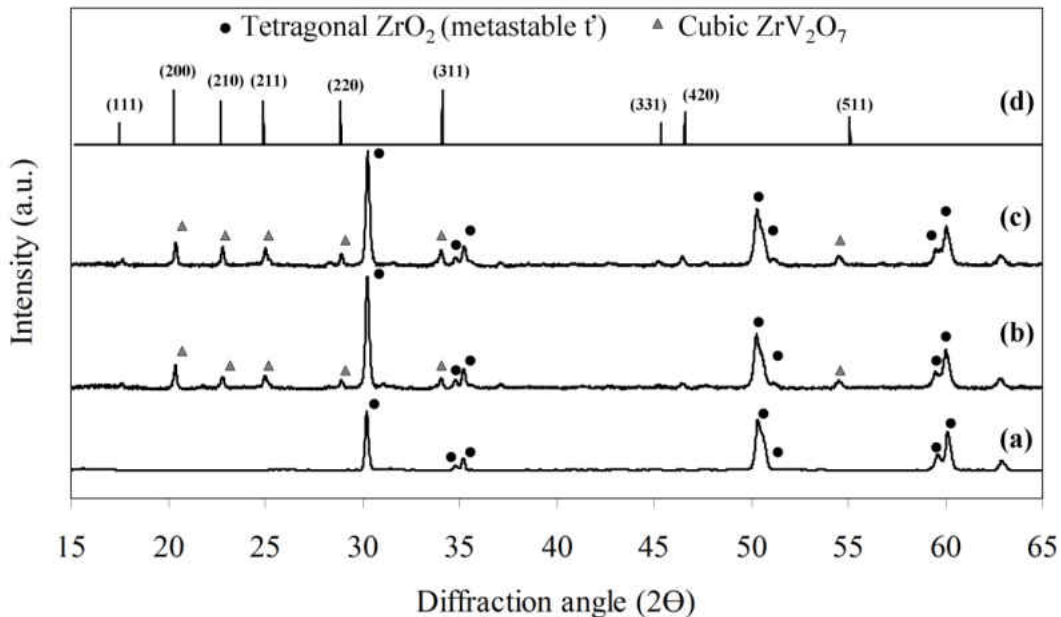
Figure 4.: XRD patterns illustrating the degradation of free-standing APS YSZ during YSZ– V_2O_5 reaction at 720°C : (a) as-sprayed; (b) 720°C for 30 minutes; (c) 720°C for 2 h and (d) ZrV_2O_7 standard.

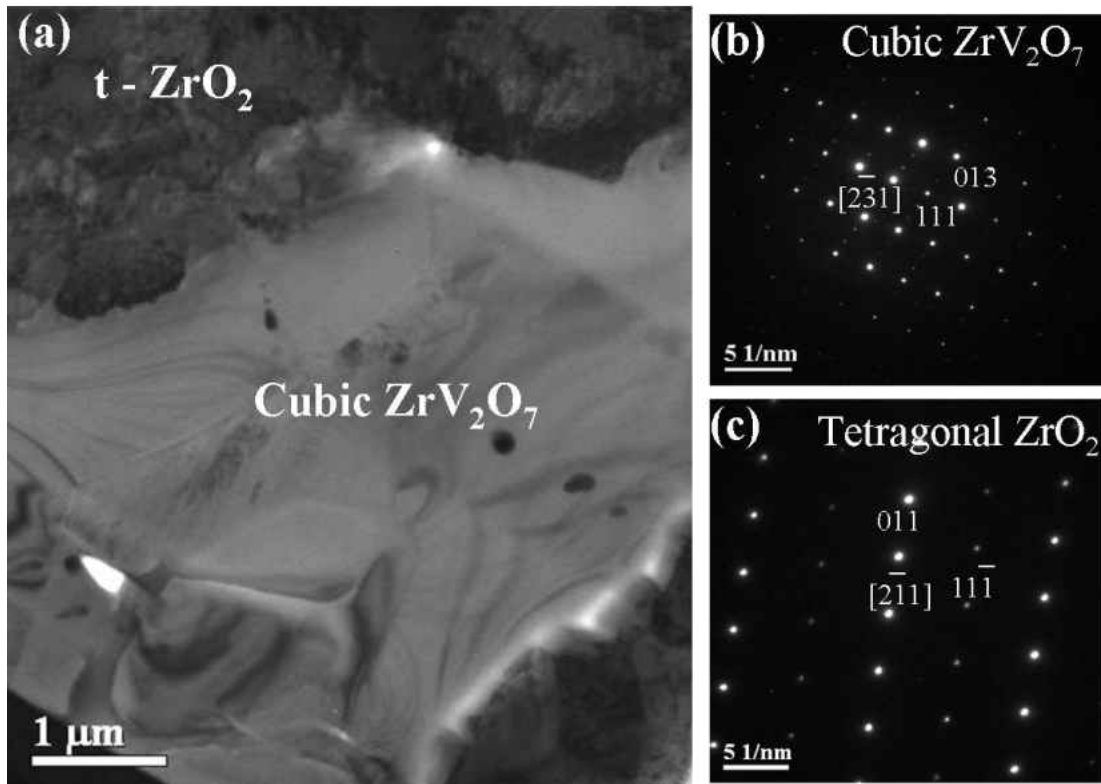
Figure 4.: (a) Bright-field TEM micrograph showing the phase constituents of the APS YSZ after reaction with V_2O_5 at 720°C for 30 minutes. Electron diffraction patterns from the two phases present are indexed as (b) cubic ZrV_2O_7 and (c) tetragonal ZrO_2 with zone axes of $[2\ 3\ 1]$ and $[2\ 1\ 1]$ respectively.

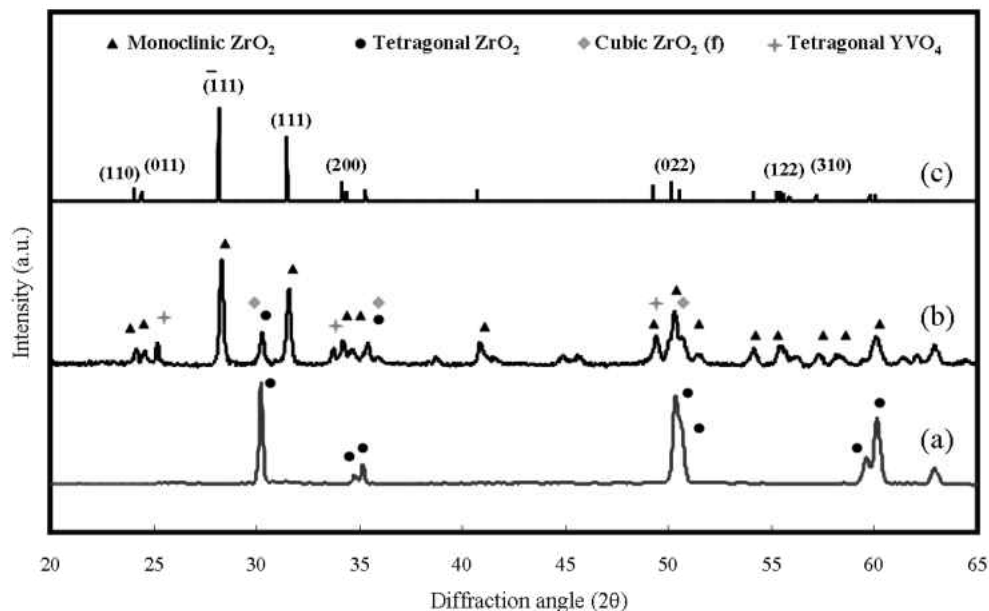
Figure 4.: XRD patterns illustrating the degradation of free-standing APS YSZ during YSZ– V_2O_5 reaction at 800°C : (a) as-sprayed; (b) 800°C for 30 minutes; (c) monoclinic ZrO_2 standard.

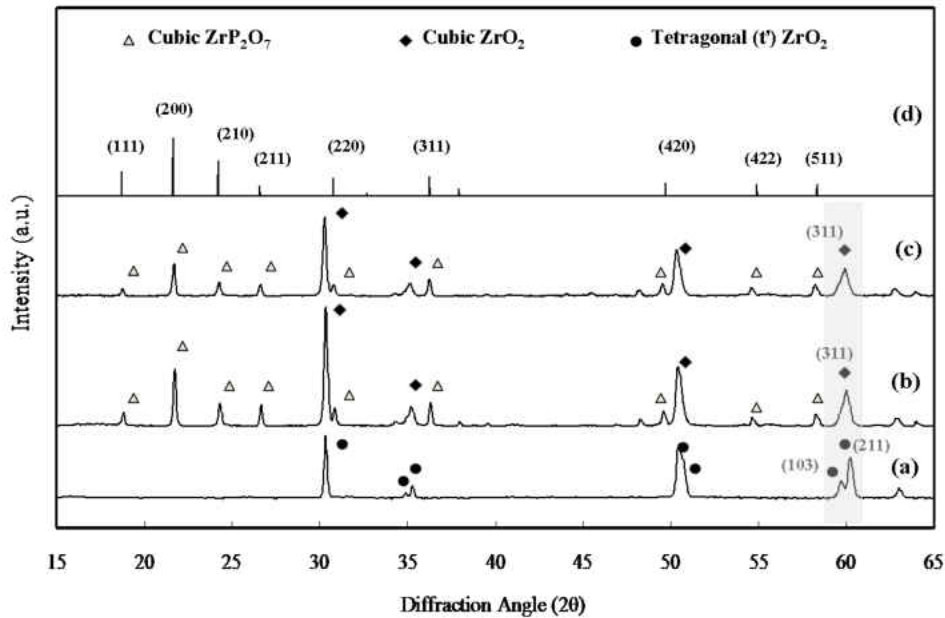
Figure 4.: XRD patterns illustrating the degradation of the APS YSZ during YSZ-P₂O₅ reaction: (a) as-sprayed; (b) 350°C for 1 h; (c) 450°C for 1 h; (d) cubic ZrP₂O₇ standard.

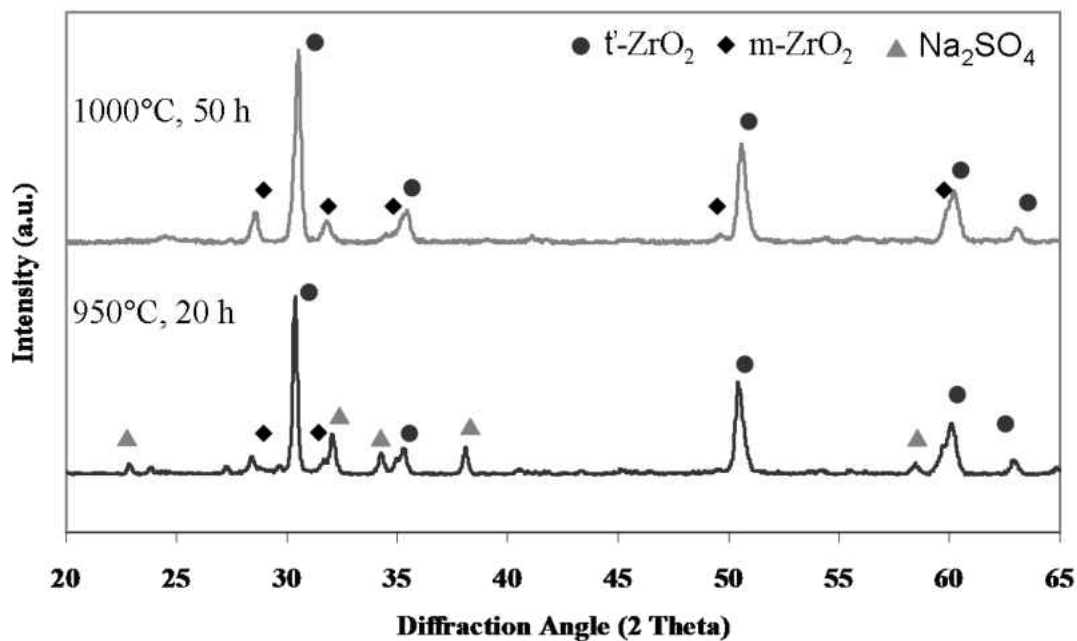
Figure 4.: XRD patterns obtained from YSZ after testing with Na_2SO_4 deposit for various durations at 950°C and 1000°C .

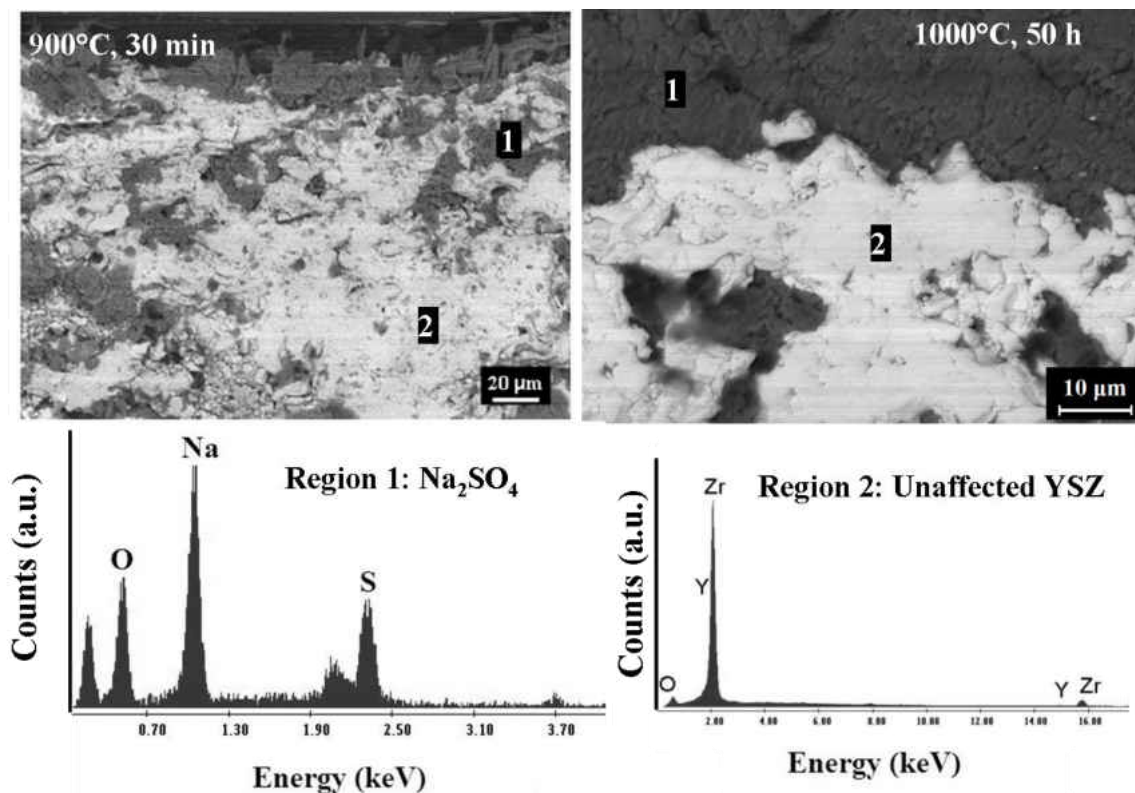
Figure 4.: Cross-sectional backscattered electron micrographs showing the inert nature of YSZ after hot-corrosion testing with Na_2SO_4 deposit and the corresponding XEDS spectra from regions of interest.

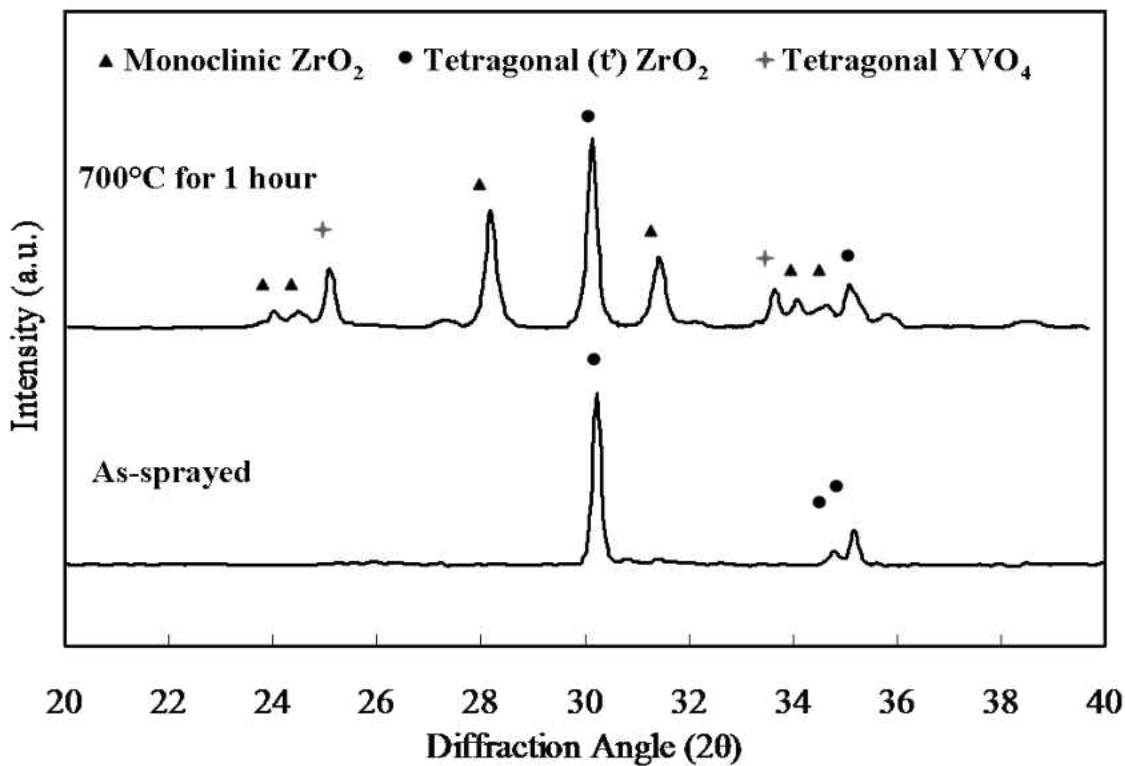
Figure 4.: XRD patterns illustrating the degradation of free-standing APS YSZ during YSZ–Na₂SO₄+V₂O₅ mixture reaction at 700°C for 1 hour due to the formation of YVO₄.

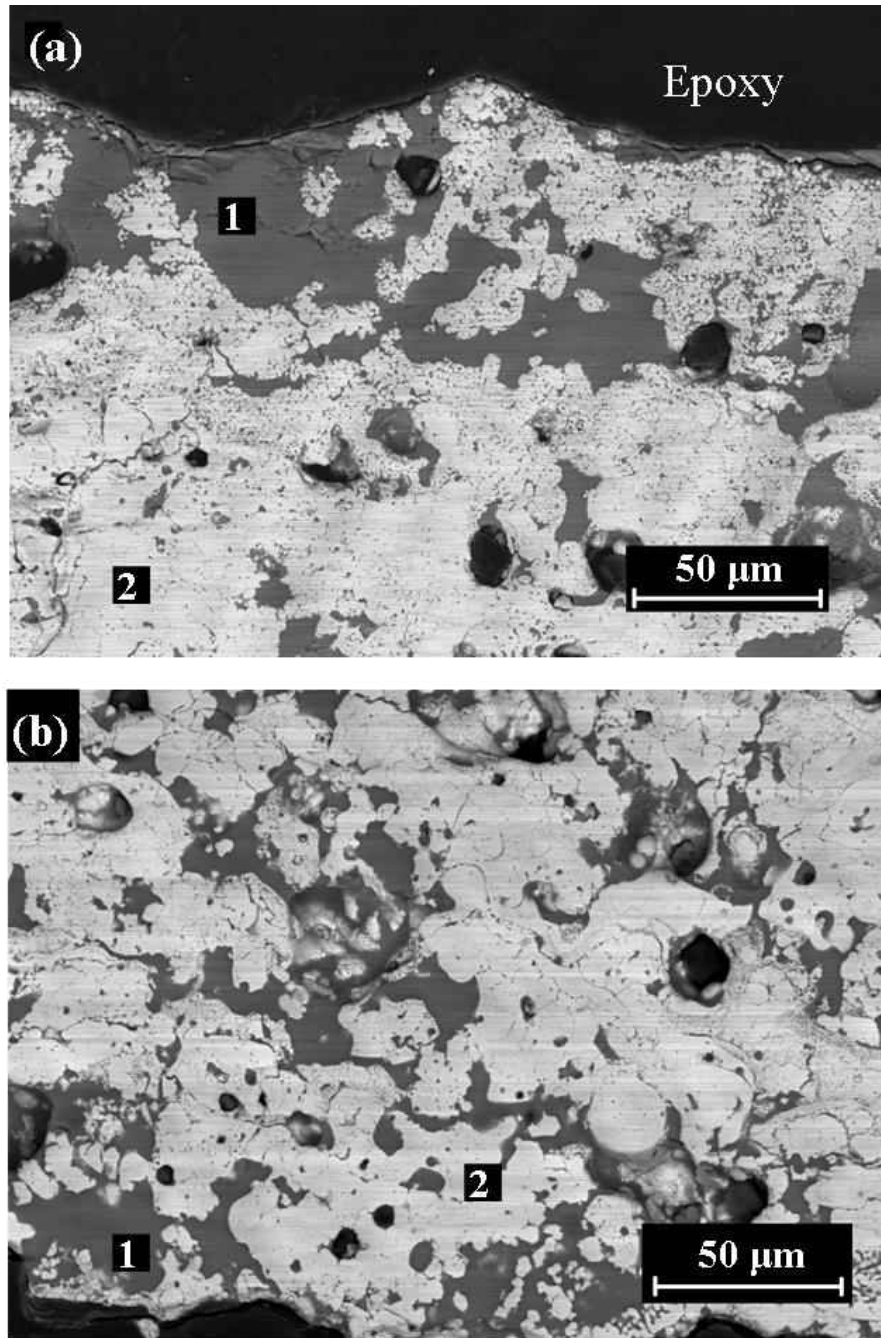
Figure 4.: Cross-sectional backscattered electron micrographs near the (a) top and (b) bottom surfaces of the APS YSZ coating subjected to molten CMAS infiltration at 1250°C for 4 h. Regions 1 and 2 correspond to solidified CMAS and bulk YSZ.

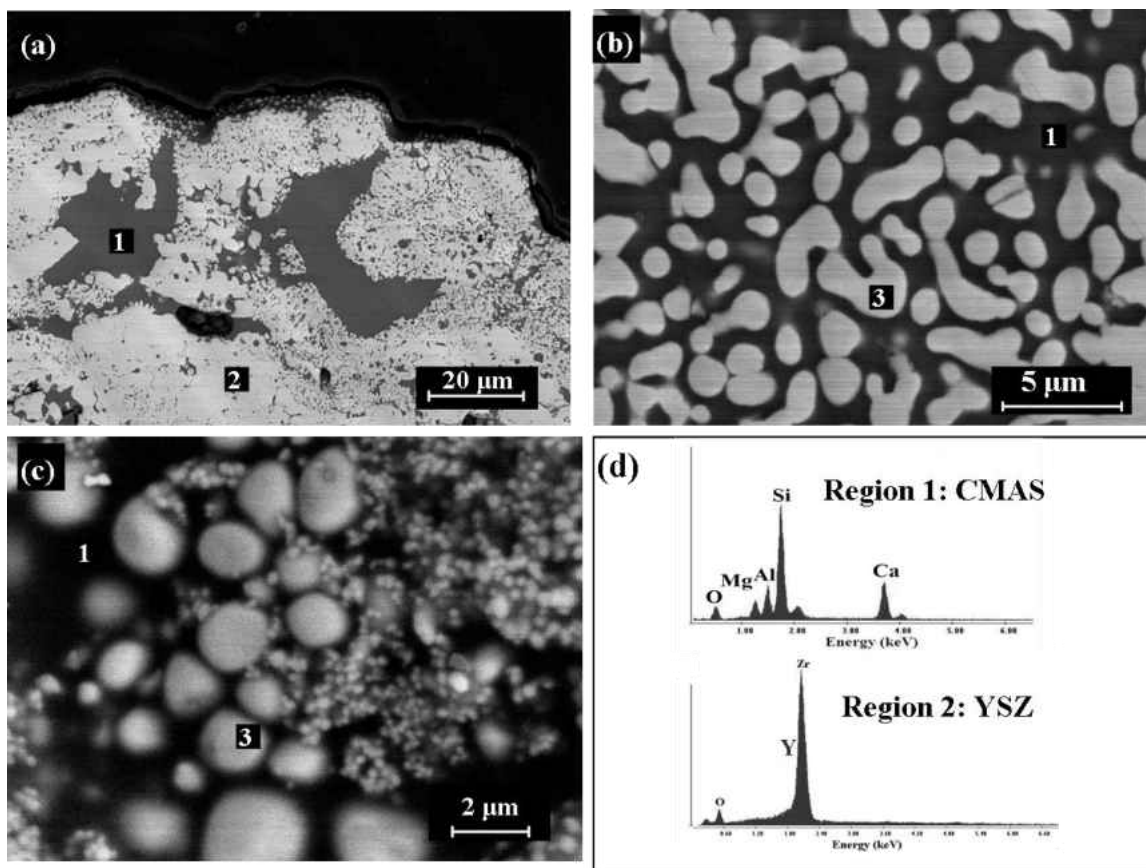
Figure 4.: Backscattered electron micrographs obtained from the YSZ coating infiltrated by molten CMAS at 1300°C for 4 h. (a) and (b) Cross-sections at low and high magnifications respectively. (c) Micrograph of surface morphology showing the CMAS infiltrated coating with coarse and fine reprecipitated ZrO_2 grains from CMAS melt. (d) Characteristic XEDS spectra from solidified CMAS and bulk YSZ. Regions 1, 2 and 3 correspond to solidified CMAS, bulk YSZ and reprecipitated ZrO_2 respectively.

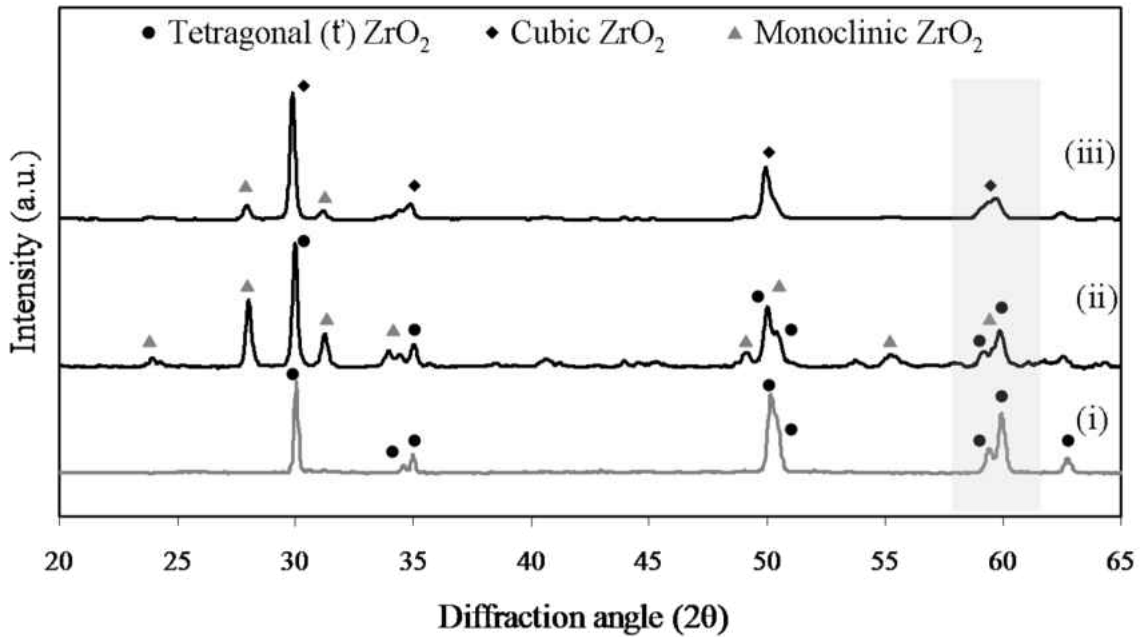
Figure 4.:X-ray diffraction patterns illustrating the phase transformation of YSZ due to CMAS infiltration: (a) Collected patterns from (i) as sprayed YSZ coating – top surface, (ii) Top surface and (iii) bottom surface of the YSZ infiltrated by molten CMAS at 1300°C for 4 h.

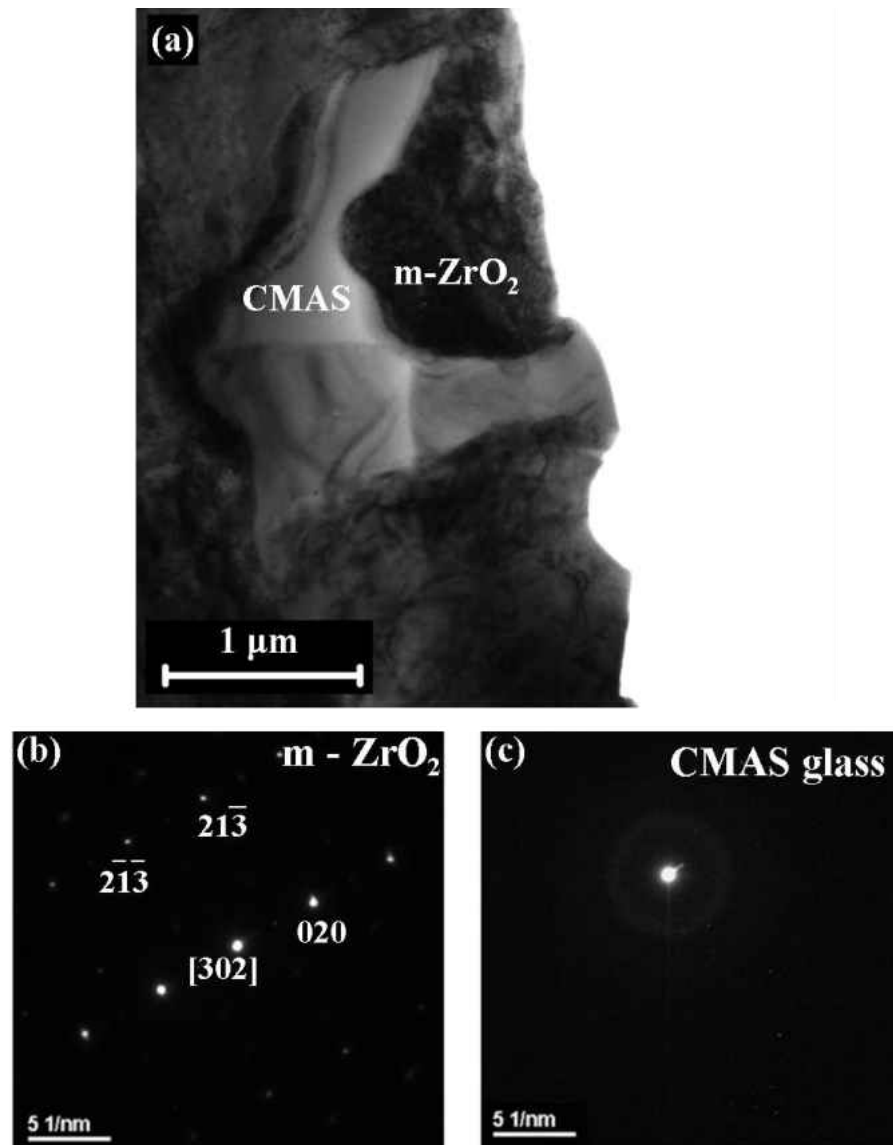
Figure 4.: (a) Bright-field TEM micrograph obtained from the APS YSZ coating subjected to molten CMAS attack at 1350°C for 2 h. The corresponding electron diffraction patterns obtained from the phases present, which are indexed as (b) monoclinic ZrO₂ and (c) amorphous CMAS glass.

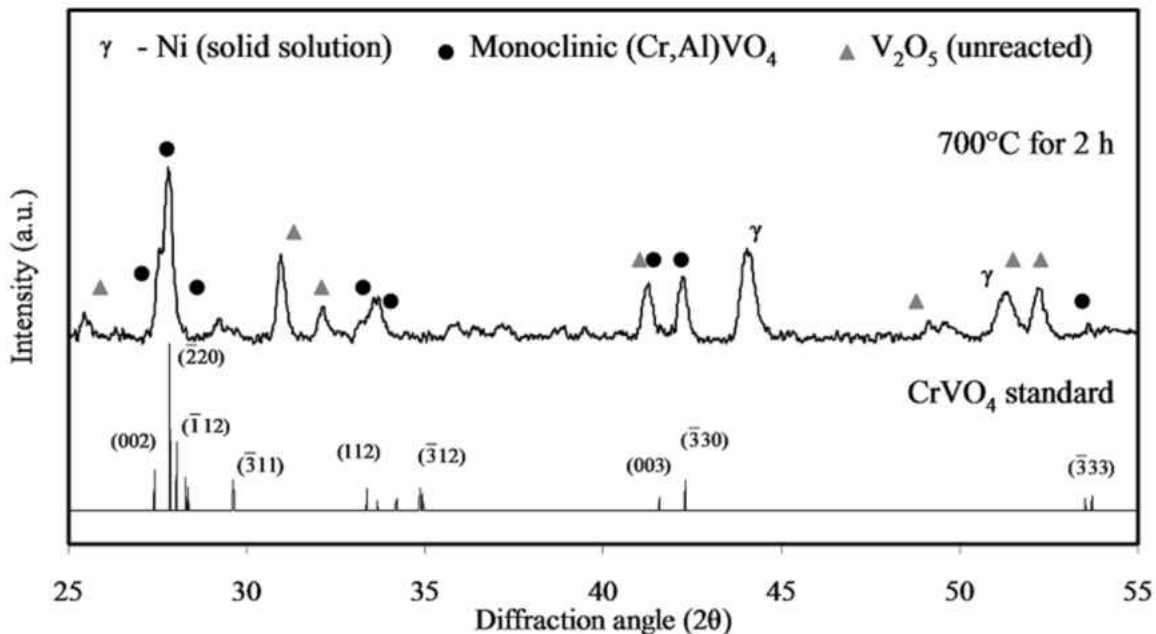
Figure 4.: XRD pattern from V_2O_5 degraded CoNiCrAlY surface revealing monoclinic $(Cr,Al)VO_4$ as the primary phase constituent evolved during thermochemical interaction between APS CoNiCrAlY and molten V_2O_5 after 2 h at 700°C.

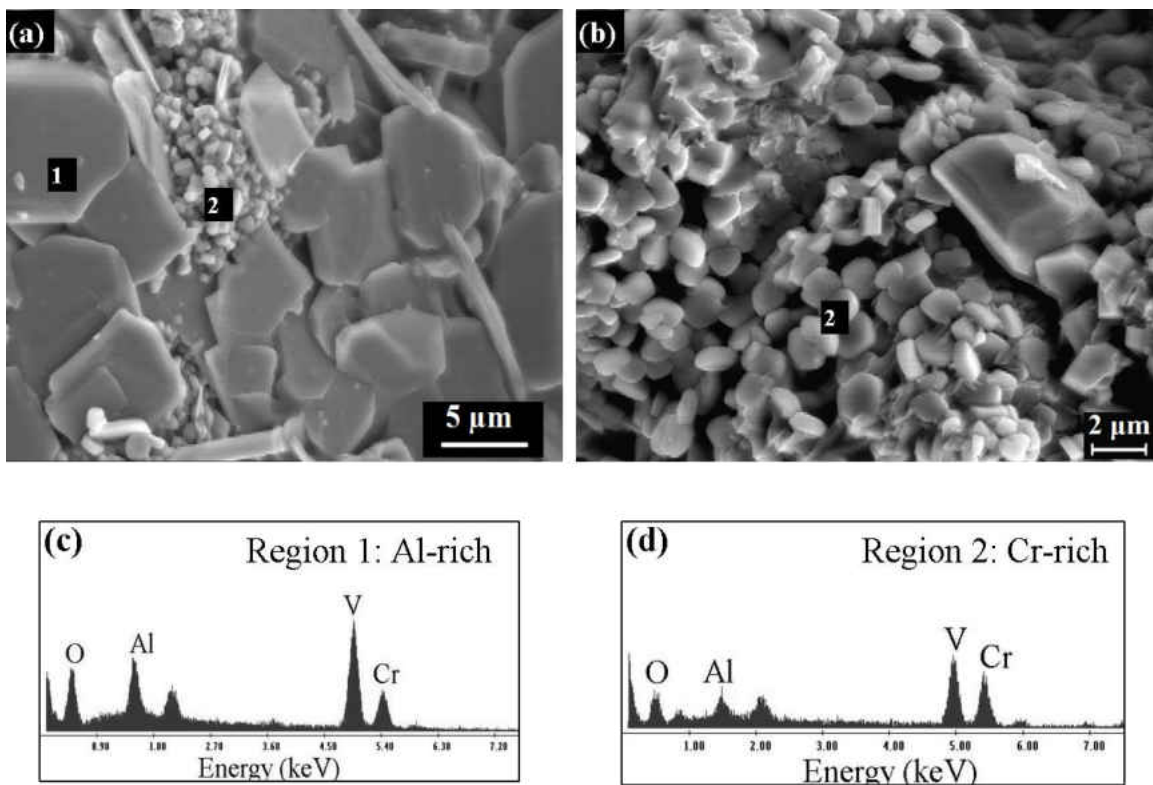
Figure 4.: (a) and (b) Secondary electron micrographs showing the surface morphologies of microstructural evolution during APS CoNiCrAlY – V₂O₅ melt interaction at 700°C for 2 h; (c) and (d) Characteristic XEDS spectra obtained from regions of interest.
