Environmental Degradation Of Oxidation Resistant And Thermal Barrier Coatings For Fuel-flexible Gas Turbine Applications

ENVIRONMENTAL DEGRADATION OF OXIDATION RESISTANT AND
THERMAL BARRIER COATINGS FOR FUEL-FLEXIBLE GAS TURBINE
APPLICATIONS

A dissertation submitted in partial fulfillment of the requirements
for the degree of Doctor of Philosophy
in the Department of Mechanical, Materials and Aerospace Engineering
in the College of Engineering and Computer Science
at the University of Central Florida
Orlando, Florida

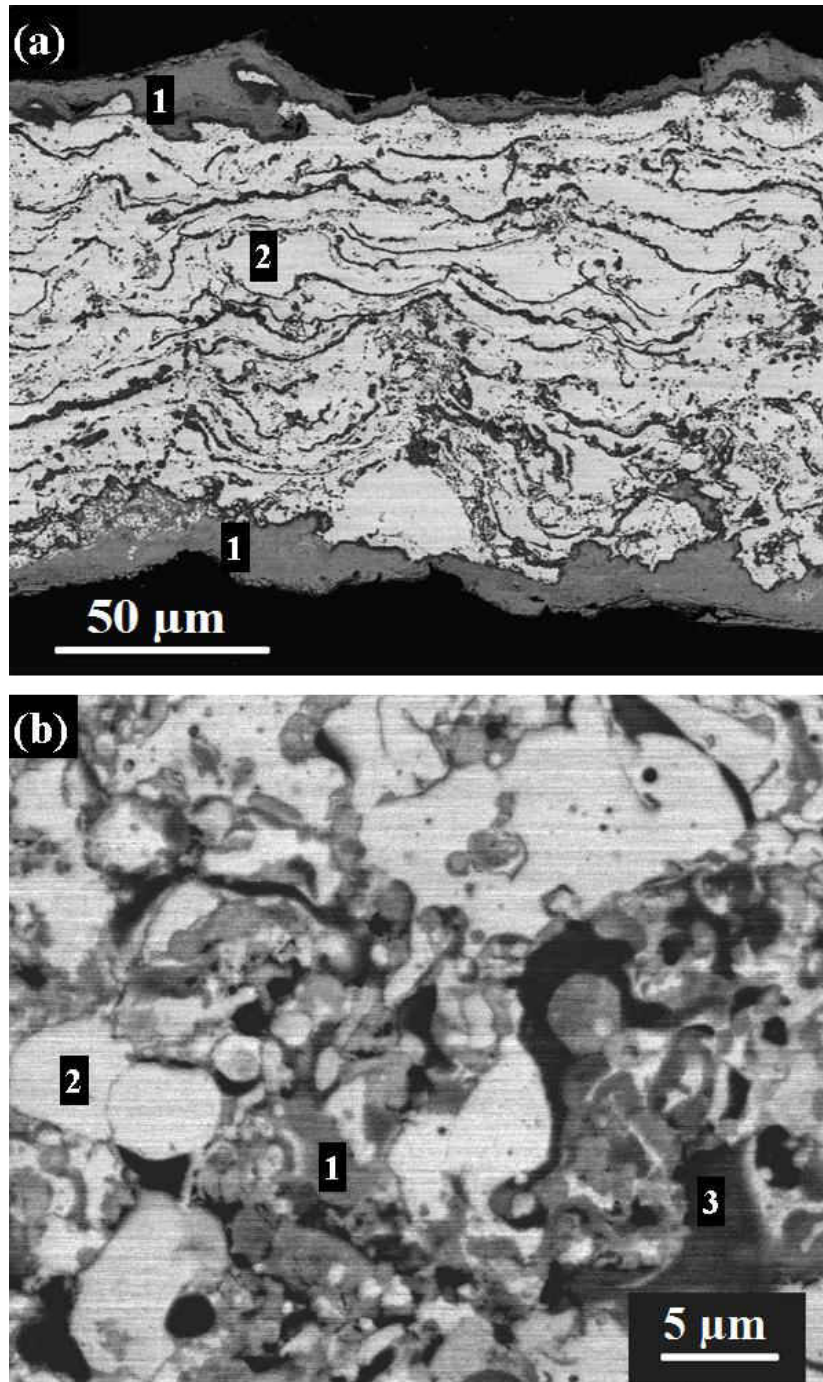
Figure 4.: Cross-sectional backscattered electron micrographs demonstrating the accumulation of V_2O_5 melt at bottom of the coating in (a) and the melt infiltration throughout free-standing APS CoNiCrAlY in (b). Regions 1, 2 and 3 correspond to V_2O_5 melt, bulk CoNiCrAlY coating and internal alumina resulted from pre-oxidation treatment, respectively.

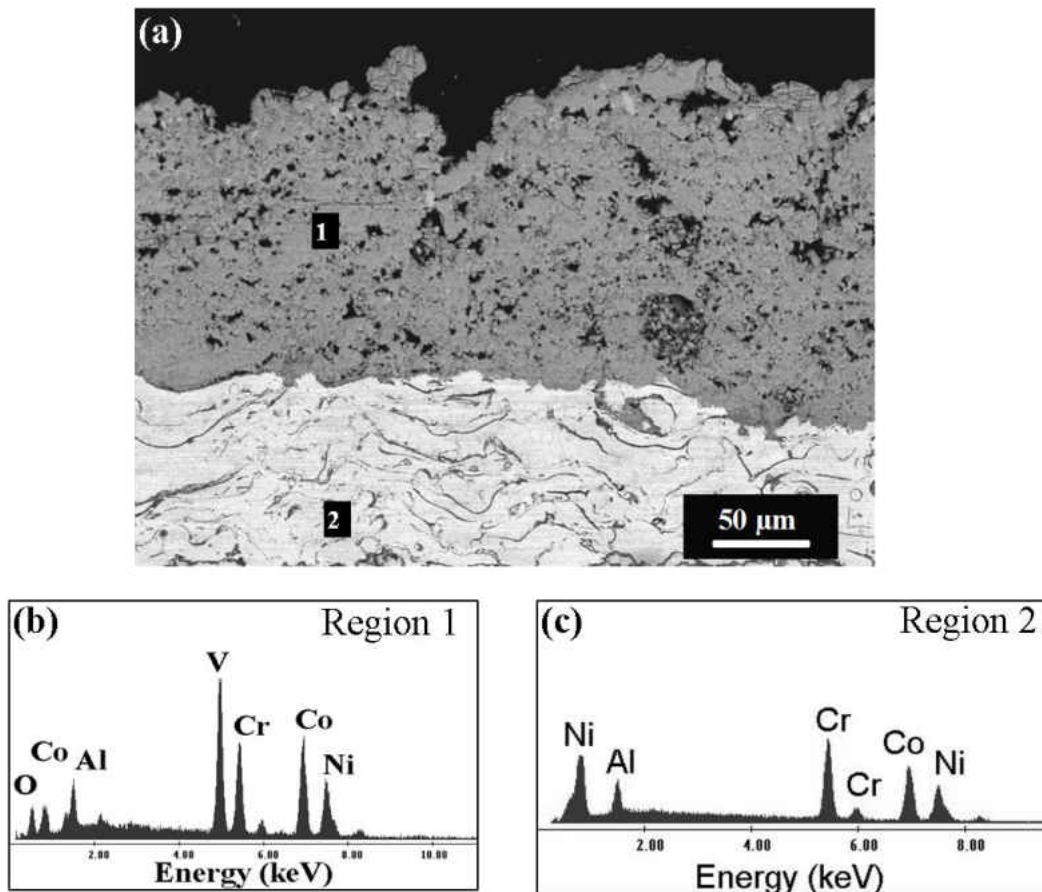
Figure 4.: (a) Cross-sectional backscattered electron micrograph demonstrating the extent of degradation by V₂O₅ melt, where region 1 is the 100 μm-thick scale developed by consumption of free-standing APS CoNiCrAlY; (b) and (c) Characteristic XEDS spectra obtained from regions of interest – region 1: V-rich corroded scale and region 2: unaffected CoNiCrAlY bulk.

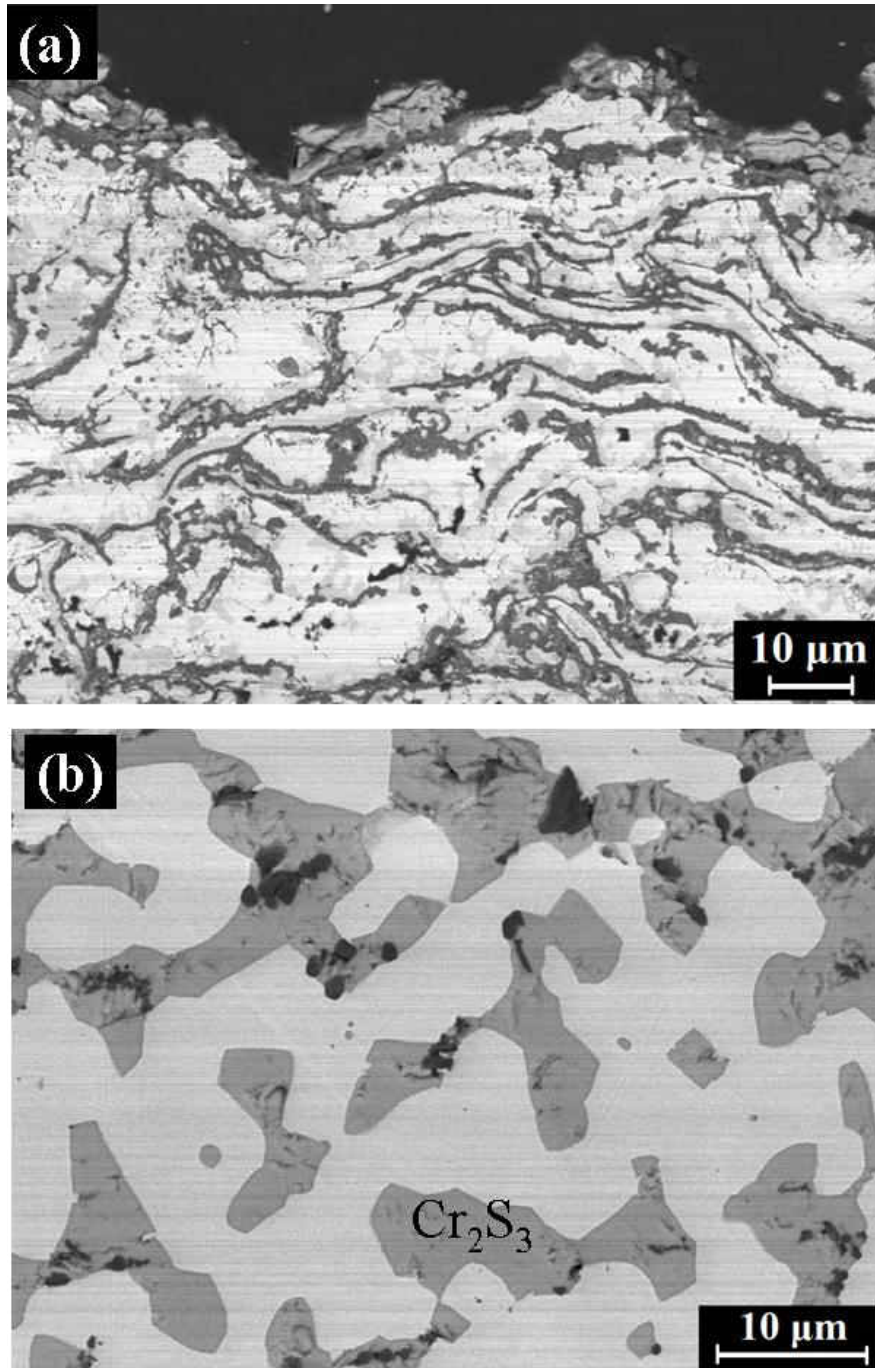
Figure 4.: Cross-sectional backscattered electron micrographs of Na_2SO_4 degraded as-sprayed APS CoNiCrAlY at 1000°C for 50 h: (a) degradation through significant internal oxidation is evident, (b) localized sulfidation resulted in formation of Cr_2S_3 within the bulk of CoNiCrAlY is observed.

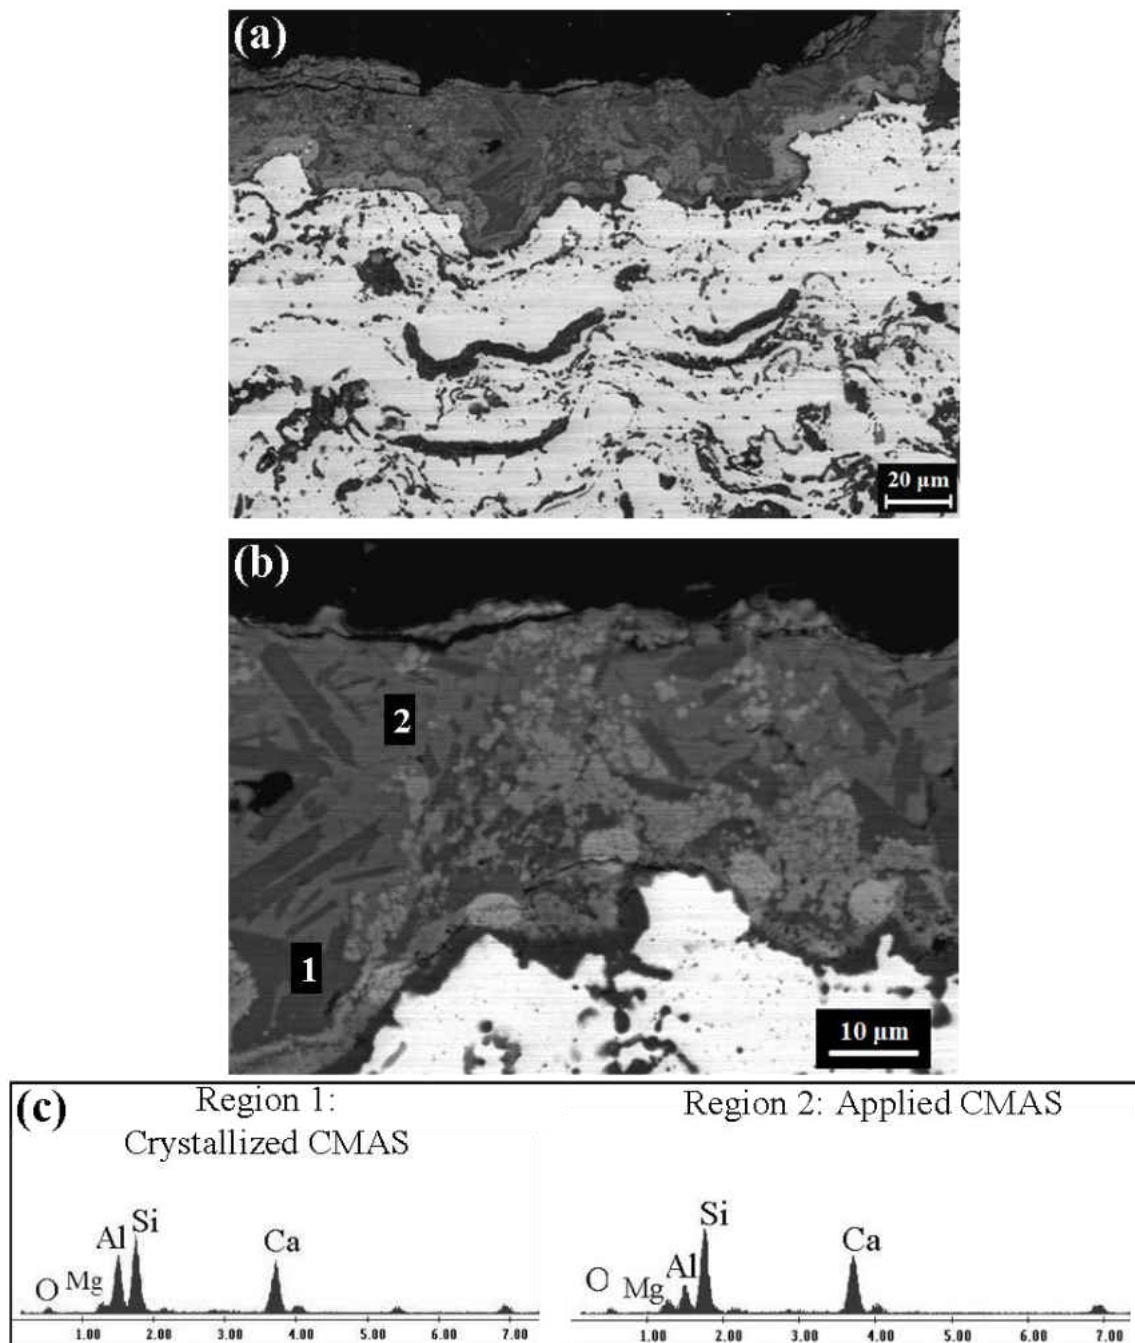
Figure 4.: (a) and (b) Cross-sectional backscattered electron micrographs of CoNiCrAlY (pre-oxidized) after degraded by CMAS deposit at 1250°C for 5 h showing microstructural evolution due to thermochemical interaction; (c) Corresponding XEDS spectra from regions of interest; region 1: crystallized CMAS, region 2: applied CMAS.

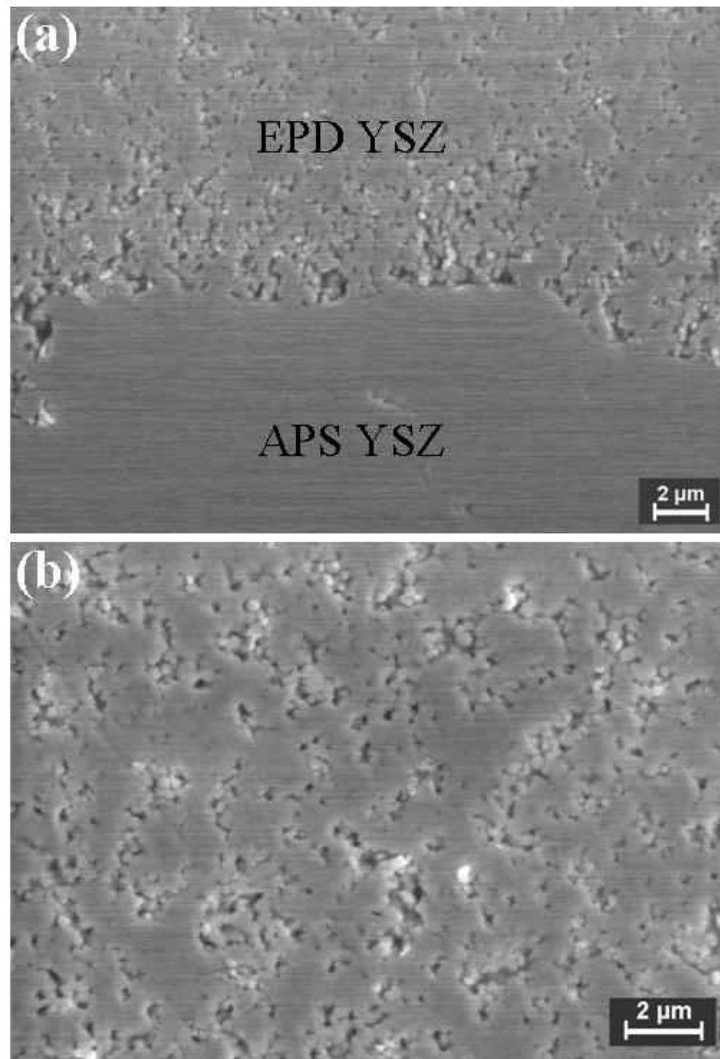
Figure 4.: Cross-sectional secondary electron micrographs showing the typical EPD overlay microstructure: (a) a continuous YSZ overlay coating fabricated by EPD followed by sintering at 1300°C for 4 h and (b) the EPD YSZ / APS YSZ coating interface.

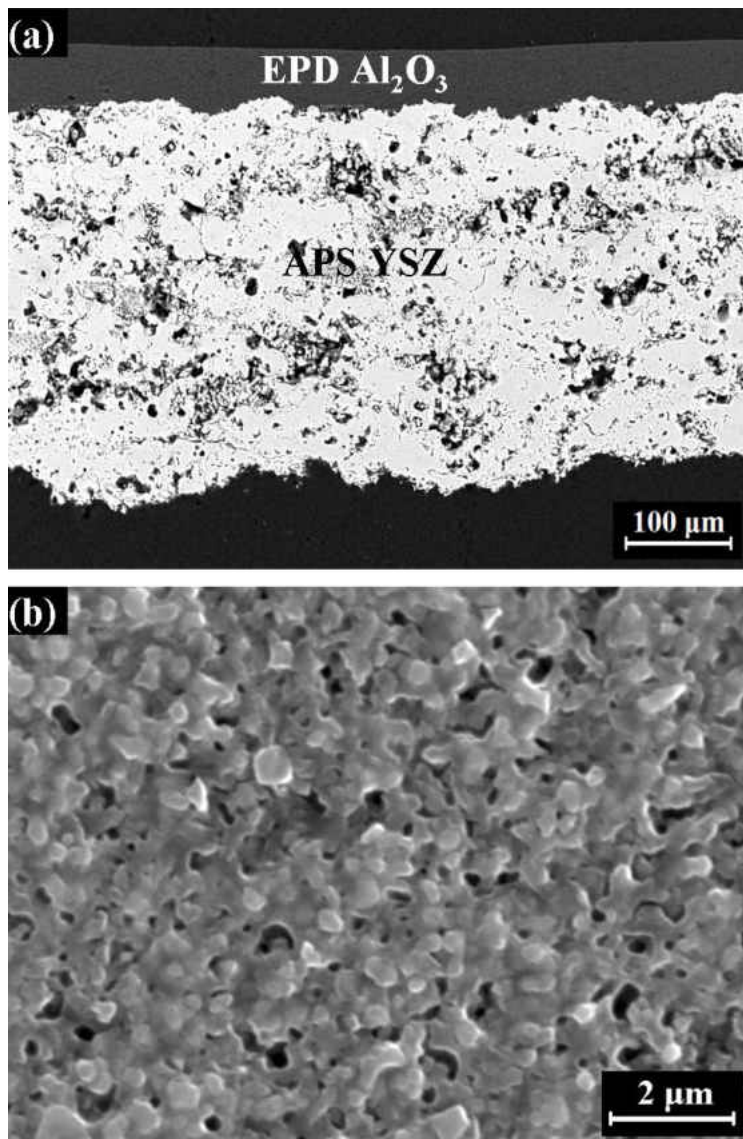
Figure 4.: Cross-sectional micrographs: (a) backscattered electron micrograph showing free-standing YSZ coatings with 60 μm thick alumina overlay achieved by EPD followed by sintering at 1200°C for 10h; (b) secondary electron micrograph showing a magnified view of cross-sectional microstructure of EPD overlay.

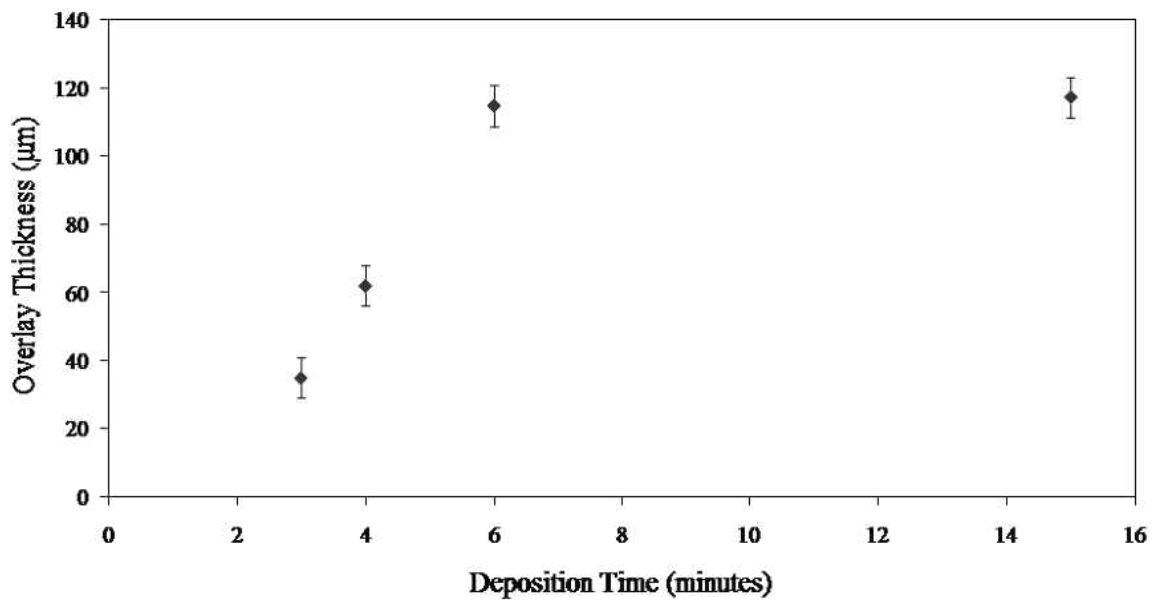
Figure 4.: Plot of sintered alumina overlay thickness vs. deposition time during EPD processing of alumina overlay for APS YSZ.

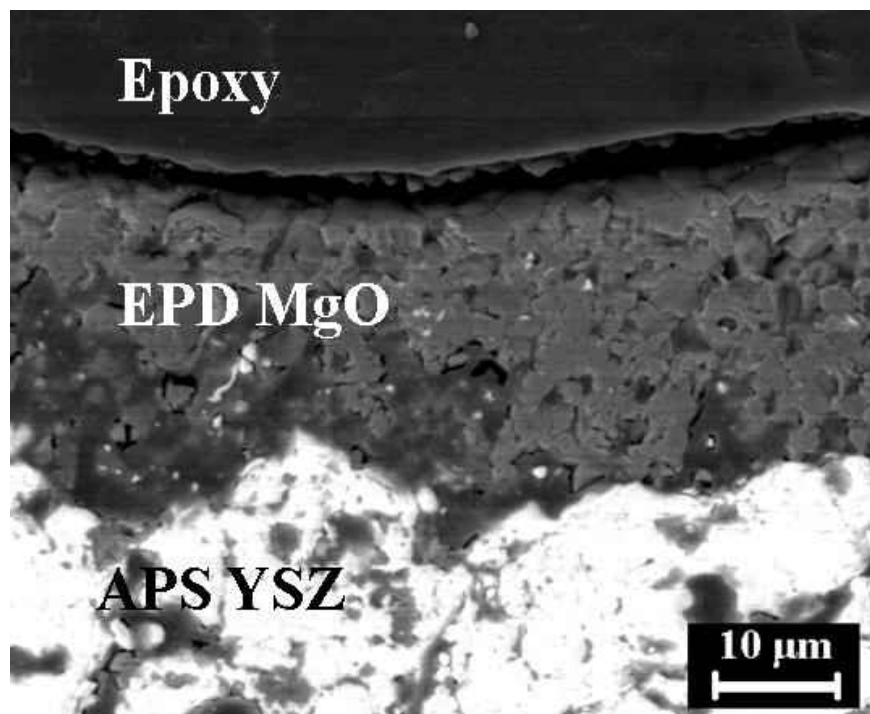
Figure 4.: Cross-sectional backscattered electron micrograph shows the 25 μm thick EPD MgO overlay on a free-standing APS YSZ specimen.
