Fiber-Reinforced Polymer (FRP) Composites in Retrofitting of Concrete Structures: Polyurethane Systems Versus Epoxy Systems

FIBER-REINFORCED POLYMER (FRP) COMPOSITES IN RETROFITTING OF
CONCRETE STRUCTURES: POLYURETHANE SYSTEMS VERSUS EPOXY SYSTEMS

A dissertation submitted in partial fulfilment of the requirements
for the degree of Doctor of Philosophy in Civil Engineering
in the Department of Civil, Environmental, and Construction Engineering
in the College of Engineering and Computer Science
at the University of Central Florida
Orlando, Florida

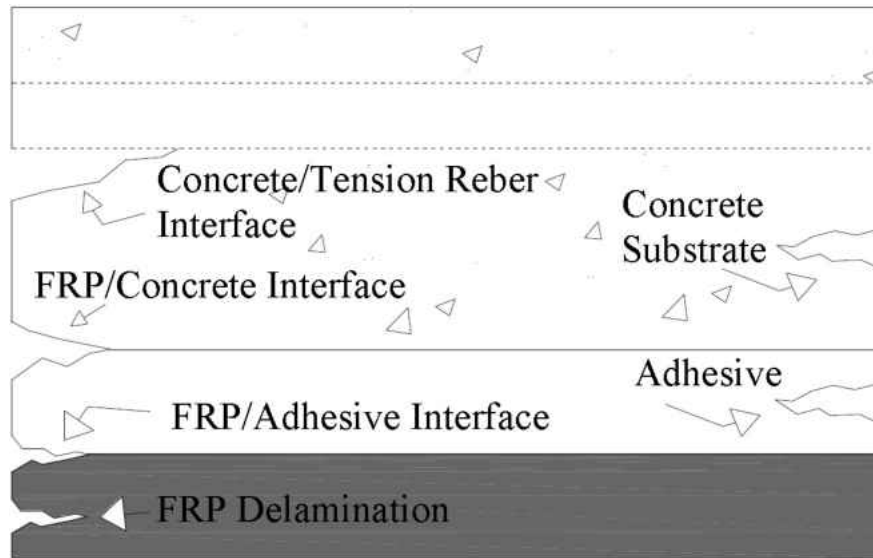
Figure 2.2: Typical Failure Modes Associated with Debonding of FRP from Concrete substrate

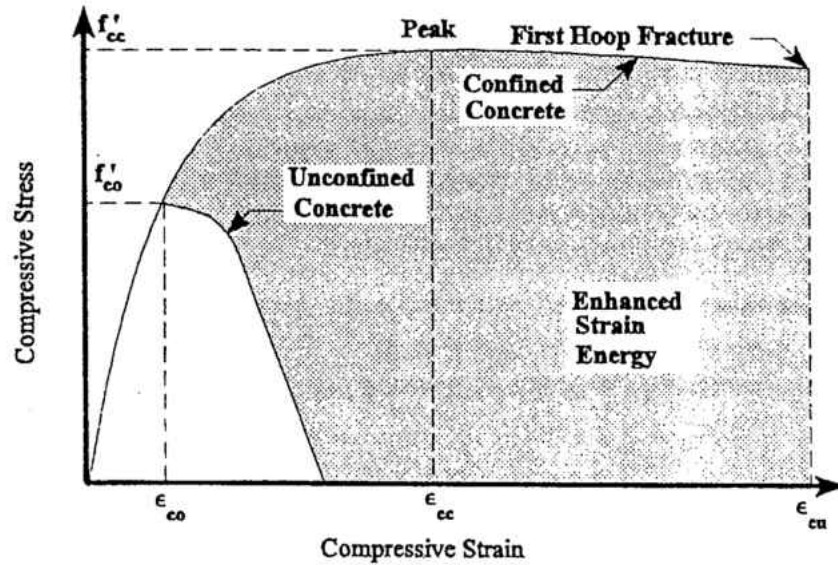
Figure 2.5: Stress-Strain Curves for confined and Unconfined Concrete

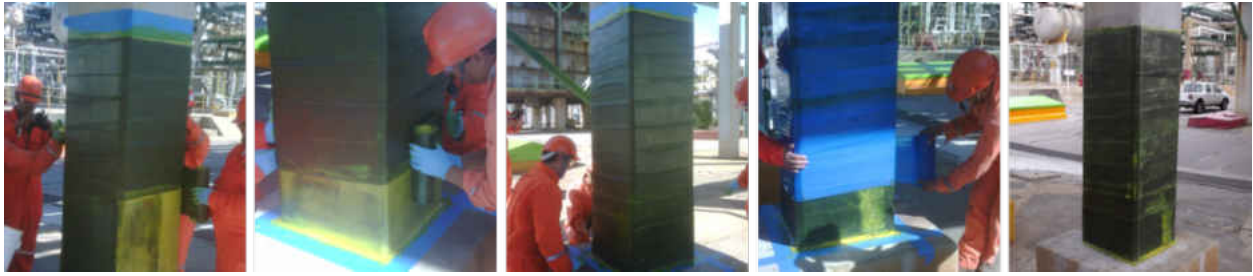
Figure 2.6: Column Wrapping with FRP (Photo Courtesy of Neptune Research, Inc Website)

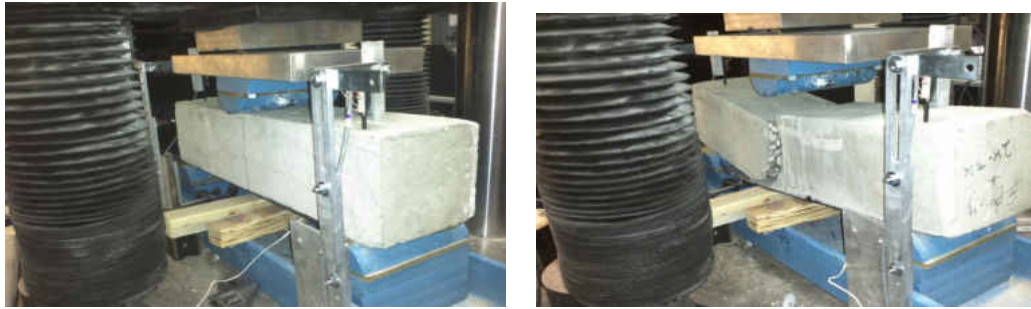
Figure 3.2: Photos from Small Scale Flexure Test

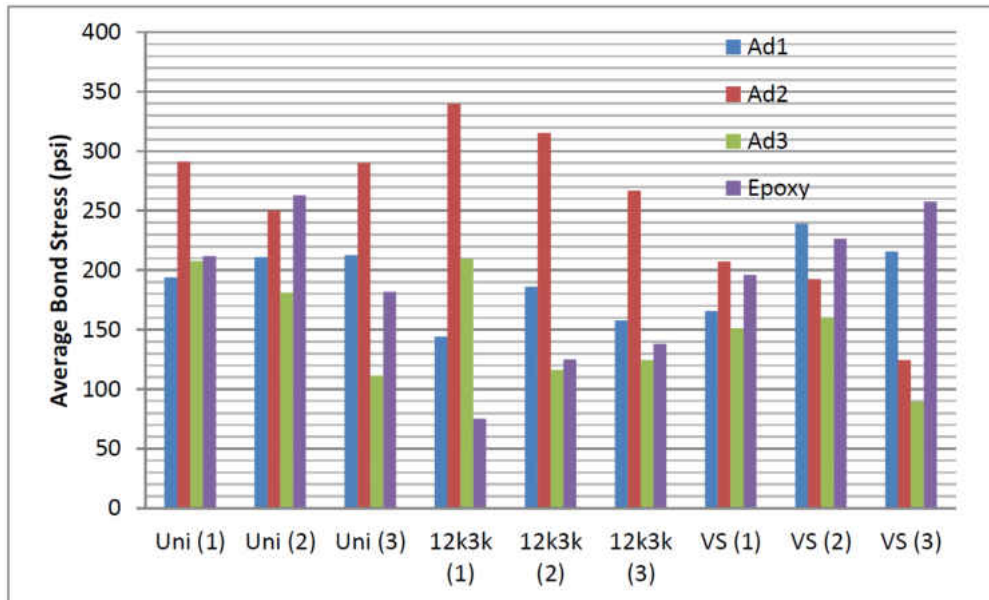
Figure 4.3: Average Shear Bond Stress at Ultimate Load from Lap Shear Experiments

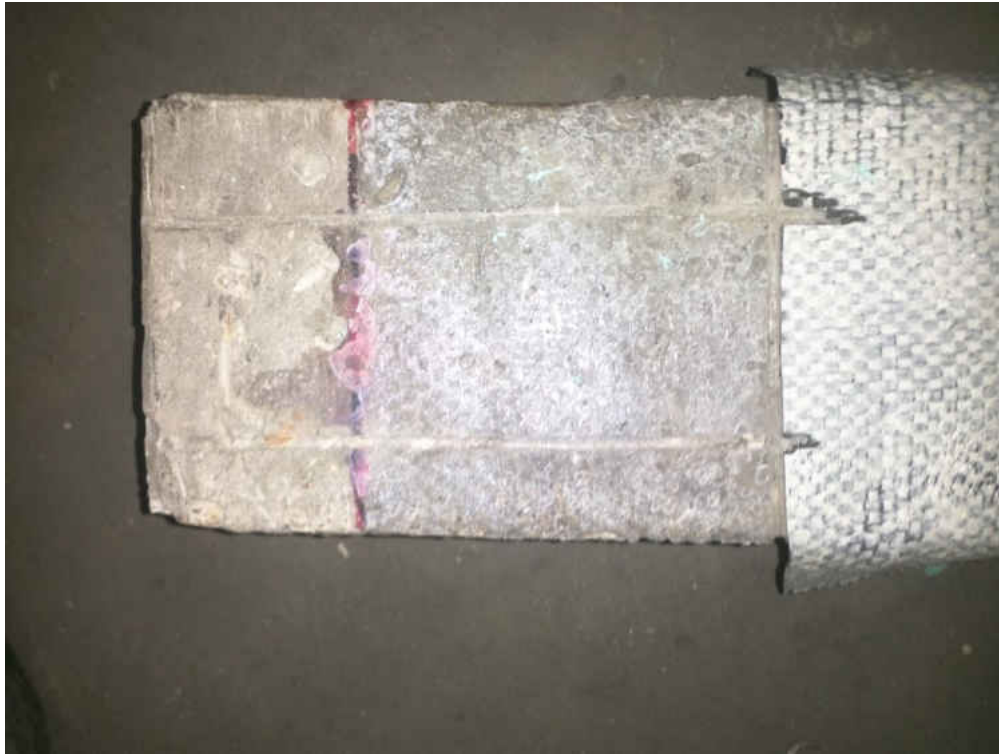
Figure 4.4: Photo of a Typical PU FRP Composite Lap Shear Failure

As mentioned previously, the polyurethane specimens all failed in the adhesive layer, as shown in figure 4.4. These types of failures are consistent with other published work [26, 13]. Of the three polyurethane primers, only Ad3 yielded inconsistent results, exhibited both in the average bond

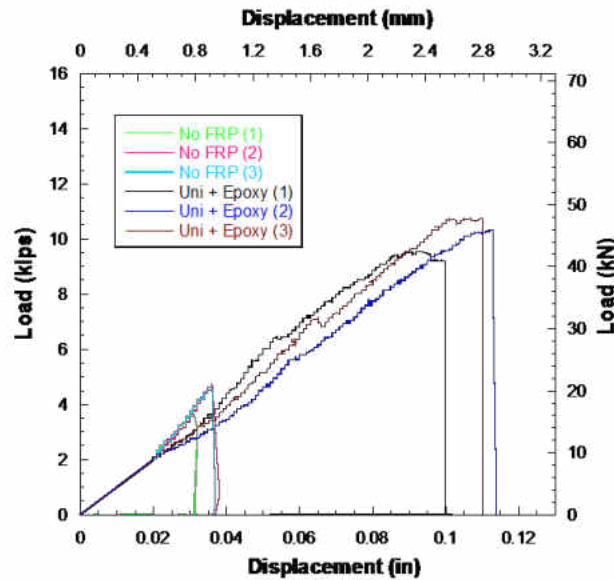
Figure 4.7: Load Versus Displacement for Epoxy Uni Compared with Unreinforced Beams

The results of the load versus displacement of polyurethane Uni + Ad1 and epoxy Uni FRP-reinforced beams are presented in figure 4.6 and figure 4.7, respectively, consistent with the systems presented from the lap shear testing. These two figures show the behavior of the strengthened beams for each composite system compared with the non FRP-reinforced control beams. The strengthened beam response followed a characteristic progression of initial concrete cracking (small drop in load) after the elastic region, post-cracking stiffness representative of the contribution of the bond between concrete and the laminate, and an ultimate load governed by debonding failure of the laminate. Due to the presence of the saw cut at the center of the beam and the three-

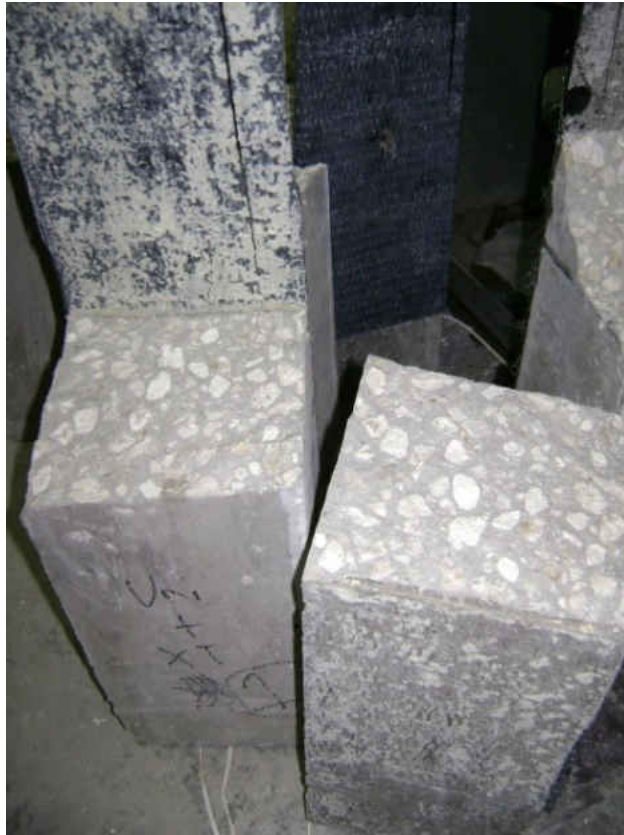
Figure 4.8: Polyurethane Uni + Ad1 De-bonding in Adhesive Layer

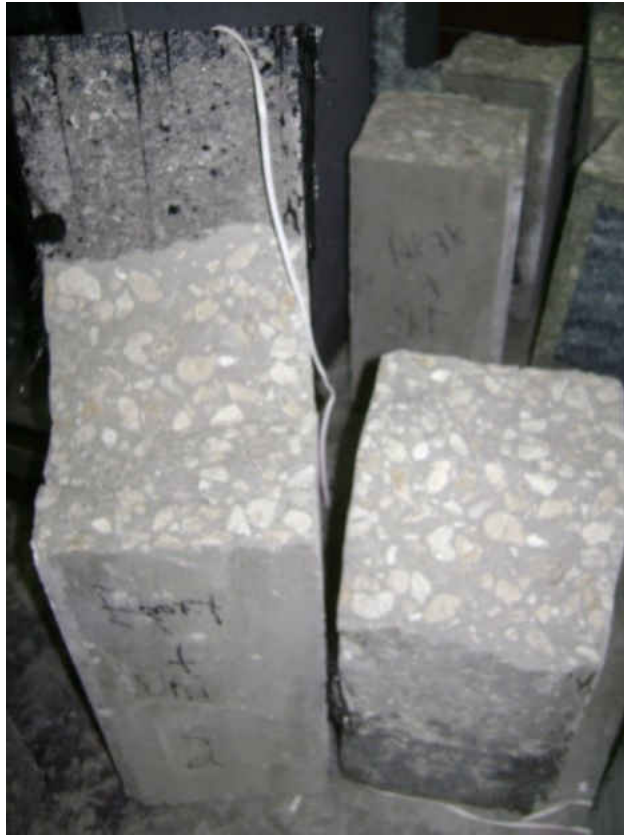
Figure 4.9: Epoxy Uni De-bonding in Substrate Layer plus Mixed mode Failure in Concrete

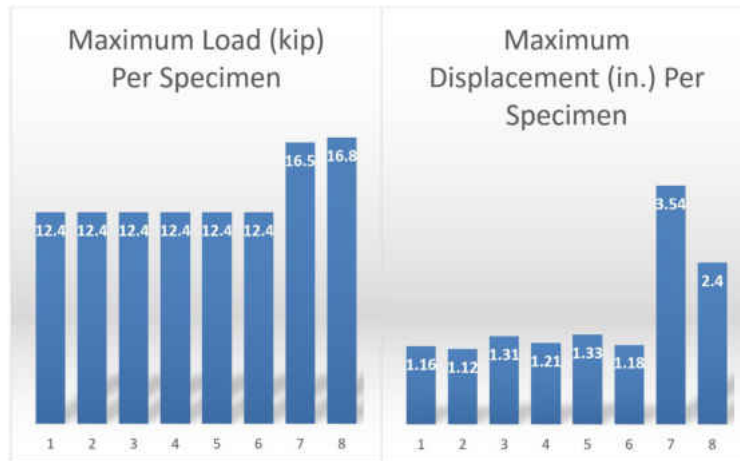
Figure 4.13: Girders Control: Load vs. Displacement

Based on the results obtained from the control, the damage phase loading protocol was generated for the remaining 8 girders. The loading protocol is shown in figure 4.12. The loading protocol is based on the ICC AC 125 sinusoidal loading protocol [1] but altered in order to prevent subjecting the bottom beam (which would be FRP-retrofitted) to compression. The maximum load and displacement levels achieved during the damage phase are shown in figure 4.13.

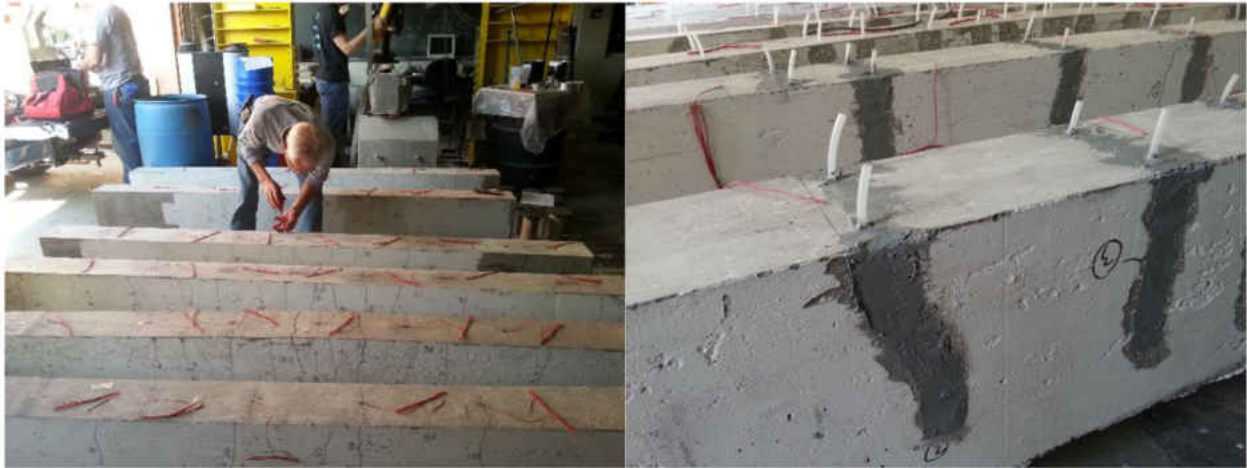
Figure 4.14: Epoxy Injection of Cracks in Girders After Damage Phase

The cracks in all 8 beams were epoxy-injected by Vector, a specialty concrete restoration group before FRP was applied. Photos from the epoxy-injection procedure are shown in figure 4.14. After the epoxy injection was performed and prior to applying the CFRP laminate, the tension face of each beam was prepared for FRP installation by grinding the surface to expose the aggregate

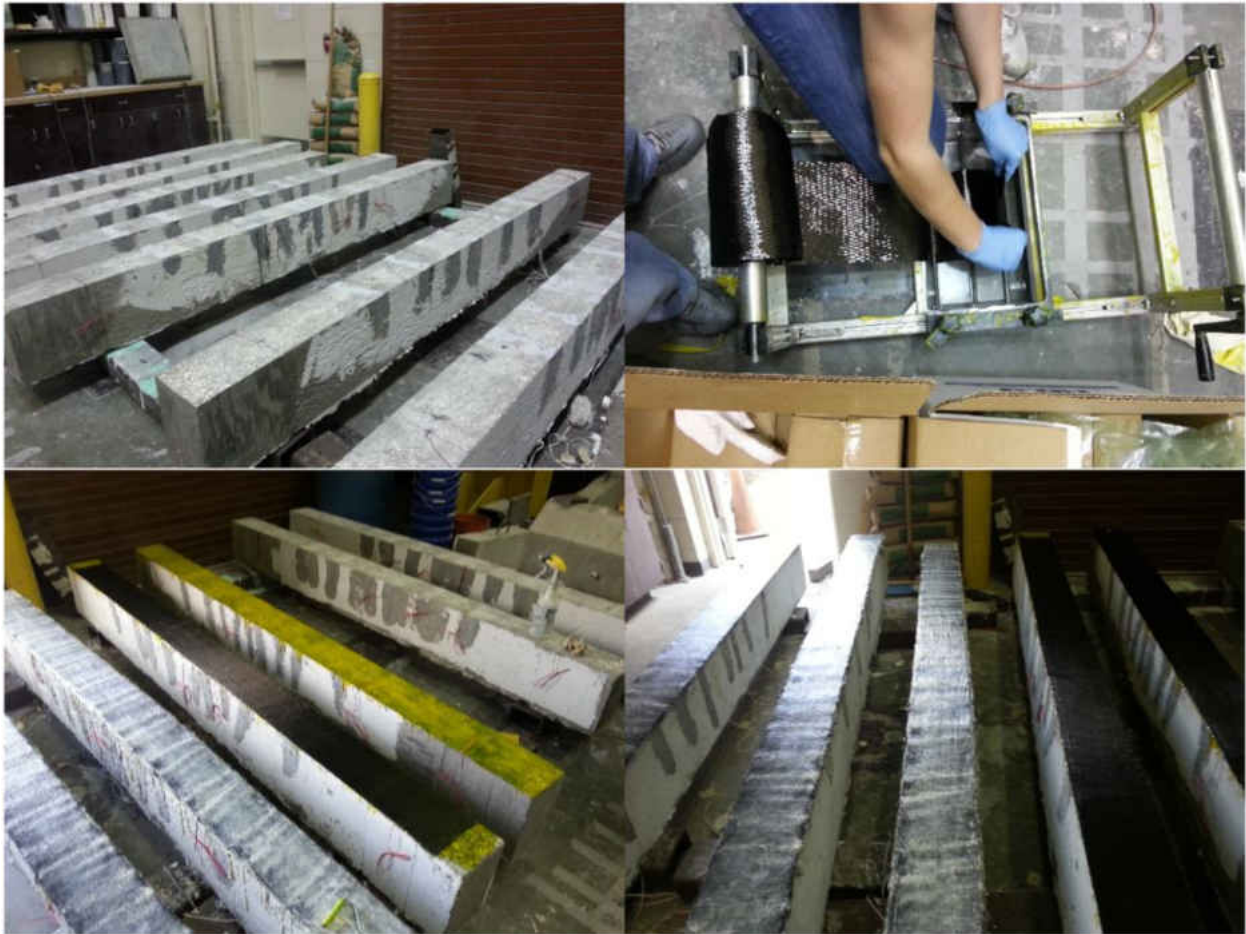
Figure 4.15: FRP Repair Photos of Girders After Damage Phase and Epoxy Injection of Cracks

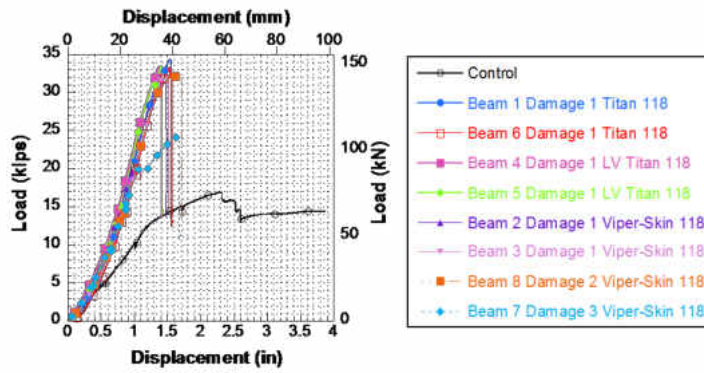
Figure 4.16: Load vs. Displacement Behavior of Repaired Girders Plots Shown alongside the Control Girder

The results of the girder tests revealed that the overall behavior of the strengthened girders was different from the control girder. FRP strengthening allowed the moment capacity of all girders to be increased by 1.3 times compared to the control girder. The total deflections at failure and stiffness for all specimens were similar at failure also revealed that the retrofitting was done without compromising the ductility and serviceability of the girders. The stiffness of the girders was increased

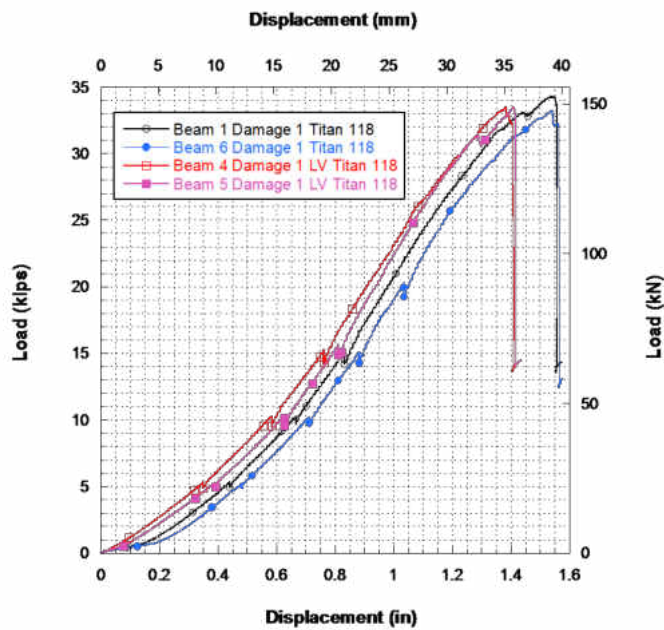
Figure 4.17: Load vs. Displacement for Epoxy-FRP-System Retrofitted Girders

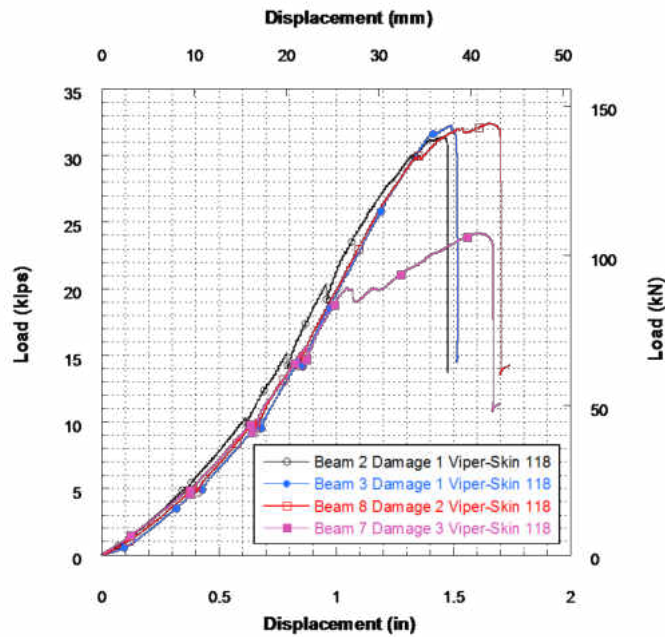
Figure 4.18: Load vs. Displacement for Polyurethane-FRP-System Retrofitted Girders

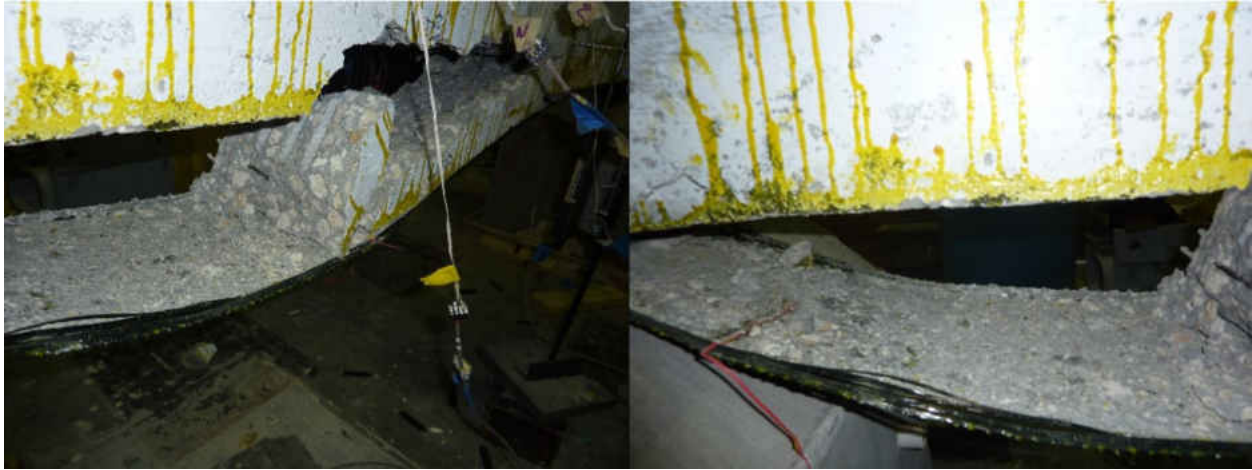
Figure 4.19: Typical Epoxy Retrofit Failure: Debonding in Concrete-adhesive layer

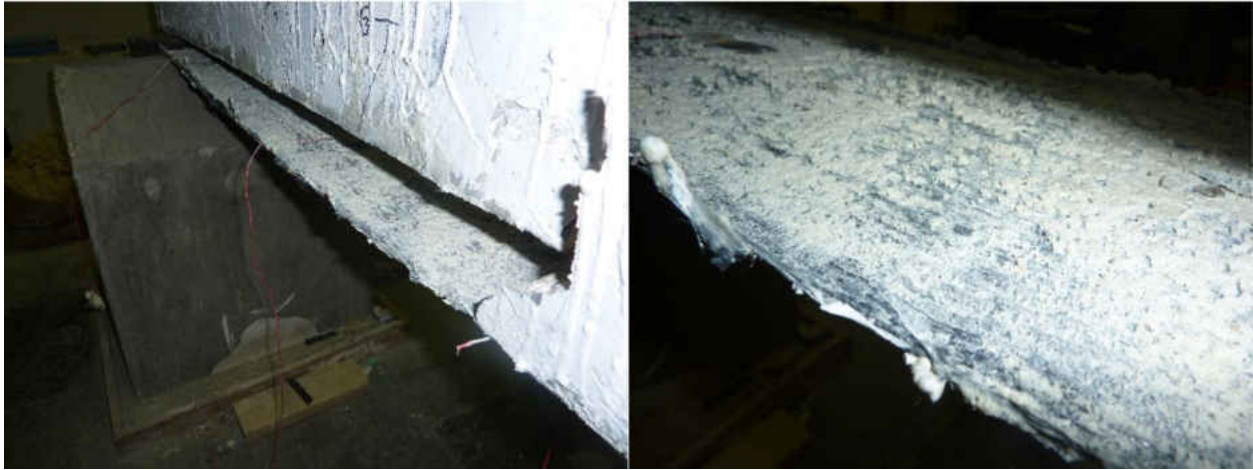
Figure 4.20: Typical Polyurethane Retrofit Failure: Debonding in Adhesive Layer

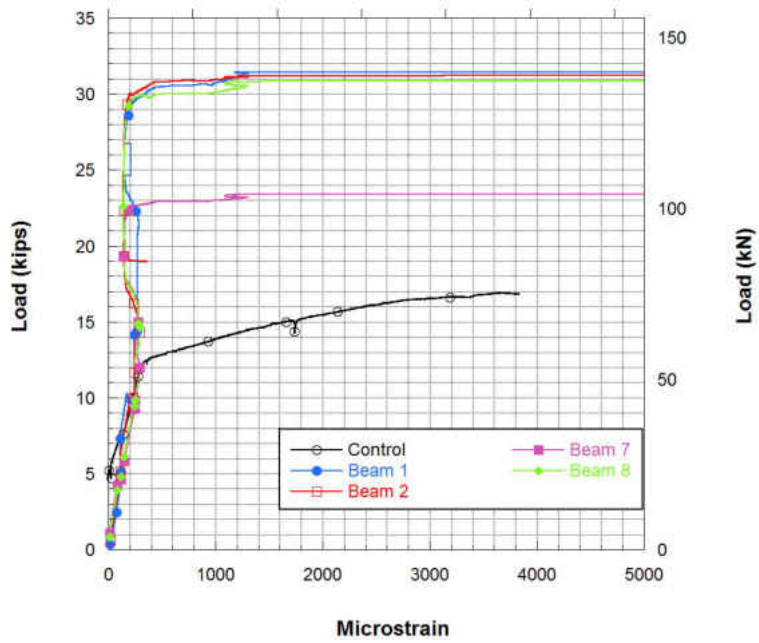
Figure 4.21: Applied Load vs Strain in Bottom Reinforcing Bar in Girders

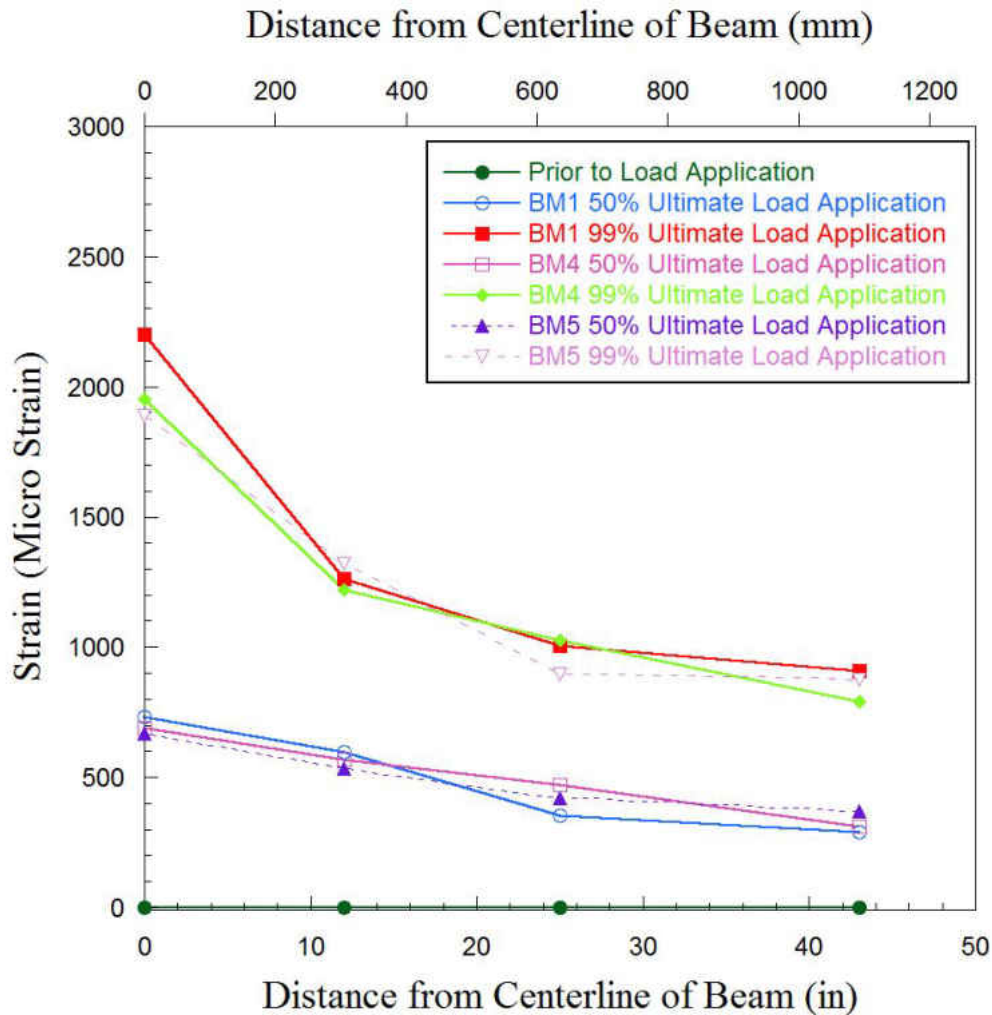
Figure 4.22: Strain Distribution along Beam vs. Applied Load for Epoxy-Retrofitted Girders

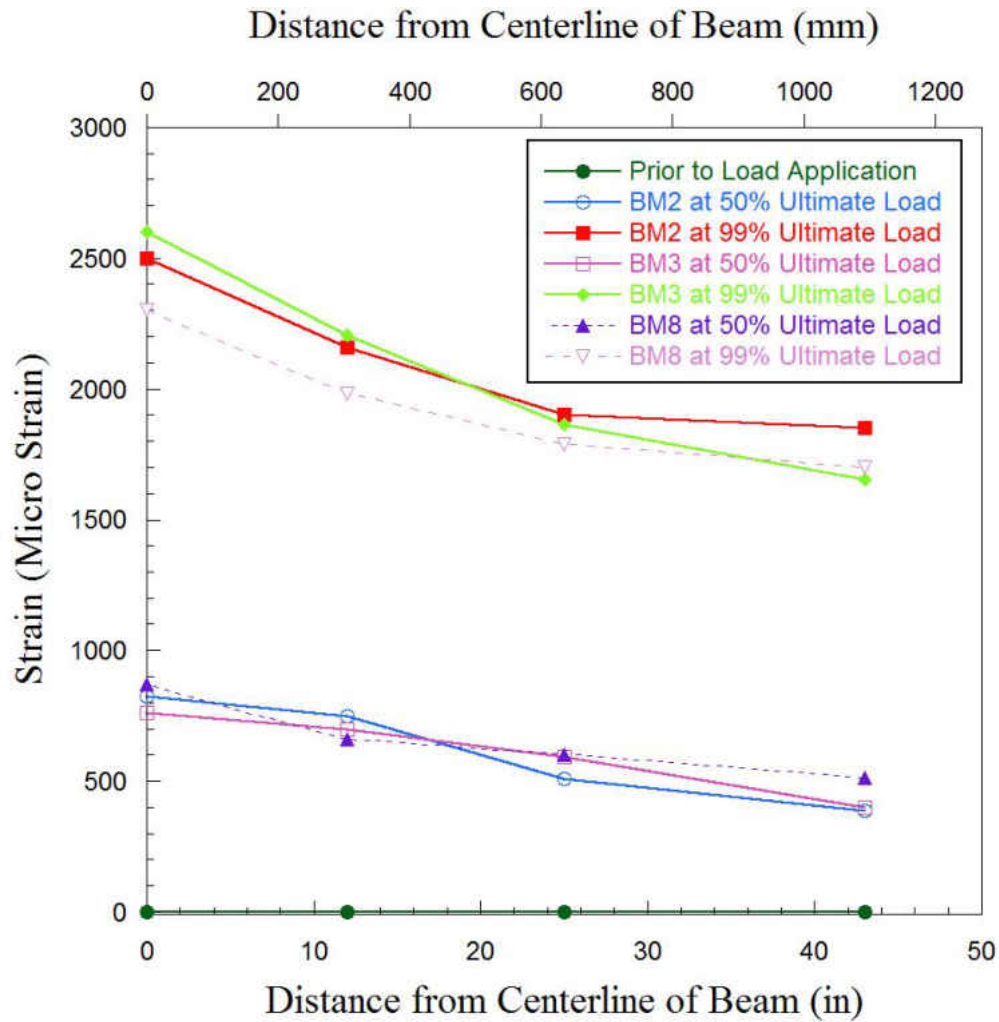
Figure 4.23: Strain Distribution along Beam vs. Applied Load for Polyurethane-Retrofitted Girders

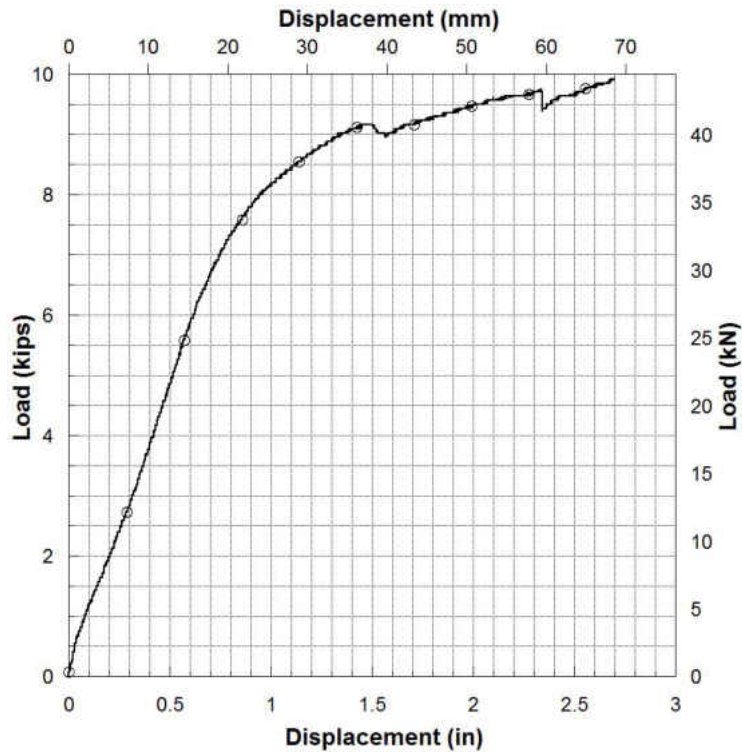
Figure 4.24: Load vs. Displacement for Column Control without Axial Load

The control column that was damaged without the axial load damaged to maximum applied displacement of 2.7 in at the tip of the column and a maximum applied moment of 9.9 kip-ft. The global yielding of the column occurred at a load of 7 kips at and at a displacement of 0.7 in. The column that was loaded axially reached maximum load of 16 kips at a displacement of 0.7 in. The global yielding occurred at 0.1 in and an applied load of 10 kips. A maximum displacement of

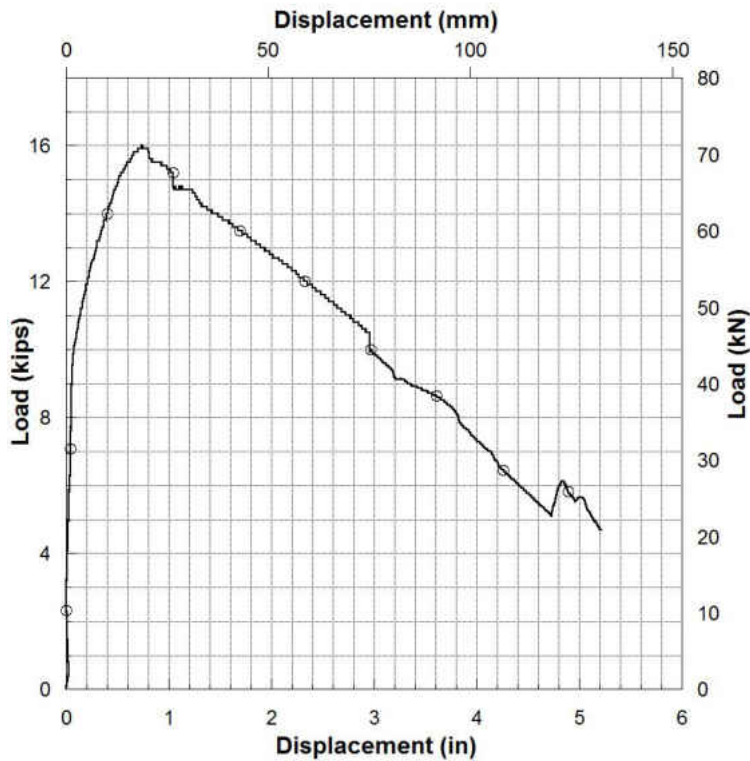
Figure 4.25: Load vs. Displacement for Column Control with 40 kips Axial Load

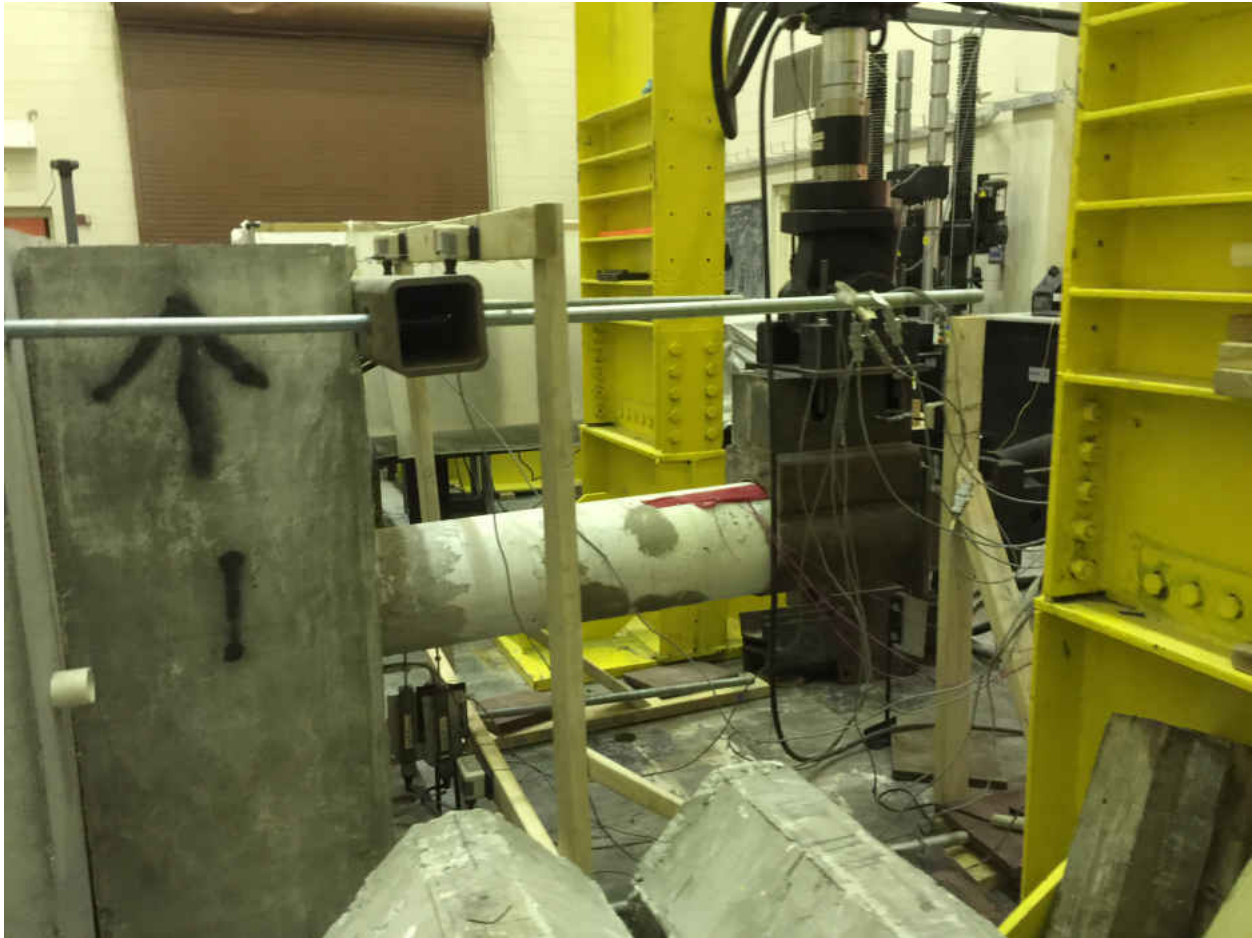
Figure 4.26: Column Setup Photo

The column setup is shown in figure 3.12. The concrete footing was attached to a reaction block (Reaction Block 2) using four 1" diameter post-tensioned rods. One MTS Actuator was attached to the second reaction block using four 1" diameter post-tensioned rods. This actuator applied

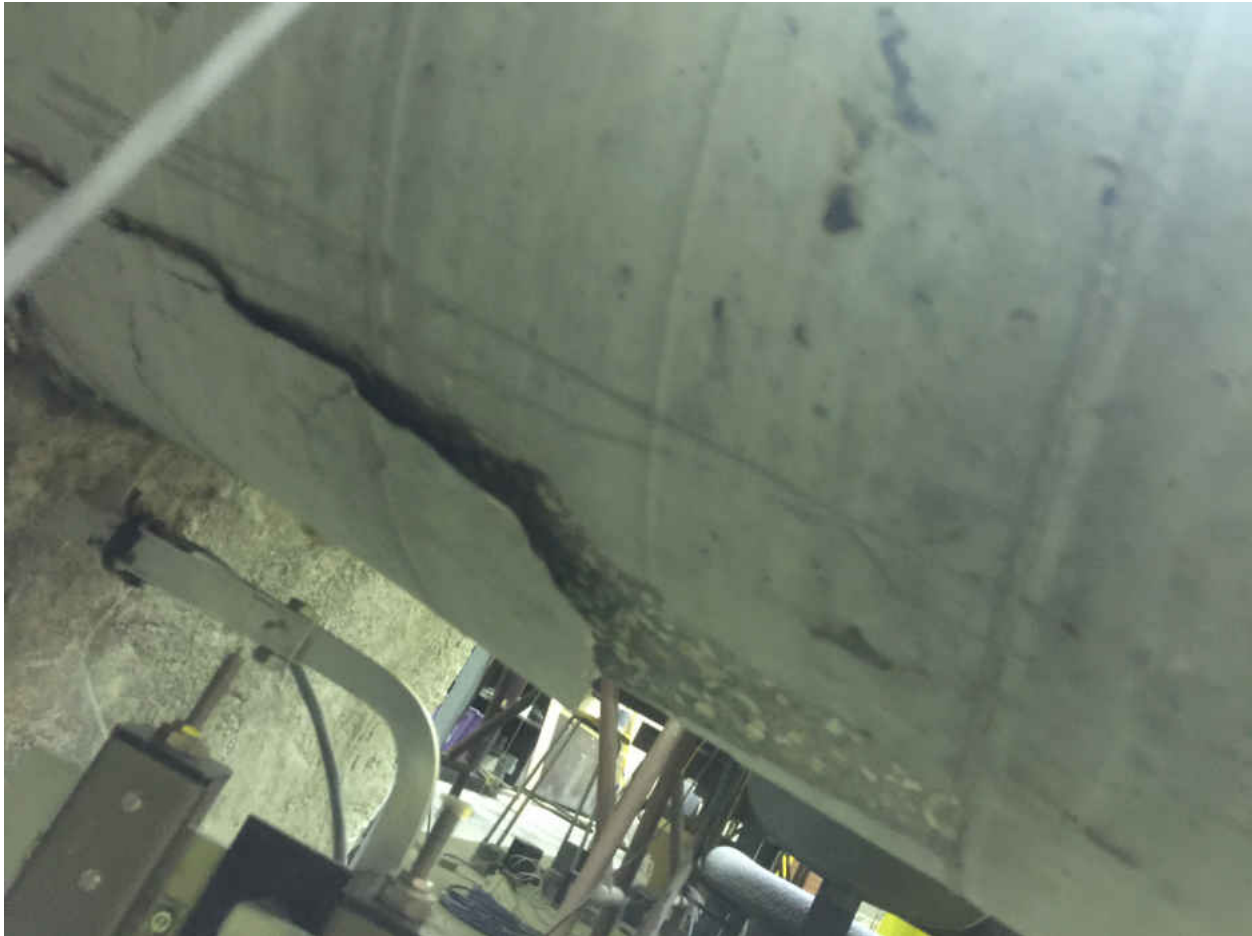
Figure 4.27: Photo of Control Column without Axial Load Application Failure

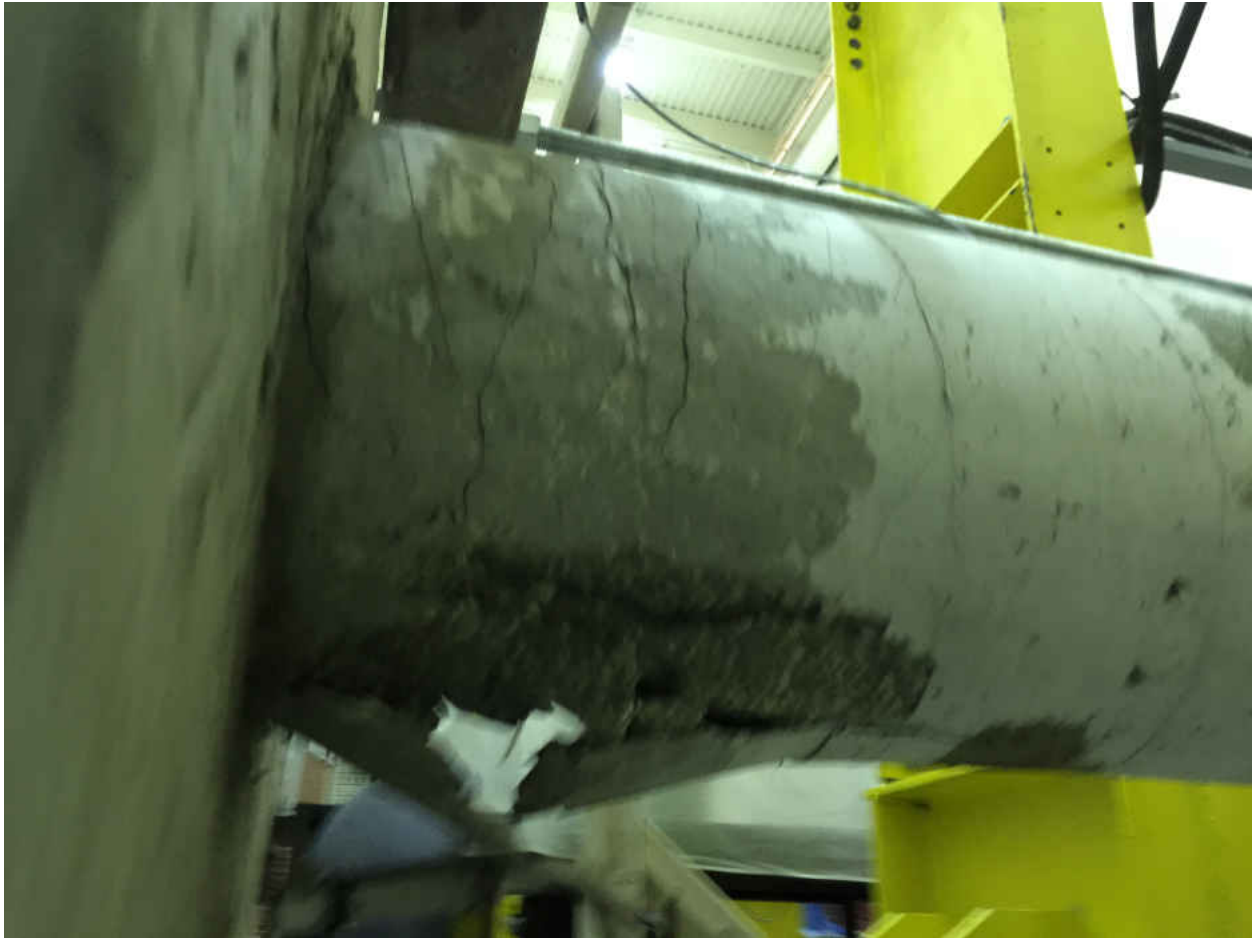
Figure 4.28: Photo of Control Column with Axial Load Application Failure

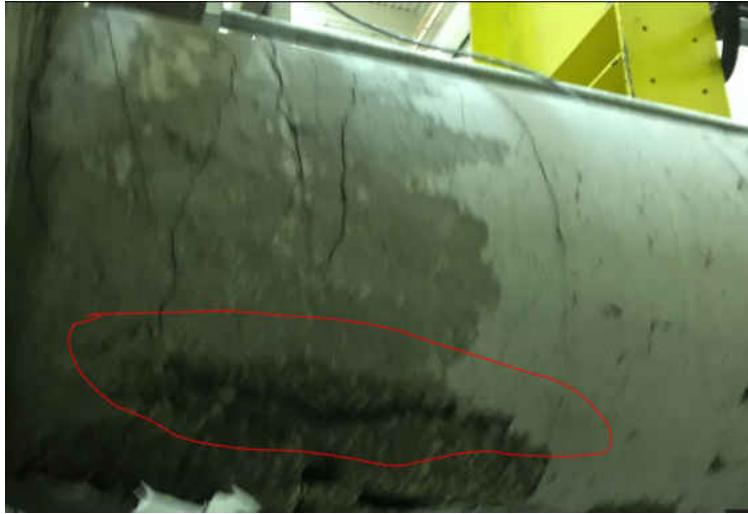
Figure 4.34: Photo Showing Longitudinal Reinforcing Bar Buckling from the Damage Phase

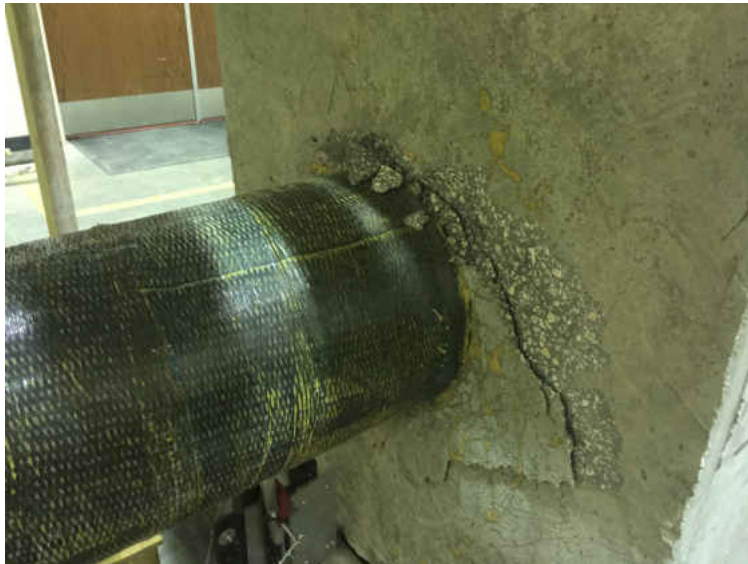
Figure 4.38: Post-Repair Typical Column Failure

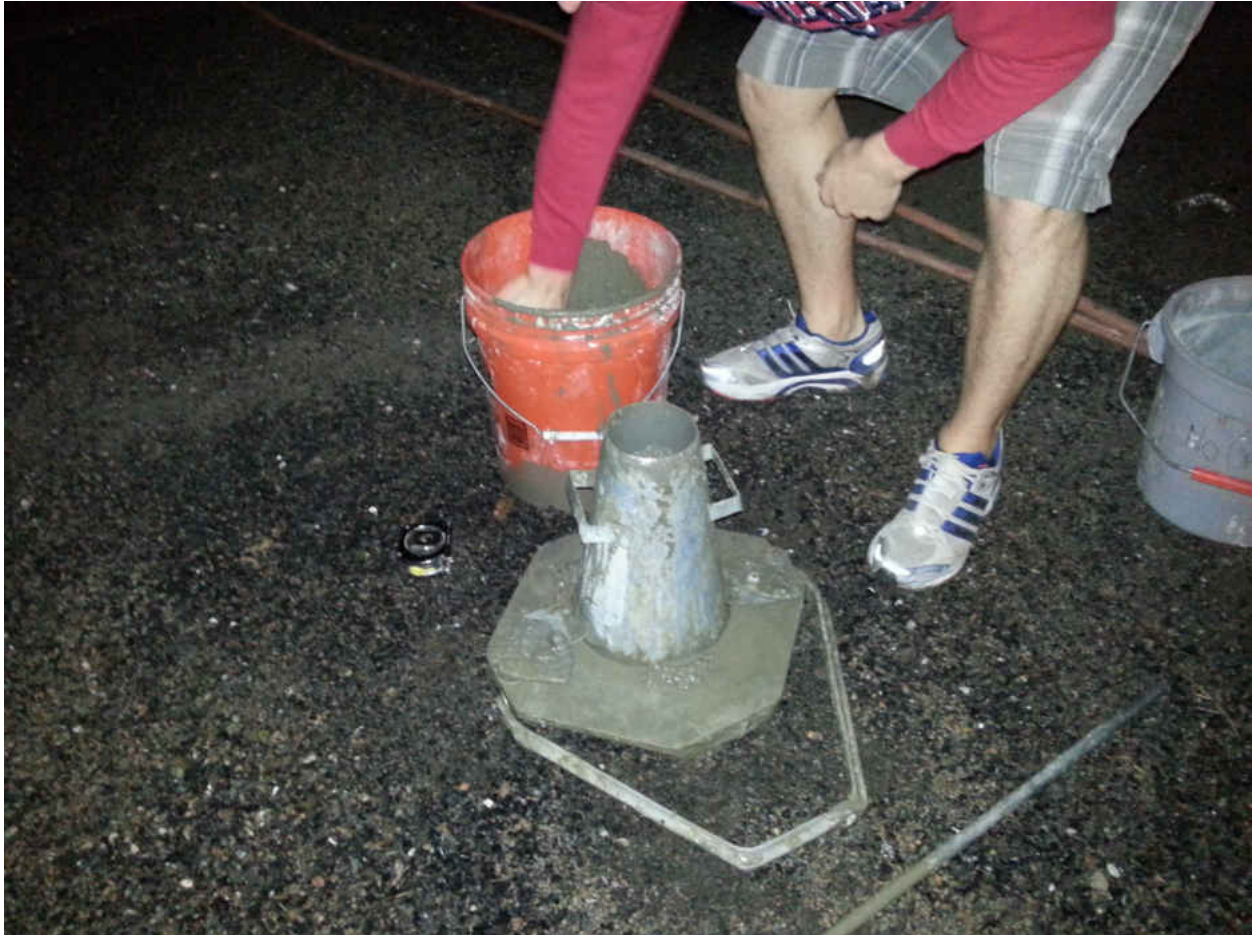
Figure C.8: Slump Test from Column Pour
