Sinkhole Analysis and Classification Using Pictometry in Genesee County, NY and Surrounding Areas

A Thesis

in Fulfillment for the
Degree of Master of Science

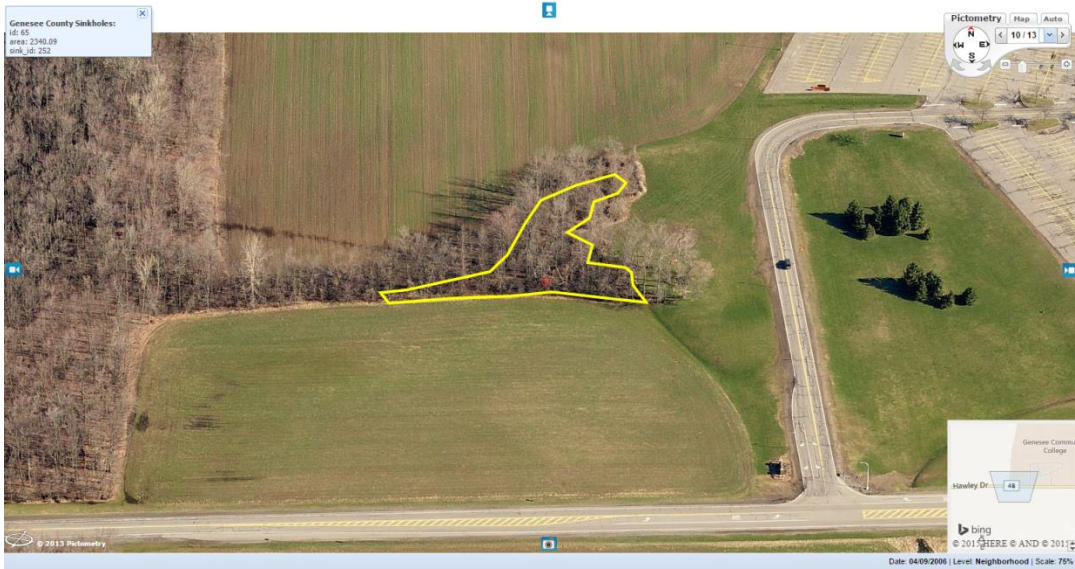
Figure 2a. A dry period time-step for Sinkhole #65 located on the campus of Genesee Community College in Batavia, NY. Although a drier period, some water is still evident flowing into the feature from the west.

The representative sinkhole for Cluster #1 is Sinkhole 65, located on Hawley Dr. on the campus of Genesee Community College in Batavia, NY. #65 was not an evident sinkhole in Pictometry, even with contours enabled, unless a snowmelt event was noted during the time series (Figures 2a & 2b). In dry time-steps, this sinkhole appears to be a stand of trees in the middle of a field. During presumed snowmelt time-steps, this feature becomes the center of water flow from at least three surrounding directions,

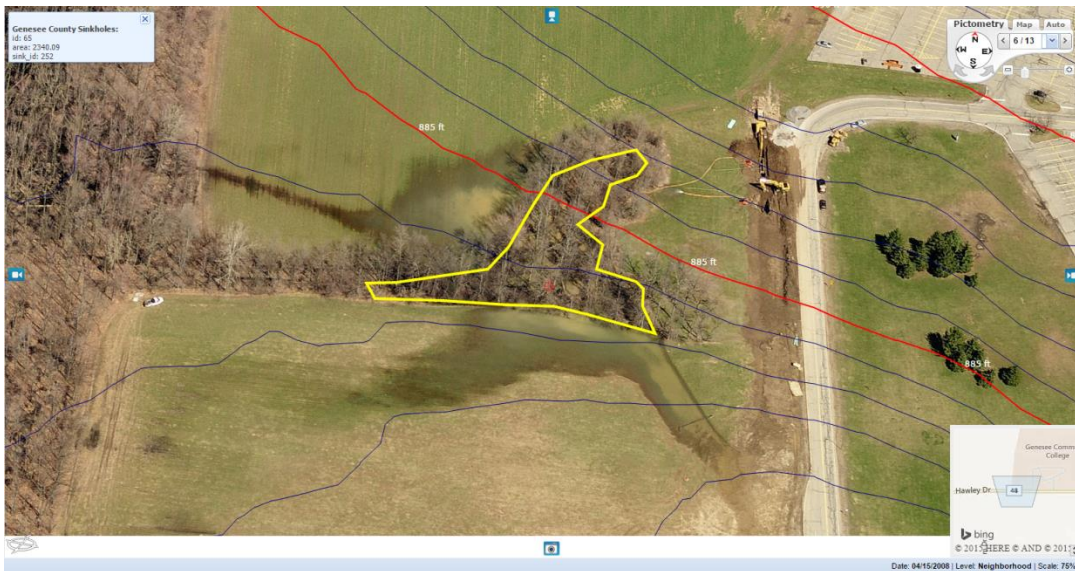
Figure 2b. A wet period time-step for Sinkhole #65 located on the campus of Genesee Community College in Batavia, NY. Water flows are evident coming in from both the west and from the south-east. Due to the amount of water and the time of year, this is a presumed snowmelt event. Of note here is that this sinkhole crosses contour boundaries; this suggests that the micro-topography represented by these contours was not accurate at the time of this map's creation.

with water inundating the tree stand and ponding up all around it. Pictometry contours appear to be a problem on this site, with a gradient from the northeast to the southwest; this gradient crosses over the sinkhole feature with a 6-7 ft change in elevation from one side of the feature to the other. Mapping the moisture boundaries for the ponding that takes place, it becomes apparent that the contours are mapped wrong on this small scale feature since they cross the assumed constant height of the water surface. This becomes one of the rare cases where mis-mapped contours can become a deterrent to finding depressions (and thus potential sinkholes) using Pictometry.

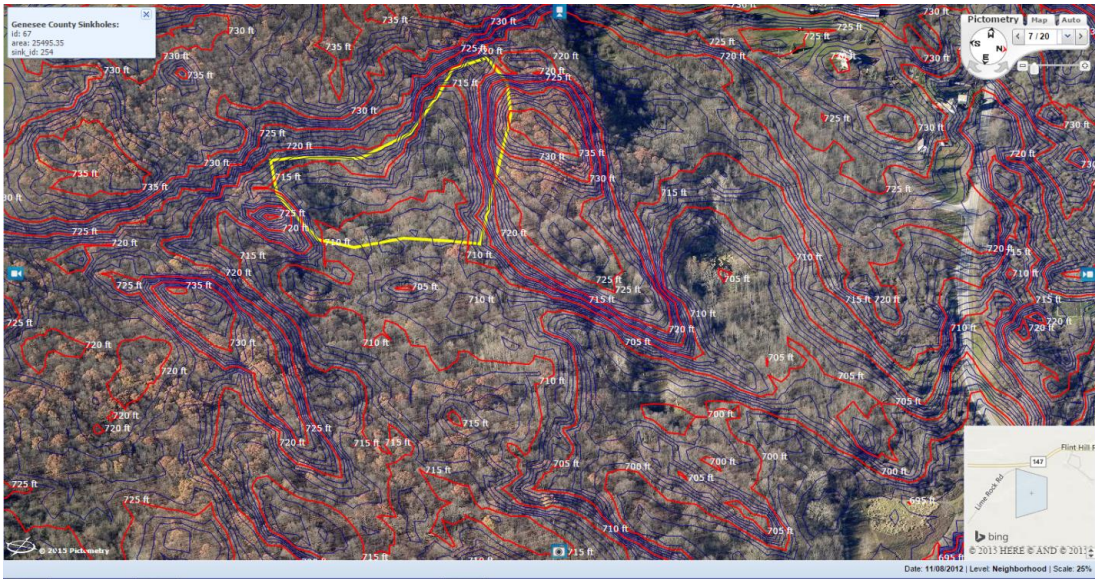
Figure 3a. Sinkhole #67 lies in a significant depression, although only falls in part of it. The sinkhole boundary crosses several contours over an elevation change of 20+ feet; this is either an error in the contour mapping or an error in the sinkhole mapping from prior studies. View from east.

The representative sinkhole for Cluster #2 is Sinkhole 67, located off of Lime Rock Rd. in Mumford, NY, just over one kilometer outside of Genesee County. #67 is generally not evident in Pictometry, due to being covered with trees; however, a couple dips in canopy height can be observed in the feature. These dips, however, are also seen in the surrounding, non-sinkhole area and thus cannot be considered a solid visual indicator of a sinkhole. With contours enabled on this site (Figure 3a), it does become evident that this site lies in part of a significant depression in the landscape. The western edge of the sinkhole feature appears to cross over 20+ feet in elevation; this is either an error in sinkhole mapping or an error in contour creation. In some spring time-steps (Figure 3b), this site appears to have some dark spots in it; whether this is shadow, moisture/water, or something else is un-determined. If it is water (likely due to a snowmelt in this case), it is a piece of visual evidence that a sinkhole (or at least a depression) is present in this site, beyond just the contour analysis.

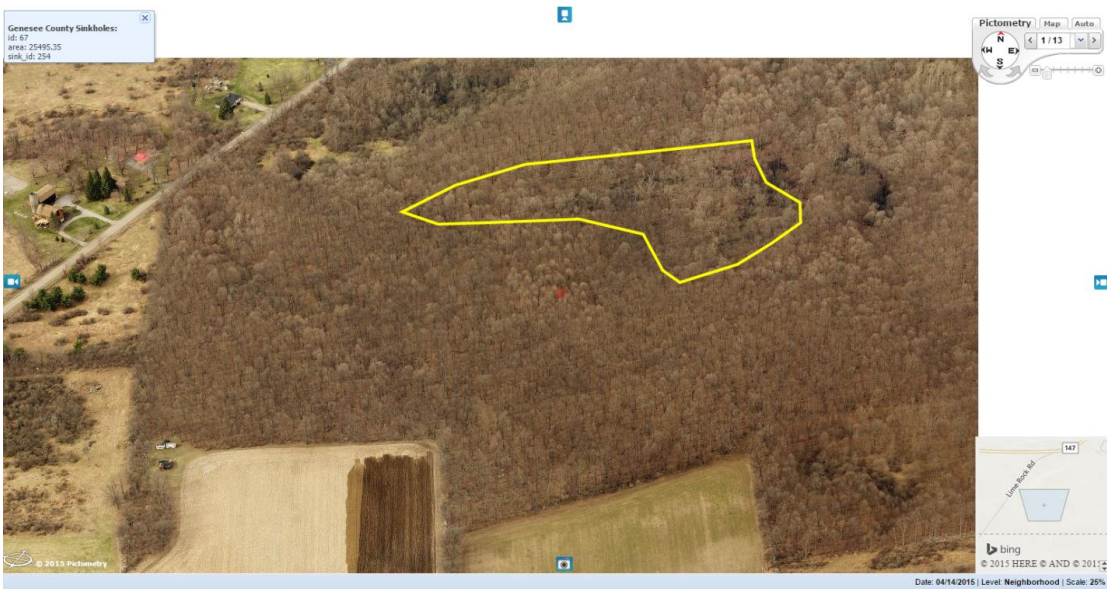
Figure 3b. A mostly dry time-step for Sinkhole #67. This time-step does show some anomalies in the far eastern reaches of the feature. These are dark regions that could be caused by a number of things – shadows, moisture/water, or darkened soils. This is one of the micro-features that are tough to discern in Pictometry.

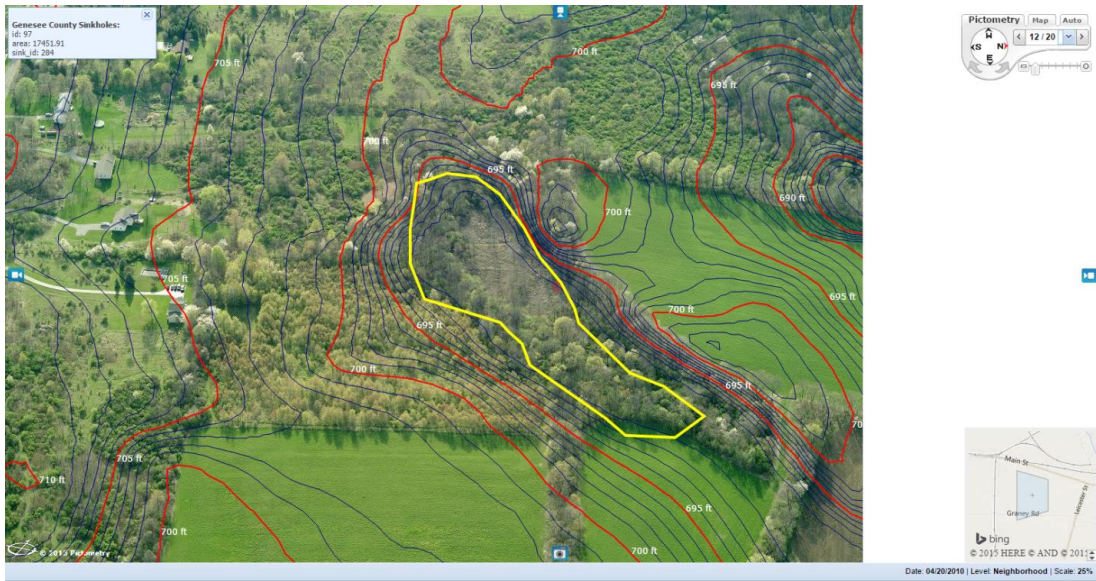
Figure 4a. This is dry-period time-step of Sinkhole #97 in Caledonia, NY. This feature is a very evident sinkhole feature, lying nicely within the contours. It appears to be a dry pond basin, possibly a vernal pool that refills with snowmelt. View from the east.

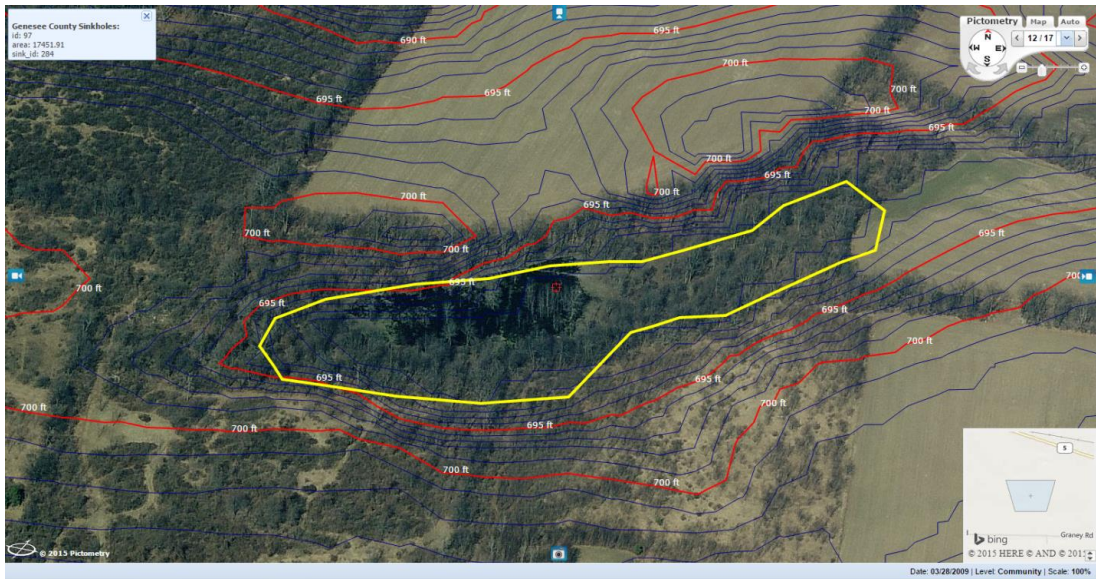
Figure 4b. A wet-period time-step for Sinkhole #97. This shows the pond basin filled with water from a likely snowmelt event. This time-step further enhances the probability that this is a vernal pool sinkhole.

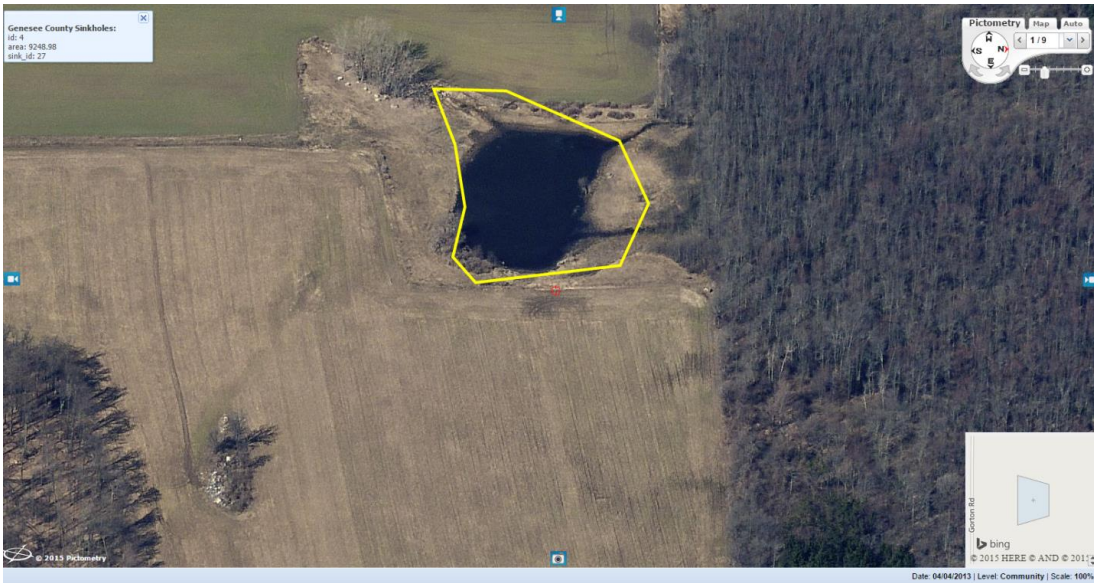
Figure 5a. Sinkhole #4 in Corfu, NY. Two pond outlets located on right side of pond (north). Small temporary inlet is present coming out of the rock spoil pile to the west (top) of the image. This inlet feature is not present in all time-steps of Pictometry. View from east.

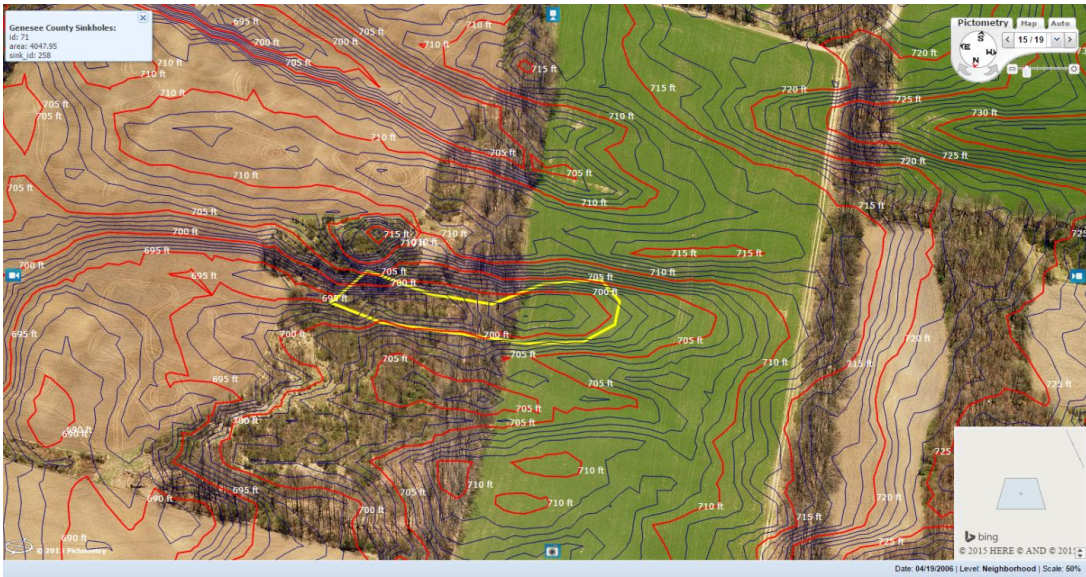
Figure 7a. Sinkhole #71 in Caledonia, NY. Pictometry with contours denoting two ridges parallel to the long axis of the sinkhole within the farm field portion of the feature. This smooth, small-sized feature is a funnel for the upslope farm field runoff. View from north.

The representative sinkhole for this cluster is Sinkhole #71, roughly 750 meters north of Rt 5. in Caledonia, NY in Livingston County. In Figure 7a from Pictometry, ridges within the field, parallel to the long axis of the sinkhole, are evident - noted by

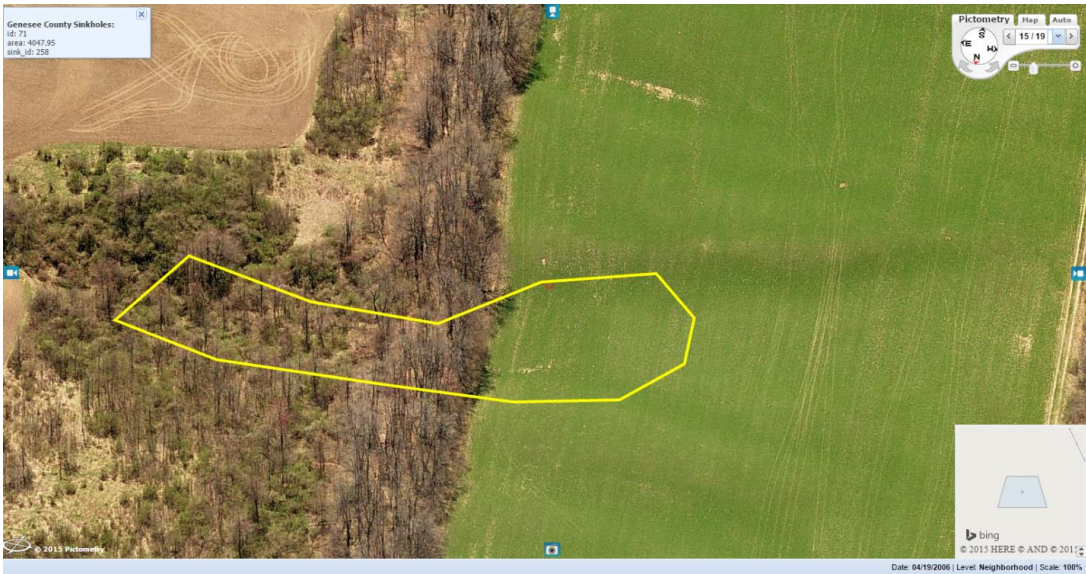
Figure 7b. Sinkhole #71 Pictometry view from north; zoomed in to show boulders and sub angular rocks scattered through the farm field. These sub-angular rocks are indicative of shallow depth-to-bedrock and karstic terrain.

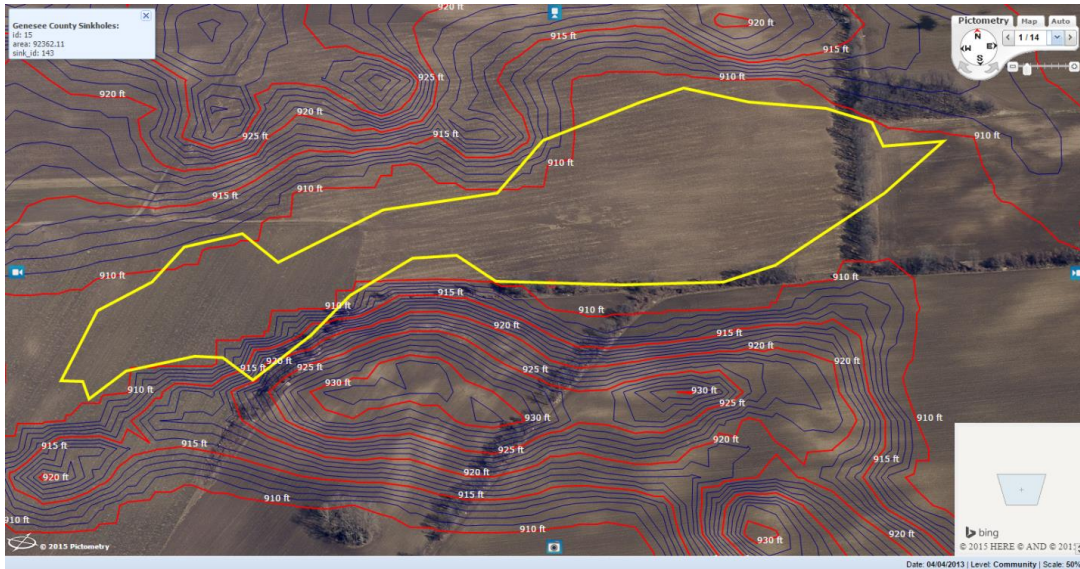
Figure 8a. Sinkhole #15 in Batavia, NY. This is from a dry time-step. The feature lies within a nice low-point in the contours within this farm field. Evident is slight soil discoloration, hinting at potential soil-type changes or differences in moisture content.

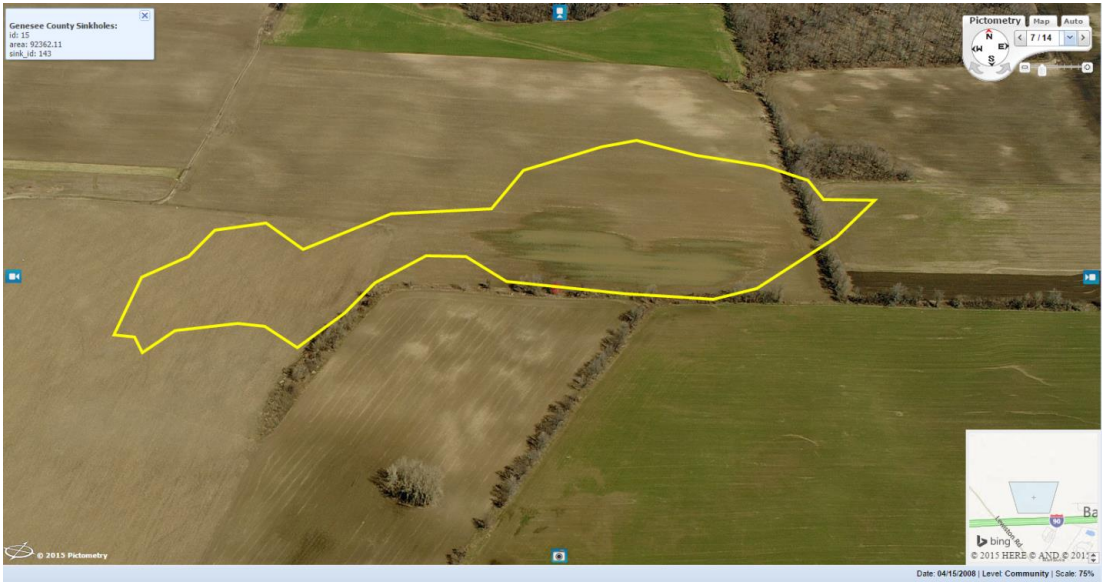
Figure 8c. Moist time-step for Sinkhole #15. Spring snowmelt has resulted in a temporary lake appearing in the middle of this sinkhole feature. This moist location matches the absent vegetation location from the prior figure.

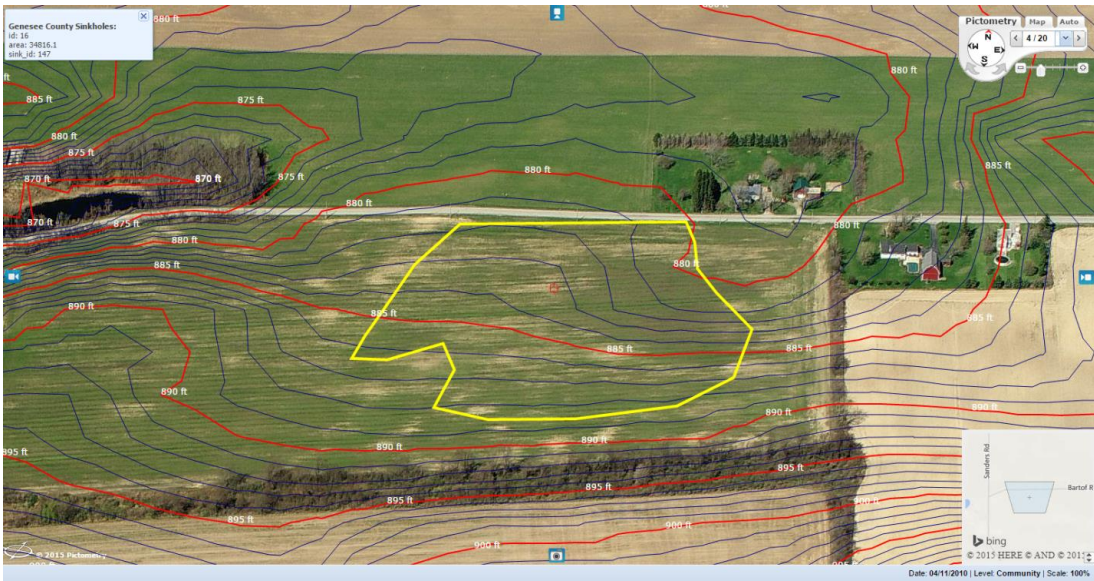
Figure 9a. Sinkhole #16 located on Bartof Rd. in Stafford, NY. This is a classic shallow depth-to-bedrock sinkhole feature. The feature itself crosses contours but has micro-topographic depression features throughout that collectively comprise the sinkhole.

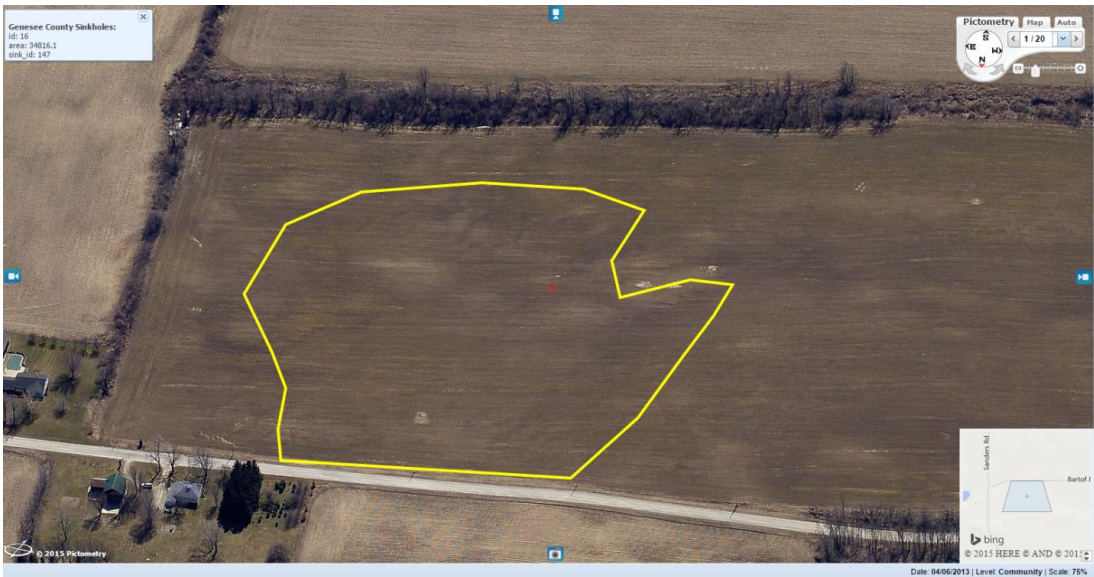
Figure 9b. Sinkhole #16 in the early spring before vegetation growth. Obvious are large clusters of sub-angular boulders, indicating shallow depth-to-bedrock. Note the soil discoloration due to enhanced moisture in micro-relief regions. View from north.

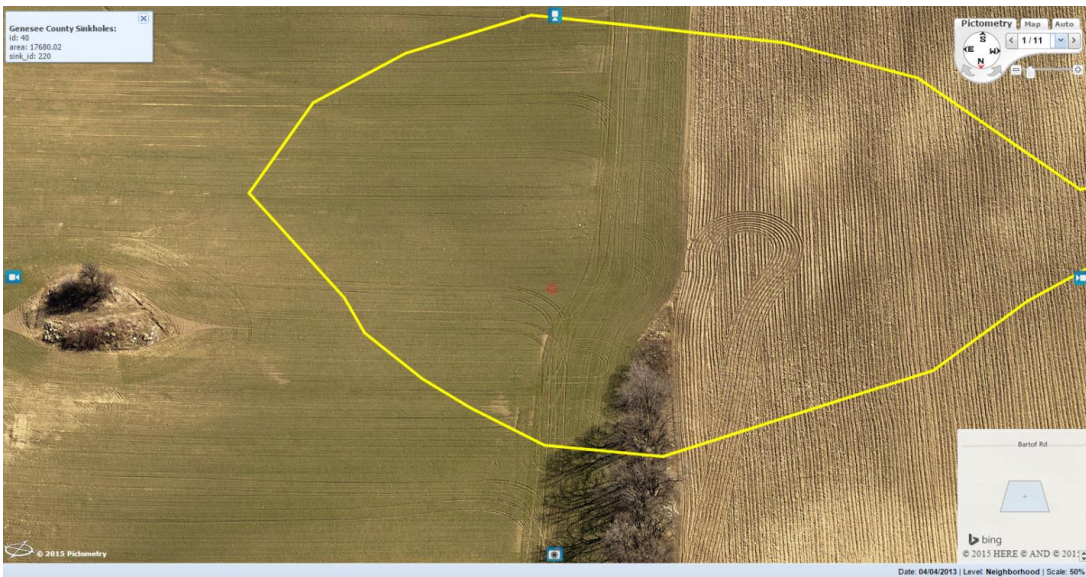
Figure 10b. Close-up of Sinkhole #40, with a spoil pile to the east of the feature (left of image). Scattered throughout both fields associated are sub-angular boulders. View from north.

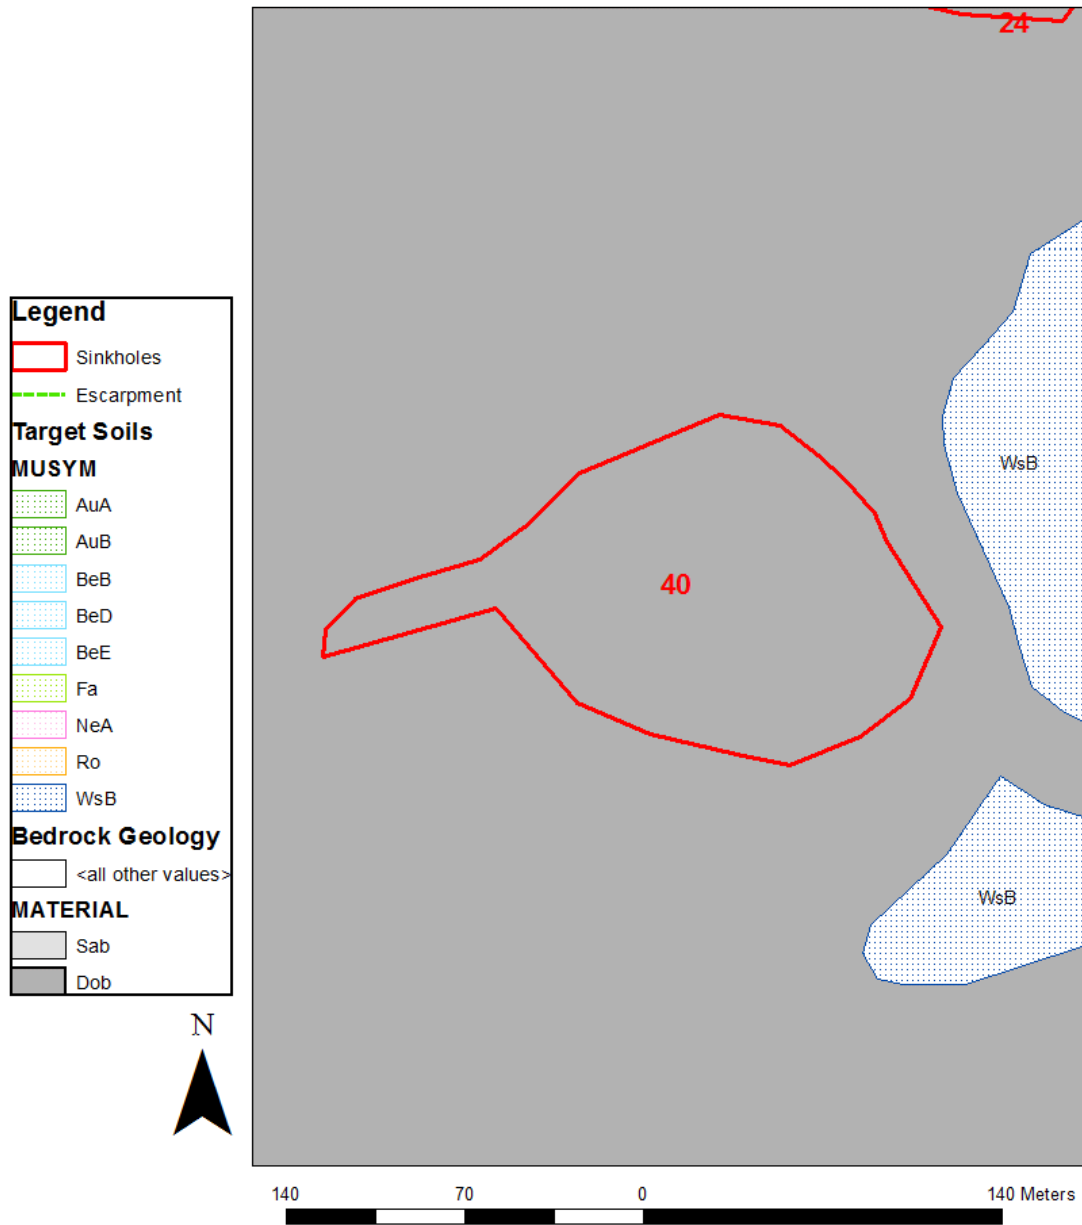
Sinkhole #40

Figure 10c. GIS-based map product of Sinkhole #40. This sinkhole is smooth and small-sized, and is within the Onondaga Formation. Target soils are absent in feature, but present nearby.

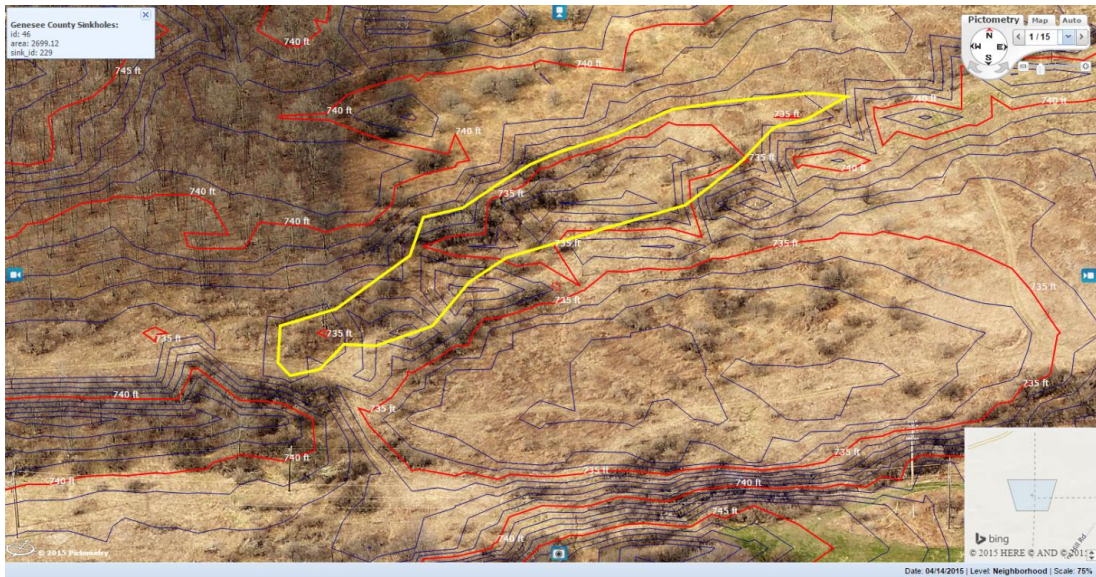
Figure 11a. Sinkhole #46 is a dry, land-based feature in LeRoy, NY. It is dominated by shrubs and soil. This feature encompasses two low points in topography, as noted by contours.

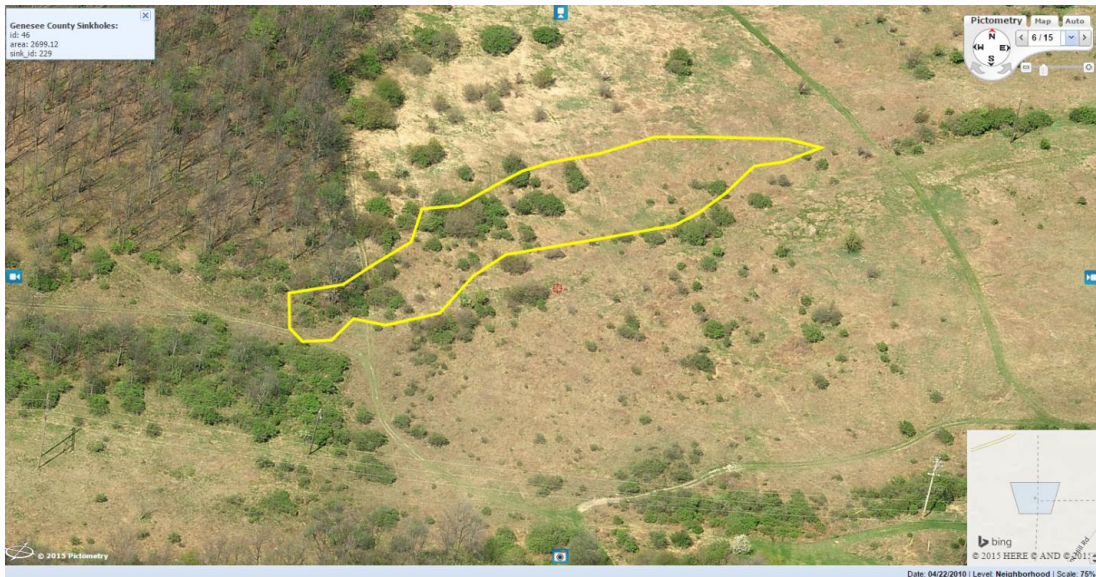
Figure 11b. Sinkhole #46 with spring growth evident. This feature is still absent any noticeable moisture on the surface, and apart from the shrubs, little else appears to grow within the feature.

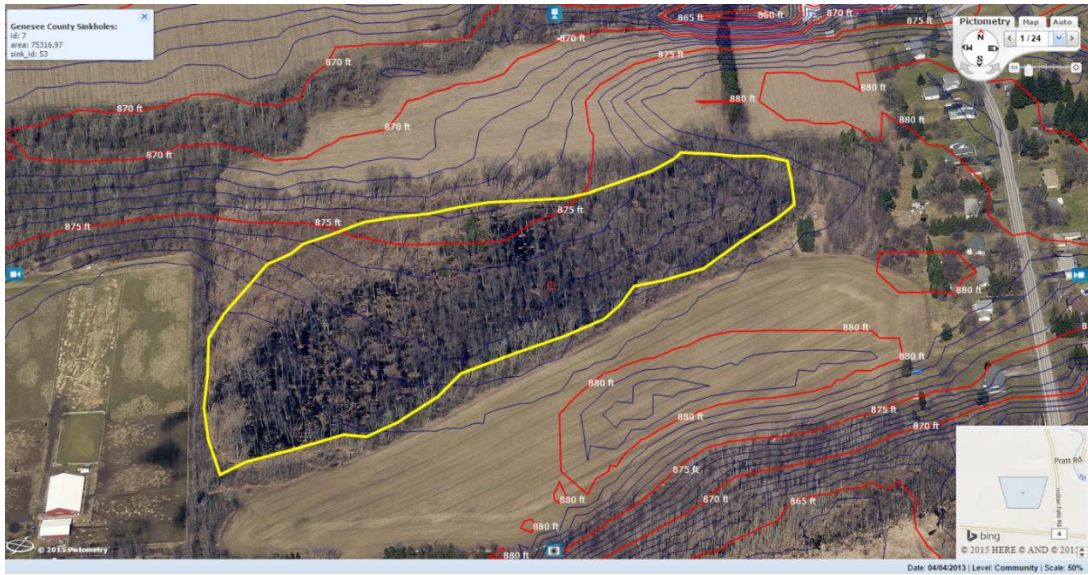
Figure 12a. This time-step shows Sinkhole #7 during a wet stage, likely from a snowmelt event. It is surrounded on three sides by farm fields, meaning this feature is likely inundated with farm-based pollution runoff.

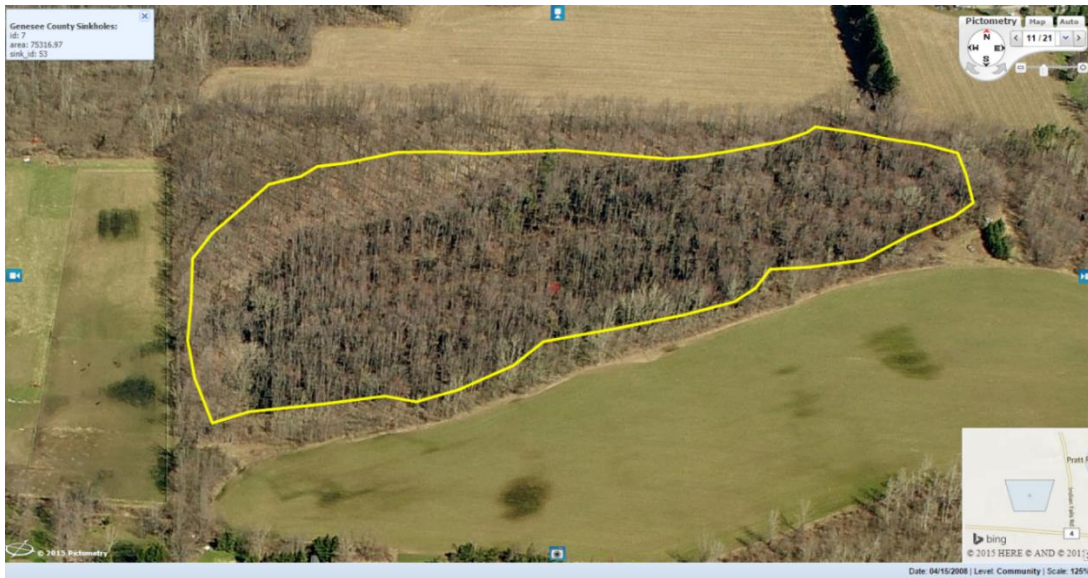
Figure 12b. A drier time-step for Sinkhole #7; while most moisture has left the sinkhole itself, soil discoloration, likely due to moisture, is observed in the surrounding fields.

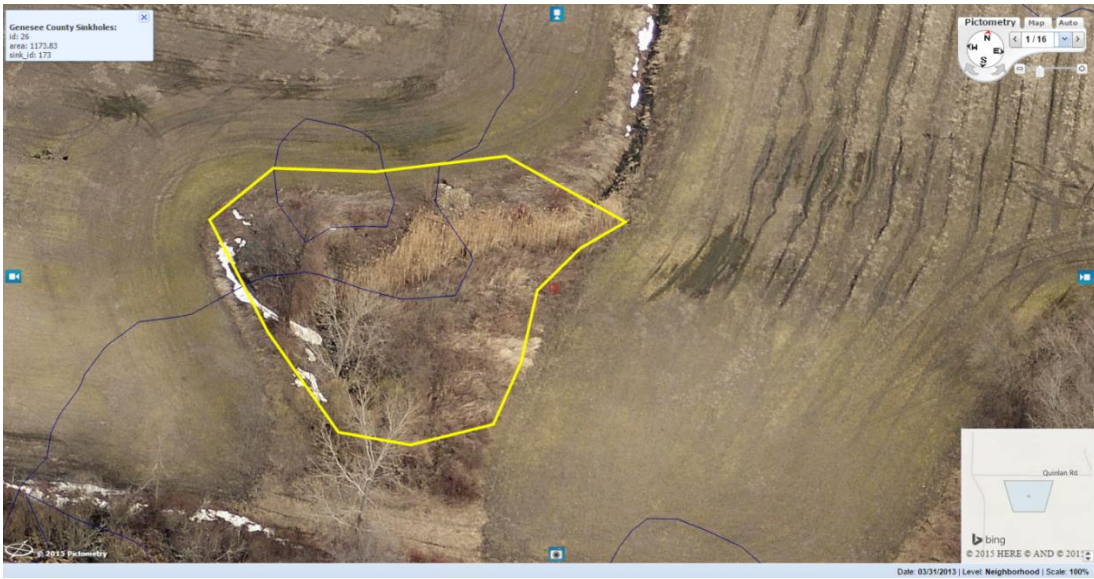
Figure 13a. Sinkhole # 26 is located along a stream section, at the low-point between to farm fields. The surrounding area appears quite moist, while inside the feature is very brush-filled and non-farmed, a sign of high moisture content extending away from the stream itself.

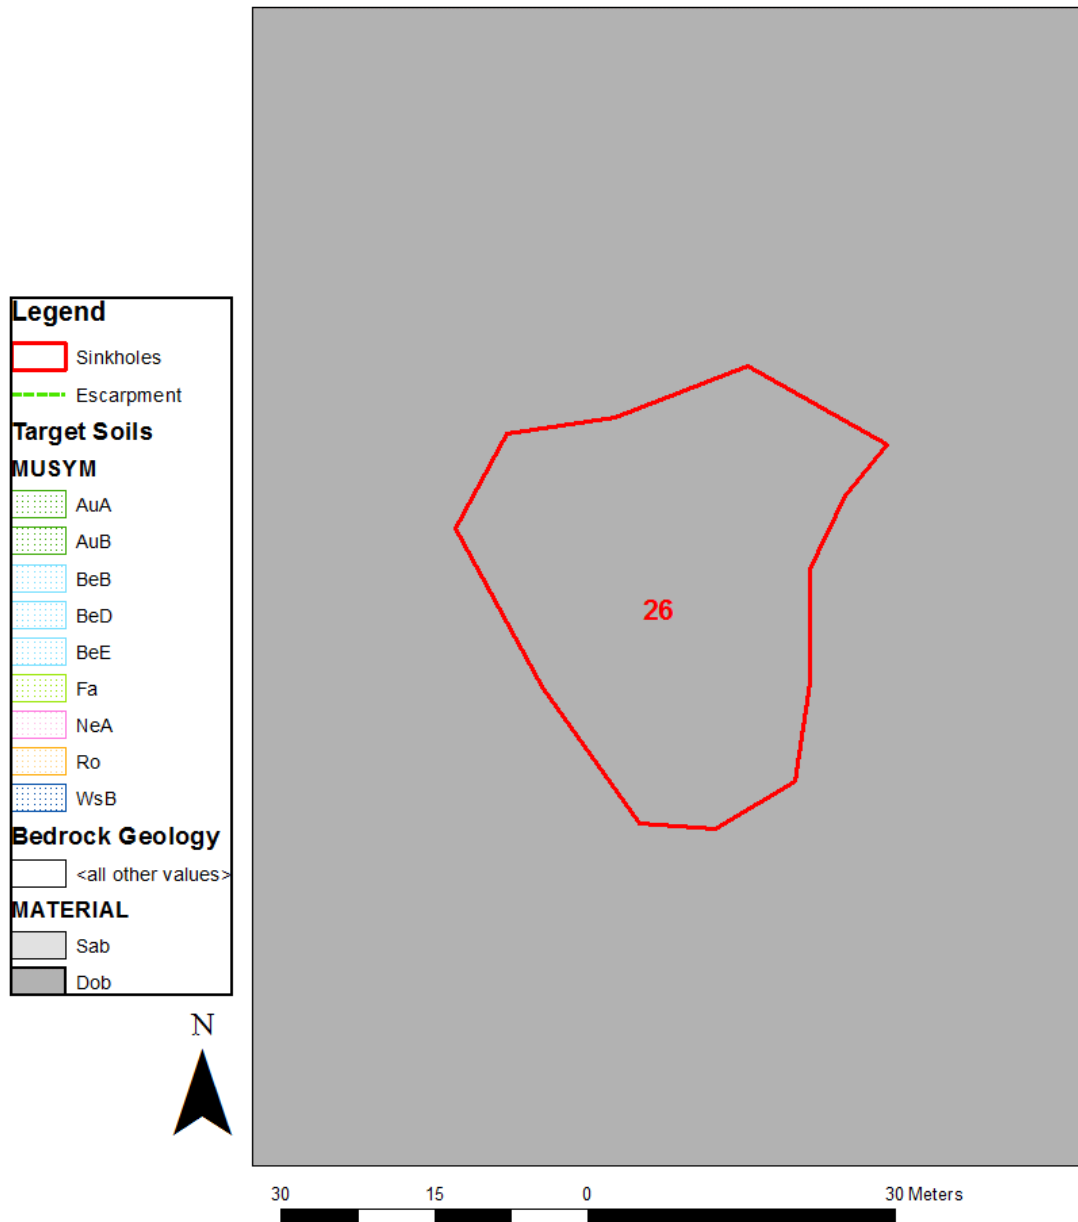
Sinkhole #26

Figure 13b. GIS-Based map product for Sinkhole #26. This feature is seen as laying solely within the Onondaga Formation (Dob) and having no nearby target soils.

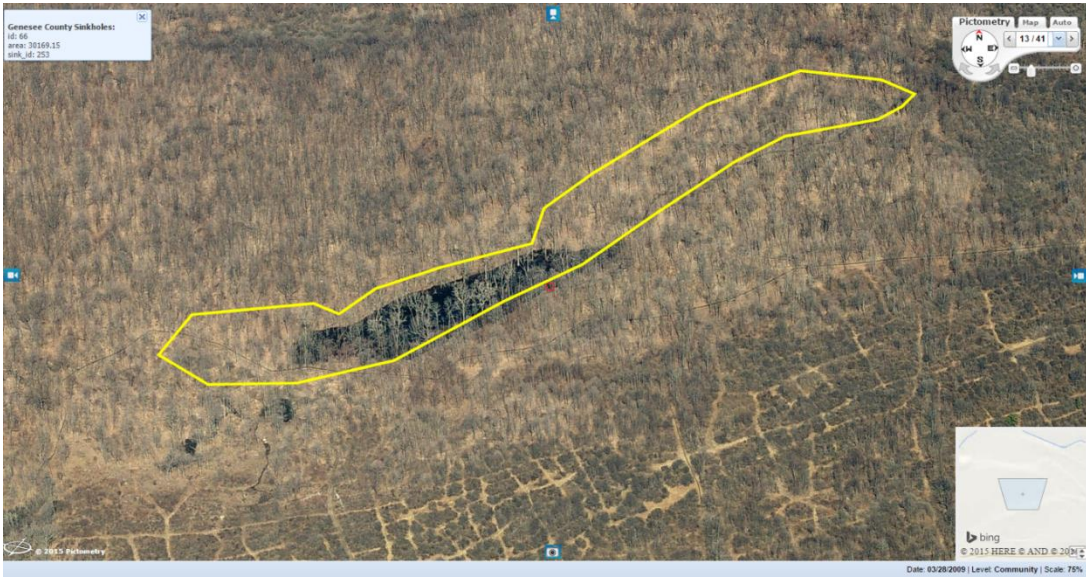
Figure 14a. A wet time-step for Sinkhole #66. This shows the feature after a snowmelt, creating a vernal pool.

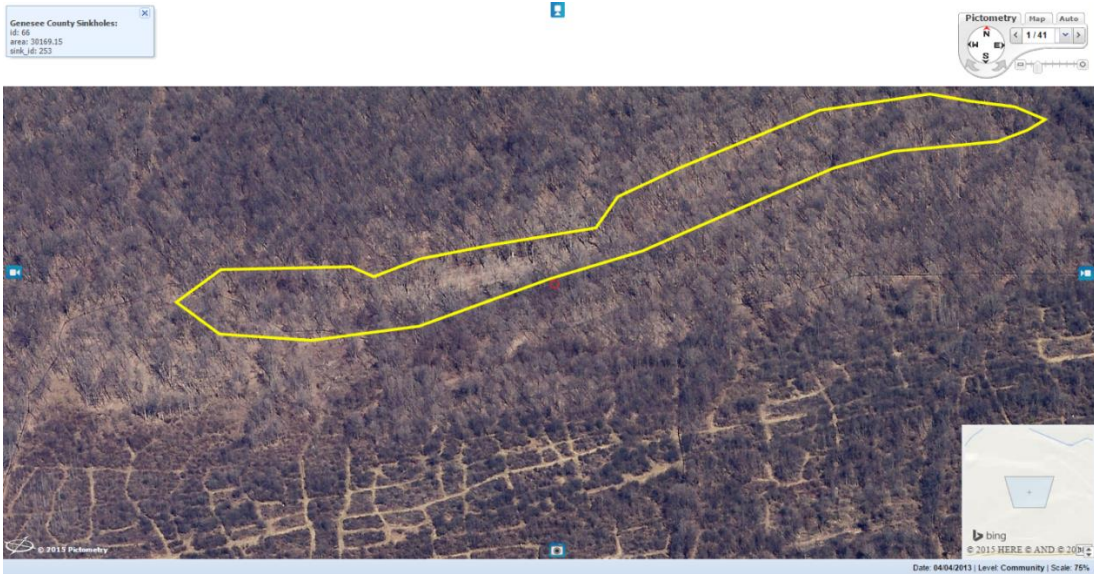
Figure 14c. Dry time-step for Sinkhole #66; this feature is completely absent of water in the visible imagery.

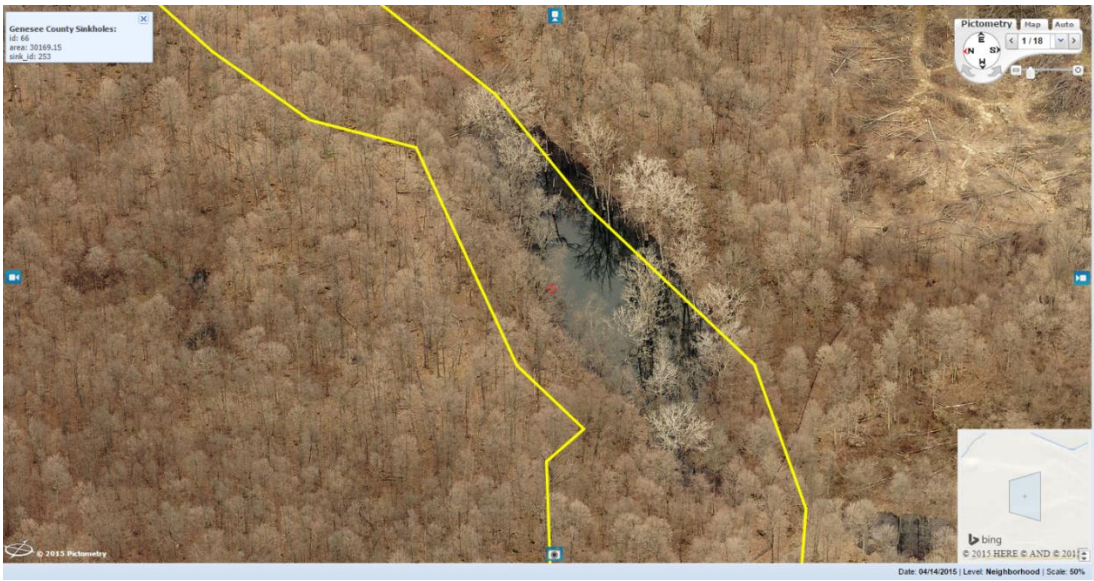
Figure 14d. Looking along the fetch of Sinkhole #66 (from the west) it shows obvious ponding with trees throughout the flooded region.

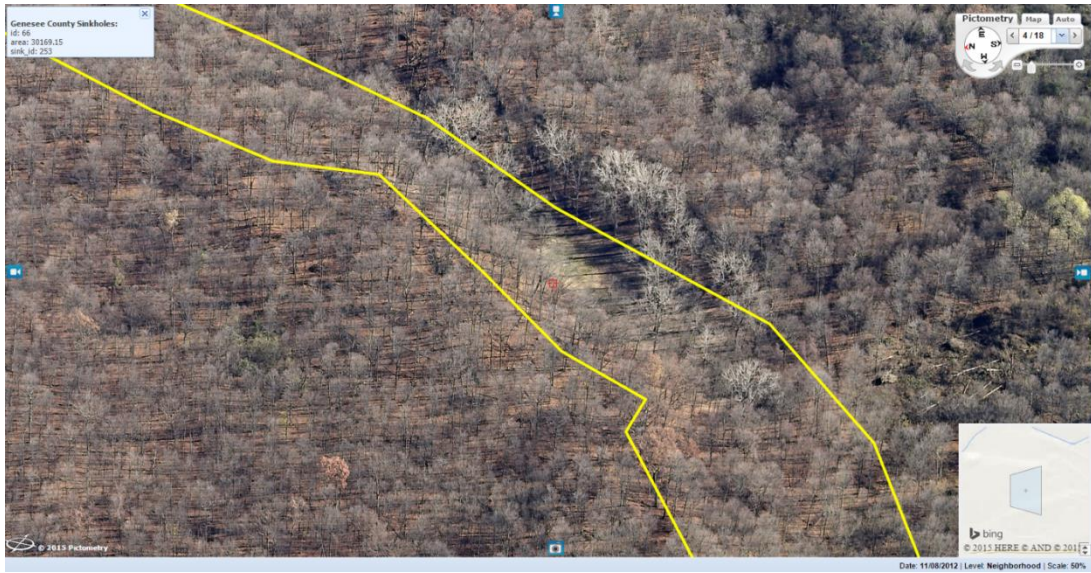
Figure 14e. Looking along the fetch of the pond in Sinkhole #66, during a dry time-step, the feature appear completely dry and barren.

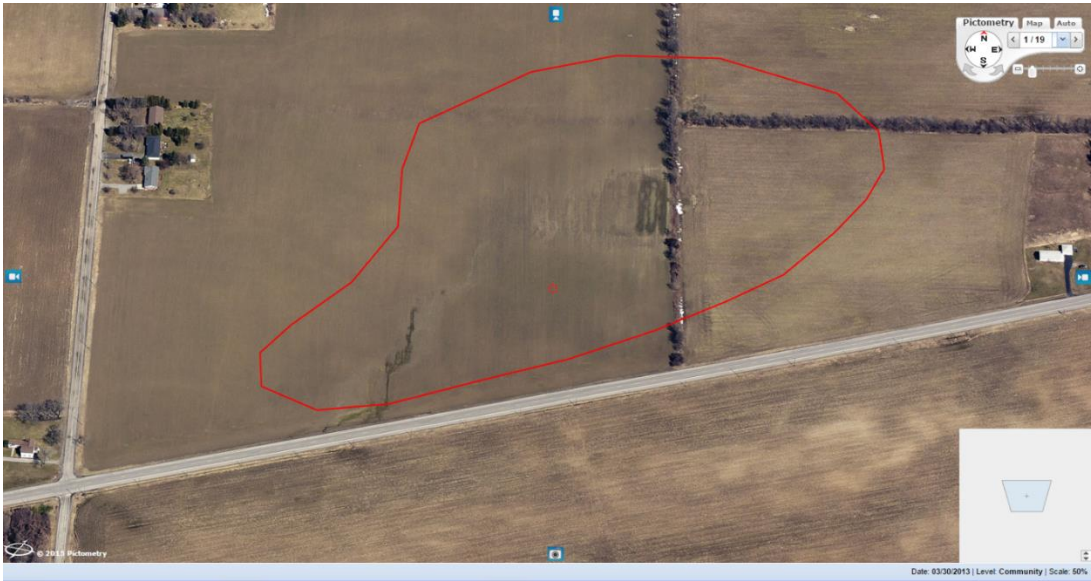
Figure 15a. Moist time-step of the disappearing lake at Ivison Rd. in Sinkhole # 25. Not only is there ponding at the very center, but visible ‘stream’ formation is seen in the southwest portion of the feature.

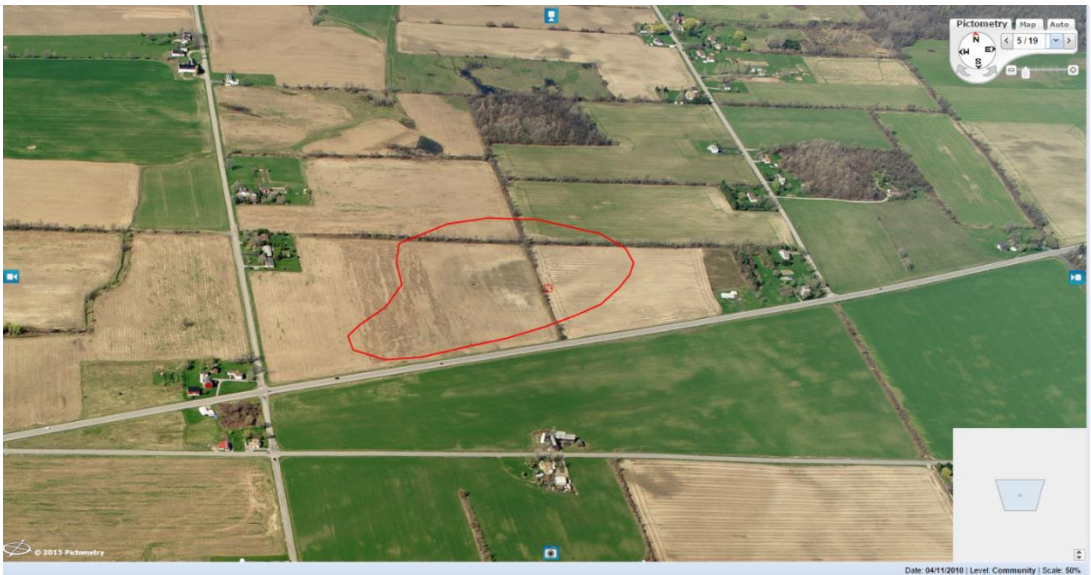
Figure 15b. Dry time-step of Sinkhole #25. Although absent of water, the Ivison Rd. disappearing lake still shows signs of soil discoloration, likely due to enhanced sub-surface moisture.

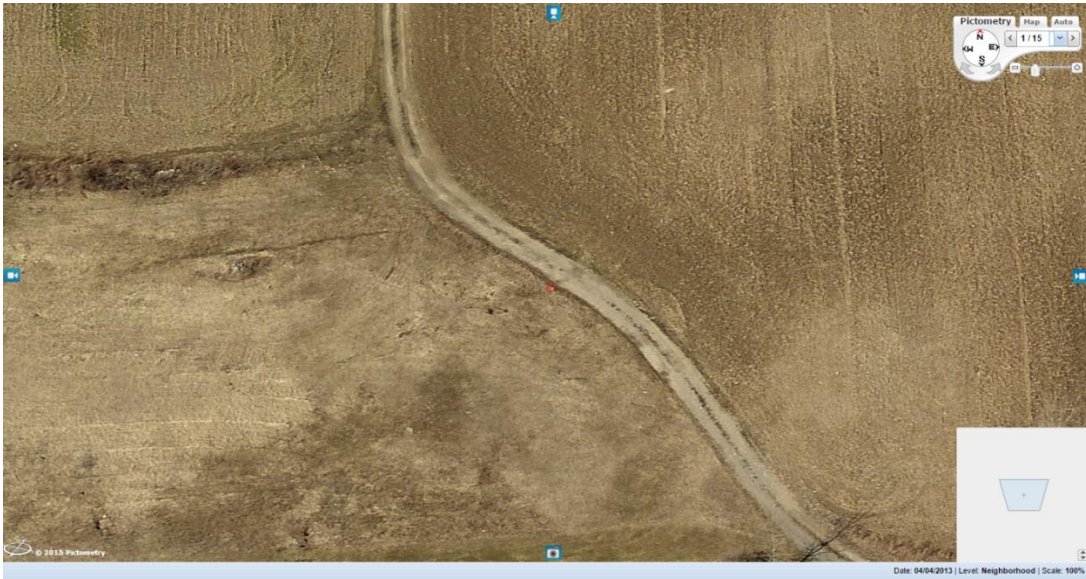
Figure 16a. Close up of the County Building 2 false-positive site. Apparent in the imagery are exposed stones and a rock outcrop, usually indicative of shallow soils when in karst terrain.

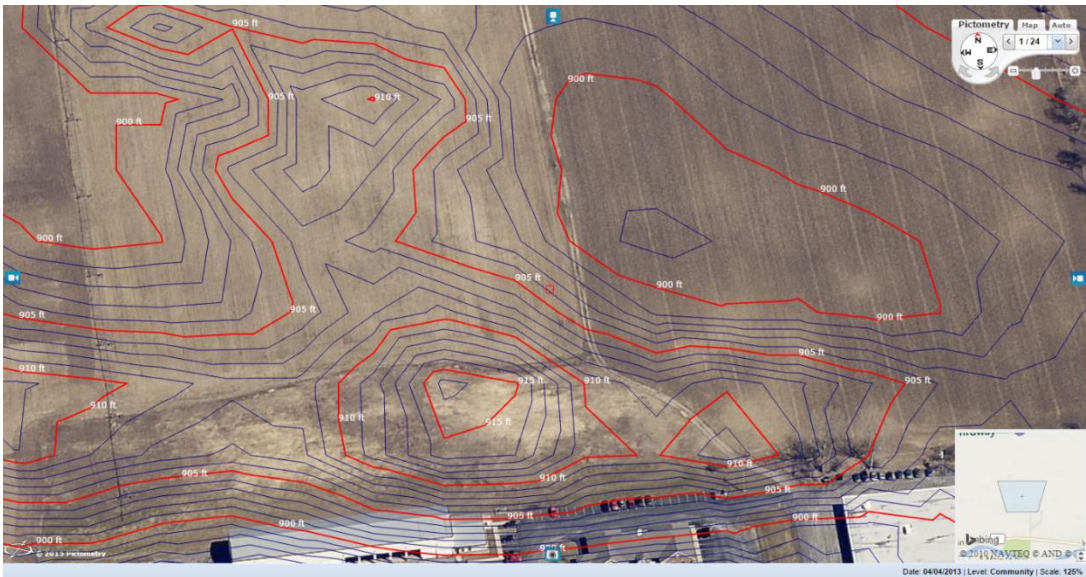
Figure 16b. Zoomed-out look at the false-positive site at County Building 2. Note the topographic low in the middle-right, which initially was mistaken as a sinkhole.
