**VALIDATION OF NEW ASPHALT CEMENT SPECIFICATION
TEST METHODS USING EASTERN AND NORTHEASTERN
ONTARIO CONTRACTS AND TRIAL SECTIONS**

A thesis submitted to the Department of Chemistry
in conformity with the requirements for
the degree of Master of Science in Engineering

Queen's University
Kingston, Ontario, Canada
(APRIL, 2009)

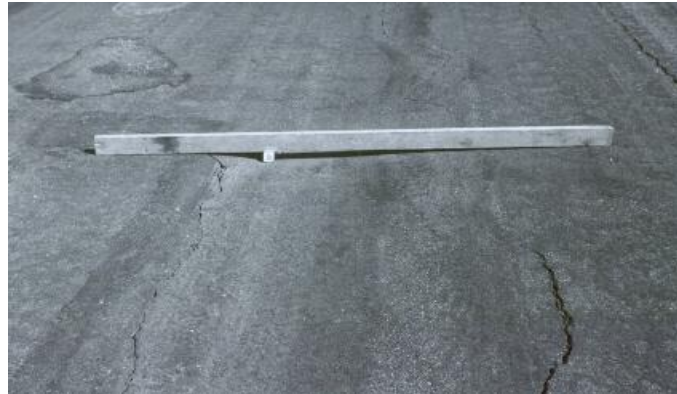
Figure 2. Measurement of rut depth on a severely damaged stretch of pavement.

properties of the asphalt play a major role in the rutting of asphalt. Heavy loads with low frequencies are major reasons for the failure of the pavement in this mode. This failure is characterized by complex modulus and phase angle values in the dynamic shear rheometer test (Asphalt Institute 2003). A typical example of a rutted pavement is provided in Figure 2 below.

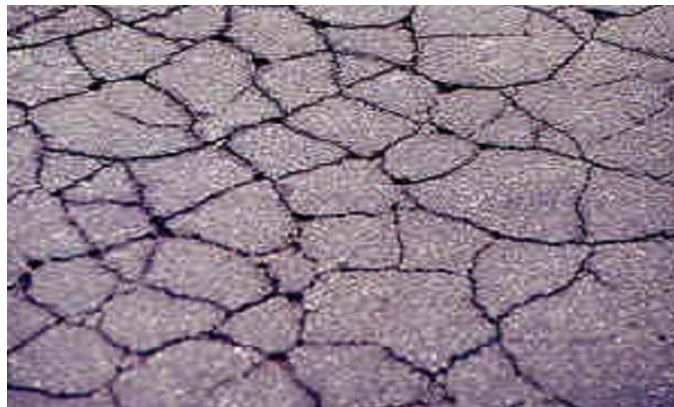
Figure 3. Area of asphalt pavement suffering from severe fatigue cracking distress.

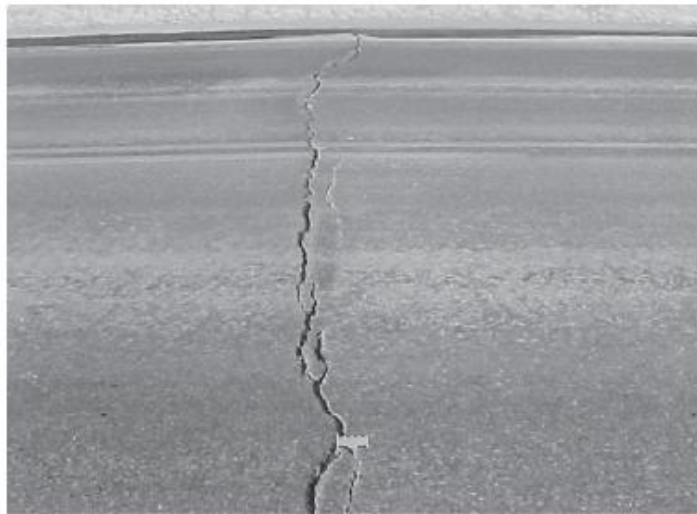
Figure 4. Typical example of a severe thermal crack in an asphalt pavement.

Typical examples of thermal cracks are provided in Figure 4 below. This thesis is mainly concerned with the validation of tests methods that prevent the occurrence of thermal cracks. It is obvious from the image in Figure 4 that thermal cracks, once formed, can have a serious negative effect on the pavement life-cycle and that they are difficult to repair. It has been found that for pavements of apparently the same design (asphalt cement grade, thickness, traffic level, and weather conditions) the cracking distress can vary a great deal. Hence, it is important to better grade the asphalt cements in order to control the onset and degree of thermal cracking distress.

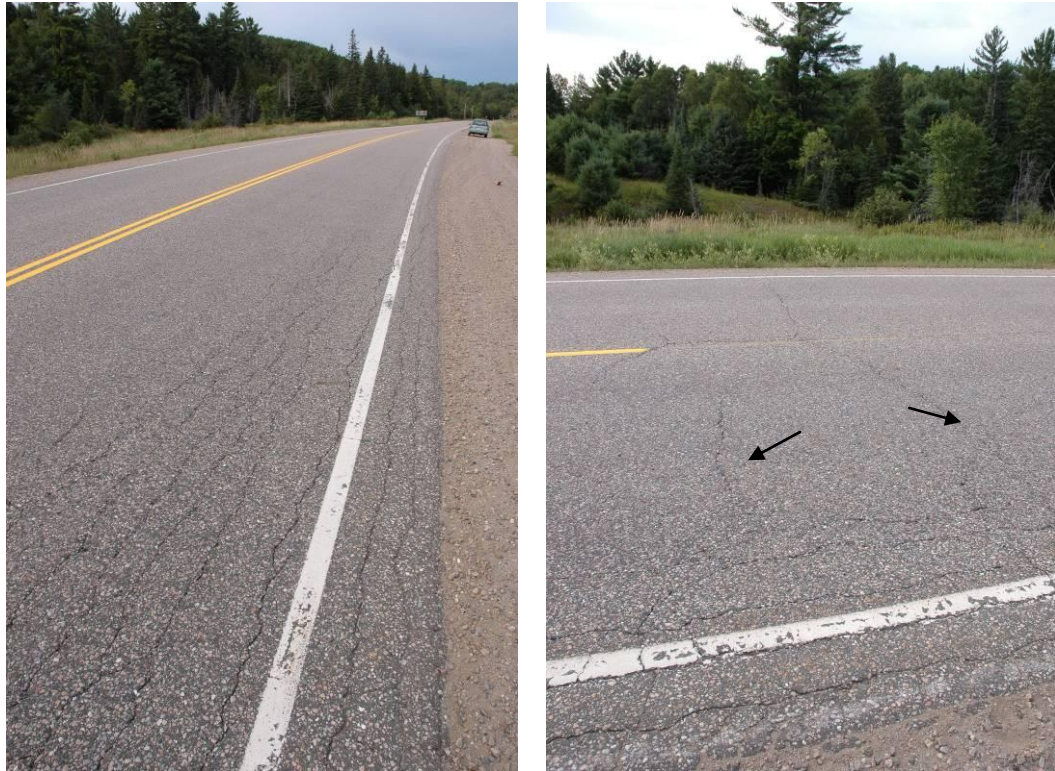
Figure 17. Typical surface condition of Highway 41 contract near Denbigh.

Note: Arrows indicate transverse cracks sprouting out from longitudinal distress.

The second and third surveys had 43 and 29 transverse cracks, respectively, most of which covered the full width of the pavement and were of intermediate severity.

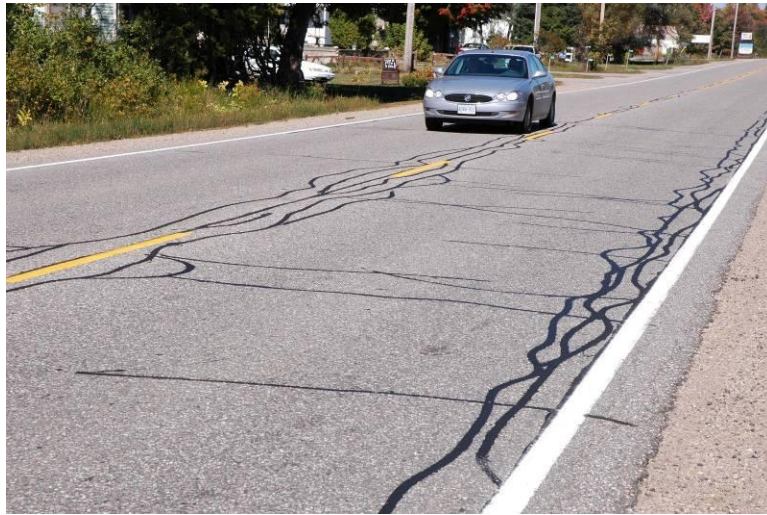
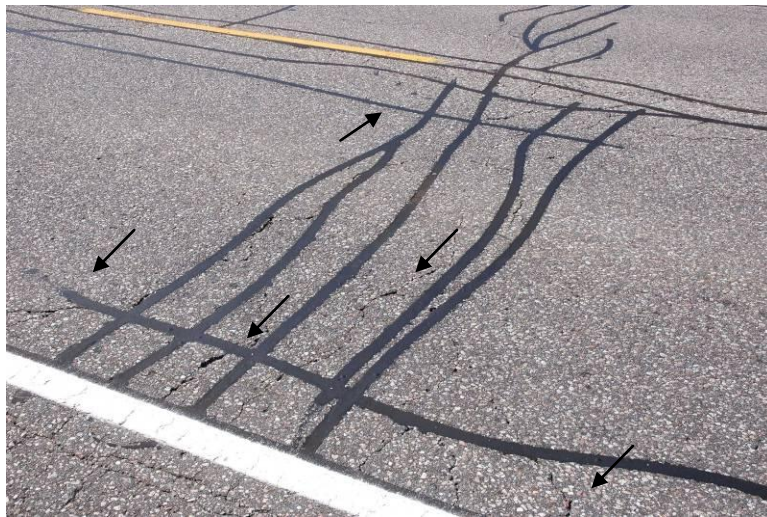
Figure 18. Typical surface condition for Highway 41 north of Kaladar. Note: Arrows indicate thermal cracks that have appeared after the original crack sealing.

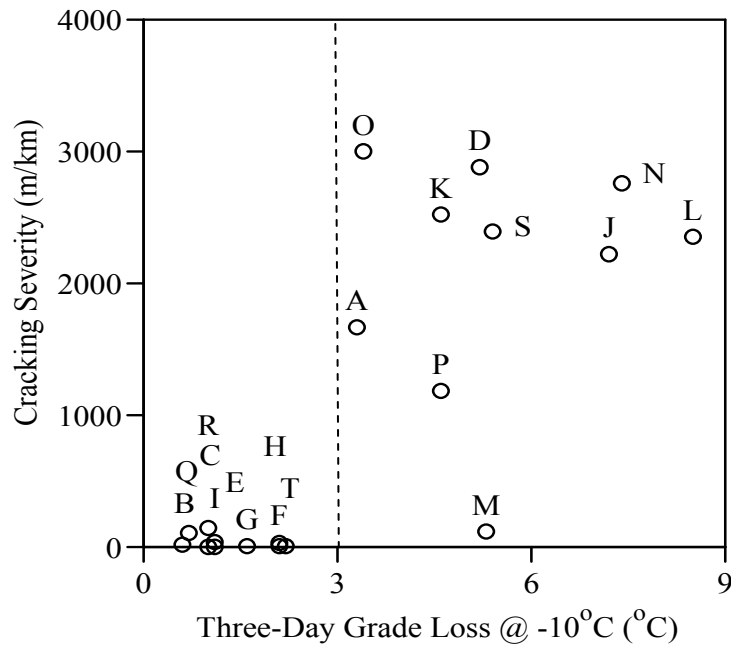
Figure 22. Three-day grade loss in LS-308 versus the cracking severity in 20 eastern and northeastern Ontario contracts.

A graph of three day grade loss at 10°C, according to LS-308 procedures, versus the distress in pavements is shown in Fig. 22. Taking the grade loss greater than three degrees as a limit in the test would provide an accuracy of 95%, which is considerable higher than the 55% for AASHTO M320 as applied in Ontario with a 3°C deficit (margin of testing error) or the 80% for AASHTO M320 without the margin or error. Of the twenty samples tested, sample M is the only outlier. The reason for the least distress in this sample is quoted as polymer modification which gives it more flexibility at low temperature conditions.

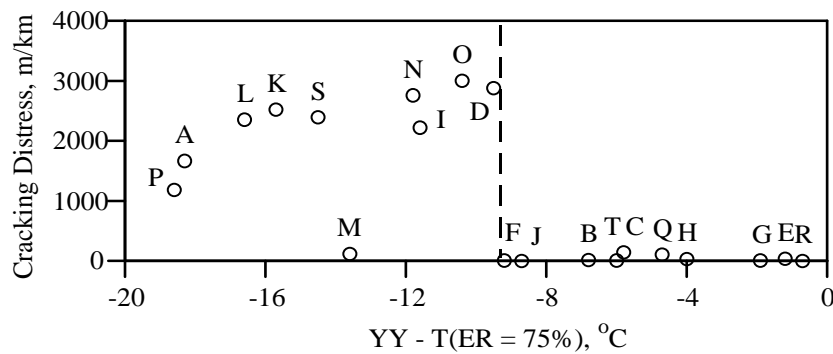
Figure 27. Cracking distress versus the limiting temperature where the elastic recovery reaches 75%. Note: Dotted line is placed in order to obtain the highest accuracy.

Figures 25-27 provide the cracking distress versus the grade deficit/surplus for the total compliance (J_t), the viscous compliance (J_v), and the elastic recovery (ER), respectively. It can be seen from these graphs that the split of viscous and elastic effects increases the accuracy by a considerable amount. While the total displacement provides only an accuracy of 75% (15 times out of 20), the viscous compliance has an accuracy of 95% (19 times out of 20), and the elastic recovery also has an accuracy of 95% (19 times out of 20). It should be noted that these increased accuracies come after only 3 h of conditioning (1 h conditioning could not be done for scheduling reasons).

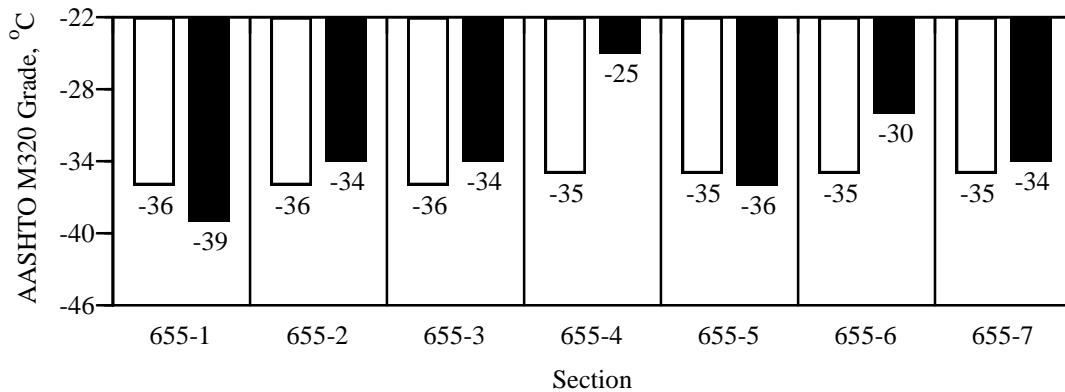
Figure 31. Regular AASHTO M320 specification grades for laboratory-aged (open bars) and recovered (closed bars) asphalt cements.

The regular AASHTO M320 specification grades are provided in Figure 31 below. The data are interesting in that the regular AASHTO M320 grade gives somewhat of an indication of the cracking distress in each section. Sections 1 and 5 give the lowest grades and they have largely been left unscathed. Section 4 shows the worst performance in both the AASHTO M320 ranking (-25°C) and in terms of cracking distress. The fact that the PGAC grade decreased by as much as 10°C beyond what the PAV residue predicted indicates that an improved laboratory ageing method is required. The RTOF/PAV is supposed to produce a material that reflects properties after 8-10 years in service.

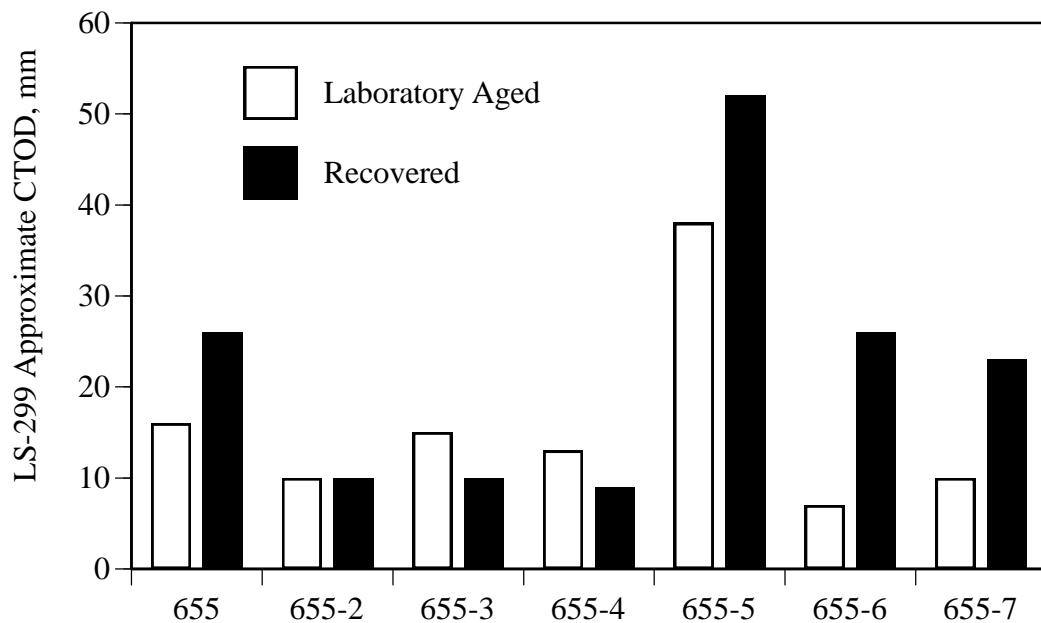
Figure 34. Approximate critical crack tip opening displacements (CTOD) for original asphalt cements (open bars) and recovered materials (closed bars).

The final evaluation for the recovered asphalt cement materials was according to the LS-299 double-edge-notched tension test protocol. The approximate critical crack tip opening displacements for all seven binders are given in Figure 34 below.
