# Investigation of electrical and impact properties of carbon fiber textile composites

A thesis submitted in partial fulfillment  
of the requirements for the Master of  
Science degree in Mechanical Engineering  
in the Graduate College of  
The University of Iowa

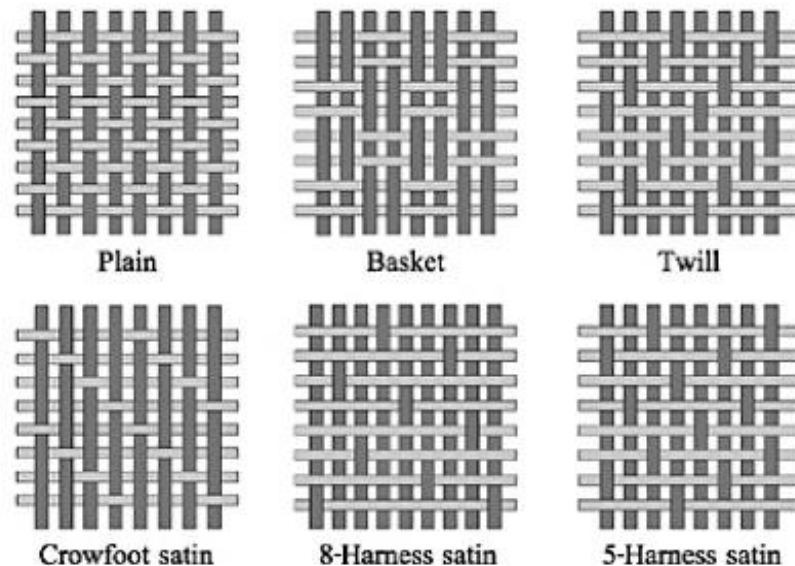
Figure 1.1: Basic Weave Types (Balaguru, 2009)

A plain weave is defined as a 1X1 weave and a twill weave is defined as a set of identical number of weave both under and over such as 2X2 and 4X4 twill weaves (Bakar, 2013). The plane weave (0/90) is the most common weave construction used and requires only four weaving yarns: two warps and two fills. For a simple plain-woven fabric, half of the fibers are in the warp (0) orientation and the other half is in the fill (90)

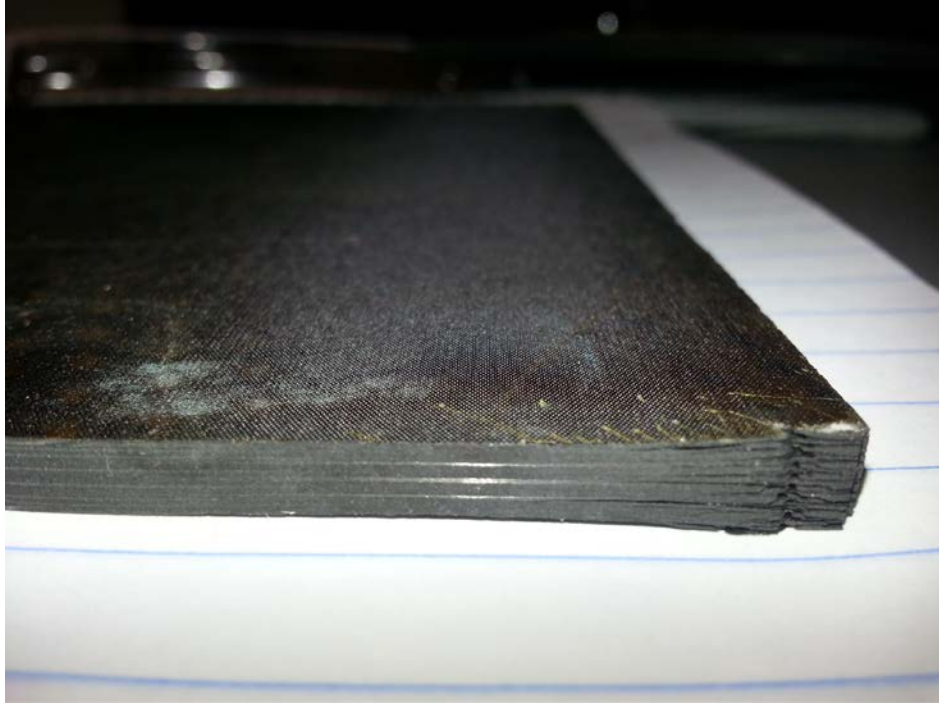
Figure 2.4: Delamination in One of the Samples

Beam samples 1-7 through 1-9 and 2-7 through 2-9 were used for the electrical characterization, as those samples featured less damage and little to no delamination, which may affect their electrical characterization.

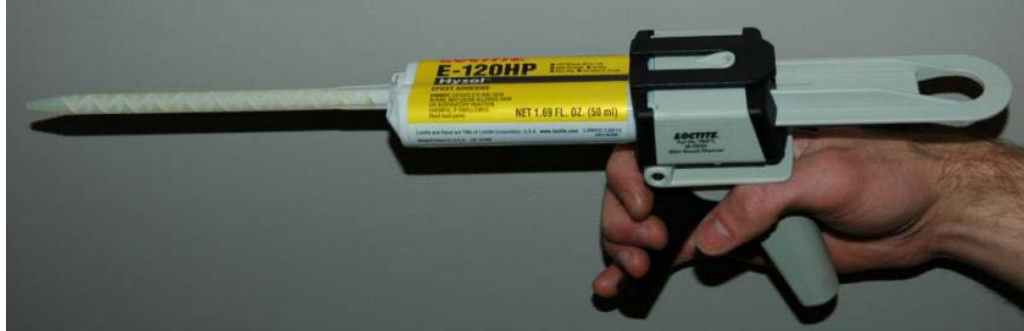
Figure 2.6: Epoxy Applicator (McAndrew, 2009)

Once all were dried, a layer of conductive epoxy was applied over the already attached electrodes. The epoxy was spread across the probes on the sample. All samples were left to dry for 24 hours to ensure the epoxy was fully cured. The last step in the sample preparation procedure was to smooth the cured epoxy surfaces to remove any excessive material and again minimize any contact resistances that could occur between the samples and electrodes (Hill, 2012). The epoxy used is seen in Figure 2.6

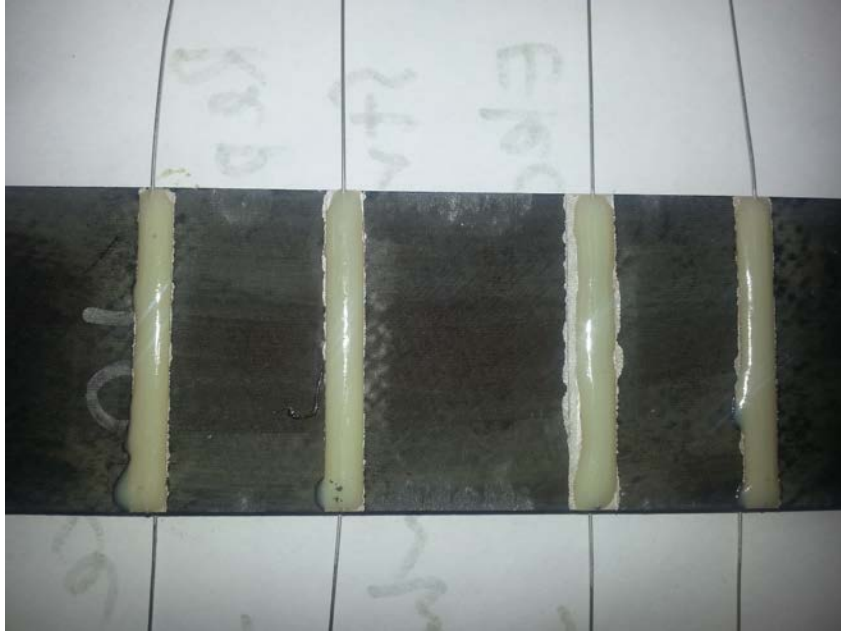
Figure 2.7: Prepared Sample

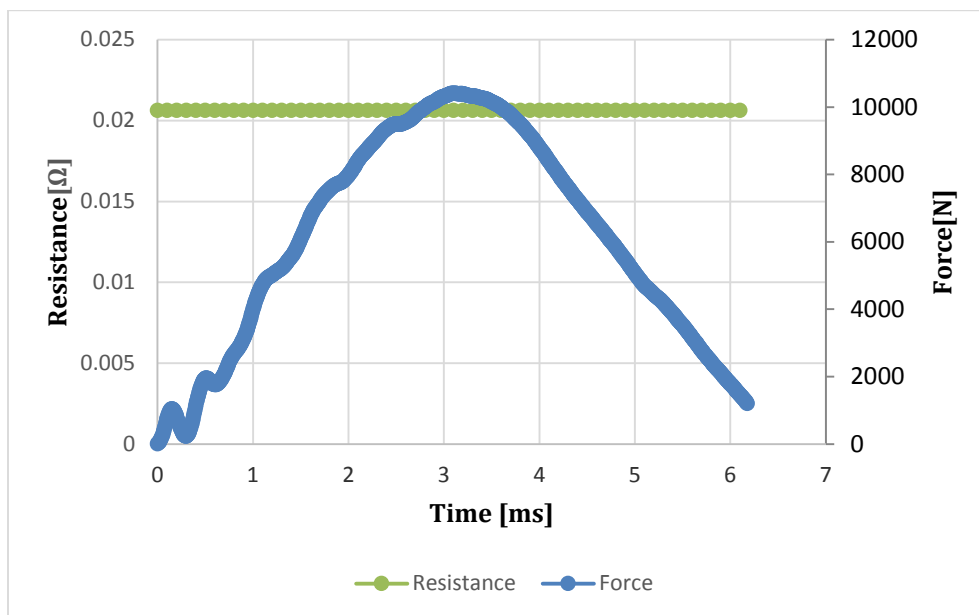
Figure 4.9: Force and Resistance vs. Time, 6<sup>th</sup> Impact, Sample 2-8

When viewing the force and resistance plotted together it is clear that there is no damage detected nor is there a corresponding change in resistance.

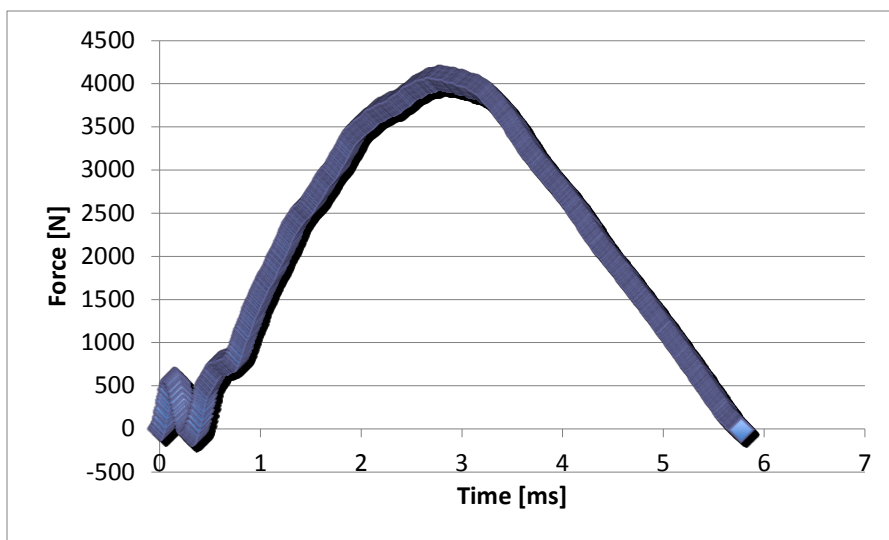
Figure 4.10: Force vs. Time, 7<sup>th</sup> Impact, Sample 2-8

that the 7th attempt shows a decrease in force from 10000 to 4000 N, which indicates that there may be some damage even though it is not visible on the laminate. Top and bottom surfaces of sample 2-8 with no visible damage after 7 impacts are shown in Figures 4.14 and 4.15.

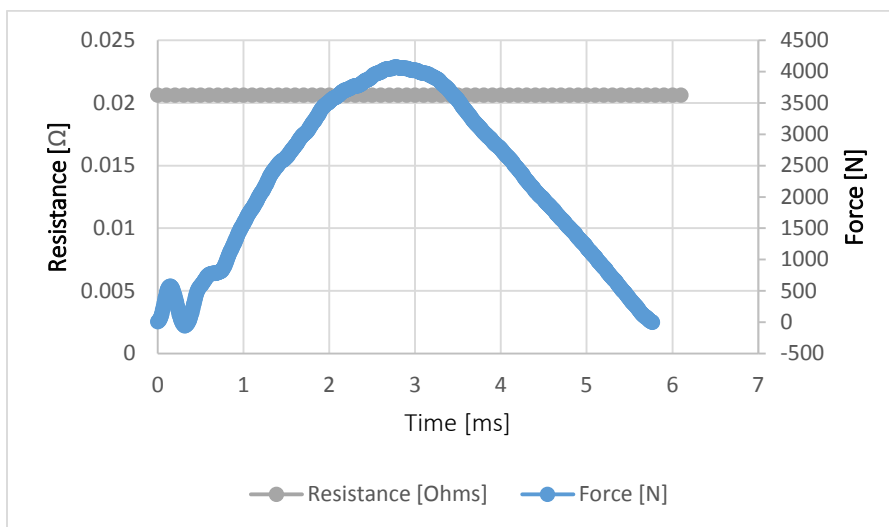
Figure 4.13: Force and Resistance vs. Time, 7<sup>th</sup> Impact, Sample 2-8

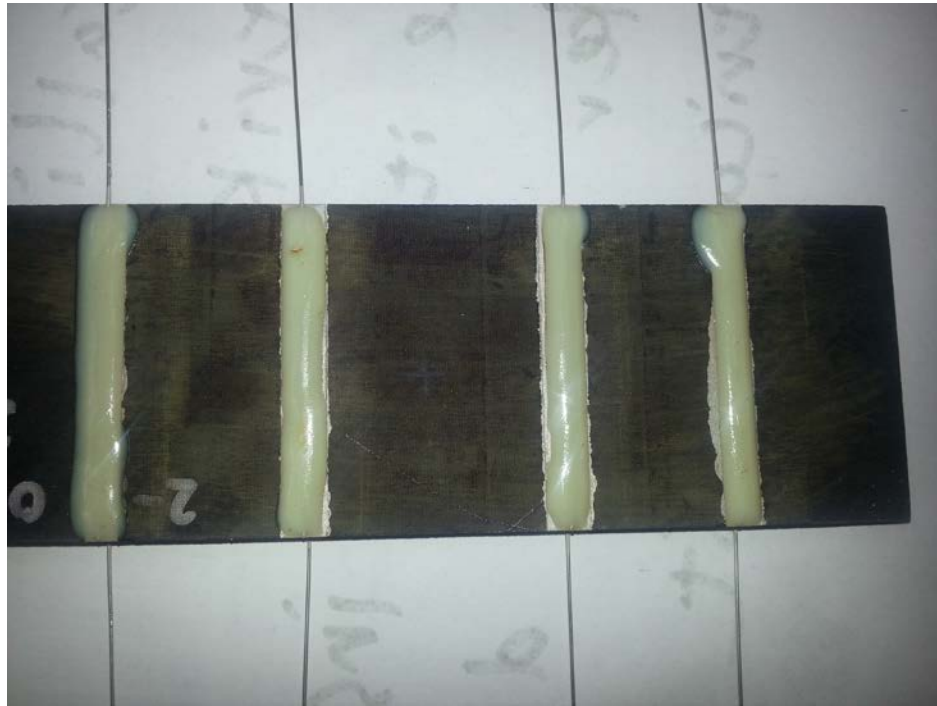
Figure 4.14: Sample 2-8 Top Surface

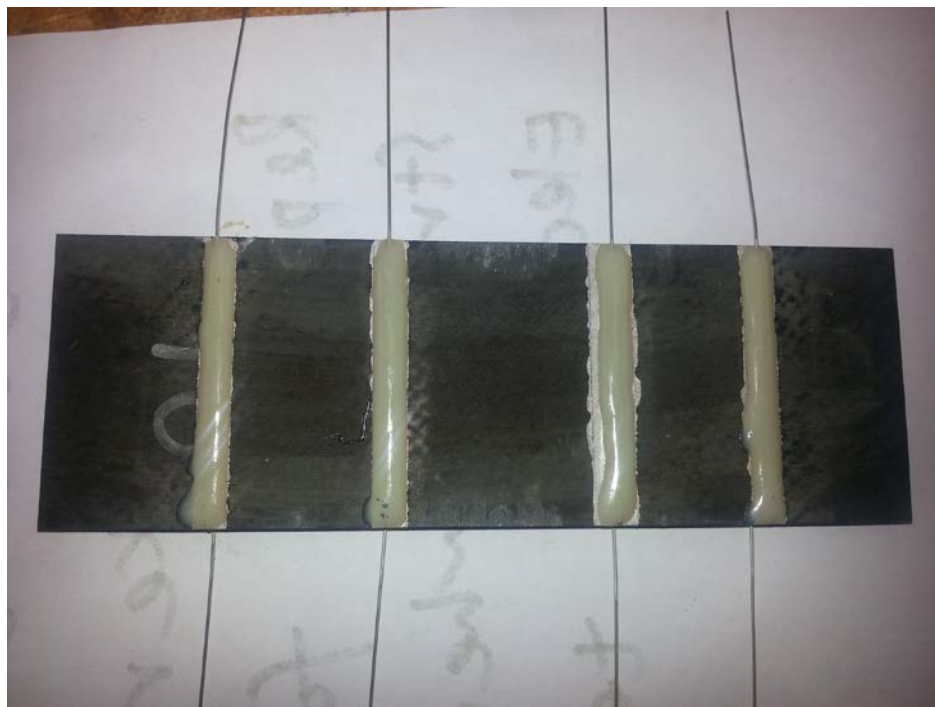
Figure 4.15: Sample 2-8 Bottom Surface

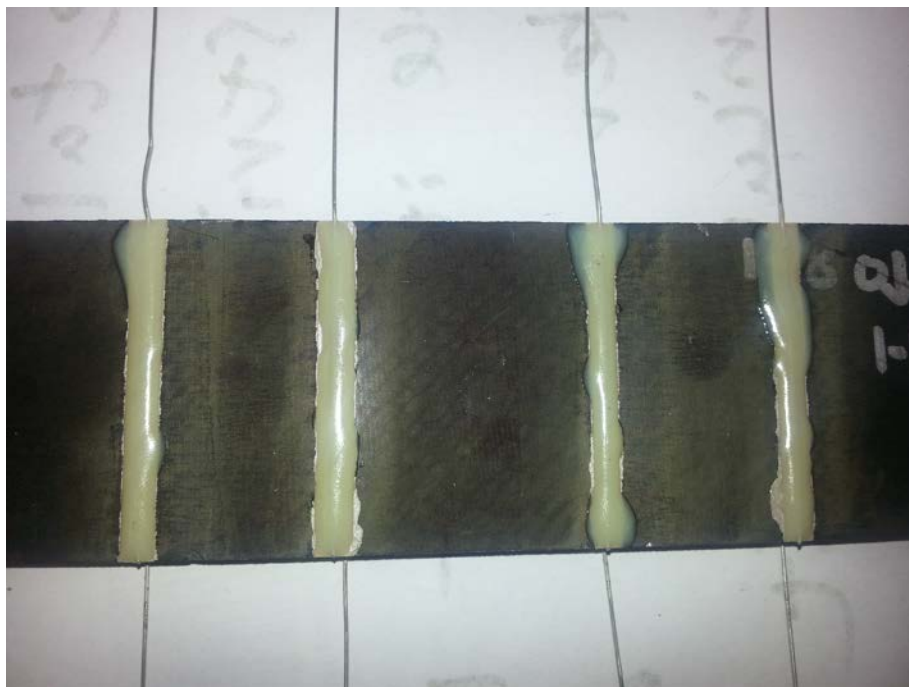
Figure 4.23: Sample 1-8 Top Surface after 2<sup>nd</sup> Impact

Despite of the reduction in the maximum impact load, there was no visible damage observed on the surface of the sample 1-8 after two impacts (see Figures 4.23 and 4.24).

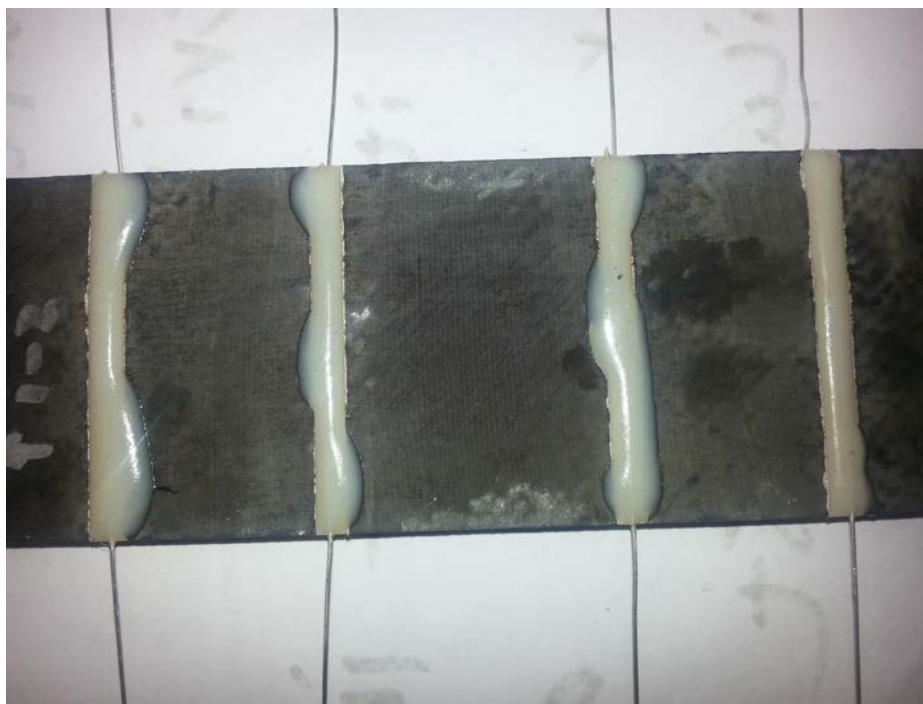
Figure 4.24: Sample 1-8 Bottom Surface after 2<sup>nd</sup> Impact

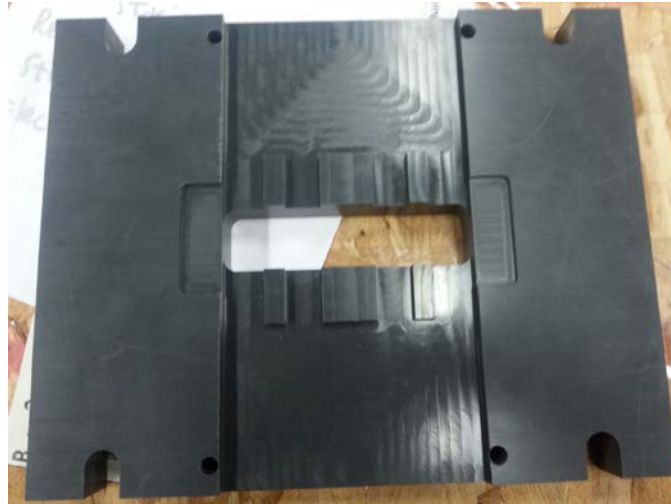
Figure 4.25: New PVC Test Fixture

A new test fixture was manufactured out of PVC to provide for better fixture resistance against impact while being non-conductive. This is seen in Figure 4.25. Due to 0.25" being added to the bottom of the PVC fixture, the zero point of the drop weight had to be moved by moving the ruler to where the drop weight rests on the composite surface.

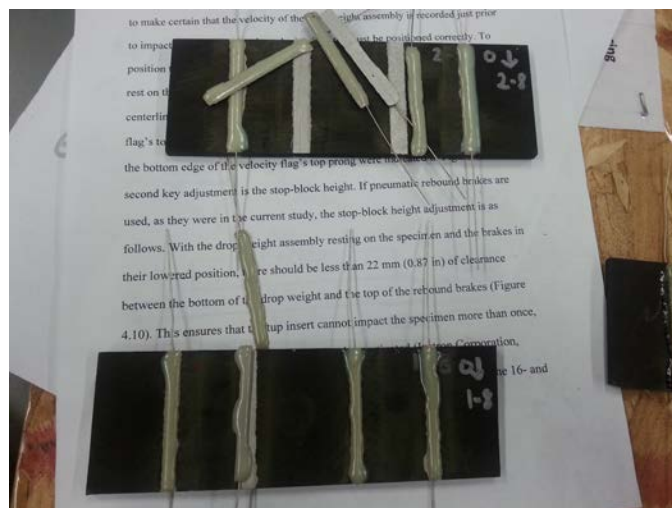
Figure 4.26: Broken Electrodes on Samples 1-8 and 2-8

Figure 4.26 shows the broken electrodes on Samples 1-8 and 2-8.

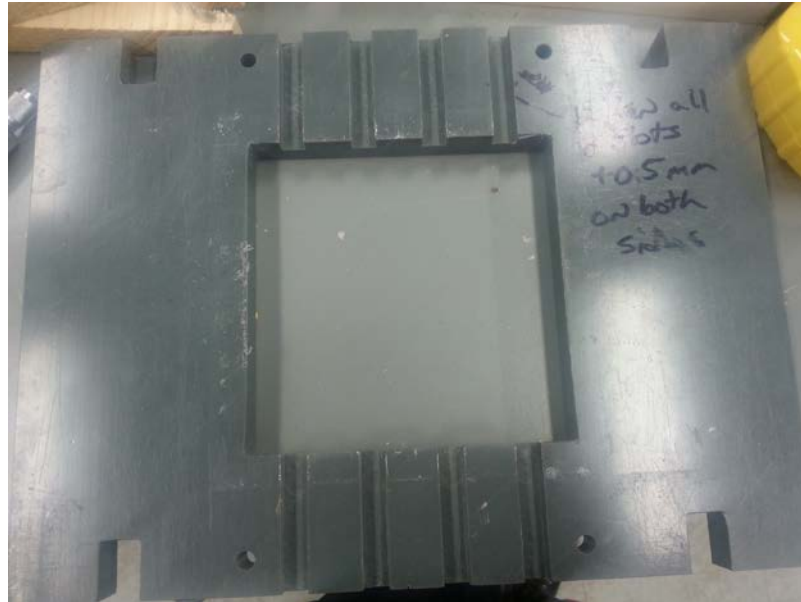
Figure 4.27: Older Test Fixture

It was determined that since there are too many supportive elements on the previous fixtures (the wooden fixture and the new PVC fixture), an older fixture with no supports was used to allow for clamping of both ends of the sample over a square hole. The previous fixture is seen in Figure 4.29. An older support fixture was used to see if this would produce visible damage along with monitoring electrode damage after impact. Although there were original concerns that a clamped sample would produce bending in the composite, it was determined that with the given fiber direction in this composite, the stiffness would negate bending concerns and perforation was more important. This is seen in Figure 4.27.

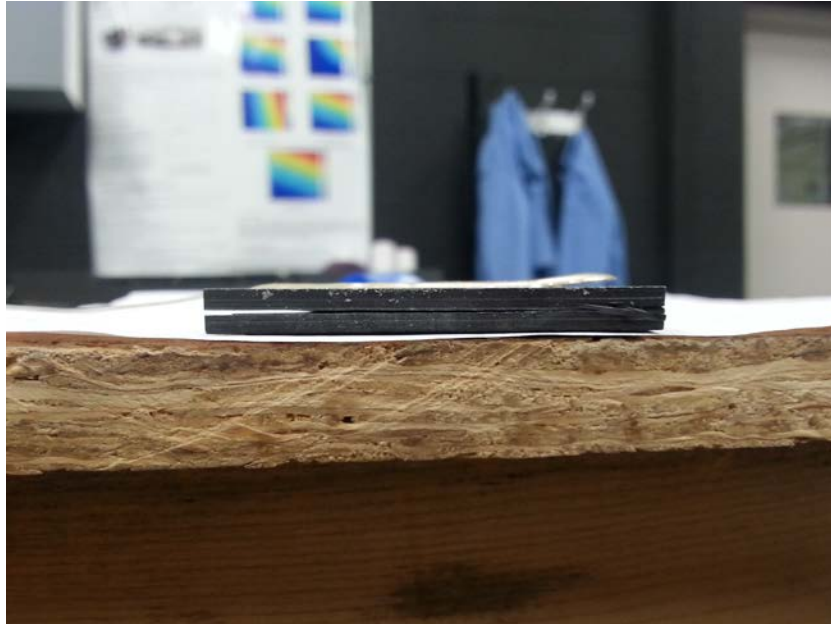
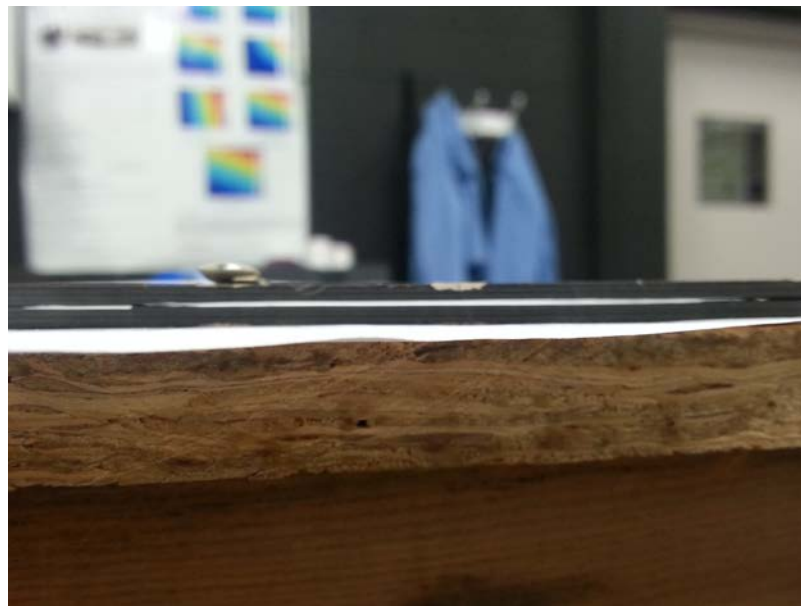
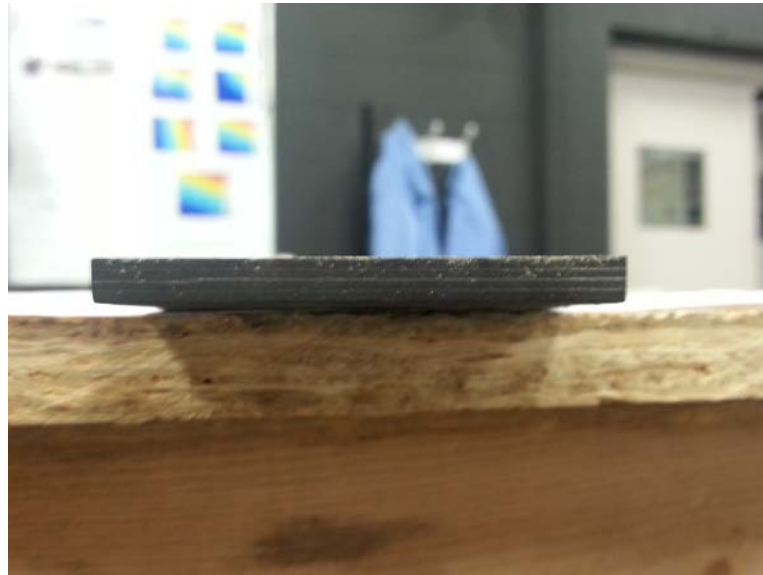
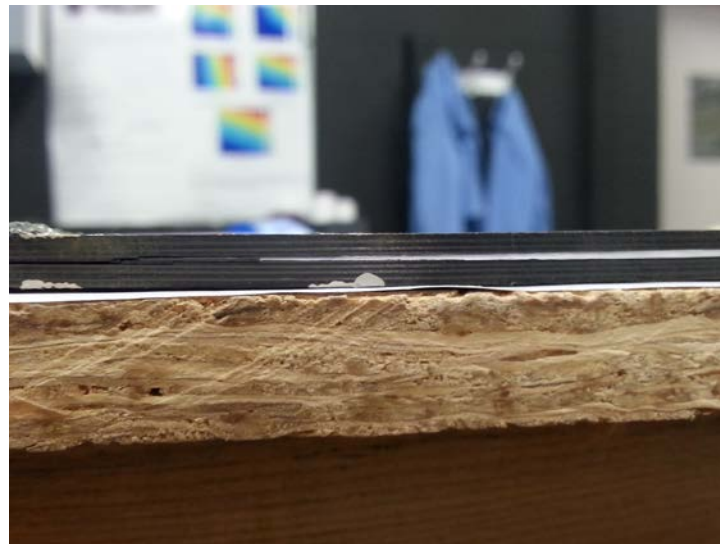
Figure 4.36: Side 1 Delamination of Sample 1-7

Figure 4.37: Delamination Side 2 of Sample 1-7

Figure 4.38: Delamination Side 3 of Sample 1-7

Figure 4.39: Delamination Side 4 of Sample 1-7

out the sample out of the fixture it was determined that there was massive delamination in the center layers of the composite. The damage is seen in Figures 4.36-4.39.
