ASSESSING CORROSION DAMAGE IN POST-TENSIONED CONCRETE STRUCTURES
USING ACOUSTIC EMISSION & A PRELIMINARY INVESTIGATION OF BIOPOLYMER
DOPED CEMENT MORTAR FOR USE IN STRUCTURAL RESTORATION

Civil Engineering

University of South Carolina

2013

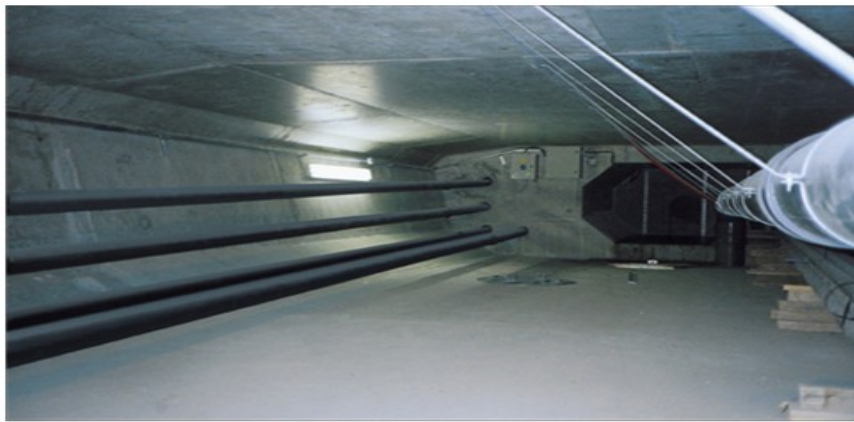
Figure 1.1: External Post-Tensioning in a bridge (www.cclint.com)

Both of these methods of PT were developed at the same time, and are extensively used. In some cases like bridges, mixed post-tensioning is also preferred wherein both internal and external post-tensioning is adopted. In both external and internal PT, the tendons pass through either metal, High Density Poly Ethylene [HDPE], or poly propylene ducts to transfer stresses from the strands to the concrete. Figure 1.1 and 1.2 shows external and internal post-tensioning.

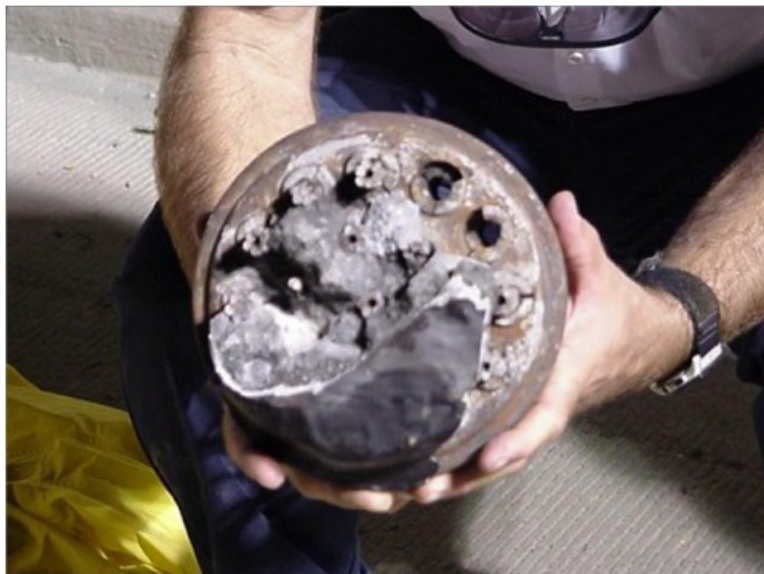
Figure 1.3: Corroded anchorage in Mid Bay Bridge (www.dot.state.oh.us)

Of 600,000 bridges in the U.S., roughly 18% are prestressed. Some of these are exhibiting corrosion in the prestressing strands. Major factors for corrosion include carbonation, high chlorides in the grout mix, ingress of chlorides due to the environment (deicing salts or location of the bridge in coastal regions), air pockets in ducts, bleed water, and faulty construction practices. High corrosion levels have been found in Florida due to the coastal climate. Some of the major bridges in that area include the Sunshine Skyway Bridge, the Niles Channel Bridge, and the Mid Bay Bridge. The Mid Bay Bridge was opened in 1993, and by 2000 the corrosion levels in some tendons were so high that 11 tendons in the bridge had to be replaced. The same was observed in the Skyway Bridge and the Niles channel bridge. Figure 1.3 shows severe corrosion in the anchorages of Mid Bay Bridge.

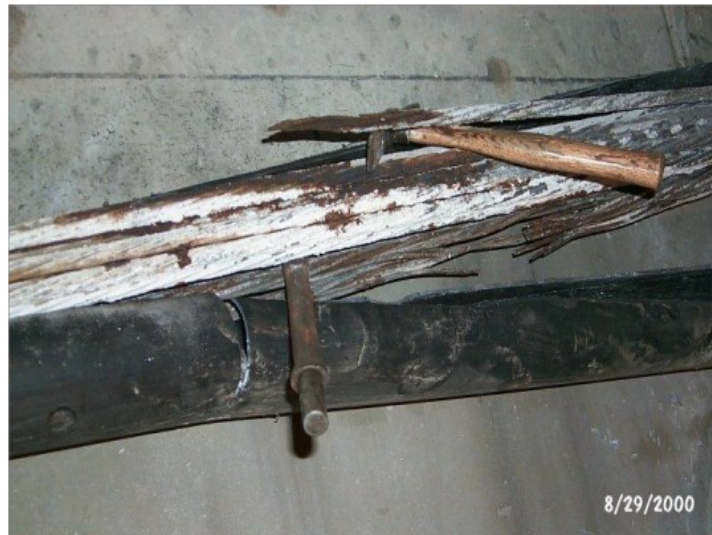
Figure 1.4: Cracked duct showing severely corroded strand (www.dot.state.oh.us)

It was also observed that cracking of the ducts due to faulty construction practices or slipping of the ducts at deviator blocks or anchorages in the Mid Bay Bridge left the strand exposed to the environment, thereby accelerating the corrosion process. In Figure 1.4 and 1.5 show cracking and slipping of ducts in the Mid Bay Bridge.

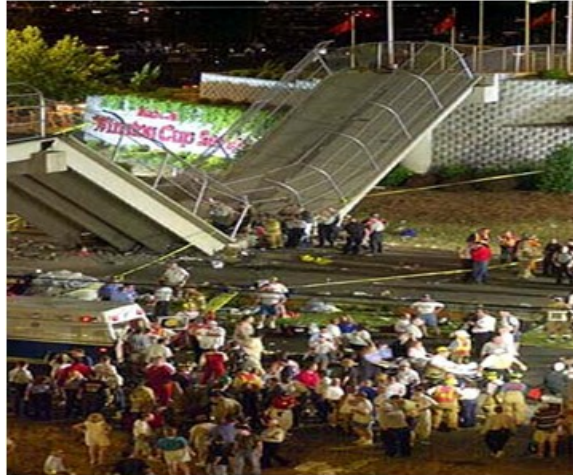
Figure 1. 7: Lowes Motor Speedway Bridge Collapse, May 2000, US
(www.onlineathens.com)

In May 2000, a 24.5 m (80-ft) section of the Lowes Motor Speedway Bridge in North Carolina collapsed killing and injuring several people. Investigations have revealed that the cause of the collapse was corrosion of the strands. This was in turn due to the use of a grout with excess calcium chloride during the general repair and maintenance procedures of the bridge. Figure 1.7 shows the collapsed section of the Lowes Motor Speedway Bridge. In 2011, the FHWA released a list of 35 post-tensioned bridges across the U.S. that are experiencing corrosion in their strands due to excess chlorides in the grout mix, and the list is expected to increase.

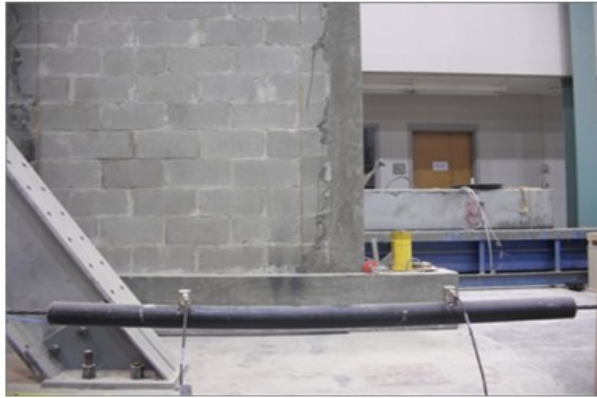
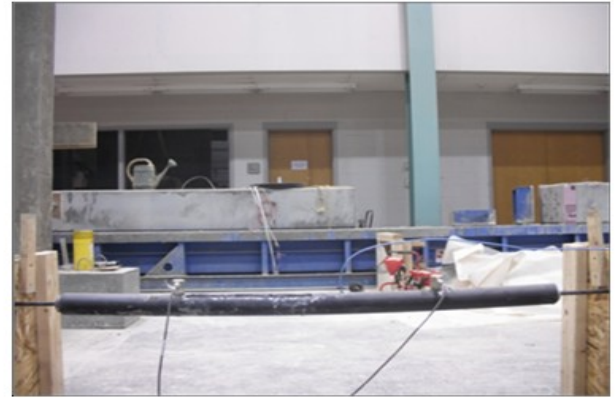
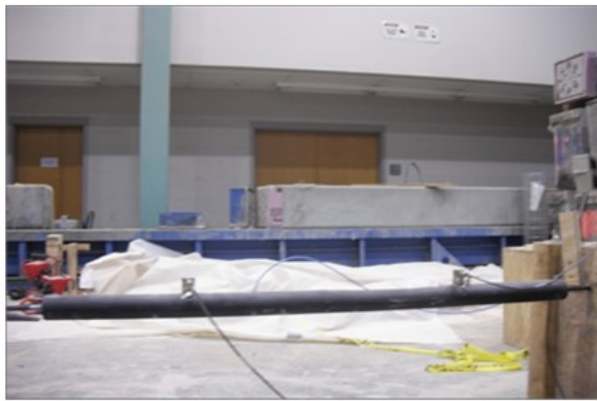
Figure 2. 2: External Post-Tensioned Specimens: (a) Control, E1; (b) Wet-dry 4 ft, E2; (c) Exposed Strand, E3; and (d) Wet-dry 10ft, E4

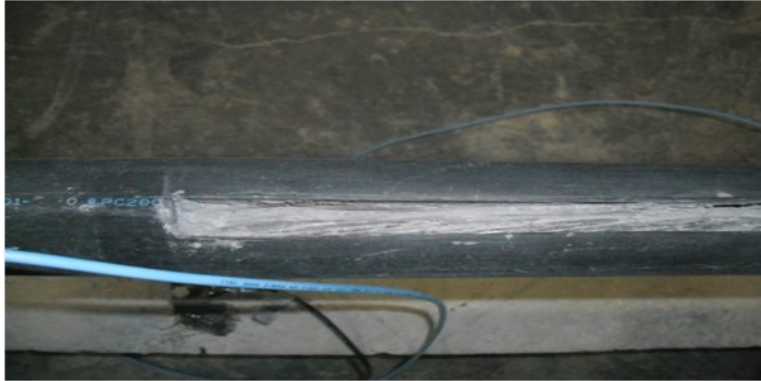
Figure 2. 3: Top view of specimen E3

Specimen E3 measured 1.22 m (4 ft.) in length and had the strand exposed to the environment mimicking an air void and corrosion under environmental conditions. To achieve this, a small section of size 300 mm x 25 mm (12 in. x 1 in.) was cut from the HDPE duct and a small piece of wood was placed, so that when the duct is grouted the grout will fill the duct leaving the strand exposed. Figure 2.3 shows the exposed strand specimen, E3. This specimen was left exposed to the atmosphere for the first 45 days, after which a small quantity of 2% NaCl solution was sprayed only once on the strand to induce corrosion. The two remaining specimens, E2 with a length of 1.22 m (4 ft.) and E4 with a length of 3.05 m (10 ft.) , had 300 mm (1 ft.) long, 25 mm (1 in.) wide and 12.5 mm (1/2 in.) deep grooves to facilitate wet-dry cycling. Figure 2.4 shows the groove for specimen E4. These wet-dry specimens were subjected to 3 days wet (Monday to Wednesday) and 4 days dry (Thursday to Sunday) cycles. Initial wet-dry cycles were started after five days of start of AE with a 2% NaCl solution. This NaCl solution was

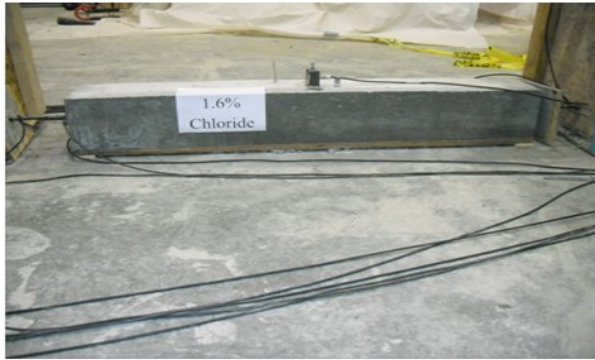
Figure 2. 5: Internal PT Specimens: (a) 0.08% Cl, I1; (b) 0.8% Cl, I2; (c) 1.6% Cl, 4ft, I3; and (d) 1.6% Cl, 10ft, I4

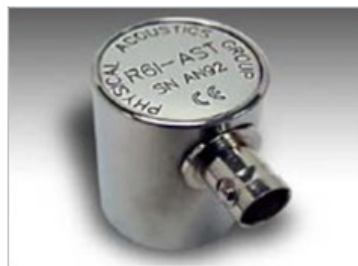
Figure 2. 6: R6i AE sensor (Mistras Group, Inc.)

Each of the specimens was monitored with two acoustic emission (AE) resonant sensors, 55 kHz with an integral 40 dB pre-amplifier (R6i) as shown in Figure 2.6, (Mistras Group, Inc.). The sensors were strategically located on the specimens to pick up corrosion activity. The sensors were connected to a 16-channel data acquisition system (Sensor Highway II, Mistras Group, Inc.). For the internal PT specimens, one AE sensor was positioned at the center of the top surface of the specimen while the other sensor was positioned on one face of the cross-section between the strand and the grout, as shown in Figure 2.7.

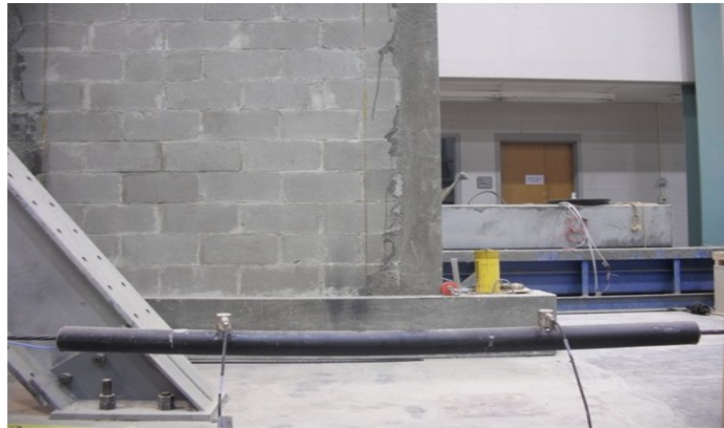
Figure 2. 8: Positioning of sensors on external PT specimens

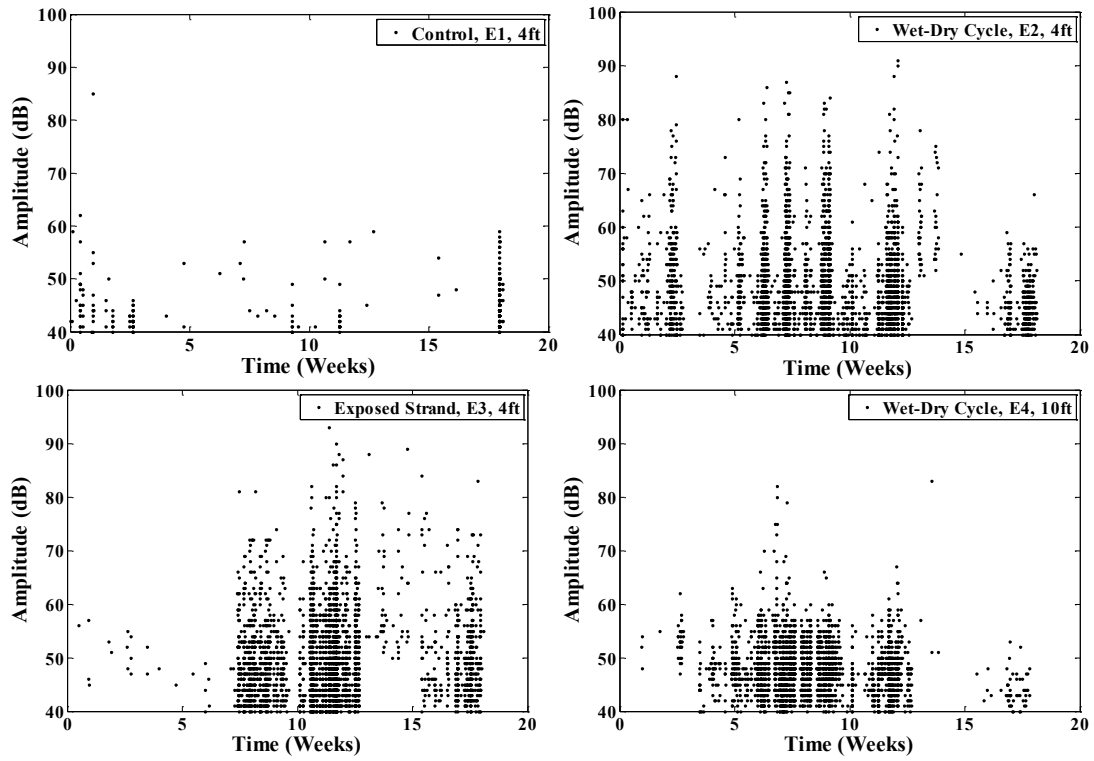
Figure 2. 13: Amplitude vs. time for external PT specimens

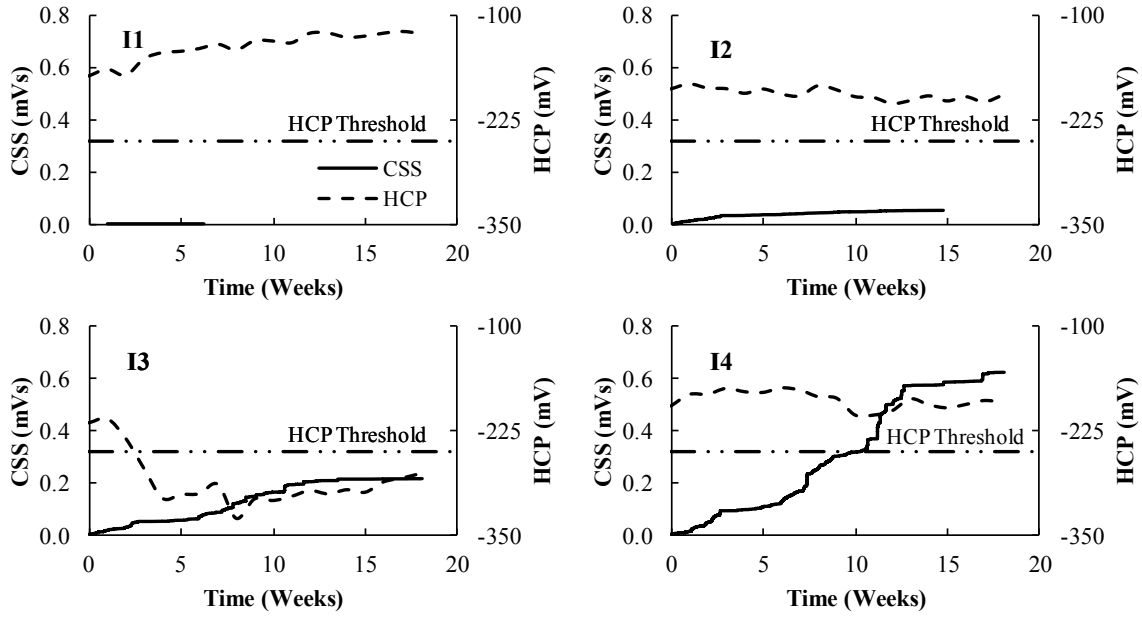
Figure 2.14: CSS vs. time and HCP vs. time for internal PT specimens
