Assessment, Prevention And Remediation Of Corrosion In Weathering Steel Transmission Line Poles

**ASSESSMENT, PREVENTION AND REMEDIATION OF CORROSION IN
WEATHERING STEEL TRANSMISSION LINE POLES**

Civil Engineering

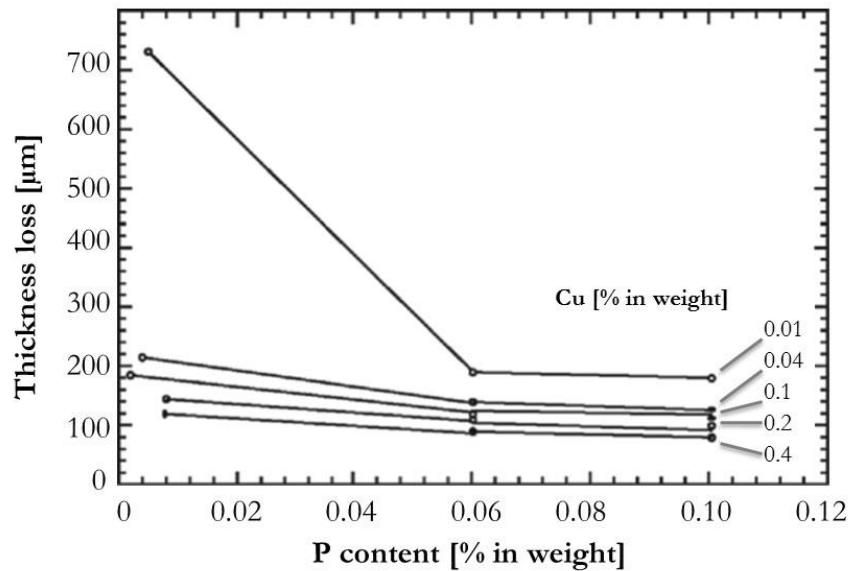
Figure 2.3 Effect of P content for different Cu contents on corrosion-induced thickness loss of steel exposed to industrial atmosphere for 15.5 years (Larrabee and Coburn 1962).

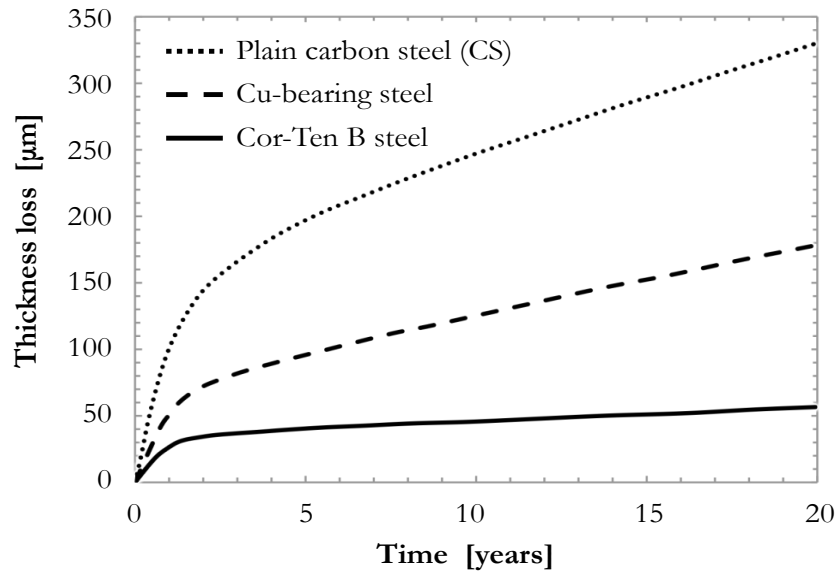
exposed to the industrial atmosphere of Kearny, NJ, are shown in Figure 2.6 (Larrabee and Coburn 1962). Cor-Ten B steel exhibited far superior corrosion resistance as a result of the formation of a stable and dense protective (self-passivating) oxide film, also known as patina, on the surface (Kamimura et al. 2002). It is noted that the corrosion index in ASTM G101 (2010) is based on the 15.5-year data from Kearny, NJ.

Figure 2.6 Corrosion thickness loss trend for CS, Cu-bearing and Cor-Ten B steel samples exposed to industrial atmosphere in Kearny, NJ (Larrabee and Coburn 1962).

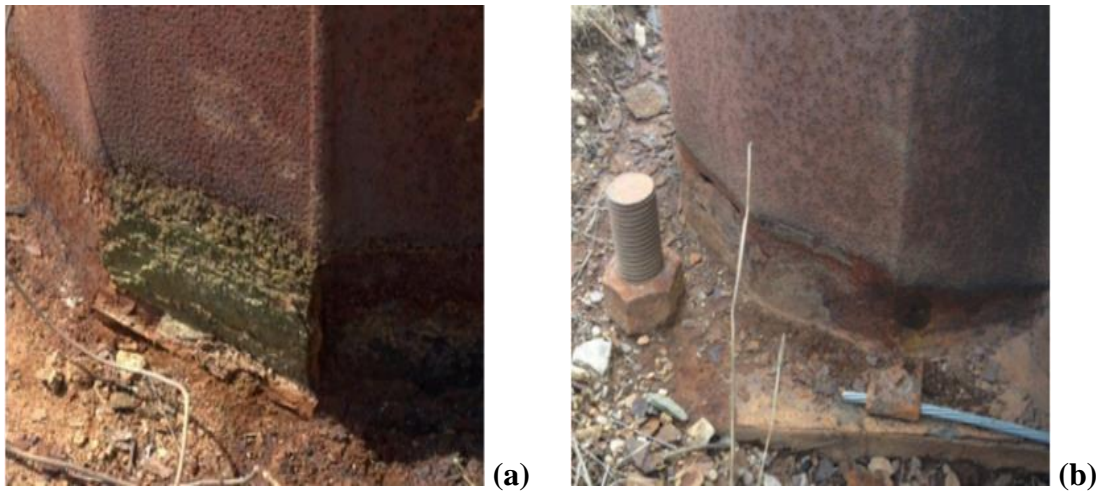
continue with the formation of multiple non-adherent and unstable oxide films, thereby producing significant thickness losses as shown in the examples in Figure 2.7.

Figure 2.7 Examples of pack-rust damage near ground line of WS poles: (a) multiple layers stacking on one another; and (b) more severe thickness loss.

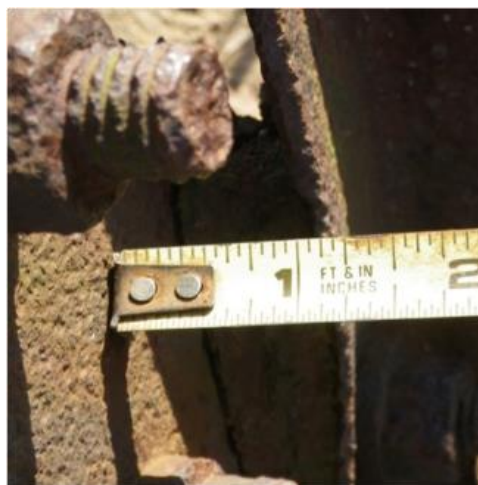
In WS structures, pack rust may build up at joints and crevices (e.g., between fasteners and steel plates), producing “pack-out” corrosion damage. In fact, pack rust has typically no room to flake off between adjacent steel surfaces in joints, and can build up. The volumetric expansion of the corrosion by-products results in significant pressures that are exerted on the adjoined steel elements, and may lead to structural damage due to large (plastic) deformations in addition to thickness losses (Dodson 2012). While this phenomenon is more likely to occur in WS lattice structures where mechanically-fastened connections are more common (Figure 2.8), it can also occur at discontinuities (e.g., coating lines) in WS transmission line poles.

Figure 2.8 Pack-out damage at connection in WS transmission line lattice structure. Note bent steel member.

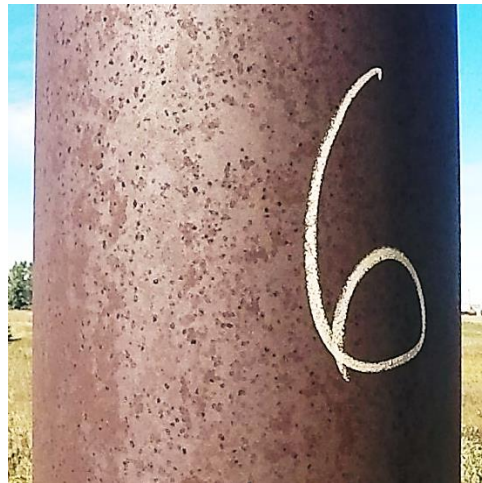
Another form of corrosion damage that is of concern in WS transmission line poles is pitting. Pitting is a localized form of corrosion by which pits form in the metal substrate (Figure 2.9). Pitting is typically initiated by the occurrence of a local cathodic site within a

regular steel surface, and can be exacerbated by chemical or mechanical damage to the protective oxide film and damage to or poor application of protective coatings. The practical significance of pitting corrosion with respect to structural safety depends on the penetration rate and the thickness of the pole wall. The former generally decreases as the number of pits increases because the cathodic area of the pole, which controls the flow of corrosion current, is common to all adjacent pits. Pitting propagates as the penetration rate increases. Conversely, pits terminate if filled with corrosion products or the local cathode becomes covered in oxide film. Furthermore, the presence or absence of moisture will respectively facilitate or offset the development of pitting corrosion (Roberge 2008).

Figure 2.9 Widespread pitting over surface of WS pole wall.

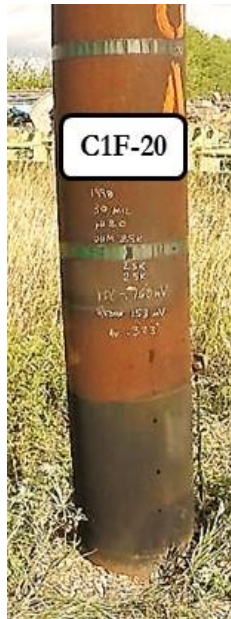
substation. At the base, Pole C1F-20 has a circular cross section with nominal diameter of 18 in. and thickness of 5/16 in. It is made of Type AT steel as defined by CSA Standard G40.21 (CSA 2013). The pole was coated with liquid-applied polyurethane coating, directly embedded into the ground, and surrounded by a gravel backfill (Figure 3.4a). The coating extended approximately 30 in. above the ground line.

Figure 3.3 Ground-level view of Pole C1F-20 at Site 1.

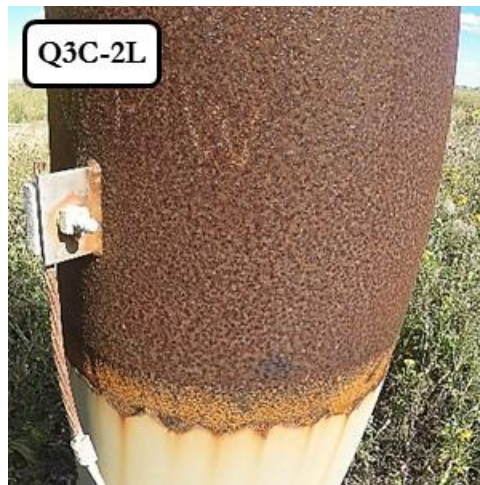
All four poles were grounded using a similar type of grounding rod electrode system and GEC configuration (Figure 3.8). Poles Q3C-1L, Q3C-2L, and Q3C-2R utilized 32-lb magnesium anodes, which were installed at time of construction, as supplementary cathodic protection. Pole Q3C-1R did not feature a magnesium anode connection because the anode attached to Pole Q3C-1L was designed to protect both poles, which were connected to form an H-frame.

Figure 3.8 Corrosion prevention measures seen on Site 2 poles, including GEC link to grounding rod and magnesium anode connection.

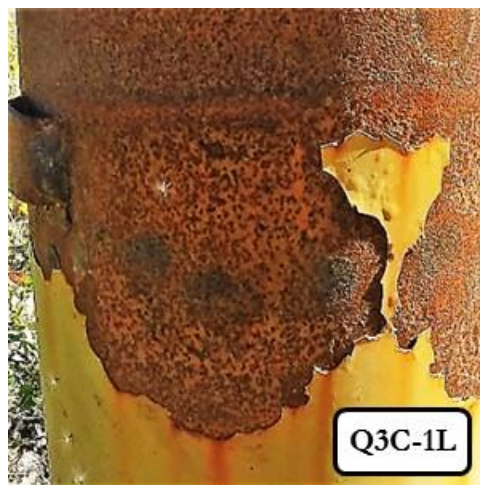
in. for Pole Q3C-1L, and 30 in. for Pole Q3C-2L. Severe degradation was evident as significant coating lip delamination was observed around the entire circumference of each pole. The worst case of coating lip delamination (on Pole Q3C-1L) had resulted in an 8-in. drop from the original coating height (Figure 3.9). Such defects facilitate moisture penetration and stagnation. As a result, pack rust was observed at these coating crevices and discontinuities.

Figure 3.9 Severely delaminated coating line accompanied by widespread pack rust and pack out on ladder clip.

On some poles, bands of discolored orange-brown rust (indicative of non-protective patina) were seen to stretch from the lips to the level where the coatings originally terminated. Pitting was also common around this region, generally at a severity of Level A3-B4 per ASTM G46 (ASTM 2013c). One way that coating delamination was seen to propagate was through the formation of pack-out rust at the pole wall-coating interface, which is clearly evident on Poles Q3C-2L and Q3C-2R (Figure 3.10). This pack-out damage results in steel section losses while at the same time prying the coating from the pole. These phenomena are reasonably attributed to repetitive moisture entrapment

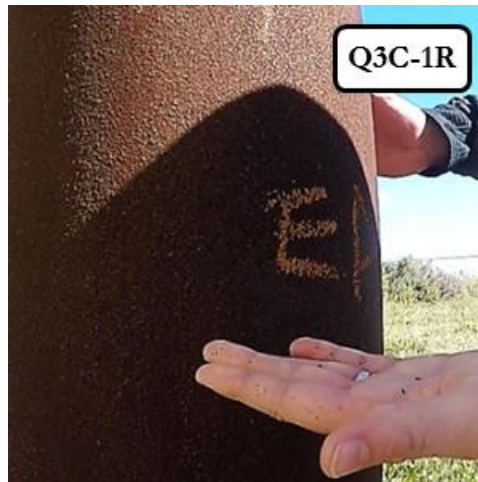
Problems were not isolated to the coating and ground-line regions. While the patina for each pole was dark-brown for the most part, grain size and roughness of the patina visibly increased on surfaces closer to the potash plant. This increase in coarseness was an indicator of the non-adherence of the patina. In fact, the plant-side outer oxide layers on Poles Q3C-1L and Q3C-1R would slough off 2-5 mm rust pieces by simply running a hand across the WS surface (Figure 3.11).

Figure 3.11 Non-adherent patina sloughing off with light rubbing of pole wall surface.

These instances of corrosion damage pointed to the formation of a non-protective oxide layer due to the continuous exposure to an industrial atmosphere. The adjacent potash mine provided a ready source of corrosive sulfur dioxide (SO_2) with the dust and exhaust fumes from its processing facilities. It is noted that the potash produced here has primarily been of the potassium chloride variety (PotashCorp 2015). A relevant implication is that, as a result of potash processing, atmospheric chlorides have also contributed to the environmental corrosivity of Site 2, lowering the effectiveness of the protective patina of nearby WS structures. This is highlighted since, to the best of the authors' knowledge, no study has been published on this type of corrosive environment, different from atmospheric chlorides at marine locations and from the use of deicing salts.

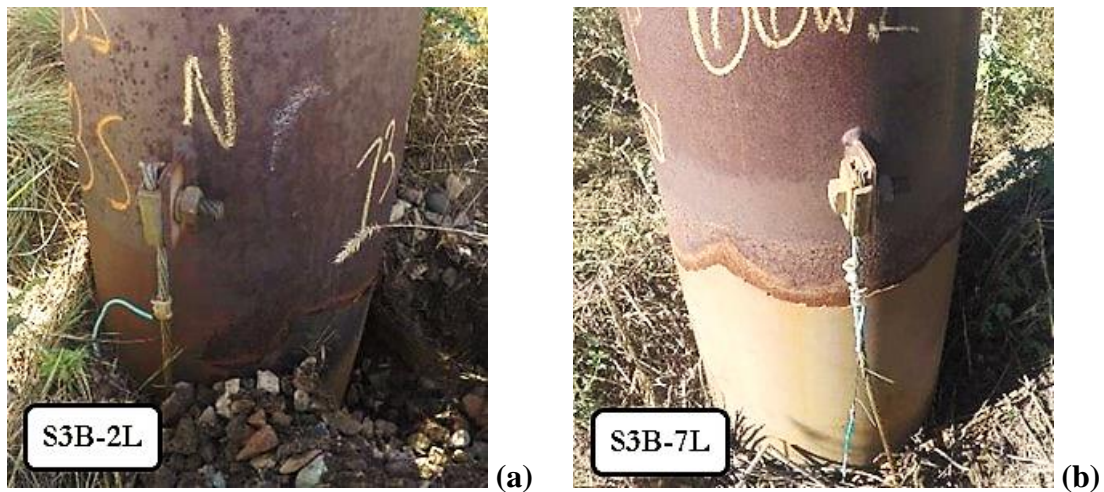
Figure 3.14 Site 3 pole bases showing corrosion prevention measures and: (a) coating barely extending above ground line; and (b) steady delamination of coating due to pack rust.

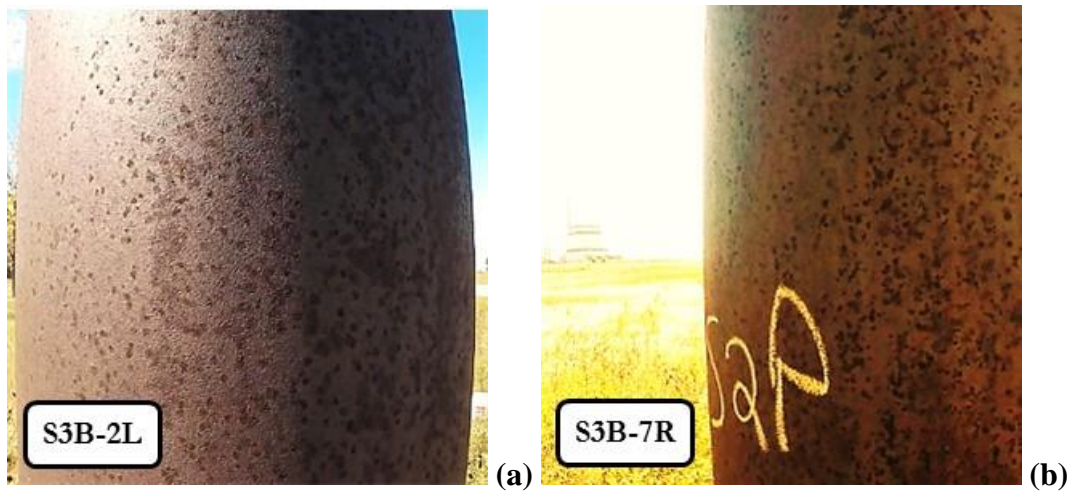
non-uniform thickness loss at the ground line. Widespread pitting occurred on the entire above-ground WS surface. The worst Level A4-B4 pitting (ASTM 2013c) was observed on the side facing the power station, as shown in Figure 3.15a.

Figure 3.15 Dense pitting sites on pole wall surfaces: (a) Pole S3B-2L facing power station; and (b) Pole S3B-7R facing coal company.

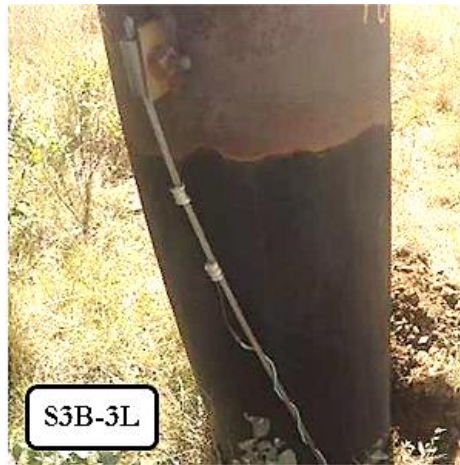
Pole S3B-3L (Figure 3.16) demonstrated that WS poles can offer satisfactory corrosion resistance if located far enough away from buildings. The patina was dense, uniform, and without pits. Minor delamination at the coating lip did occur, but the adjacent rust layer was more stable than those seen in other poles (e.g., Pole S3B-7L in Figure 3.14b). Also, the coating lip reached approximately 36 in. above the ground line (Figure 3.16), thus minimizing concerns for ground line corrosion damage.

Figure 3.16 Pole S3B-3L showing minor coating delamination but overall dense and adherent patina.

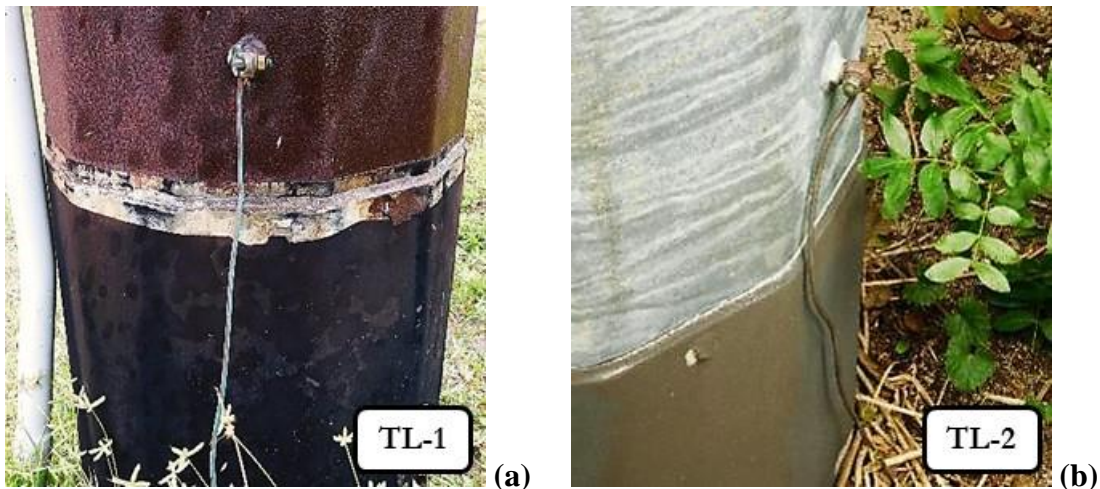
Figure 3.19 Ground-line coating on poles at Site 4: (a) Pole TL-1; and (b) Pole TL-2.

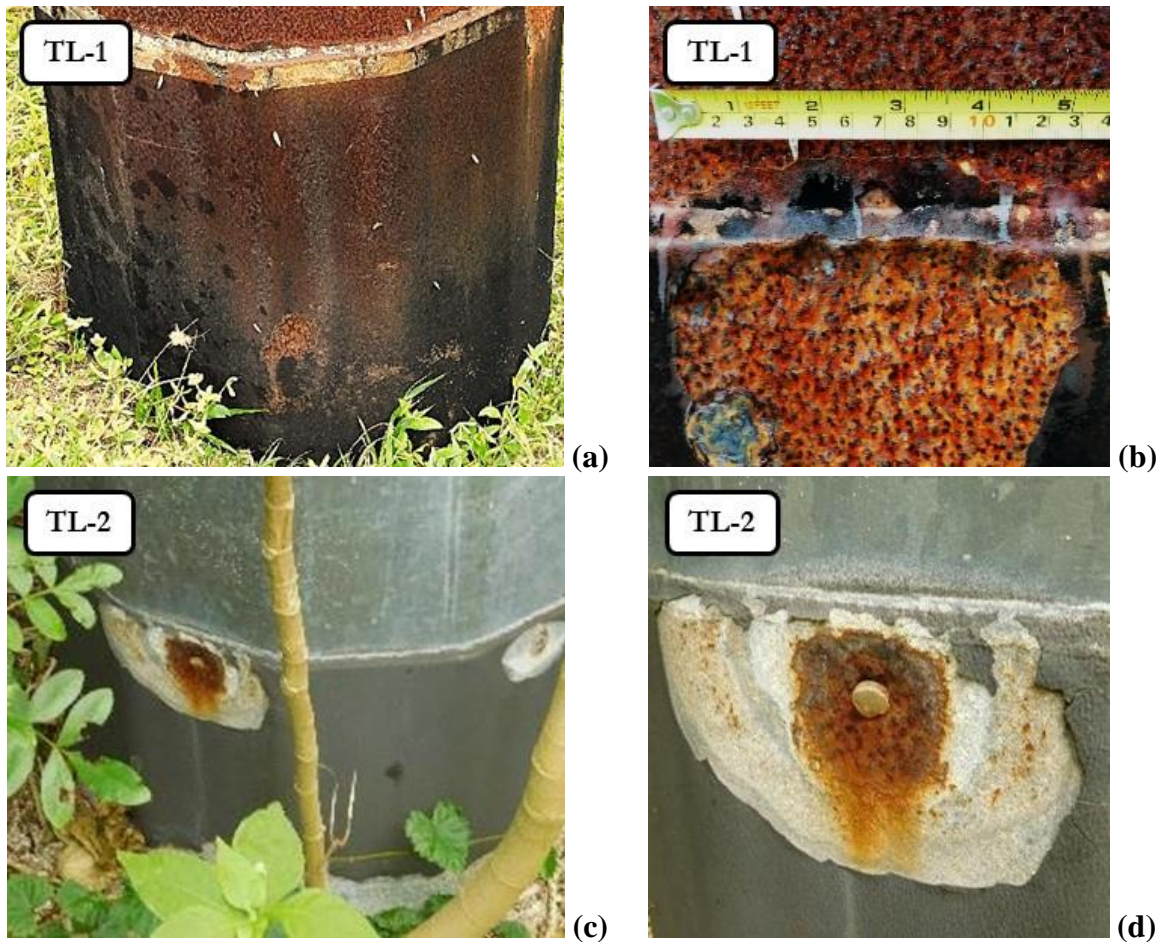
Figure 3.20 Damage around coating region in WS Pole TL-1 and GS Pole TL-2 near ocean: (a) deterioration of Pole TL-1 coating with visible pits; (b) pitting and pack-rust corrosion damage at Pole TL-1 coating lip; (c) coating delamination around bolted sleeve on Pole TL-2; and (d) crevice corrosion on Pole TL-2.

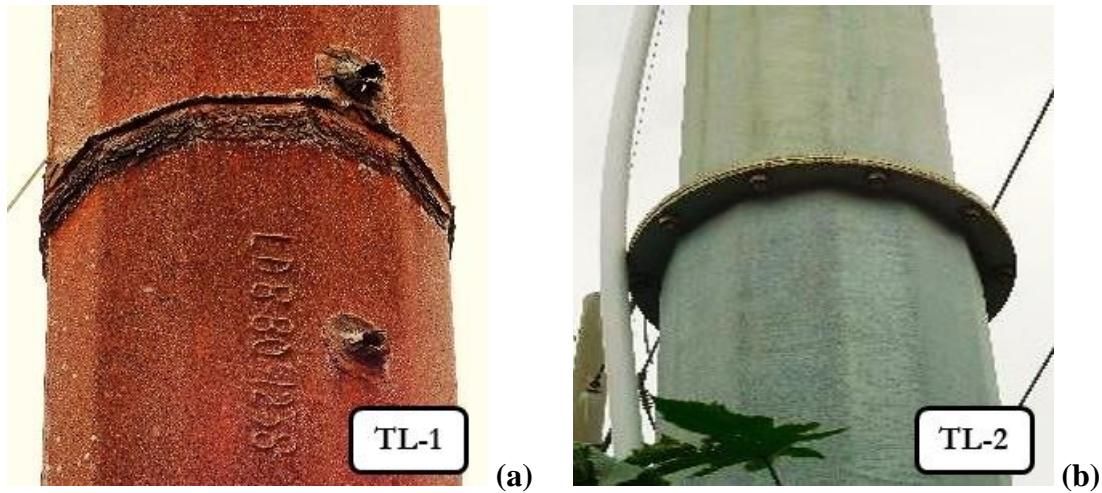
Figure 3.22 Condition of overhead slip joints near saltwater: (a) pack-rust damage on WS Pole TL-1 sections; (b) apparently sound, corrosion-free GS Pole TL-2.

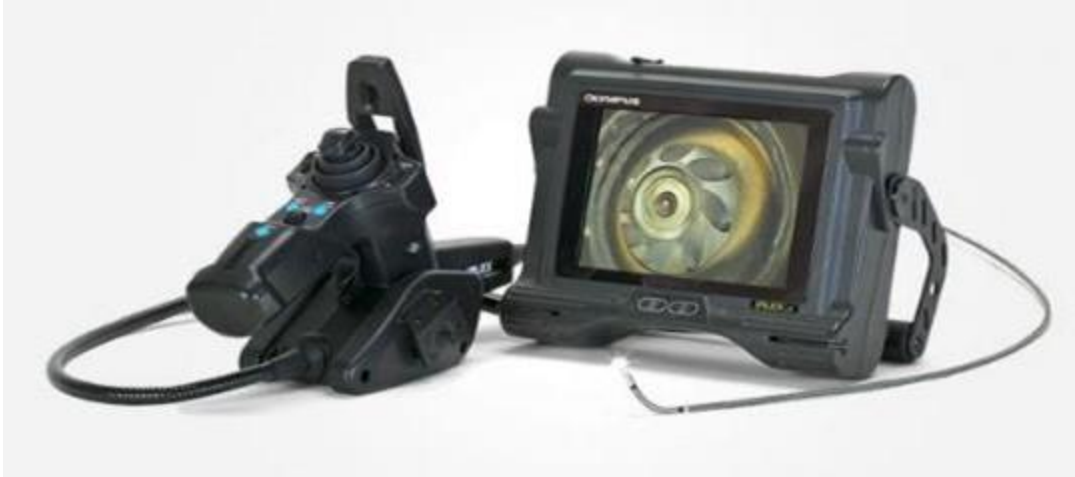
Because of the extent and degree of corrosion damage observed on Pole TL-1, the possibility of moisture penetration into the pole (and subsequent internal corrosion phenomena) was further investigated by inspecting the interior walls using a borescope camera (model IPLEX LX, Olympus Corp., Figure 3.23). The process of using a borescope to inspect tubular poles, shown in Figure 3.24, consists of: pole wall grinding; drilling; surface cleaning; hole threading; insertion of the borescope camera; examination of pole interior; and plugging the hole after inspection with a threaded bolt. This bolt is left to rust over in order to fill the newly made hole in the pole wall.

Figure 3.23 IPLEX LX borescope camera (Olympus Corp.).

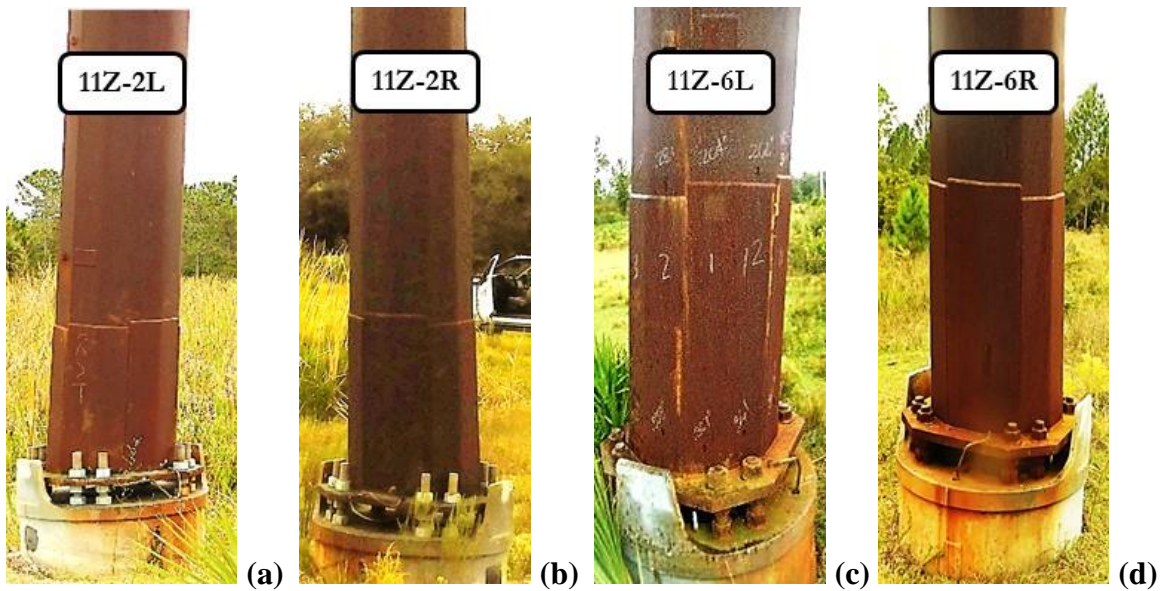
Figure 3.28 Ground-level view of Site 5 poles of Line 11Z: (a) Pole 11Z-2L; (b) Pole 11Z-2R; (c) Pole 11Z-6L; and (d) Pole 11Z-6R.

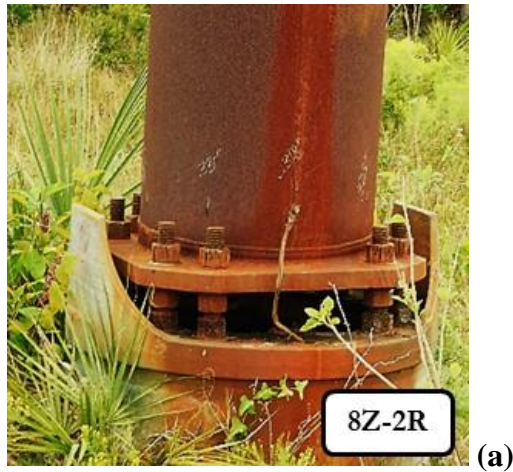
The caissons had been stained brown to different extents due to rain run-off from the WS pole surfaces. Vegetation build-up was noted around some of the pole bases, creating an environment that may facilitate moisture retention instead of wet/dry cycles. Different forms of corrosion damage were observed (Figure 3.29). Poles 8Z-2L and 8Z-2R (Figure 3.29a) exhibited large streaks of discoloration on their walls. In addition, their nuts and bolts at the base plate connections were no longer galvanized and were heavily corroding. Poles 11Z-6L and 11Z-6R (Figure 3.29b) exhibited a smooth and adherent patina, but their nuts and bolts at the base plate connections were also corroding. Conversely, Poles 11Z-2L (Figure 3.29c) and 11Z-2R seemed to be good condition with respect to the quality of the patina and the galvanized layer on the GS fasteners. To this end, it is important to note that these two poles had been remediated within the past five years by filling the caisson foundations with concrete, replacing corrosion-damaged GS fasteners, and introducing cathodic protection in the form of two magnesium anodes connected to the caisson foundation of Pole 11Z-2L.

Figure 3.29 Visual assessment of poles at Site 5: (a) discolored patina, corroding fasteners, and vegetation build-up around Pole 8Z-2R; (b) uniform patina but corroding fasteners on Pole 11Z-6R; and (c) uniform patina and GS fasteners on Pole 11Z-2L.

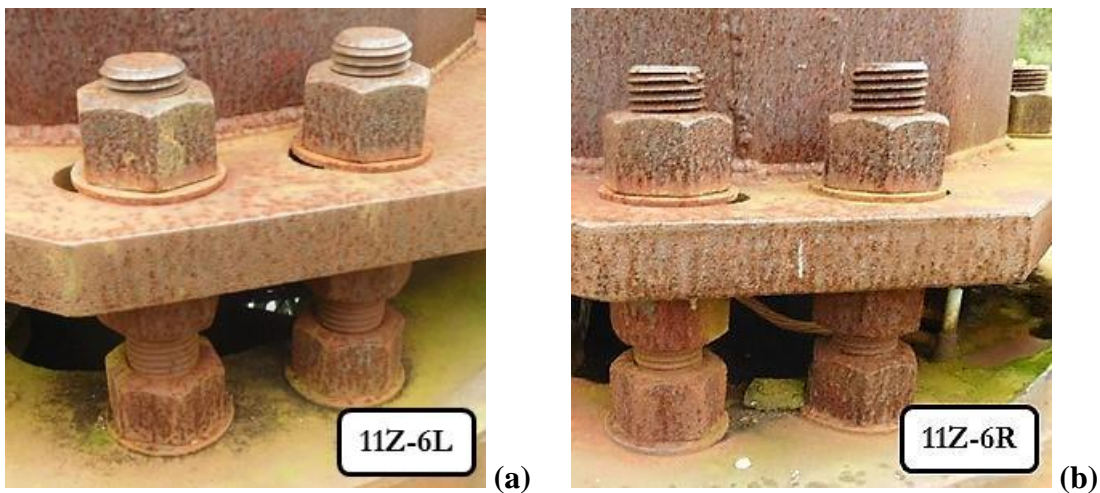
Figure 3.31 Corrosion of GS fasteners connecting WS pole to GS caisson for Line 11Z poles at Site 5: (a) depletion of protective zinc layer on GS nuts of Pole 11Z-6L; and (b) pack-rust damage on bottom GS nuts of Pole 11Z-6R.

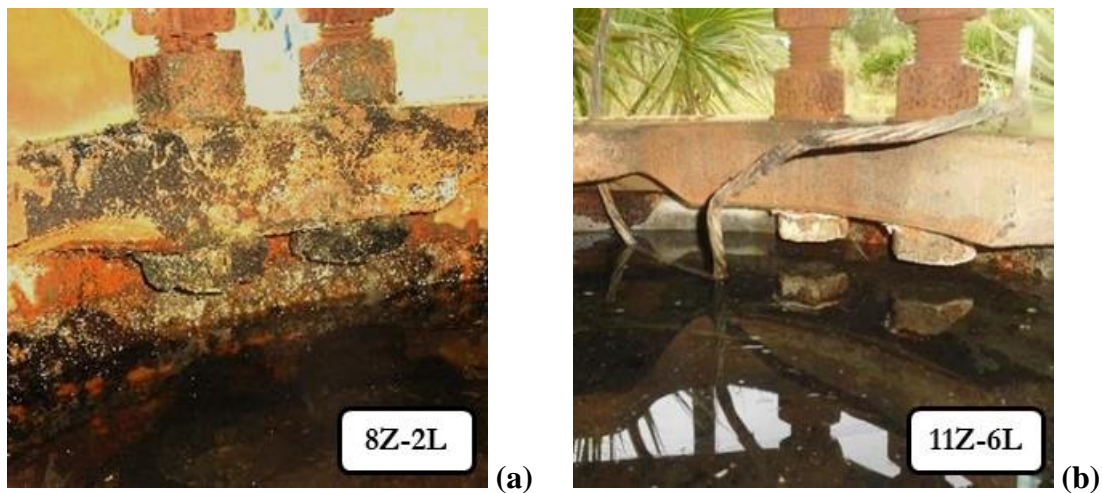
Figure 3.33 Water pooling in GS caisson foundations leading to: (a) sludge build-up; and (b) pack-rust damage on GS nuts.

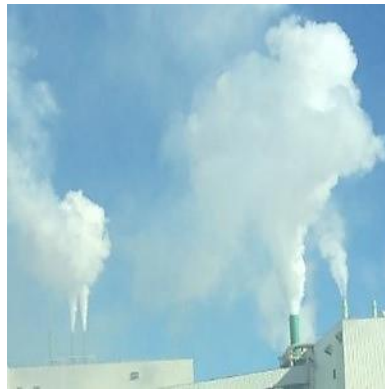
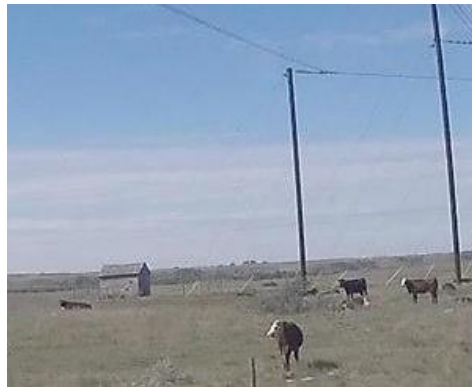
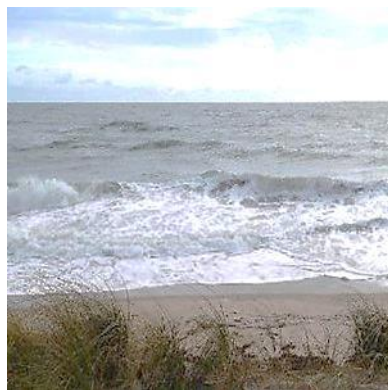
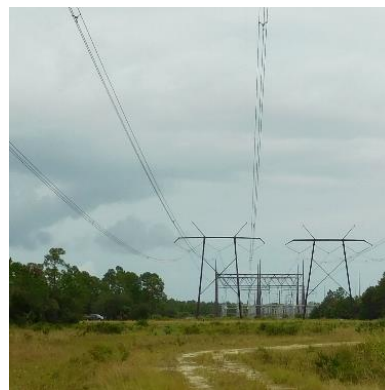
Figure 4.1 Photographs illustrating atmospheric exposure of WS pole structures in: (a) Site 1; (b) Site 2; (c) Site 3; (d) Site 4; and (e) Site 5.

The main factors that influence atmospheric corrosivity for WS alloys are moisture, presence of airborne contaminants, especially sulfur dioxide and chloride (Sereda 1960), and temperature. The five test sites covered in this study offer a representative and significant range of exposure environments, as illustrated in Figure 4.1. In fact, Sites 1, 3, and 5 generally exhibit rural atmospheres but each has peculiarities that may significantly affect corrosion behavior, such as: proximity to a metropolitan area and steel plant (Site 1),

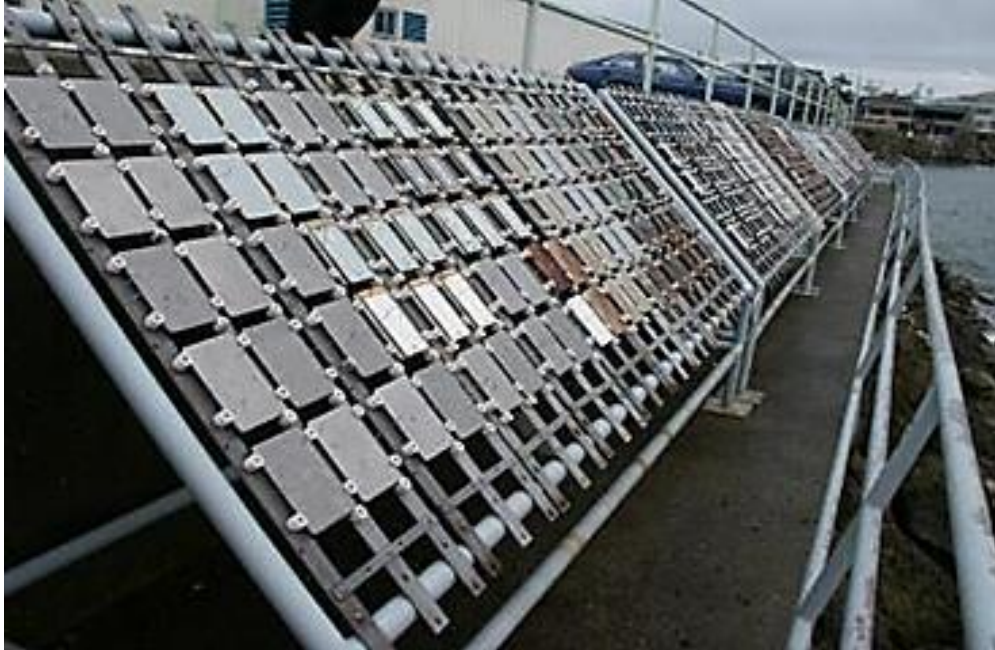
Figure 4.7 Steel panel specimens mounted on inclined rack for corrosion testing in chloride-laden atmosphere (Roberge 2008).

Standard test methods are available to monitor atmospheric properties. Galvanic cell monitoring can be enlisted to estimate TOW per ASTM G84 (ASTM 2012c). Likewise, sulfation plate tests can be used to estimate the deposition rate of SO₂ in accordance with ASTM G91 (ASTM 2011b), and the “wet-candle” method can be used to measure chloride deposition rates in accordance with ASTM G140 (ASTM 2014a). In addition, different test specimens, experimental setups and protocols, and measurement methodologies can be enlisted to evaluate the corrosion resistance of WS materials and structures vis-à-vis atmospheric environments and exposure conditions. Steel panel specimens are typically considered for atmospheric corrosion testing, in addition to standard tensile specimens for basic mechanical characterization and, when needed, stress corrosion cracking (SCC) specimens (Roberge 2008). Panel specimens should be prepared, cleaned (e.g., using acetone), and evaluated in accordance with ASTM G1 (ASTM 2011a). These specimens are typically mounted in racks that are inclined with respect to the horizontal plane and face the source of corrosive atmosphere, as shown in Figure 2.5 (Larrabee and Coburn 1962) and Figure 4.7 (Roberge 2008). Representative panel specimen dimensions are 100-150 mm in width and length with thickness of 2 mm. The specimens are electrically insulated from the racks and arranged to prevent cross-contamination with adjacent panels (Albrecht and Hall 2003).

Atmospheric corrosion tests on steel (including WS) panels are typically performed in accordance with ASTM G50 (ASTM 2015b). Depending on the test objectives, specimens may be fully exposed or partially sheltered. In most exposure experiments, a relatively large number of specimens are used to enable a comprehensive characterization of corrosion damage (e.g., including the chemical composition of the protective oxide film as reviewed in Section 1.1) at different test times such as 1, 2, 7, and 20 years or 2, 5, 10, and 20 years, whereas short-term experiments are of lesser use as they are likely to yield evidence that is inconclusive or difficult to interpret in a meaningful fashion.

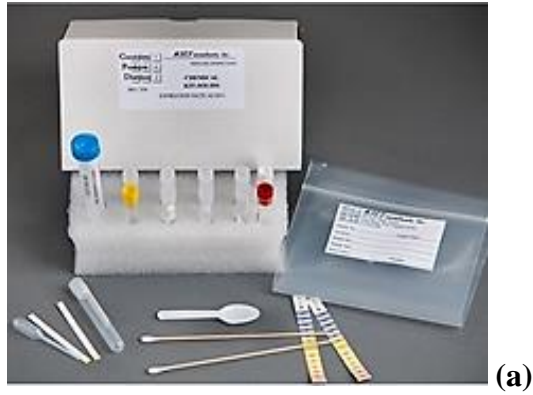
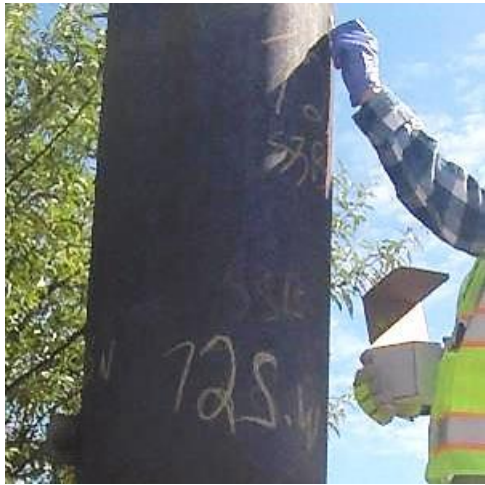
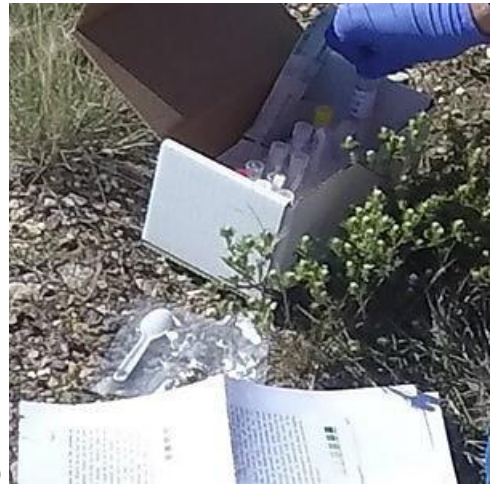
Figure 4.13 Surface-swab testing for chloride and sulfate deposition: (a) test kit by MSES Consultants, Inc.; (b) pole swabbing; and (c) on-site analysis of swab samples.

Surface-swab tests were chosen as the means for quantifying contaminant deposition. In fact, surface swabbing seemed to be more expedited and repeatable than Bresle patch tests and, more importantly, allow to collect chloride as well as sulfate samples whereas the Bresle patch method is not applicable to sulfate depositions. Surface-swab chemical inspection kits (Figure 4.13) were obtained from MSES Consultants, Inc. (Clarksburg, WV). These kits were used to quantify chloride as well as sulfate concentrations on pole surfaces at each test site using color-indicator strips, expressing the results in contaminant mass per liter of deionized water (DI) (Figure 4.14). In fact, sulfate depositions originate from SO₂ that has reacted with other elements (Ferm et al. 2006), and serve as an indicator of the presence of atmospheric SO₂. It is also noted that these kits allow to quantify pH, and iron, sulfide, nitrite, nitrate, carbonate, calcium, and manganese depositions.

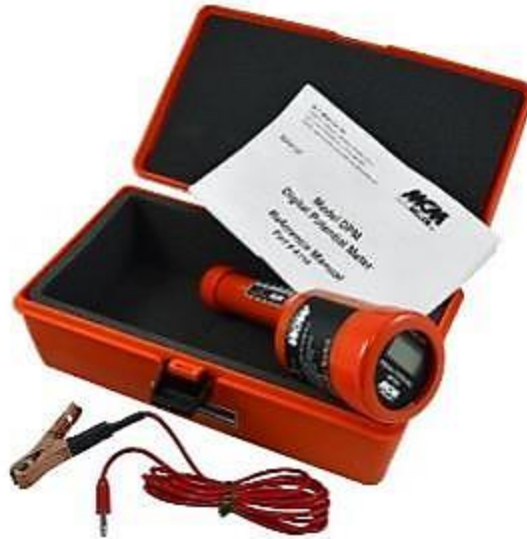
Redox potential measurements were obtained using a digital potential meter (M.C. Miller Co., Inc., Sebastian, FL) with copper/copper sulfate reference electrode (CCSRE), which is shown in Figure 4.16. The DPM can register potential ranges of 0-2 V and 0-20 V DC with $\pm 0.5\%$ accuracy and 20 M Ω input resistance on both ranges in accordance with ASTM G200 (ASTM 2014b). The use of a CCSRE is typically favored over other reference electrodes for potential measurements of systems buried in soils due to its relatively constant half-cell potential. The half-cell potential of a CCSRE is dependent only upon the electrochemical equilibrium of Cu and its ions, which is stable under most conditions.

Figure 4.16 Digital potential meter with CCSRE (M.C. Miller Co., Inc.).

copper/copper sulfate reference electrode (CCSRE) that was also used to measure redox potentials (Figure 4.16), as reported in Section 4.2.3. A photograph documenting the SSP measurement on a WS pole at Site 2 is shown in Figure 5.7.

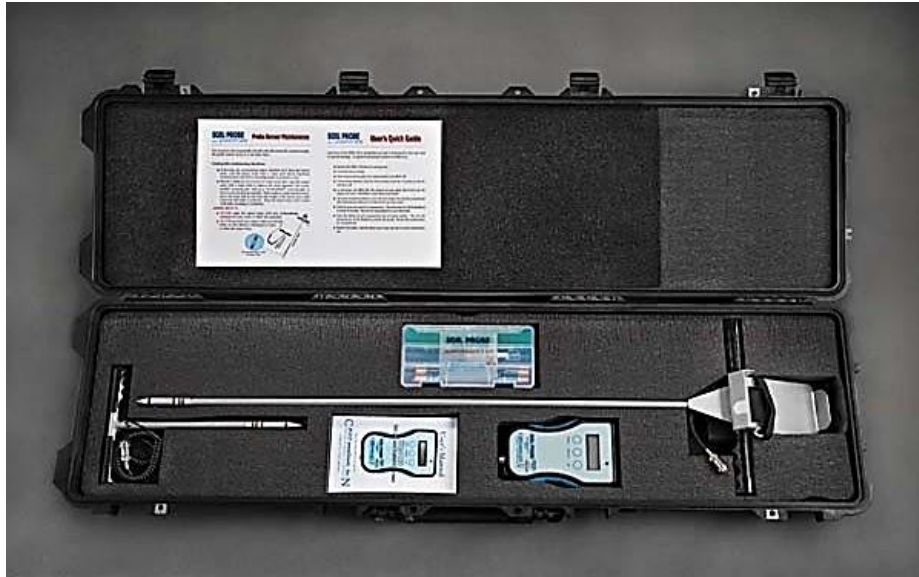
The single-measurement probe testing meter shown in Figure 4.17 (model SRM-100, MSES Consultants, Inc., Clarksburg, WV) was utilized to measure soil pH and resistivity. This instrument can register an acidity range of 3-10 standard pH units with $\pm 0.5\%$ accuracy, and a resistivity range of 0-1.5M Ω -cm with $\pm 5\%$ accuracy in accordance with ASTM G51 (ASTM 2012a). This instrument can utilize either a bell-hole probe or a subsurface probe, and essentially acts as a two-pin resistivity-measuring device where both electrodes are mounted on a single rod, similar to the two-pin testing method defined in ASTM G187 (ASTM 2012d). While this method is less accurate than the four-pin Wenner method defined in ASTM G57 (ASTM 2012b), it has the benefit of producing resistivity readings more quickly, thus lending itself to field testing.

Figure 4.17 Soil pH and resistivity meter (SRM-100, MSES Consultants, Inc.).

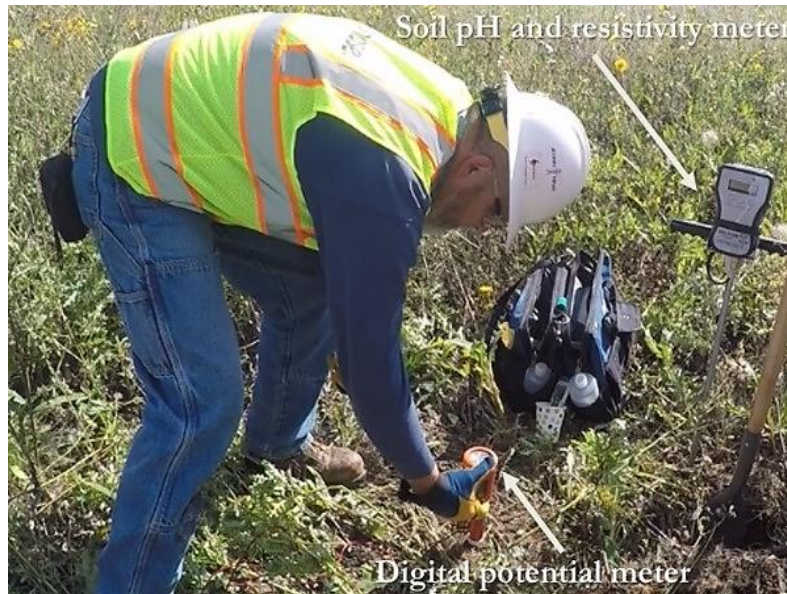
The selected digital potential meter and soil pH and resistivity meter, which are pictured in a field test in Figure 4.19, are employed in practice by Osmose Utility Services, Inc. on a regular basis. The soil inspection tests were performed for each structure in up to 30 minutes.

Figure 4.19 Field testing of soil corrosivity.

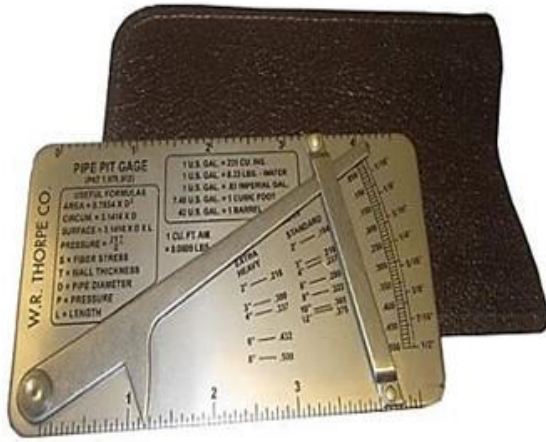
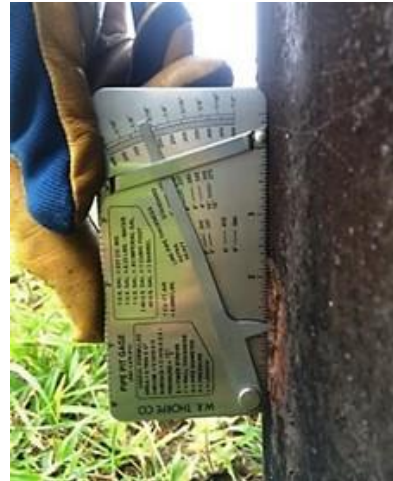
The maximum pit depths at the base of Pole TL-1 (Figure 3.20a-b) were measured using a pipe pit gage (W.R. Thorpe & Co., Bixby, OK), as illustrated in Figure 5.2. The gage can be used to measure thicknesses up to 0.625 in. (15.9 mm) with an accuracy of ± 0.005 in. (0.127 mm).

Figure 5.2 Deep pit measurement: (a) pit gage (W.R. Thorpe & Co.); and (b) measurement being performed on Pole TL-1.

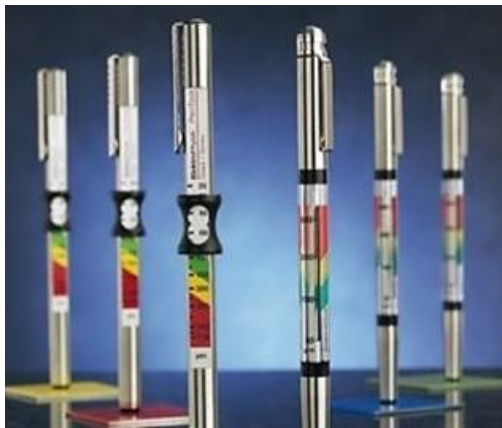
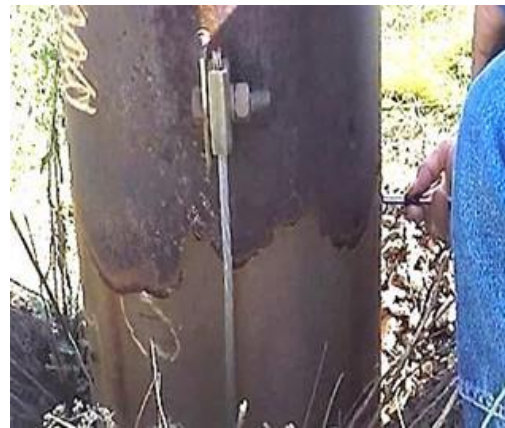
The thickness of the protective coating (t_c) was measured using a dry-film thickness (DFT) pen gage (model PenTest, ElektroPhysik, Cologne, Germany), as illustrated in Figure 5.3. The DFT pen gage is designed for quick-check measurements on steel panels in compliance with ISO 2178 (ISO 2016). The gauge works by placing the tip onto the coated steel surface, applying firm contact with the thumb, and carefully pulling up the black slide until the magnet lifts off from the coating surface. Coating thicknesses can be measured within a range of 1 to 30 mils (25 to 700 μm) with an accuracy of $\pm 10\%$ over a temperature range of 14 to 176°F (-10 to 80°C).

Figure 5.3 Coating thickness measurement: (a) thickness gage (model PenTest, ElektroPhysik); and (b) measurement being performed on Pole S3B-7R.

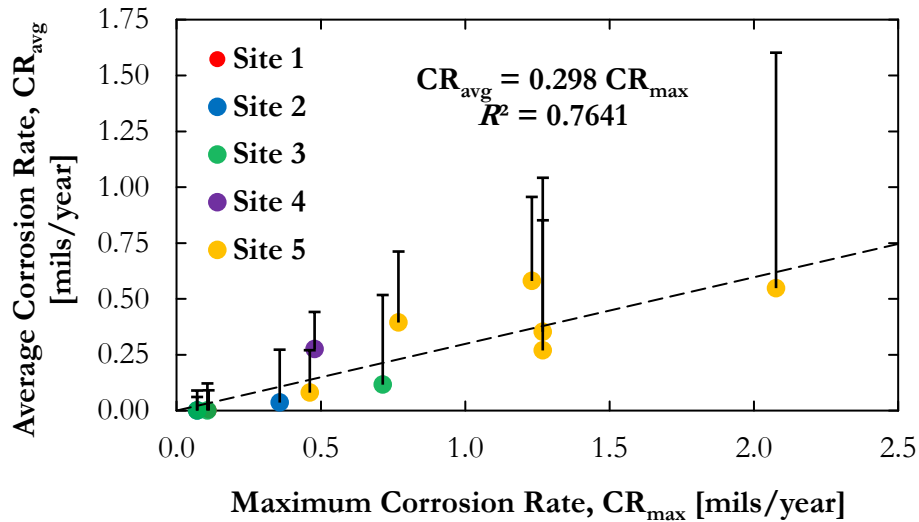
Figure 5.4 Comparison of average and maximum corrosion rate for all WS poles.

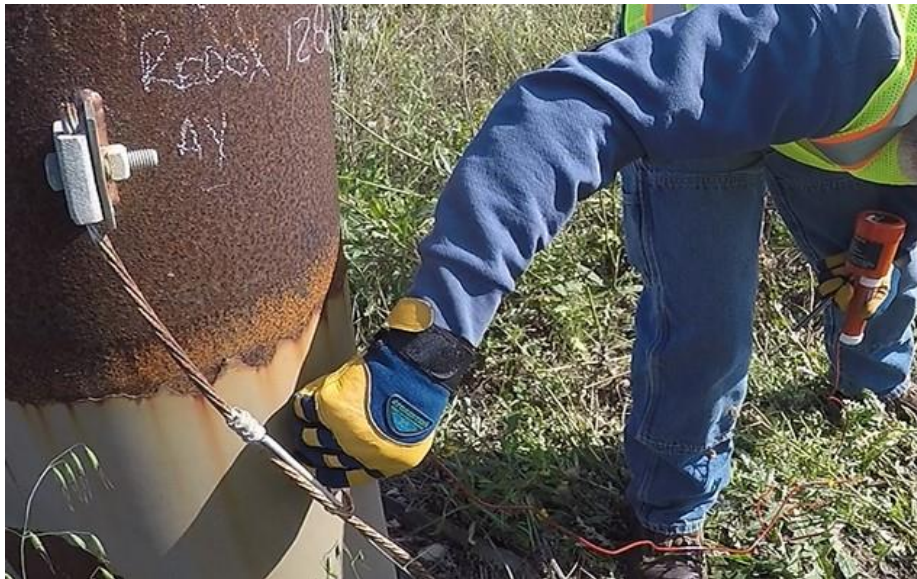
For structures with added cathodic protection, the digital potential meter was electrically attached to the magnesium anode connection (instead of the WS structure itself) to account for the influence of cathodic protection on the SSP. Otherwise, the digital potential meter was attached to a low-lying ladder clip to ensure good electrical connection, thereby providing measurements for the WS surface region and above-ground height that were covered in the visual inspections and thickness measurements.

Figure 5.7 Measurement of structure-to-soil potential on WS pole at Site 2.

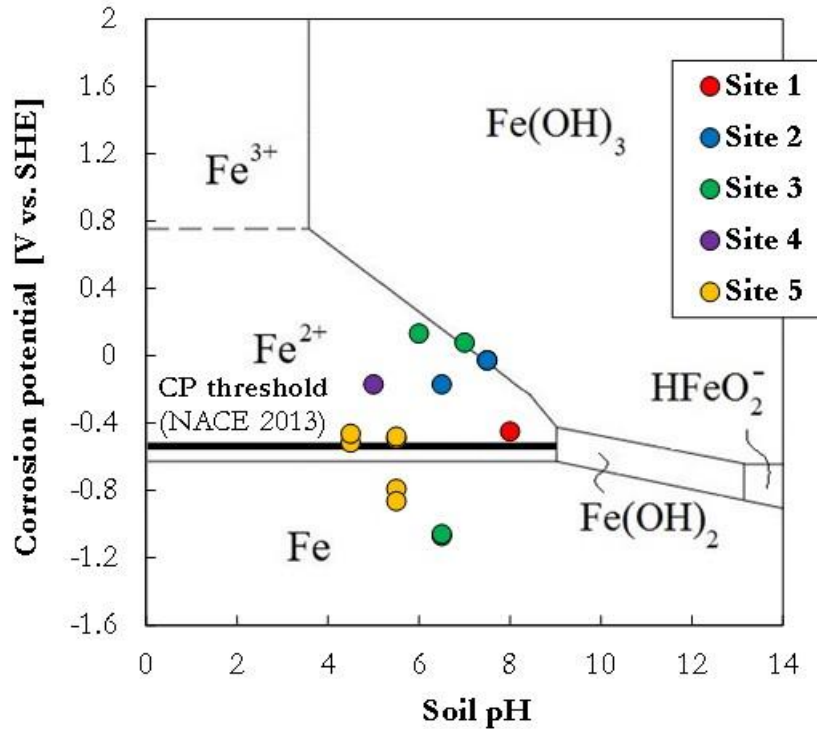
Figure 5.8 Pourbaix diagram of Fe with NACE (2013) cathodic protection threshold and corrosion potential-soil pH markers for WS poles at Sites 1 through 5.

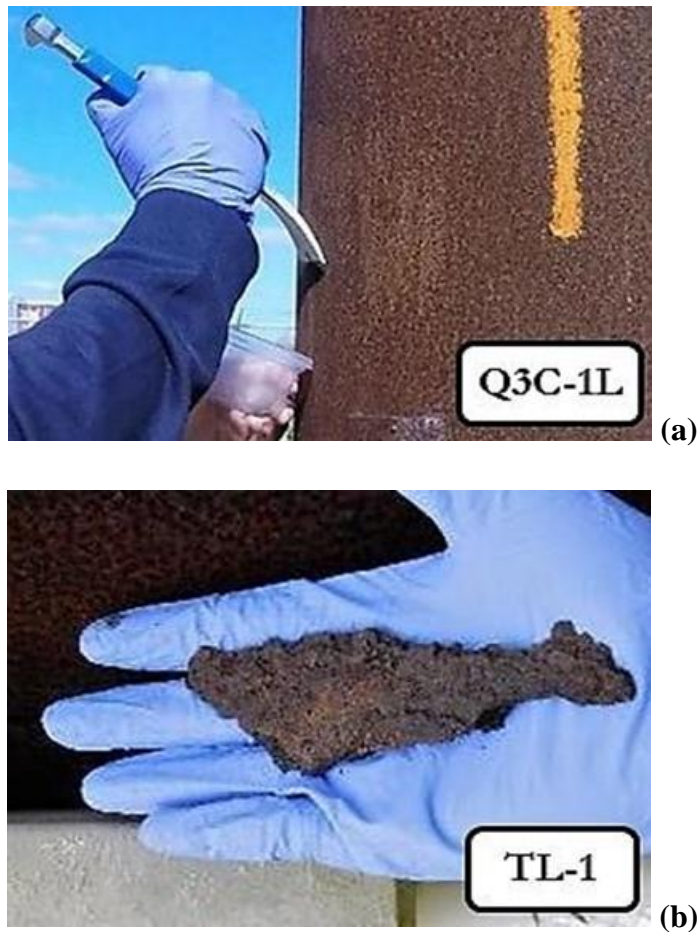
- Oxide (patina) powder samples, which were collected from each WS pole by scraping the wall surface (Figure 6.4a) throughout a maximum area of 1 ft² (1 ft by 1 ft) for no more than ten minutes. For each sample in Table 6.2, 0.1 g were used for XRD and MS analysis.
- Larger solid rust samples, which were removed by tool or hand from pack-rust and pack-out deposits (Figure 6.4b). These larger rust samples were obtained from seven WS poles at Sites 2, 4 and 5 (Table 6.2). Portions of these samples were: (a) used to extract small samples (i.e., with the surface smaller than that of a circle with diameter of 0.5 in., and thickness up to 0.2 in.) for SEM/EDX analysis; and (b) ground into powder using a sterilized agate mortar and pestle to obtain 0.1 g samples suitable for XRD and MS analysis.

The removal of oxide samples was performed using a forged high-carbon steel chisel scraper and/or a hardened, tempered, and polished steel putty knife. Specimens were then transferred to sterile sealable plastic containers using nitrile gloves, and were kept in these containers until testing.

Figure 6.4 Collection of surface oxide samples: (a) scraping of patina to obtain powder sample; and (b) pack-out rust sample removed by hand from junction box area of Pole TL-1.

The key difference between the two models is that Equation 6-2 consistently classifies the patina samples (i.e., the “powder” samples obtained by scraping the pole walls as illustrated in Figure 6.4a) as better than the solid rust samples that were removed from corrosion-damaged areas. In fact, all patina samples are characterized by $\alpha\gamma/\gamma^+$ values that exceed those of the solid rust samples, and of the pack-rust powder sample removed from the reflective tape section on Pole C1F-20 (Site 1). Conversely, the α/γ^* values from Equation 6-1 lend themselves to some improbable interpretations. For example, Equation 6-1 (Kamimura et al. 2006) rates the inner pack-out rust sample from Pole TL-1 ($\alpha/\gamma^* = 0.47$) as higher, albeit marginally, than the patina samples collected from the same pole ($\alpha/\gamma^* = 0.46$) and from the WS poles at Site 2, except Pole Q3C-2L ($\alpha/\gamma^* = 0.48$). This result likely occurs because chlorides did not penetrate deep enough into the pack-out rust on Pole TL-1 to cause the formation of akaganeite where the inner sample was collected. Despite the lack of akaganeite, it is impractical to consider pack-out rust to be more protective than patina.

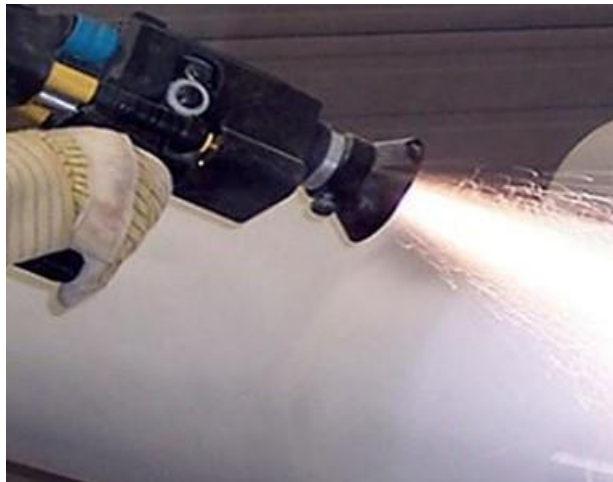
Metallizing, which consists of thermally spraying metal onto a suitably prepared steel surface to be protected (Figure 7.1), can enhance the corrosion resistance of WS poles. The primary materials that have been used for thermal-spray coatings include aluminum, brass, bronze, copper, iron, lead, molybdenum, monel, nickel, nickel-chrome, steel, tin, and zinc. These materials are used in the form of metallic wires or powders that are fed into a flame and melted. The molten stock is then pulverized by a high-velocity stream of compressed air, and propelled onto the steel substrate. Bonding may occur due to mechanical interlocking with roughened steel surfaces, localized diffusion and alloying, van der Waals forces, and combinations thereof.

Figure 7.1 Metallizing of steel pole.

Metallizing techniques include flame spraying, high-velocity oxy-fuel spraying, electric arc spraying, plasma spraying, ion plating, and use of detonation guns (Roberge 2008). The resulting coating tends to be relatively oxidized and porous, and thus metallized steel surfaces should be top-coated with an organic coating.

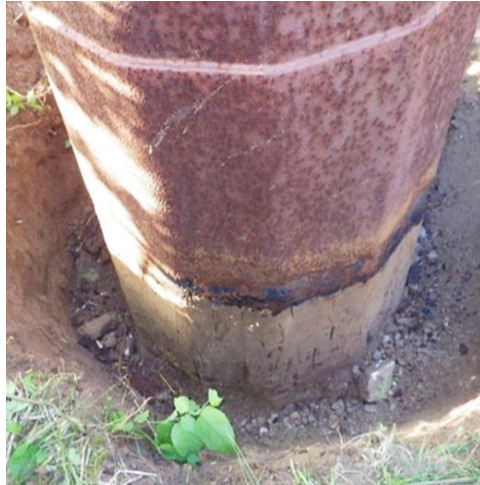
Another way to effectively “coat” a pole is through the application of sacrificial sleeves. An additional sheet of WS can be welded over a structural WS pole wall to inhibit corrosion. The application of WS sleeves is similar to coating in that it is supposed to isolate the surface from the environment. The steel sleeves are added to act as a sacrificial layer and protect the underlying steel surface. Sacrificial sleeves are typically placed where the WS pole intersects the ground line. The size of sacrificial ground line sleeves typically

mirrors the thickness of the underlying pole wall, encompasses the entire circumference of the pole, and is between three and five ft in height. An example of sacrificial WS sleeve is shown in Figure 7.2.

Figure 7.2 Sacrificial WS sleeve installed at base of WS pole.

This control and prevention strategy can be paired with organic coatings to more effectively hinder corrosion effects on the WS pole walls. However, this protection becomes ineffective when poles are set either too low so that the ground line is above the top of the sleeve, or too high, so that the bottom of the sleeve is above the ground line.
