Assessment, Prevention And Remediation Of Corrosion In Weathering Steel Transmission Line Poles

**ASSESSMENT, PREVENTION AND REMEDIATION OF CORROSION IN
WEATHERING STEEL TRANSMISSION LINE POLES**

Civil Engineering

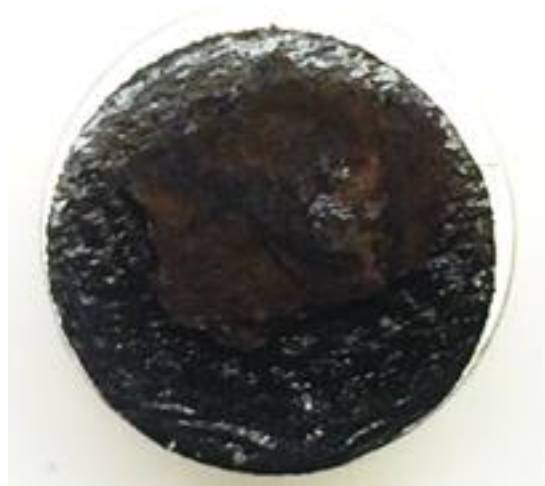
Figure A.3 Pack-rust sample from coating line region of Pole Q3C-2L at Site 2.

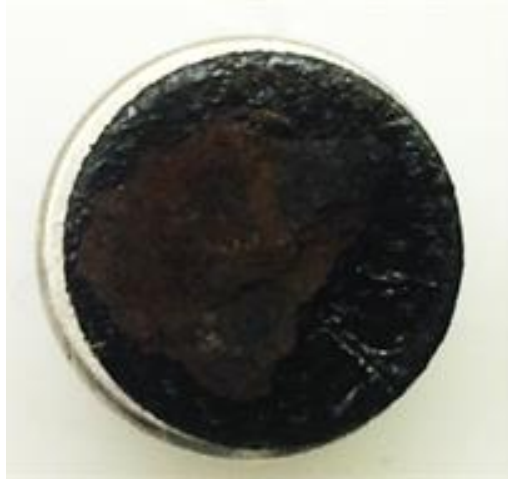
Figure A.5 Pack-rust sample from coating line region of Pole Q3C-2R at Site 2.

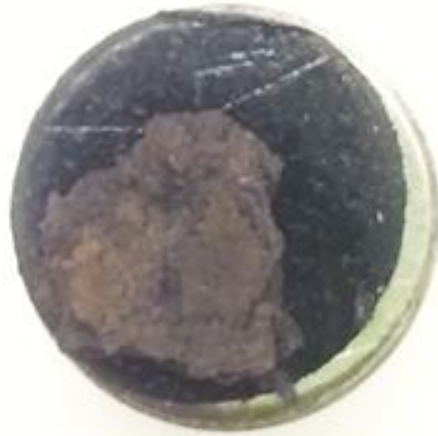
Figure A.7 Outer pack-out sample from Pole TL-1 at Site 4.

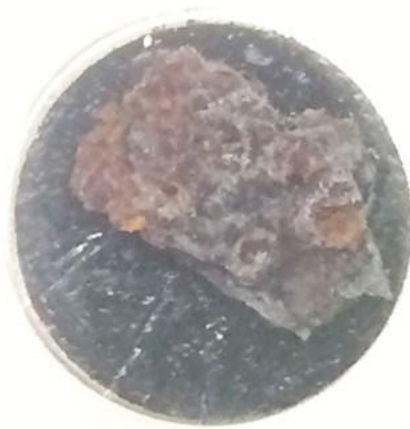
Figure A.9 Inner pack-out sample from Pole TL-1 at Site 4.

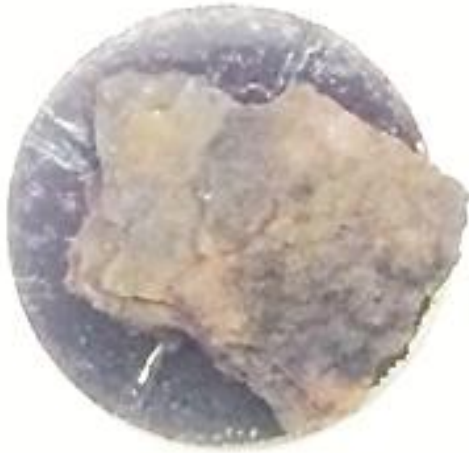
Figure A.13 Loose rust sample from GS fastener region of Pole 8Z-2R at Site 5.

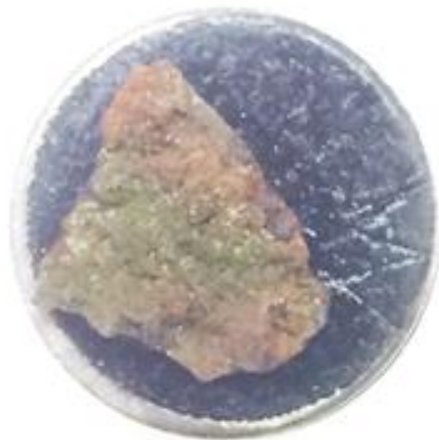
Figure A.15 Loose rust sample from GS fastener region of Pole 11Z-6R at Site 5.
