# Performance Assessment of Deteriorated and Retrofitted Steel HP Piles

A THESIS

Presented to the Faculty of  
The Graduate College at the University of Nebraska  
In Partial Fulfillment of Requirements  
For the Degree of Master of Science

Deterioration of aging bridges can be attributed to an assortment of mechanisms throughout the structure, with remediation policies also varying. This study focused on assessing the validity of the Nebraska Department of Roads' (NDOR) reinforced concrete encasement retrofit for corroded steel HP piles. Experiments were designed and conducted to test the capacity of the NDOR retrofit and evaluate failure limit states. Two pile locations were considered: abutment and pile bent. For each location there was a non-deteriorated, deteriorated, and retrofitted case. These cases represented the pile at key stages during its life. NDOR's concrete encasement retrofit provided the required stability and composite action to return the pile to full capacity. The key finding of the experimental study was a greater than anticipated steel-concrete bond stress. The bond stress observed was three times greater than the nominal recommended by AISC. A computation

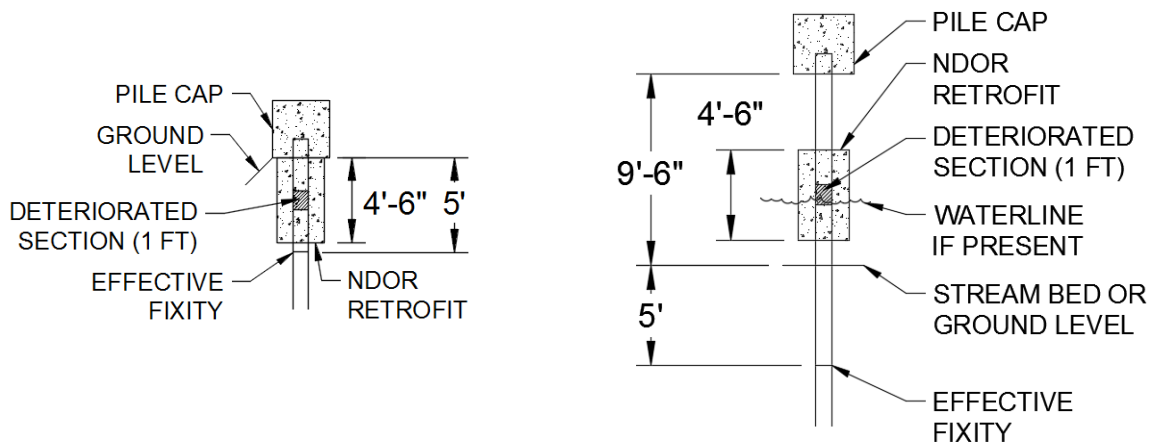
Rebar was placed within the form to create a cage, as illustrated in repair plans supplied by NDOR, see Appendix B. Finally, the concrete was placed and vibrated to consolidation, resulting in test specimens that represented the two scenarios presented in Figure 3.6. Instrumentation to be installed outside the concrete was deferred until after the concrete had been placed, while the concrete was curing.

**Figure 3.6** Retrofitted test cases

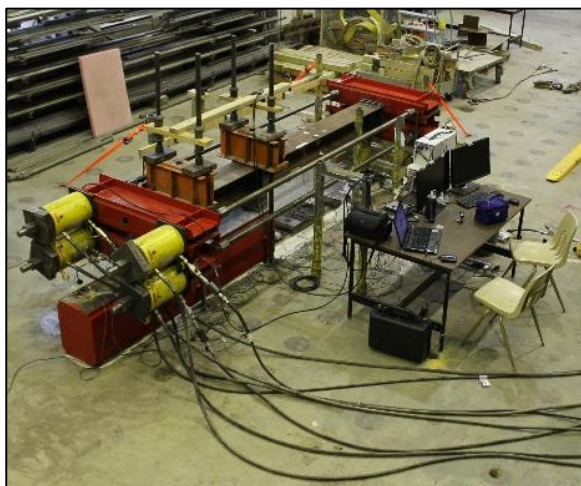
**Figure 5.4** Non-deteriorated abutment test

The non-deteriorated abutment test, shown pretest in Figure 5.4, resulted in a compression flange local buckling failure as calculated. Based on calculations done using AISC (2011) equations, the pile was expected to experience compression flange local buckling in pure flexure and flange local buckling in pure compression. Since both the compression and flexure limits had similar failure cases, a local buckling failure of the top flange near the base end of the pile was anticipated, as shown in Figure 5.5 and Figure 5.6.

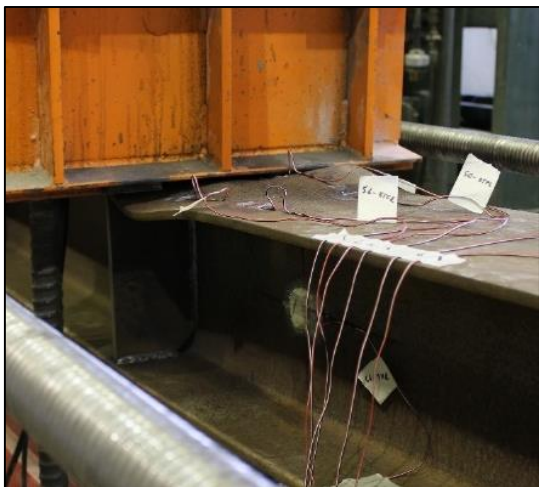
**Figure 5.6** Localized failure of base section flange

The localized failure, shown in Figure 5.6, began due to residual stresses that occur in the steel from production, and this led to the global failure of the section. Figure 5.10 provides a clear picture of the top flange of the base section reaching yield and then proceeding to buckle. This occurred after reaching the 350 kip axial load (as indicated by the encircled 1) and prior to the maximum shear (as indicated by the encircled 3) being reach. This again was the anticipated failure due to the geometry of the pile.

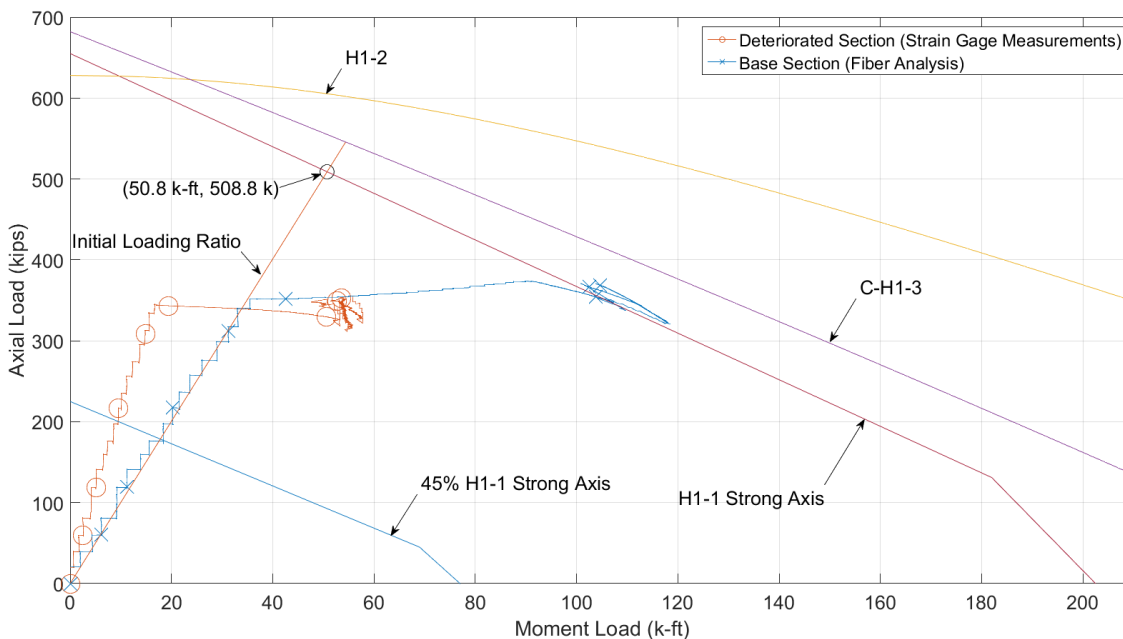
**Figure 5.7** Non-deteriorated abutment case axial vs. moment

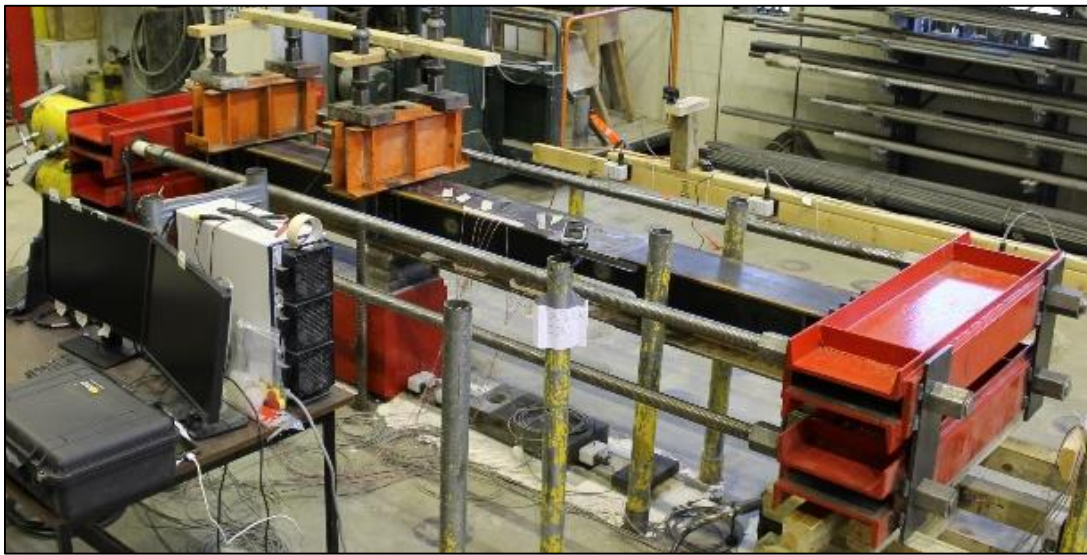
For the deteriorated abutment case (pictured in Figure 5.11) the initial failure of the deteriorated section was not as predicted, a local failure of the deteriorated section top flange, but began with buckling of the web instead. This led to load being shed to the flanges and the top flange taking control of the failure. The pile then exhibited a hinged shear failure, as illustrated in Figure 5.12, through the section as the test carried on. The section proved to be stronger than calculated and exceeded 250 kips in compression.

**Figure 5.11** Deteriorated abutment test

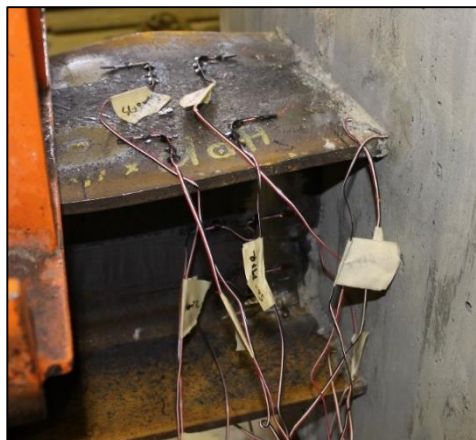
**Figure 5.19** Retrofitted abutment buckling of base section

The pile failed in a similar manner to the non-deteriorated pile and the third failure case presented above. As a reminder, the Failure Case 3 was a local buckling failure outside of the retrofitted section. The pile buckled locally in the top flange on either side of the web as illustrated in Figure 5.19. This buckling was limited in the distance along the pile that it could propagate by the tie down and the concrete. The

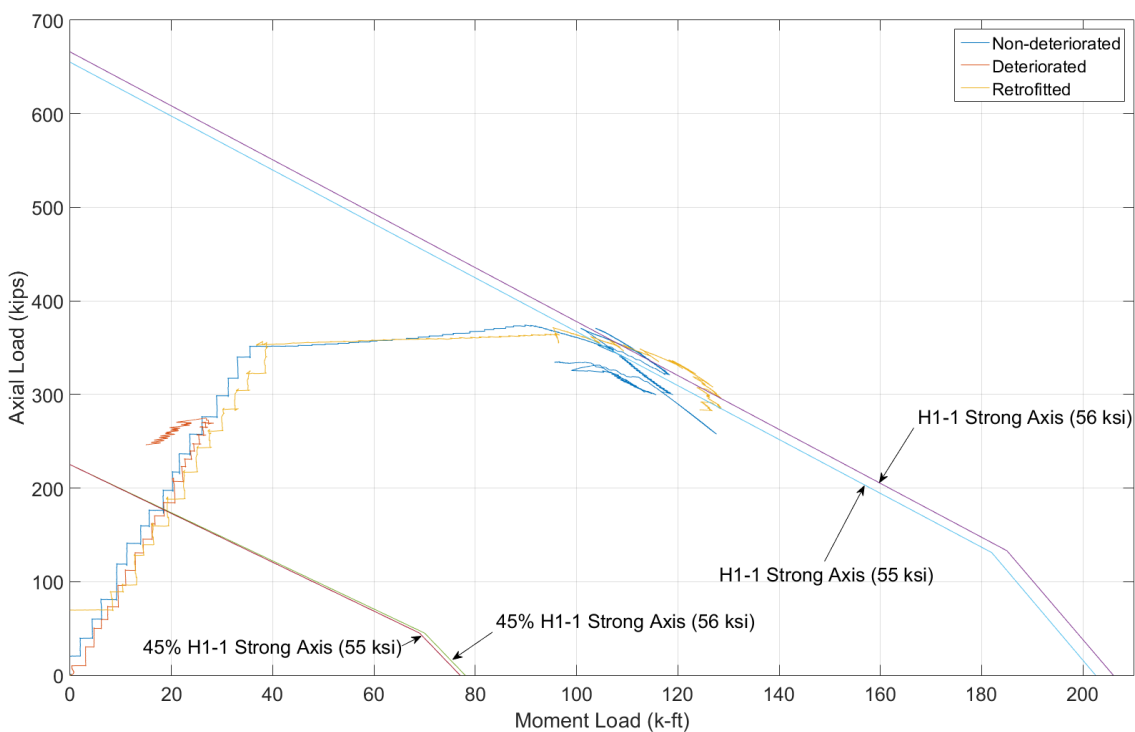
The abutment case was different from the pile bent case in that it had one pile with a different steel strength. The difference was 1 ksi and does not appear to have adversely affected the results. Looking at the base section results, Figure 5.24, it can be seen that the non-deteriorated case and the retrofitted case under went similar loading but differed during the softening of the pile. The difference does not appear to be one that gives one pile an advantage over the other.

**Figure 5.24** Abutment case base section axial vs. moment

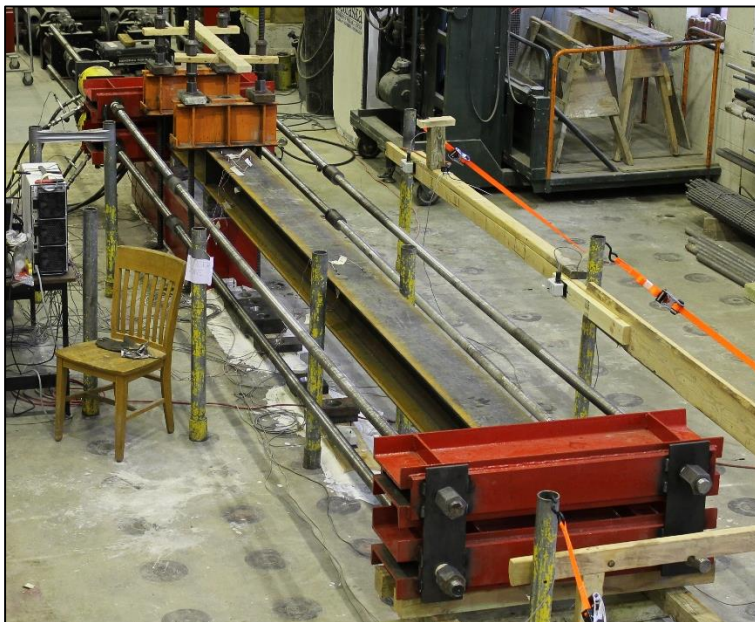
Of the four test without concrete, the non-deteriorated pile bent case pile (pictured in Figure 5.26) experienced the greatest combination of failures. There were two localized failures, as well as a global failure. The first localized failure was of the top flange behind the tie down location, and the second was a local failure of the top flange at the base section. The final failure the pile experienced was an out of plane failure. The localized failure behind the tie down was not expected but did not impact the test outcome. The other failures where predicted and matched the analytical limit states.

**Figure 5.26** Non-deteriorated pile bent test

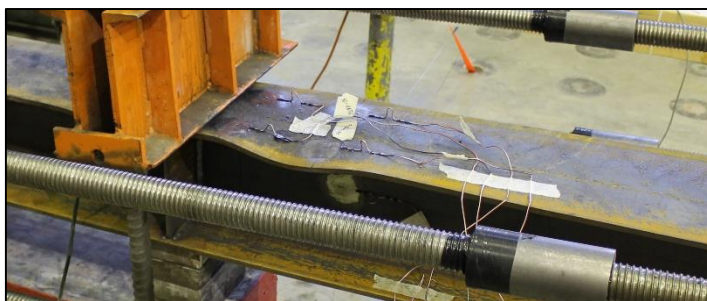
**Figure 5.27** Non-deteriorated pile bent local buckling of base section

The initial buckling of the pile, along its top flanges behind the tie down spreader beam, was caused by rotation of the spreader beam. The moment was strong enough at the base to cause the tie down spreader beam to pivot on top of the pile and deform the flange behind it. Further into the loading, the pile began to locally buckle in a similar manner to the abutment non-deteriorated case at the

base location, which is visible in Figure 5.27. The pile's stocky geometry and length still indicated that the full plastic moment was the calculated capacity at which the pile should

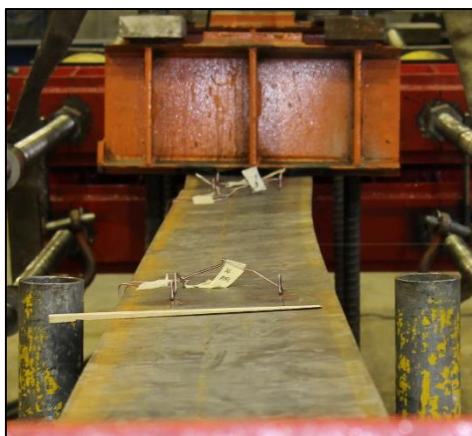
**Figure 5.28** Non-deteriorated pile bent LTB failure

fail, but the unbraced length was approaching that of the Inelastic Lateral Torsional Buckling (LTB) limit.

Once the pile began to buckle, the instability allowed the pile to start twisting and displacing laterally. This lead to a notable LTB failure between the deteriorated section location and the base, as shown in Figure 5.28.

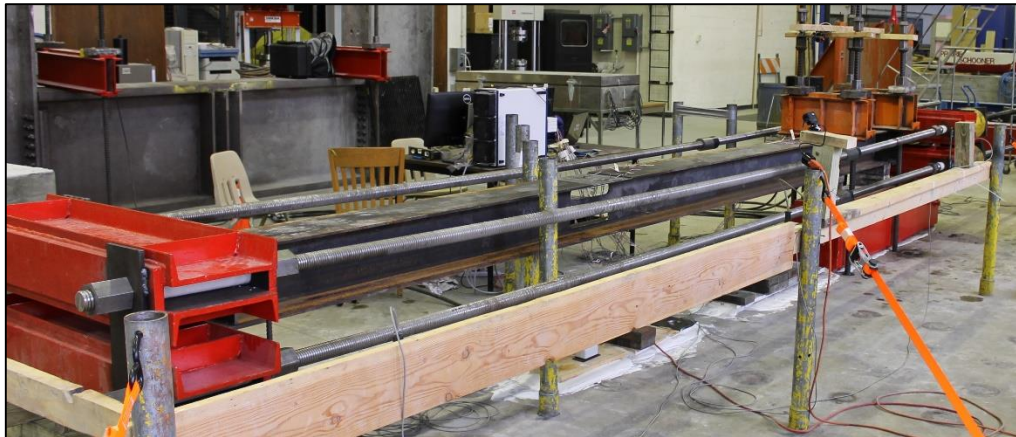
The deteriorated pile bent case (pictured in Figure 5.33) underwent the most sudden failure that was observed during the pile testing. Local buckling in the web of the deteriorated section preceded a global buckling (pictured in Figure 5.34) of the cross section at the deteriorated location. The pile buckled in plane in the upper flange and out of plane in the web. The deteriorated section shortened by half an inch in the top flange, and the web buckled out approximately 7/8 of an inch. Overall, the pile displaced vertically 5.5 inches, 4.4 inches of which were gained during the sudden failure, as shown in Figure 5.35. The pile still carried some load after the buckling as shown in Figure 5.36, but any additional load would have resulted in continued deformation.

**Figure 5.33** Deteriorated pile bent test

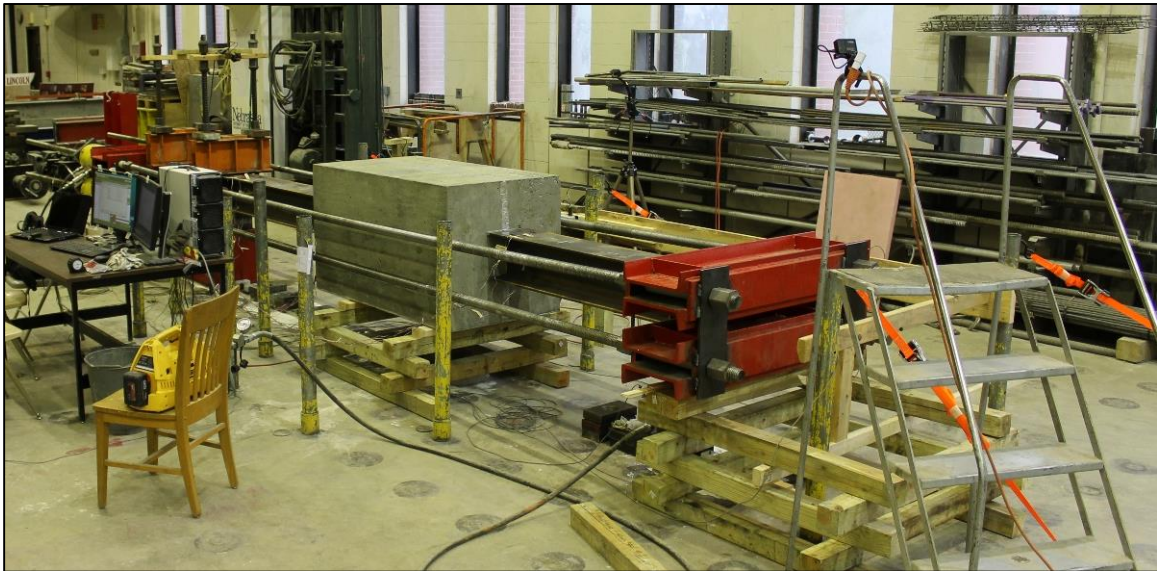
Similar to the retrofitted abutment case, the pile first began to fail by buckling locally at the base. The retrofit prevented the failure of the deteriorated section that was seen in the deteriorated test. Like the abutment case, this was the intended and desired result. The pile (shown in Figure 5.40) was able to withstand the same loading as the non-deteriorated pile and resisted a slightly higher shear load.

**Figure 5.40** Retrofitted pile bent test

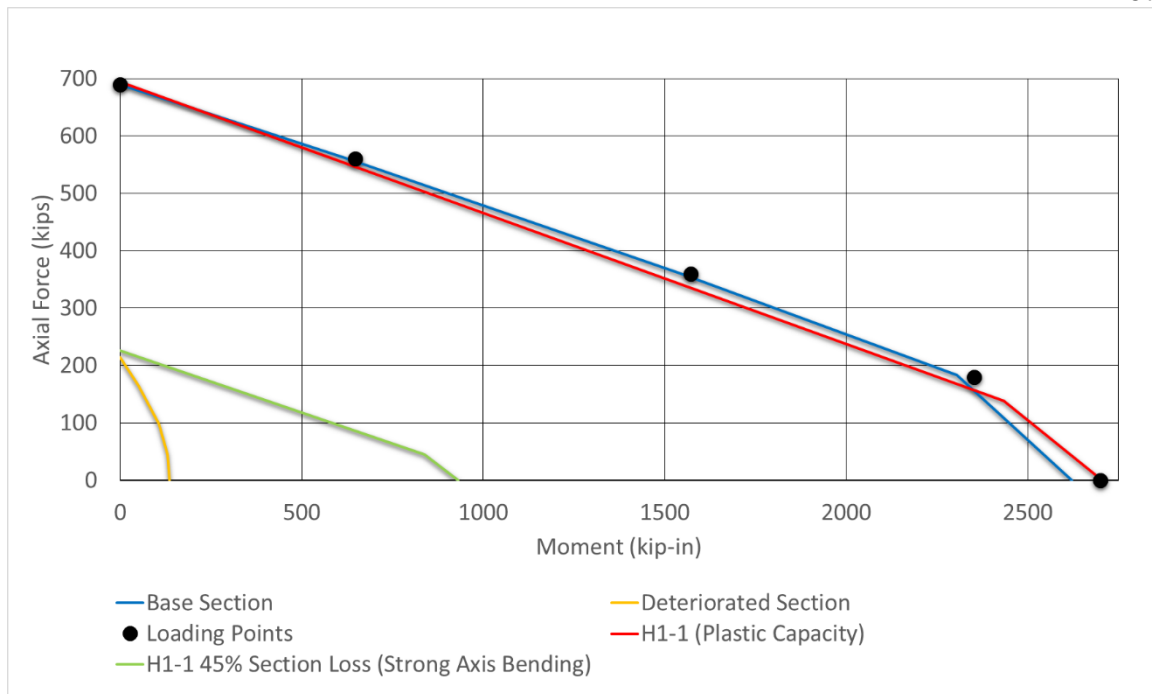
**Figure 6.14** Model 1 interaction diagram with loading ratios and results
