FINITE ELEMENT MODELING AND UPDATING OF A FIVE-TIERED PAGODA STYLE TEMPLE

A THESIS

Major: Civil Engineering

May, 2018

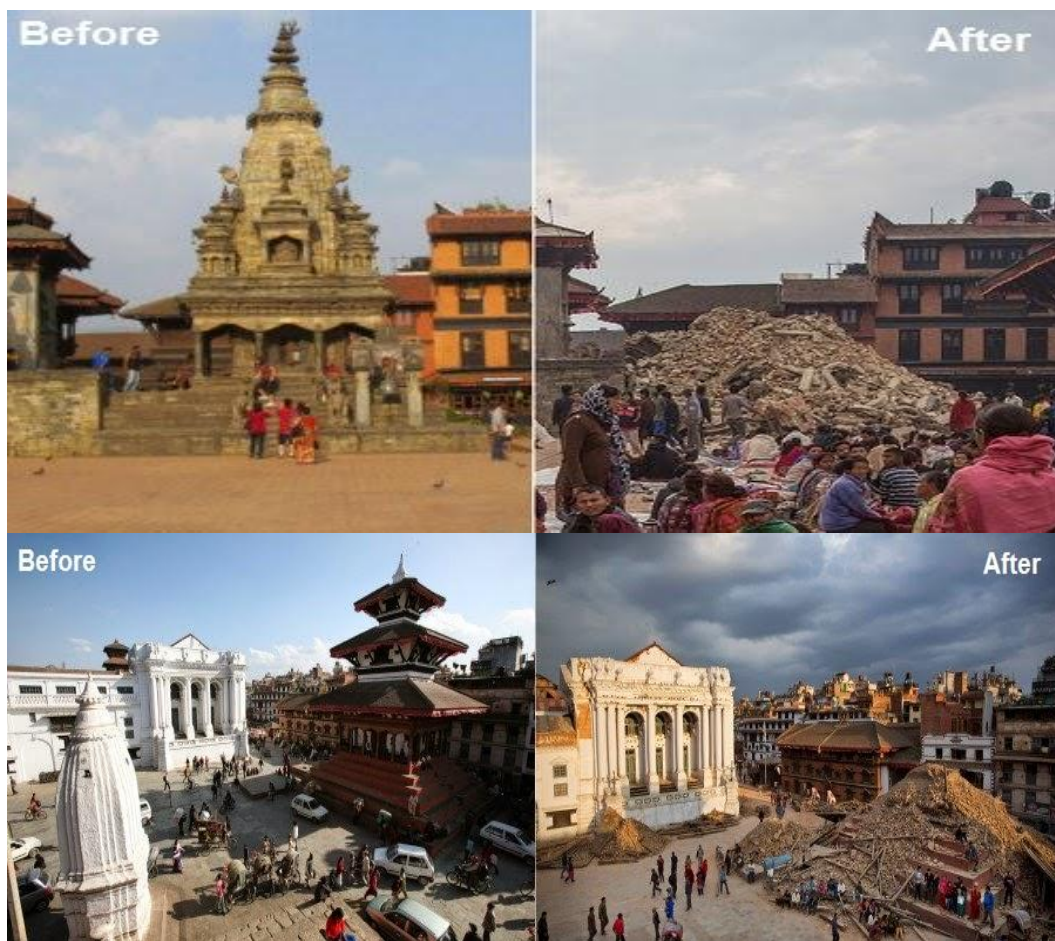
Figure 1.1: Examples of the UNESCO world heritage sites in Kathmandu and Bhaktapur Durban squares destroyed by Gorkha earthquake, 2015 (Nepal Current News 2015).

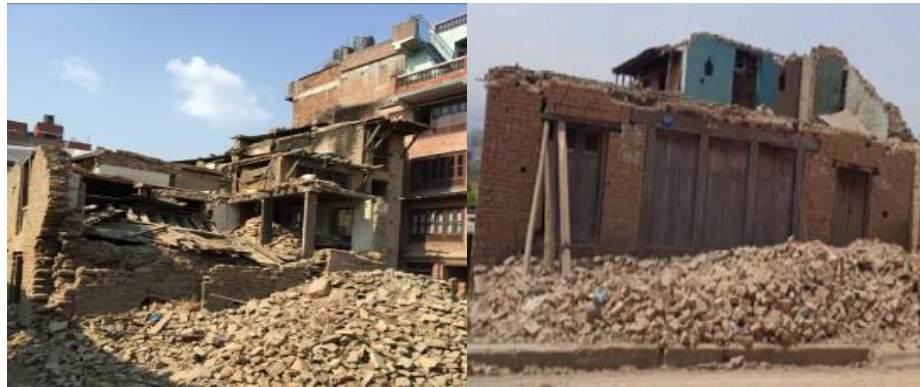
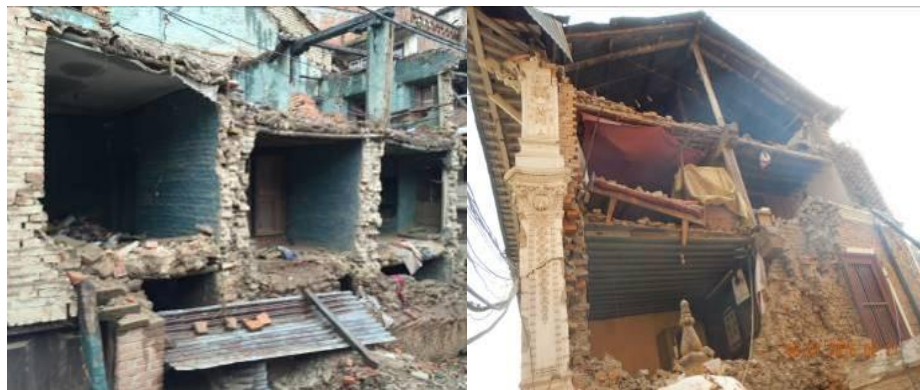
Figure 2.1: Example on URM buildings in Bungmati and Bhaktapur areas following the Gorkha earthquake: (a) complete collapse of URM buildings and (b) typical out- of-plane collapse of URM walls (Brando et al. 2015).

Earthen unreinforced masonry (URM) structures are common throughout southeast Asia and Nepal. However, these structures are vulnerable to lateral loads induced by seismic events, and can led to severe destruction through severe cracks (predominately shear) and life-safety hazards because of out-of-plane and in-plane wall collapses. This is primarily due to the design detail of the lateral-load resisting system and the connection between the walls and the confining structural elements (floor diaphragms in temples and beam and column elements in other structures). Following the 2015 Gorkha earthquake and its aftershock sequence, widespread damage was observed throughout Nepal. Figures 2.1 and 2.2 illustrate some damaged URM and reinforced concrete structures.

The poor construction methods used in the Kathmandu region made the infrastructure vulnerable to extreme levels of damage under the anticipated seismic hazard. Rai et al. (2016), surveyed damaged following the 2015 Gorkha earthquake. During the Gorkha earthquake and its aftershocks, numerous reinforced concrete (RC) buildings in the Kathmandu valley were damaged due to the weak reinforcement columns, open ground level leading to soft stories, inadequate masonry infill walls, and geometric irregularities, as presented in Figures 2.2a and 2.2b. In addition, most URM buildings experienced severe cracks to complete collapse as shown in Figures 2.1 and 2.2c.

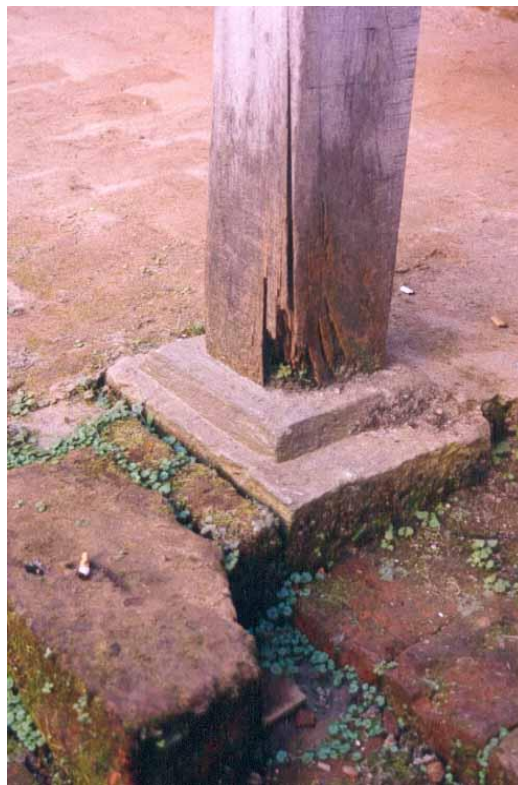
Figure 3.6: Base column rotted due to rain (Nienhuys 2003).

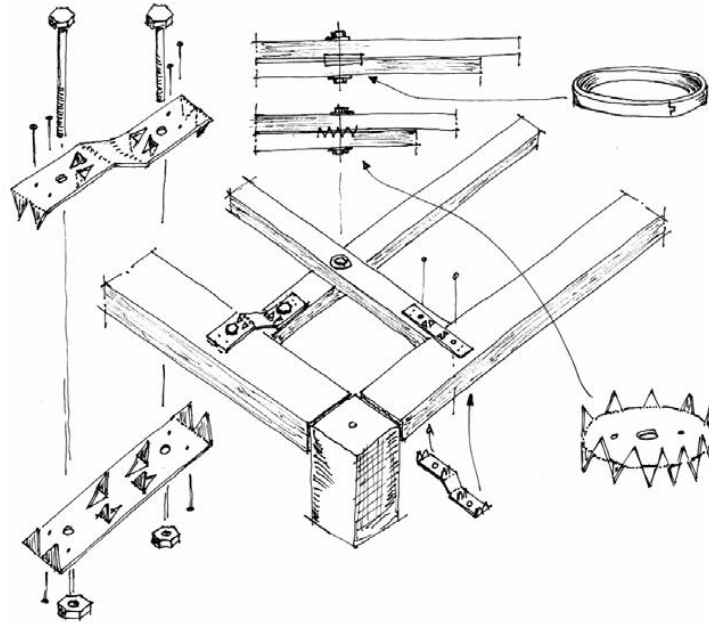
Figure 3.7: Connection timbers using special techniques (Nienhuys 2003).

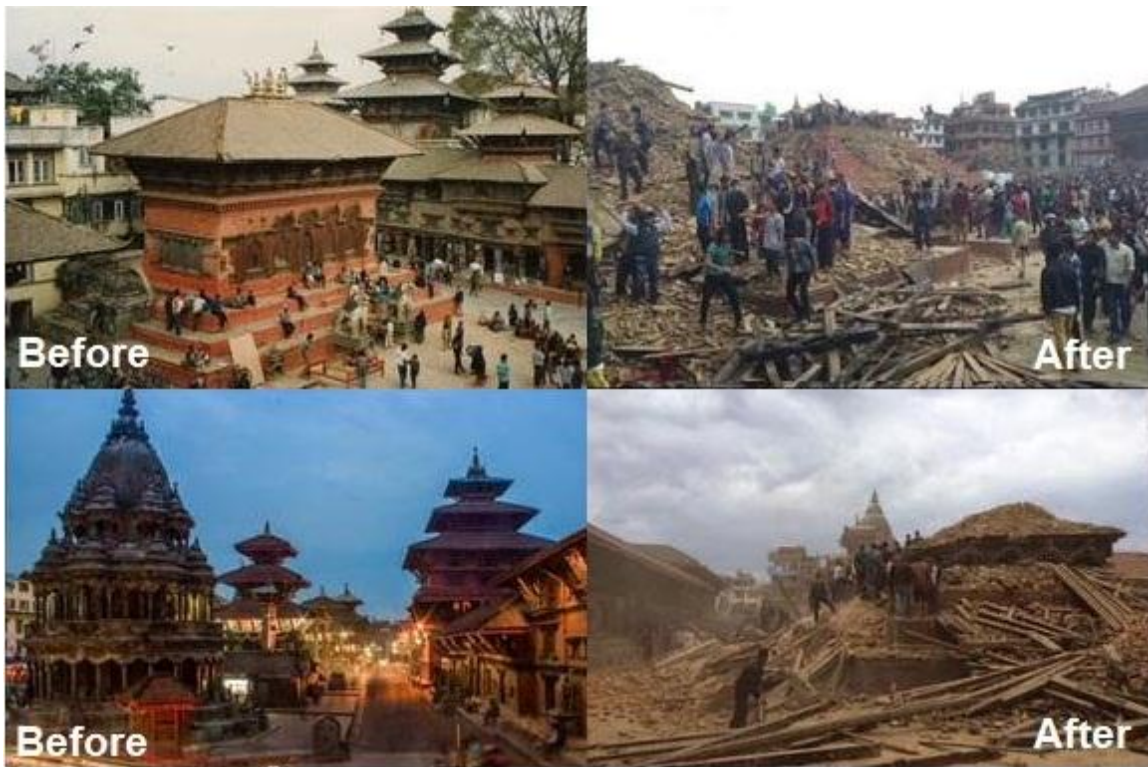
Figure 3.10: Examples of the cultural heritage sites in Kathmandu and Patan Durbar Squares destroyed by Gorkha earthquake, 2015 (Nepal Current News 2015)

During Gorkha earthquake and the aftershocks that followed, thousands of structures were devastated across numerous regions of the country. This is in addition to destroyed and heavily damaged cultural heritage sites creating both large economic and cultural losses. According to one report, the earthquake resulted in large-scale destruction in Nepal illustrated by 202,157 completely collapse structures, while 214,202 structures had moderate damage. Furthermore, this accounted for 10.95% of residential construction in the Kathmandu Valley (Nepal Disaster Risk Reduction Portal 2016). While the residential impacts of this earthquake were pronounced, various cultural heritages sites also suffered irreplaceable damage and collapse (Brando et al. 2015) as shown in Figure 3.10.

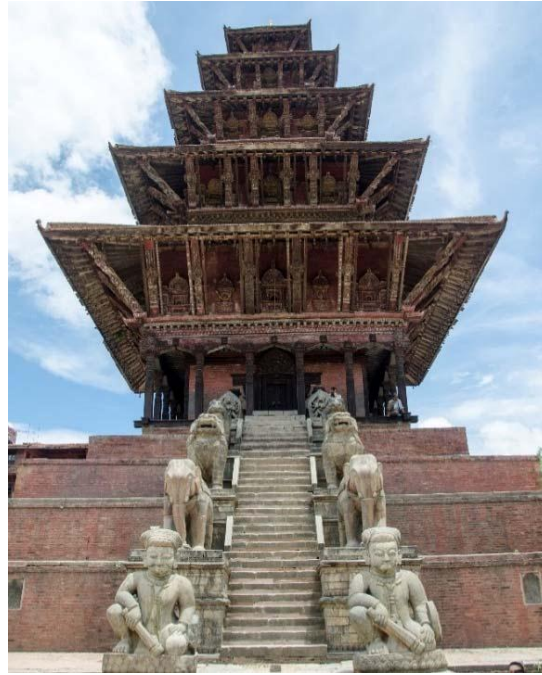
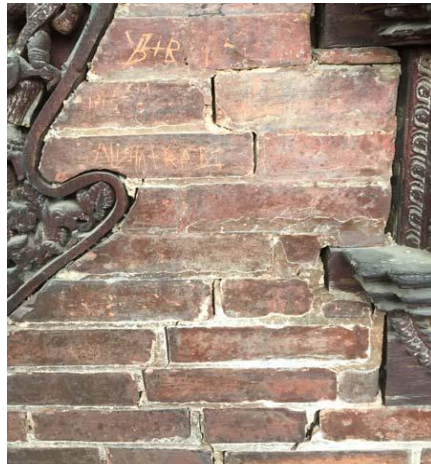
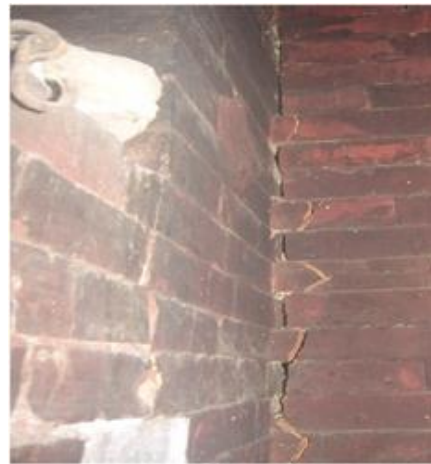
Figure 3.11: View of the Nyatapola Temple: (a) the southern entrance of the temple, (b) north wall cracks from outside, and (c) shear wall cracks from inside (Wood et al. 2017a).

unreinforced brick masonry walls with the mud-mortar and timber members. The five-tiered temple was built in 1702 A.D and still in existence today, as illustrated in Figure 3.11a. The distinctive roof systems surround all levels of the temple, where the wall thicknesses vary from 1.40 m at first level to a minimum value of 0.67 m at the uppermost level.

Despite numerous collapses in pagoda temples, the Nyatapola temple remained upright, but with large observed cracks up to 20 mm wide. Example views of this temple are illustrated in Figure 3.11. One study by Wood et al. (2017b) utilized both ambient vibrations and 3D ground-based lidar for the damage assessment. The authors found that Nyatapola temple sustained a significant shear crack at the base level just above the plinth with maximum width of 3 cm above on the north wall as demonstrated in Figure 1.2. Another crack of 81 cm in length was found in the east wall. Using the identified crack patterns, the damage was the most intense in the north wall and in decreasing values in the east, west, and then the south.

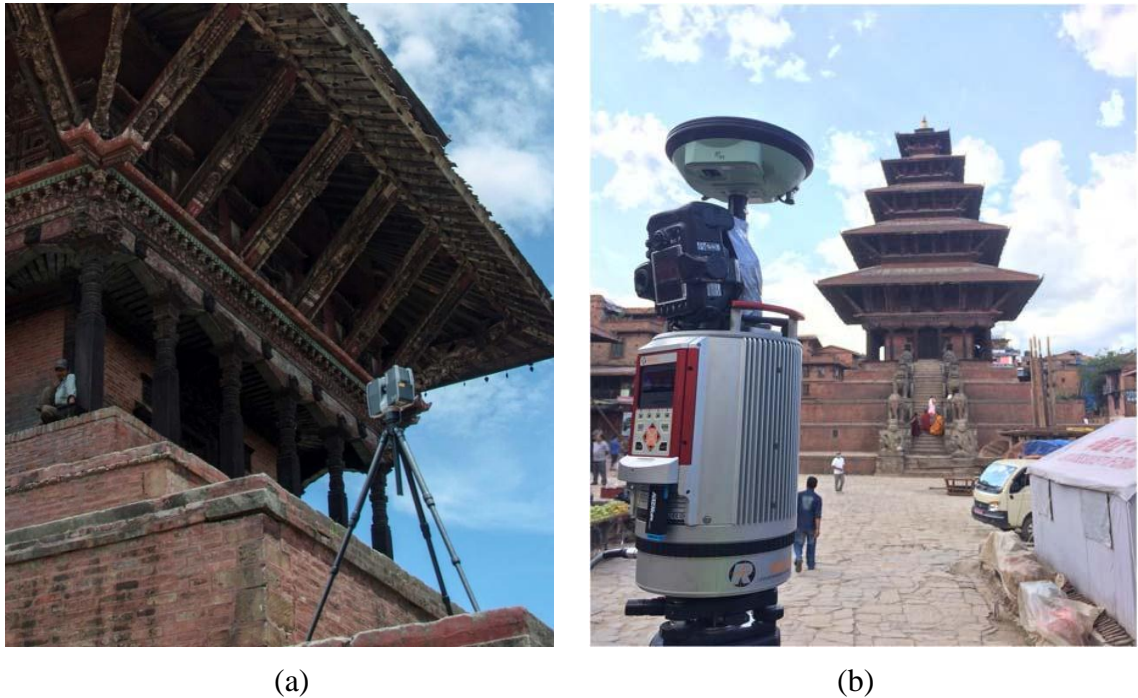
Figure 4.1: Lidar scanning at Nyatapola Temple: (a) Faro Focus^{3D} X 130 and (b) Riegl VZ-400 laser scanners (Wood et al. 2017a).

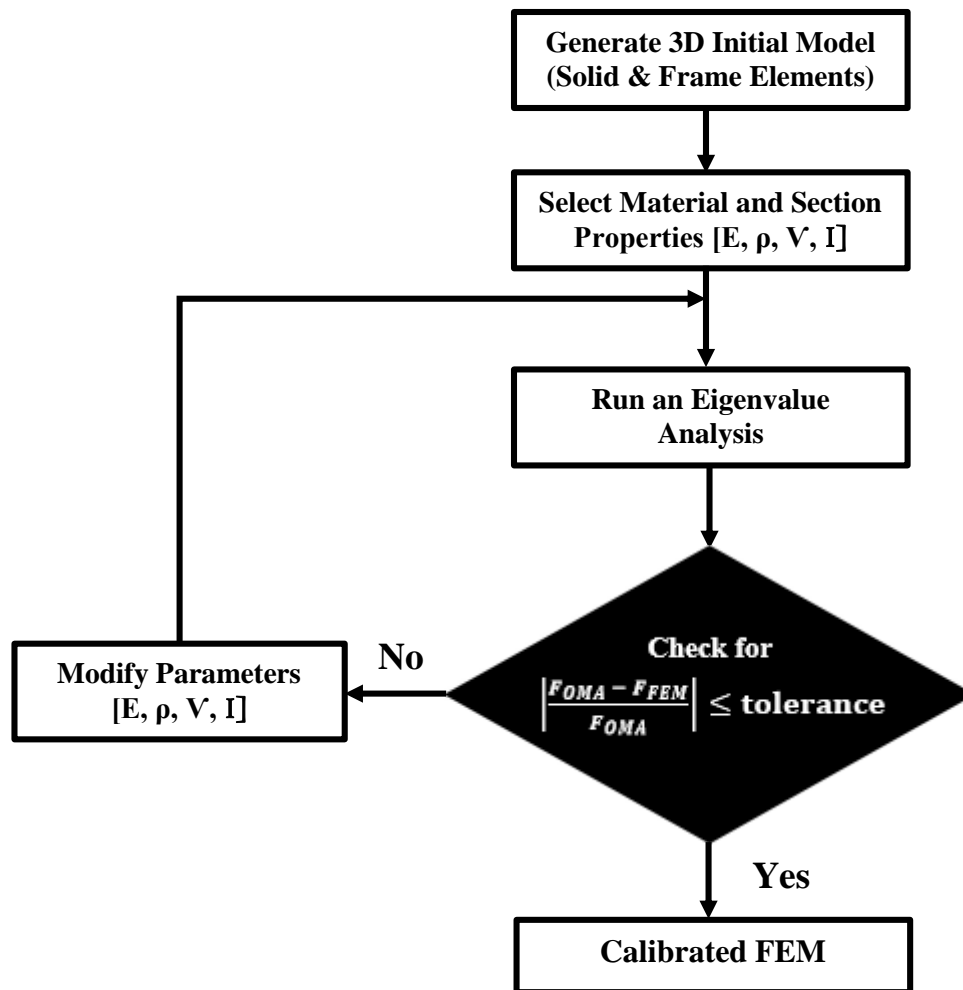
Figure 4.10: General flowchart of FEM processes.

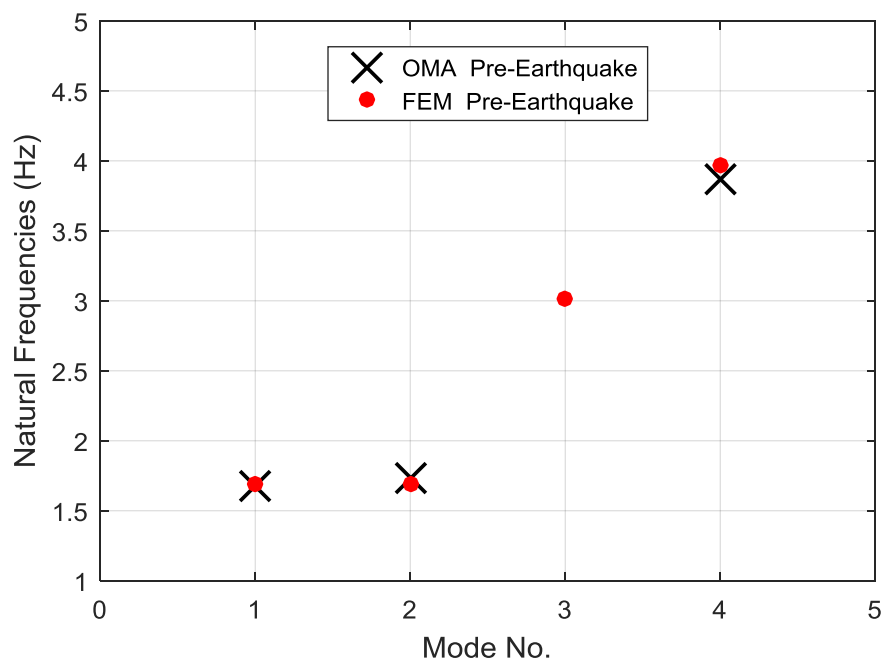
Figure 4.13: Comparison of the first four natural frequencies of OMA and FEM for pre-earthquake. Note mode 3 was not identified in the pre-earthquake system identification.

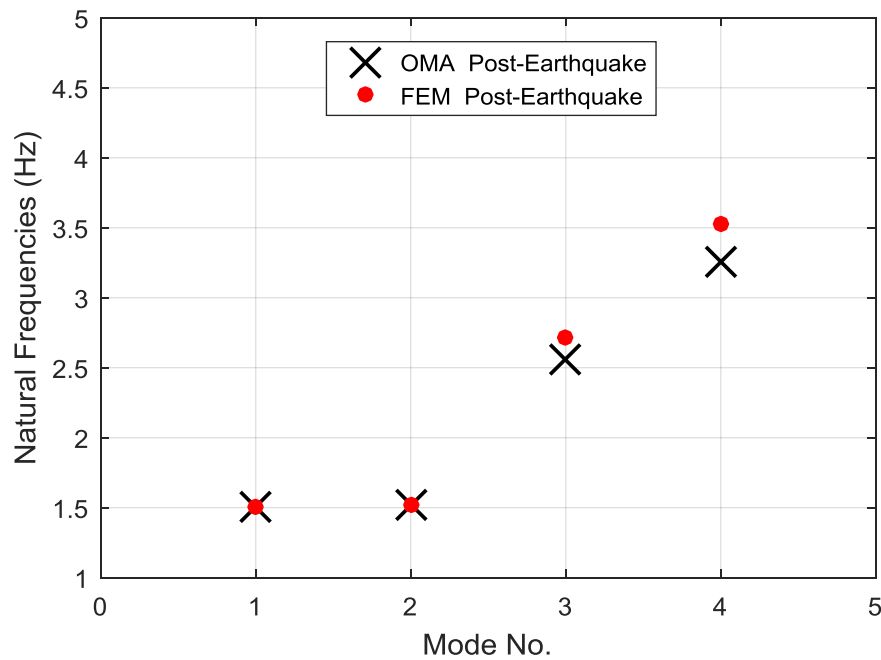
**Figure 4.16: Comparison of the first four natural frequencies of OMA and FEM for post-earthquake.**

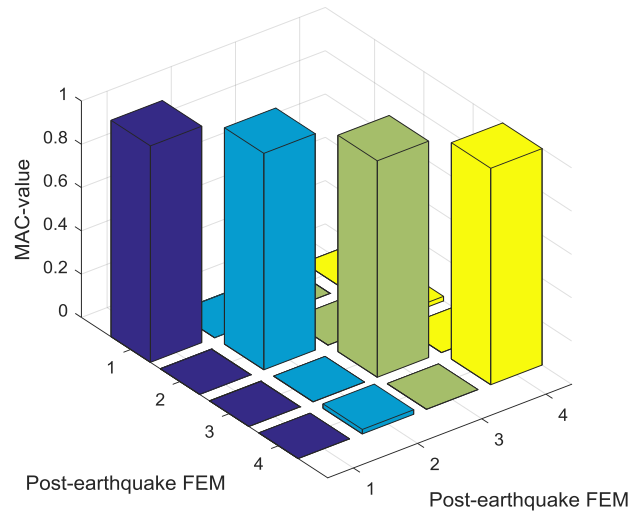
**Figure 4.17: 3D plots of MAC values for the first four mode shapes of post-earthquake.**

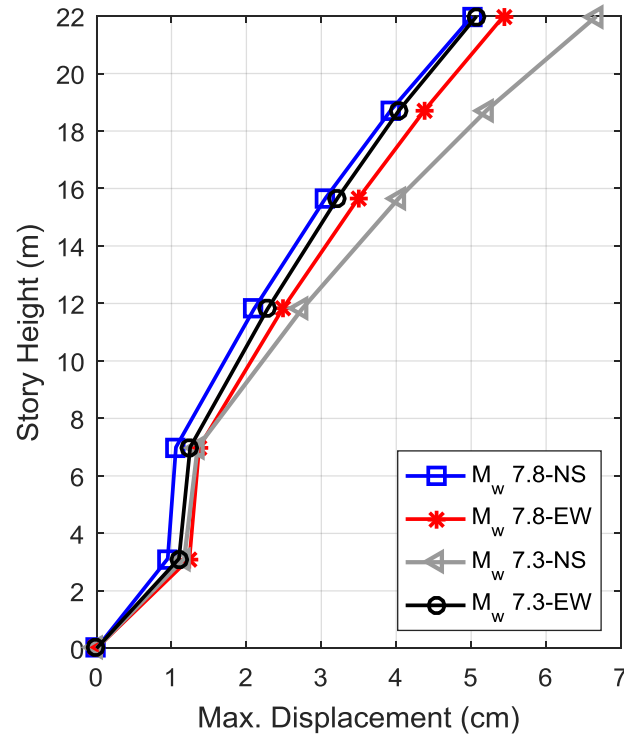
Figure 5.11: Maximum floor displacement envelope curves for the Nyatapola temple.

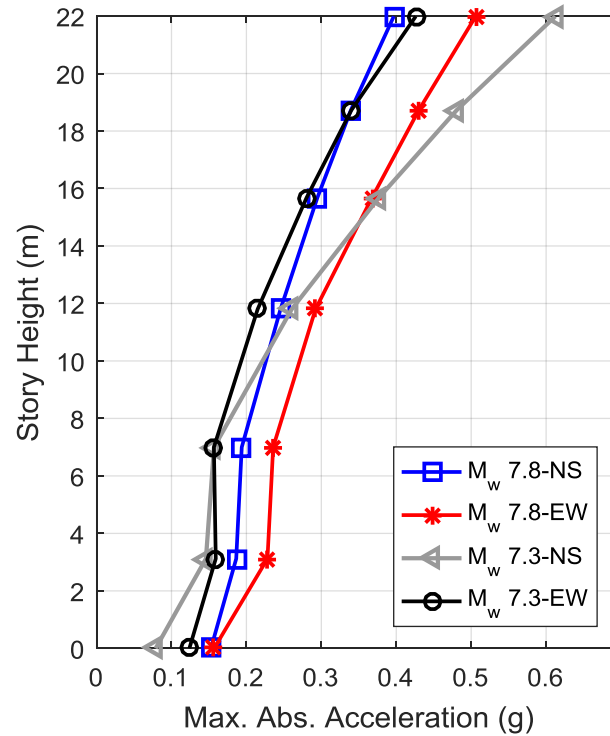
Figure 5.13: Maximum absolute acceleration envelope curves for the Nyatapola temple.

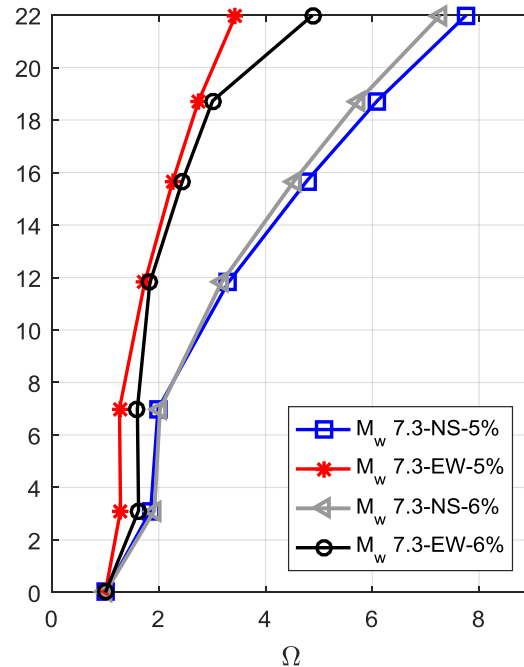
Figure 5.26: Uncorrelated acceleration amplification ratio for Nyatapola temple using two damping techniques: Rayleigh damping set as 5% for 1st and 3rd modes and MPD as set 6% for 1st mode.
