# Examination of Steel Pin and Hanger Assembly Performance – Retrofit to Replacement

A THESIS

For the Degree of Master of Science

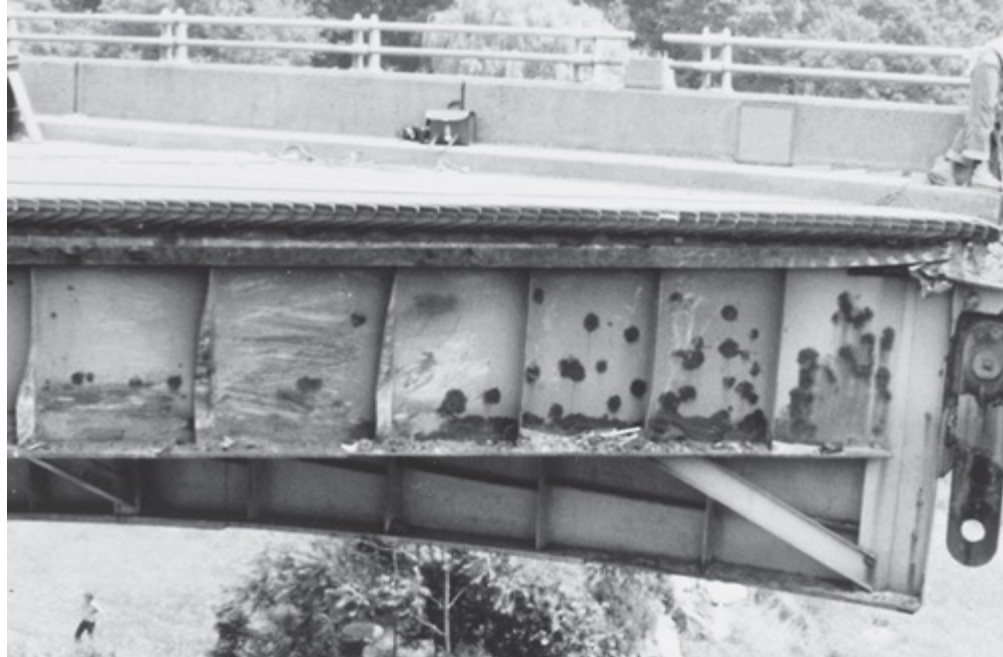
In 1983, the I-95 Mianus River Bridge in Greenwich, Connecticut collapsed (Figure 2.1). The collapse was determined to occur when one of the pin and hanger assemblies fractured. This assembly was subjected to excessive corrosion due to water leaking through the deck joints and from drainage modifications (NTSB, 1984).

Figure 2.1 Mianus River Bridge collapse (Connor et al. 2005)

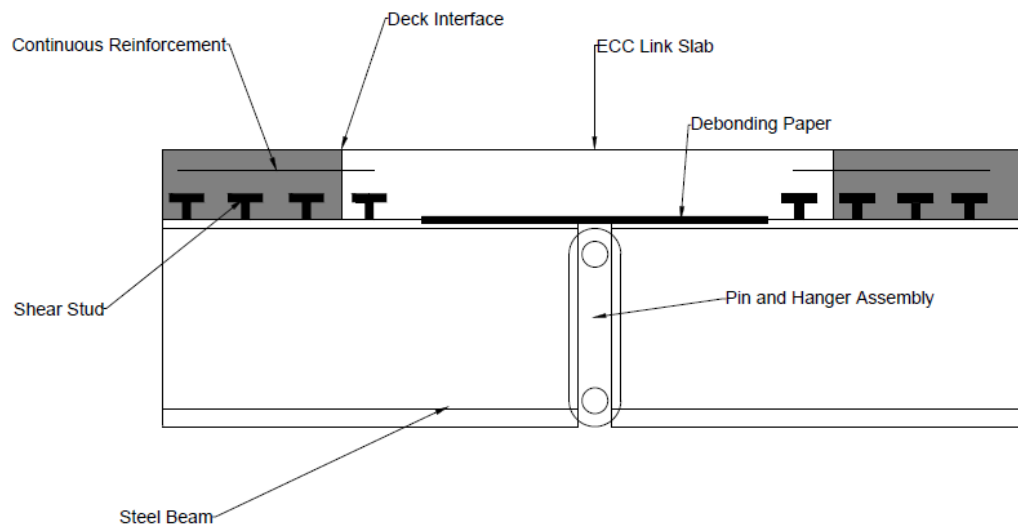
Another possible retrofit option, termed a “link slab”, has also been discussed in the research (Caner & Zia, 1998). In this method, expansion joints are removed at the pin and hangers, the deck is debonded from the girders for a minimum of 5 % of the span length on each side of the splice, and the joint is replaced with link slab, which renders the deck continuous while maintaining some level of rotational freedom for the girders beneath the link slab (Figure 2.2). Reducing the number of expansion joints via the placement of link slabs (Caner & Zia, 1998) would minimize or eliminate corrosion damage due to water leaking through the deck joints. Further discussion of this retrofit option can be found in *Section 4.2.2 Link Slab*.

Figure 2.2 Link Slab detail

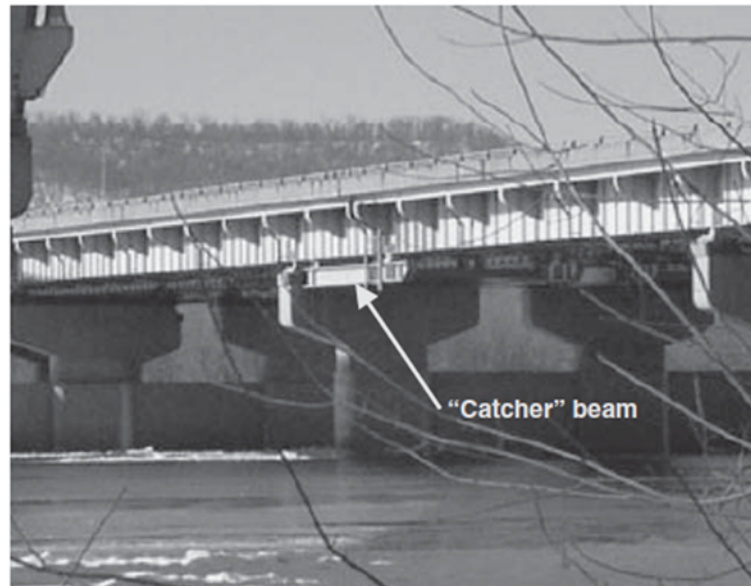
- Placement of a catcher beam system. These systems are added below the location of the pin and hanger assembly to catch the suspended girder when the existing pin and hanger assembly fails (Figure 2.3).

Figure 2.3 Catcher beam system. (Connor et al. 2005)

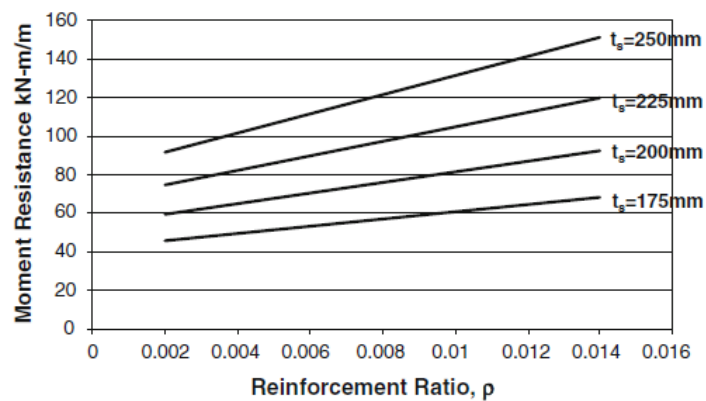
In 2009, further investigation on link slab was carried out by (Lepech & Li, 2009). In this study they have developed a chart (Figure 2.4) for required reinforcement ratio of the link slab with respect to slab thickness. Moment demand is determined based on the following equations. Specific reinforcement steel bar is selected with respect to obtained reinforcement ratio from the chart for the link slab region.

Figure 2.4 Link slab required reinforcement ratio design chart (Lepech & Li, 2009)

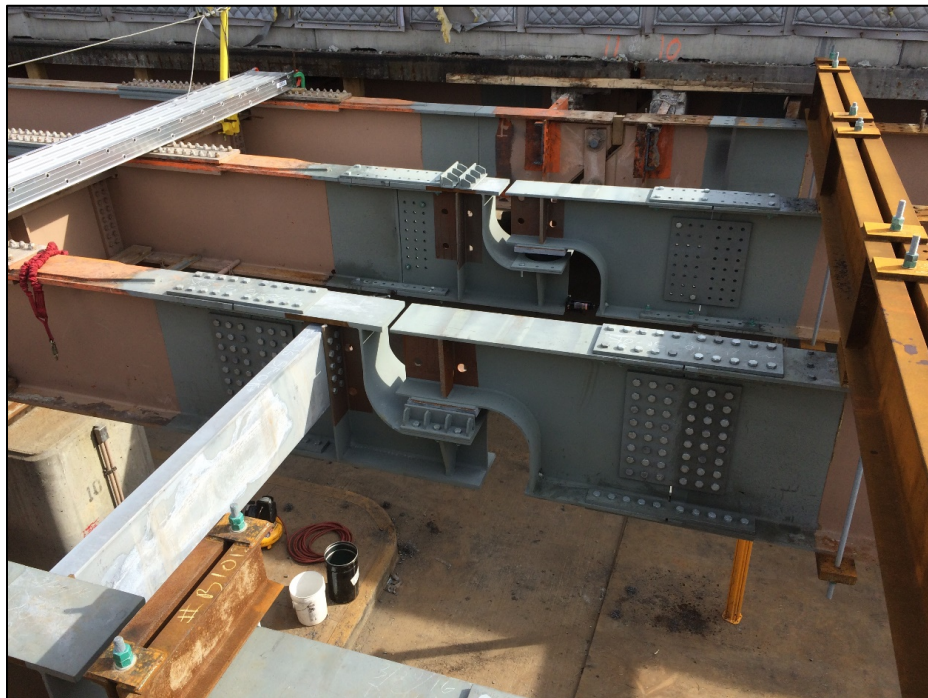
The Massachusetts DOT has utilized a different type of pin and hanger replacement option they refer to as a “ship lap joint.” In this option, which performs in similar fashion to the original pin and hanger assembly, bearings were used to carry loads at the joint location, with girder sections being modified to act as short “cantilevers” that transfer loads across the joint in shear and bending. This detail is depicted for a specific project, the I-91 viaduct in Springfield, Massachusetts, in Figure 3.7 and Figure 3.8.

Figure 3.7 Ship lap joint at bearing at joint locations (Mass DOT, 2014)

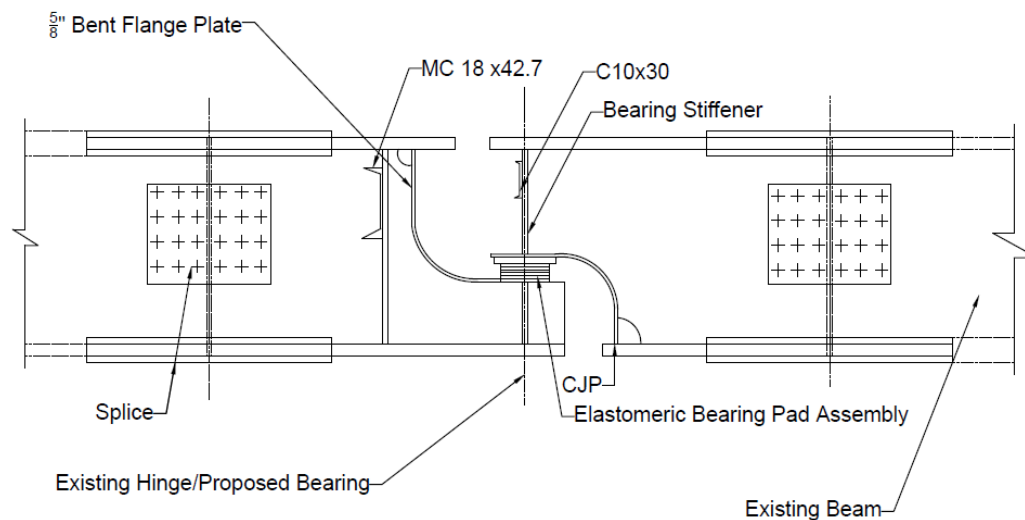
Figure 3.8 Ship lap joint detail (Mass DOT, 2014)

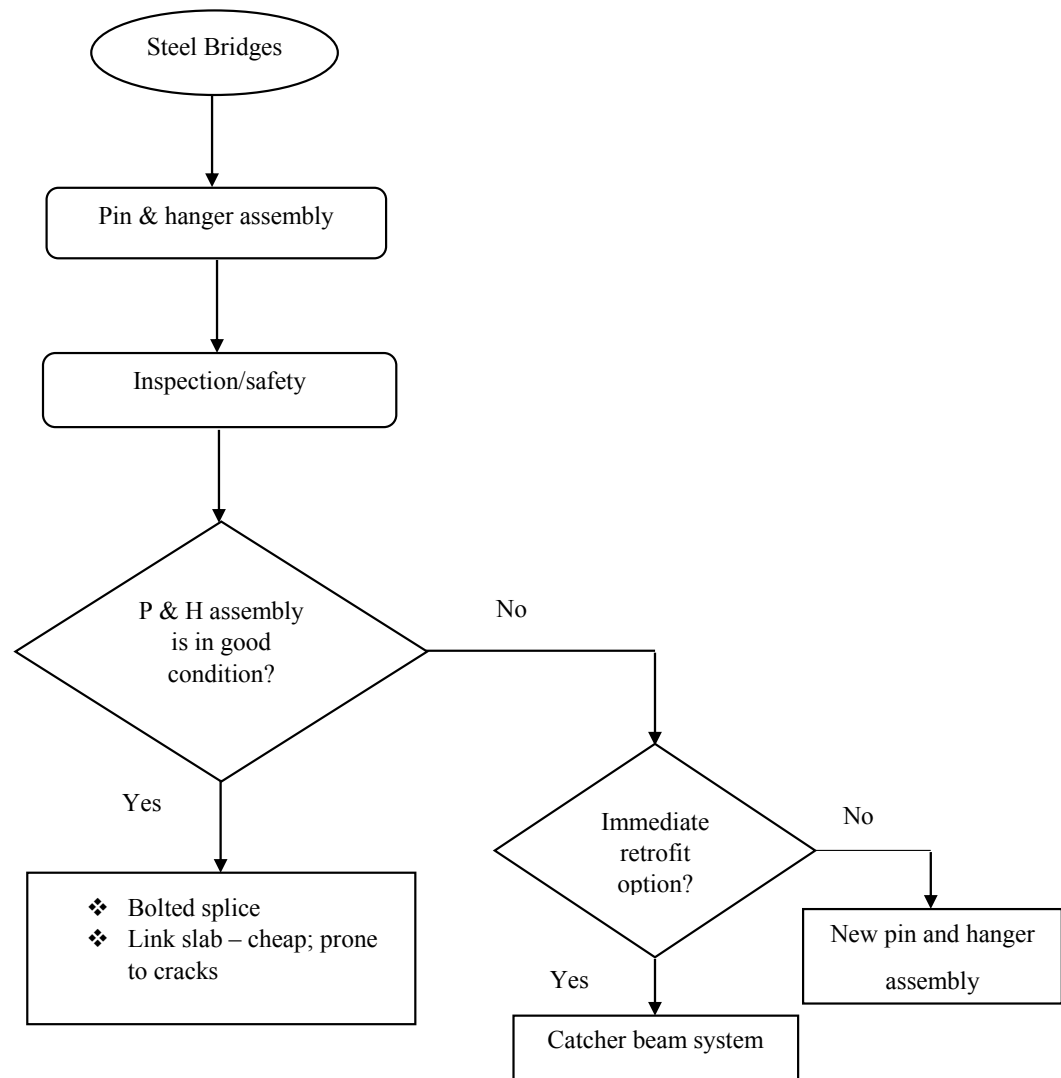
Figure 4.1 Flowchart demonstrates decision – making process

The objective of this chapter is to provide flowcharts that describe steps associated with completing feasible options associated with addressing pin and hanger assembly retrofit and/or replacement. Approaches for which flowcharts are provided are categorized as retrofit, rehabilitation, or removal and replacement options as shown in Figure 4.1. The intention is that these flowcharts will provide an organized decision-making tool that would assist engineers with assessing options and their consequences when pin and hanger assembly retrofit and/or replacement are being considered. As appropriate, each cell in the flowcharts refers to corresponding articles in appropriate state and federal design specifications. These include the *AASHTO Standard Specifications for Highway Bridges*, the *AASHTO LRFD Bridge Design Specifications* and *NDOT's Bridge Office Policies and Procedures (BOPP) manual*.

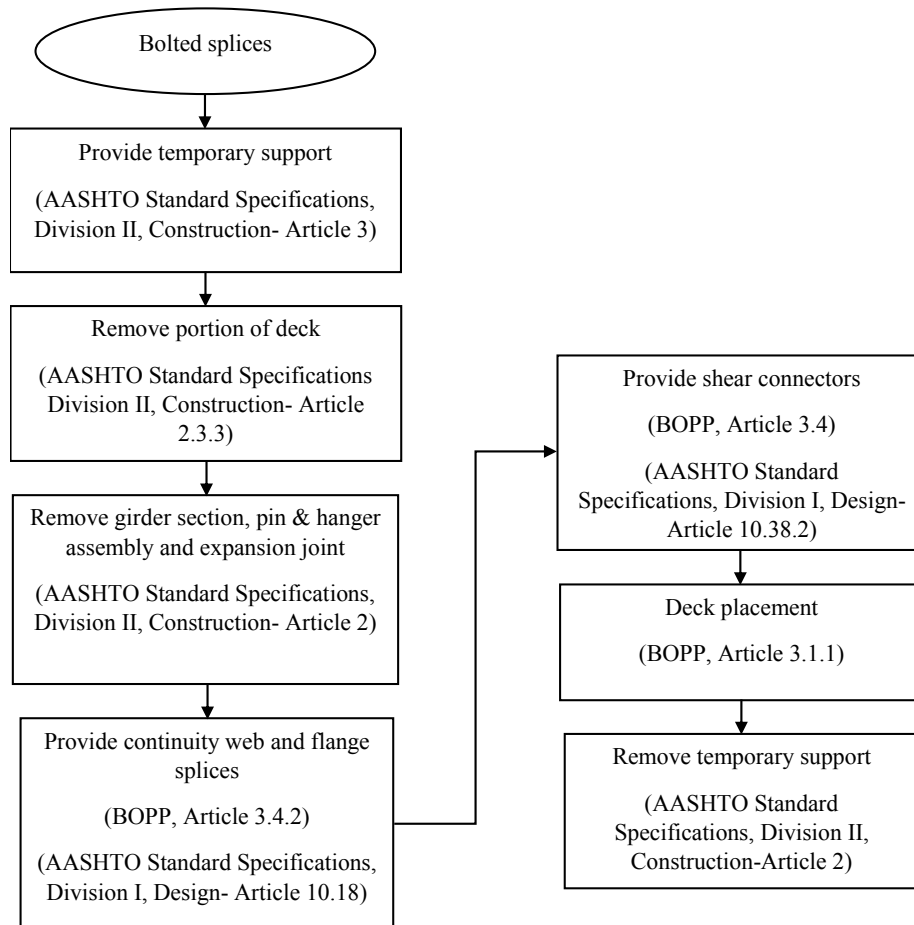
Figure 4.2 Bolted splice design process

As shown in Figure 4.2, when considering replacing the assemblies with bolted splices, the process starts with following steps. While replacing the pin and hanger assemblies with bolted splices, the girder should be supported by temporarily support beam and this support should be provided according to Standard Specifications, Division II-Construction (Article 3). The portion of the deck along the expansion joints are removed as per the design dimensions of the splices according to Standard Specifications, Division II-Construction (Article 2.3.3). The portion of the girder section near the pin and hanger location, pin and hanger assembly, and the expansion joints are removed according to Standard Specifications, Division II-Construction (Article 2). The drop-in span is completely converted into continuity support which is provided through bolted splices connection according to Standard Specifications, Division I-Design (Article 10.18) and BOPP Specifications (Article 3.4.2). Here demand of the girder changes, so demand should be recalculated. Provide shear connectors along the newly constructed girder, shear connectors are designed to provide a composite action between the slab and the girders according to Standard Specifications, Division I-Design (Article 10.38.2) and BOPP Specifications (Article 3.4). Place the deck according to BOPP Specifications (Article 3.1.1). Finally, after construction temporarily support should be removed according to Standard Specifications, Division II-Construction (Article 2).

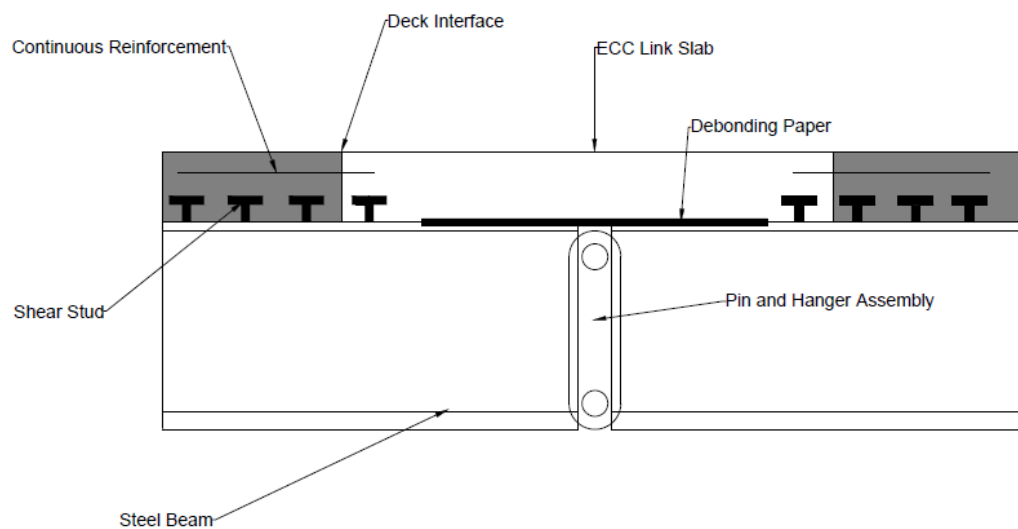
The deck expansion joint is a significant component in the functioning of bridge structures (Chang & Lee, 2002). Deck expansion joints accompany the pin and hanger assemblies. The elimination or reduction of expansion joints reduces costs. One identified option that would help eliminate deck joints is via providing “link slabs” at joint locations. Figure 4.3 referred from (Caner & Zia, 1998). A flow-chart detailing general steps involved in the process is located in Figure 4.3.

Figure 4.3 Link Slab detail

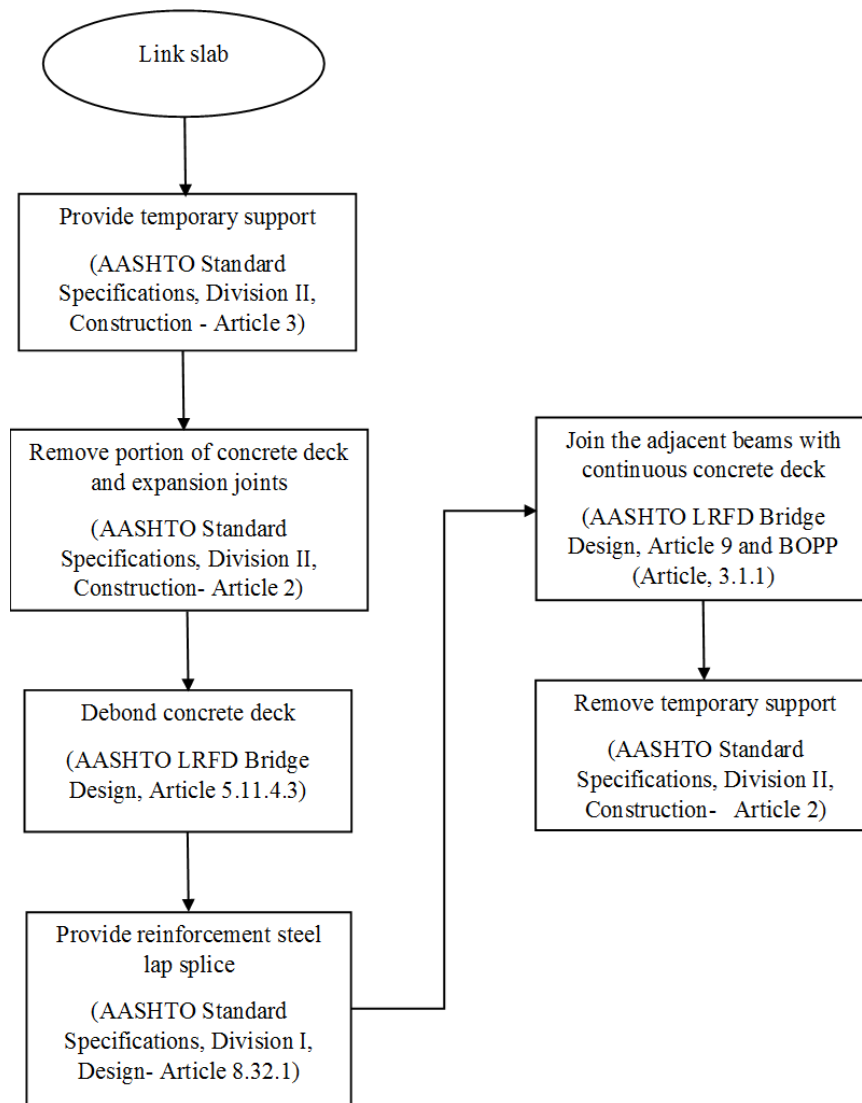
Figure 4.4 Link slab design process.

As shown in Figure 4.4, when considering rehabilitation with link slab, the process starts with following steps according to (Caner & Zia, 1998). While replacing the pin and hanger assembly with a link slab, the girder should be supported by temporarily support beam and this support should be provided according to Standard

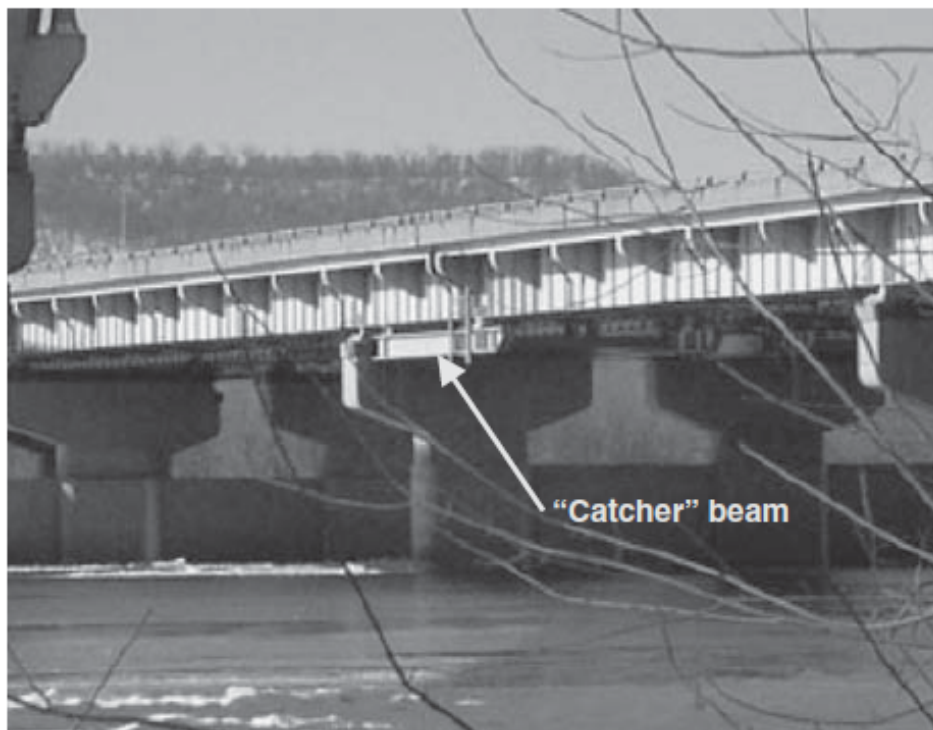
Figure 4.5 Catcher beam system. (Connor et al. 2005)

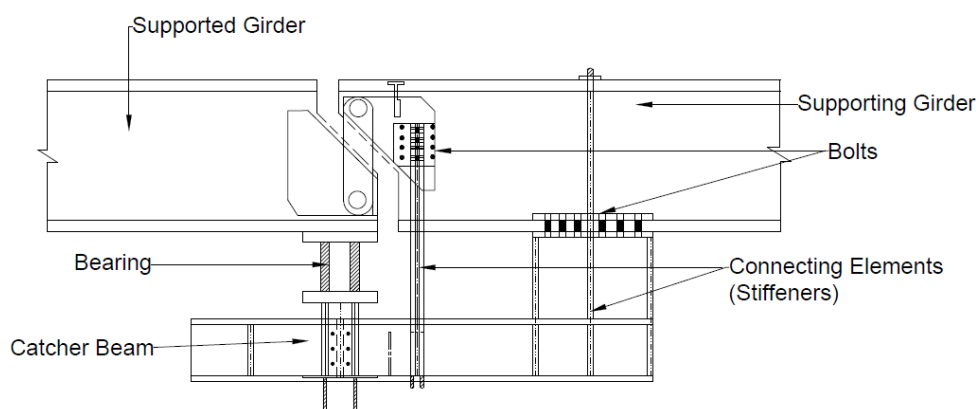
Figure 4.6 Catcher beam system representative detail

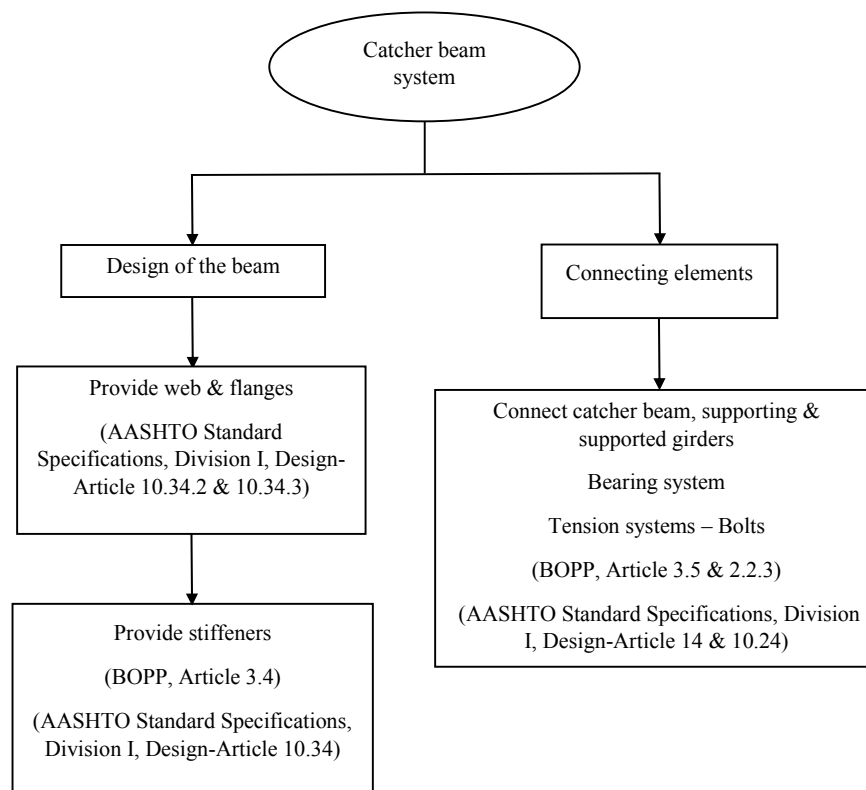
Figure 4.7 Catcher beam design process

As shown in Figure 4.7, when considering retrofit of pin and hanger assemblies with catcher beam, the design process is explained below. Catcher beam system design consists of two components: design of the beam and the connecting elements.

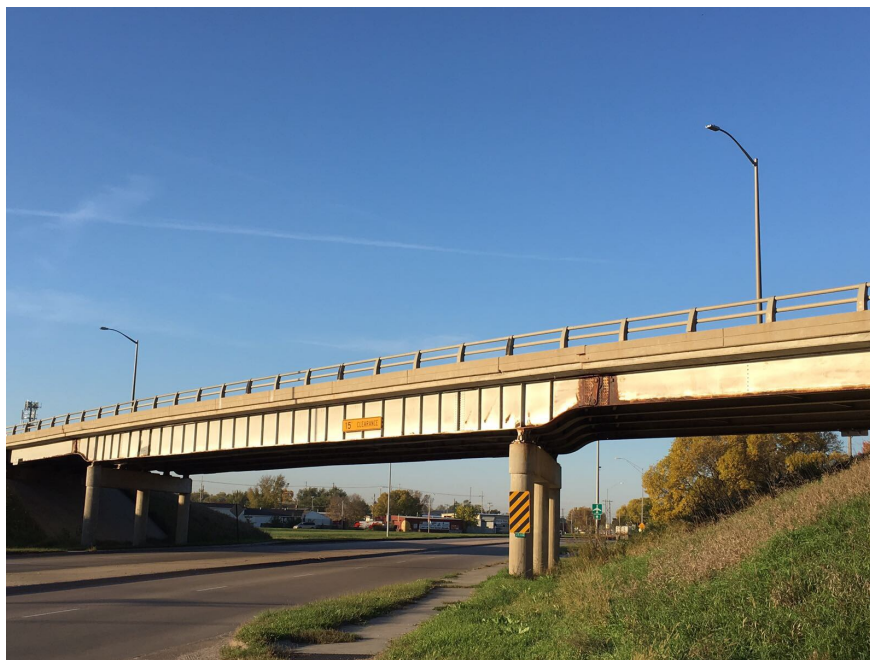
The selected girder was taken from a 3-span, continuous, plate girder bridge having an overall length of 65.00 meters (214 feet). This bridge is located in Lincoln, Nebraska and was built in 1961. The model focused on an exterior (fascia) girder and an elevation view of the girder is shown in Figure 5.2. NDOT design drawings were used to create the models, with the original girder curved haunch shown in Figure 5.2 being replaced by a linear haunch. Figure 5.3 provides details on the pin and hanger assembly.

Figure 5.1 Modeled bridge

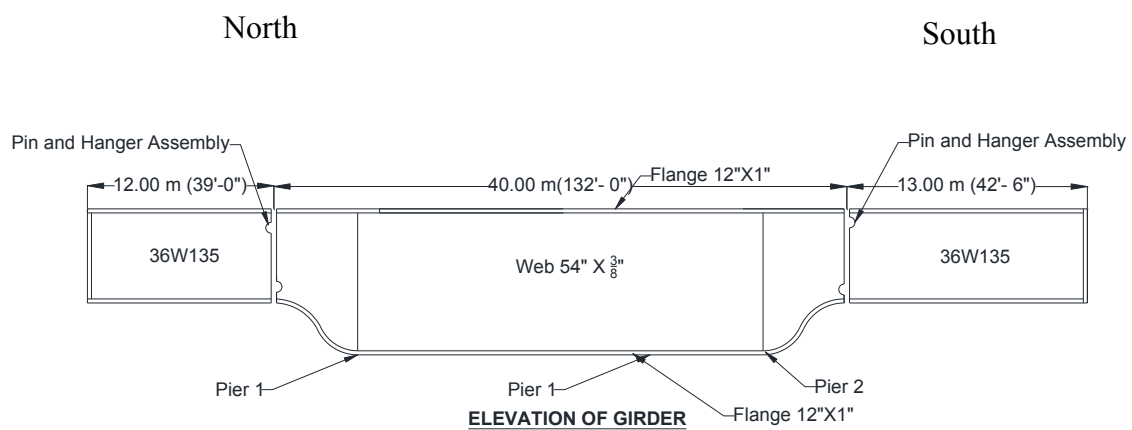
Figure 5.2 Original girder elevation

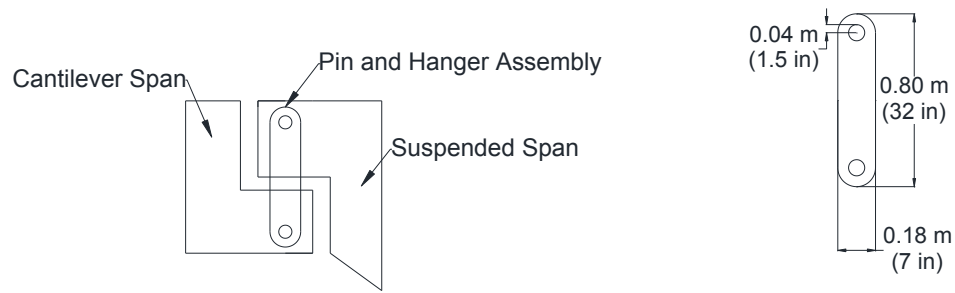
Figure 5.3 Pin and hanger assembly

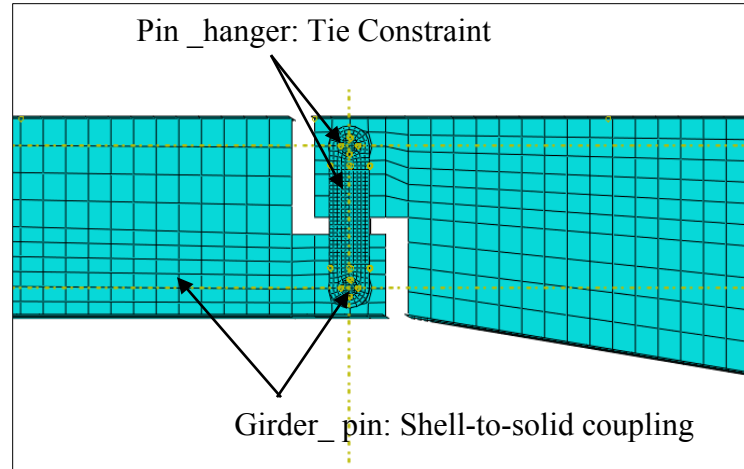
The pins and hanger plates were modeled using 8-noded, reduced integration, brick elements (C3D8R) elements. Solid-to-shell coupling was used to couple these solid elements to girder shell elements (Figure 5.4). Results indicated that the stresses are below the yield stress, as expected when subjected only to dead loads.

Figure 5.4 Pin and hanger assembly model

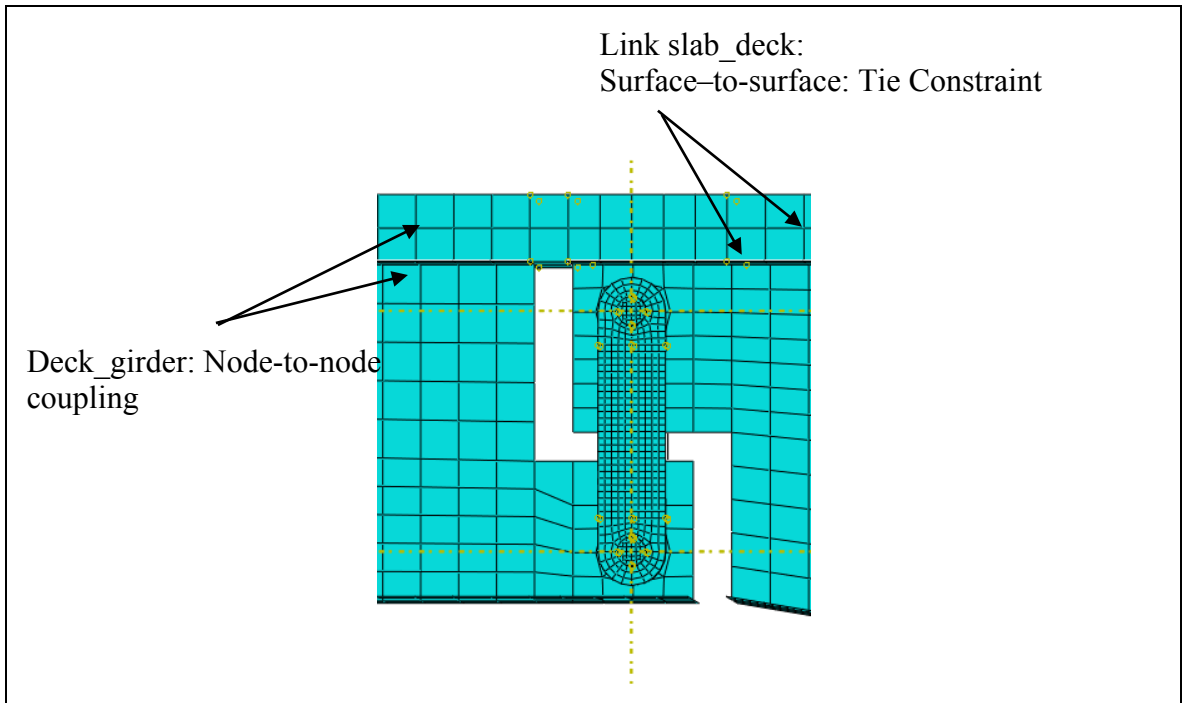
The link slab case included in the pin and hanger assembly items discussed in Chapter 2 and Chapter 4 modeled by utilizing 8-noded, reduced integration, brick elements (C3D8R) for the transformed section of concrete deck and was modeled linear elastically with small deformations. Reinforcement rebars using 2-noded, linear, beam elements (B31) for the rebar. The interactions shown in Figure 5.5 were used to render the link slab continuous over the assembly. The link slab was minimally reinforced of  $0.002\rho$  based on moment induced in the link slab due to end rotation with respect to deck thickness (Lepech & Li, 2009) Figure 2.4. Results indicated that the stresses are below the yield stress.

Figure 5.5 Link slab

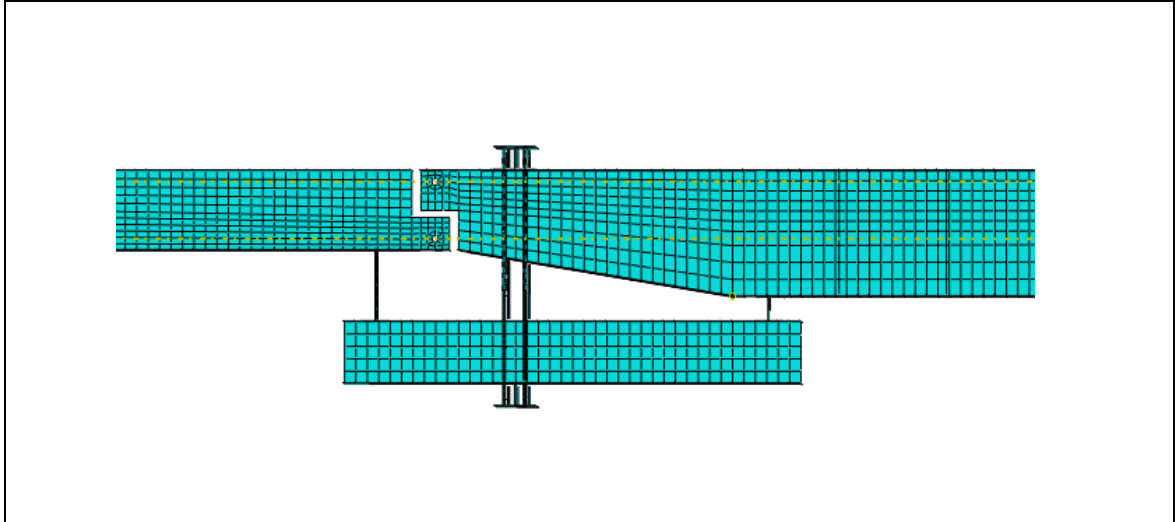
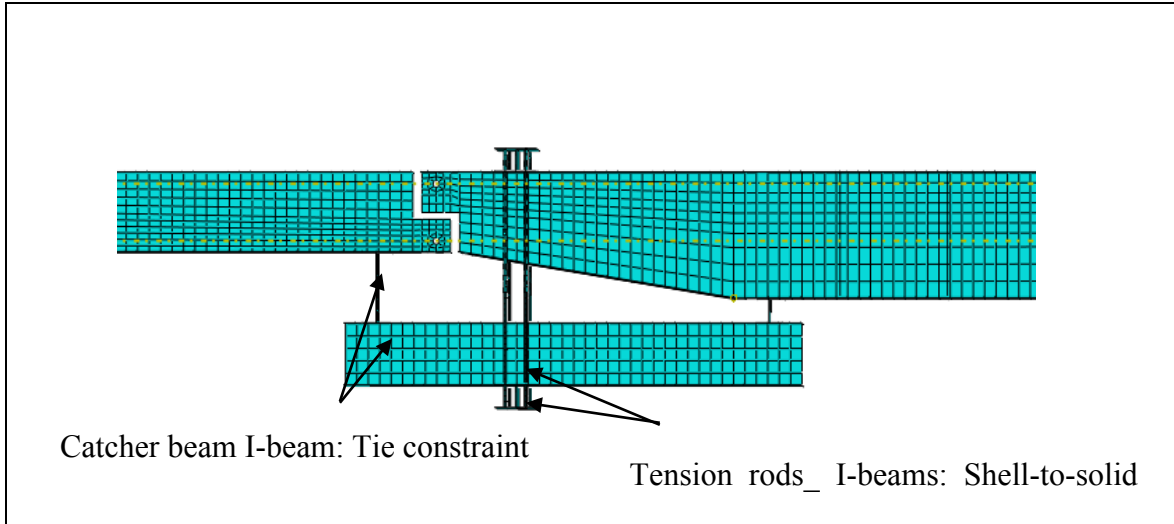
The modeled catcher beam system was based on the previous NDOT projects that utilized this retrofit. The system was modeled by utilizing 4-noded, reduced integration, shell elements (S4R) for I-beams. Tension rods were modeled using 8-noded, reduced integration, brick elements (C3D8R) as shown in

A catcher beam system provides a mechanically independent alternate load path to prevent a sudden loss of span when a pin and hanger assembly is deemed insufficiently reliable to carry required loads. Three models were generated at the two pin and hanger locations (Figure 5.7), with catcher beams provided at each location and with them simultaneously provided at both locations. Providing catcher beam at one location (north or either south) is feasible option by assuming assembly as failed at either of these locations. But, in this study separate models were generated for north and south location due to the unsymmetrical in span length. Providing catcher beam at both locations is not a feasible option because it shows that both assemblies has failed but modeled to check how it behaves having catcher beams at both locations.

Figure 5.6 Catcher beam system

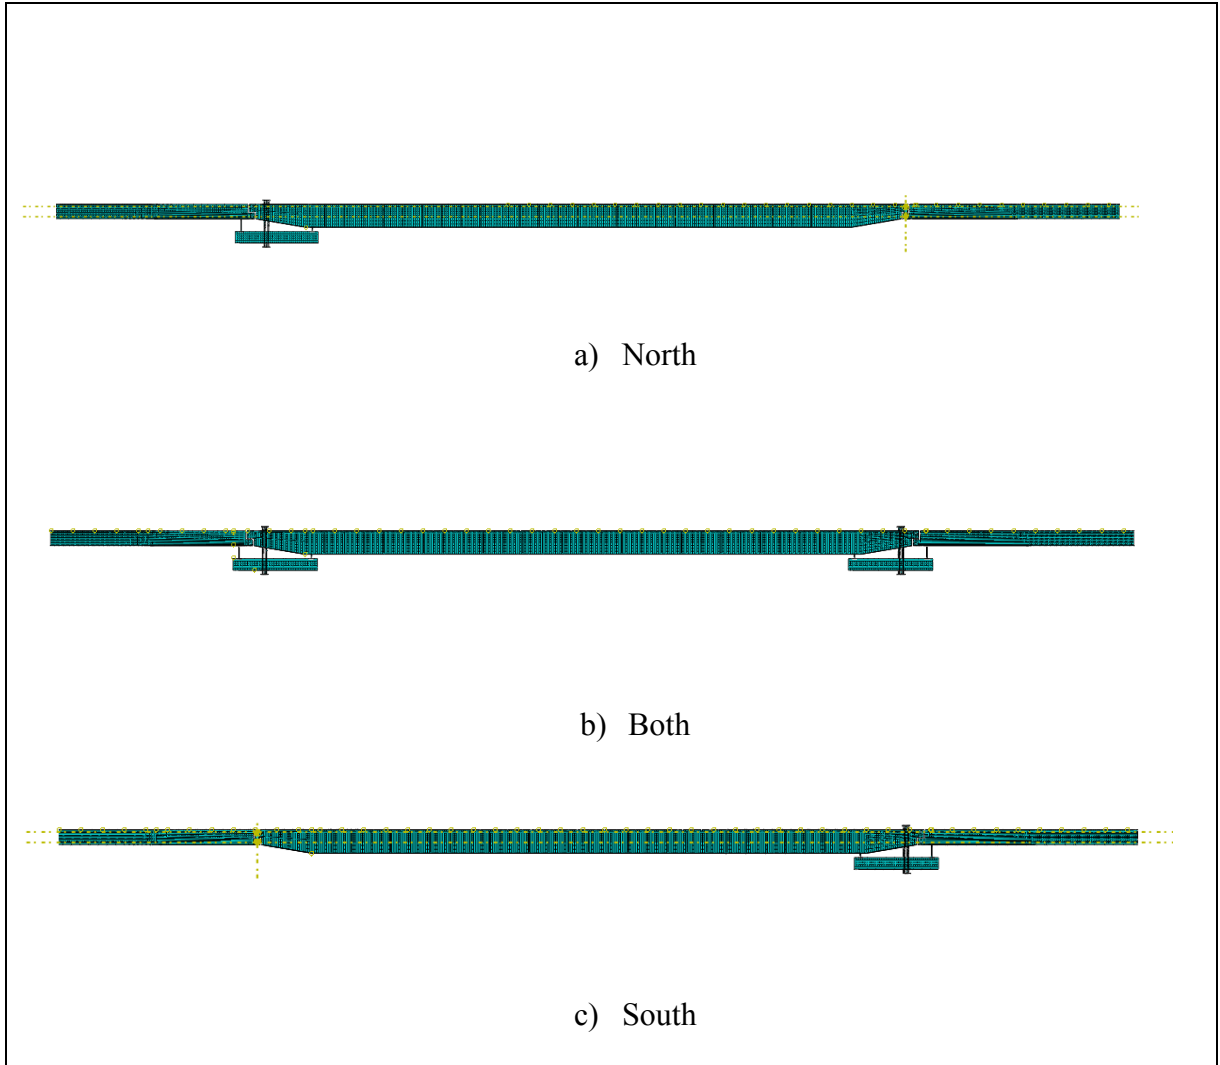
Figure 5.7 Modeled catcher beam cases

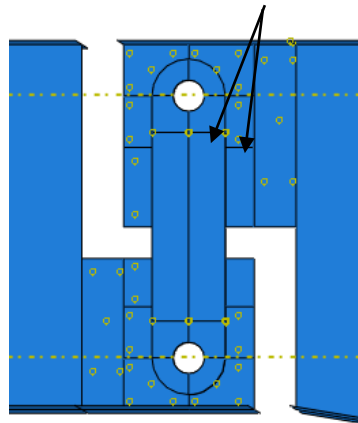
Figure 5.8 Frozen pin and hanger condition

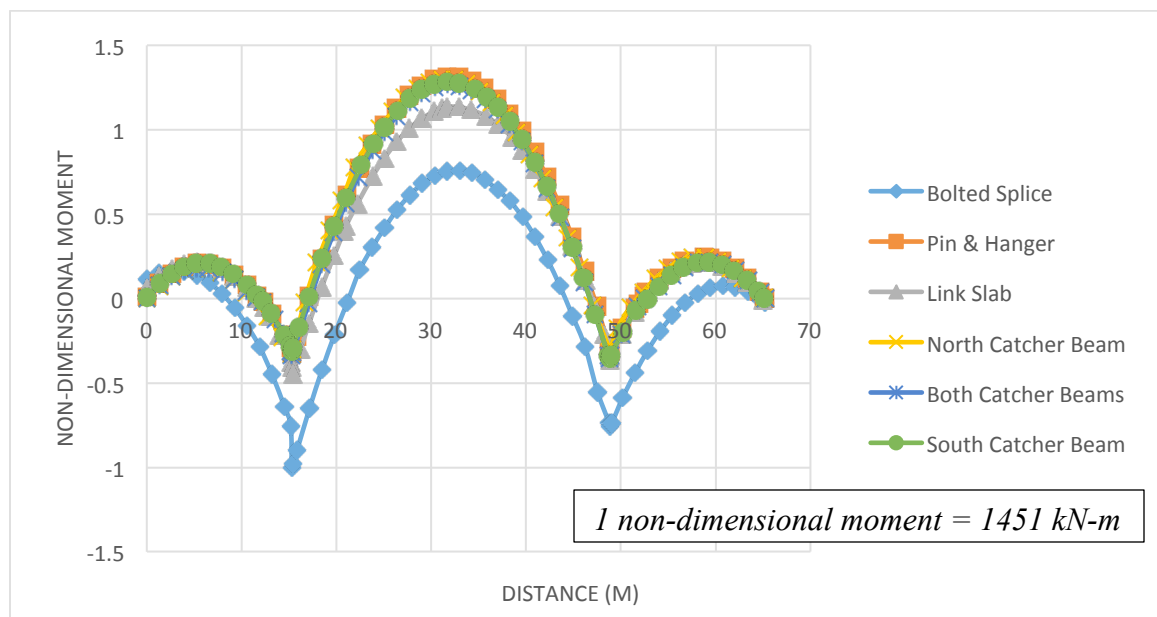
When looking at the non-dimensionalized ratios along the girder, the ratio for dead loads at pier 1 and pier 2 are nearly the same for the pin and hanger assembly (0.31-0.32), the catcher beam system (0.31-0.35), and the link slab (0.41-0.36) (Table 5.1). Similarly, at maximum positive moment location, the original pin and hanger assembly, the catcher beam systems are 1.32 and 1.30 and the link slab is 1.12. With regard to the shear diagram, indicates that the shear force plays a very negligible role when compared with the moment. Example of non-dimensionalized equation shown in the below section.

Figure 5.9 Non-dimensionalized moment diagrams for dead loads at pier 1

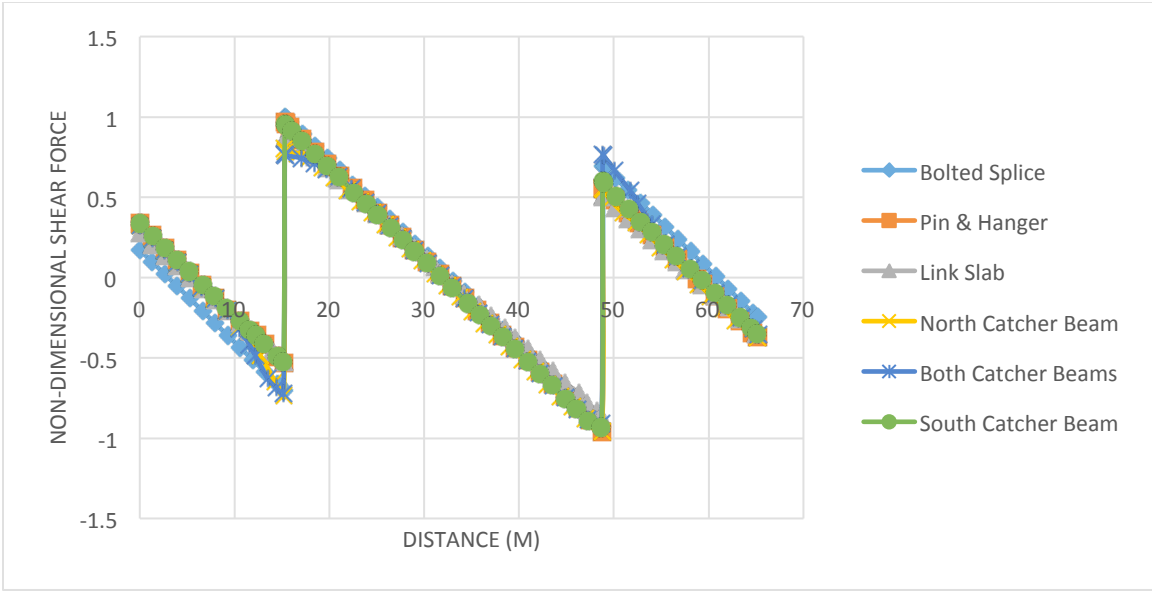
Figure 5.10 Non-dimensionalized shear diagrams for dead loads at pier 1

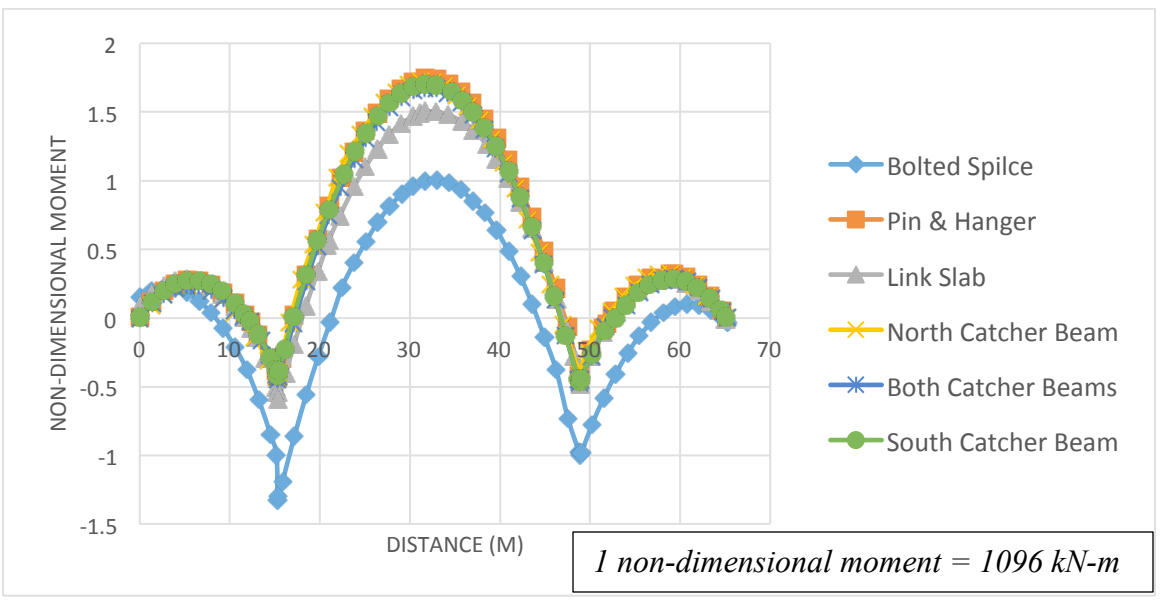
As indicated in Figure 5.11, the retrofit options providing the highest level of continuity when compared against the bolted splice for each model were presented in Table 5.2. When looking at the non-dimensionalized ratios along the girder, the ratio for dead loads at pier 1 and pier 2 are nearly the same for the pin and hanger assembly (0.41-0.42), the catcher beam system (0.41-0.47), and the link slab (0.54-0.50) (Table 5.2). Similarly, at maximum positive moment location, the original pin and hanger assembly, the catcher beam systems are 1.74 and 1.70 and the link slab is 1.50. From the shear diagram shown in Figure 5.12 it is implied that shear force plays a negligible role when compared with the moment. Example of non-dimensionalized equation shown in the below section.

Figure 5.11 Non-dimensionalized moment diagrams for dead loads at Pier 2

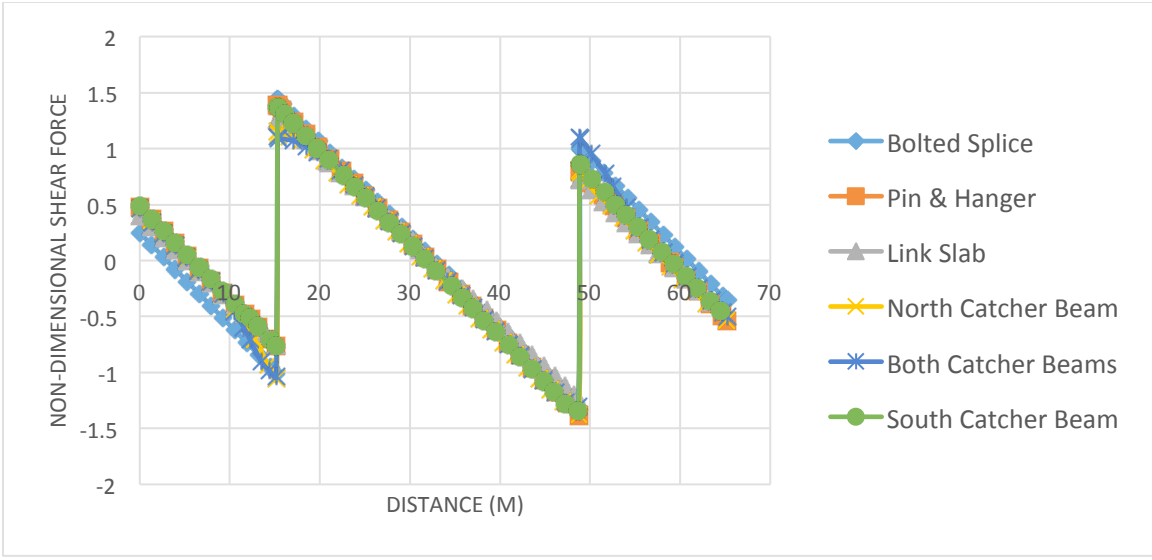
Figure 5.12 Non-dimensionalized shear diagrams for dead loads at Pier 2

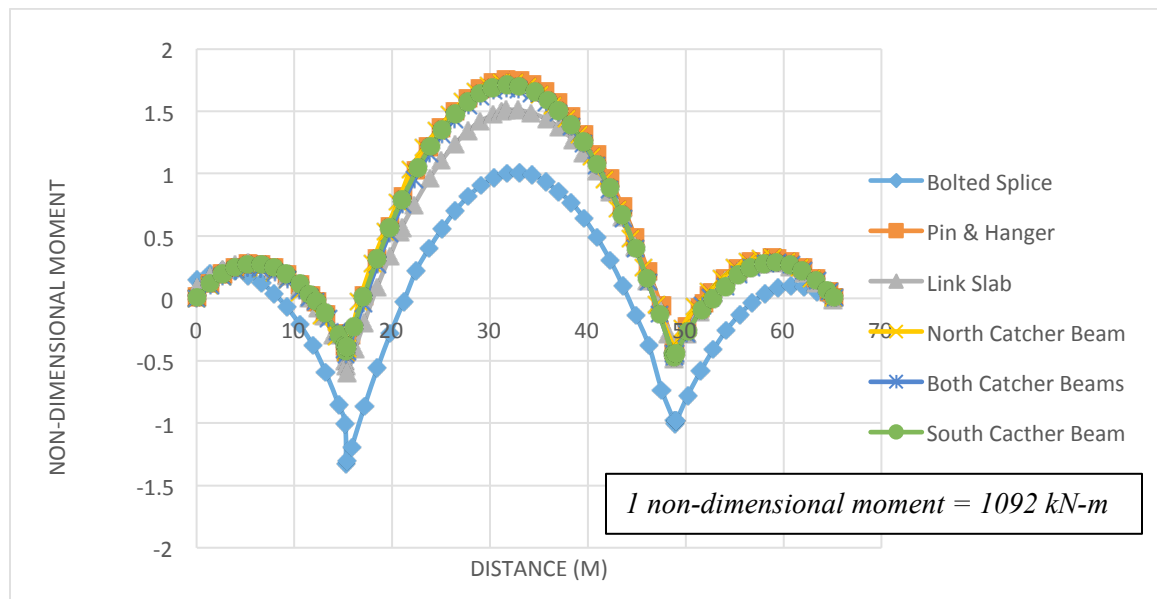
As indicated in Figure 5.13, the retrofit options providing the highest level of continuity when compared against the bolted splice for each model was presented in Table 5.3. When looking at the non-dimensionalized ratios along the girder, the ratio for dead loads at pier 1 and pier 2 are nearly the same for pin and hanger assembly (0.41-0.42), catcher beam system (0.41-0.47) and link slab is (0.54-0.50) (Table 5.3). At maximum positive moment location, original pin and hanger assembly, catcher beam systems are 1.74 and 1.70 and link slab is 1.50. Example of non-dimensionalized equation shown in the below section.

Figure 5.13 Non-dimensionalized moment diagrams for dead loads at maximum positive moment

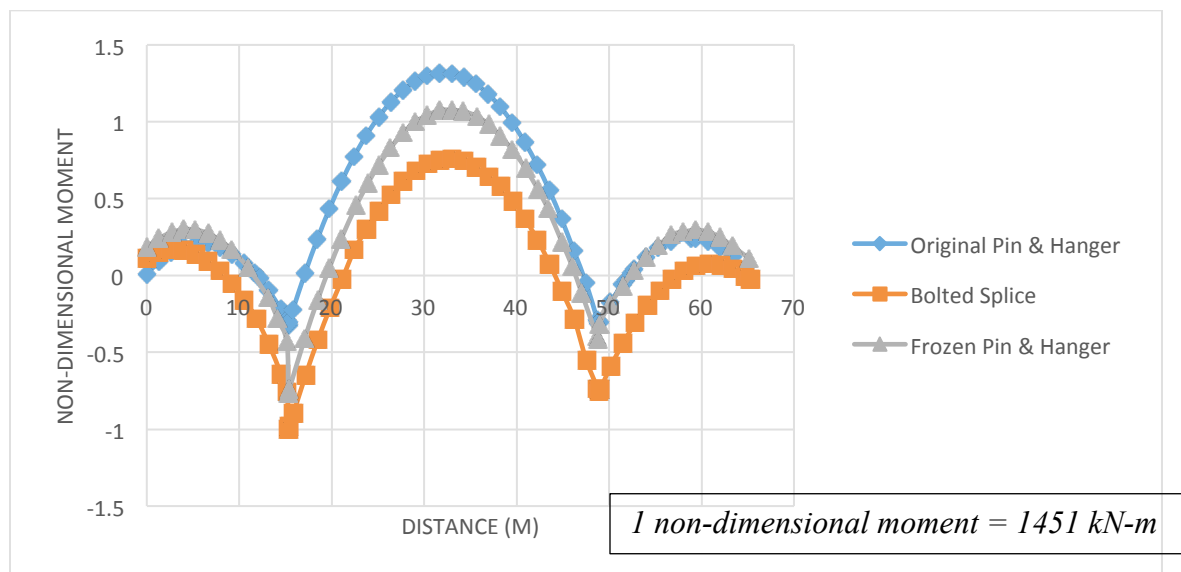
Figure 5.14 and Table 5.4 compare levels of continuity for the bolted splice to the original pin and hanger assembly and to the frozen assembly case Table 5.1. When looking at the non-dimensionalized ratios along the girder, which indicates that the ratio for dead loads at pier 1 and pier 2 locations for the original pin and hanger assembly (0.32-0.31), and for the locked pin condition is (0.76-0.45) (Table 5.4). Similarly, at maximum positive moment location, the original pin and hanger assembly is 1.32, and the locked pin condition is 1.10. Example of non-dimensionalized equation shown in the below section.

Figure 5.14 Non-dimensionalized moment diagrams for dead loads at pier 1 for locked condition

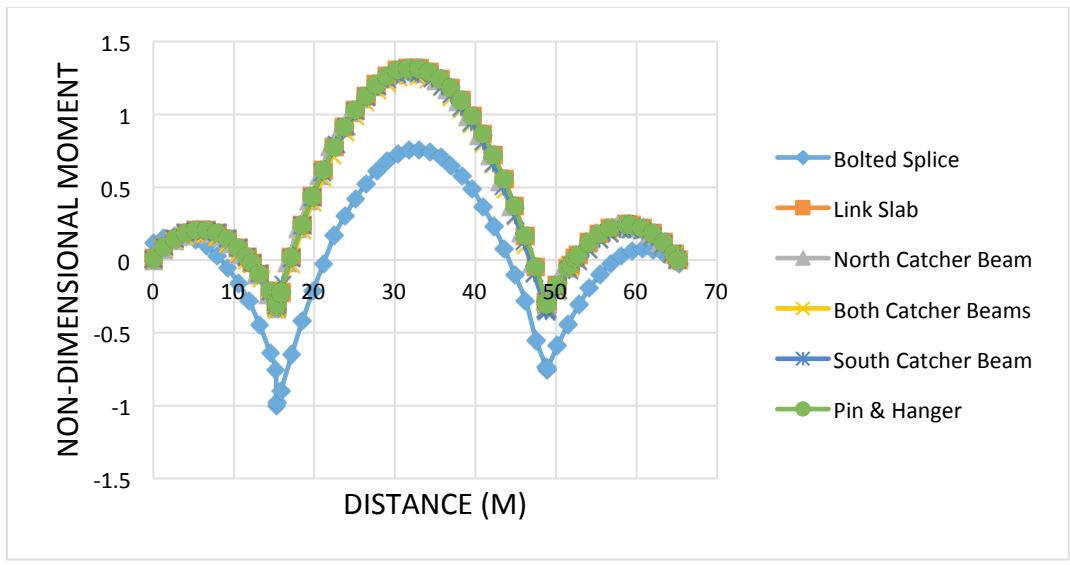
As indicated in the Figure E.1, the retrofit options providing the highest level of continuity when compared against the bolted splice for each model were presented. This finding is supported when looking at the non-dimensionalized ratios show in Table E.2 , which indicate that the ratio for DC1 is identical for pin and hanger, link slab and catcher beam system at pier1 (0.32-0.33), pier2 (0.30-0.35) and, maximum positive moment (1.3-1.28). From the shear diagram Figure E.2 indicates that shear force as very negligible effect compare to moment. Example of non-dimensioned equation is presented below.

Figure E.1 Non-dimensionalized DC1 moment diagrams at pier 1

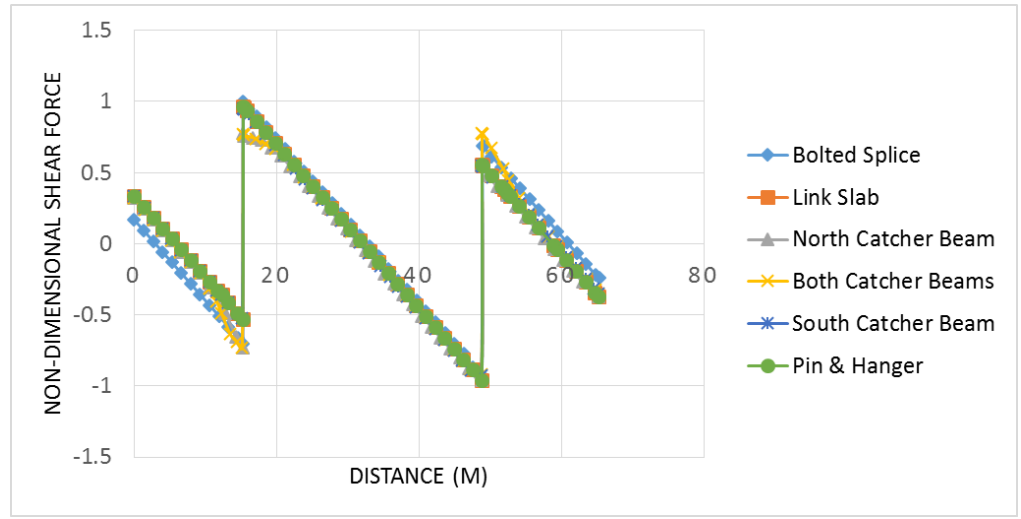
Figure E.2 Non-dimensionalized DC1 shear diagrams at pier 1
