# Examination of Steel Pin and Hanger Assembly Performance – Retrofit to Replacement

A THESIS

For the Degree of Master of Science

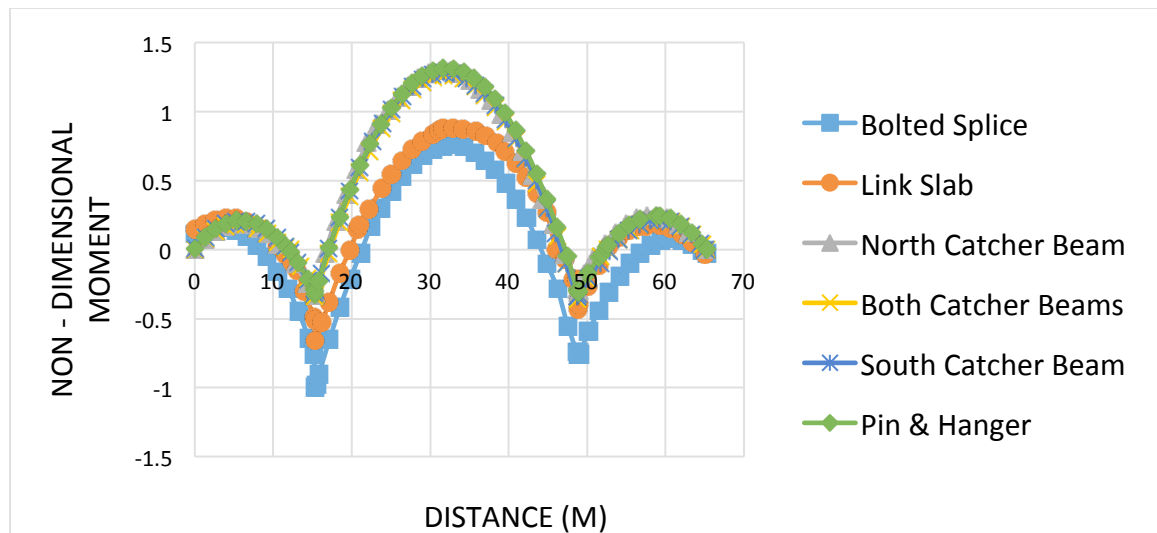
As indicated in the Figure E.3, the retrofit options providing the highest level of continuity when compared against the bolted splice for each model were presented. This finding is supported when looking at the non-dimensionalized ratios show in Table E.2, which indicate that for link slab as a ratio at pier1 (0.52), pier2 (0.044) and, maximum positive moment (0.9) followed by catcher beam system (3 locations) and pin and hanger assembly with ratio of pier1 (0.32-0.34), pier2 (0.301-0.35) and, maximum positive moment (1.31-1.28) level of continuity. From the shear diagram Figure E.4 indicates that shear force as very negligible effect compare to moment.

Figure E.3 Non-dimensionalized DC2 moment diagrams at pier 1

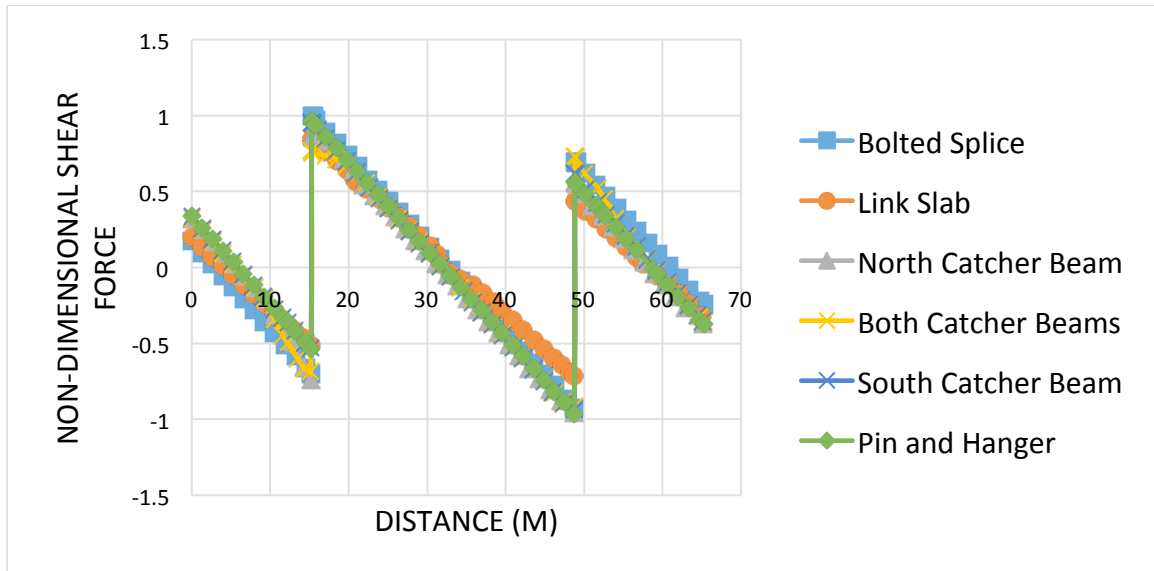
Figure E.4 Non-dimensionalized DC2 shear diagrams at pier 1

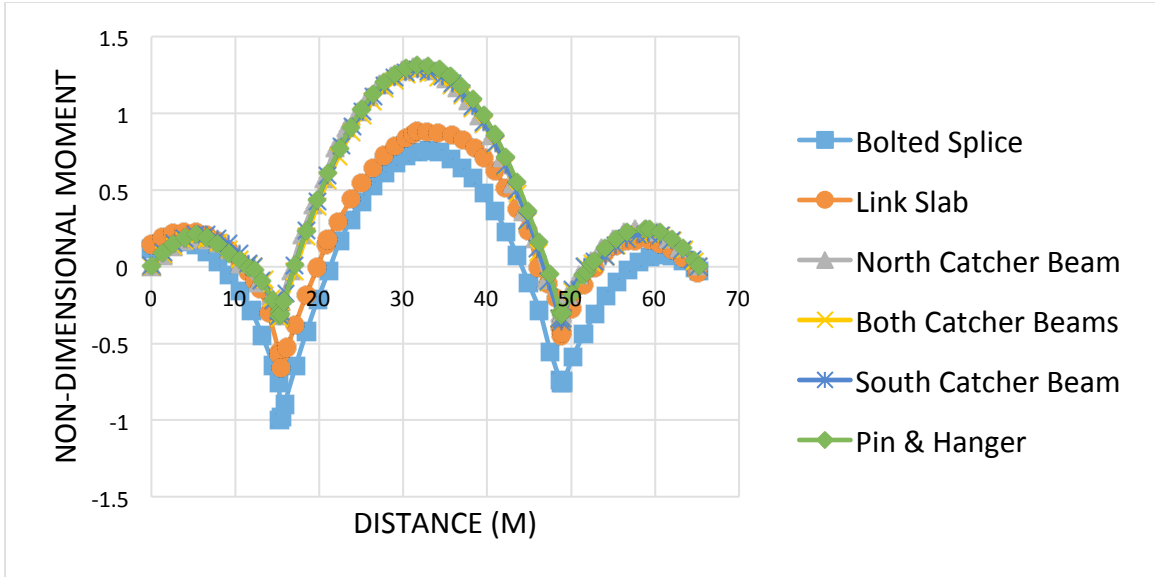
As indicated in the Figure E.5, the retrofit options providing the highest level of continuity when compared against the bolted splice for each model was presented. This finding is supported when looking at the non-dimensionalized ratios show in Table E.2, which indicate that for link slab as a ratio at pier1 (0.52), pier2 (0.44) and, maximum positive moment (0.9) followed by catcher beam system (3 locations) and pin and hanger assembly with ratio of pier1 (0.32-0.34), pier2 (0.30-0.36) and, maximum positive moment (1.30-1.28) level of continuity. From the shear diagram Figure E.6 indicates that shear force as very negligible effect compare to moment.

Figure E.5 Non-dimensionalized DW moment diagrams at pier 1

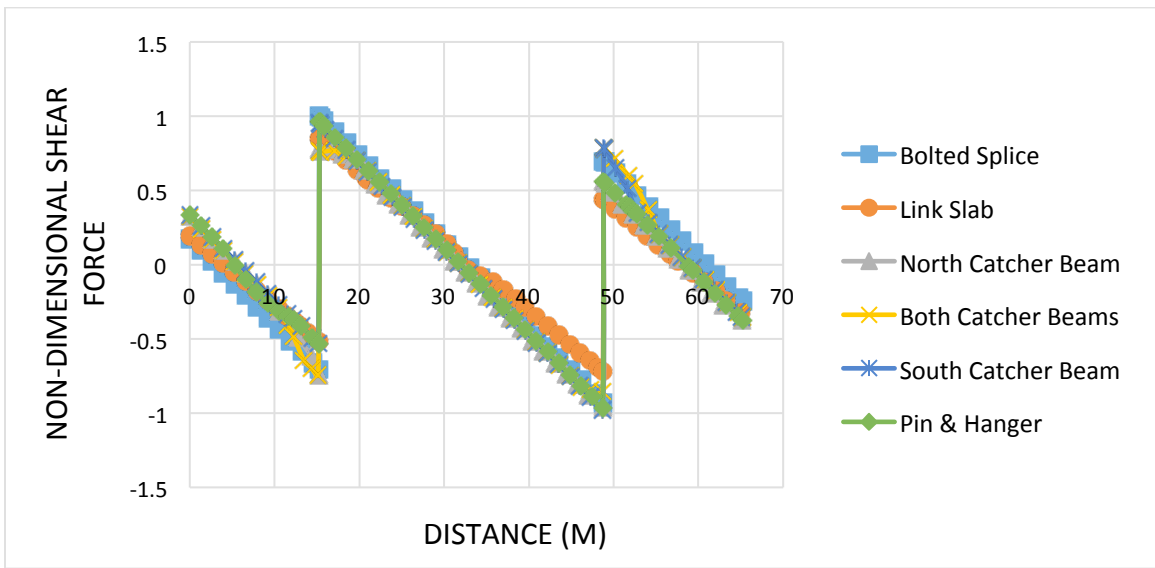
Figure E.6 Non-dimensionalized DW shear diagrams at pier 1
