# HYDROLOGIC CHARACTERIZATION OF A RAIN GARDEN MITIGATING STORMWATER RUNOFF FROM A COMMERCIAL AREA

John T. McMaine

THESIS

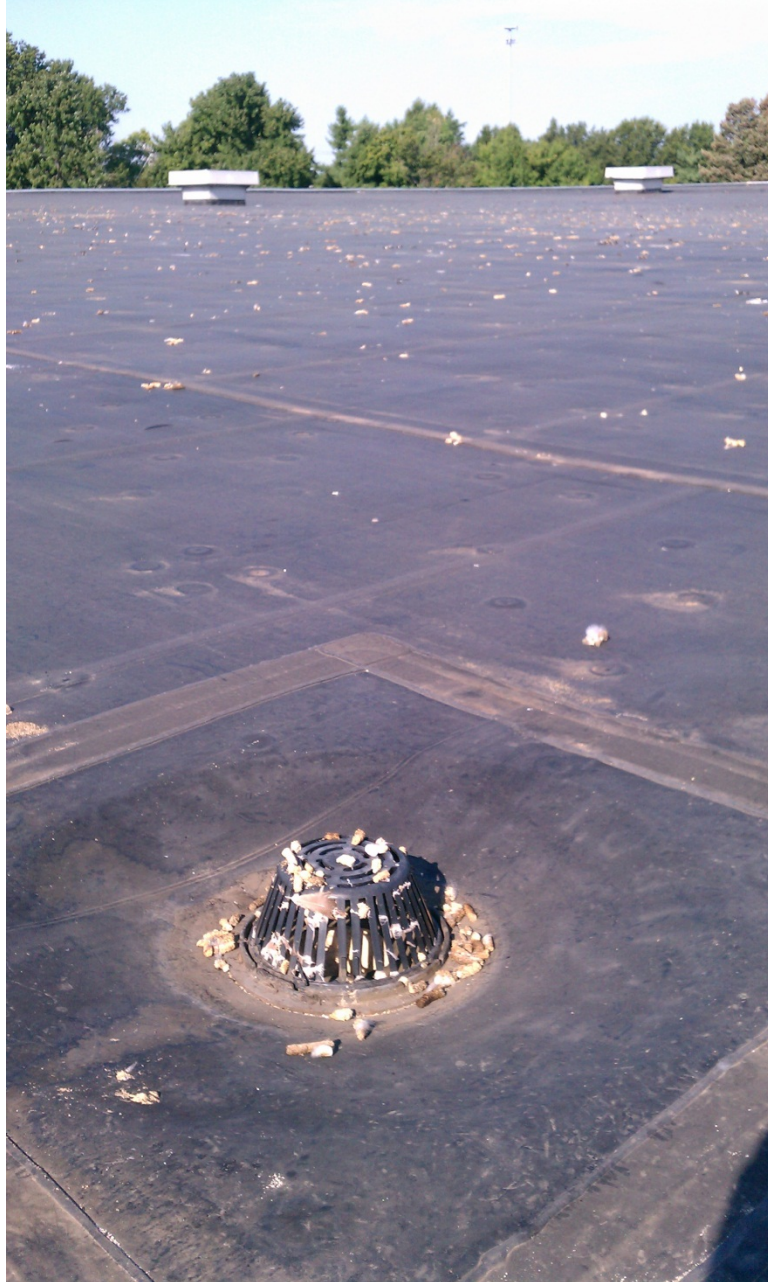
Figure 3.3. Goose feathers and droppings at the roof drain of the Coca-Cola Refreshments USA, Inc. warehouse rooftop.

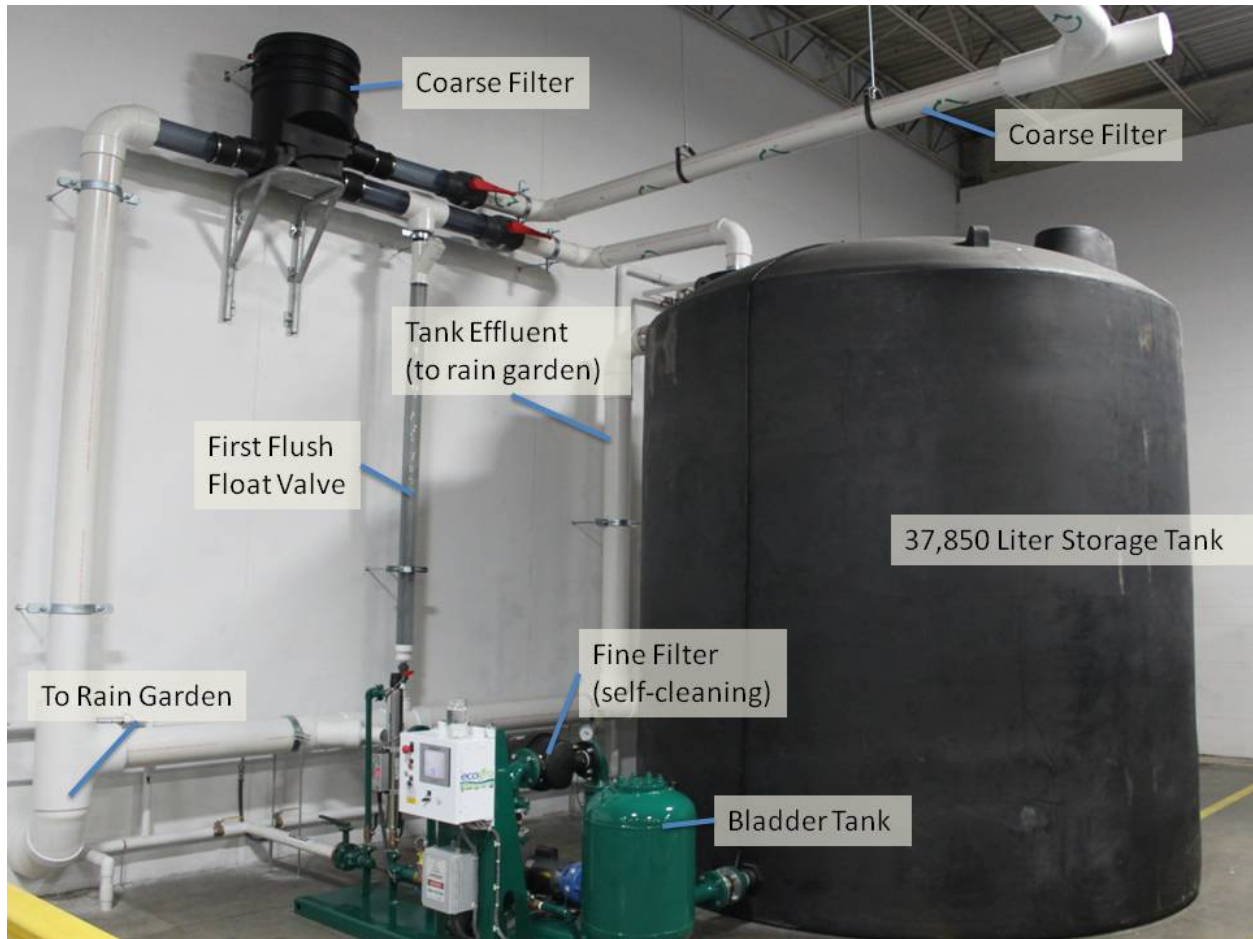
Figure 3.4. The rainwater harvesting system consists of three filters, a storage tank, and a control panel.

The rainwater harvest system consists of three filters of decreasing grain size, a control panel, and a 37,850 L storage tank (Figure 3.4). The filters consist of a coarse filter (350  $\mu\text{m}$ ), a floating filter (100  $\mu\text{m}$ ) inside the storage tank, and a self-cleaning filter (5  $\mu\text{m}$ ) on the same skid as the control panel. Runoff from the warehouse roof (influent) enters the rainwater harvest system via the coarse filter. After exiting the coarse filter, stormwater flows to the right towards the first flush pipe. The pipe to the left of the coarse filter is a complete bypass of the system and remains closed; it is only for use if the rainwater harvesting system is in need of maintenance. The first flush (approximately 20 L) of a runoff producing rain event bypasses the storage tank and flows directly into the rain garden via the first flush pipe and the bypass pipe. Once the first flush event has bypassed the rainwater harvesting system, a float valve redirects runoff into the storage tank. Following the first flush, the tank is filled to about 30,280 L (not maximum capacity). Once the tank is full, all of the remaining runoff flows into the rain garden via a 30 cm HDPE smooth wall pipe which serves as the overflow. Following the storm event, stormwater in the first flush pipe is slowly released to the rain garden via the bypass pipe. Figure 3.5 shows an example of the stormwater once it has passed through the rainwater harvesting system for either storage in the tank or discharge to the rain garden. As seen in this figure, the water is quite clear and with no visible suspended particles.

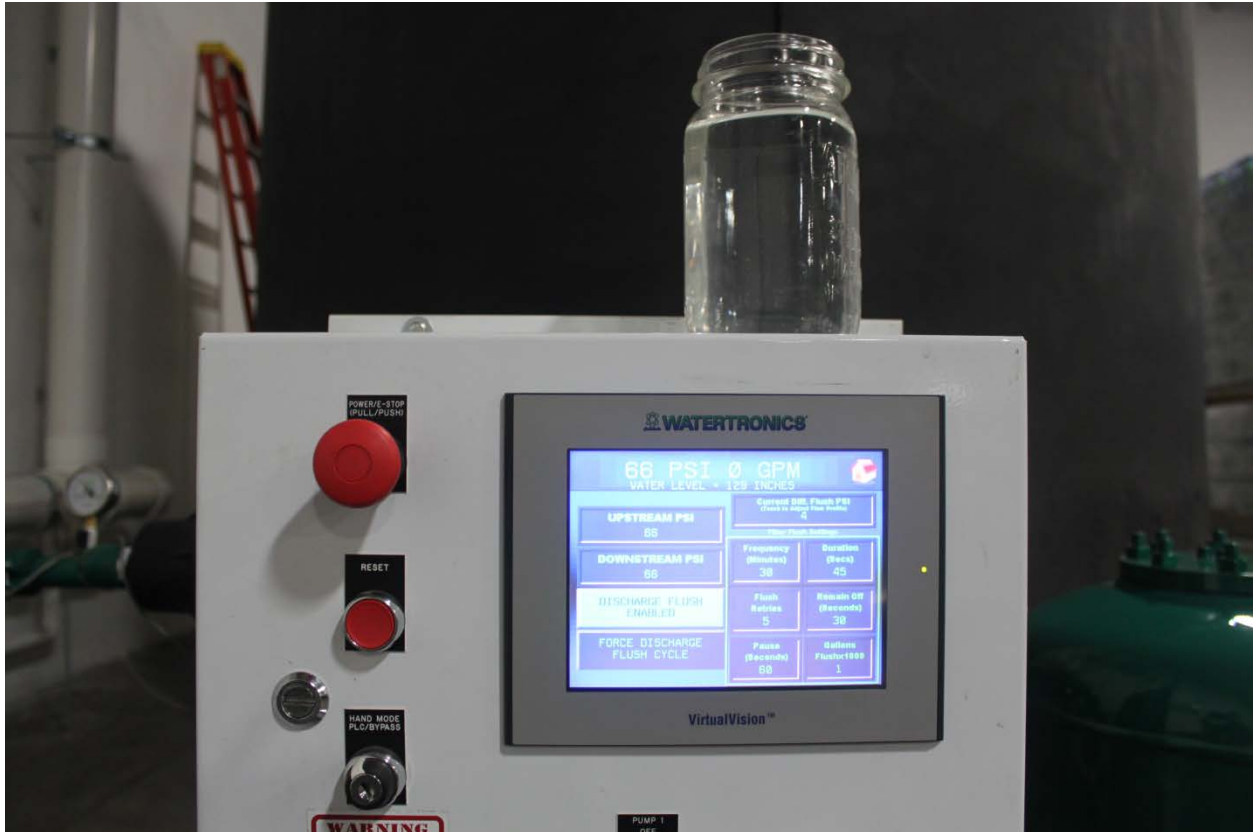
Figure 3.5. The mason jar contains water from the rainwater harvesting system.

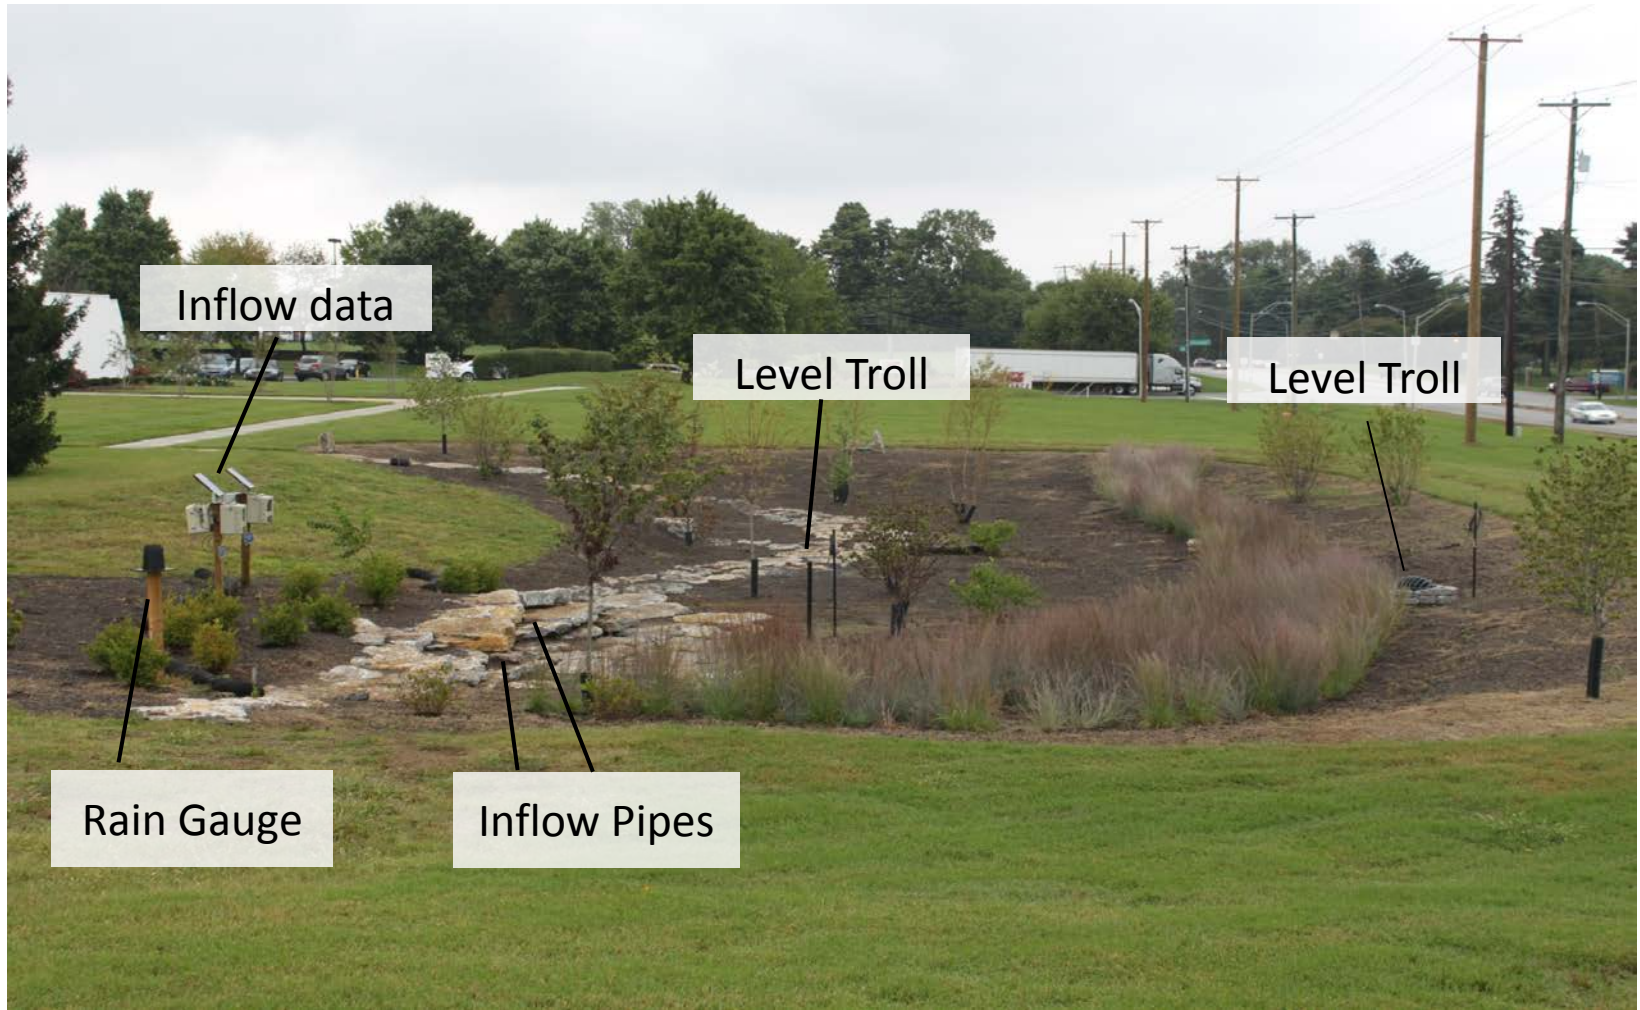
Figure 3.6. Layout of the instrumentation for measuring hydrologic performance of the rain garden.

Stormwater entered the rain garden through two pipes: 25 cm vitrified clay pipe and a 30 cm HDPE smooth wall pipe. Water level and average velocity were recorded every 10 minutes using two 4250 flow meters (one per pipe) (Teledyne-ISCO, Lincoln, NE) (Figures 3.6-3.7). Water level was measured using an integral pressure transducer and average velocity was measured using

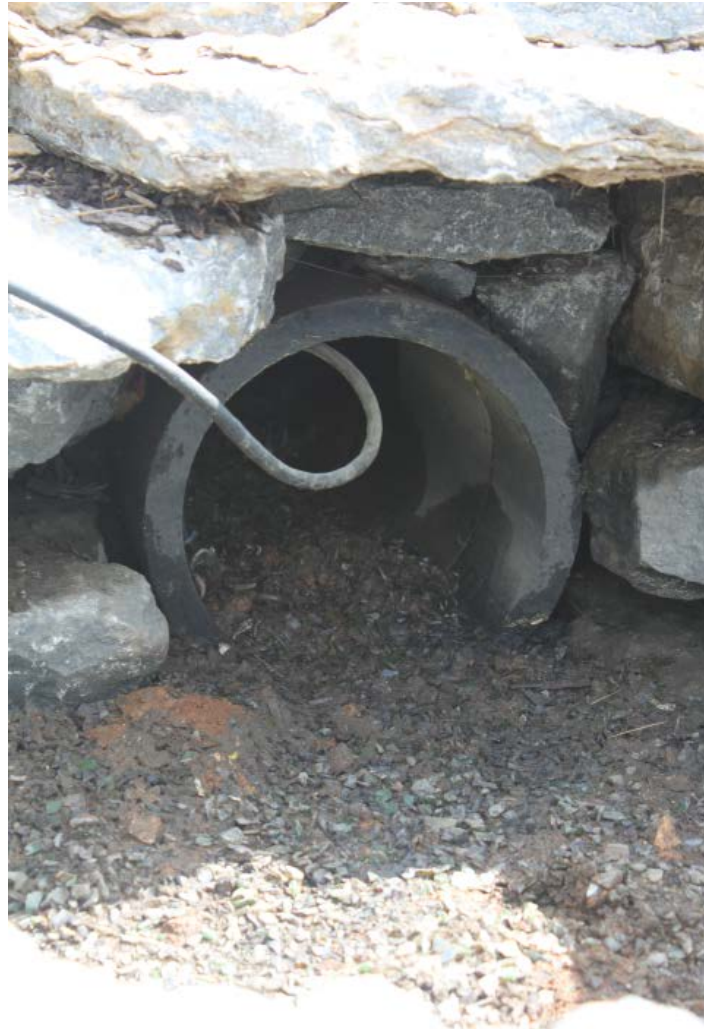
Figure 3.8. Sediment placed in the 30 cm HDPE pipe by a groundhog.

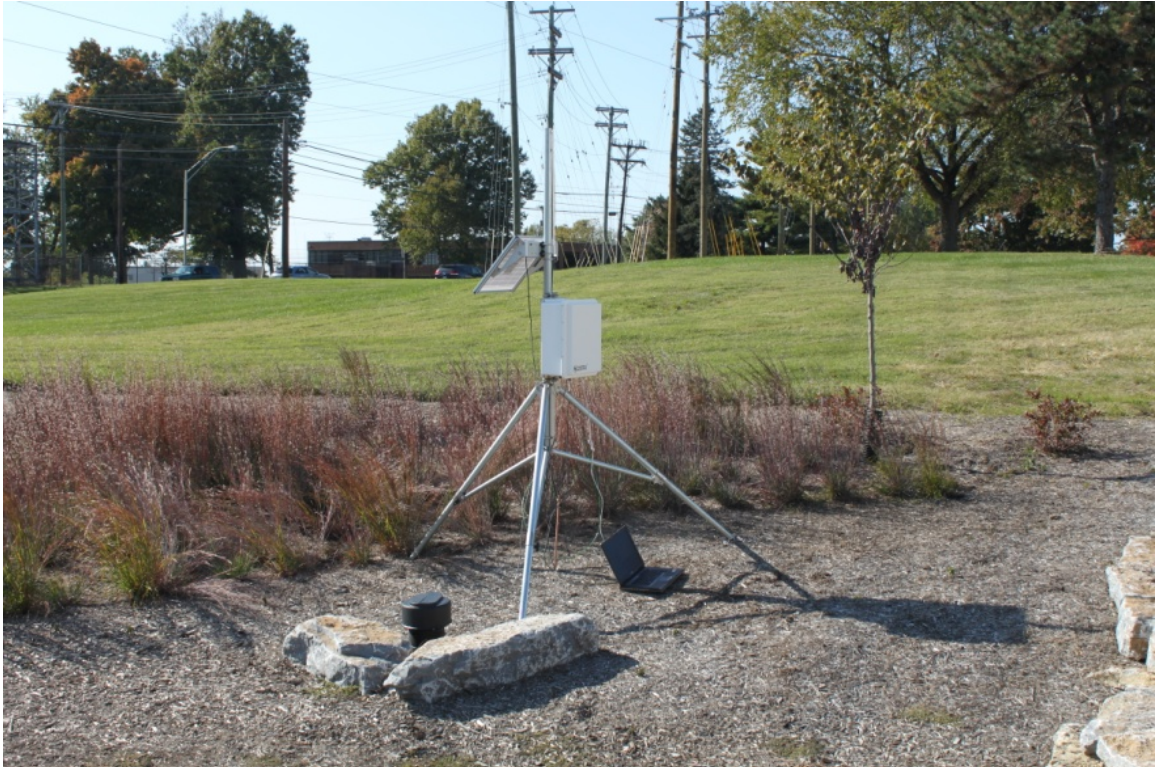
Figure 3.9. An EnviroScan soil moisture sensor with a Campbell Scientific datalogger (shown) were used to collect soil moisture data at seven vertical intervals.

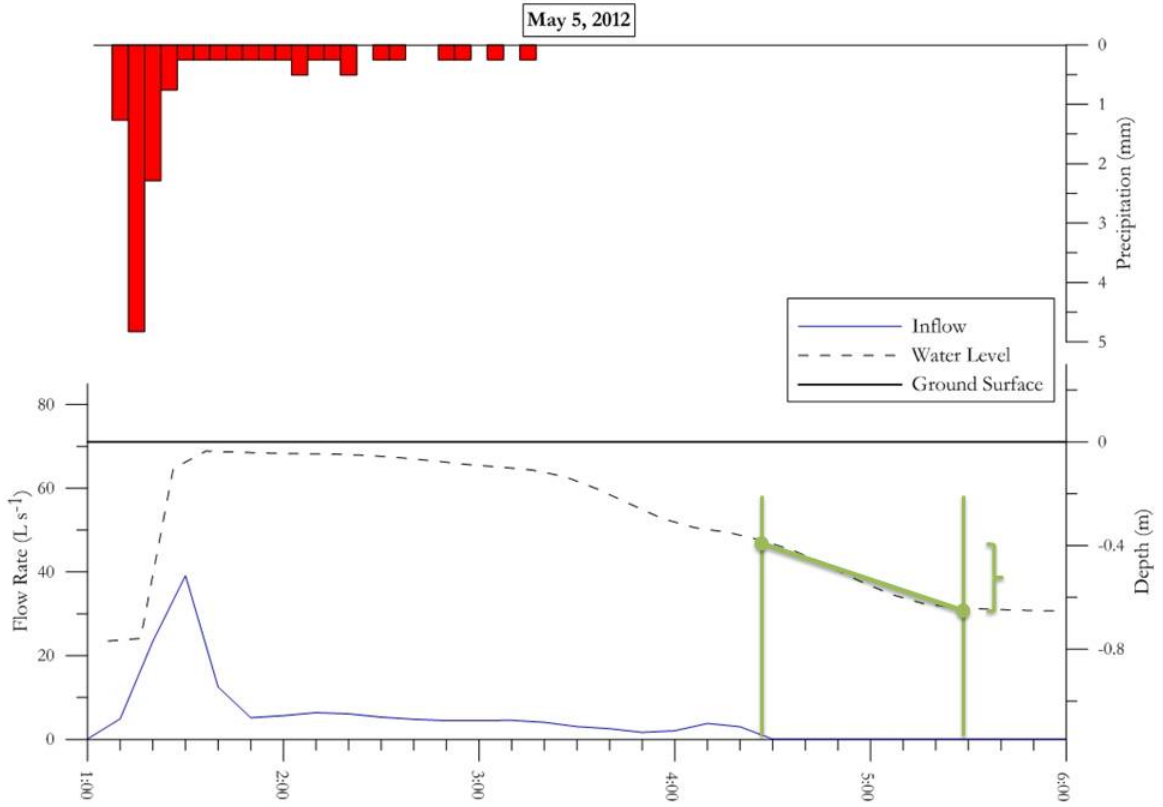
Figure 3.10. Infiltration rates were determined by noting the point of inflow cessation to the point of inflection for the water level.

Water level data in the well (Section 3.3.5) were used to determine infiltration rates for each storm event. Infiltration rates were computed using the rate of falling head as described in Selbig and Balster (2008) with the exception that these infiltration rates were determined for subsurface water levels as no ponded or above ground water was recorded during the monitoring period. Once inflow ceased, infiltration rates were computed from this point until the point at which there was less than a 1.5 cm drop in a 10 minute period (less than  $9 \text{ cm h}^{-1}$ ). This end point was chosen as it seemed to consistently represent the inflection point between quick infiltration and steady state conditions. For example, a starting time of 4:26 with a depth of 0.71 m and an ending time of 5:26

with a depth of 0.449 m were used for the storm event occurring April 5, 2012 (Figure 3.10). The starting point is the water level point closest to the time inflow ceased. The ending point represents the occurrence of a 1.5 cm depth difference in a 10 minute period (e.g. 0.449 m at 5:26 to 0.439 m at 5:36). Multiple infiltration rates were computed for a single storm event (with gaps in the rainfall) in cases where the minimum infiltration rate ( $9 \text{ cm h}^{-1}$ ) was reached more than once.

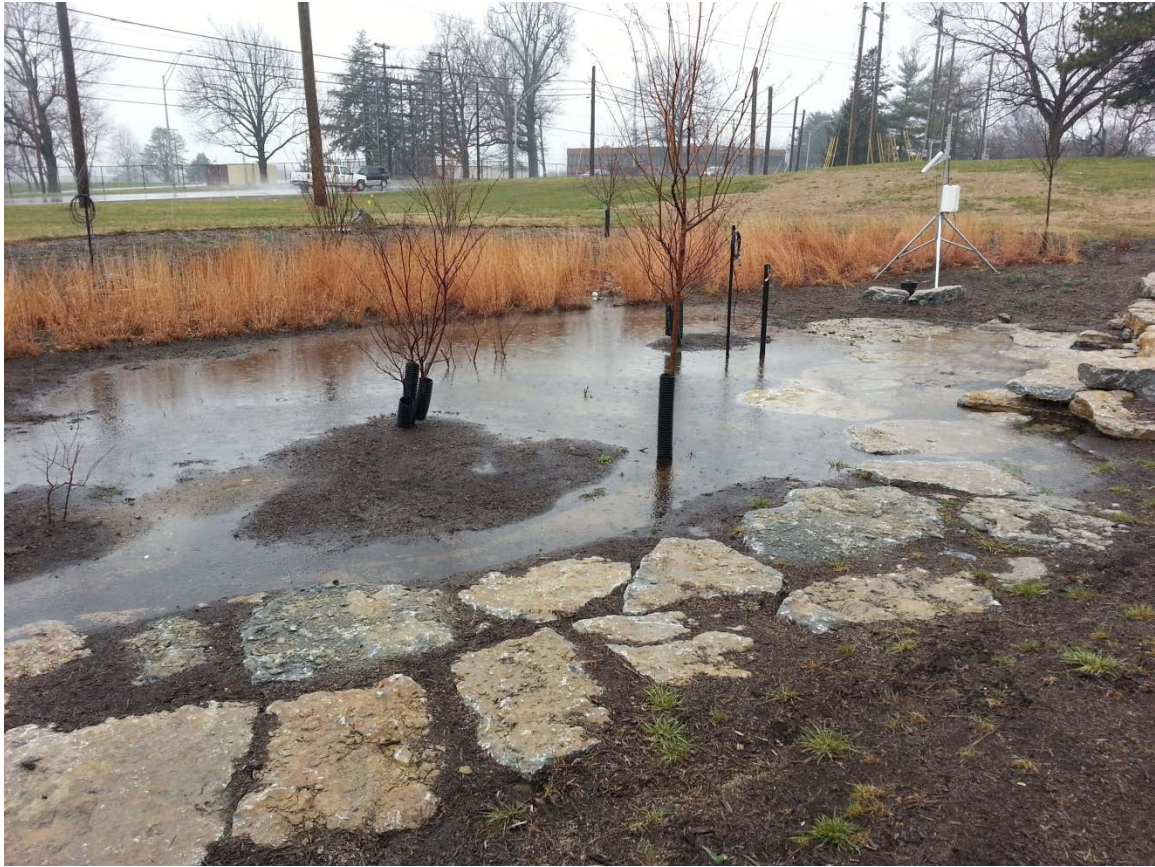
Figure 3.11. Ponded water was observed in the rain garden on March 24, 2013.

During the latter part of the monitoring period, a rain event occurred (March 24, 2013) in which water was observed to pond at a depth of 2.5 cm; however, the pressure transducer in the well indicated that the water level was 14 cm below ground surface (Figure 3.11). Pondered water was also photographed by Eric Dawalt (the designer and builder) on March 18, 2013 but the depth of pondered water could not be determined from the photograph (Figure 3.12). At the time of the photograph, the pressure transducer recorded a pondered depth of 4 cm. To ensure that there was no error in the pressure transducer, a calibration of the level loggers was performed (Appendix C). The test of the pressure transducer revealed that it was recording water levels accurately.

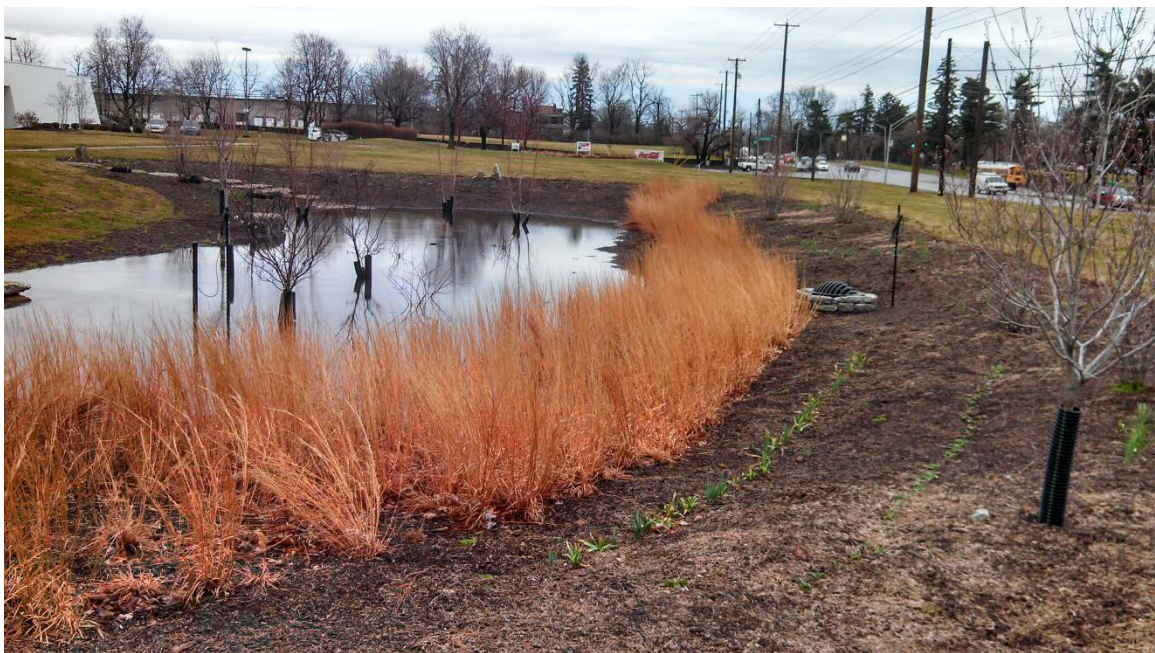
Figure 3.12. Ponded water was observed in the rain garden on March 18, 2013.

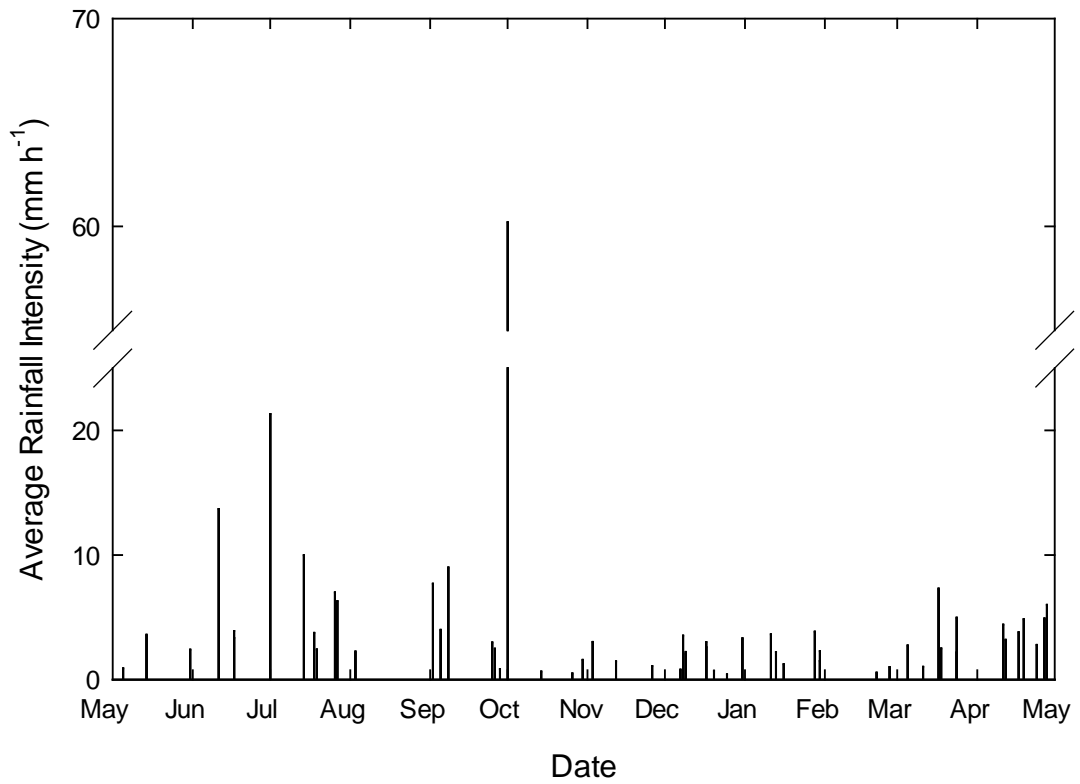
Figure 4.5. Average rainfall intensities for the project period.

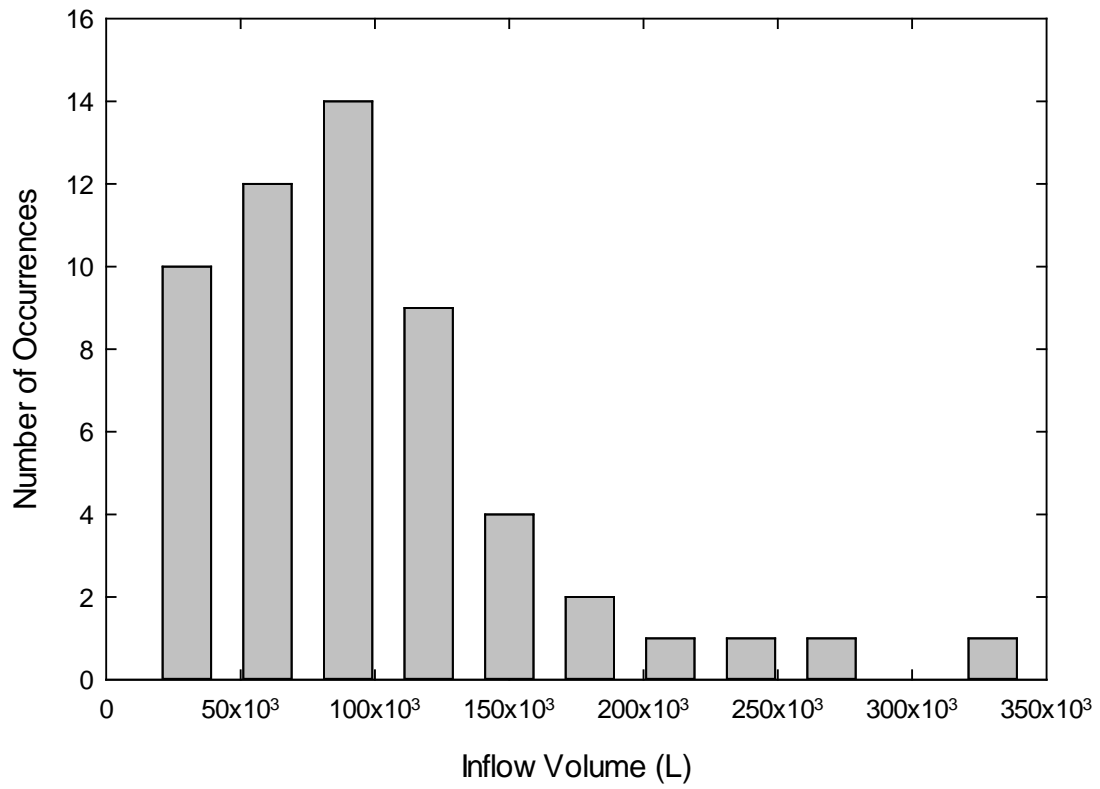
Figure 4.6. Distribution of inflow volumes, as measured by the flow meters.

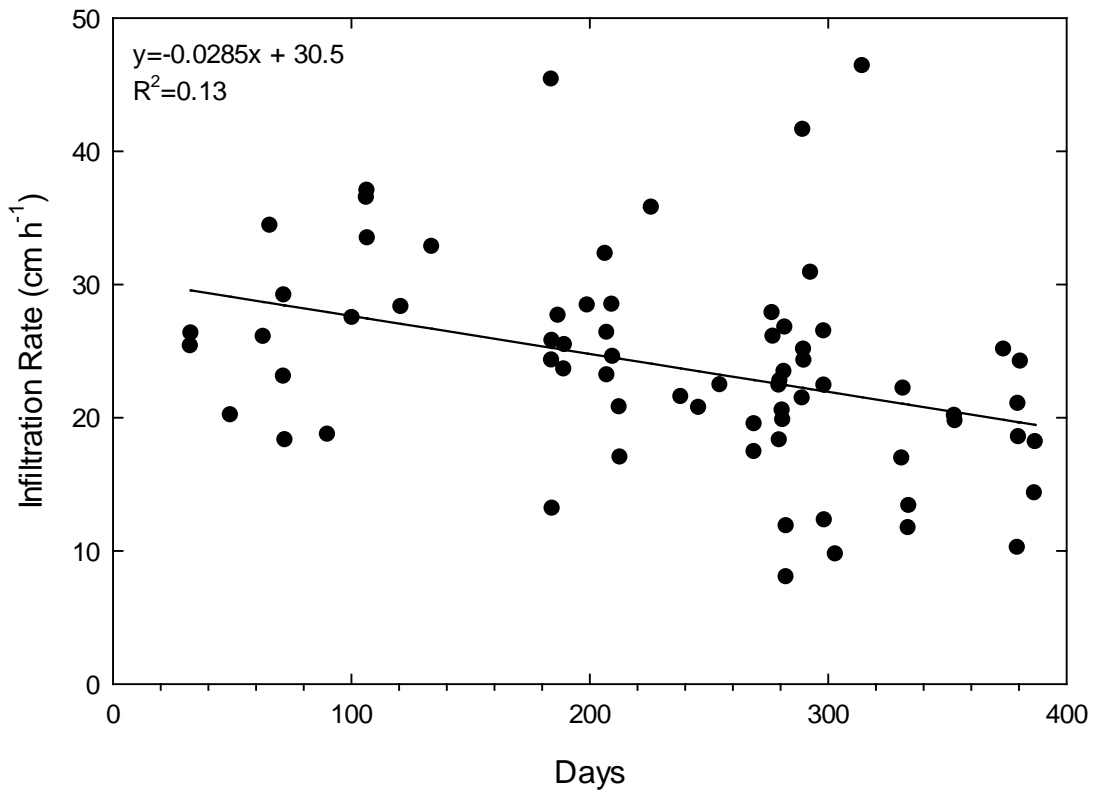
Figure 4.7. Temporal changes in rain garden infiltration rates.

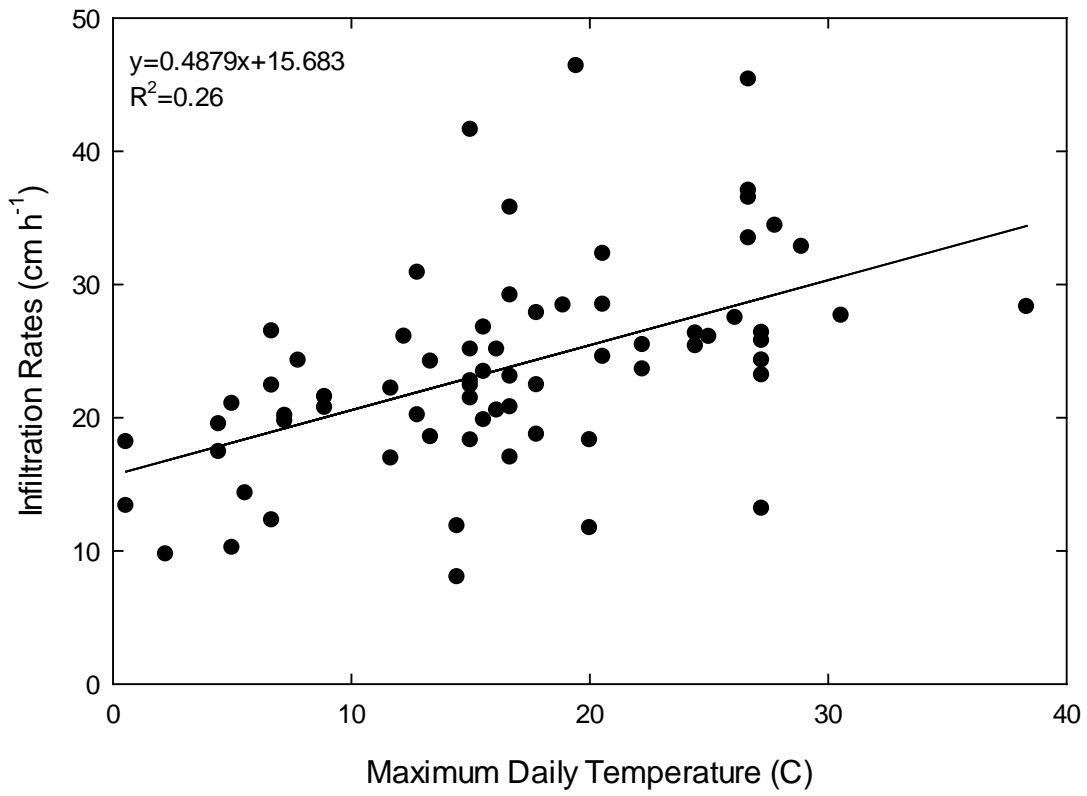
Figure 4.8. Effect of temperature on infiltration rates.

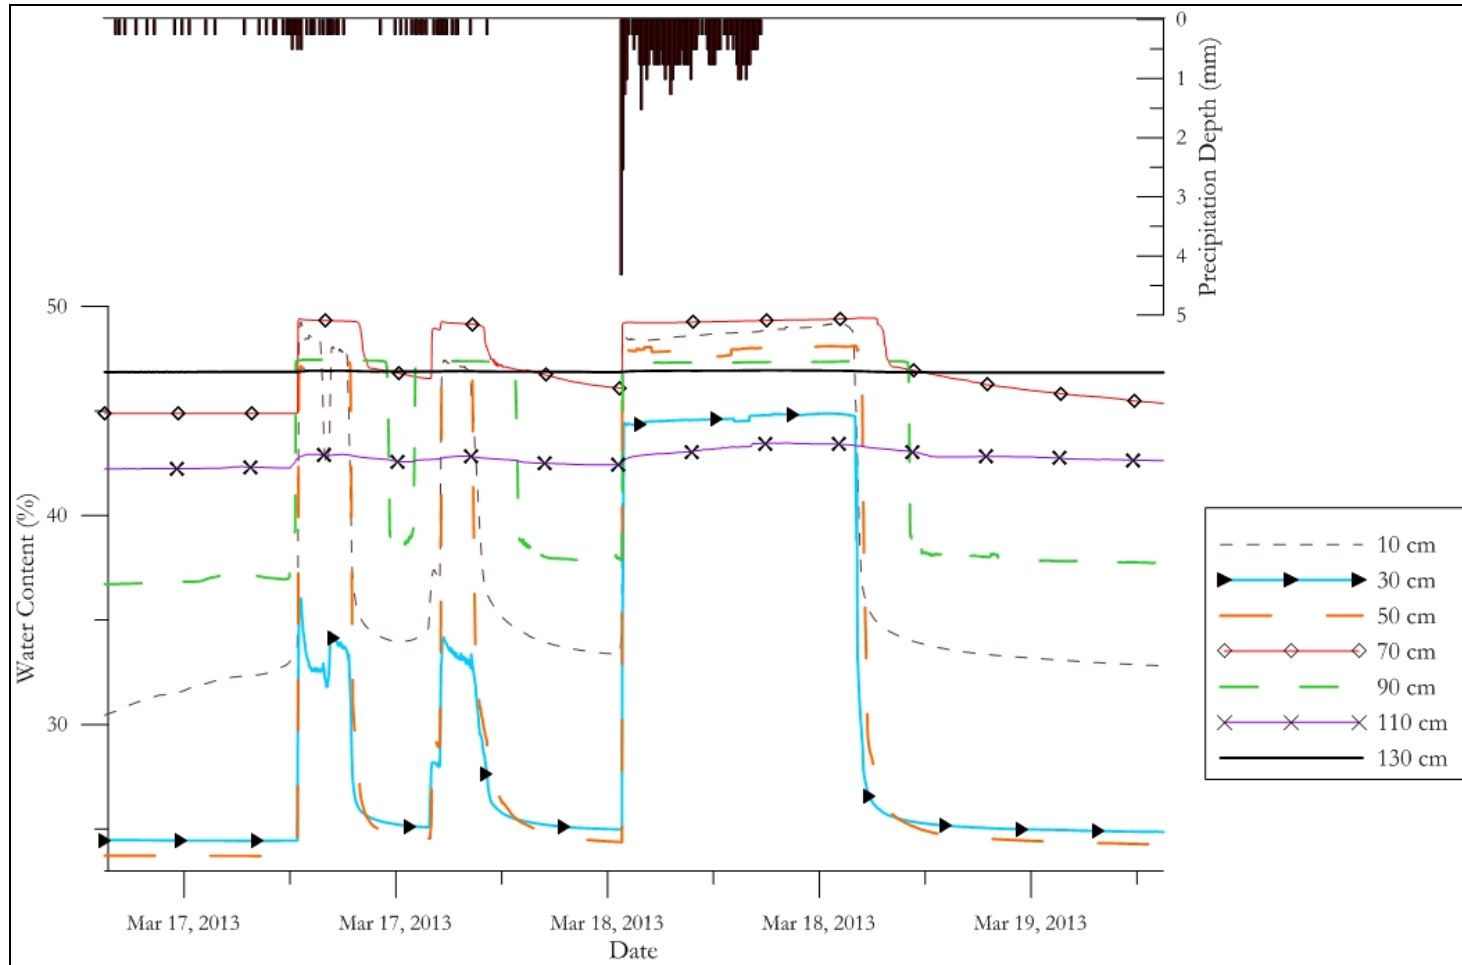
Figure 4.9. Soil moisture data March 17, 2013.

The 30 and 50 cm depths experienced large and rapid changes in soil moisture. The soil moisture at the 30 and 50 cm depths was typically about 25% in between storm events. When it rained, the soil moisture at these levels quickly rose to saturation (or almost saturation). And as expected with the high infiltration rates measured in the well, the soil moisture at the 30 and 50 cm depths quickly returned to equilibrium as the water was drained to greater depths. Soil moisture at the 70 and 90 cm depths had a higher equilibrium than the 30 and 50 cm depths, but like those two depths, it increased quickly in response to inflow. However, it took a little longer for the soil moisture at the 70 and 90 cm depths to return to equilibrium. The slower return to equilibrium was likely related to the closeness of these two sensors to the boundary between the amended and existing soil; it was estimated that this boundary occurred at about 120 cm. It was not known why the soil moisture at 90 cm experienced changes of greater magnitude than the 70 cm sensor or vice versa why the soil moisture at 70 cm had a higher equilibrium. The difference could be due to variations in the amendment mixture (e.g. lack of uniform mixing and thus the presence of more clay at 70 cm).

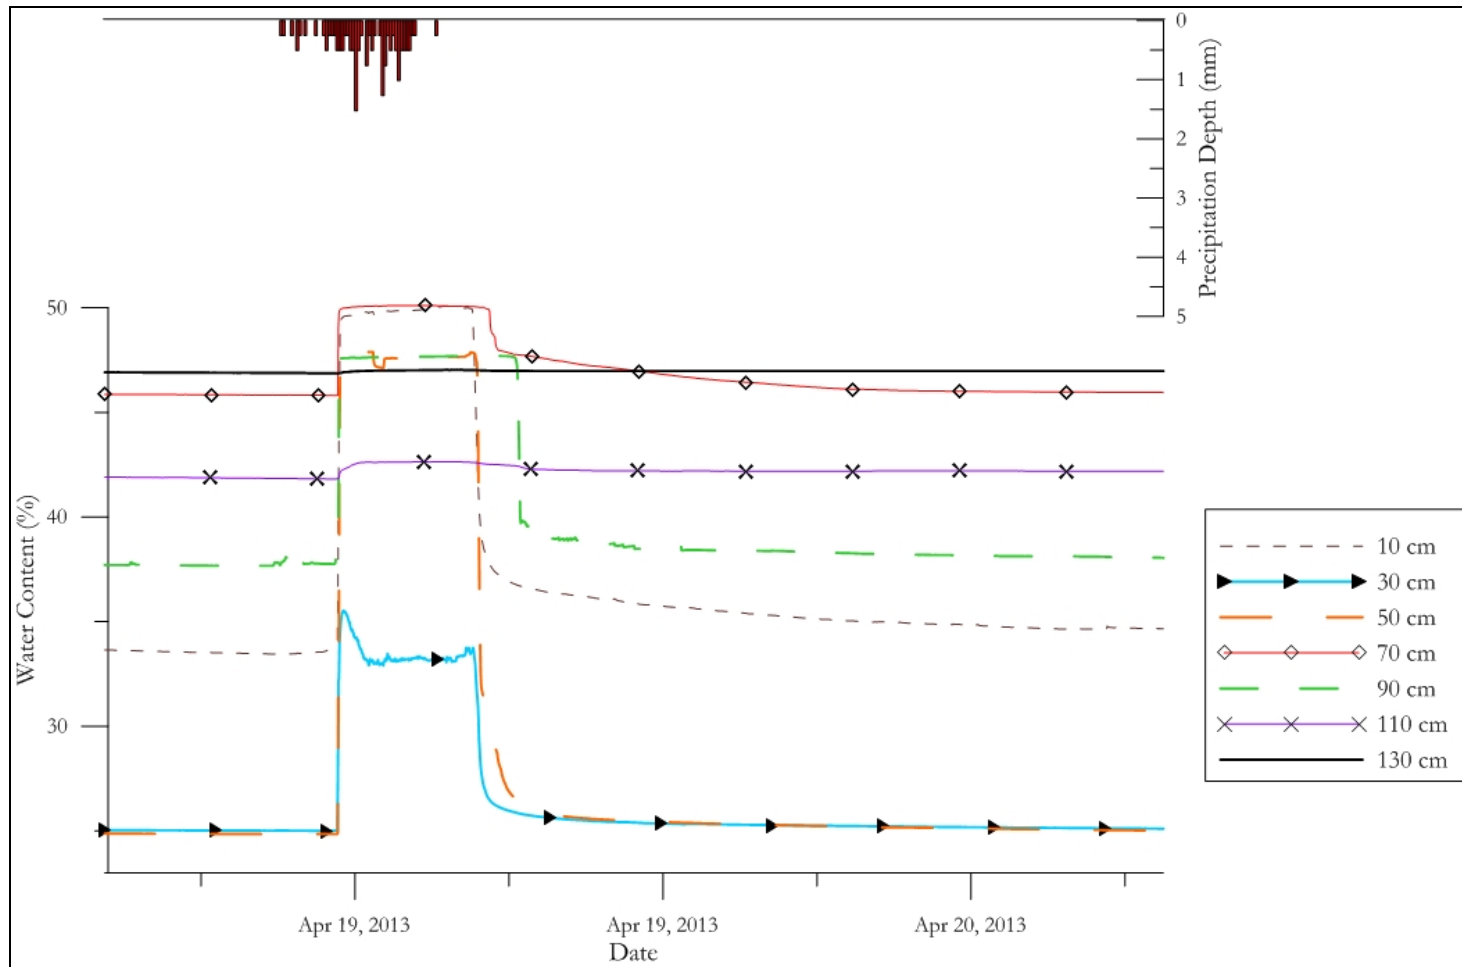
Figure 4.10. Soil moisture readings April 19, 2013.

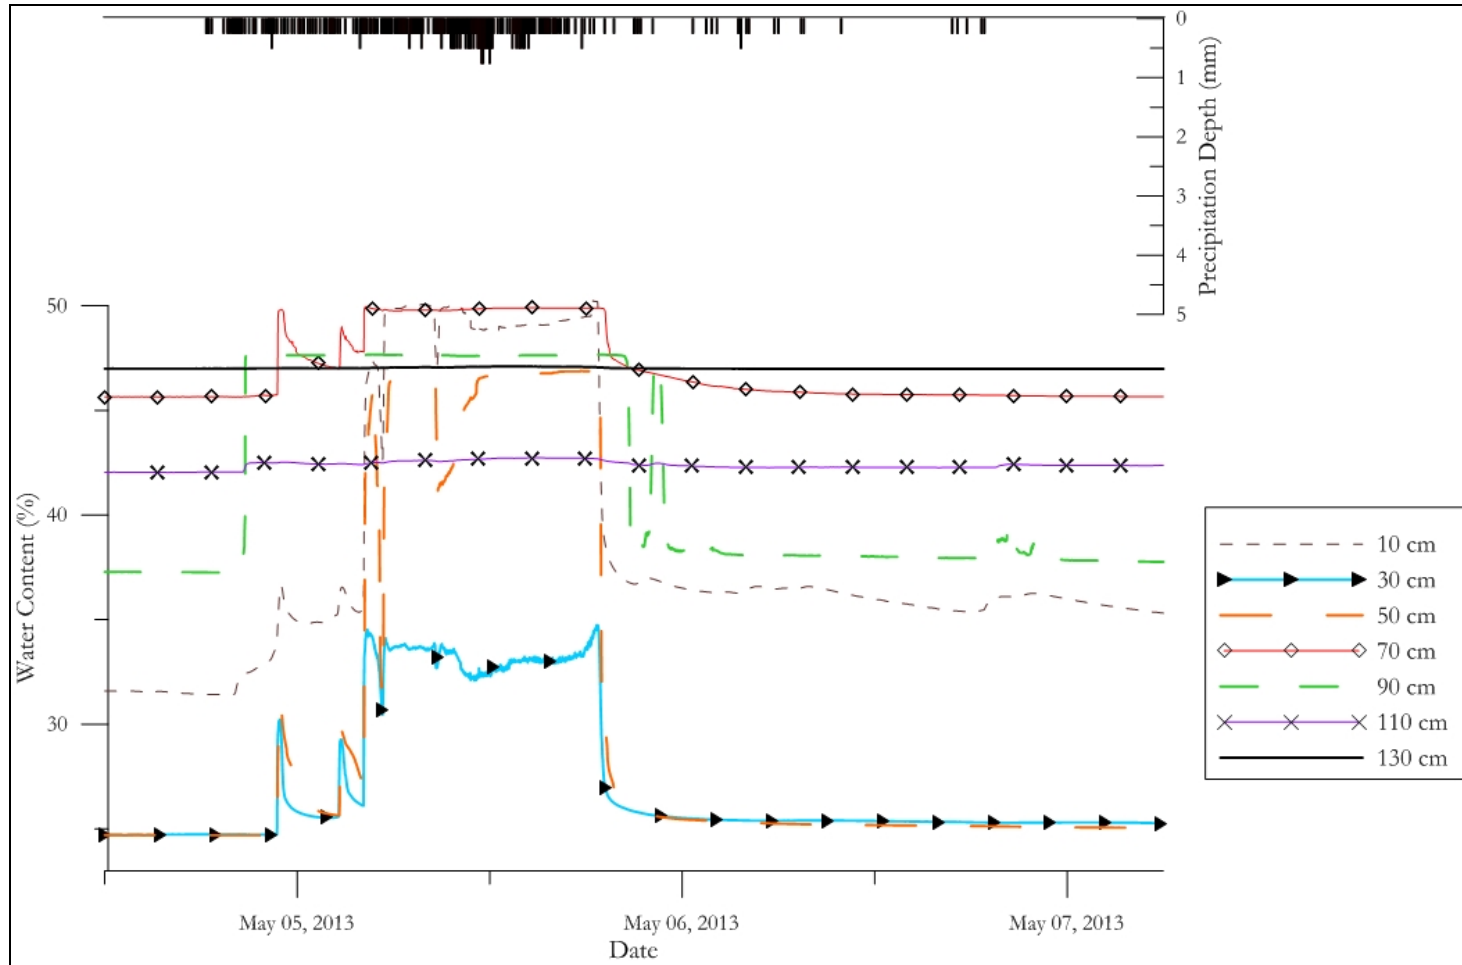
Figure 4.11. Soil moisture data May 5, 2013.

Soil moistures at the 110 and 130 cm depths experienced the least amount of change in response to storm events. These depths represent soil moisture immediately above and below the amended/existing soil boundary. Soil moisture at the 110 cm depth remained at about 42% during storm events while it was about 47% at the 130 cm depth. The existing soil has a measured field capacity of 50 % (Table 4.1), hence soil at the 130 cm depth was nearing saturation.

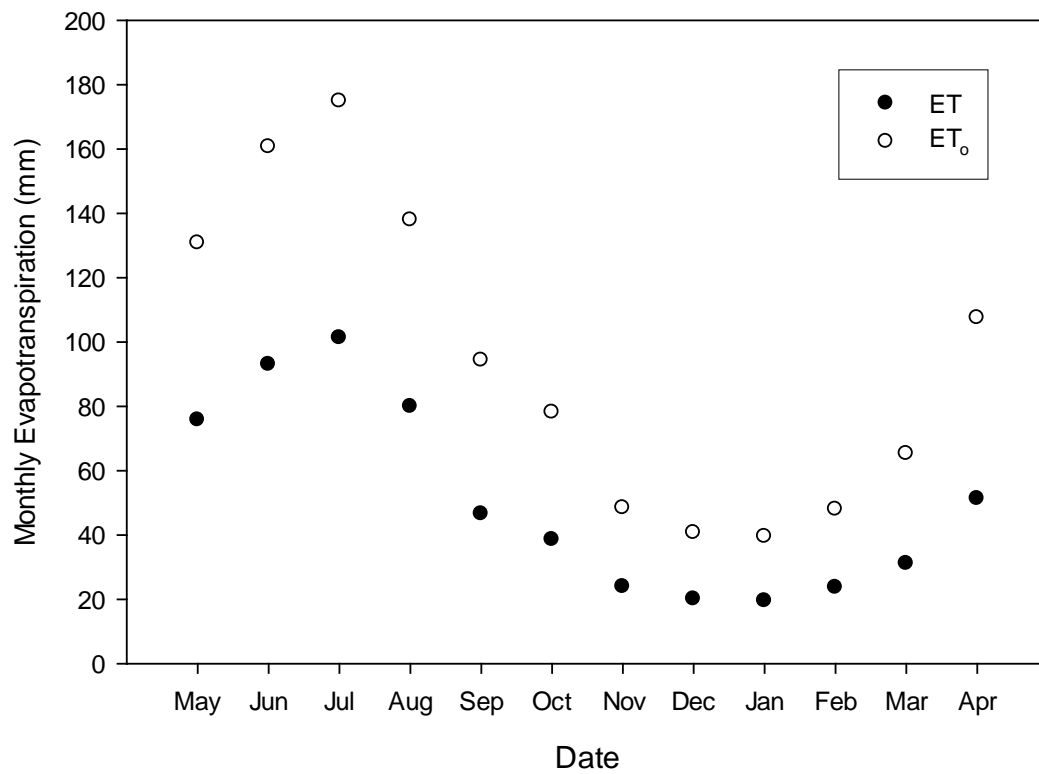
Figure 4.12. Reference ( $ET_0$ ) and predicted (ET) evapotranspiration depths during the study period.

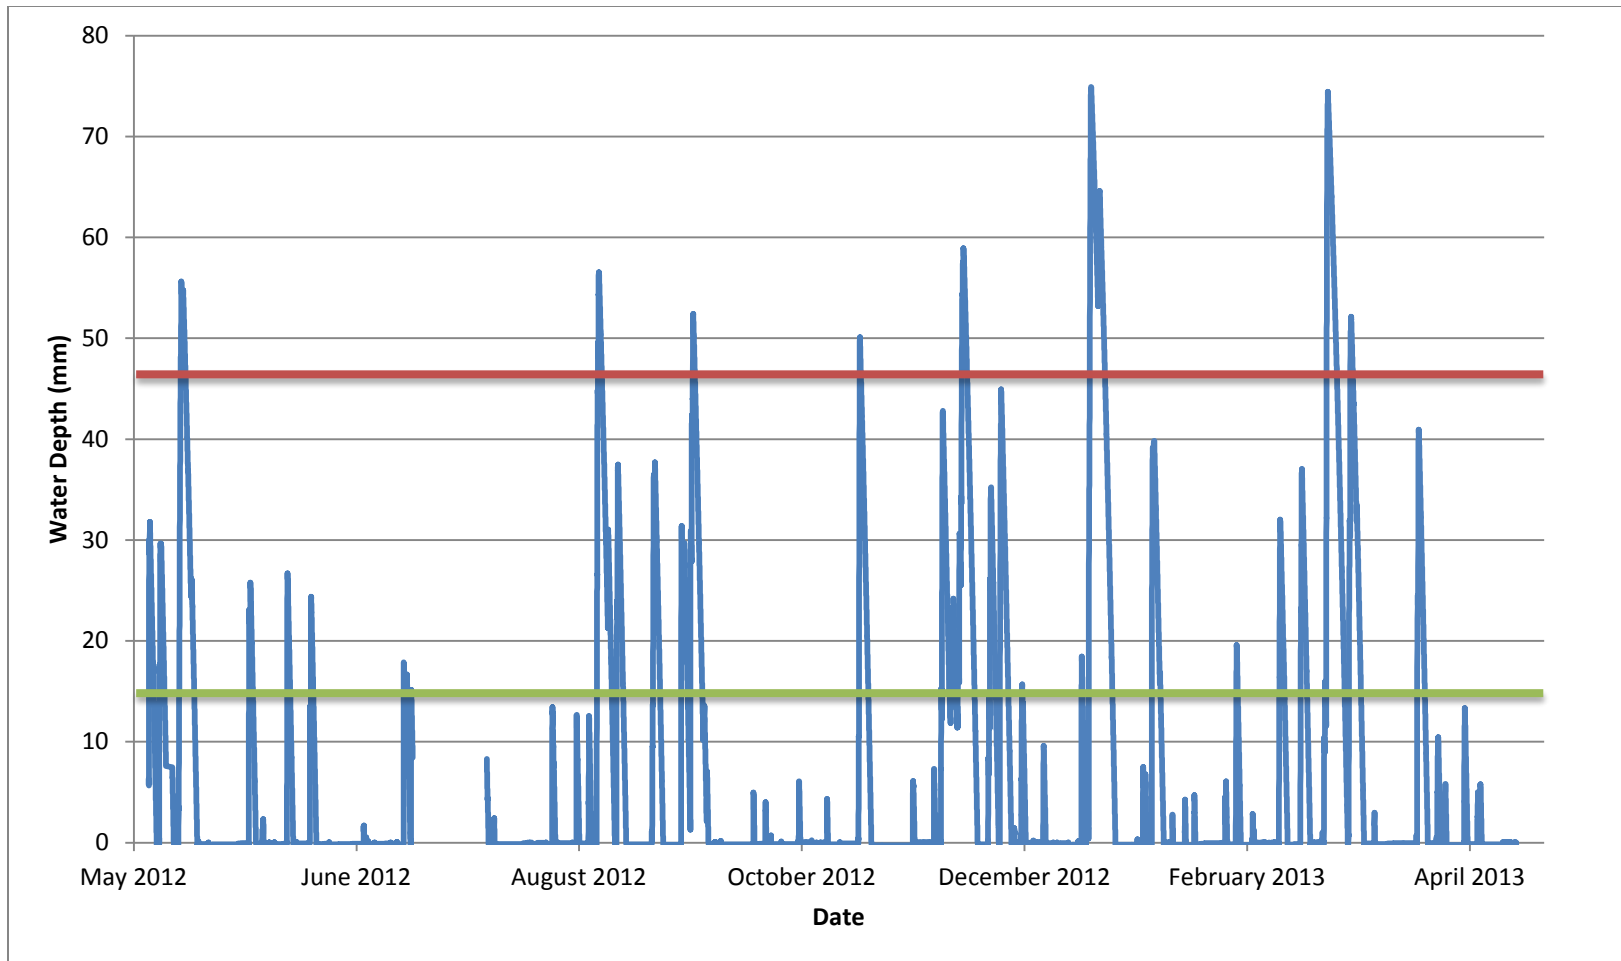
Figure 4.13. Predicted ponded water level in the rain garden (coefficient of permeability= $1.27 \text{ cm h}^{-1}$ ) with the designed maximum ponding depth of 46 cm and the LFUCG (2009) recommended ponding depth of 15 cm.

amended soil to infiltrate runoff. The coefficient of permeability measured in this study had an average of 21.3 cm h<sup>-1</sup> (excluding AS4 with a value of 3.6 cm h<sup>-1</sup>), which was much greater than the LFUCG recommended value of 0.625 cm h<sup>-1</sup> and the value of 3 cm h<sup>-1</sup> used by the designer.

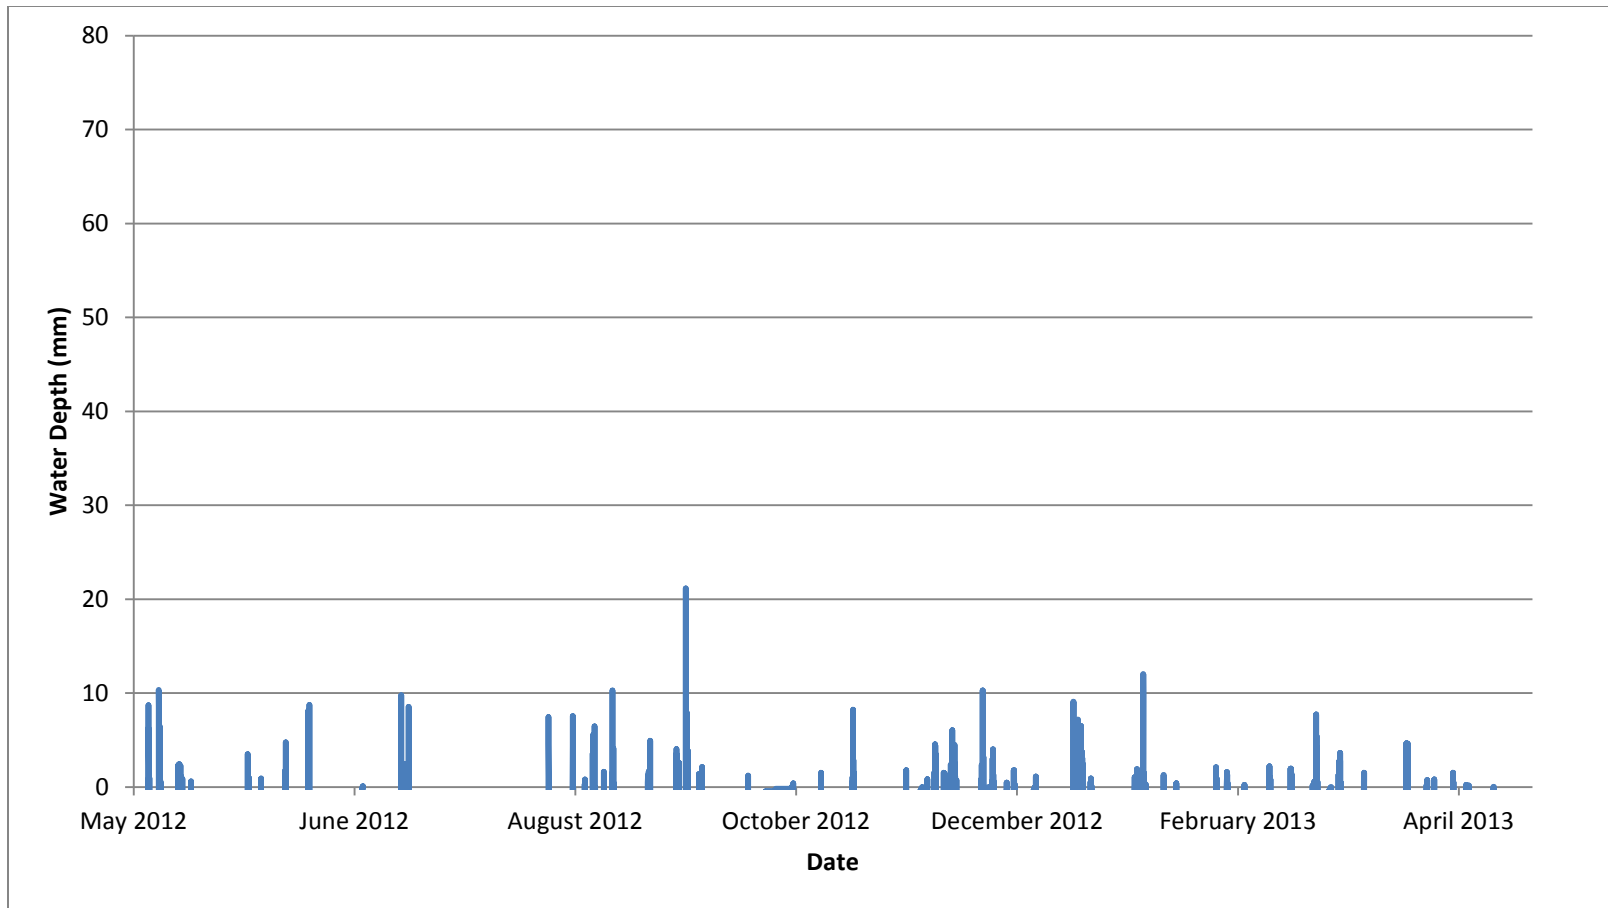
Figure 4.14. Predicted ponded water level in the rain garden based on measured average coefficient of permeability of  $21.3 \text{ cm h}^{-1}$ .
