# HYDROLOGIC CHARACTERIZATION OF A RAIN GARDEN MITIGATING STORMWATER RUNOFF FROM A COMMERCIAL AREA

John T. McMaine

THESIS

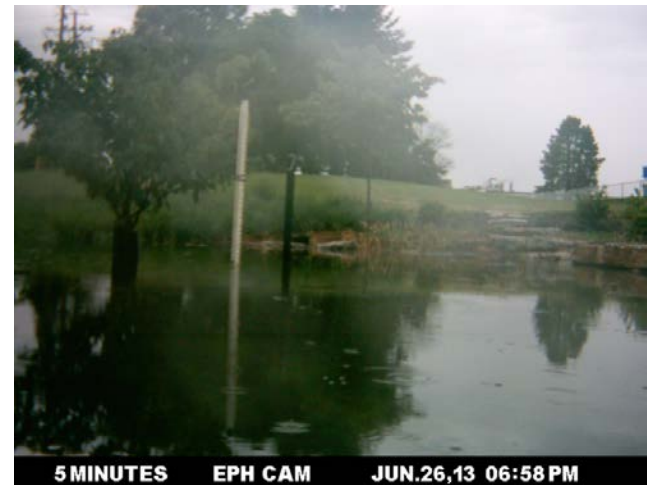
(d)

Figure A.4. Infiltration and rainfall continue on June 26, 2013: a) 55, b) 60, c) 65, and d) 70 minutes after start of rainfall.

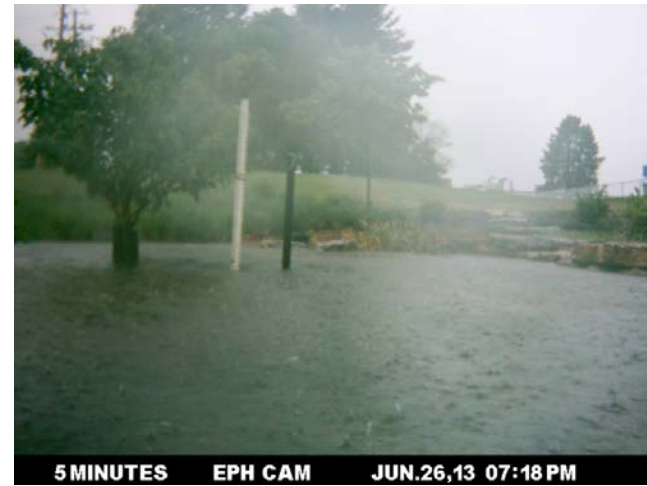
(d)

Figure A.5. Infiltration and rainfall continue on June 26, 2013: a) 75, b) 80, c) 85, and d) 90 minutes after start of rainfall.

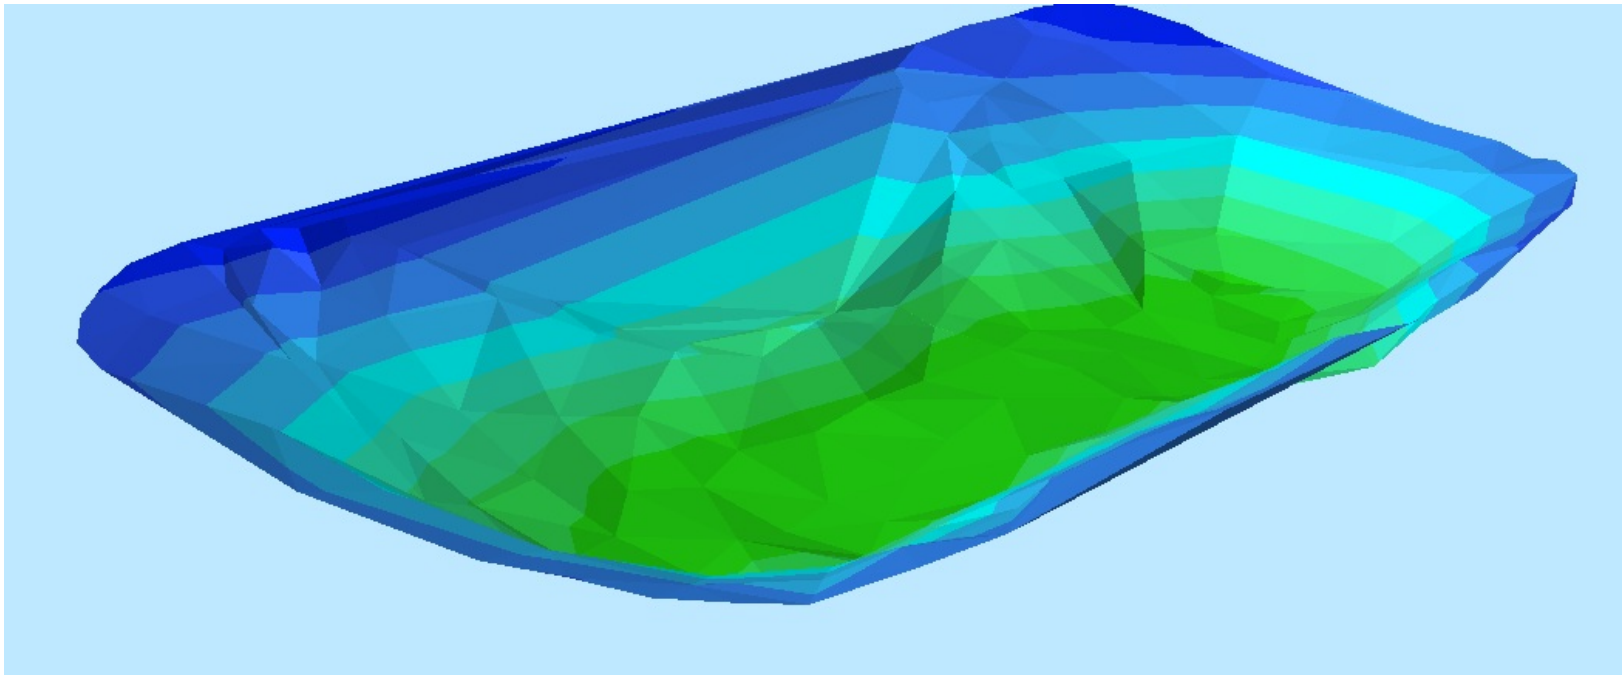
Figure B.2. Stage-volume rating curve for rain garden.
