**STUDY OF ROTATIONAL FRETTING OF QUENCHED AND TEMPERED 4340
STEEL**

In Partial Fulfillment
Of the Requirements for the Degree
Master of Science in Mechanical Engineering

Georgia Institute of Technology
August 2013

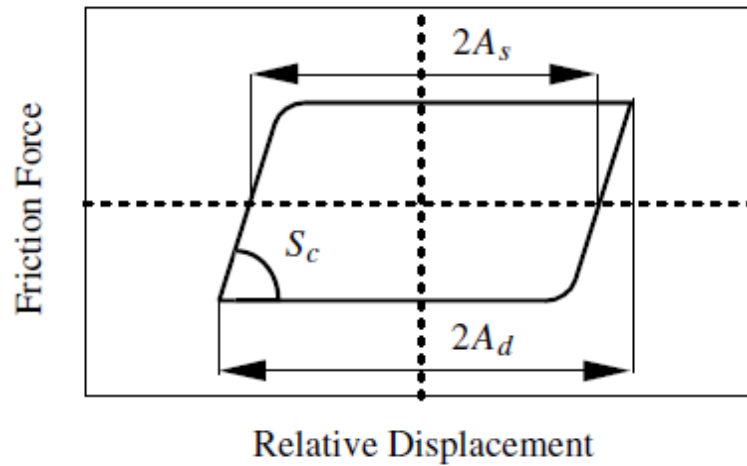
Fig 2.5– Friction Loop details [13] By Permission of Springer, October1, 2004

method of classification. Fig 2.5 is a schematic which provides the friction loop details. Slip index, δ , is defined as the ratio of Displacement amplitude, A_d , times stiffness S_c , divided by the normal load N . Slip Ratio, S , is defined as the ratio of Slip amplitude, A_s to Displacement amplitude, A_d .

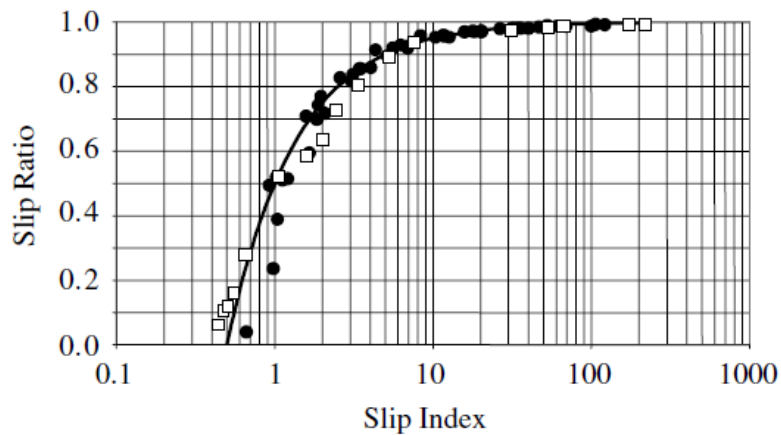
Fig 2.6 – Variation in Slip Ratio S with Slip Index δ [13] By Permission of Springer, October1, 2004

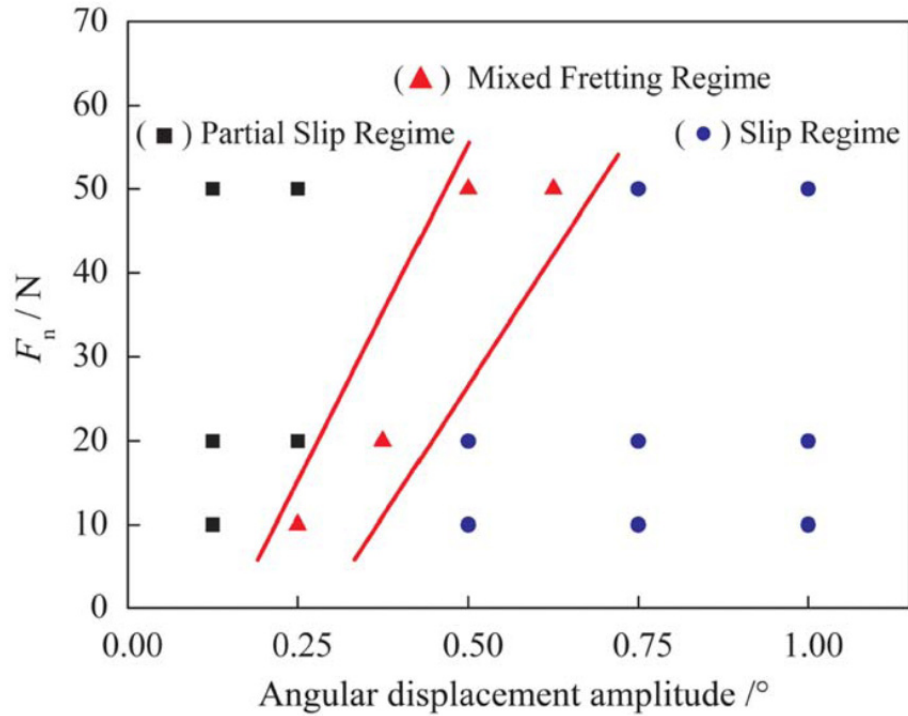
Fig 2.7 Running condition map for 7075 Aluminium alloy under rotational fretting [5] *By Permission of Elsevier Ltd., May-June, 2010*

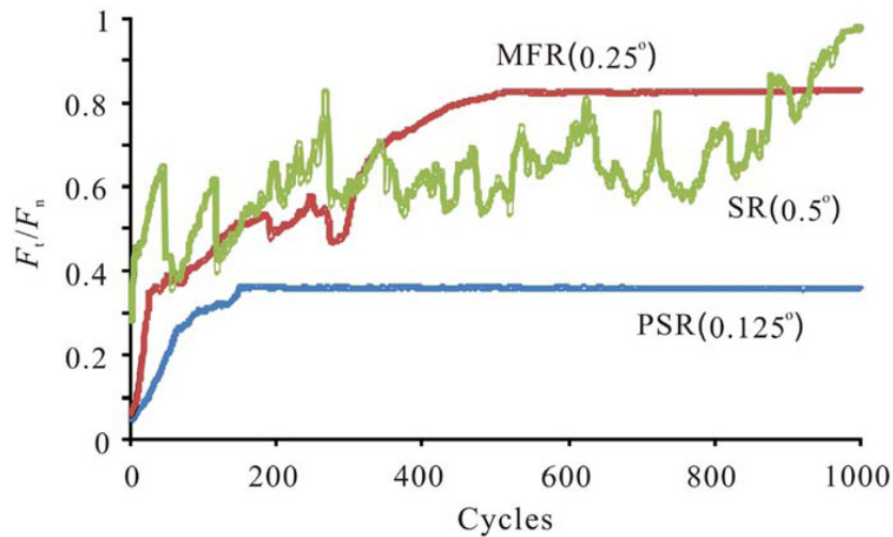
Fig 2.8 F_t / F_n curves for varying angular displacements [5] *By Permission of Elsevier Ltd., May-June, 2010*

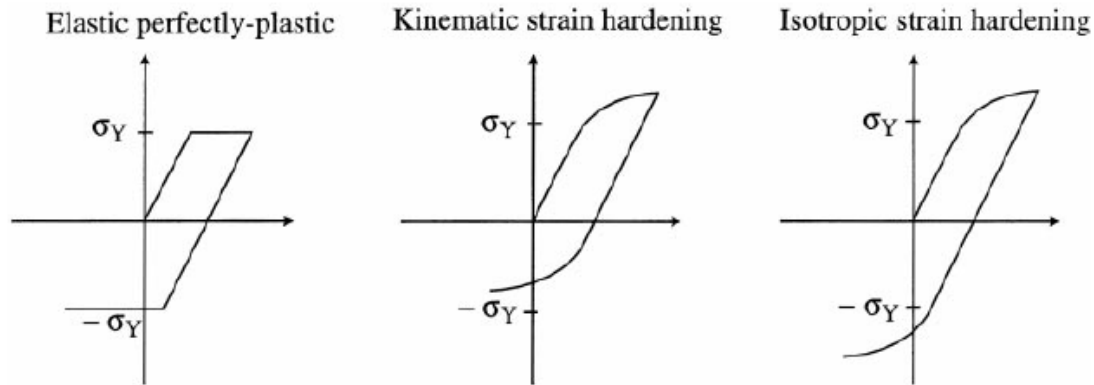
Fig 2.9 Categories of plastic flow behavior of materials [41] By Permission of Elsevier Ltd., November, 2000

The combination of fretting load and friction coefficient at the contact region determines if the material will undergo plastic straining. The mechanism for plastic strain accumulation due to cyclic loading at the contact can be divided into three regimes a) *Cyclic Plastic Straining*, in which material experiences steady, reversed cyclic plastic strains b) *Ratcheting* in which the plastic strain magnitude increases continually with each loading cycle c) *Shakedown* in which the plastic strains saturate after a few cycles and subsequent material response is entirely elastic [41]. The intrinsic plastic flow stress behavior of materials can be categorized into three categories 1) Elastic- Perfectly plastic 2) Kinematic Strain hardening 3) Isotropic Strain hardening, as depicted in Fig 2.9

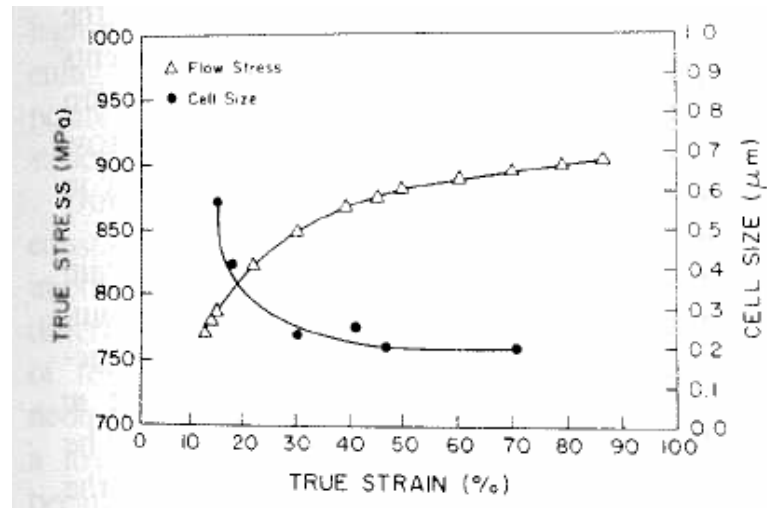
Fig 2.15 Variation of dislocation cell size, true stress, true strain for AISI 4340 steel [43]

during which annihilation of dislocation in the cell walls takes place at higher strains, which leads to very low work hardening. The appearance of a mixed dislocation cell-microband structure indicates the hardening behavior transition from Stage 3 to Stage 4, which eventually leads to onset of instability and fracture at large tensile strains [43].

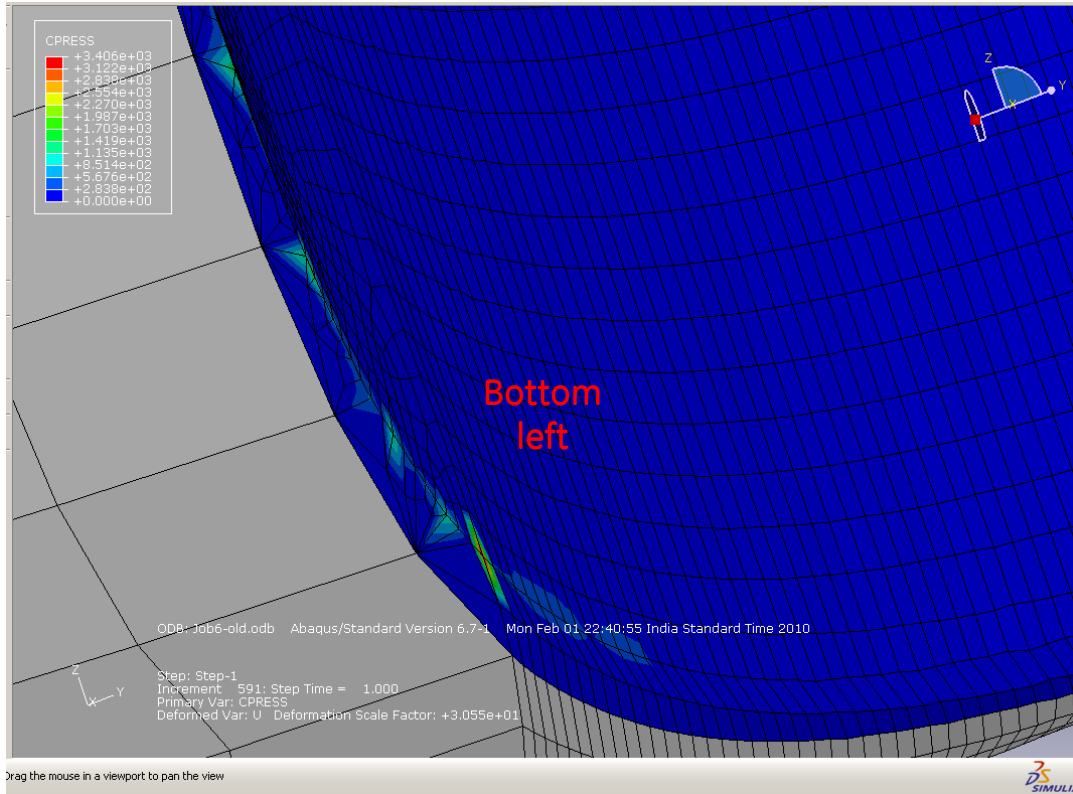
Fig 3.8b Contact pressure at the groove edges

At the application of load, a maximum initial contact pressure of 3.41GPa was observed at the groove chamfer edges (red color, Fig 3.8b) while no initial contact was made at any other location inside the groove at the start of test (blue color). Figs 3.8b, 3.8c, 3.8d show the various locations on the chamfer edge of the grooved sample where the specimens make initial contact.

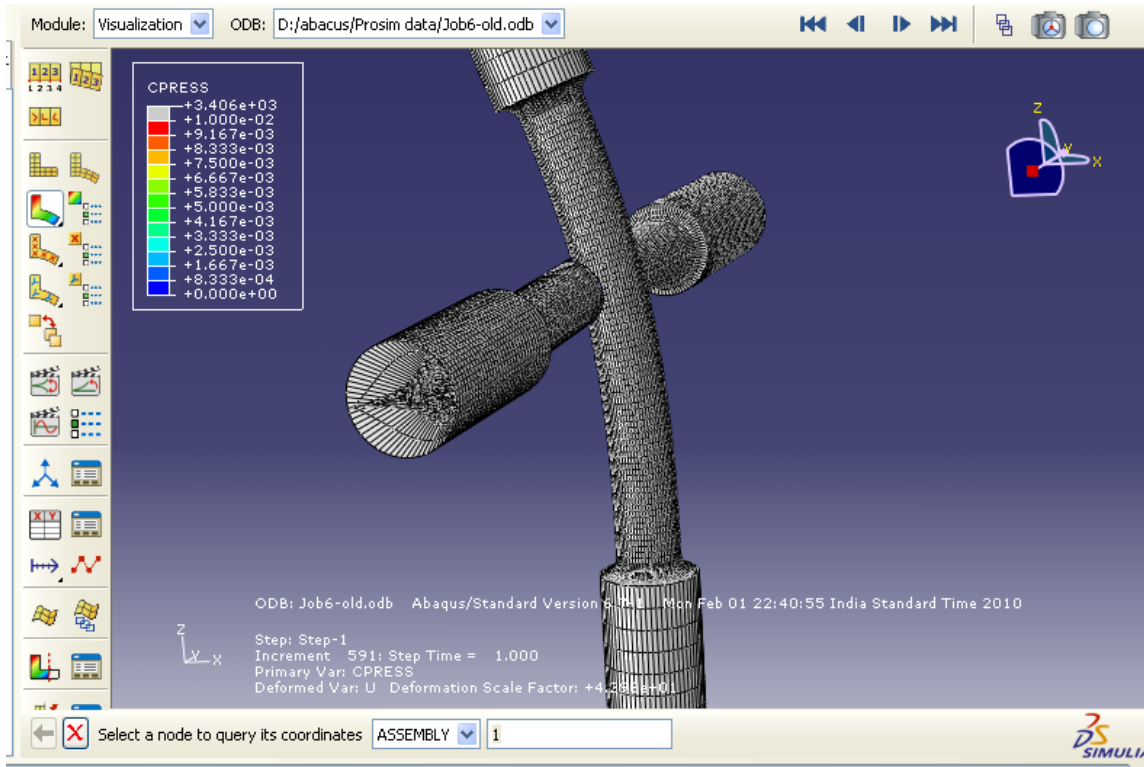
Fig 3.9a Specimen pair after the application of radial load

(Fig 3.9a) at an angle to the vertical axis as well as the axis of load application along with the simultaneous bending (“thrust out”) of the horizontal sample about the vertical axis (Fig 3.9b). In the process, the groove also becomes elongated as shown in Fig 3.9c which “pinches” the vertical sample at the contact locations.

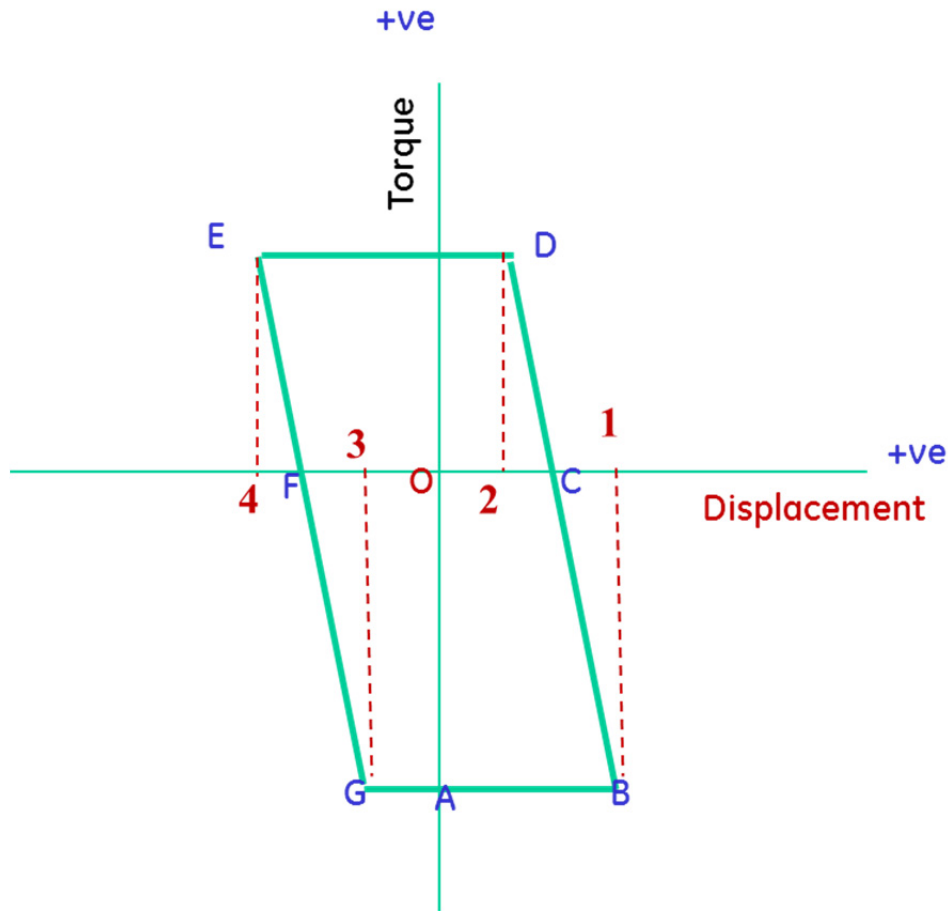
Fig 4.1 Typical Gross Slip Torque Displacement curve obtained from this test set-up

Schematic of a typical fretting loop as obtained from the set-up used in this particular study is shown in Fig 4.1. The angular displacement is displayed on the X-axis, while the corresponding torque is displayed on the Y-axis.

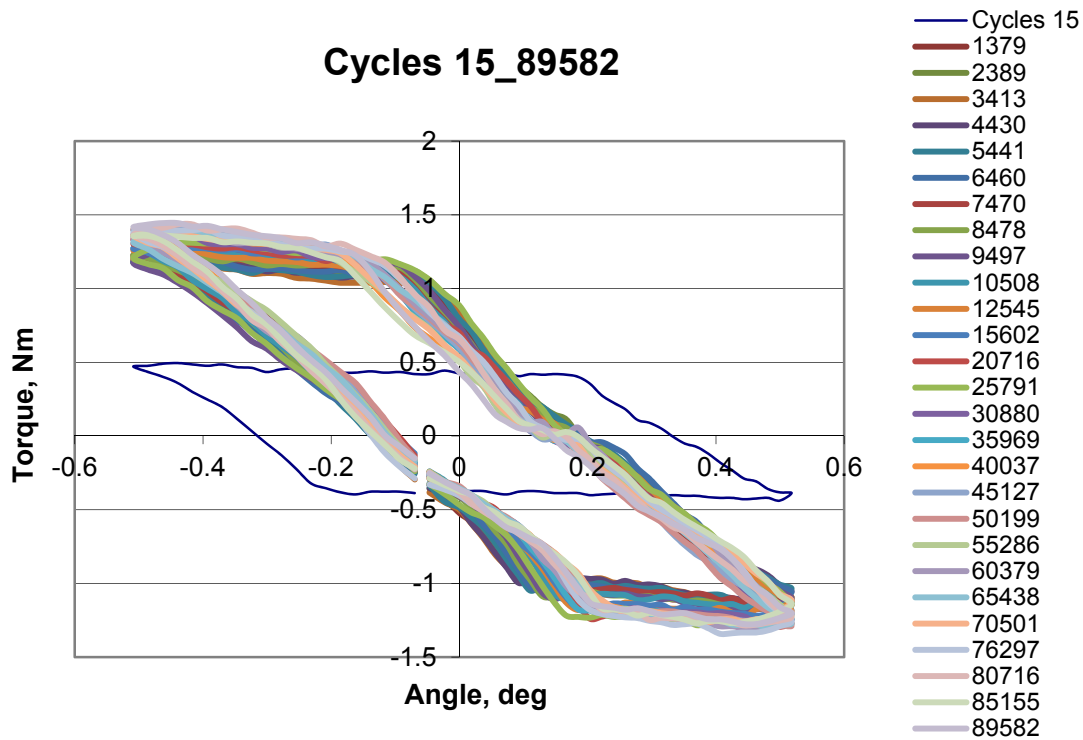
Fig 4.4 Torque -Angle plot, 89K_B specimen.

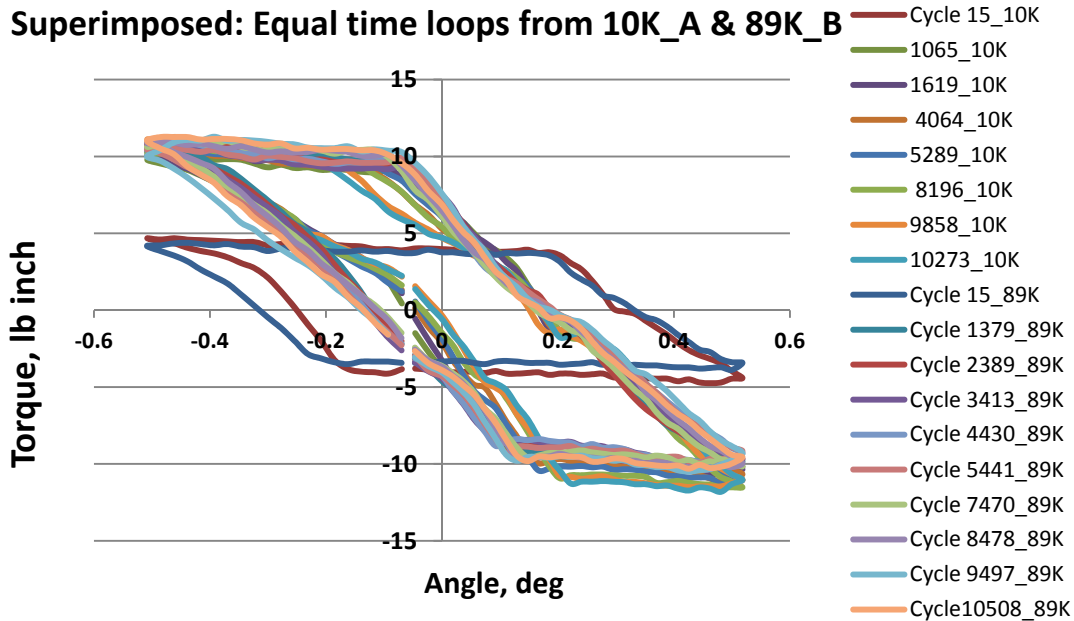
Fig 4.6 Superimposed loops, 10K & 89K.

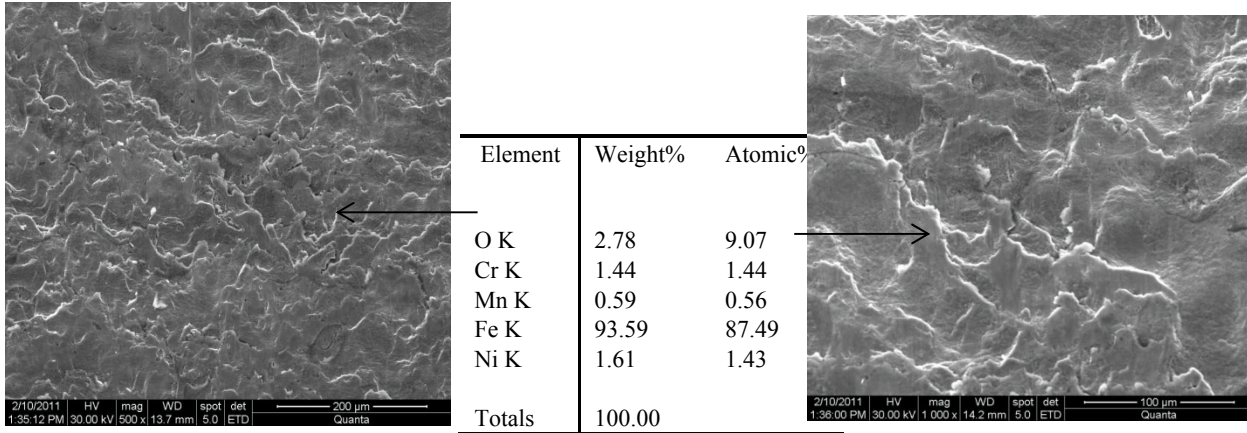
Fig 5.7a SEM image of inner region (region2), ungrooved 89K_B specimen
