# Tightening the large diameter anchor bolts of sign, signal, and luminaire structures

**Tightening the large diameter anchor bolts of sign, signal, and luminaire structures**

A thesis submitted to the graduate faculty

Major: Civil Engineering

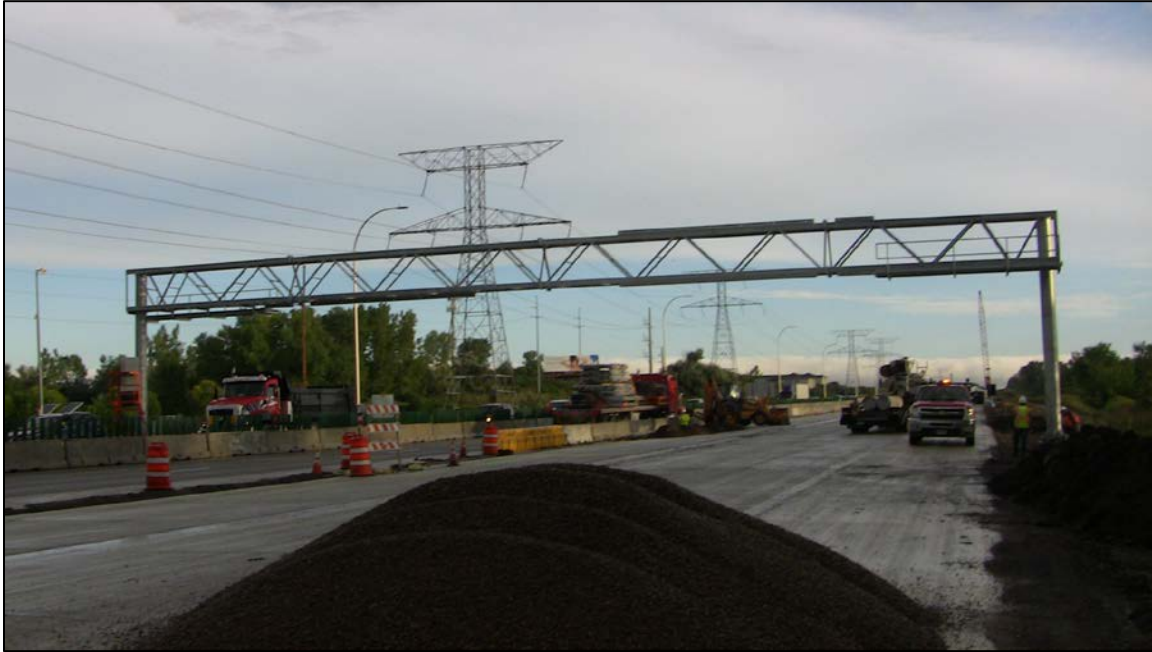
Figure 1.9 - *Overhead Sign Truss on Interstate 494 Near Maple Grove*

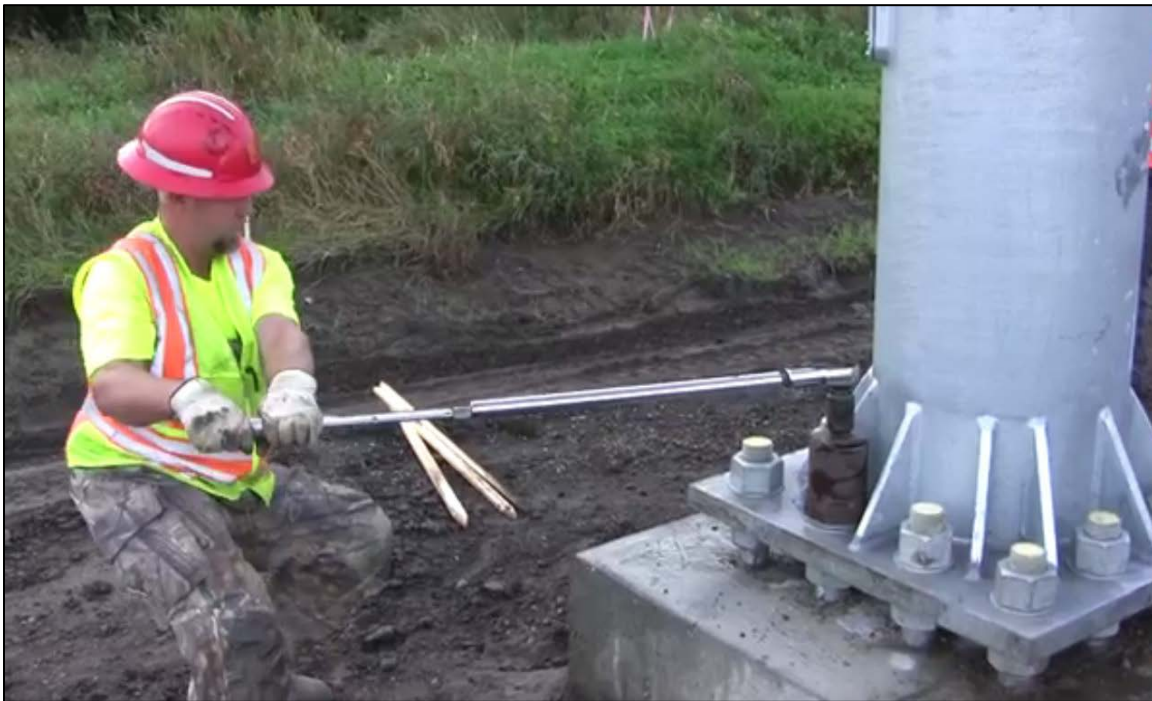
Figure 1.14 - *Top Nut Tightening with Calibrated Wrench in Minnesota*

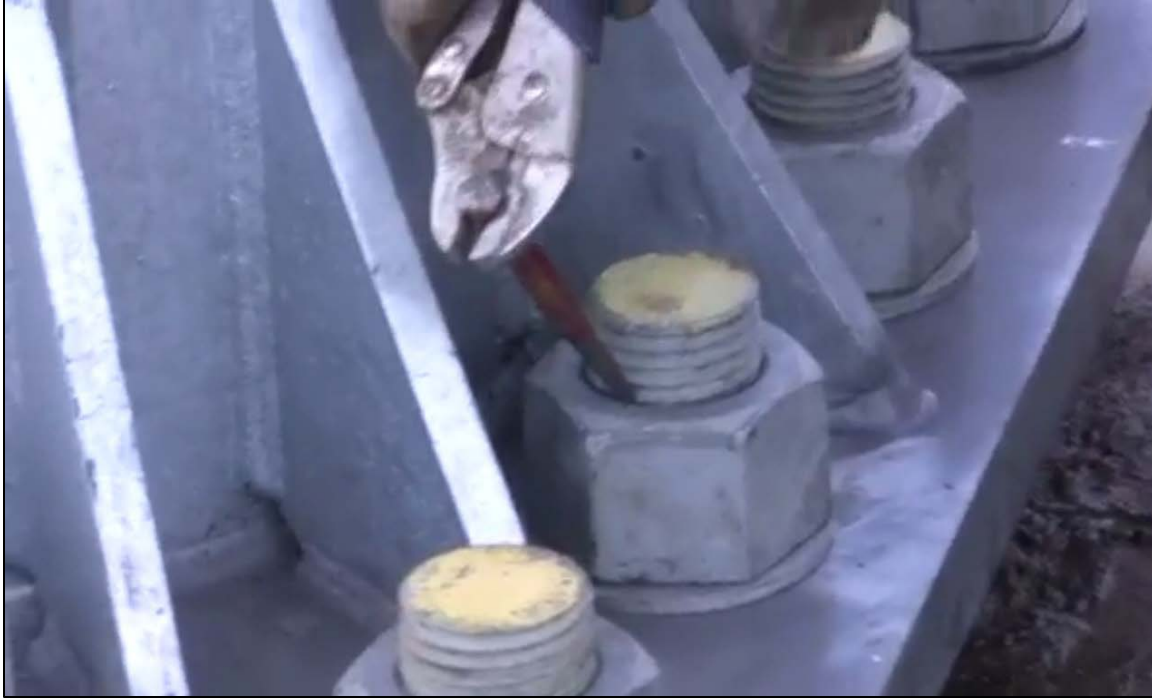
Figure 1.15 - *Puncturing of Threads after Tightening*

bolts cannot be properly pretensioned. He did state that lack of lubrication or overtightening would cause damage to threads.

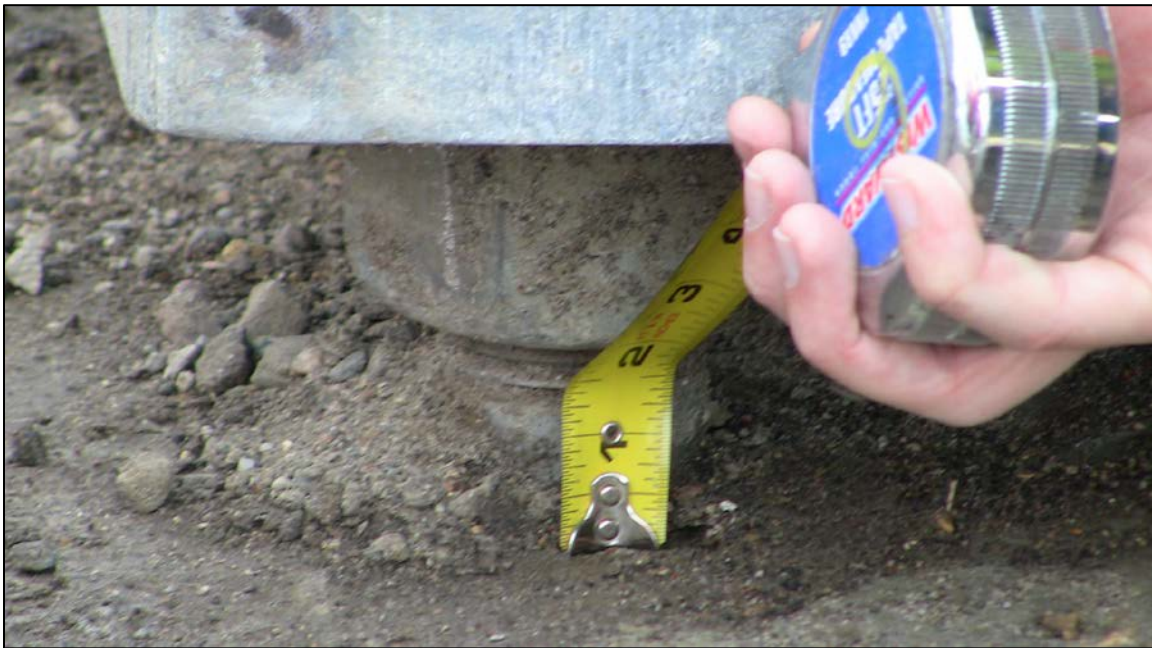
Figure 1.16 - *Distance from Foundation to Bottom Leveling Nut*

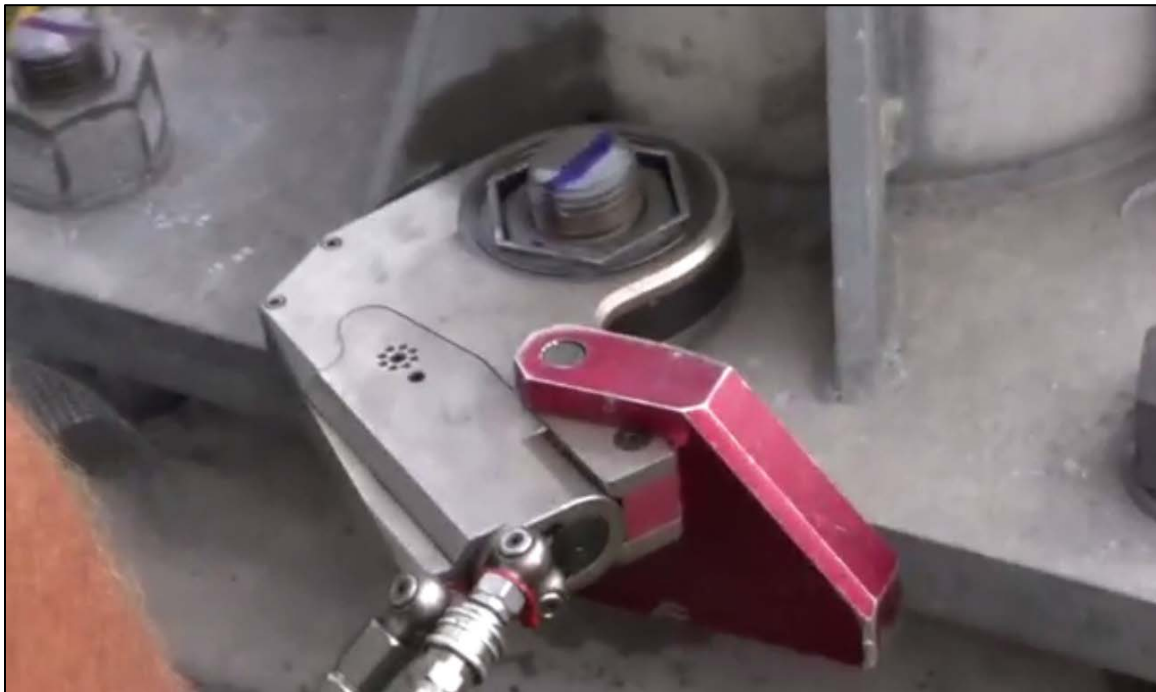
Figure 1.20 - *Hydraulic Wrench Used for Maintenance Retightening*

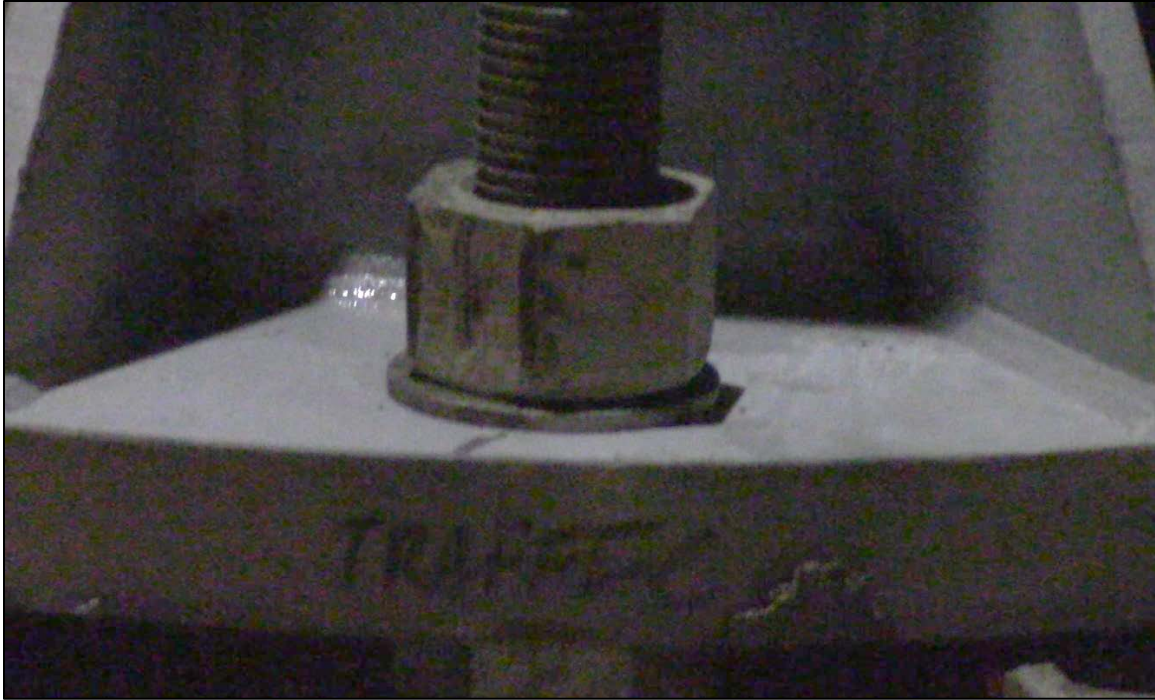
Figure 1.29 - *Post Tightening with Reference Marks Shown*

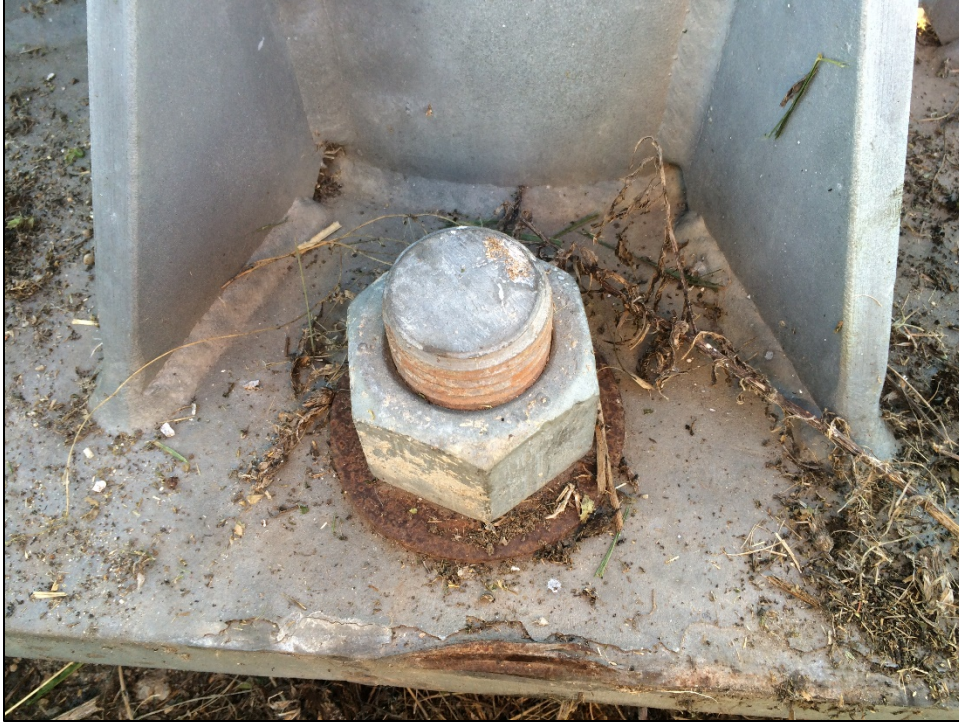
Figure 1.31 - *Rusted Washers Found in District 6*

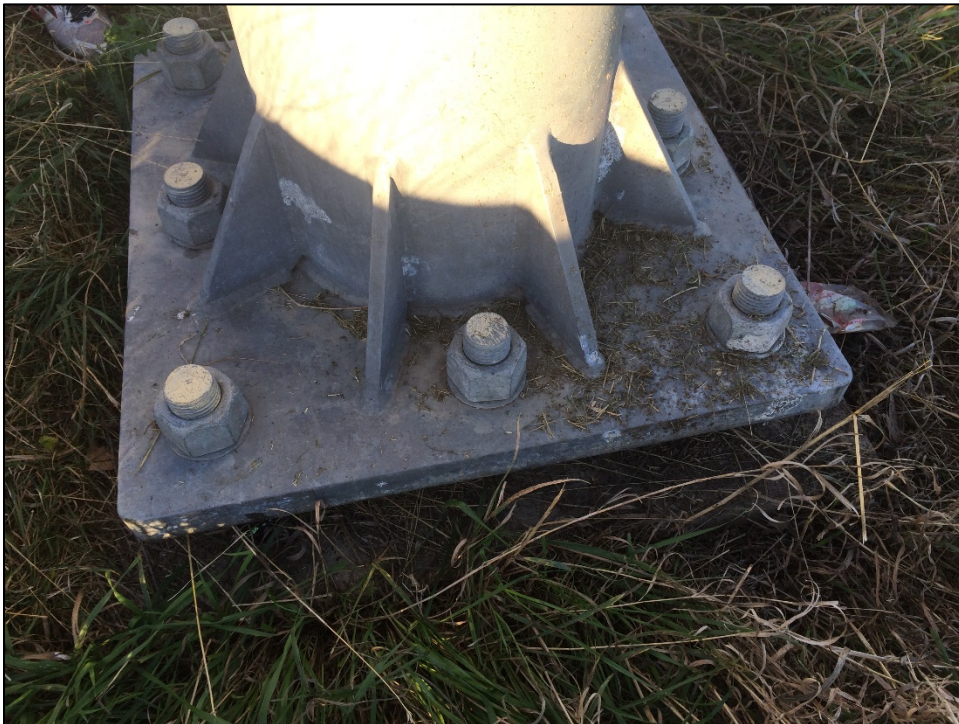
Figure 1.32 - *Undersized Washers Found in District 6*

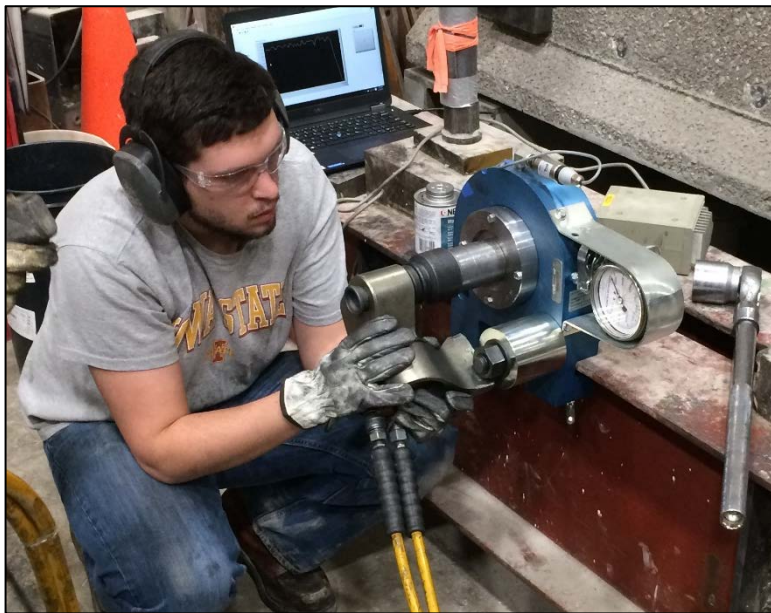
Figure 2.1 - *Hydraulic Wrench Tightening*

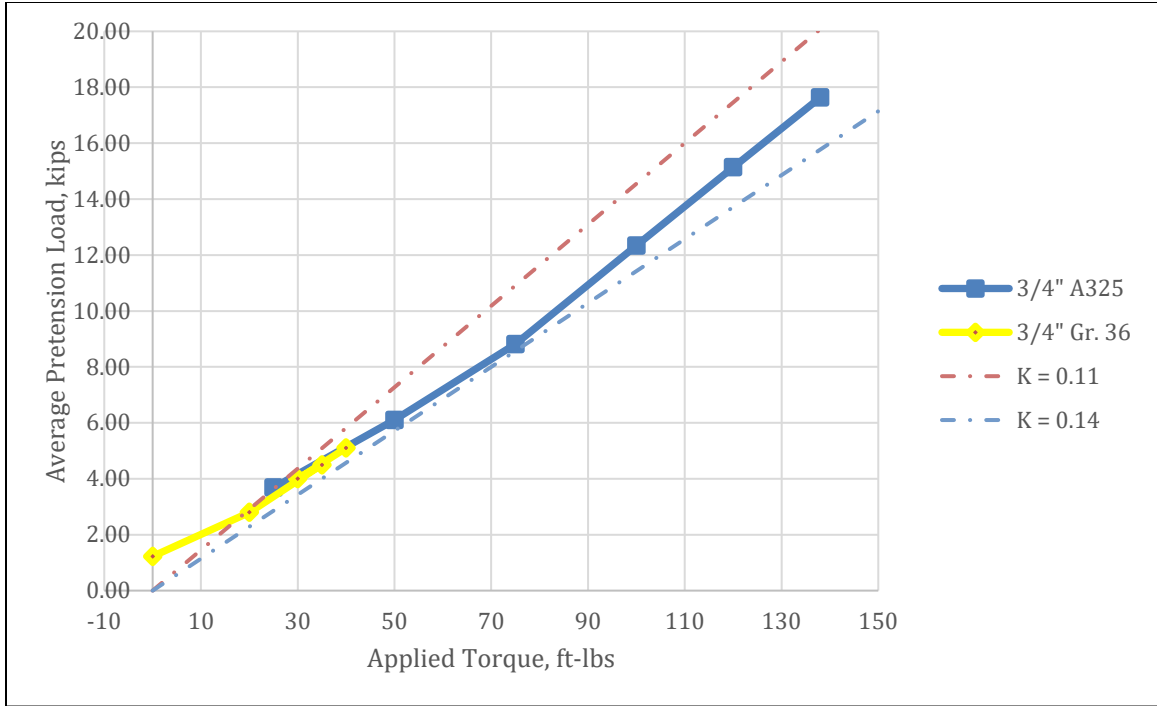
Figure 2.8 – 0.75" Bolts Torque vs. Tension

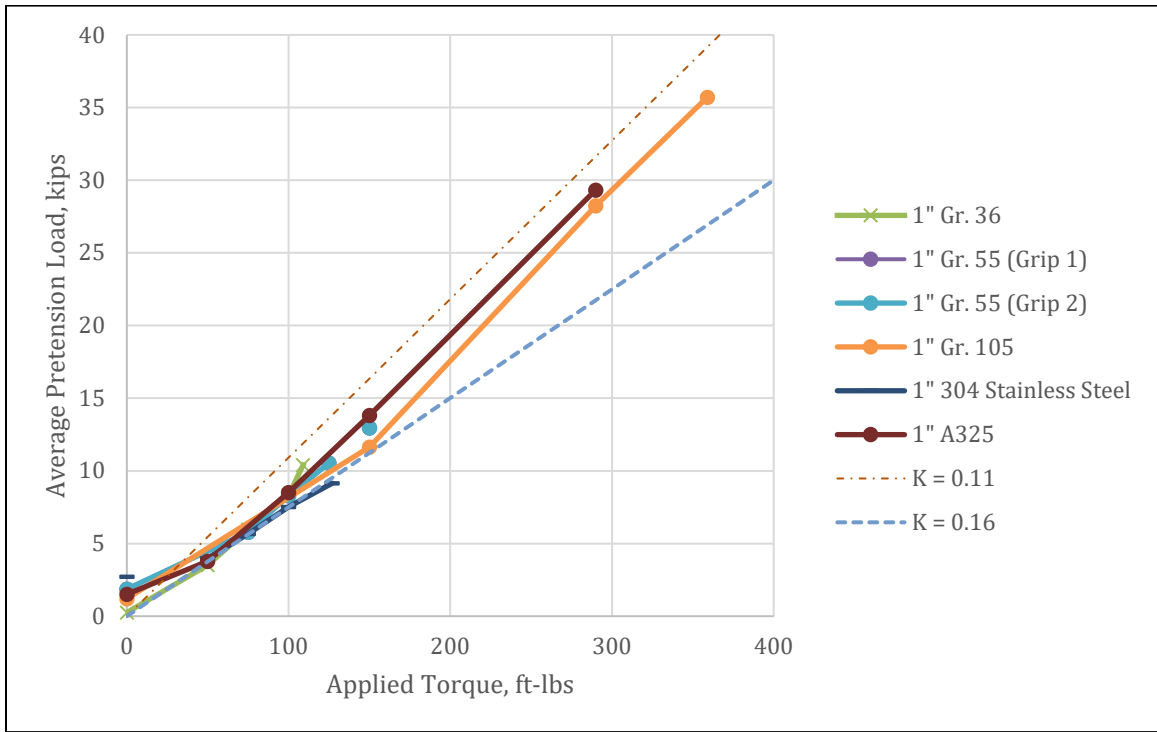
Figure 2.9 - 1" Torque vs. Tension

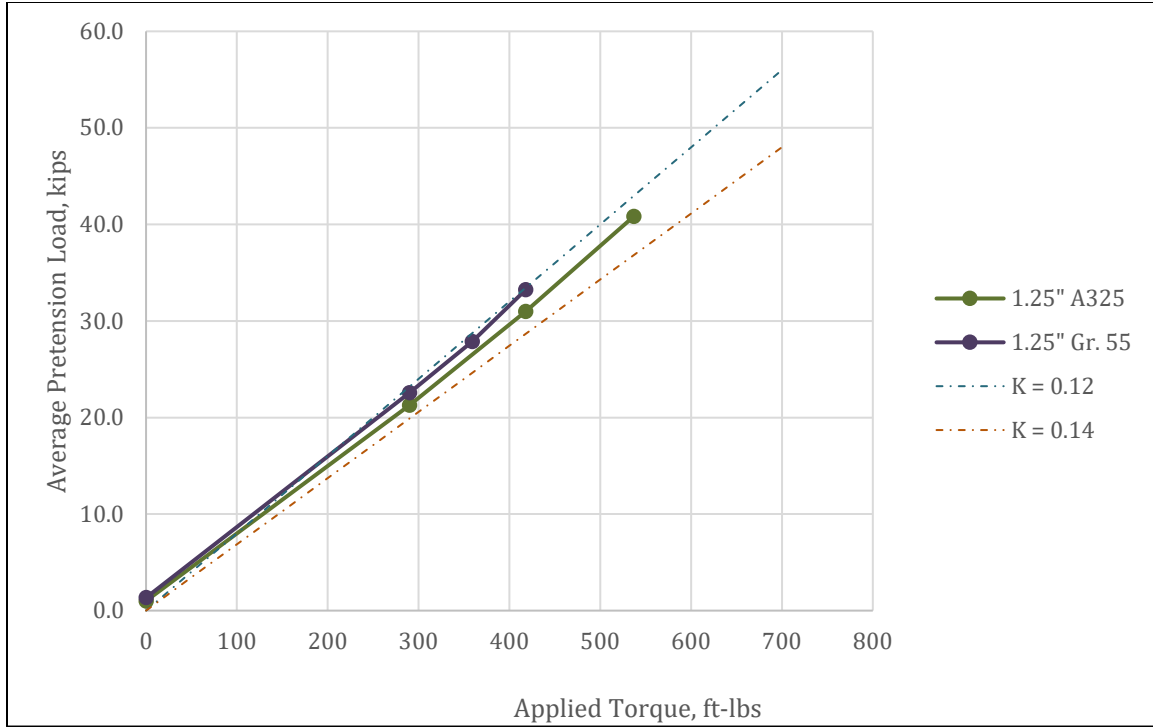
Figure 2.10 – 1.25" Torque vs. Tension

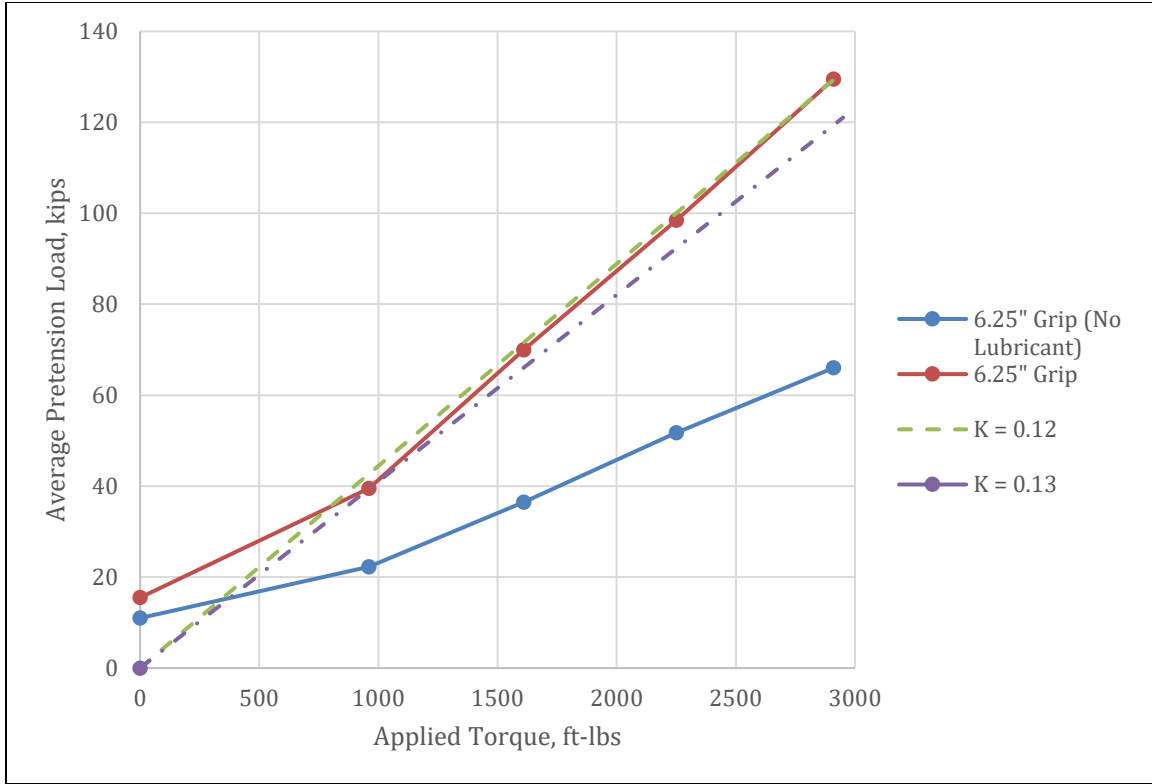
Figure 2.14 – 2.25” Torque vs. Tension

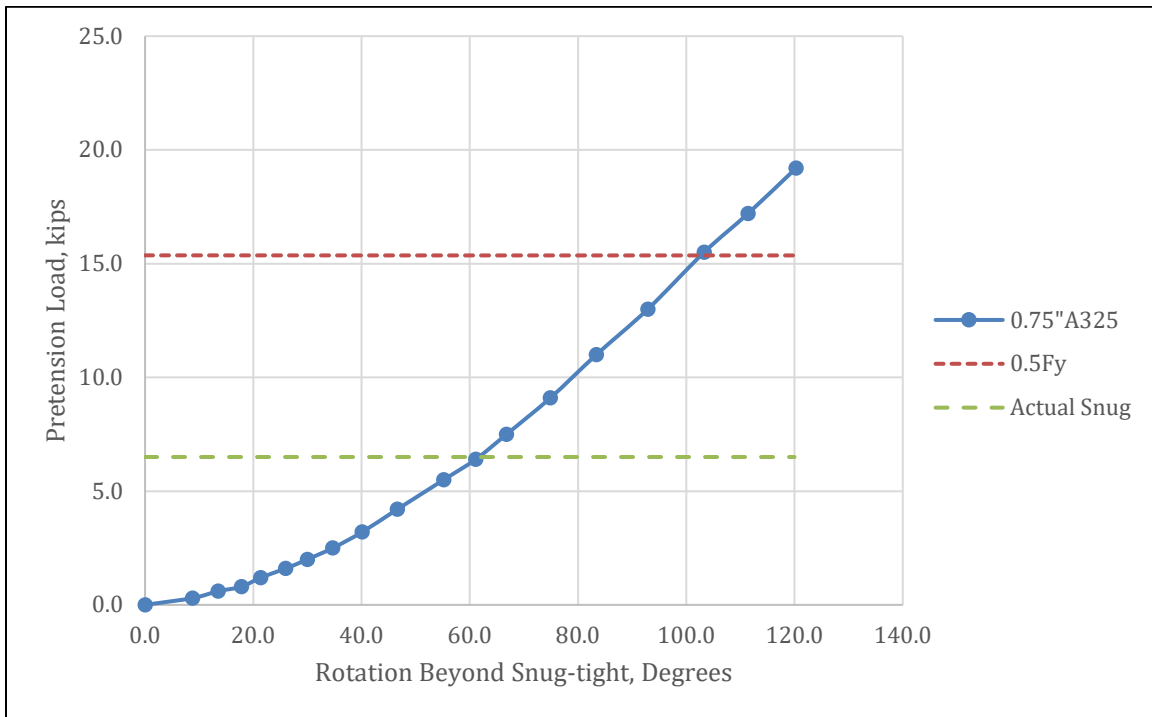
Figure 2.15 - Pre-Snug & Rotation Beyond Snug Curve

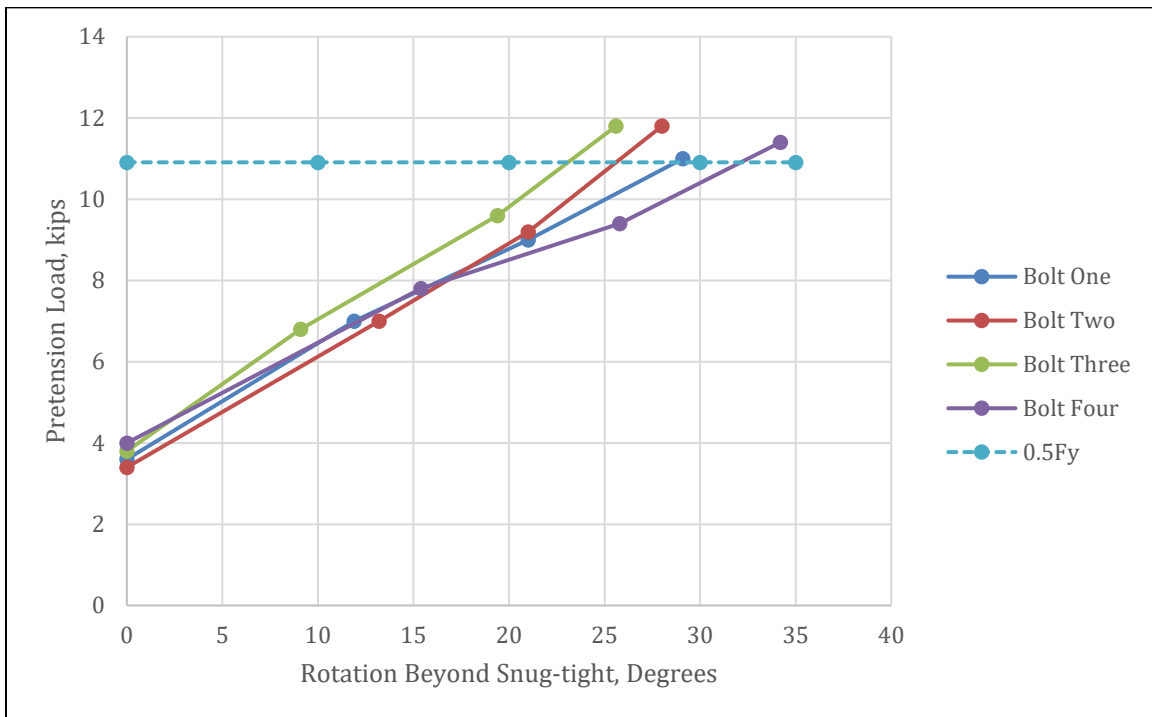
Figure 2.17 - 1" Gr. 36 Rotation vs. Tension

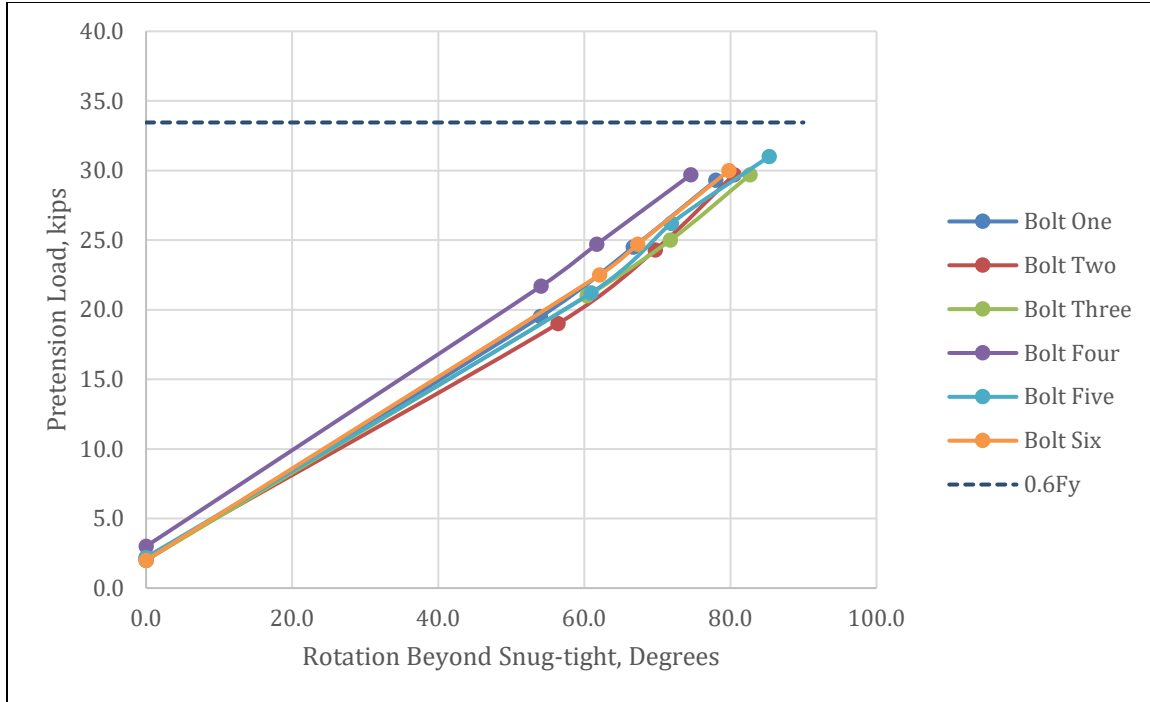
Figure 2.22 - 1" A325 Rotation vs. Tension

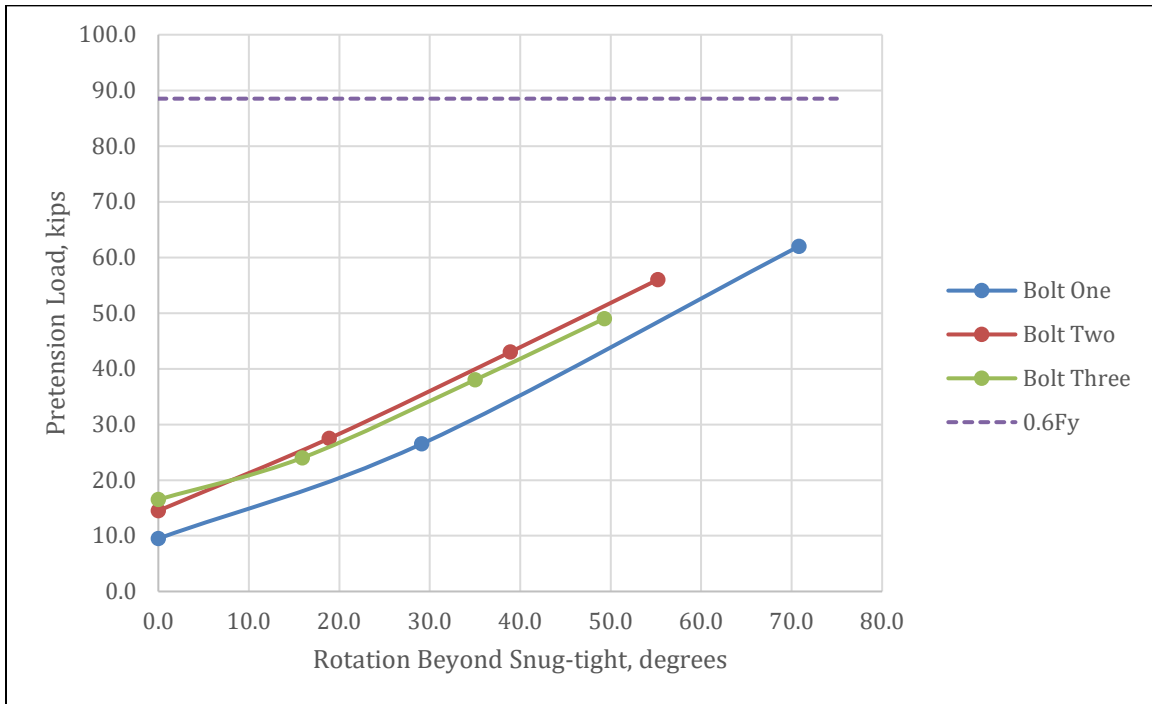
Figure 2.25 - 1.5" Gr. 105 with 2.5" Grip Rotation vs. Tension

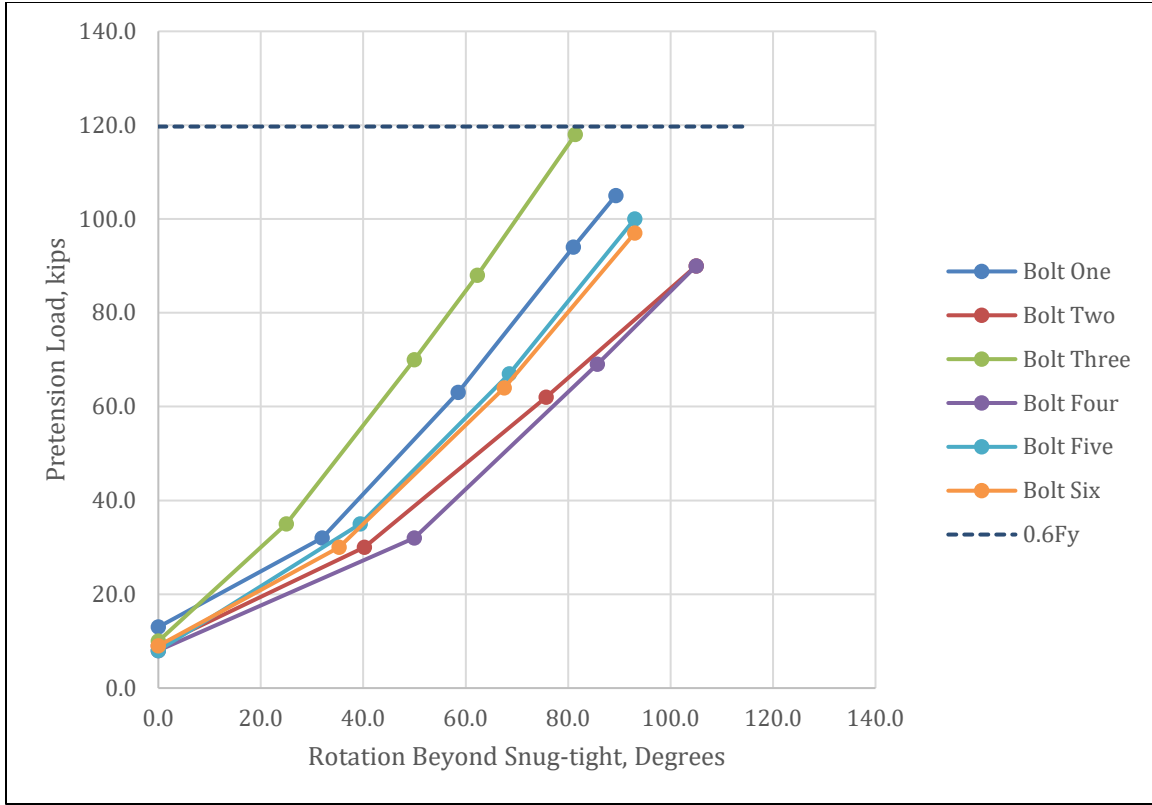
Figure 2.30 - 1.75" Gr. 105 with 5.75" Grip Rotation vs. Tension

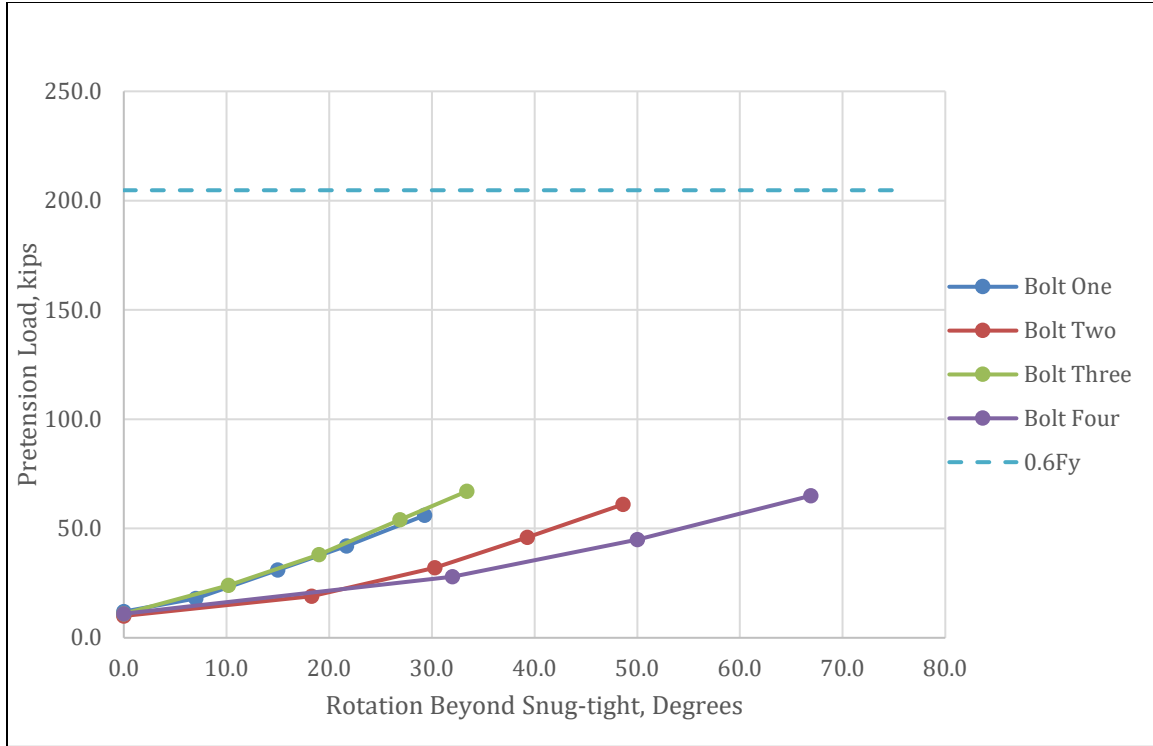
Figure 2.34 - 2.25" Gr. 105 with 6.25" Grip Rotation vs. Tension (No Lubricant)

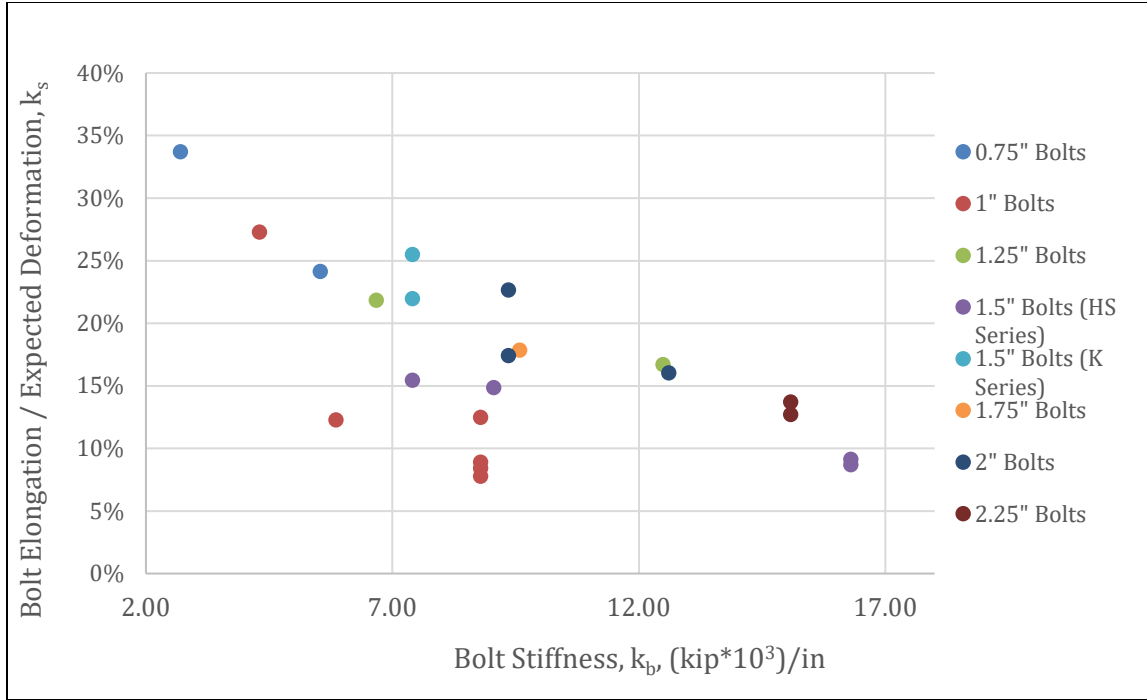
Figure 2.36 - Bolt Stiffness vs.  $k_s$

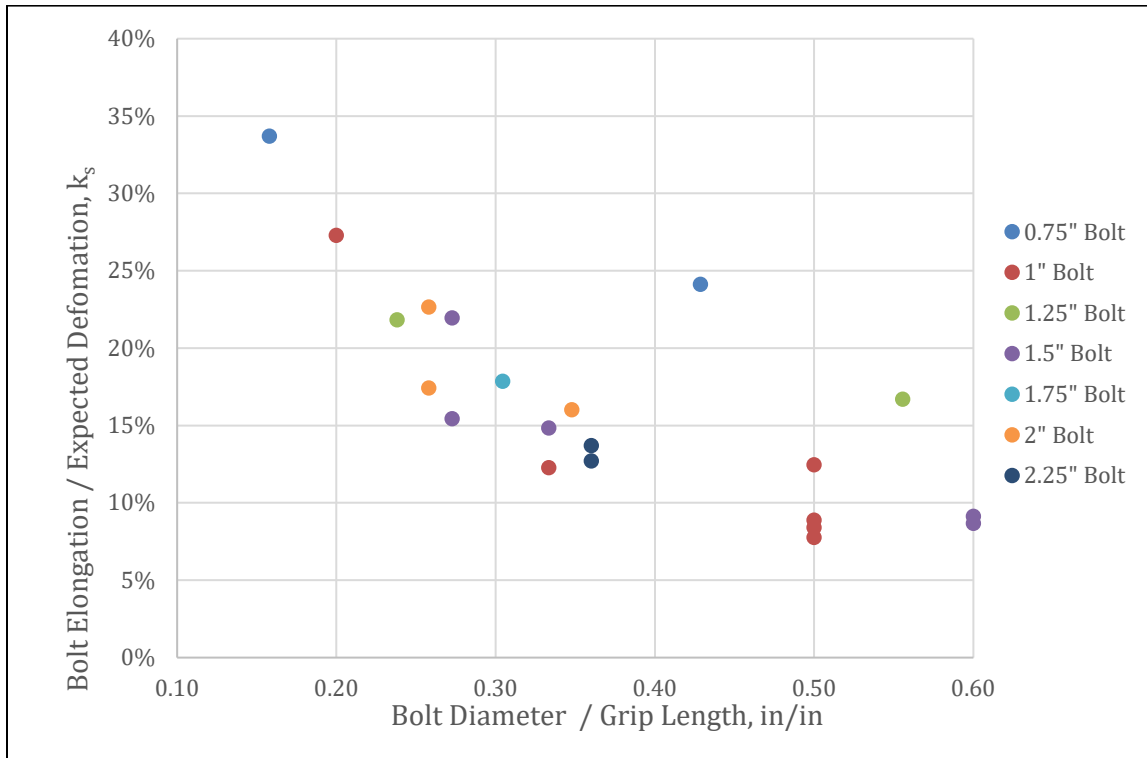
Figure 2.37 - Bolt Diameter / Grip Length vs.  $k_s$

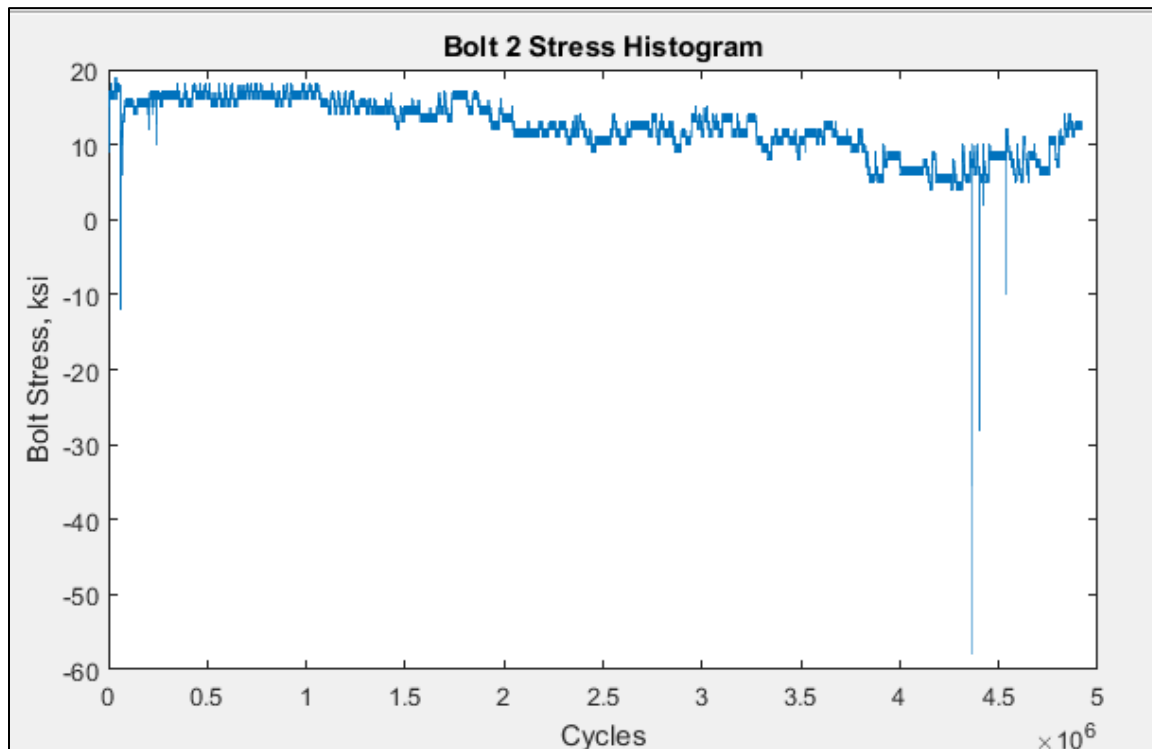
Figure 3.14 - Bolt 2 Stress Histogram

After analyzing the long term data, it was found that the effective stress range was 1.0 ksi. The majority of stress ranges experienced were under 1.0 ksi. If the stresses under 1.0 ksi are ignored due to the minimal damage caused by each stress, the adjusted effective stress range is 5.9 ksi. Furthermore, no bolt exceeded the criteria for AASHTO's CAFL of 7 ksi. The stress range and cycle data is shown in Table 3.2. The maximum stress range was 73 ksi, which occurred for one cycle in Bolt 2. When looking at *Figure 3.14*, it is clear that the maximum induced compression was nearly 55 ksi, with a maximum induced tension of 18 ksi, totaling a stress range of 73 ksi.

The typical stress range was nearly 1 ksi, while some large stresses were caused by wind events. It is very difficult to correlate wind speed with bolt stress, as wind direction is just as important. A smaller wind gust acting perpendicular to the sign panel is going to create larger stresses than a high wind gust acting parallel to the sign panel.

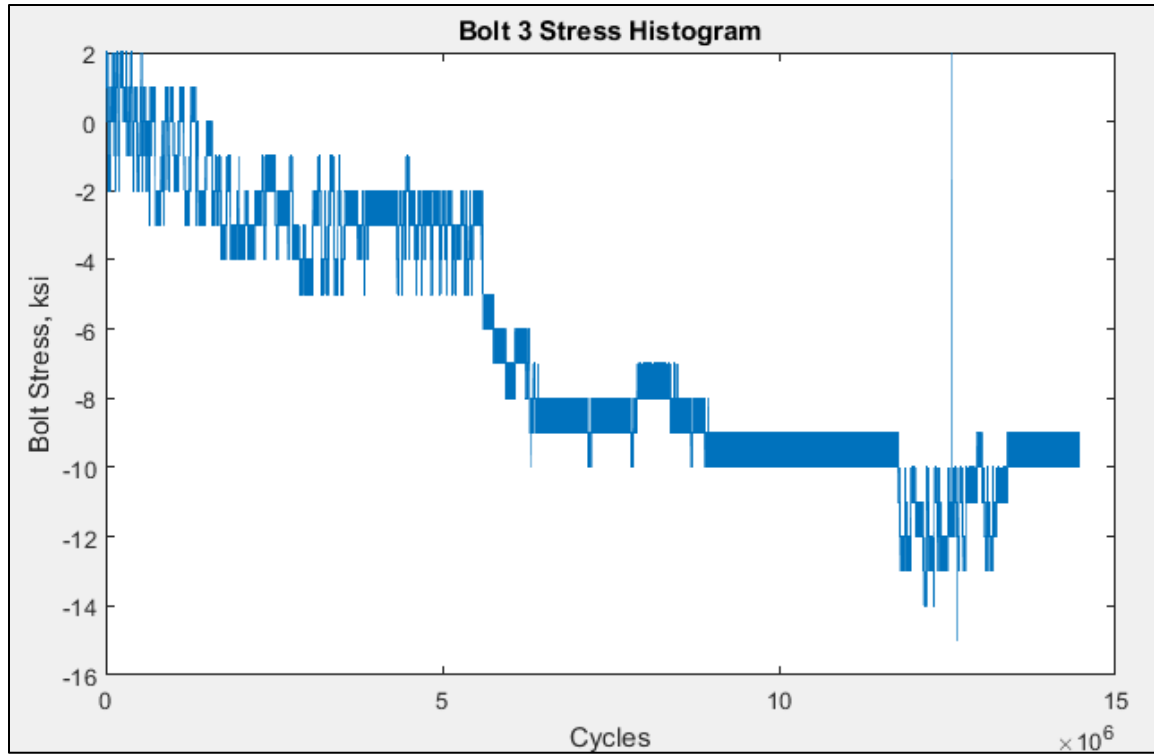
Figure 3.15 - Bolt 3 Stress Histogram

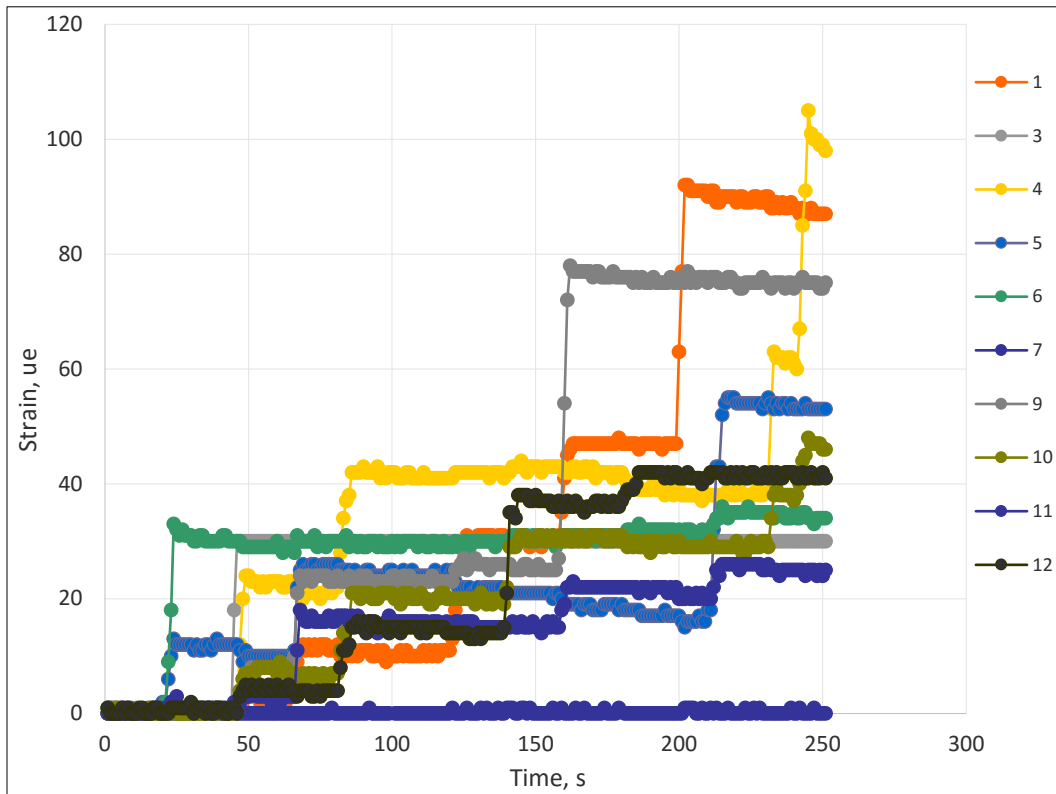
Figure 3.40 – Star Pattern Data

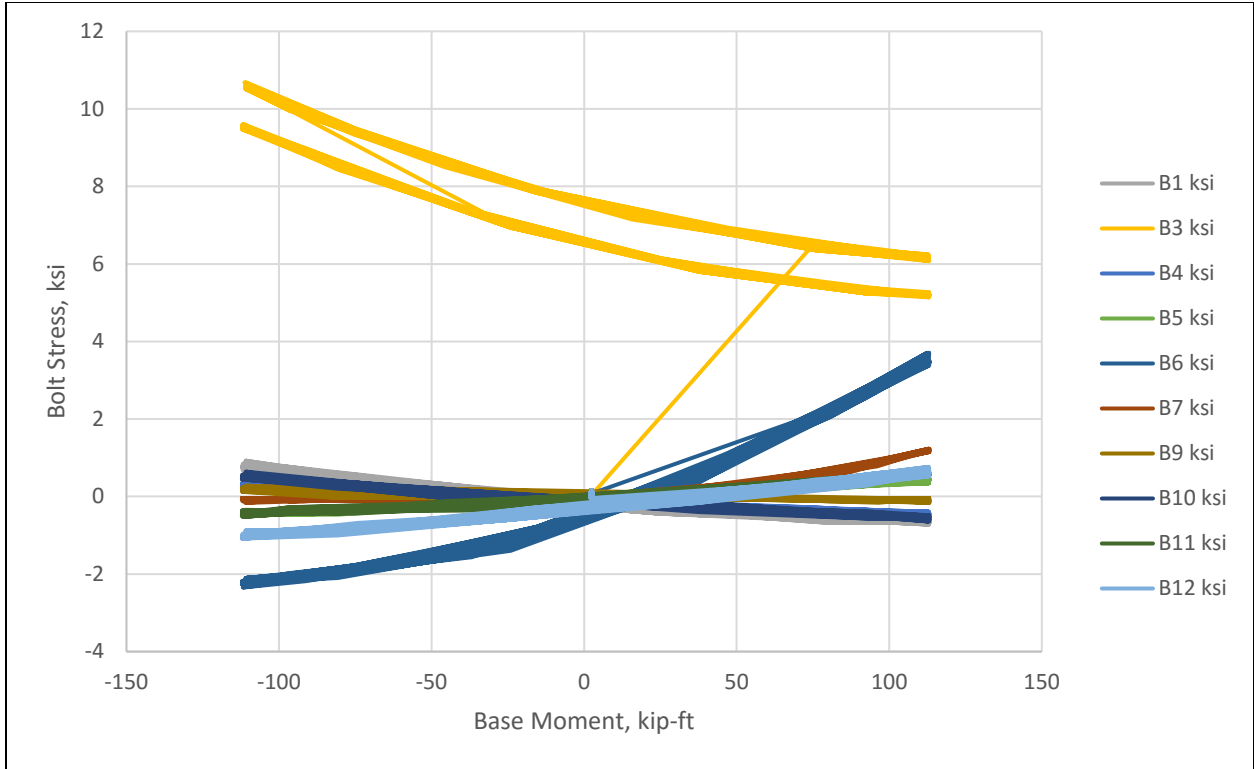
Figure 3.48 - Bolt Stress vs. Base Moment

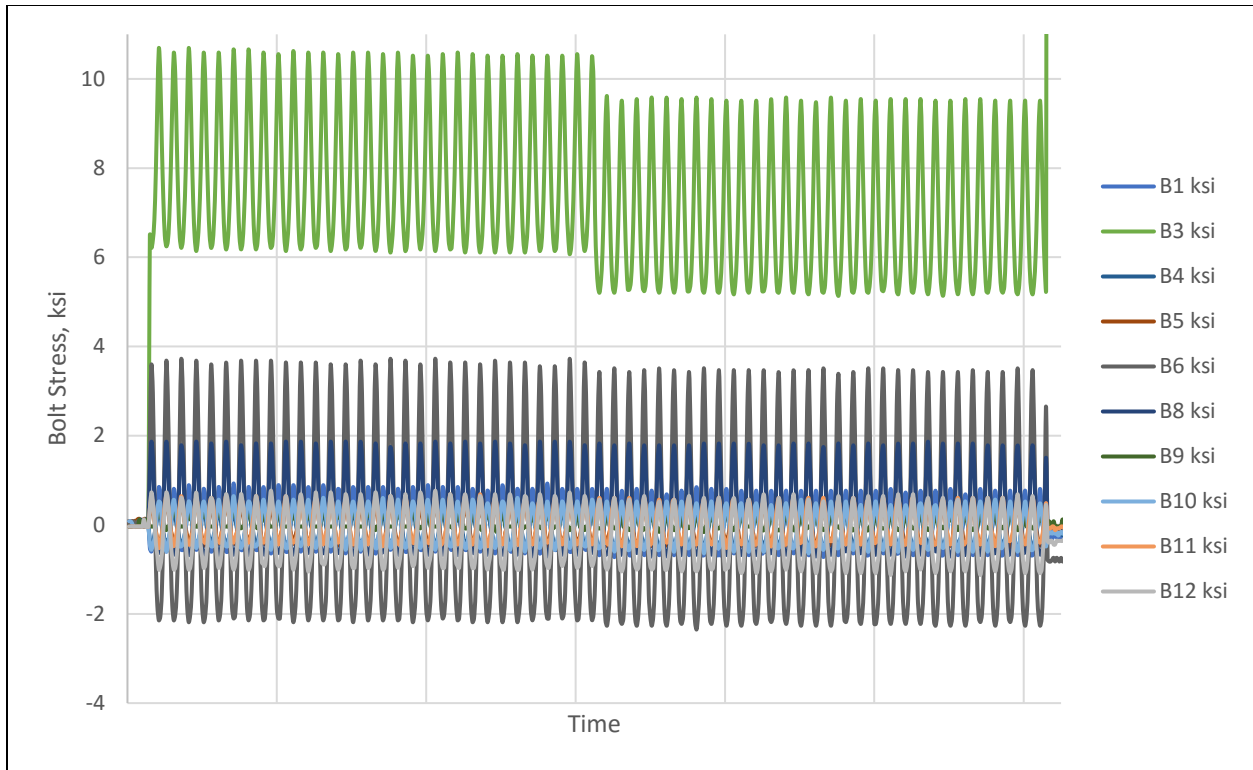
Figure 3.50 - Bolt Stress vs. Time

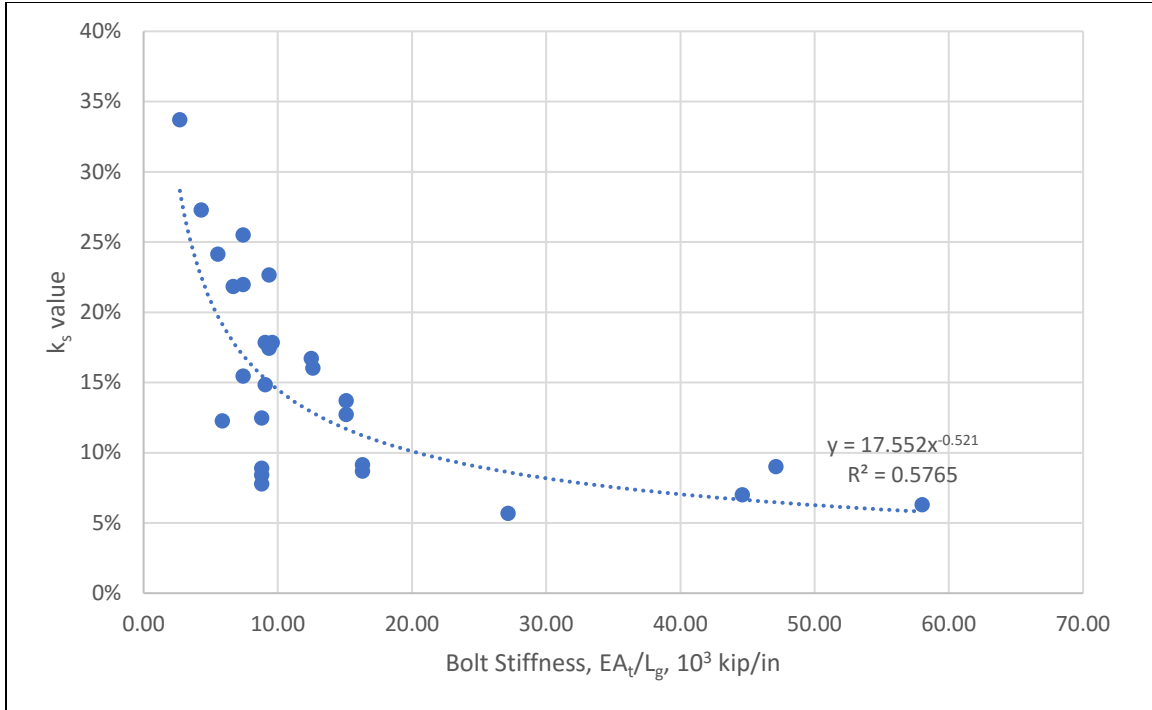
Figure 5.1 - *k<sub>s</sub> Value vs. Bolt Stiffness*
