# Tightening the large diameter anchor bolts of sign, signal, and luminaire structures

**Tightening the large diameter anchor bolts of sign, signal, and luminaire structures**

A thesis submitted to the graduate faculty

Major: Civil Engineering

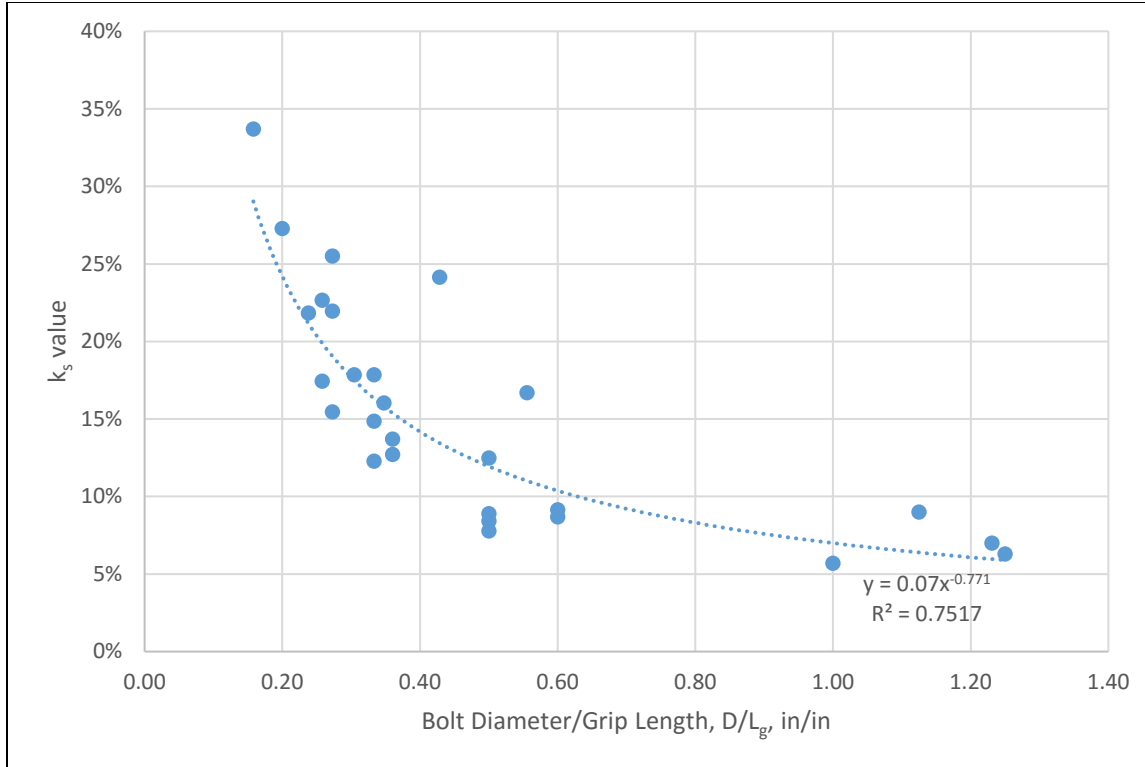
Figure 5.3 -  $k_s$  Values vs. Ratio of Bolt Diameter to Grip Length

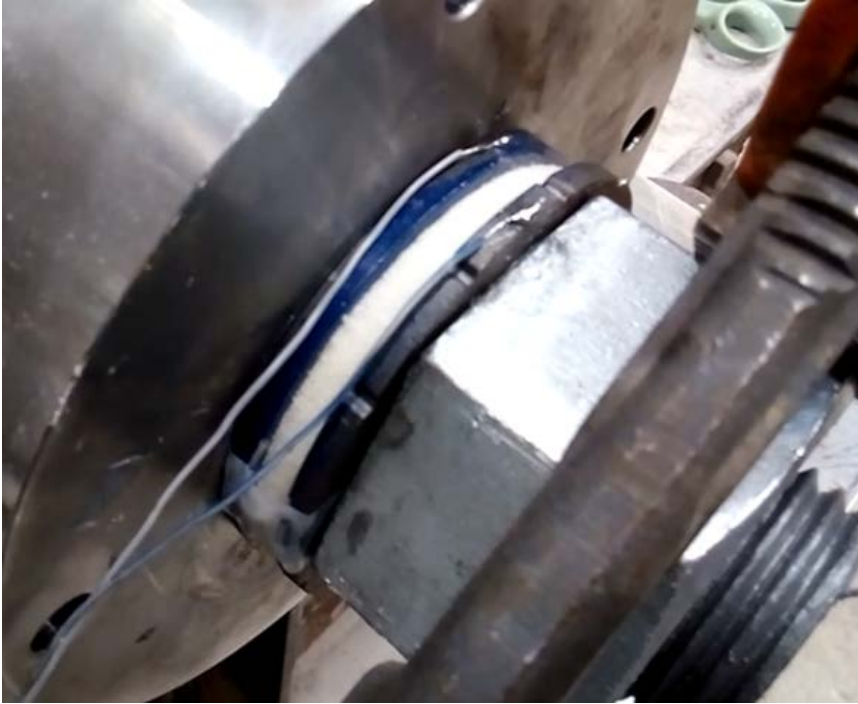
Figure 6.5 - *Memory Foam Capacitor during Loading*

In order to resolve the issue of damage caused by the rotating nut, the insulation was reinforced with insulation tape where the nut and DTI meet. The electrical insulation tape not only serves as an additional insulation layer, but it also reduces physical damage caused by the rotating nut. More testing using a pipe wrench was completed on the memory foam capacitor. The capacitance increased from an initial value of 24.50pF to 71.87pF, falling back to 28.92pF after load was removed. The insulating tape layer helped provide a more stable value of capacitance. Another rubber capacitor was tested, but it continued to show a negative value of 246.62pF when 20 kips was applied on the capacitor. These results demonstrate that a memory foam capacitor is more stable than a rubber capacitor when used in this prototype design. Insulation has proven to be the key factor in affecting the quality of the capacitor.

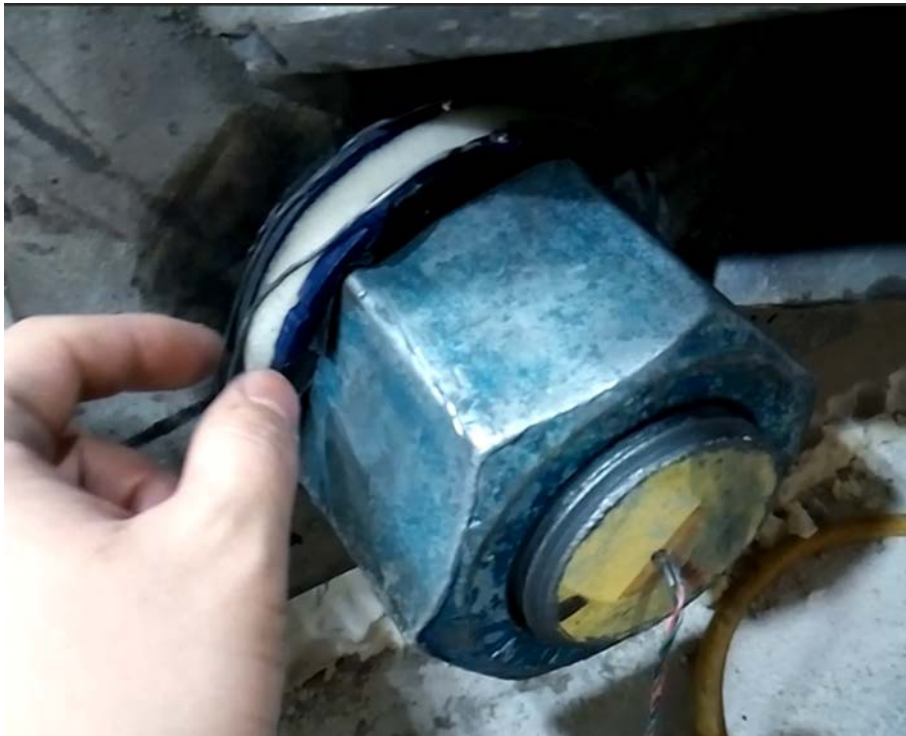
Figure 6.6 - *Examining the Capacitor after Loading*

tested, and a hydraulic wrench was used for tightening. At very low torque values (under 500 ft-lbs) the Keysight capacitance measuring device began to read out of range. The insulation was insufficient, and it was causing the capacitance to be unstable. Essentially, the insulation was insufficient, and the baseplate and nut began to use the bolt to create a circuit. In order to create additional insulation, small neoprene washers were machined and placed above and below the capacitor. This added some stability, but the insulation between the washers and bolt was still insufficient. In an attempt to mitigate this issue, some insulation was added to the bolt where it would touch the capacitor. Another issue that was encountered was the neoprene deformation. At very low pretension values, the neoprene was compressed and began to squeeze out from around the capacitor. The capacitor design continues to be optimized to decrease the issues with insulation.
