# Acceleration of bridge construction with prolonged service life

**Acceleration of bridge construction with prolonged service life**

A thesis submitted to the graduate faculty  
in partial fulfillment of the requirements for the degree of

Major: Civil Engineering (Structural Engineering)

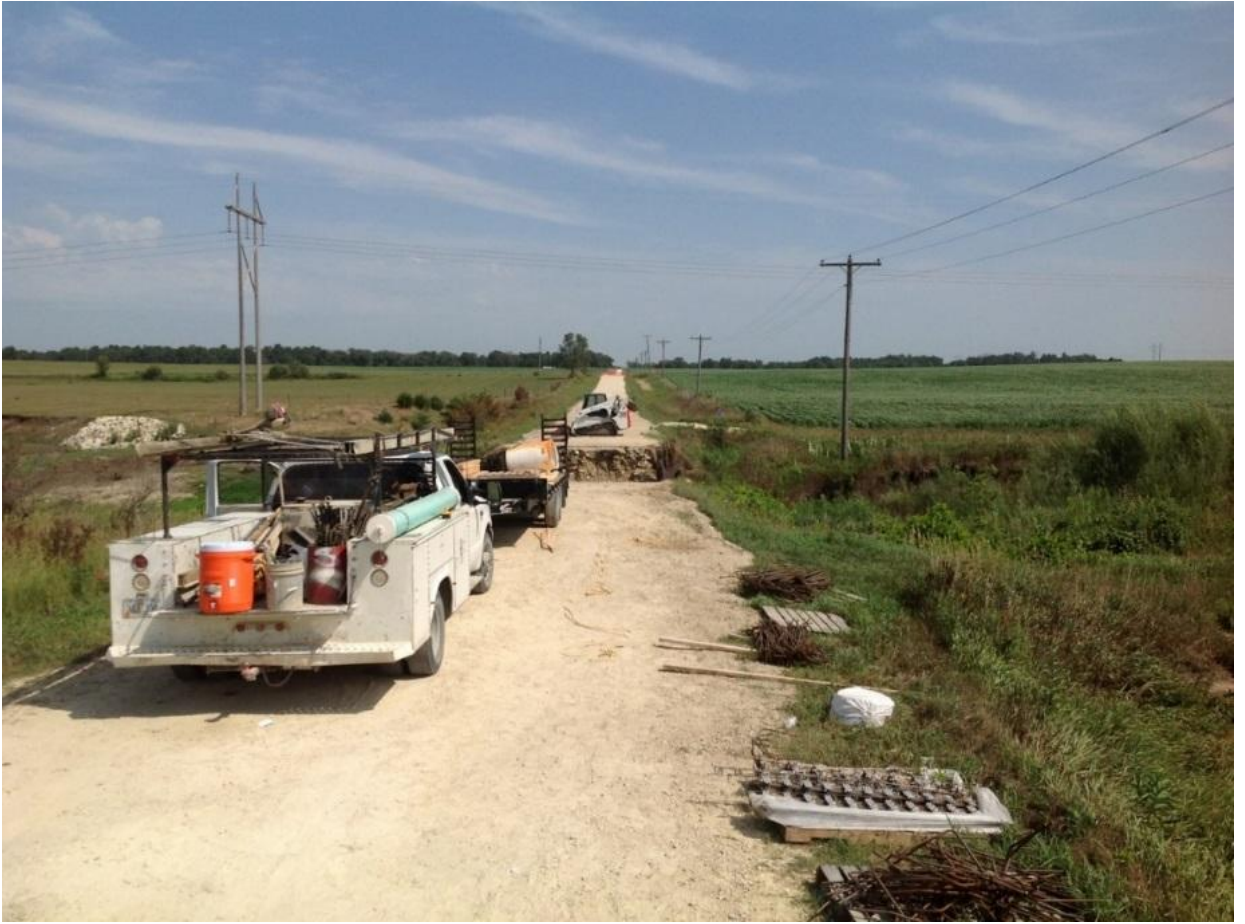
Figure 7 is a photograph of the Prairie Creek bridge construction site after removal of the existing bridge. At the time this photograph was taken the new abutments nor the replacement box beams had yet been constructed.

**Figure 7. Construction job site**

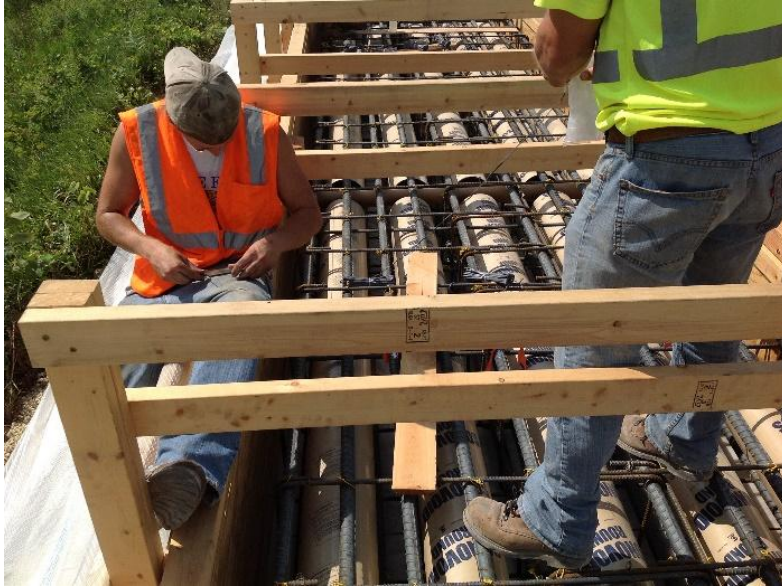
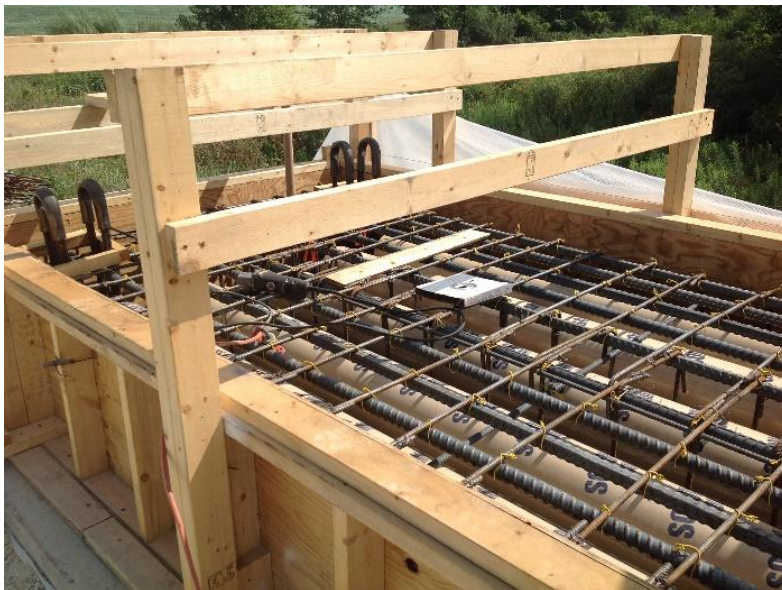
The timber formwork used for beam fabrication is shown in Figure 8. This figure also shows the top longitudinal and lateral reinforcement, and lifting loops at the end. Note that in this photograph a series of longitudinal sonotubes used to create the internal voids can be seen. Recall that one of the goals of this project was to construct the bridge without the use of a conventional crane. Along these lines, one of the original ideas for moving the beams in place was to use a large tow truck to “drag/launch” the beams into place. Given uncertainties in the practicality of this, a “test” beam was first constructed. This test beam was constructed

following the original design plans and is the beam shown in Figure 8. Beams used in the actual bridge were constructed similarly but did not include the internal voids.

**Figure 8. Steel reinforcing cage for beam**

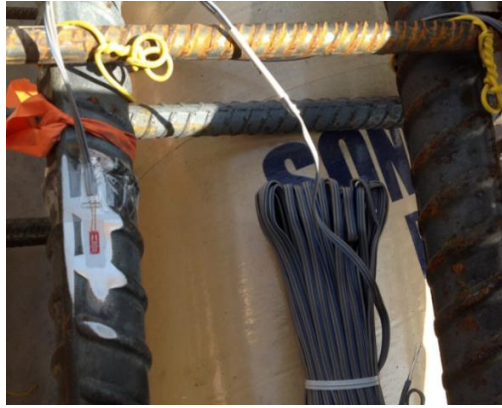
Figure 10 shows a typical installation of the strain gage on the longitudinal reinforcement.

**Figure 10. Gage installation on reinforcement**

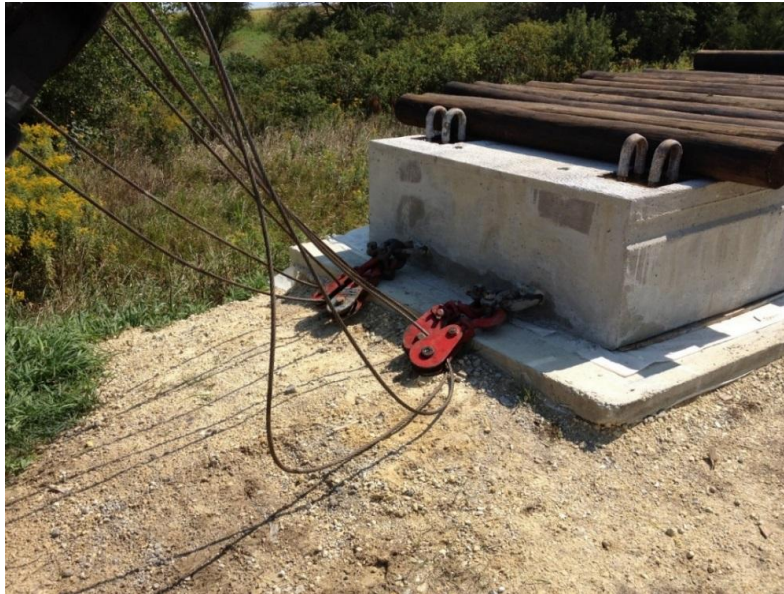
As mentioned previously the first attempt to position a beam was with a tow truck. Figure 11 shows the pulling loops on the sides (horizontal pulling loops) that were installed for this purpose. In theory, the beam was planned to be moved by putting wooden cylinders (shown in Figure 11) below it and then sliding it over those cylinders.

**Figure 11. Lifting/pulling setup**

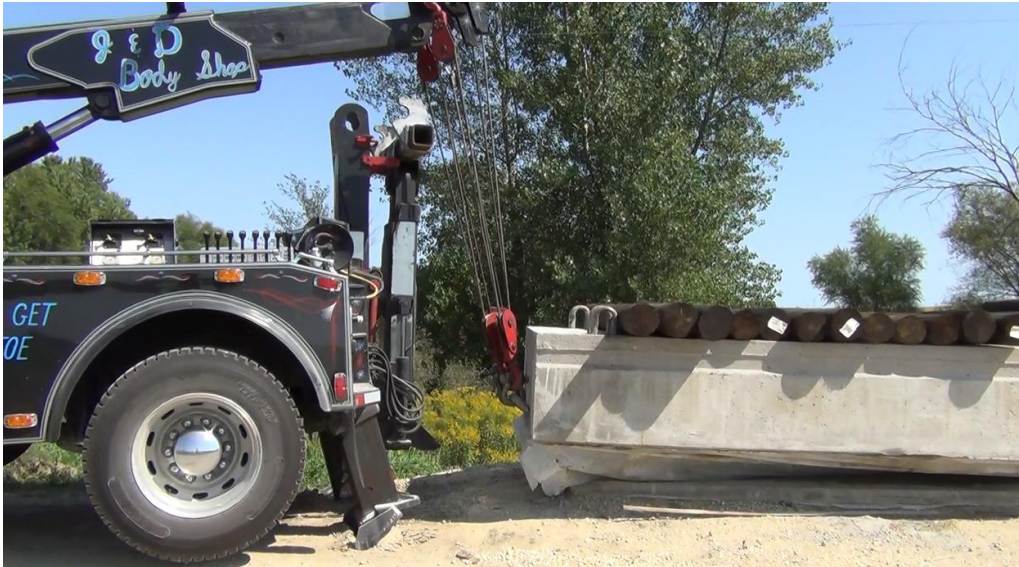
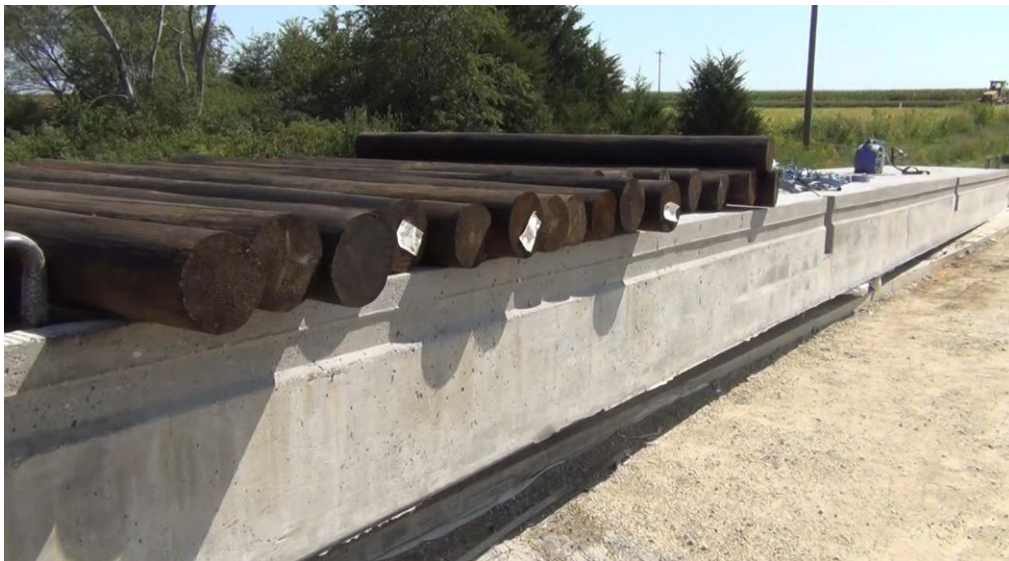
Figure 12a and Figure 12b shows the beam when it was lifted about six to seven inches at one end. The lifting was stopped at this point to make observations. The lifting force was then gradually released to let the beam rest on the ground.

**a) Beam lifted by tow truck**

**b) The beam when one end was lifted by the tow truck**

**Figure 12. Beam lifted by the tow truck**

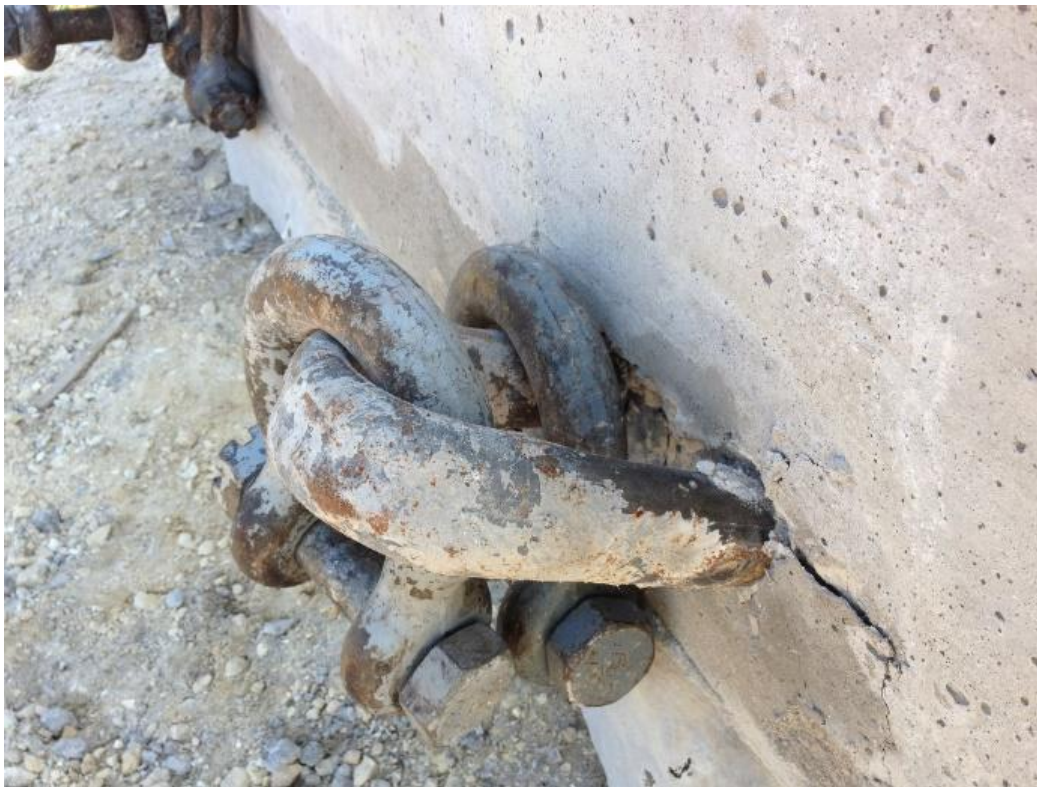
During the lift of the beam, three important observations were made. First, **Figure 13** shows the extreme bending of the pulling loops and a crack that propagated from the pulling loop. Second, Figure 14 shows concrete spalling on the other end (opposite to the pulling end) of the beam. Finally, although the tow truck could vertically lift the beam, it did not have sufficient capacity to “pull” the beam forward any appreciable distance. In the eyes of the design and construction teams, the use of a tow truck for this purpose was deemed unsuccessful.

**Figure 13. Horizontal pulling loops after lift**

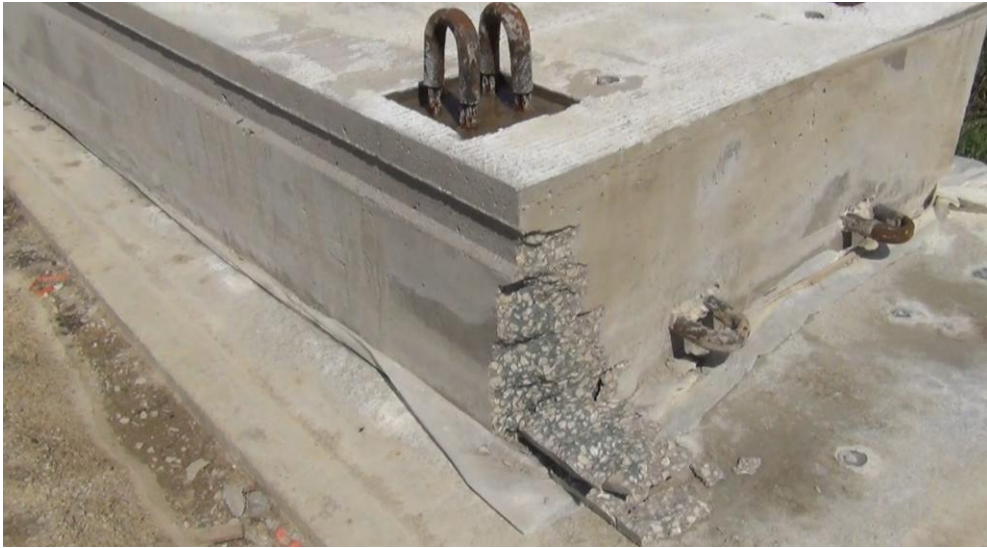
**Figure 14. Concrete spalling on non-pulling side of the beam**

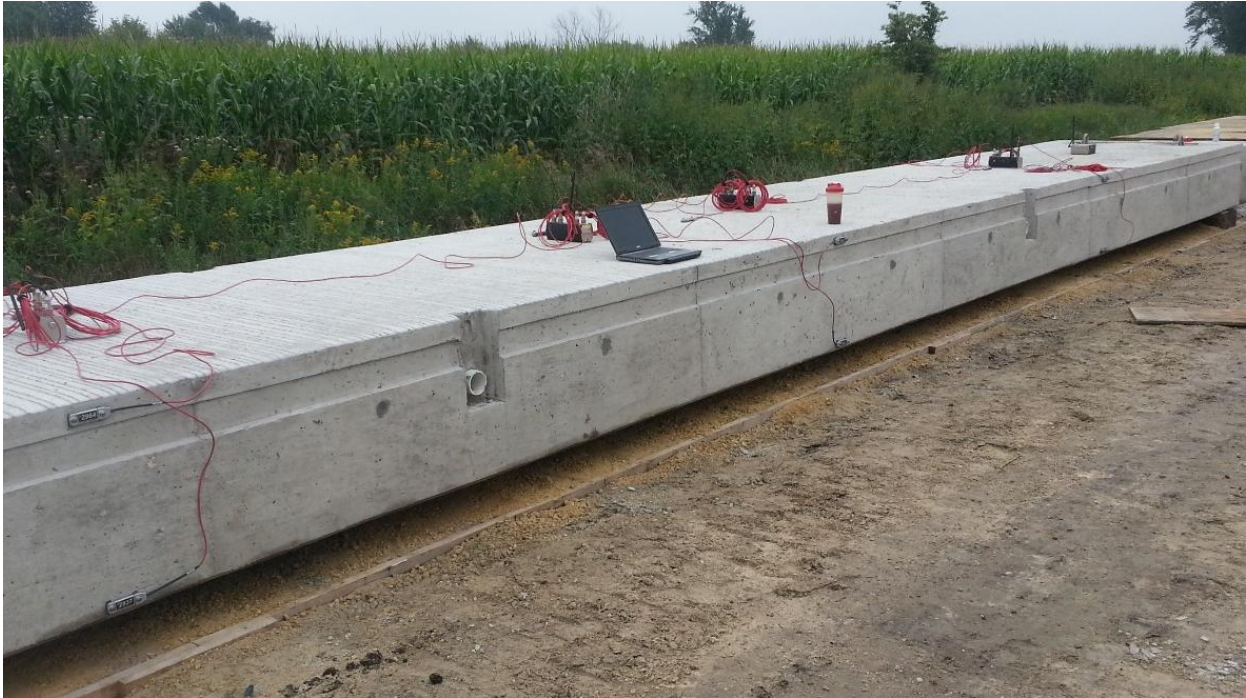
Figure 16 shows the strain gages mounted on the beam and data collection system that was used to record the strain during the beam move. All externally mounted gages had an effective gage length of 3-in.

**Figure 16. Installed strain gage and data collection system for lift/move**

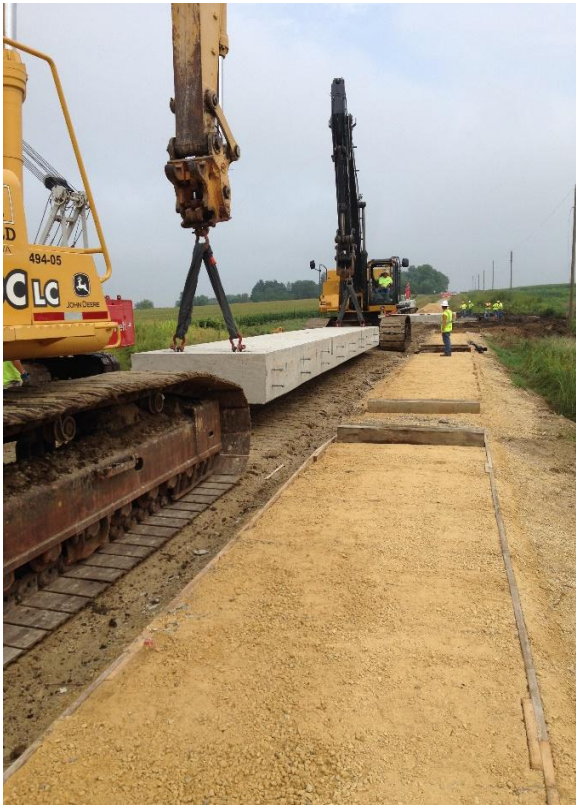
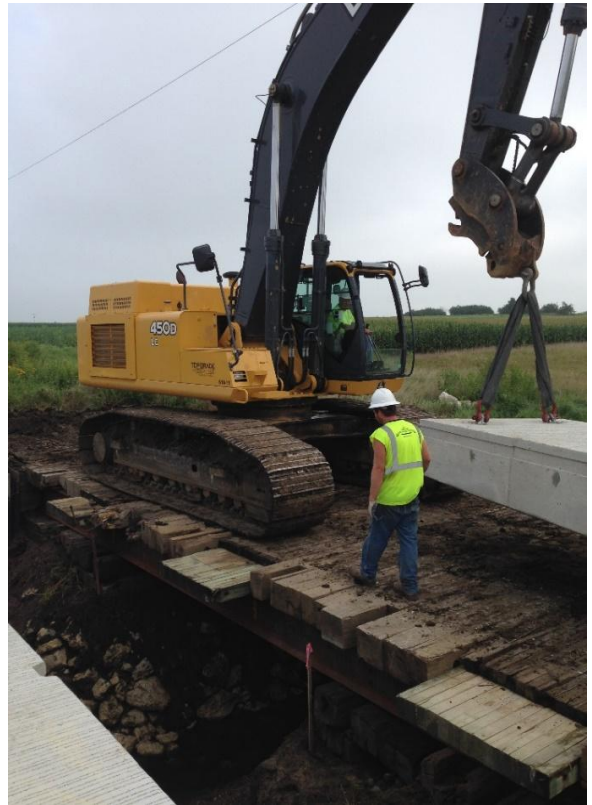
To facilitate placing the beams, a temporary bridge was constructed over the creek by placing steel girders across the creek and placing timber deck panels over the girders to make a traversable surface. As shown in Figure 17a, the two backhoes lifted the beam using preinstalled lifting loops. After the beams were lifted, the backhoes moved the beams from where they were placed towards the creek by slowly tracking together in a coordinated fashion. Figure 17b shows one backhoe crossing the creek over the temporary bridge. Figure 18 shows four beams that had been placed on the concrete abutments while Figure 19 shows the fifth beam being moved to its designed location.

**a) Beam lift**

**b) Beam move over the creek**

**Figure 17. Beam launching using backhoes**

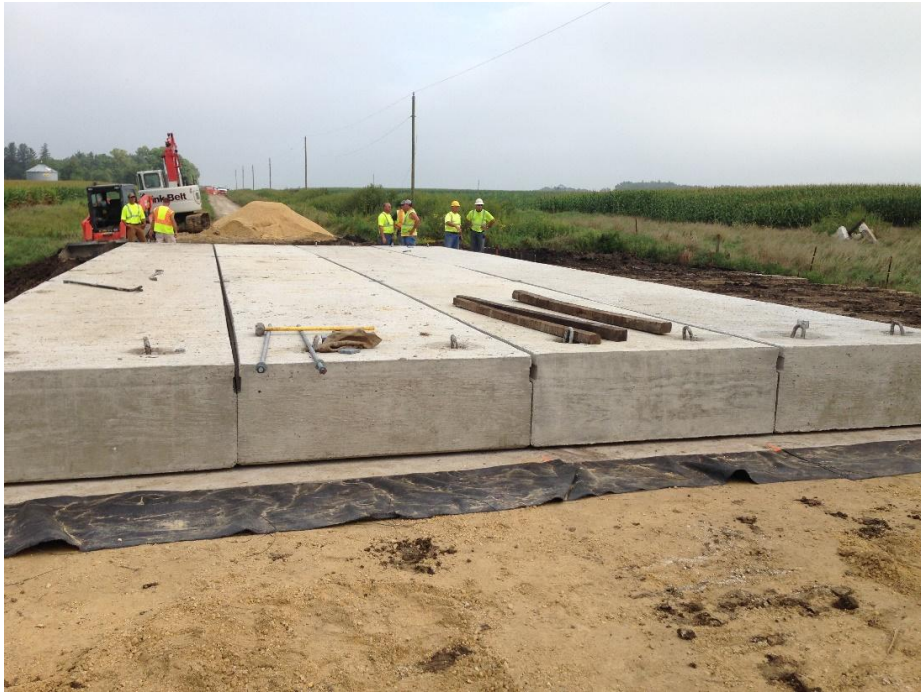
**Figure 18. Four beams placed over the creek on the concrete abutments**

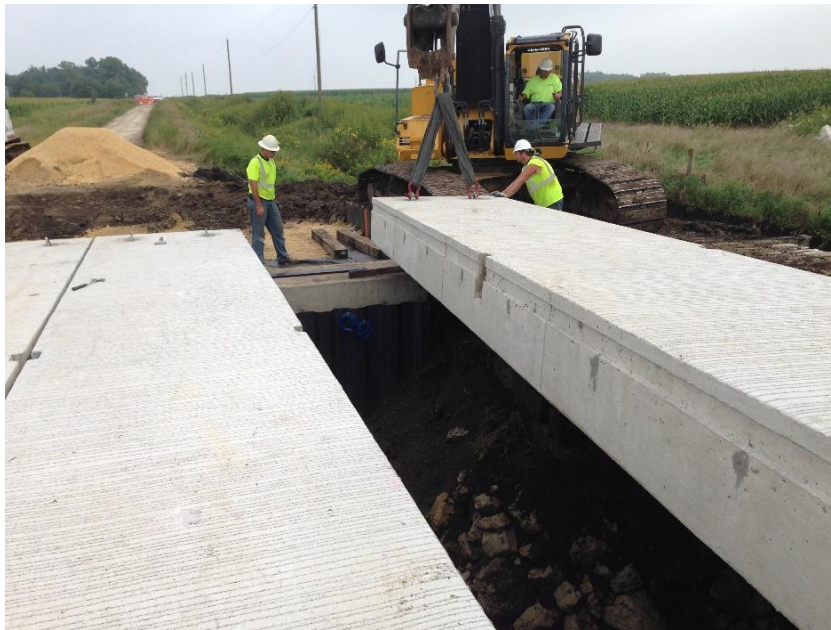
**Figure 19. Fifth beam being moved to its position using backhoe**

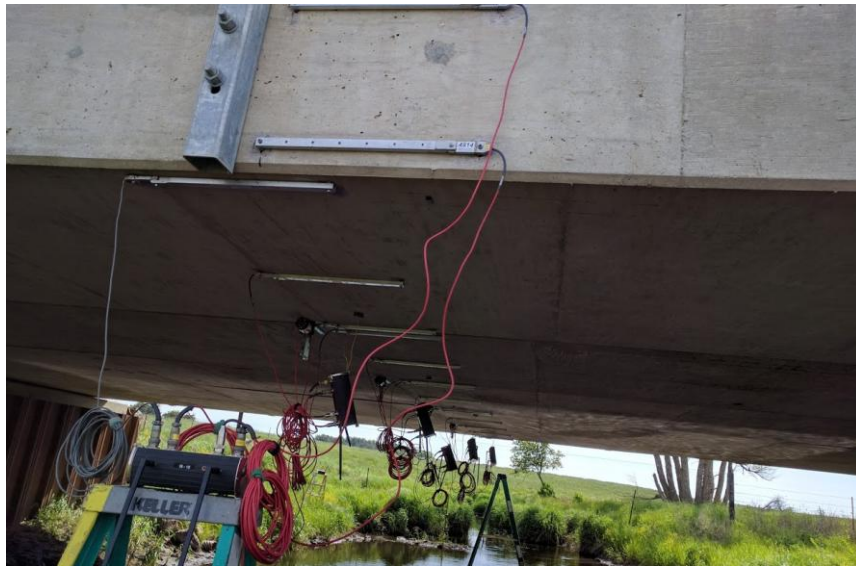
Figure 28 shows the bridge after all external instrumentation had been installed. Figure 29 shows a close-up view of the relative displacement gage setup that was used to monitor for relative moment between adjacent beams.

**Figure 28. Instrumentation mounted on the bridge**

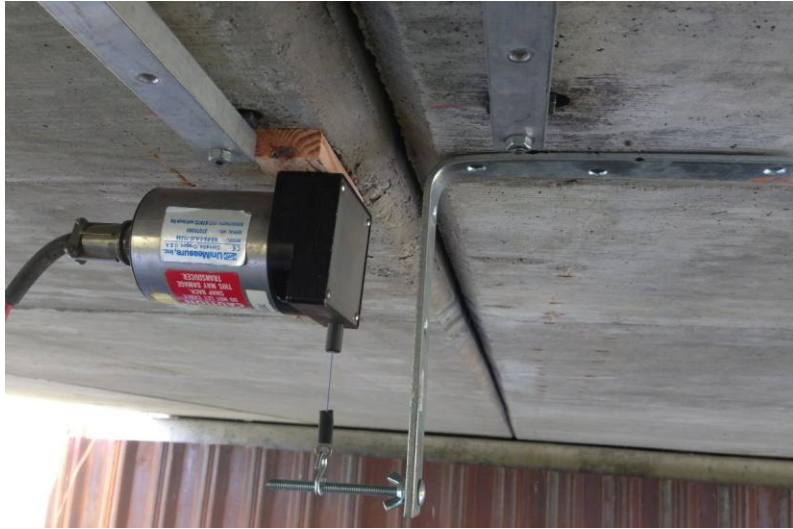
**Figure 29. Relative displacement gage setup**

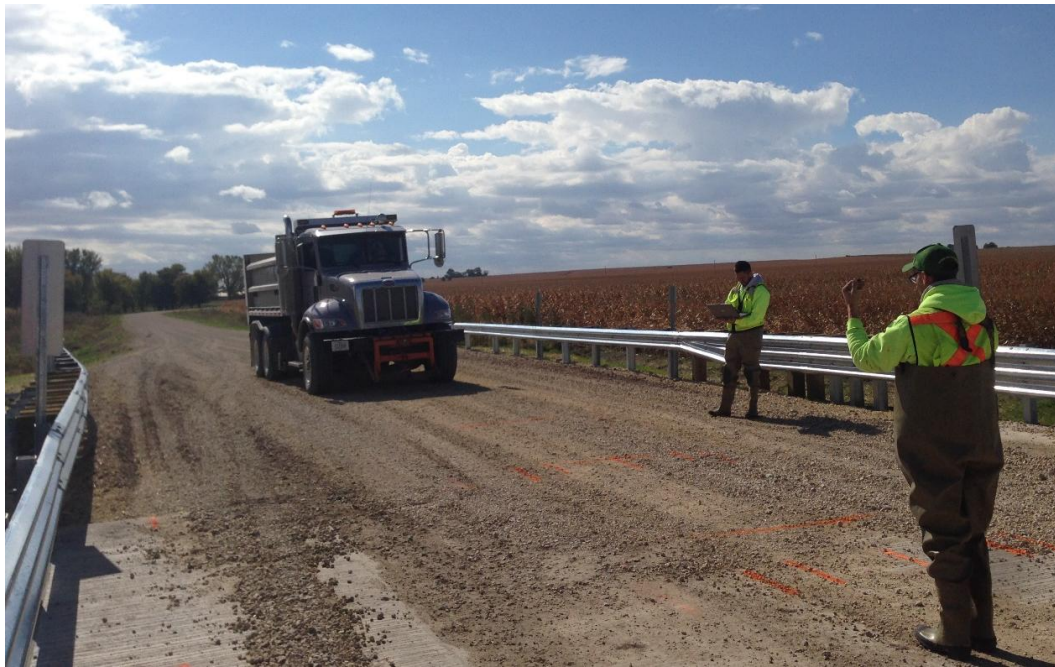
Figure 30 shows the loaded tandem axle dump truck being guided across the bridge in a pre-designated truck position. For each load case, the truck was slowly driven (approximately 3mph) from one end to other while keeping the truck in a consistent transverse position.

**Figure 30. Carrying out the load test on the bridge**

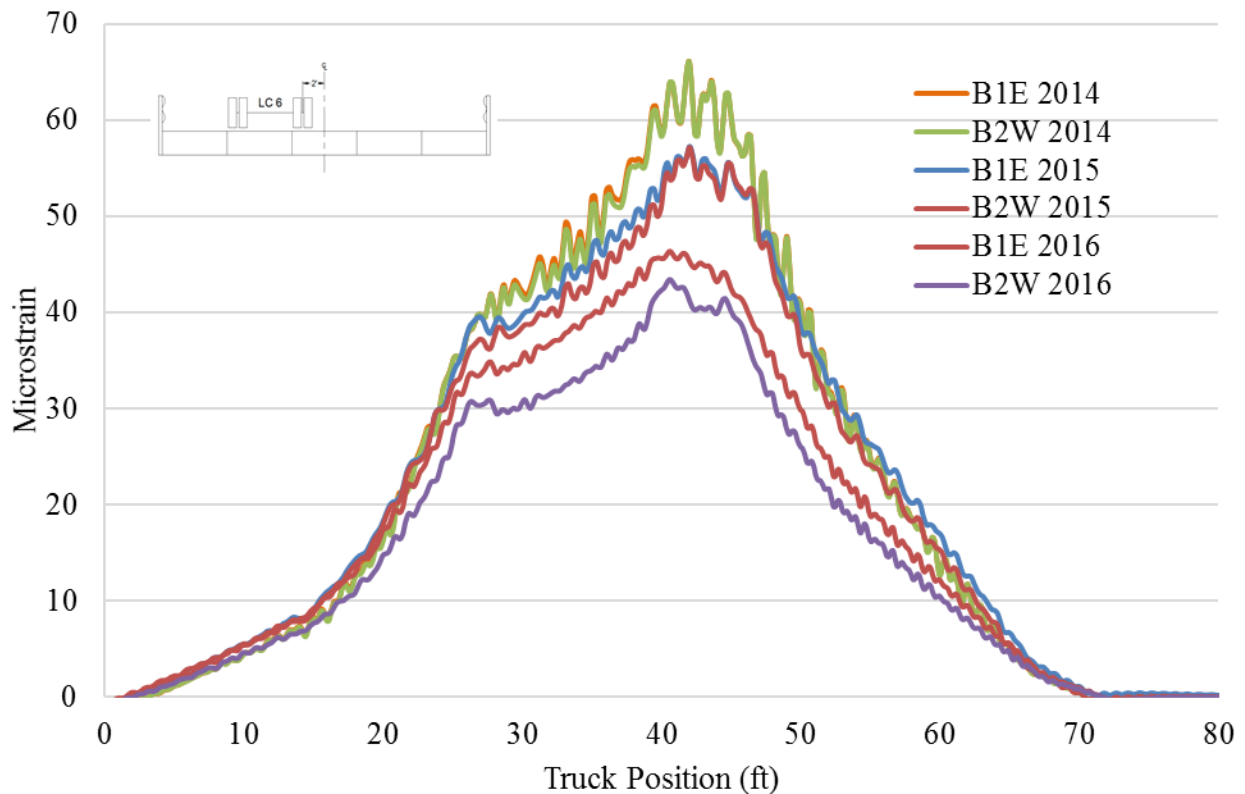
Figure 34 shows the history of strain gages (B1E and B2W) mounted near joint J1 for LC-6. The peak strain value is reached when the truck is above strain gages i.e. mid-span.

**Figure 34. History of the strain gages by J1 (LC-6)**

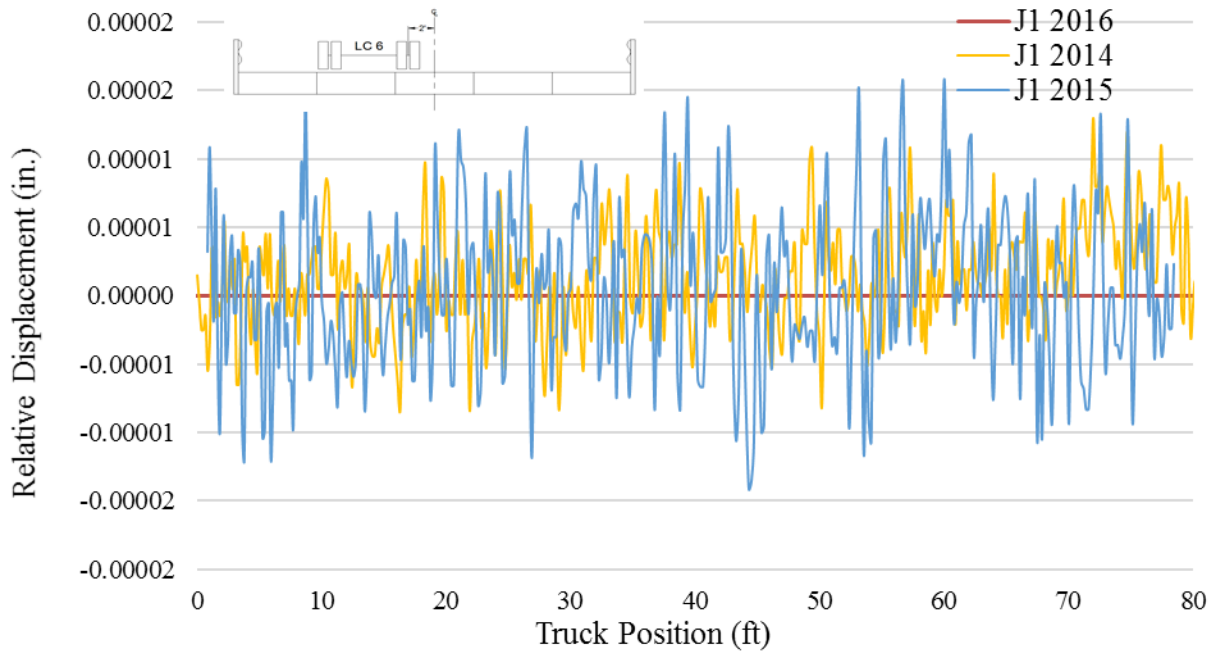
Figure 36 shows the history of relative displacement between Beam 1 and Beam 2 at joint J1 for LC-6 for all three years. From this history, it can be seen that, the relative displacement transducer for the year 2016 failed. The peak relative displacement value was around 0.00002 in., which is significantly small.

**Figure 36. History of relative displacement at J1 (LC-6)**

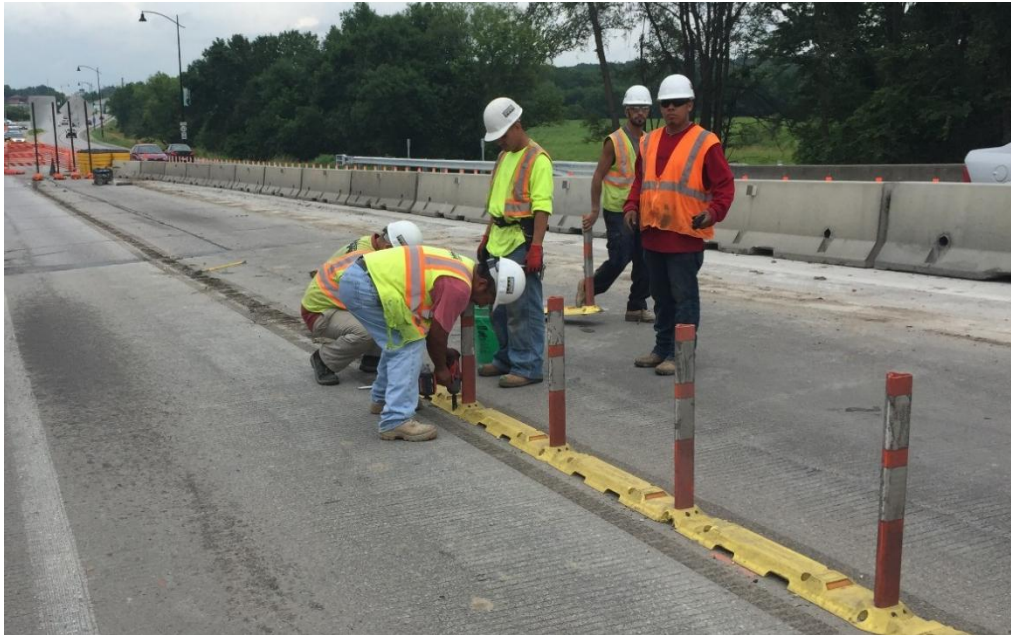
direct traffic safely. The bollards that were used were bolted to the deck and had to be detached using a hand drill as shown in the Figure 40.

**Figure 40. Temporary bollards being detached by workers**

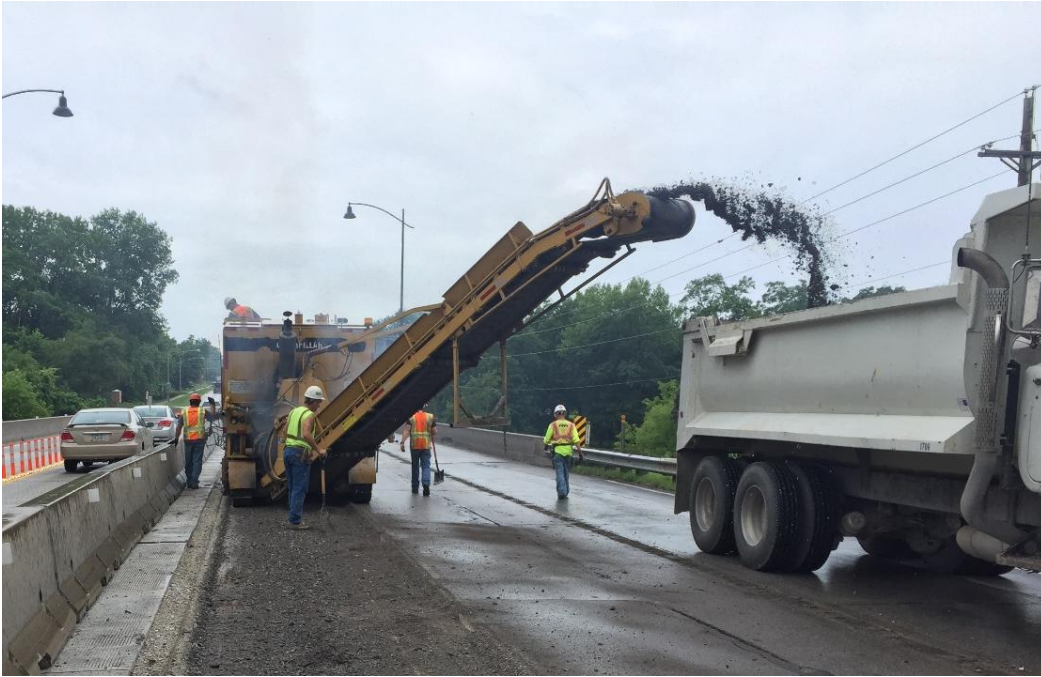
One person operated the machine and four workers watched over the machine and guided the operator. The milled concrete was transferred to a dump truck by a conveyor connected to the milling machine as shown in Figure 41.

**Figure 41. Milling machine removal of top layer of the deck**

In one pass from one end of the bridge to the other, the milling machine was able to remove about 2 to 3 in. of concrete, so that there would be only 0.5 to 1 in. deep concrete on top of reinforcing steel. The milling required an hour to finish one pass and, once a pass was done, it took 15 to 20 minutes to turn around and start working on the next pass.

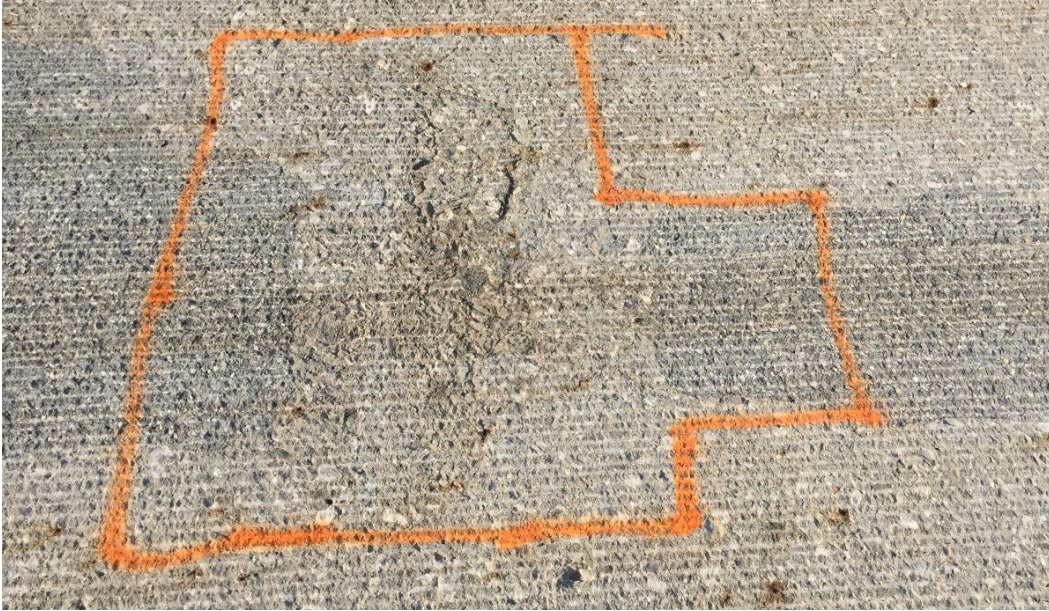
for unsound and damaged areas, which were marked for more in-depth removal as shown in Figure 42.

**Figure 42. Area marked for more in-depth removal**

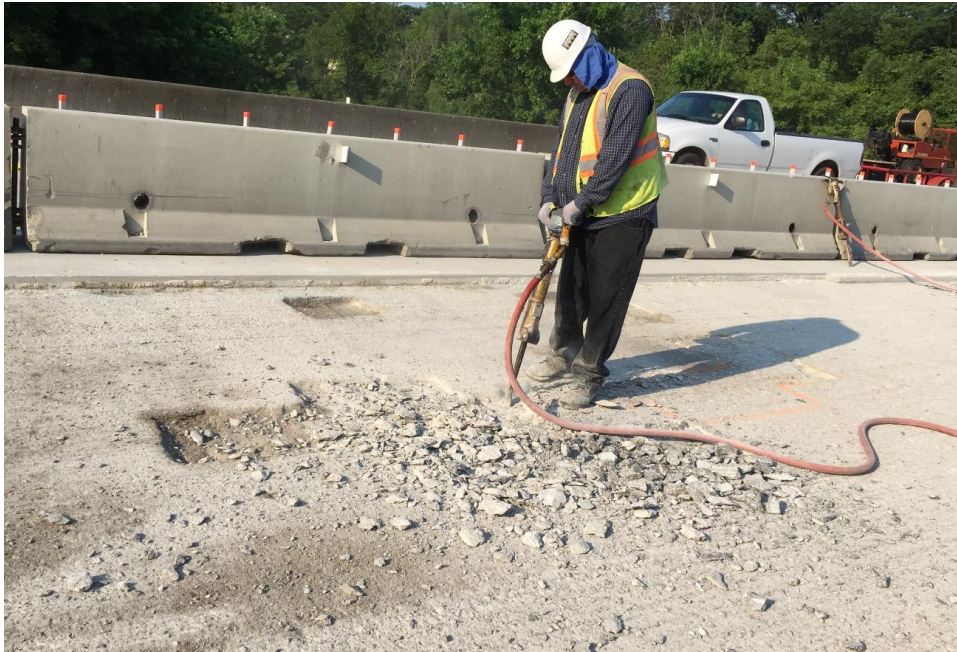
Considering that it took three days for removal of the substrate concrete, utilizing additional workers could lead to shorter completion time. Also, according to standard practice for overlay construction in Iowa, if more than half of the bar becomes exposed during substrate removal, additional sound concrete needs to be removed such that the entire bar is exposed. Considering the large area of concrete needing removal, removing the additional sound concrete around the bar may have taken a significant amount of time.

**Figure 43. Removal of unsound concrete using jackhammer**

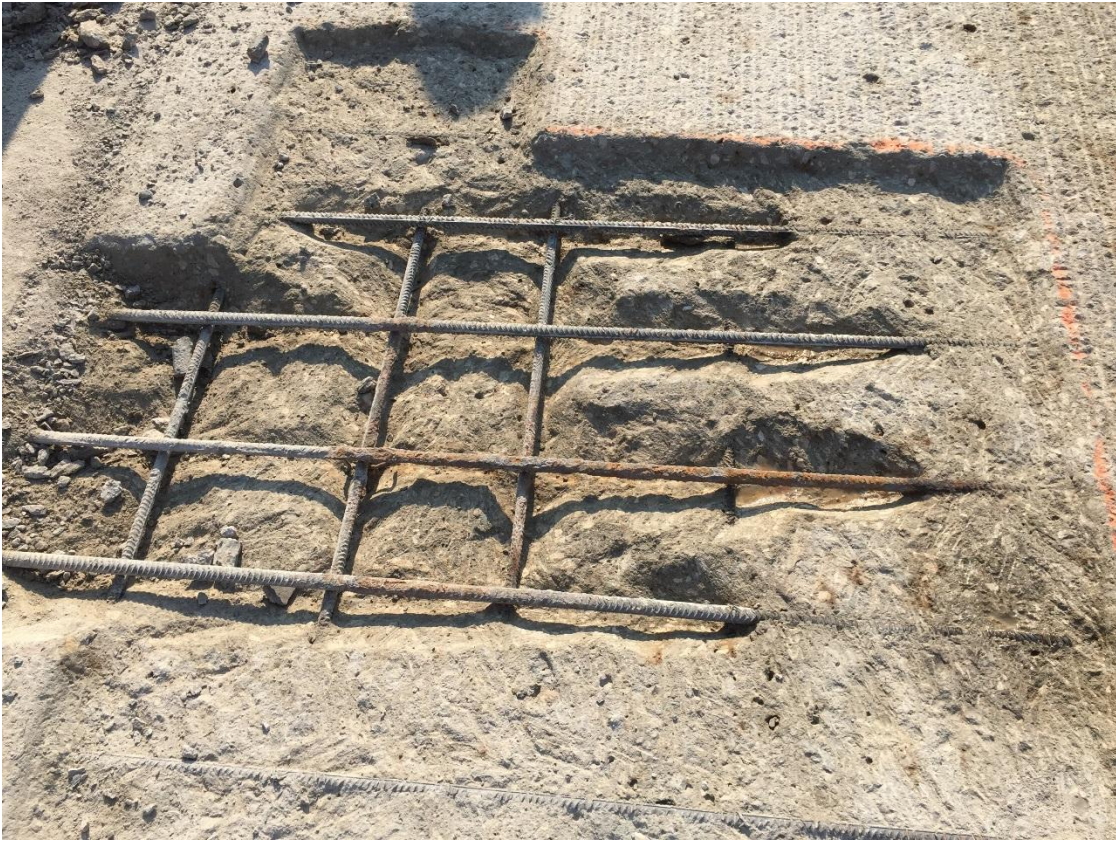
On the third day, the deck was inspected for areas where the entire reinforcing steel bar needed to be exposed. According to the contractor, about 30% of the time, the damaged concrete level is between half the diameter to the full diameter of the bar and the workers need to expose the entire reinforcing steel bar. This extra removal may take many hours to complete depending on how deep the deteriorated concrete is and over how much area it extends. In a best case scenario, it may have been possible for the entire third day of concrete removal to have been almost entirely avoided if the deteriorated concrete was just barely below the half diameter point. It seems fair to say that this additional removal may have taken 4 to 8 hours. Figure 44 shows a deteriorated area of deck concrete after removal of the substrate concrete.

**Figure 44. Deteriorated area of the deck after removal of the substrate concrete**

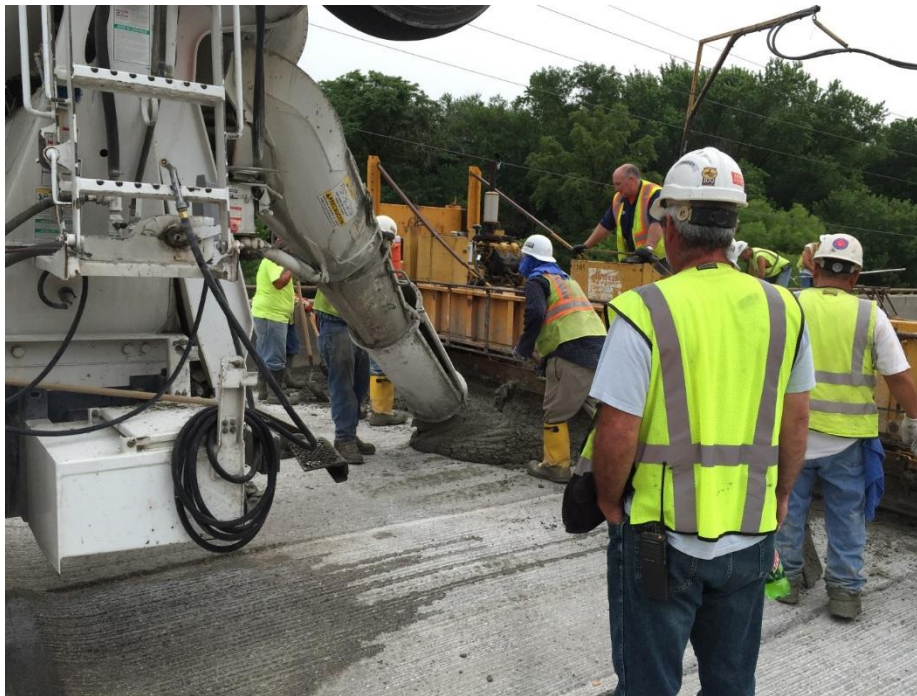
Followed by the preparation work, the ready-mixed concrete was placed on the deck as shown in Figure 45.

**Figure 45. Ready-mixed concrete being placed on the deck**

About 20 workers worked on the overlay placement at the same time. Many tasks were carried out by workers including watching over the overlay concrete for proper placement, operating the machinery, laying wet burlap for curing, moving the machinery and equipment, and scooping extra concrete from one place and dumping it to another place. The whole process took about four hours. The concrete was cured for three days before opening to traffic.

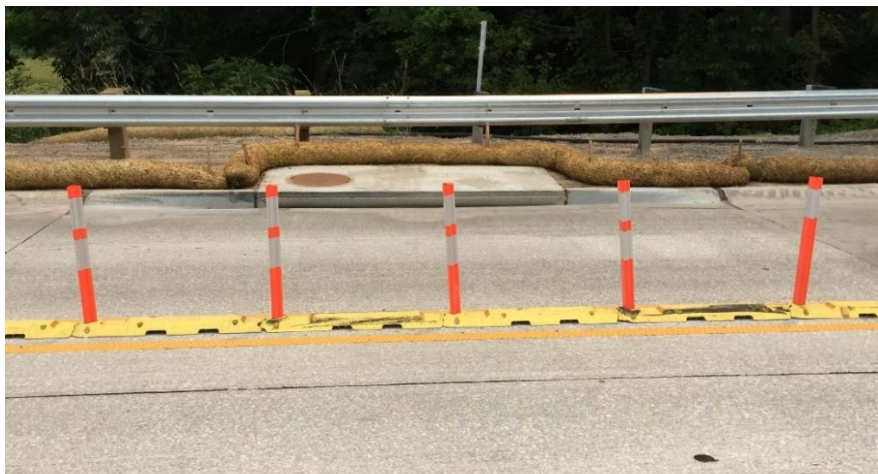
During overlay installation on the westbound lanes prior to the research team's observations on the eastbound lanes, a fiber optic cable was found near the bridge. In addition, the contractor found a manhole at the approach to the westbound lanes, which was not shown in the plans, as shown in Figure 46. Although the true impact of these observations on the project schedule are not known, the contractor, when asked, did mention this as an unexpected factor.

**Figure 46. Manhole discovered near the approach to the westbound lane**

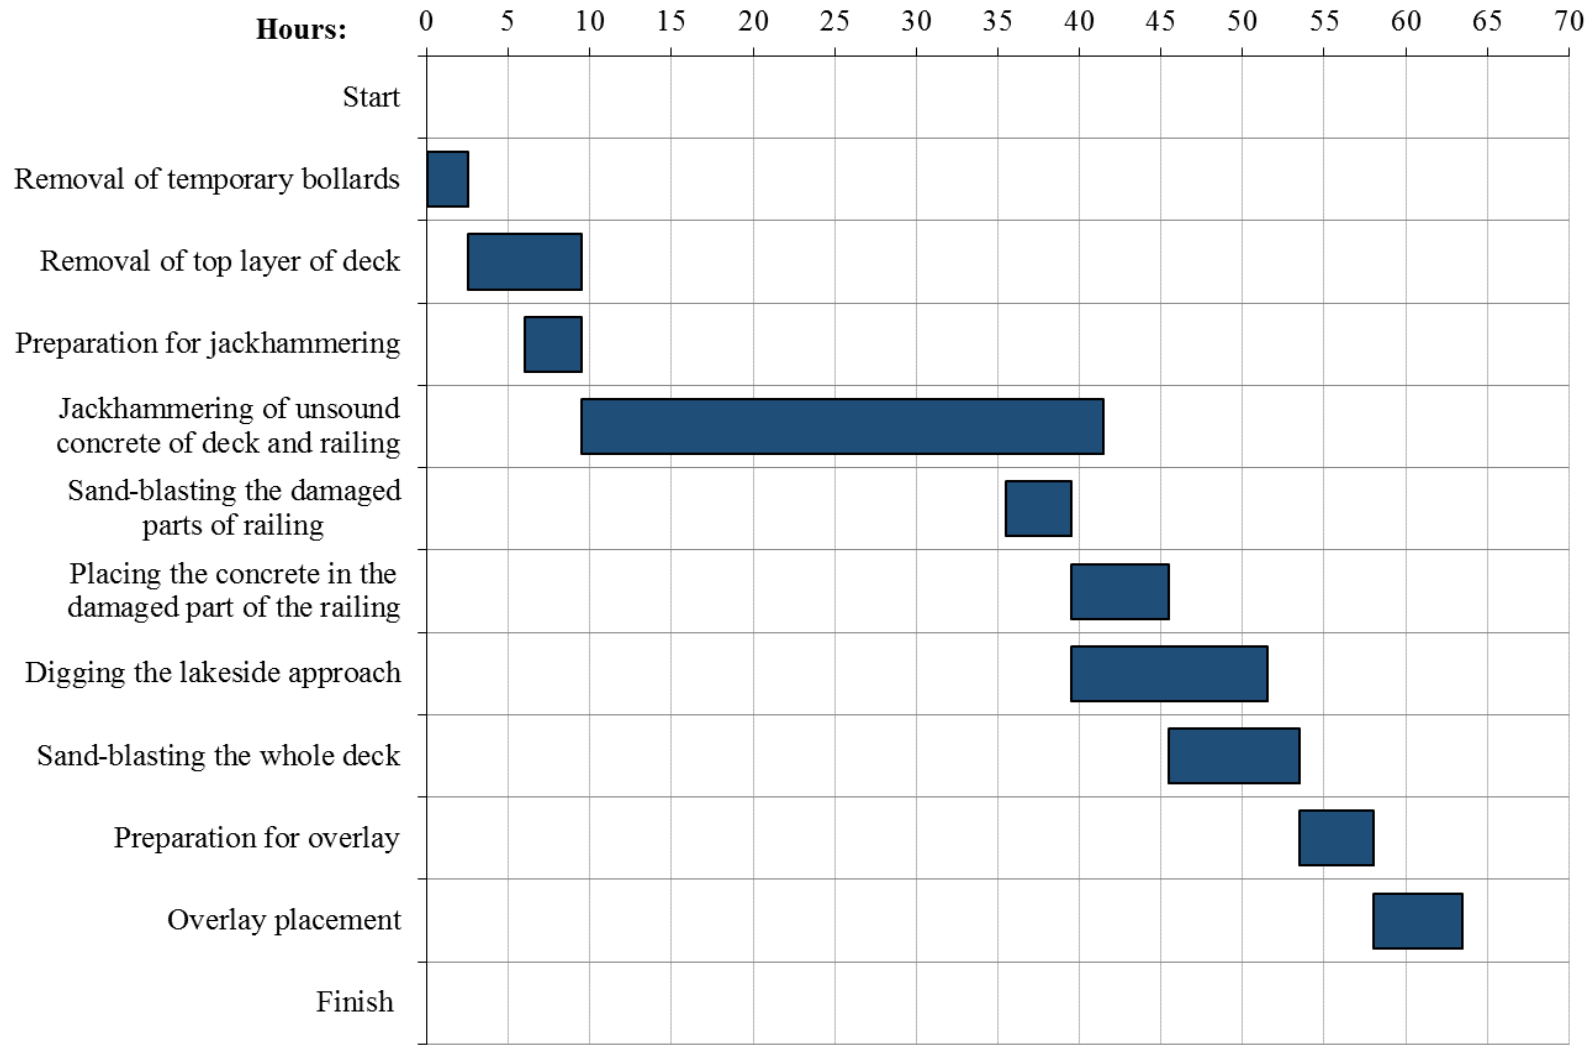
The contract proposal for the entire bridge deck overlay construction (eastbound and westbound lanes) shows a contract period of 40 working days. During this project, however, the research team only observed the overlay portion of the project, as the goal was to identify areas when traffic mobility was impacted. Collectively, the two most time-consuming operations were old concrete removal and overlay placement. If the rapid set alternatives briefly described in section 3.2 were shown to provide the durability, permeability, abrasion resistance, freeze-thaw resistance, etc. that is needed, and if the additional concrete removal below the one-half bar diameter requirement was eliminated, it seems possible that up to 77 hours of the estimated 136 could have been saved.

**Figure 47. Eastbound overlay construction schedule as observed**

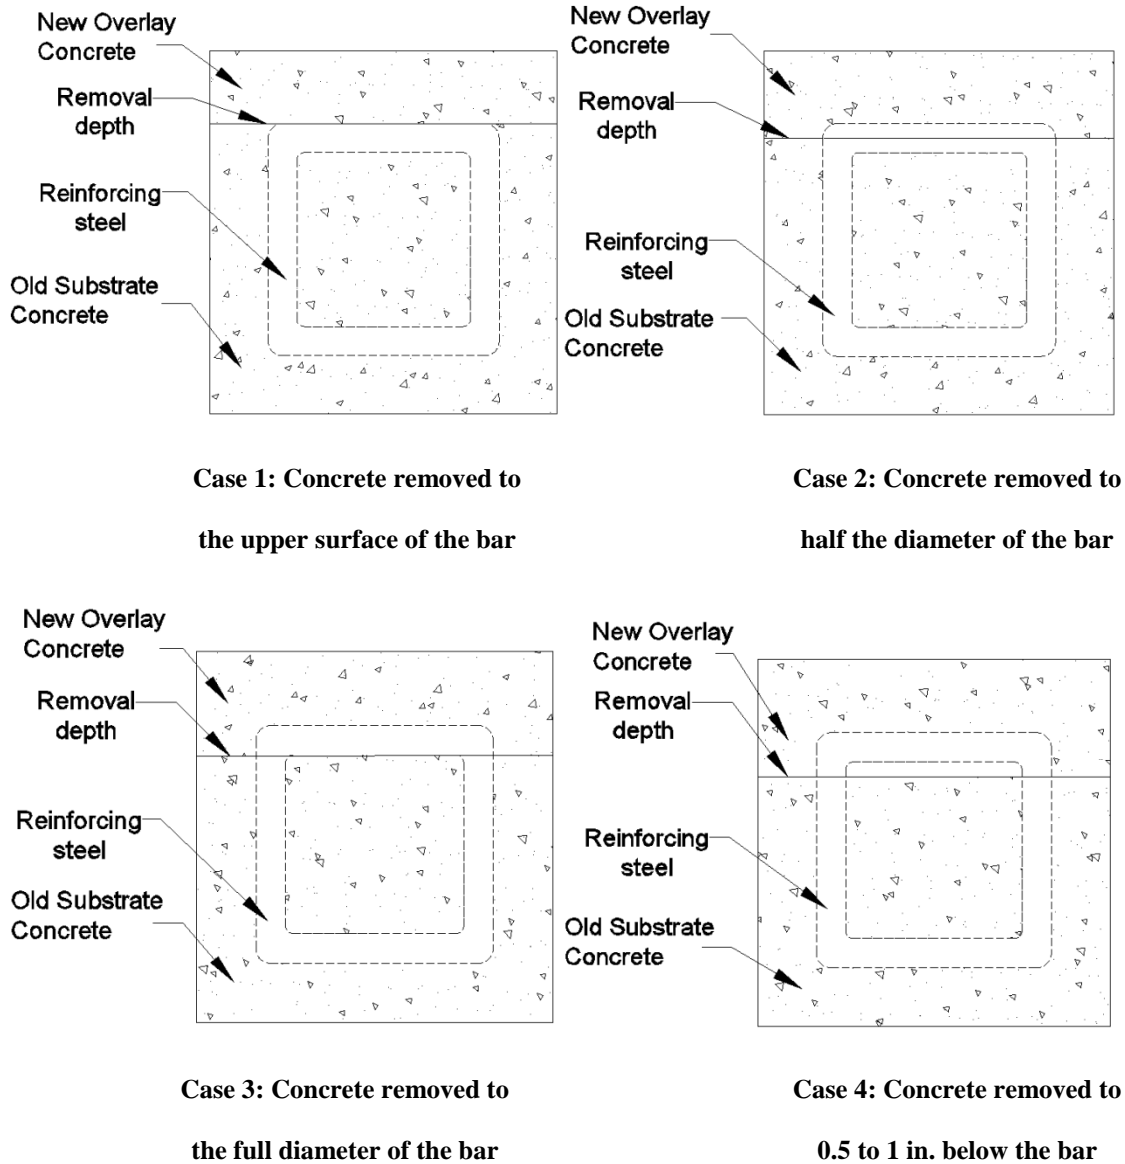
**Figure 48. Different depths of concrete removal considered**
