# Acceleration of bridge construction with prolonged service life

**Acceleration of bridge construction with prolonged service life**

A thesis submitted to the graduate faculty  
in partial fulfillment of the requirements for the degree of

Major: Civil Engineering (Structural Engineering)

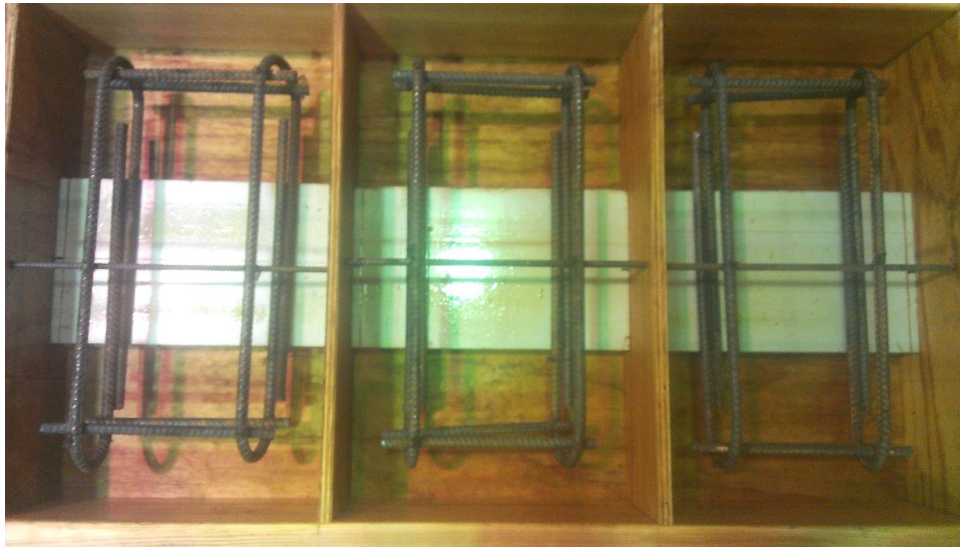
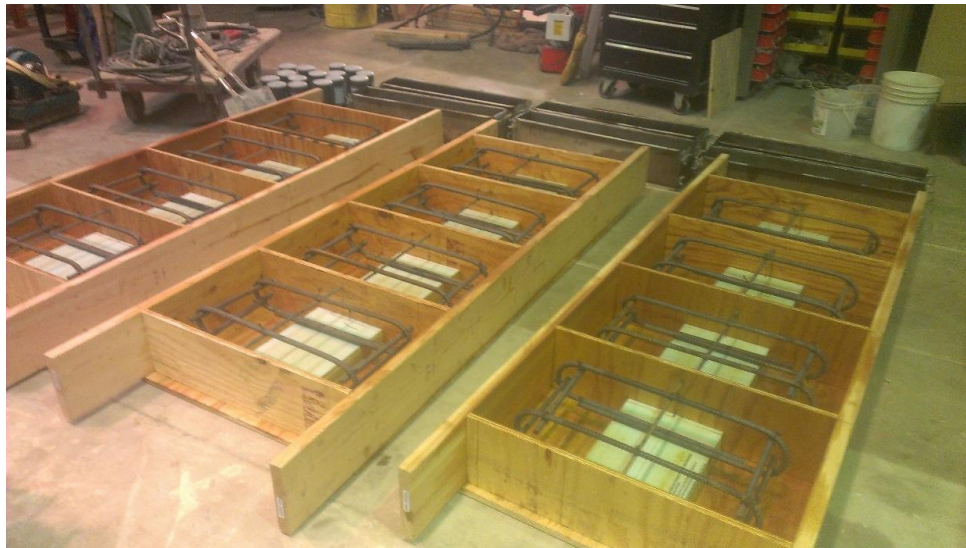
Wooden formwork (as shown in Figure 50) was fabricated for the construction of the pull-off test specimens. The shaded part in Figure 49 was to be filled by the new overlay concrete after the concrete being used for the substrate concrete had cured. To create the voids to be filled later, foam was used to fill the shaded parts until the substrate concrete hardened and the overlay concrete could be placed. To keep the foam stable, the formwork was built upside down and the reinforcing steel was placed on the foam. An extra reinforcing steel bar was used to keep the main reinforcing steel stable horizontally. The reinforcement arrangement can be seen in Figure 50.

**Figure 50. Pull-off test formwork for substrate concrete placement**

C4 concrete was placed into the formwork and the specimens were vibrated appropriately. The specimens were covered with plastic and wetted periodically to maintain the moisture level inside. After curing the specimens for three days, the foam and formwork were removed. The depth of the foam was only up to the face of the reinforcing steel (i.e., 2.5 in.) deep. To achieve the different depth conditions, the portions where foam was used were chipped below the face of the bar and the exposed C4 concrete was then roughened using a jackhammer (Case 1 specimens only needed to have the C4 concrete roughened).

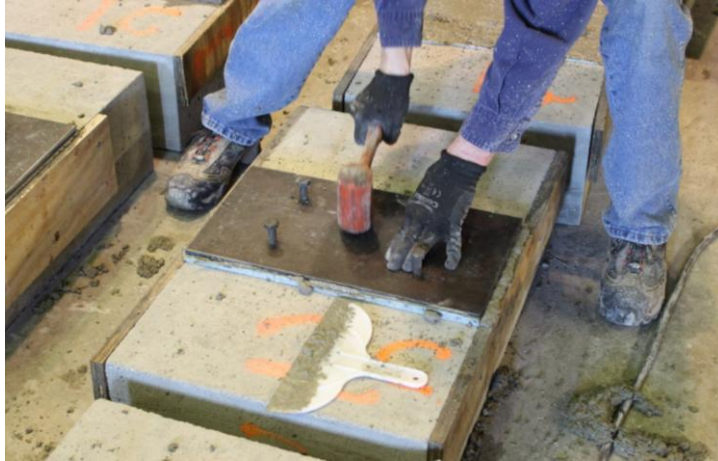
To bond the new overlay concrete to the previously placed concrete, a grout consisting of a mixture of about 5 to 6 gallons of water to each 94 lb bag of cement (12.5 to 13.8 in<sup>3</sup> of water per lb of cement) was used. The grout material was applied to the chipped portion using a stiff hand brush, just prior to placing of the overlay concrete. As soon as the grout was applied, the overlay concrete was placed so that the applied grout would still be wet when the concrete was placed. After the concrete was placed, the steel plate studs were embedded in it by firmly tapping the plate using a rubber hammer as shown in Figure 53.

**Figure 53. Tapping the steel plate to embed the shear studs on a pull-off test specimen**

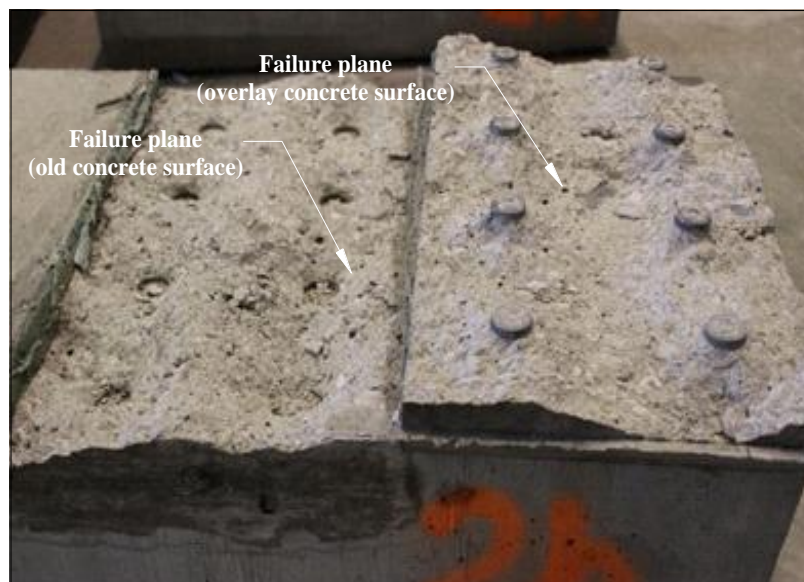
Figure 58 shows the failure of the specimen in the overlay concrete at the heads of the shear studs and the surface at which the break in the bond was observed.

**Figure 58. Case 2 pull-off test specimen failure in concrete overlay**

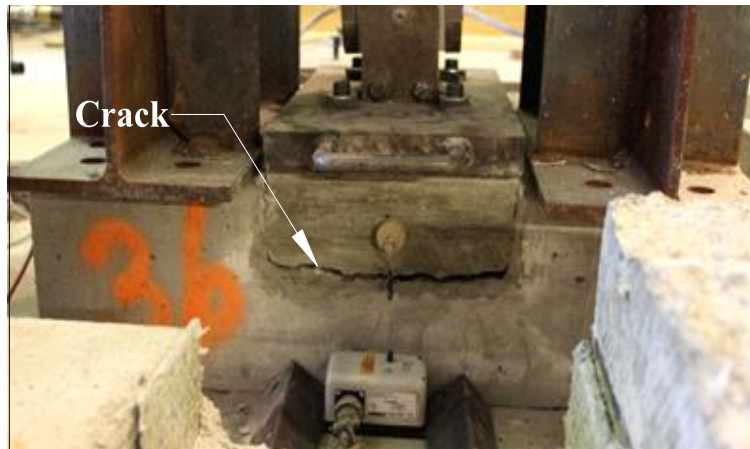
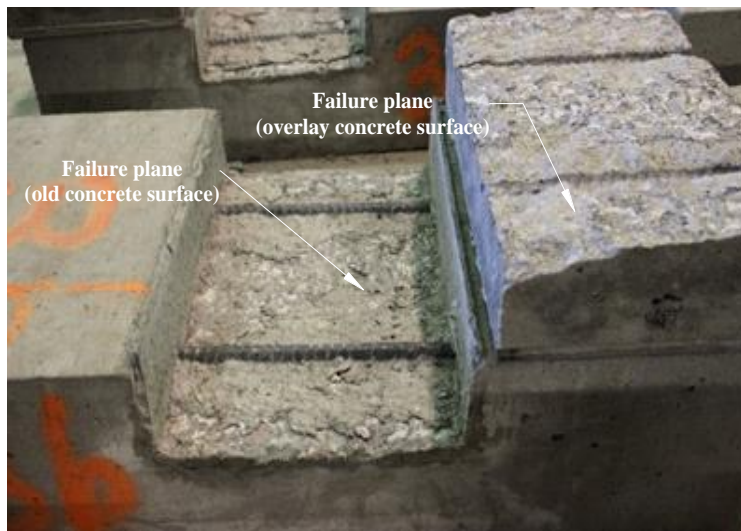
All of the specimens in this case failed at the interface level as shown in the Figure 59.

The figure shows the pattern of the crack and the interface surface.

**Figure 59. Case 3 pull-off test specimen failure at concrete bond interface**

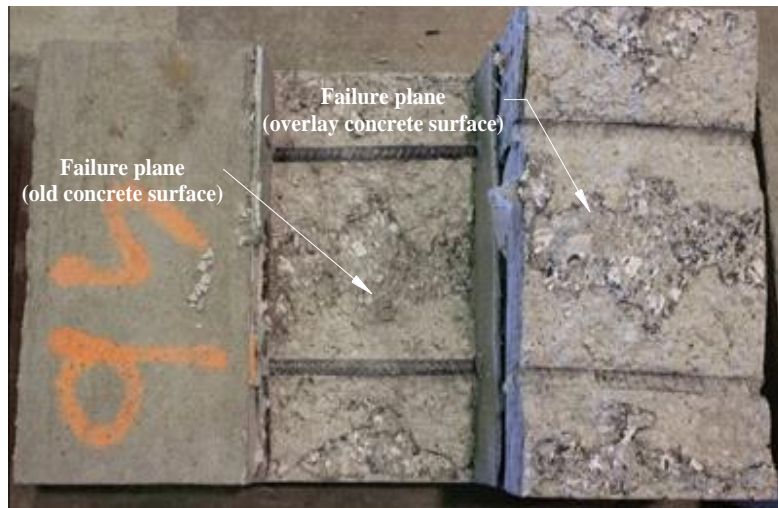
In this case, two of the specimens failed in the overlay and one specimen failed at the interface. Figure 60 shows the failure of the specimen at the interface of the substrate concrete and new overlay concrete.

**Figure 60. Case 4 pull-off test specimen failure at concrete bond interface**

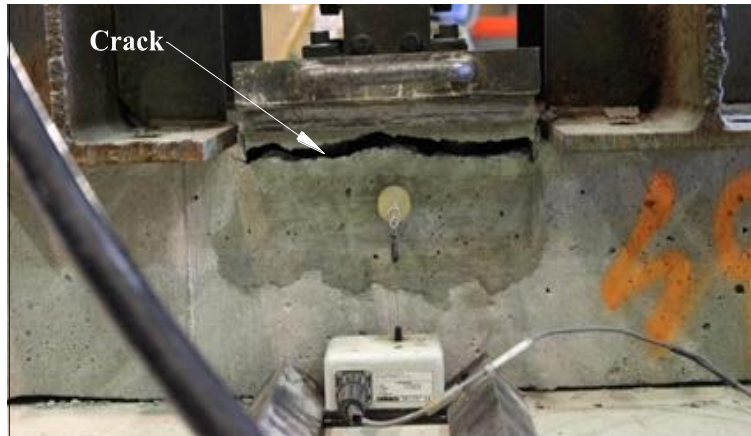
Figure 61 shows a side view of the failure of the specimen in the overlay concrete at the heads of the shear studs and a top view of the interface surface after the failure.

**Figure 61. Case 4 pull-off test specimen failure in concrete overlay**

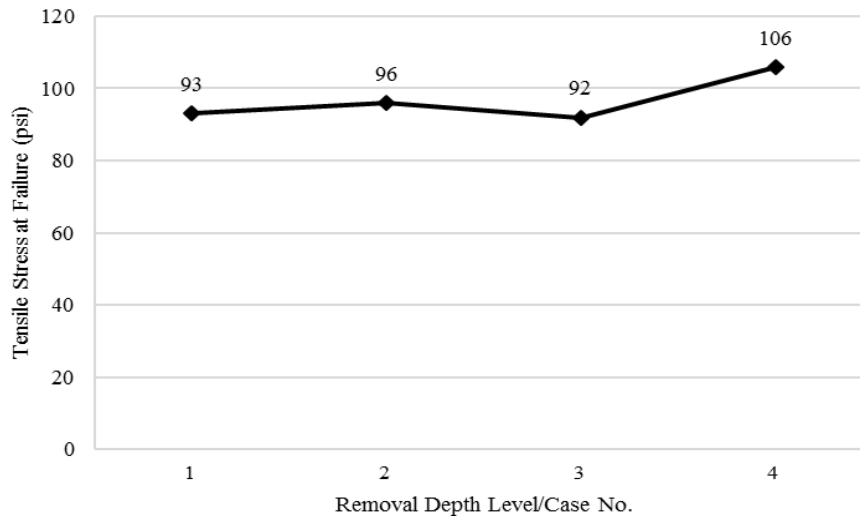
**Figure 63. Average tensile stress at failure versus concrete removal depth (pull-off test)**

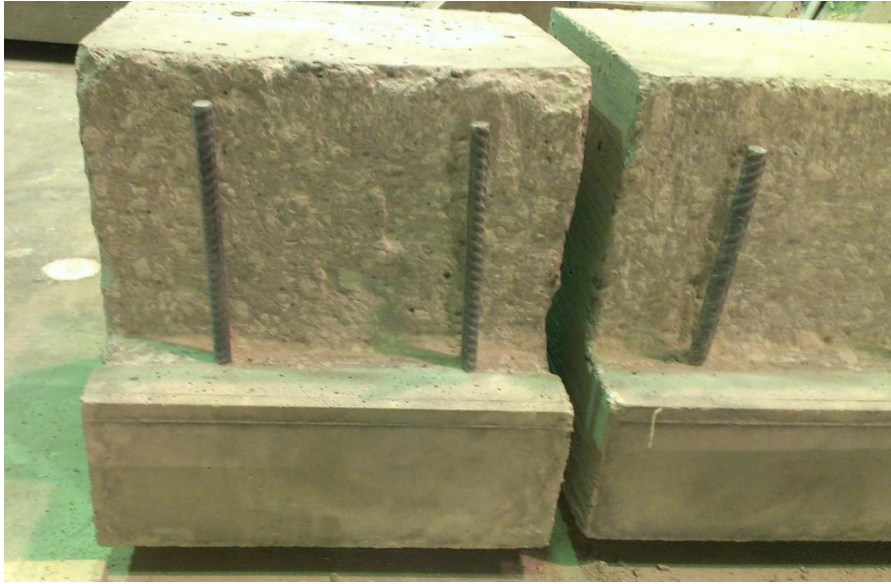
**Figure 67. Pair of push-out test sub-specimens after concrete removal (Case 4)**

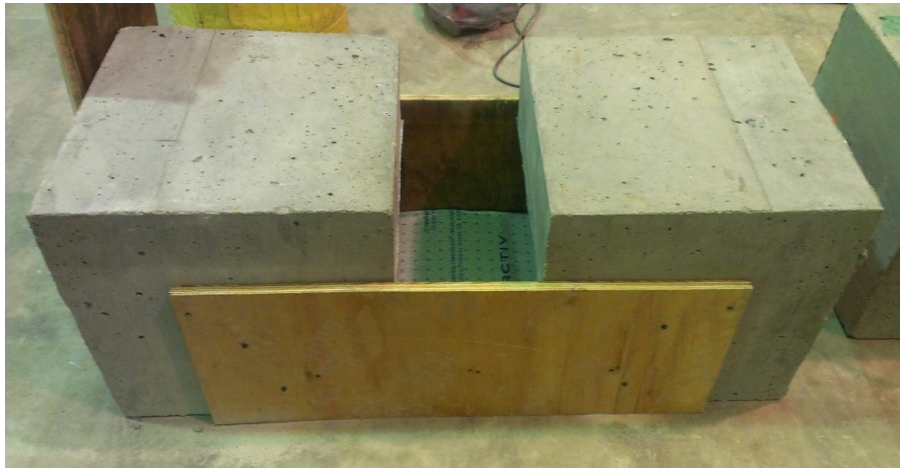
Note that a small (0.25 in.) gap was needed between the substrate concrete and the top of the overlay concrete (as shown in the schematic in Figure 64) to eliminate any tensile bond between the substrate concrete and the top of the overlay concrete. To create this gap, 0.25 in. thick foam was glued to the substrate concrete. Wooden forms were attached to the sides of each pair of sub-specimens as shown in Figure 68 to create the space for the placement of the overlay concrete.

**Figure 68. Push-out test formwork for overlay concrete placement**

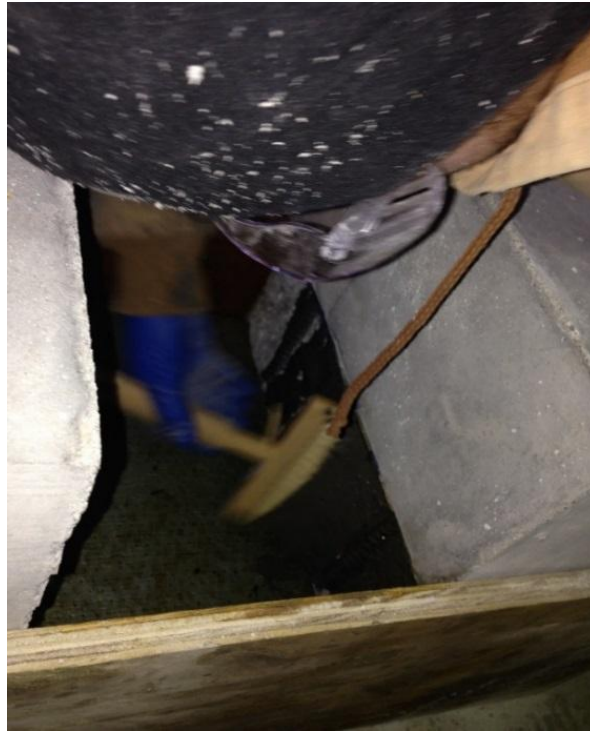
To fill the 1 in. gap below the overlay concrete, a 0.75 in. thick sheet of plywood coupled with 0.25 in. thick foam was used. To bond the overlay concrete to the previously placed substrate concrete, a grout consisting of a mixture of about 5 to 6 gallons of water to each 94 lb bag of cement (12.5 to 13.8 in<sup>3</sup> of water per lb of cement) was used. The grout material was

applied to the roughened concrete using a stiff hand brush just prior to placement the overlay concrete as shown in Figure 69.

**Figure 69. Application of grout for push-out test specimen**

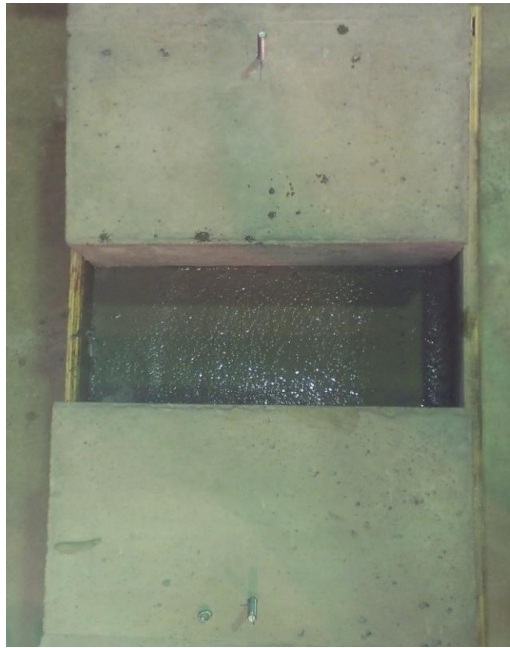
The overlay concrete was placed until it touched the bottom of the foam, which was used to break the bond between the substrate concrete and the top of the overlay concrete on each specimen. The overlay concrete was vibrated and wet-cured on the top exposed surface. Figure 70 shows a specimen after placement of the overlay concrete.

**Figure 70. Push-out test specimen after overlay concrete placement**

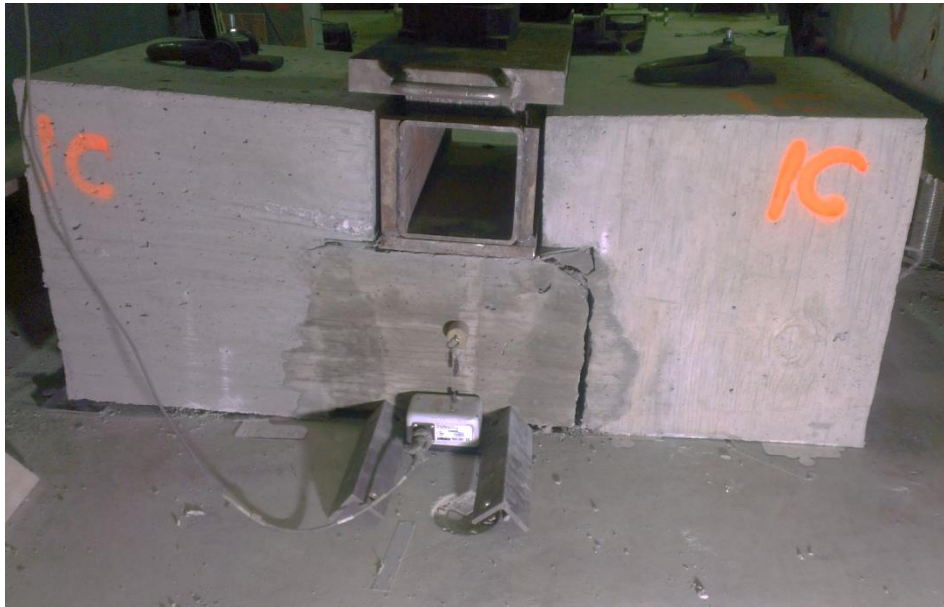
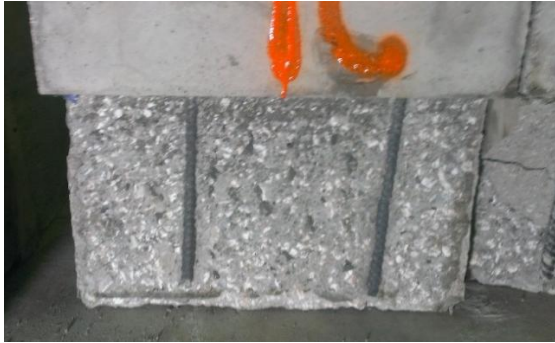
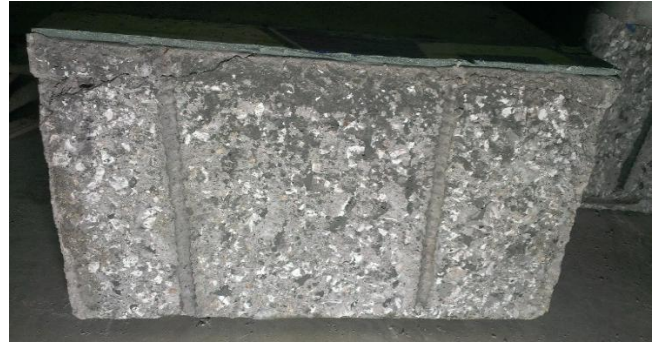
During application of the loads, sudden failures (a large drop in load and separation of one of the bonds) were observed. Figure 72(a) shows a failure surface with a crack and Figure 72(b) and (c) show an interface surface between the substrate concrete and the overlay concrete after failure.

**Figure 72. Case 1 push-out test specimen failure at concrete bond interface**

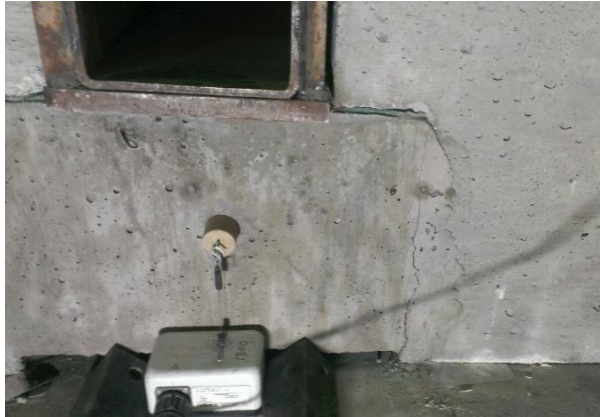
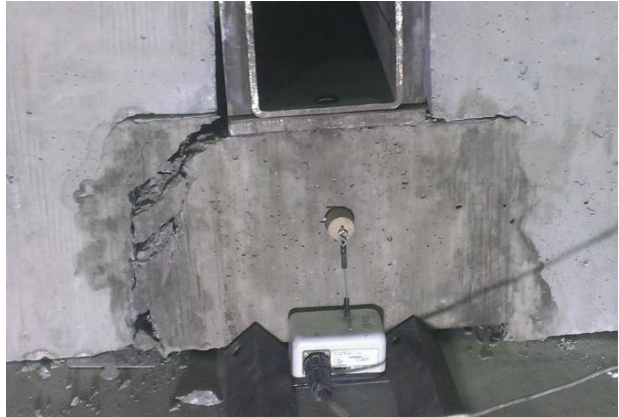
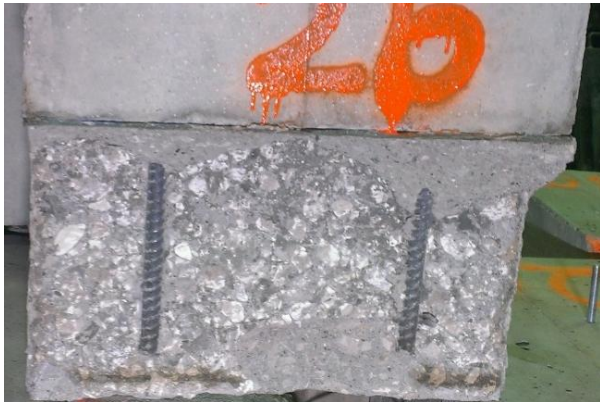
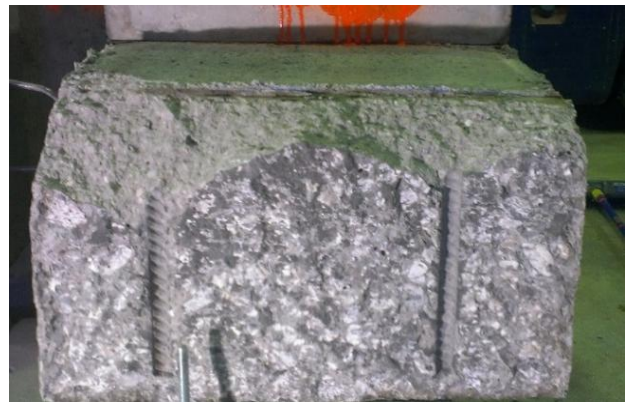
The overlay concrete for Case 2 specimens was exposed to half the diameter of the reinforcing steel. After the first cracks were observed, as shown in Figure 73(a), the specimens had not completely failed.

The overlay concrete after the initial crack development was still bonded to the reinforcing steel. After further load application, a final break of the bond took place. Total separation of a bond and two interface surfaces after the separation are shown in Figure 73(b), (c), and (d).

**Figure 73. Case 2 push-out test specimen failure at concrete bond interface**

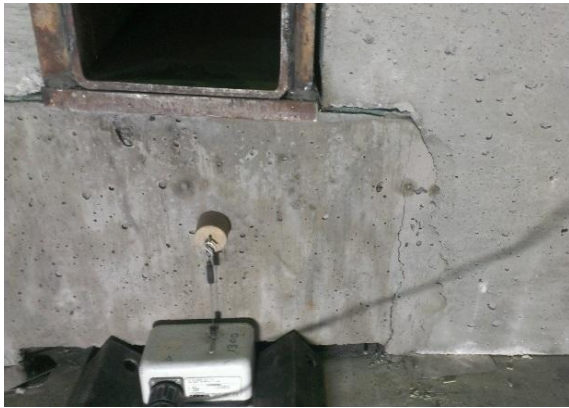
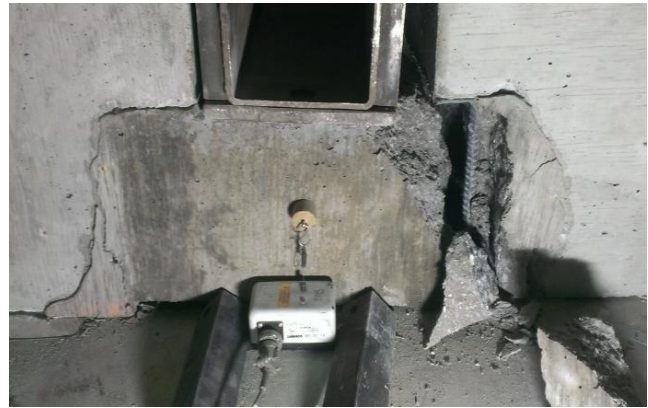
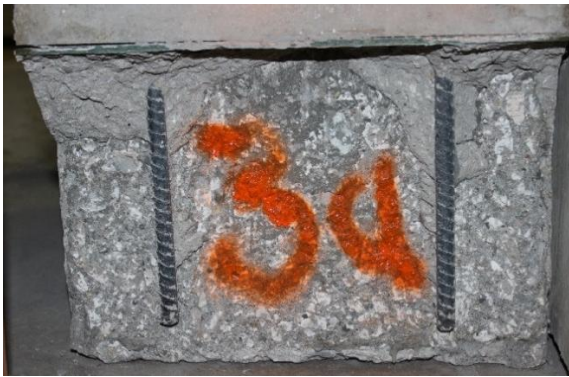
Failures similar to Case 2 were observed for Case 3 specimens; but, due to the additional exposure of the reinforcing steel to the concrete, the bonds were stronger between the concrete and the reinforcing steel, withstanding a greater load after crack initiation. Figure 74 shows the failure of a specimen.

**Figure 74. Case 3 push-out test specimen failure at concrete bond interface**

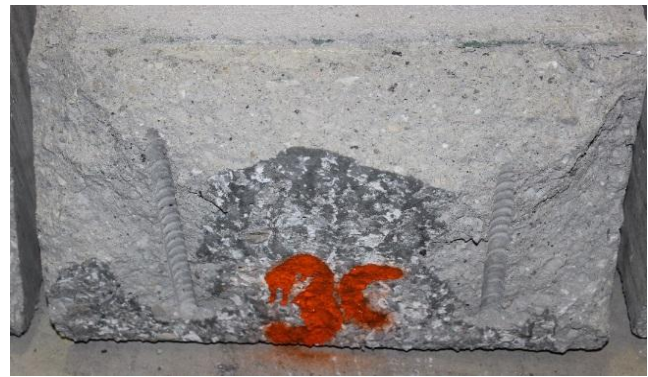
**d) Bond interface (overlay concrete)**

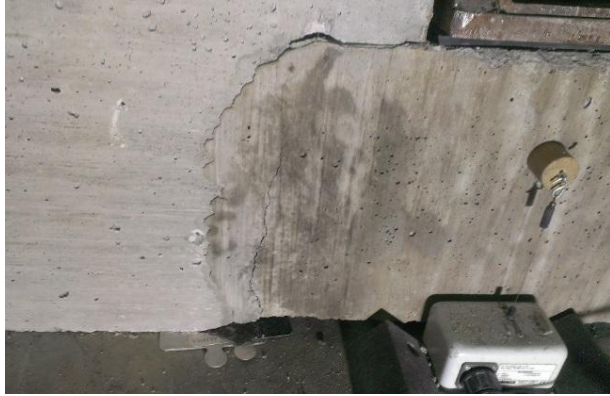
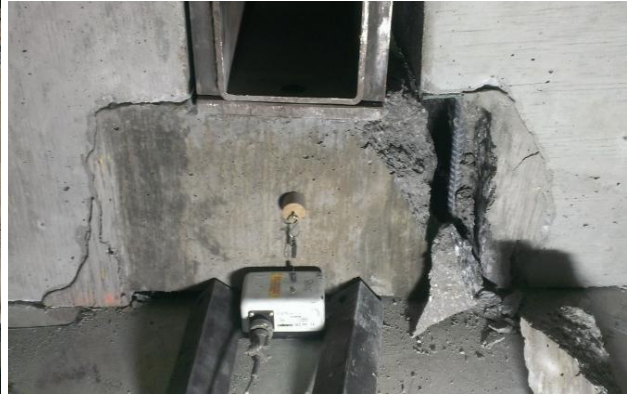
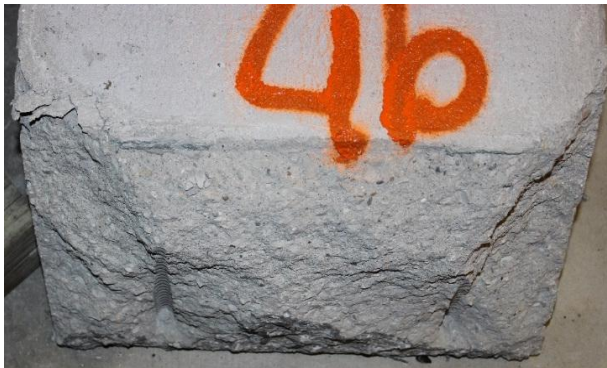
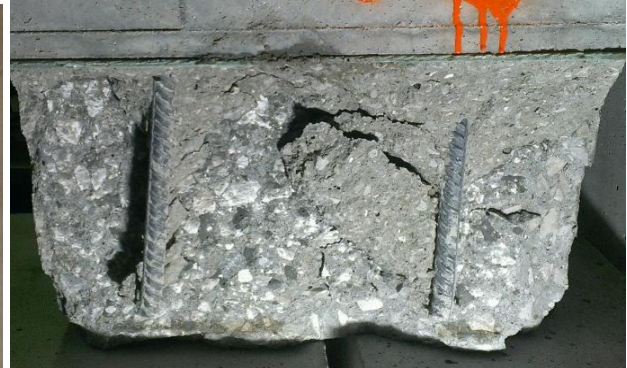
**Figure 75. Case 4 push-out test specimen failure at concrete bond interface**

The loads for total separation of a bond were greatest for Case 4 specimens. Figure 75 shows a crack and total separation at a bond interface.

a) Propagation of crack

b) Separation at interface

c) Bond interface (substrate concrete)

d) Bond interface (overlay concrete)

Perhaps not surprising, the concrete bonded to more of the reinforcing steel on these specimens, as shown in Figure 75(d).

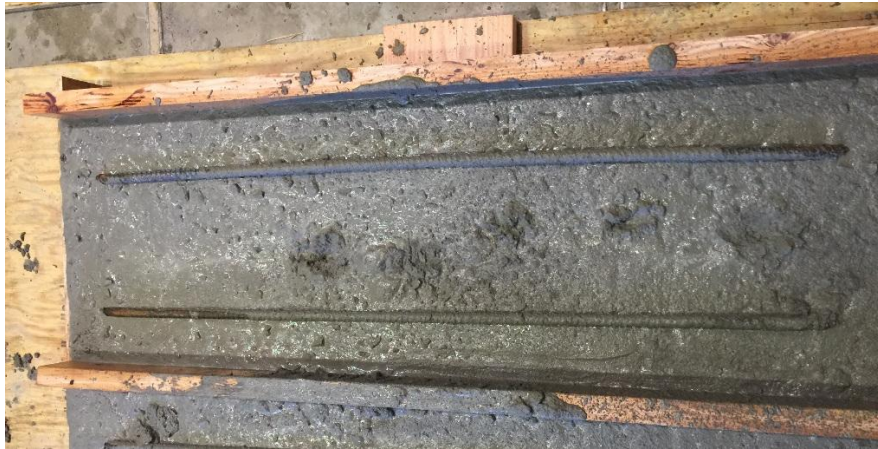
**Figure 82. Positive bending flexural test specimen after substrate concrete placement (Case 4)**

The substrate concrete was placed 0.5 in. above the required concrete removal depth level of each specimen so that a 0.5 in. of concrete could be chipped using a jackhammer to give it a proper roughened finish. Figure 82 shows a Case 4 specimen with the substrate concrete placed up to the bottom of the top reinforcing steel bars (i.e., 0.5 in. extra on top of the concrete removal depth level for Case 4).

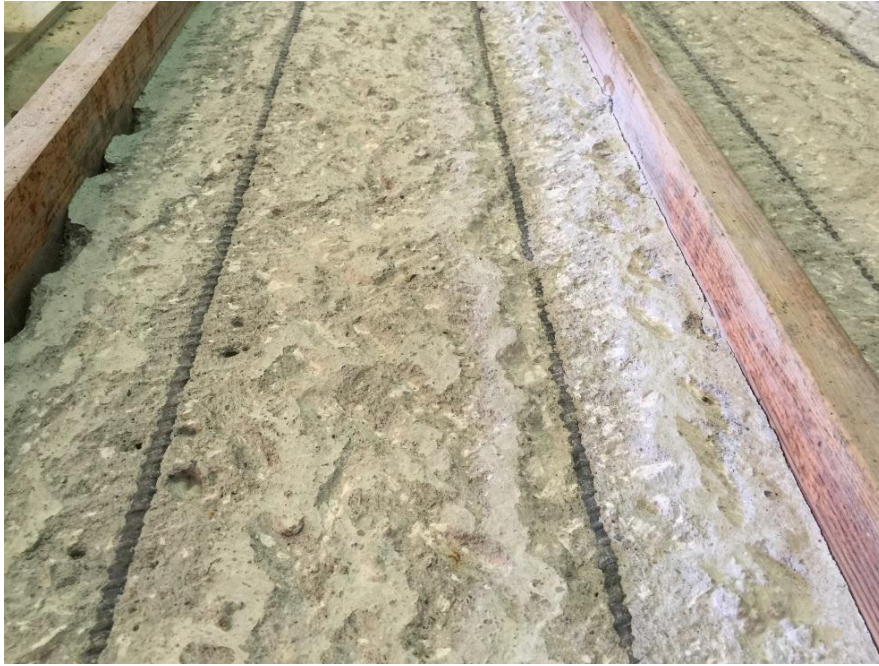
**Figure 83. Positive bending flexural test specimen after roughening of substrate concrete (Case 1)**

This concrete was then cured with regular water application and covered with plastic. After two days of curing, the plastic cover was removed and the chipping process was started. Figure 83 shows the typical roughness of a substrate surface.

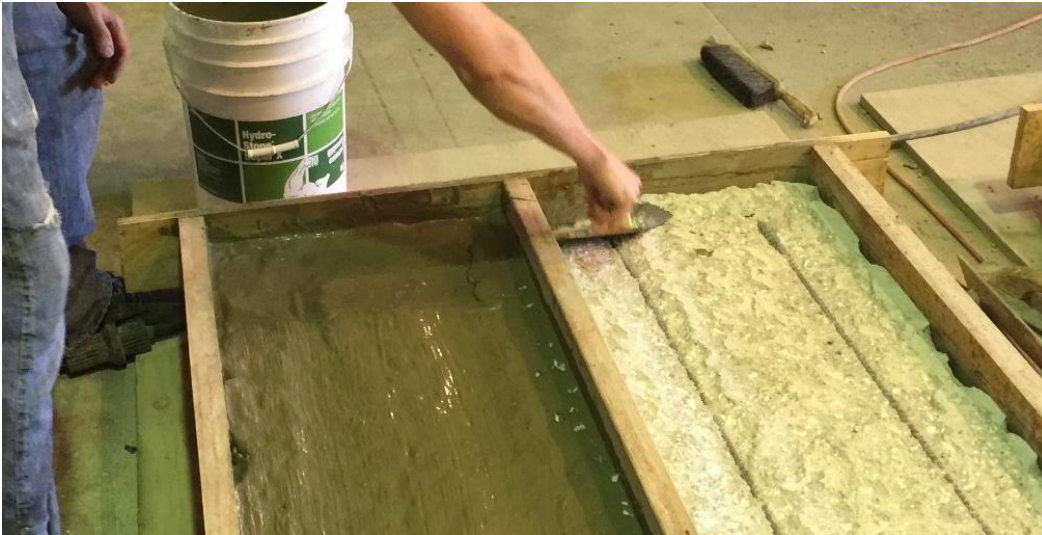
**Figure 84. Application of grout to positive bending flexural test specimen (Case 1)**

After curing the substrate concrete for 28 days, the specimens were prepared for the overlay concrete layer. The grout material as described in the previous tests was applied on the roughened surface with a brush as shown in Figure 84.

Immediately after applying the grout, the HPC-O mix overlay concrete was placed on top to create a 8.5 in. total specimen depth. After overlay placement, the specimens were covered with plastic to maintain the moisture level. These specimens were cured for three days.

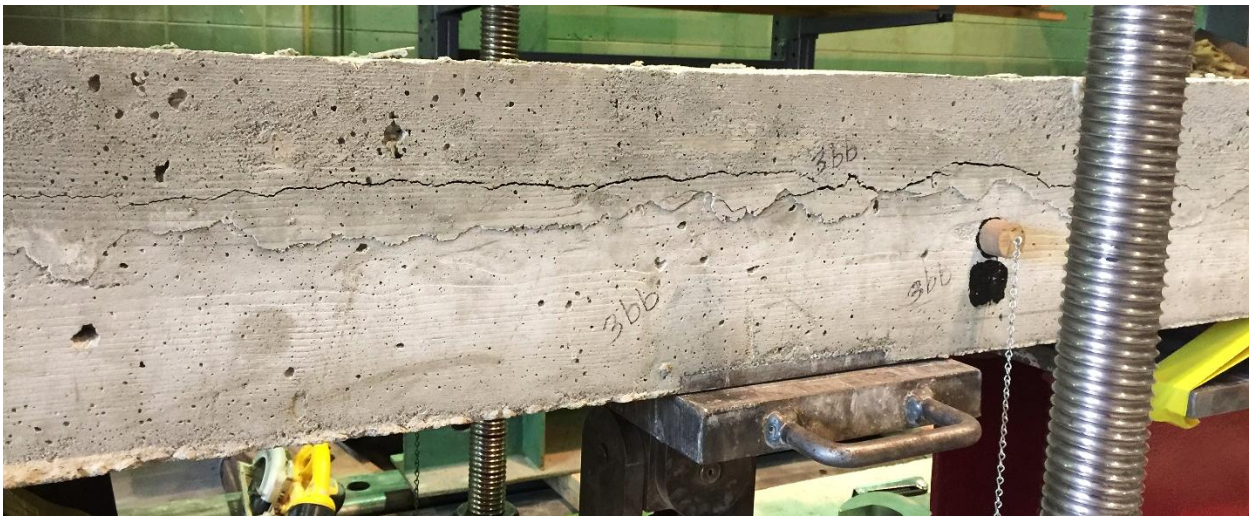
**Figure 88. Case 3 positive bending flexural test specimen failure at concrete bond interface**

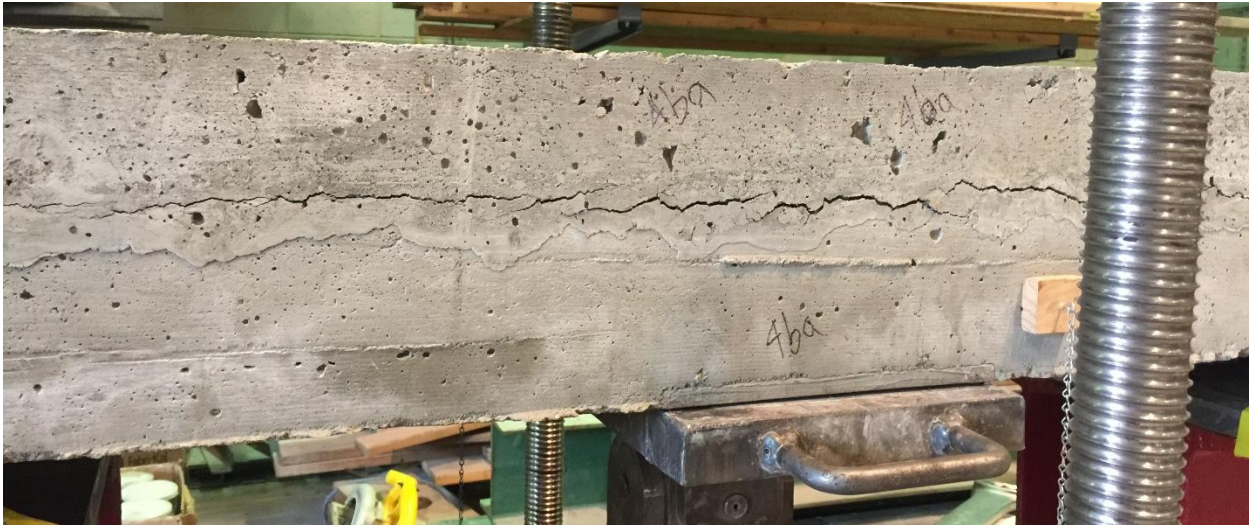
**Figure 89. Case 4 positive bending flexural test specimen failure at concrete bond interface**

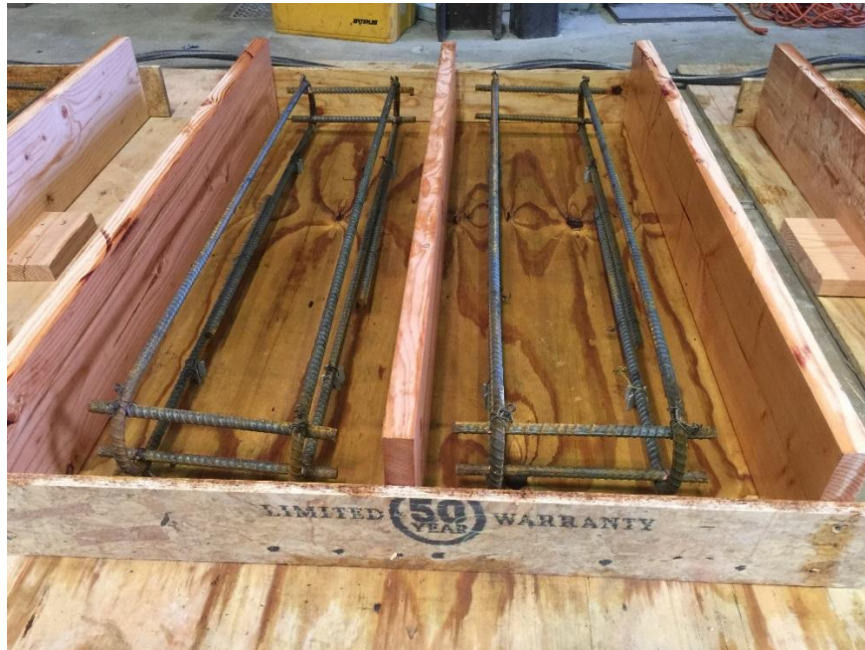
**Figure 94. Negative bending flexural test formwork for substrate concrete placement**

Figure 94 shows the formwork for the specimens.

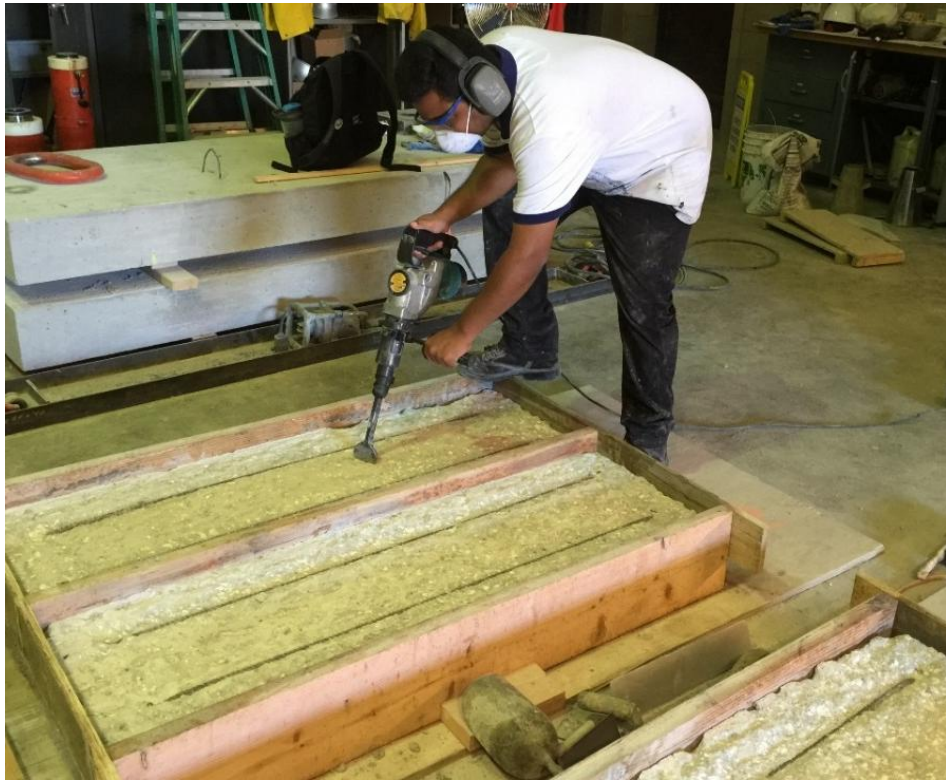
**Figure 95. Chipping of substrate concrete for negative bending flexural tests**

The substrate concrete was placed into the formwork first. As with the other tests, C4 concrete was used. After curing the concrete for about two days, the concrete was removed by chipping it to its required depth with an electric demolition jackhammer, as shown in Figure 95, also giving the surfaces the proper roughness.

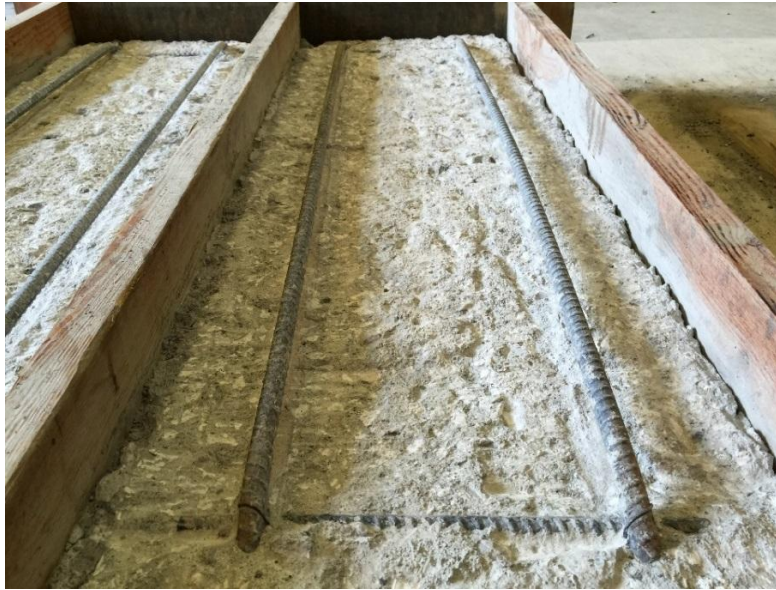
**Figure 96. Negative bending flexural test specimen after concrete removal to required depth (Case 3)**

The typical roughness of the surface after chipping and roughening is shown in Figure 96.

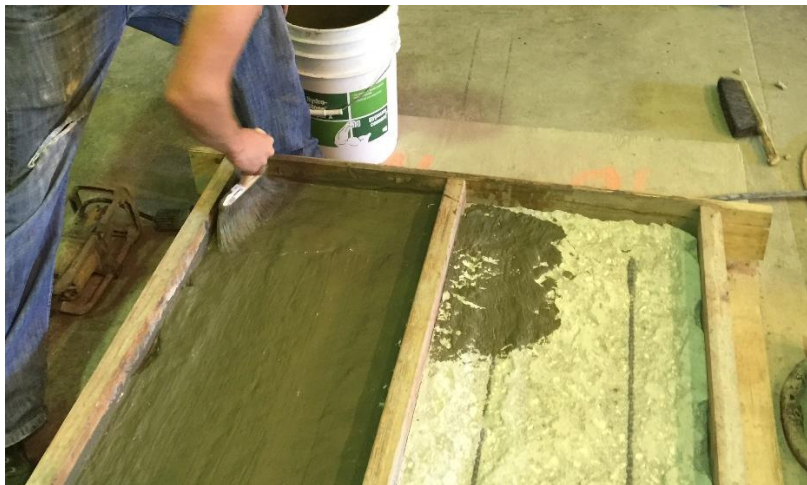
**Figure 97. Application of grout to negative bending flexural test specimen**

As described for the other tests, the same grout material was applied with a brush to the surface of the substrate concrete, as shown in Figure 97, before placement of the overlay concrete.

The overlay concrete was placed on the substrate concrete up to the total depth of the specimen.

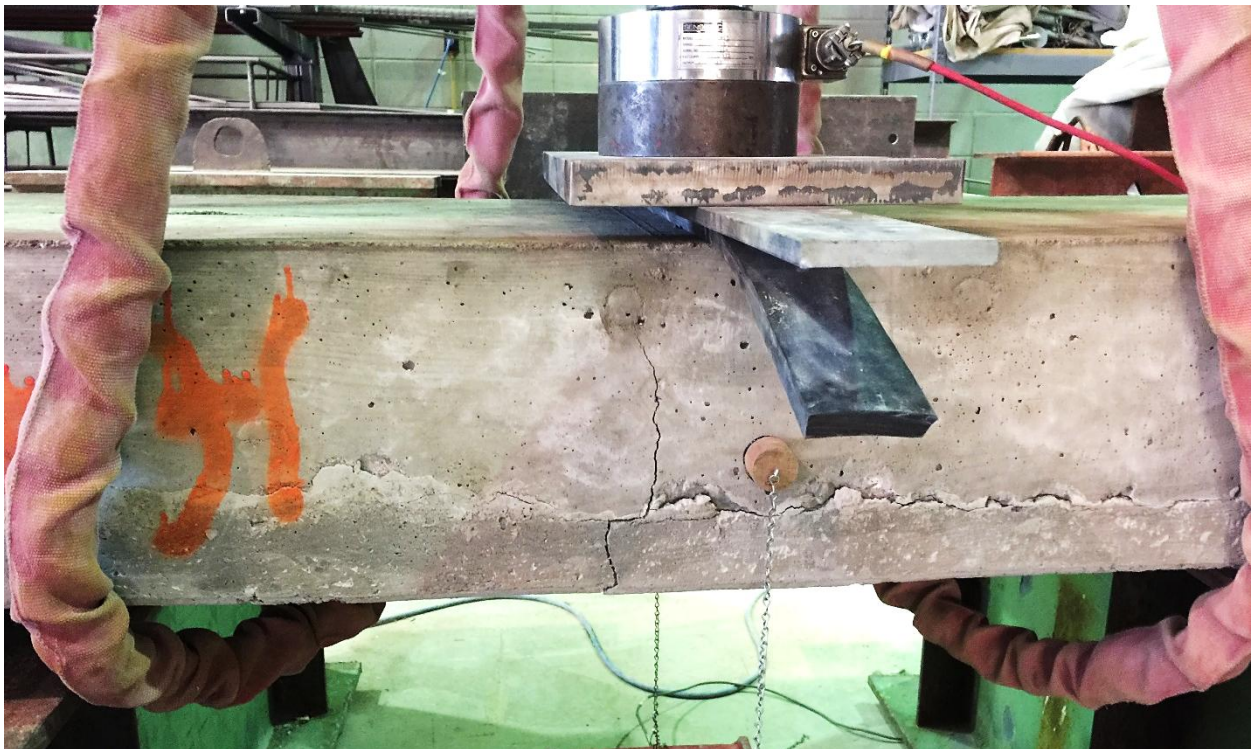
**Figure 99. Case 1 negative bending flexural test specimen failure at concrete bond interface**

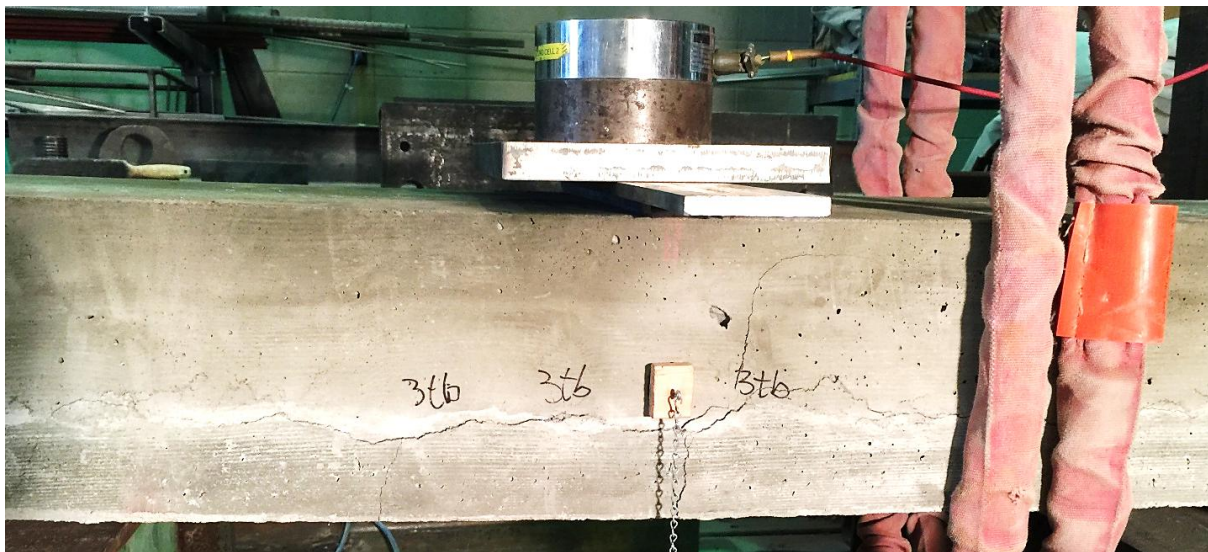
**Figure 101. Case 3 negative bending flexural test specimen failure at concrete bond interface**
