Modeling Corrosion Damage and Repair to a 3<sup>rd</sup> Scale Concrete Bridge Bent

A thesis submitted in partial fulfillment  
of the requirements for the degree of  
Master of Science in Civil Engineering  
Department of Civil and Environmental Engineering  
College of Engineering  
University of South Florida

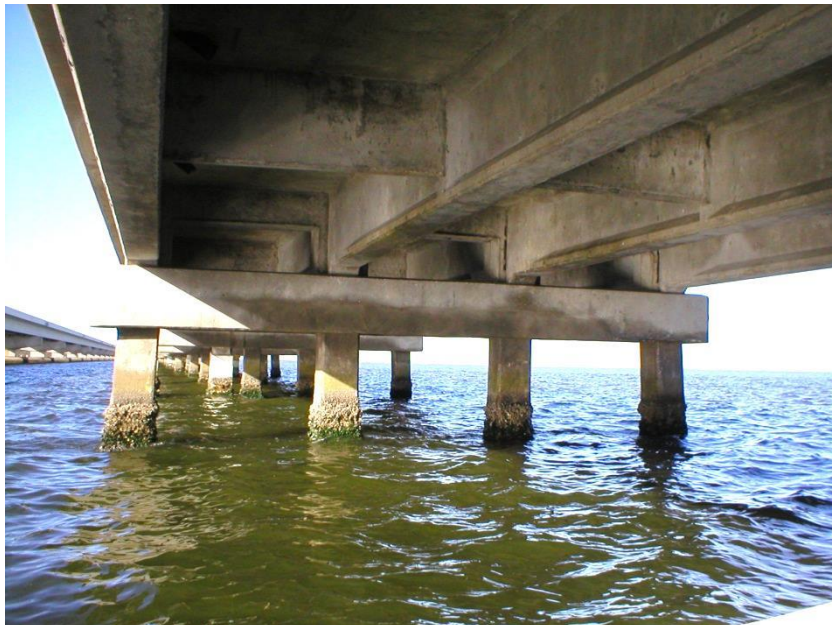
Figure 1.1 Pile bent from 1950s era Gandy Bridge, Tampa Bay, Florida.

Many of today's aging overwater bridges were built using pile bents to form the pier foundation support. Figure 1.1 shows a pile bent which is a group of piles (usually driven piles) with a pile cap that also serves as the support for the beams that span from pier to pier. Until the late 1970s and 80s, pile bents were the pier type of choice for lower level bridges due to economy. For higher portions of the bridge that might need to provide vessel clearance, the pile bent configuration becomes too tall and slender to provide the required stability and were often exchanged for a cap and column configuration (Figure 1.2) which is more economical and effective in those situations. Note in Figure 1.2 a water level pile cap (footing) is formed around a group of piles and a larger stronger column then extends up to the base of the bridge.

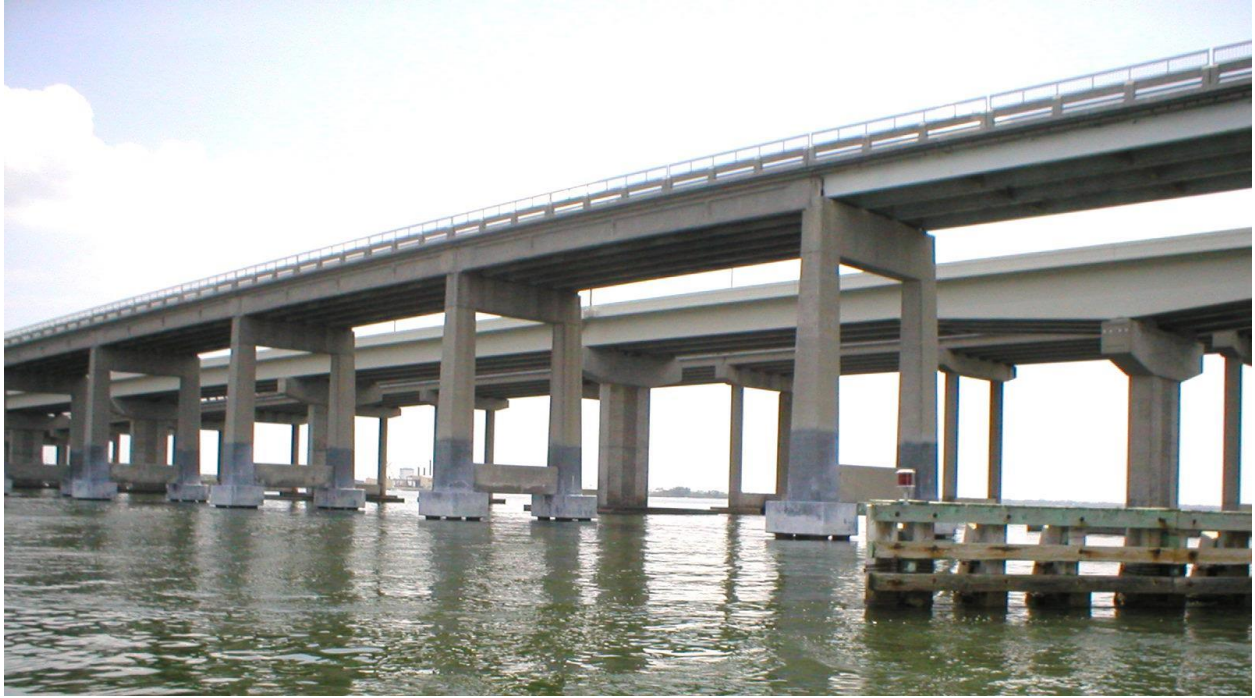
Figure 1.2 Cap and column configuration - Gandy Bridge adjacent to the navigation channel.

In later years, cap and column designs with far more piles per footing became more common for all over water bridges with large vessel traffic so that all piles could contribute more effectively in resisting lateral forces associated with vessel collisions. However, pile bents still support a significant portion of intra-coastal waterway crossing bridges over corrosive marine environments.

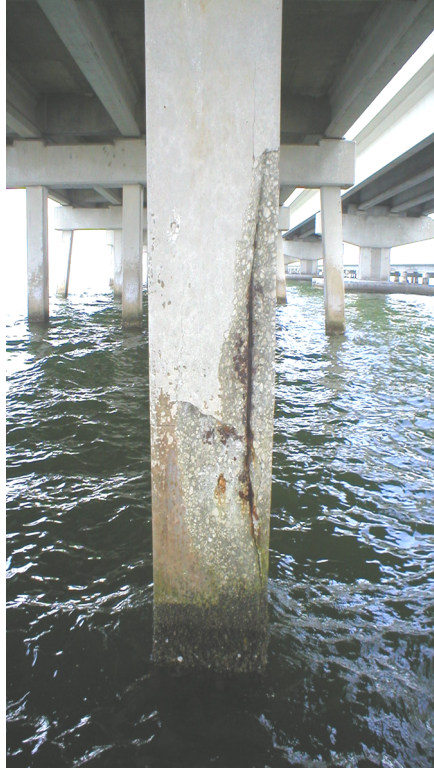
Figure 1.3 Corroding steel in one bent pile in east bound Gandy Bridge (built circa 1970).

Aside from the pile driving stresses associated with first installation of the piles, the highest stresses experienced by piles in bents stem from lateral forces from hurricane force winds or vessel collisions. Corrosion of the reinforcing steel in piles results in drastic reductions in bending resistance due to loss of concrete and steel section (Figure 1.3).

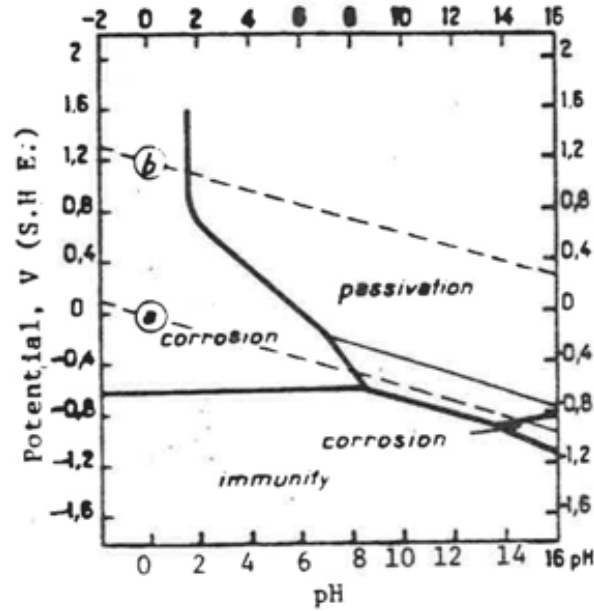
Figure 2.1 Pourbaix diagram for iron (ACI 222R-89).

Upon meeting the critical threshold required for steel to de-passivate, Iron-oxide reaction products form on the steel surface and volumetrically occupy several times the volume of iron steel unsubverted by corrosion. Pourbaix diagrams for iron illustrate regions where iron in concrete is actively corroding, immune to corrosion or is in a passive state, with respect to pH and voltage potential (ACI 222R-3). The Pourbaix diagram for iron is illustration in Figure 2.1.

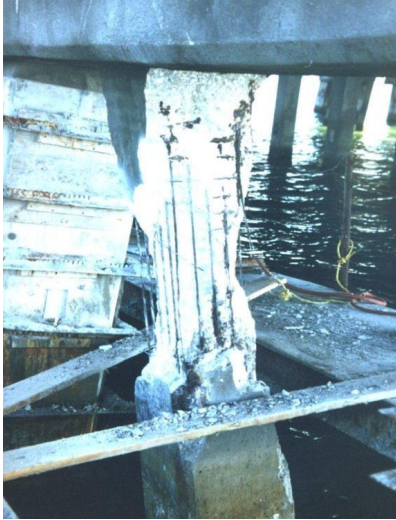
Figure 2.2 Pre-repair removal of chloride contaminated concrete.

Commonly suggested repair practices involve the removal and replacement of all chloride contaminated concrete with uncontaminated concrete before the application of a repair material. This is often accompanied by sacrificial anodes used to administer cathodic protection to a corrosion damaged structural system. Even with excellent project execution considered, this method of repair requires extensive procedures that involve high labor costs, which often times control the overall cost of a given bridge restoration project. When compared to an increase in a structural service life, labor cost to remove contaminated concrete and uncertainty in the complete removal of contaminated concrete, this conventional repair alternative is not often fiscally conservative.

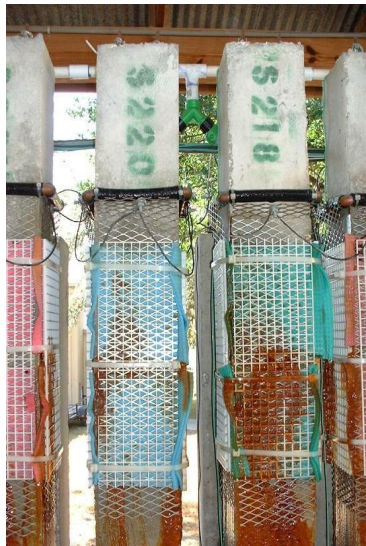
Figure 2.3 Corrosion cells instrumented on piles.

Figure 2.3 shows cyclically wetted impressed current accelerator equipment attached to the pile face within the designated damage zone region. This condition accelerated measurable reductions in steel area to then be quantified by a percent loss in the area of prestressing steel. Approximate times were calculated to determine the targeted degrees of damage of 0%, 10%, 30% and 50% area loss of steel. Once a 5-pile set achieved the sought level of corrosion damage, it was cast into a reinforced concrete footer and bent pier cap in preparation for instrumentation and testing.

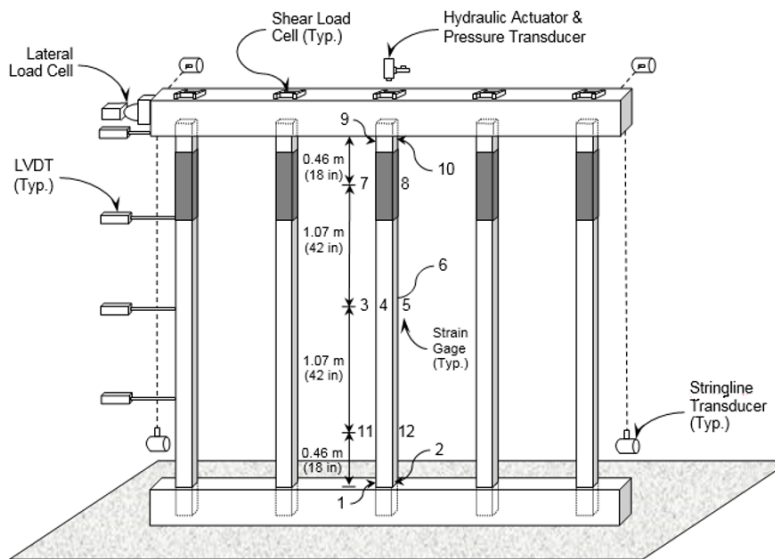
Figure 2.5 Testing instrumentation on pile bent (Goulish, 2002).

Figure 2.5 shows the instrumentation required to measure point specified displacements, test equipment shear resistance, pile stresses and bent lateral translation and bent parallel translation. Hydraulic actuators placed atop the concrete cap directly above the piles, sustained 10 kip axial loads on all five piles. This was regulated though pressure sensor transducers with an automatic pump relay set to maintain 4000 psi in the hydraulic line. Linear variable displacement gauges (LVDT) were placed at quarter points along the pile to measure lateral displacement.

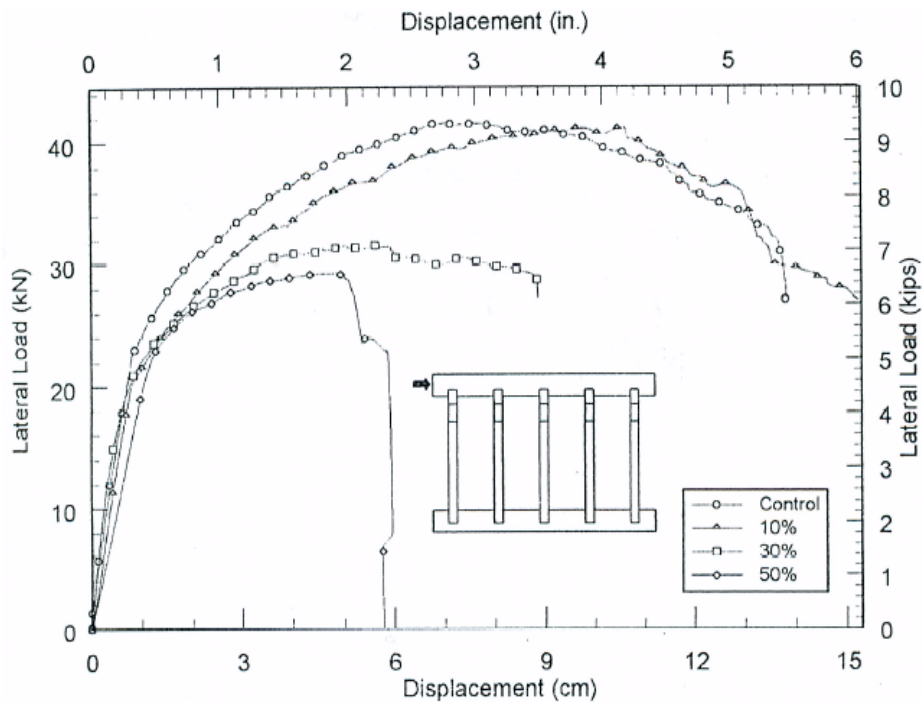
Figure 2.6 Lateral load vs lateral displacement at pile cap (Goulis 2002).

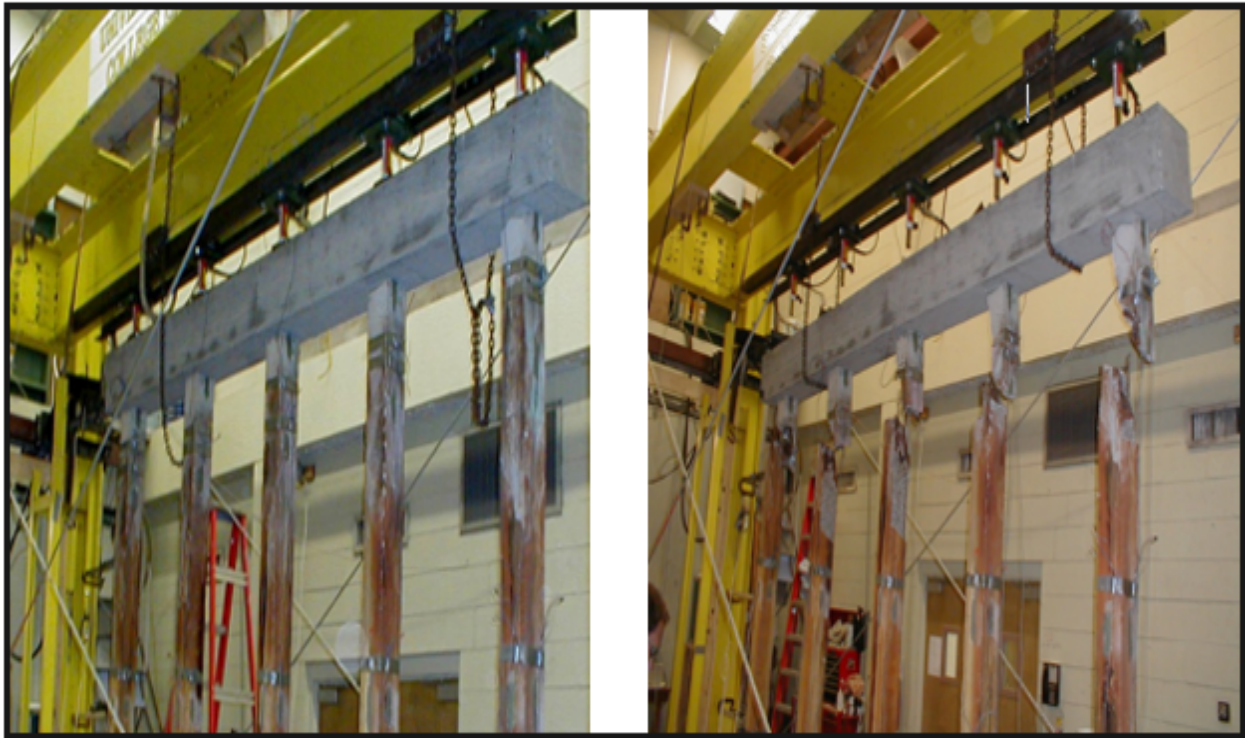
Figure 2.7 50% damage bent prior to testing.

Figure 2.7 shows the 50% damaged pile bent configuration inset within the testing frame pre-test and post-test of pile cap severance. Approximately twenty years after the piles were originally cast, a FRP pile repair scheme will be developed with the intent of fully restoring the capacity of the piles and bridge bent to the uncorroded conditions.

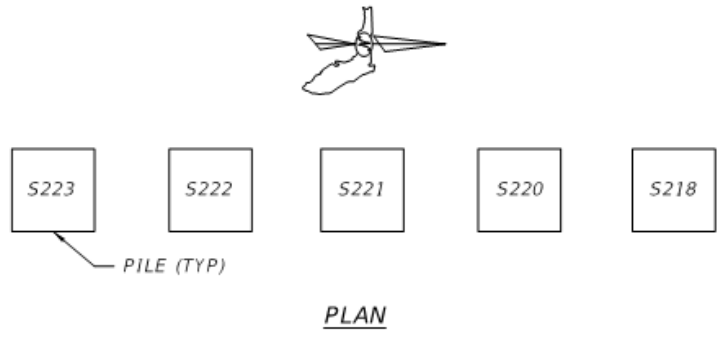
Figure 2.8 Existing pile identification.

Figure 2.8 is a plan view of the existing piles that indicates their position at the USF civil engineering research facility and their identification markings. Figure 2.9 is an elevation view of the test bent. Figure 2.10 provides the reinforcing scheme of the pile cap for the test bent. Both Figure 2.9 and 2.10 replicate the dimensioning used in the past experiment in order to isolate variability in testing results.

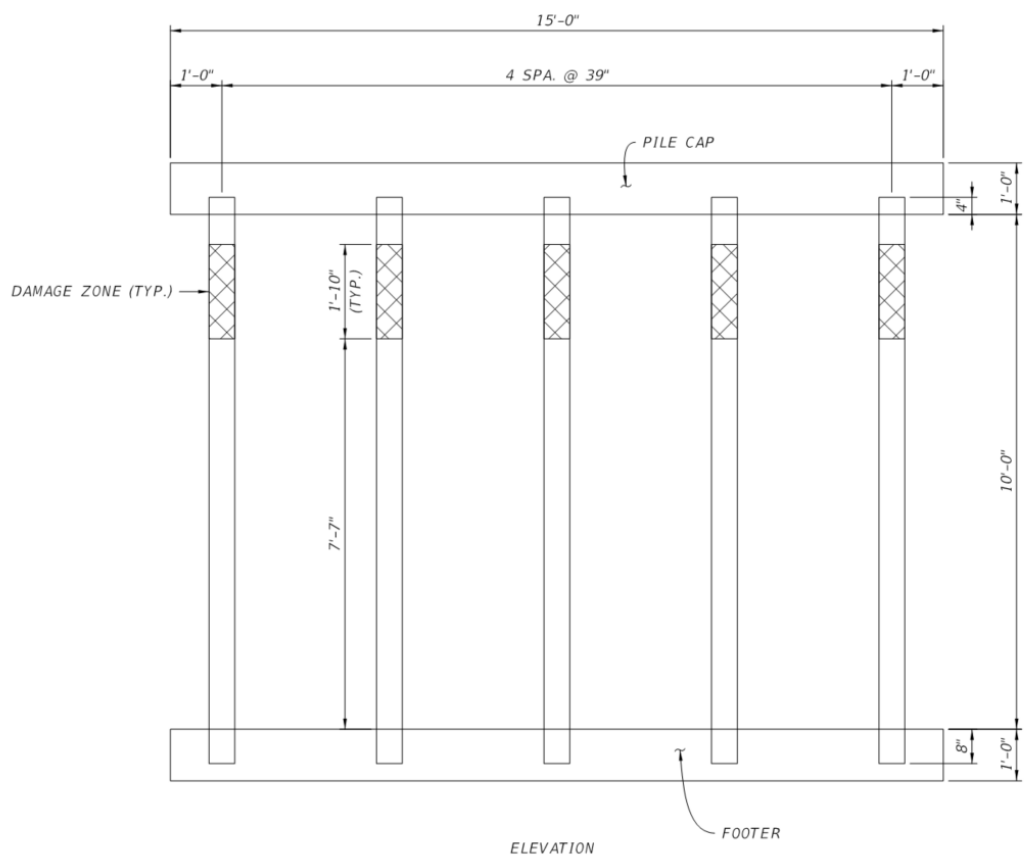
Figure 2.9 Elevation view of bent.

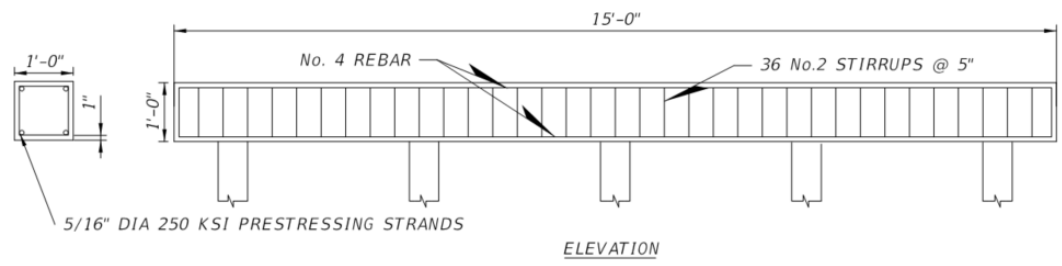
Figure 2.10 Pile and cap reinforcing scheme.

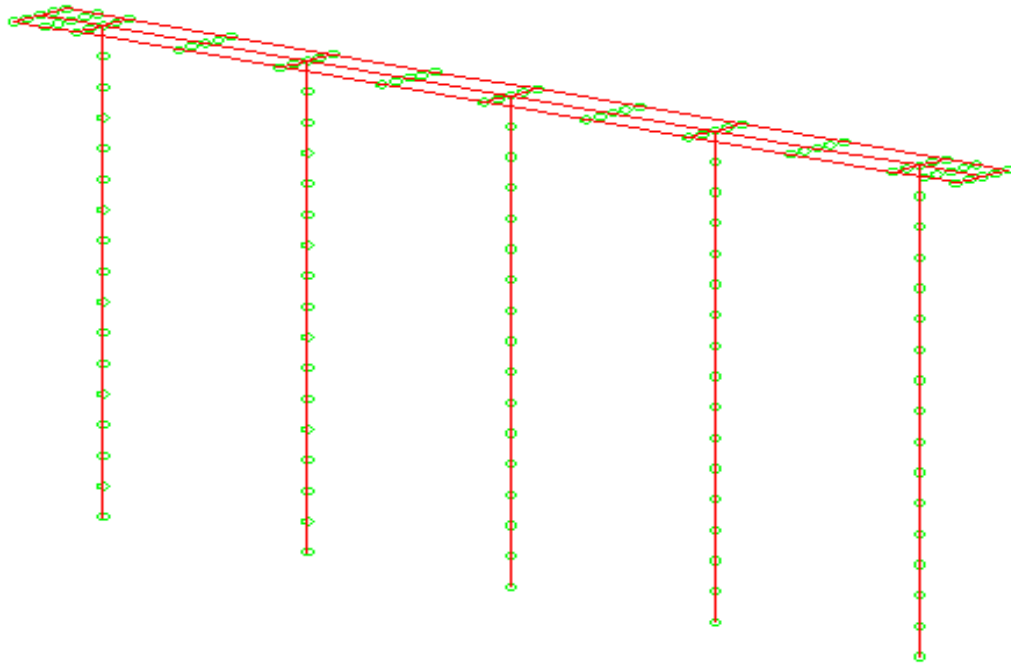
Figure 3.1 FLPIER nodes.

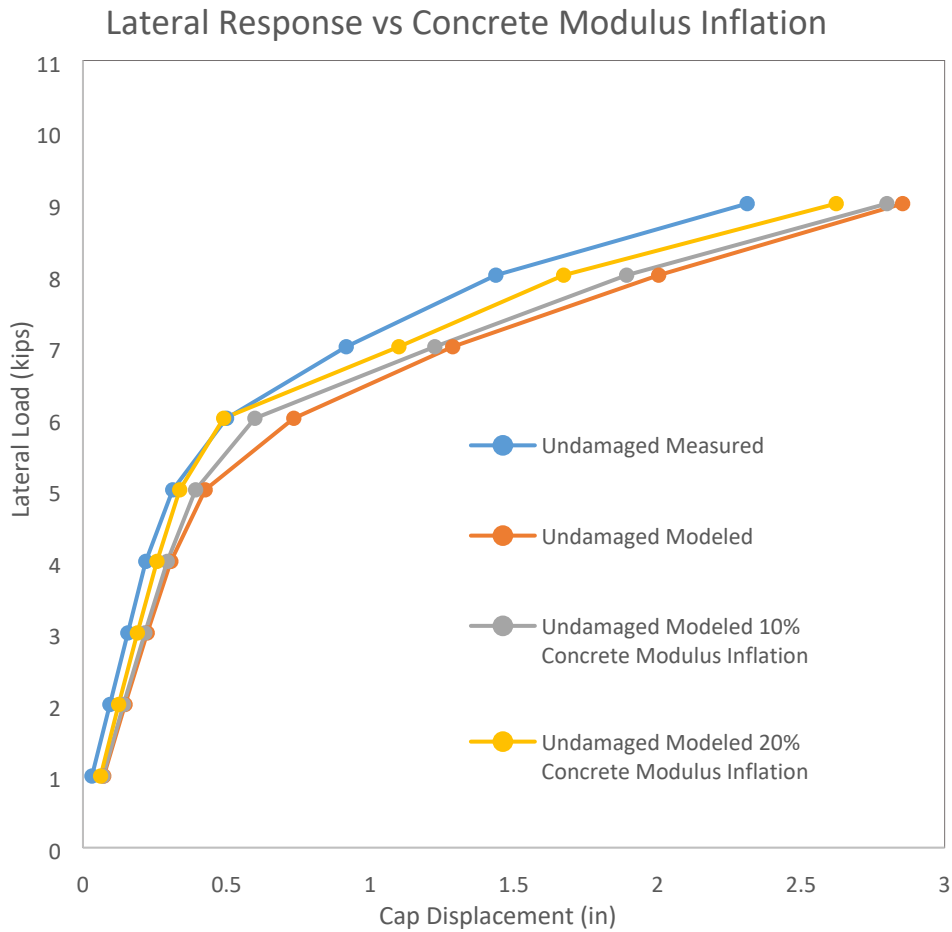
From the above statement, the initial damage model's cap and piles were swept with the suggested measured elastic modulus percent range. The inflation and deflection percentage applied to the average measure concrete compressive strength provided a range of curves that was used to isolate an influencing variable that may result in deviations from accurate displacement model data analysis. Figure 3.2 illustrates that within the elastic region of the curve, a model run with a concrete compressive strength at the high range of 20% inflation, results in a curve that is elastically similar to the measured undamaged control model. In subsequent repair models, no moduli inflation percentages were considered as to apply a conservative assumed stiffness to the repaired models.

Figure 3.2 Modeling undamaged bent varying concrete modulus.

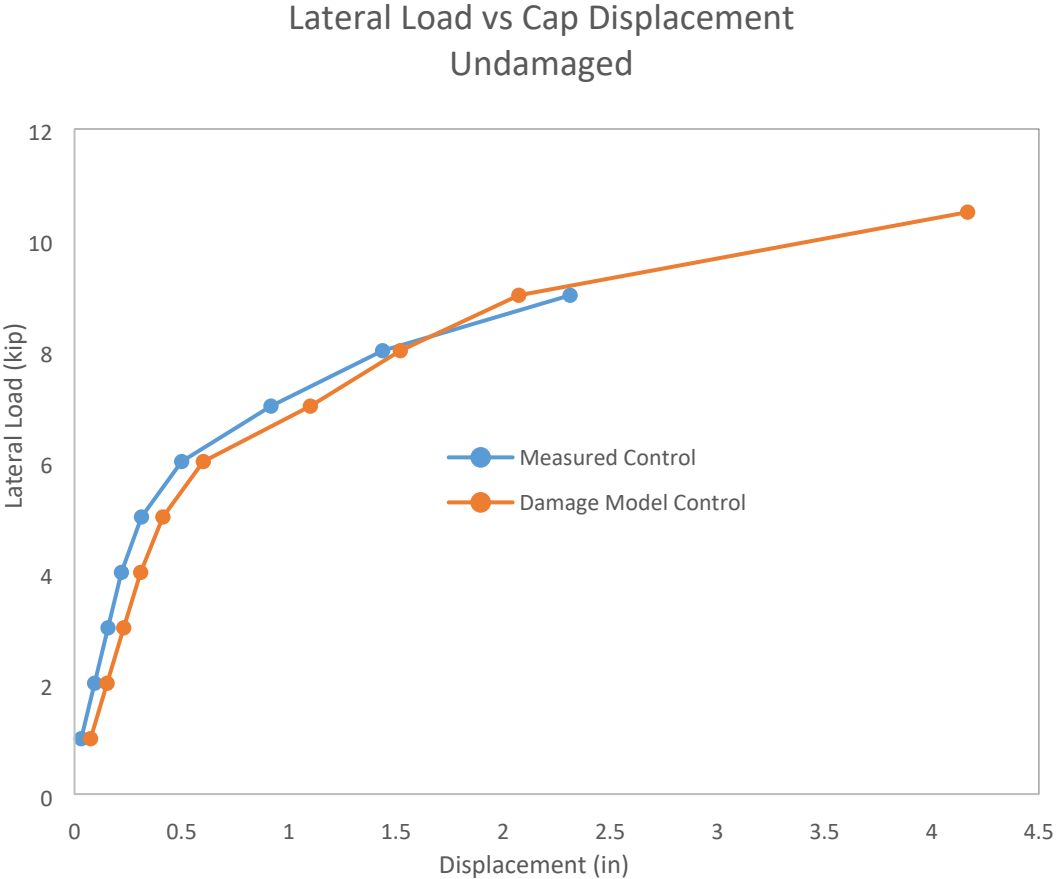
The undamaged model, used as a basis for damaged models and subsequently repaired bent models, utilized the parameters outlined throughout the preceding chapter three sections. As noted, the undamaged model was generated to replicate laboratory testing results referenced to the previous study. Figure 3.6 illustrates the measured structural response versus the models structural response for the undamaged pile bents.

Figure 3.6 Measured vs undamaged model load-displacement curve.

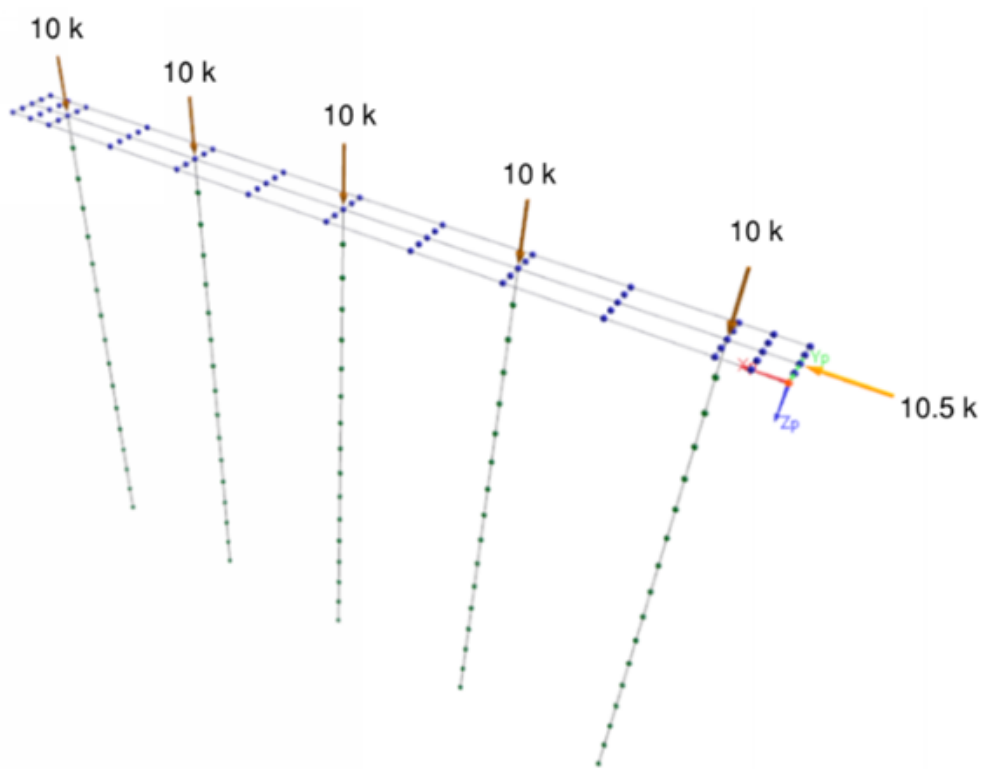
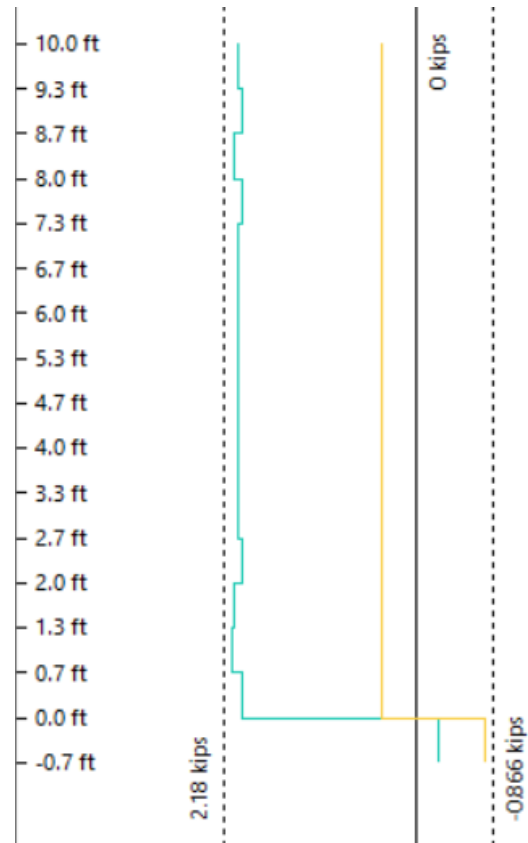
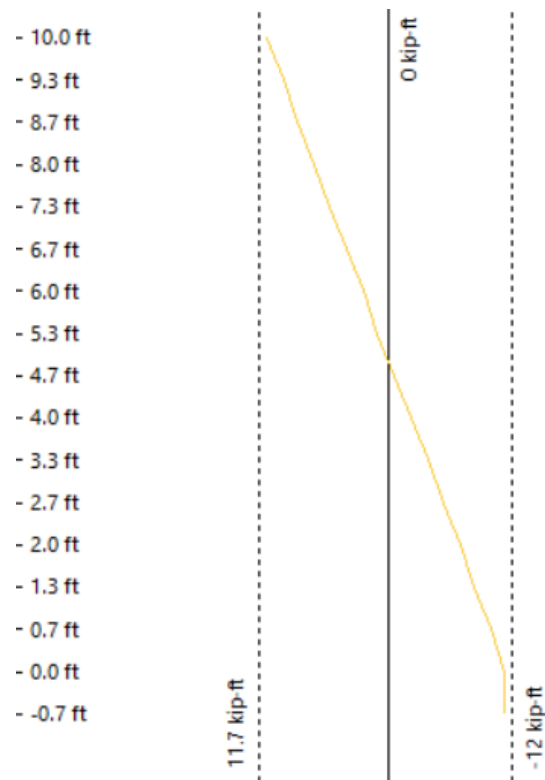
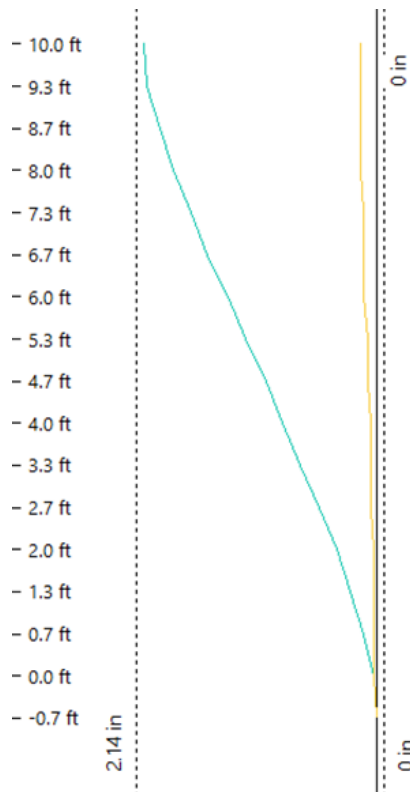
The figures to follow illustrate post analysis results from the undamaged model. The maximum lateral load equals 10.5 kips and the maximum shear within the bent occurred in pile 1 at nearly 2.2 kips. The maximum moment of 12 k-ft occurred at the foot of pile 5. The maximum deflection occurred in Pile-1 at 2.1 kips.

Figure 3.8 Undamaged model with sustained service loads and at ultimate lateral load.

Figure 3.9 Undamaged model max shear.

Figure 3.10 Undamaged model max moment.

Figure 3.11 Undamaged model max displacement.

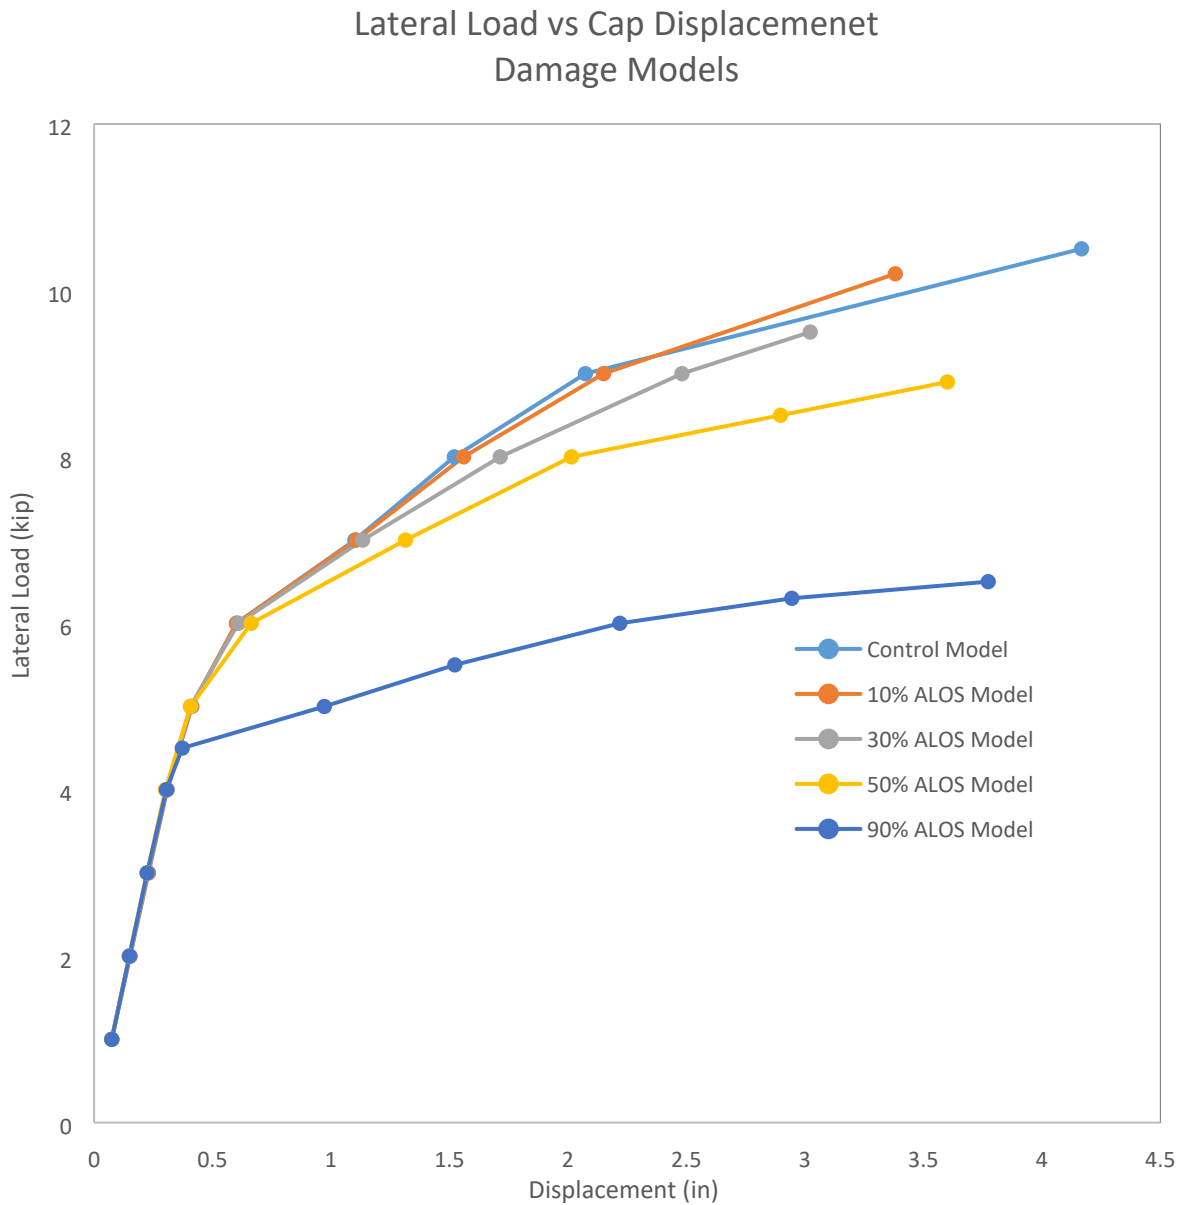
Once the determined control model was set as a basis, models were run with increasing damage and lateral load vs displacement curves and interaction diagrams were generated and compared with the control model. Figure 3.13 and Figure 3.14 illustrate the response to lateral loading and the developed capacity with respect to increasing levels of damage, respectively.

Figure 3.13 Response curves for all models.

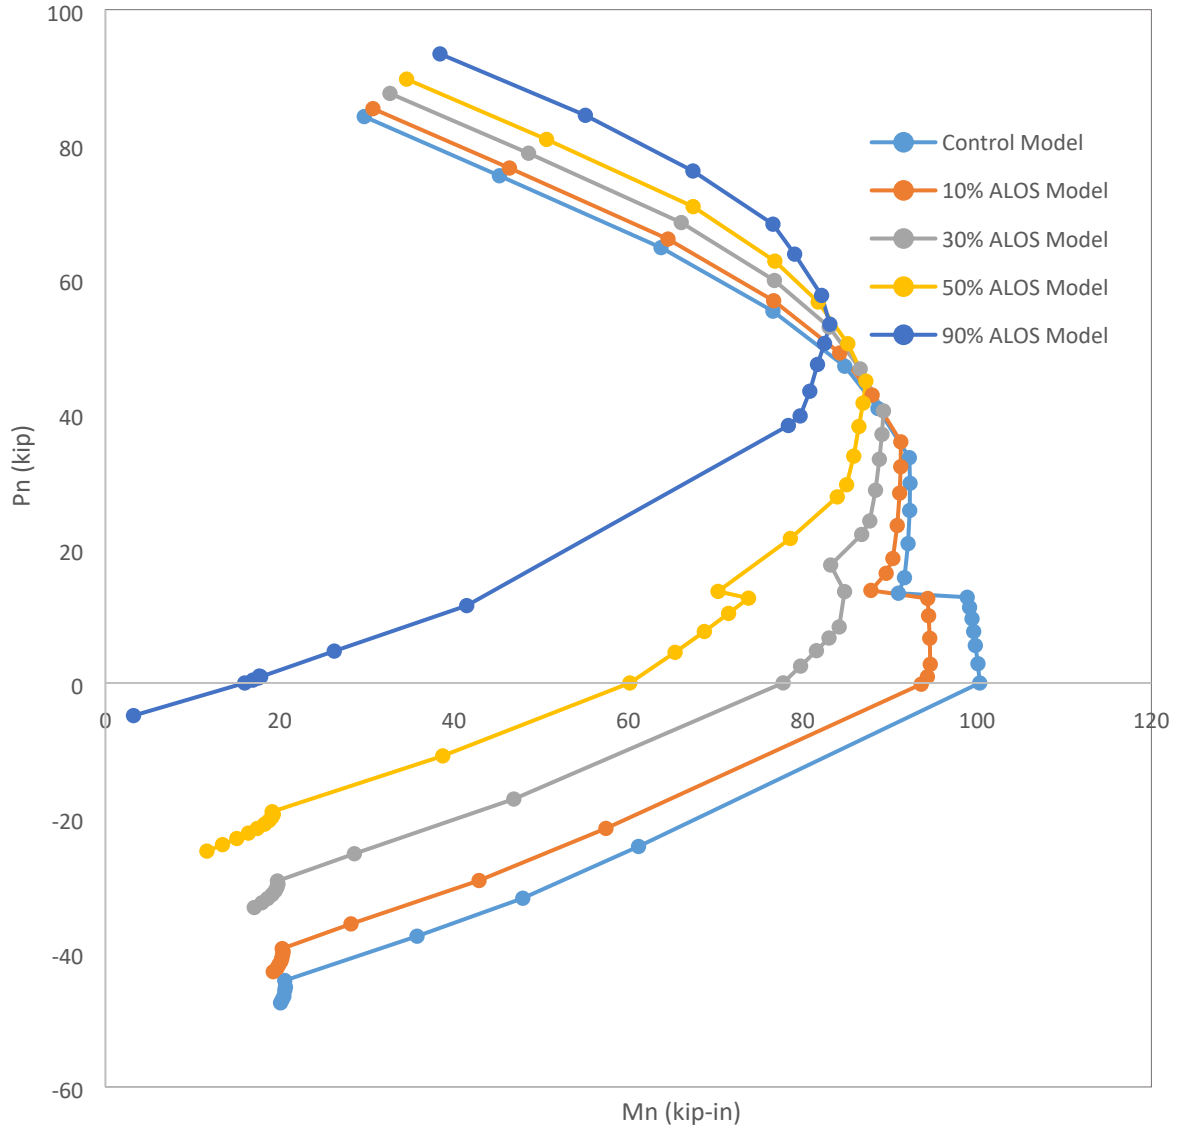
Figure 3.14 Interaction envelope for all models.

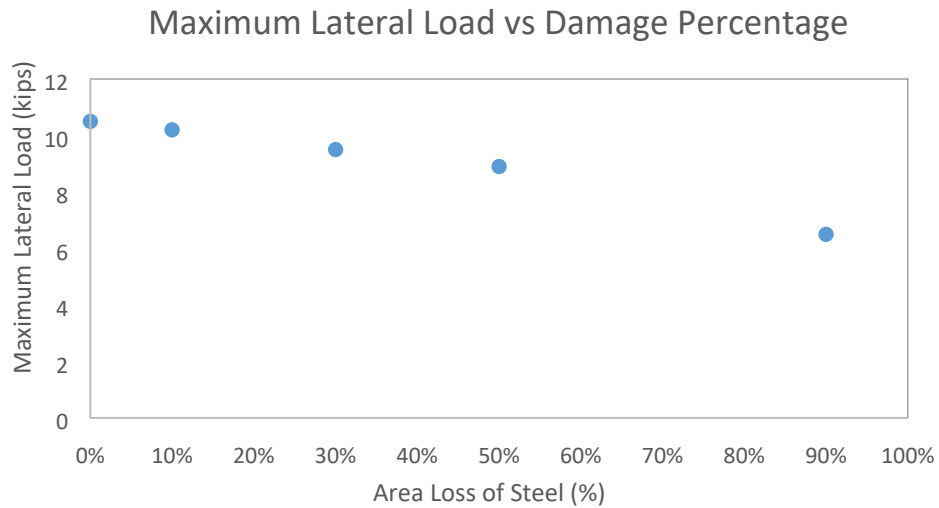
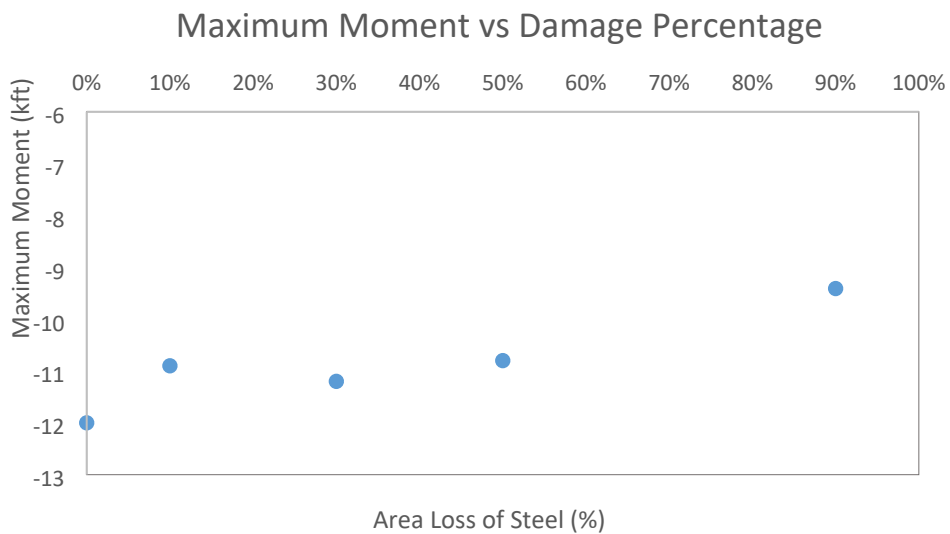
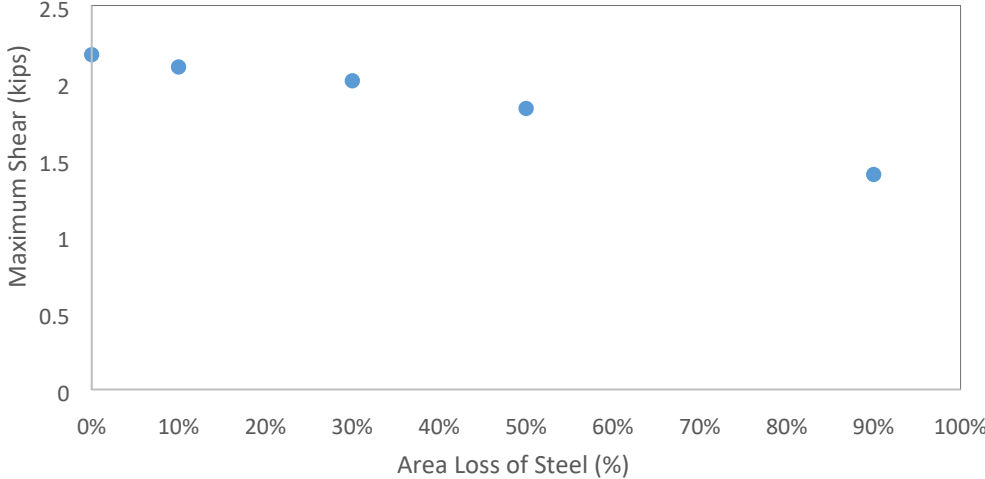
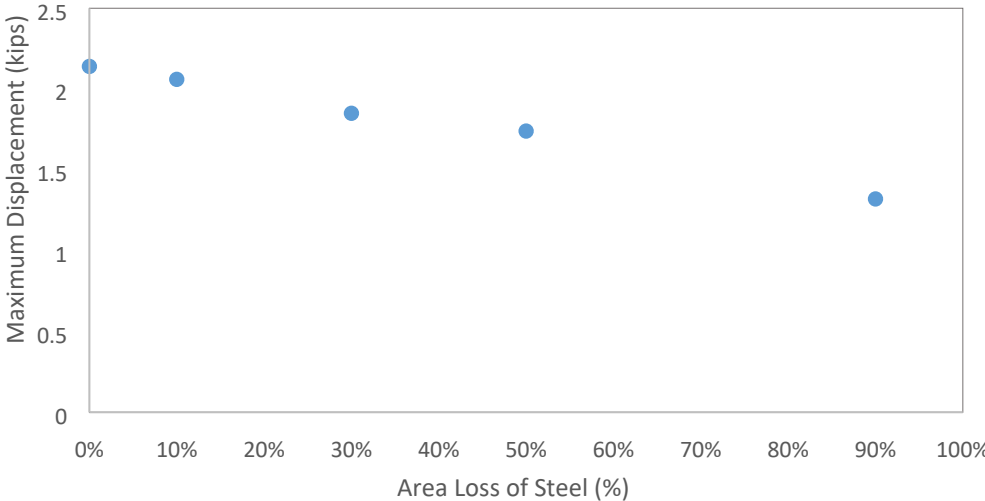
Damaged					
Damage (%)	0%	10%	30%	50%	90%
Shear (kip)	2.18	2.1	2.01	1.83	1.4
Displacement (in)	2.14	2.06	1.85	1.74	1.32
Axial (kip)	51.1	-44.4	-45.8	-39.6	-34.9
Moment (k-ft)	-12	-10.9	-11.2	-10.8	-9.41
Max Lateral Load (kip)	10.5	10.2	9.5	8.9	6.5

Figure 3.22 Maximum applied lateral load with respect to loss in steel area.

Figure 3.23 Maximum moment in bent with respect to loss in steel area.

Figure 3.24 Maximum shear in bent with respect to loss in steel area.

Figure 3.25 Maximum lateral displacement in bent with respect to loss in steel area.

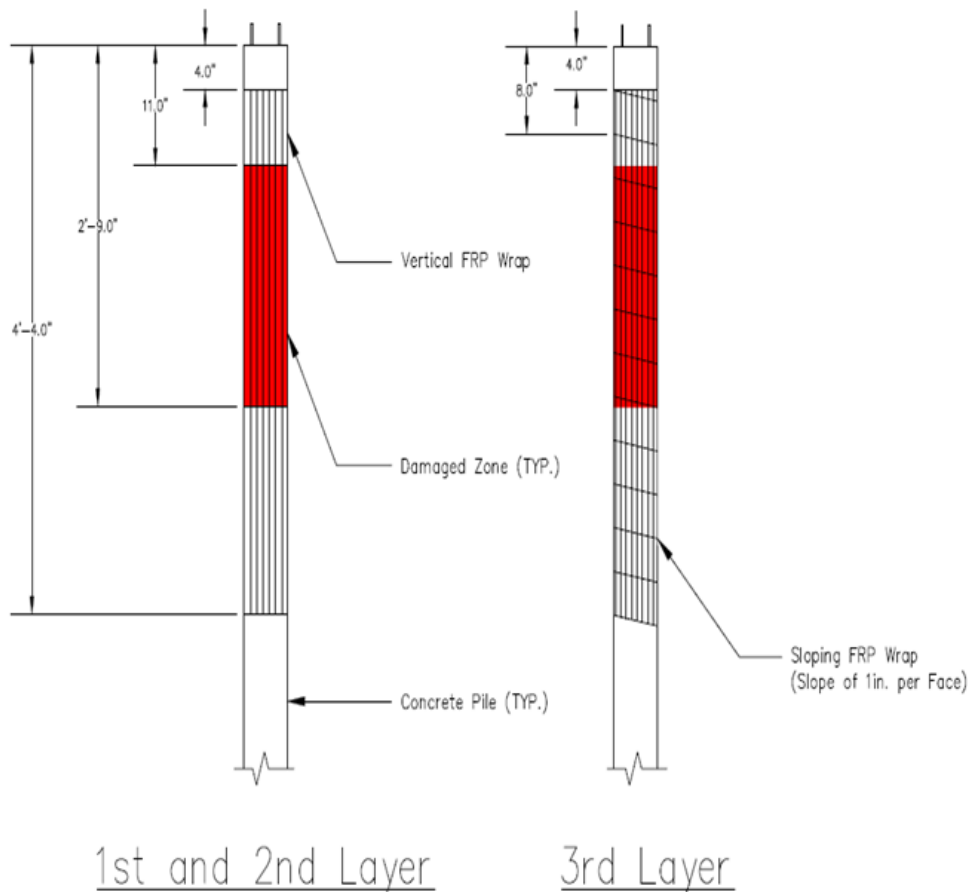
Figure 4.1 illustrates the three layers of repair which effectively is modeled as two layers because the third layer does not assume to provide bending resistance to the structural system but instead provides passive confinement and shear resistance.

Figure 4.1 CFRP design schematic.

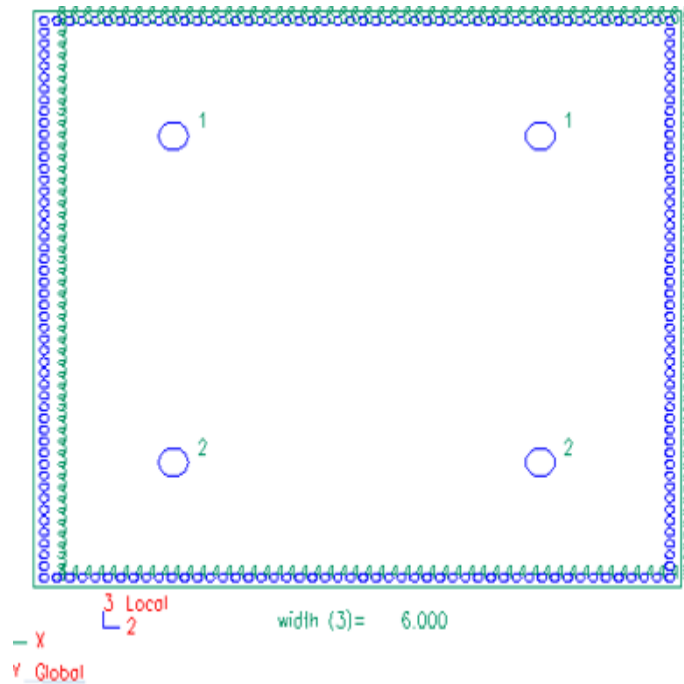
Repair models used what is called “mild steel” within the program. These groups of steel are listed within the .in file as groups 3-6. Each group is located on the exterior of each of the pile cross-section, 2.9in from the center of the square cross-section. The repair groups are representative of the materialistic properties of the repair materials selected. Each repair group has 50 circular carbon bars distributed along the 6-inch dimension of each face of the piles amounting to 4 faces per pile and five piles in total. Figure 4.3 shows a repaired models cross section, where an added exterior layer was applied by inputting structural properties of carbon fiber material and distributing the repair material area over the width of the cross section.

Figure 4.3 Square cross section with custom reinforcement.

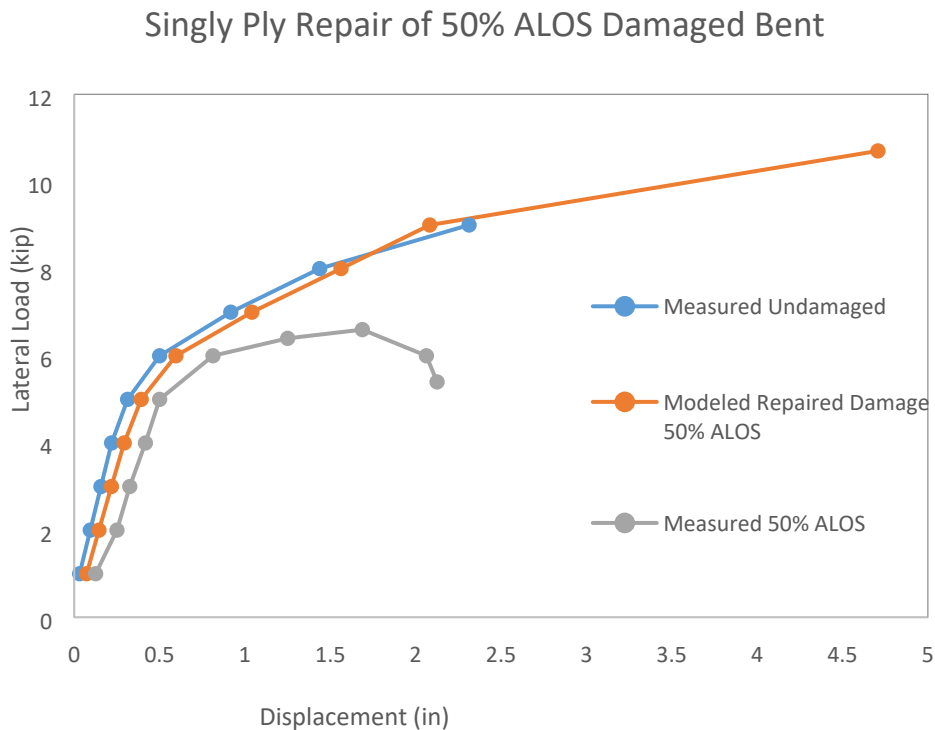
Figure 5.1 Response of measured, modeled and repaired at 50% damage.

The objective of this experiment was to accurately model corrosion damage and the repair of corrosion damage to a third scale bridge bent using exteriorly applied carbon fiber properties with non-linear analysis. To do so, the utilization of test results from a previous study were considered in order to provide a reference undamaged control model to generate damaged and repaired damage models. Results indicated that in wrapping a pile with CFRP, pile stiffness within the elastic region minimally increases and plastic ductile capacity significantly increases.
