# Permeability and lateral earth pressure in granular backfill against bridge abutments

Lance David Keltner  
*Iowa State University*

A thesis submitted to the graduate faculty

Major: Civil Engineering (Geotechnical Engineering)

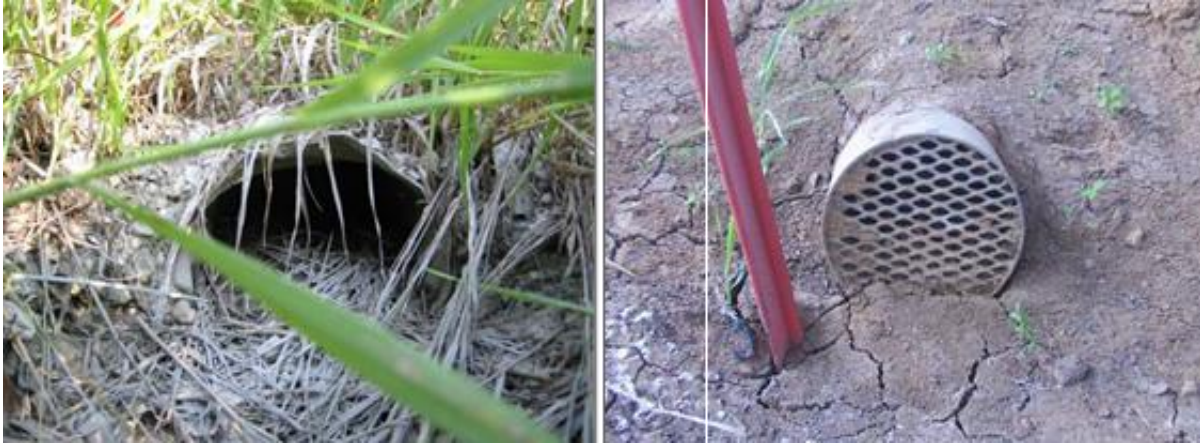
**Figure 1. Examples of clogged end drains at I-80 bridge over McPearson Avenue (left) and the bridge on US 218 over South Skunk River (right) (White et al. 2005)**

White et al. (2007a) reported results of inspection on 74 bridges in Iowa and indicated that about 60% showed poor water management with clogged subdrains and end drains, and unsealed expansion joints (Figure 1). The authors inspected the subdrain outlets of six bridge sites which showed that the subdrains were either dry (despite wet field conditions), collapsed, or plugged with soil. They also reported that surface drainage features suffered from similar problems while bridge end drains were often blocked by debris or showed erosion outside of the tile.

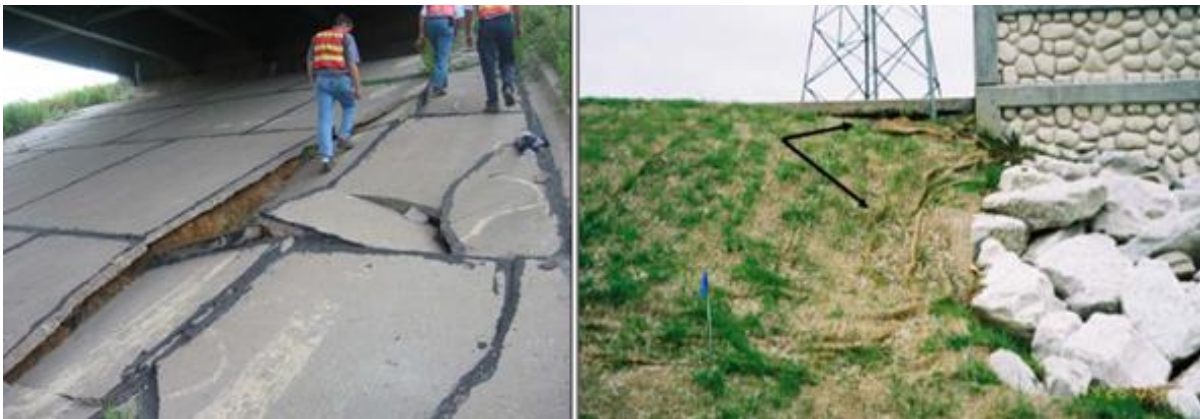
**Figure 2. Examples of (left) severe damage of concrete slope protection due to erosion on I-380 bridge over Hwy 6 in Iowa (White et al. 2005), and (right) slope instability on West Beloit Road Bridge over Root River in Wisconsin (Helwany et al. 2007)**

Water that is not properly drained, seeps down between the abutment and the bridge approach through joints, cracks, or flows around the bridge resulting in erosion of the backfill

(Figure 2). Erosion can lead to voids developing underneath the bridge due to backfill moving to fill in eroded slopes, or slope failures due to the soil being removed away from abutment walls (Helwany et al. 2007; Jayawickrama et al. 2005). Based on field observations in Texas, Jayawickrama et al. (2005) noted that poor compaction of abutment backfill material, poor construction of joint sealants, and poor surface and subsurface drainage systems were the primary causes of erosion in backfill materials.

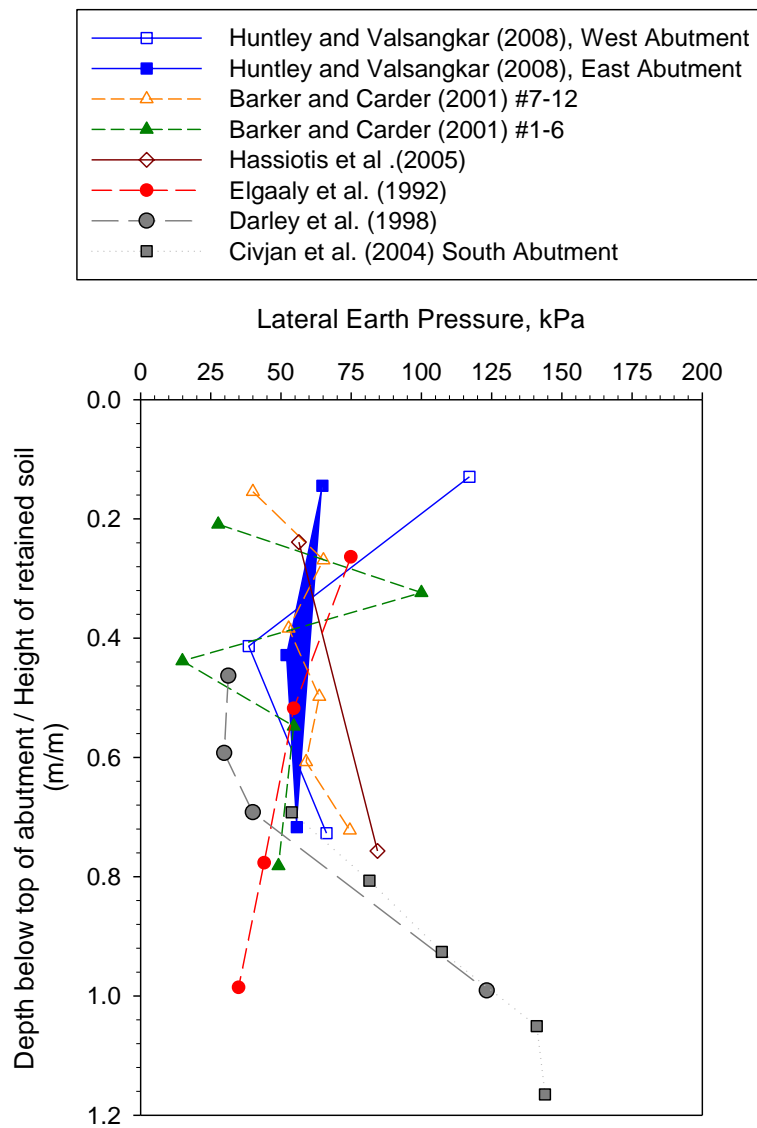
**Figure 18. Comparison of maximum earth pressure behind various abutments  
(Reproduced from Huntley and Valsangkar 2013)**

than the Rankine coefficient for passive earth pressures. The sensors located in the bottom portion of the abutment showed lower ratios. Figure 18 shows the results from Huntley and Valsangkar (2013) in comparison with results reported by other researchers (Barker and Carder 2001; Civjan et al. 2004; Darley et al. 1998; Elgaaly et al. 1992; Hassiotis et al. 2005). Most studies showed that maximum earth pressures were found to occur during summer months.

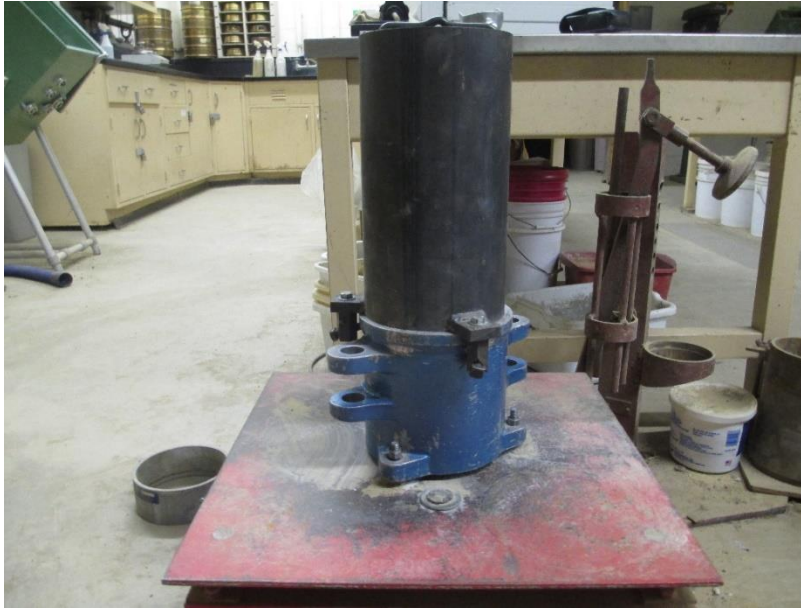
**Figure 22. Vibrating table for relative density tests**

Vibratory compaction tests were conducted to determine the minimum and maximum dry densities following ASTM D4253 “*Standard test methods for maximum index density and unit weight of soils using a vibratory table*” and ASTM D4254 “*Standard test methods for minimum index density and unit weight of soils and calculation of relative density.*” An electromagnetic vibrating table was used in this study (Figure 22).

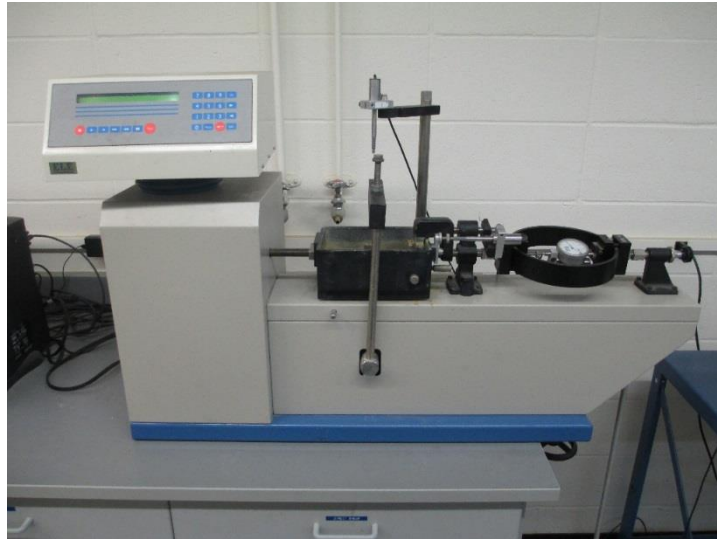
**Figure 28. Direct shear test device**

material was compacted to 100% standard Proctor dry density and was saturated by adding water during the consolidation stage. The direct shear test apparatus is shown in Figure 28.

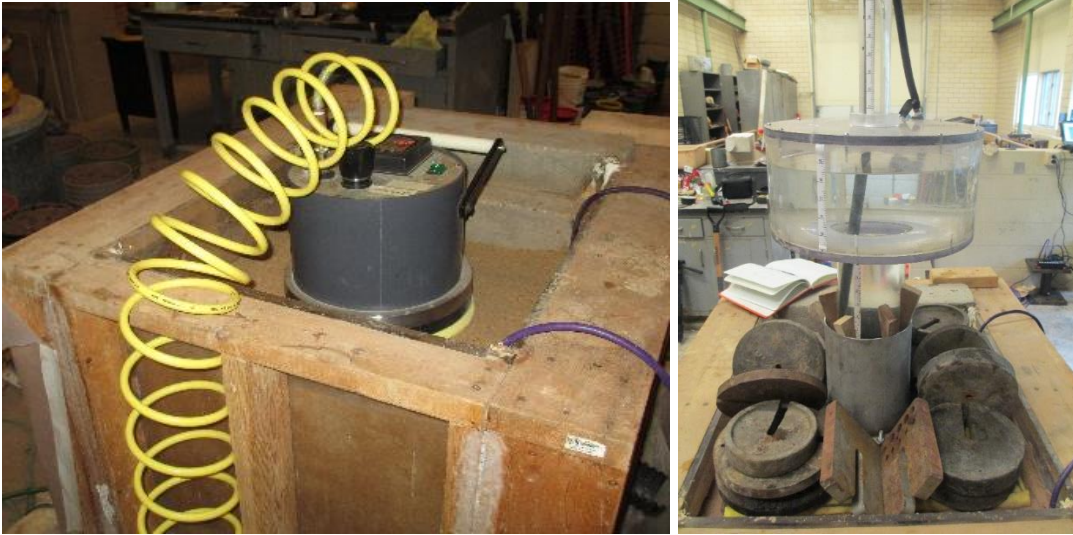
**Figure 32. APT test setup (left) and CHP test setup (right)**

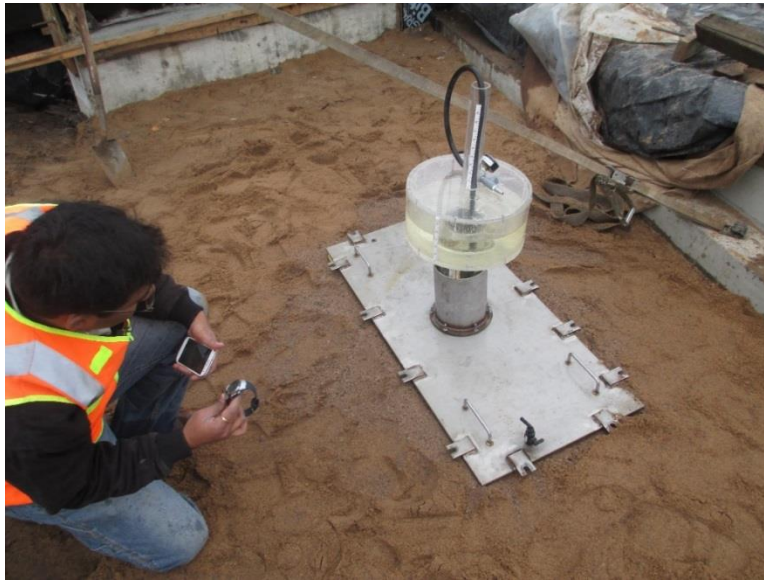
**Figure 37. Corehole permeability test setup**

The setup involved placing a base plate on a compressible closed-cell foam over the backfill material, to prevent water leakage between the base plate and the material. A core hole sleeve was then attached to the plate. CHP was then inserted in the core hole and was sealed at the bottom of the device and against the interior of the hole. To seal the bottom of the CHP, an open cell foam ring is compressed under the CHP. By inflating a rubber tube between the outside of the CHP ring and the hole wall, the perimeter of the CHP is sealed against the hole wall. About 20 to 25 psi air pressure was used to inflate the rubber tube.

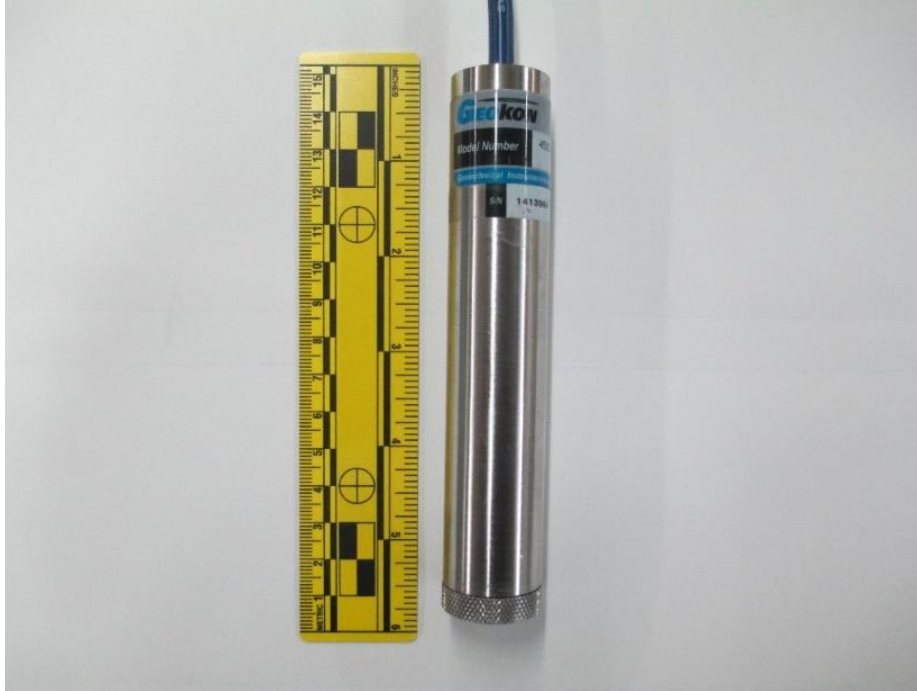
**Figure 42. Geokon 4500 piezometer**

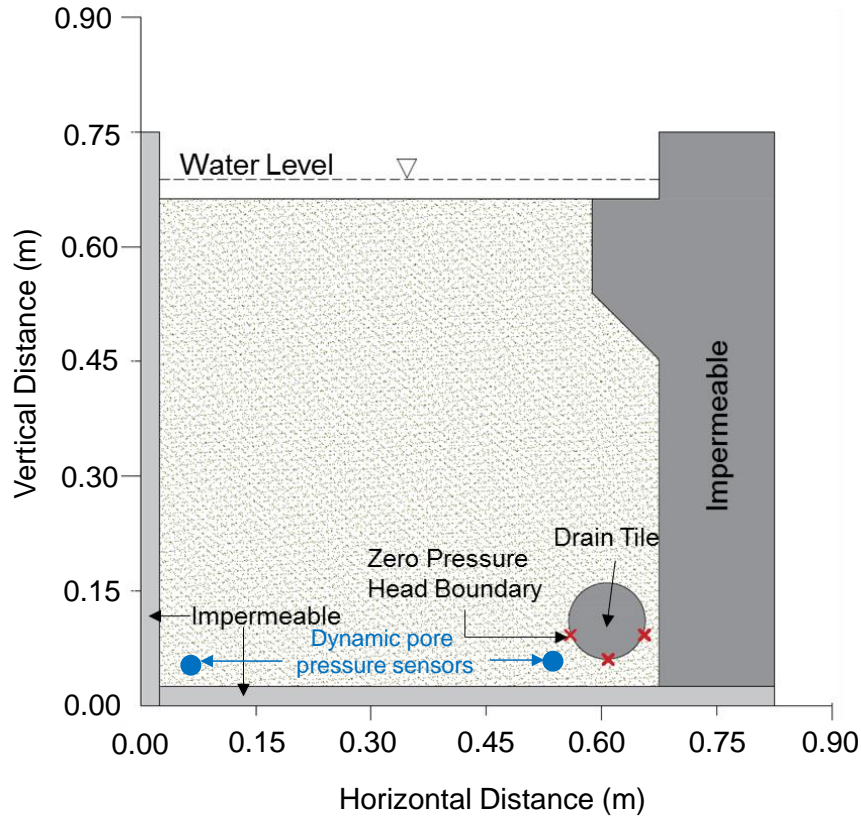
**Figure 44. Abutment model setup in FEM analysis**

In this study, results obtained from the laboratory abutment scaled model tests were used to calibrate the input parameters used in the FEM models, and the calibrated values for the different materials were used to assess field conditions. The primary goal of the numerical analysis was to determine the rate of change in pore pressures with time (i.e., time for drainage). In the following discussion, the input parameters used in the FEM model, the methods followed to determine those parameters, and results of a parametric study that was conducted to assess the influence of the different input parameters are presented. The abutment model setup is shown in Figure 44. The FEM model was setup with an average mesh size of 15 mm with 1542 elements and 1628 nodes.

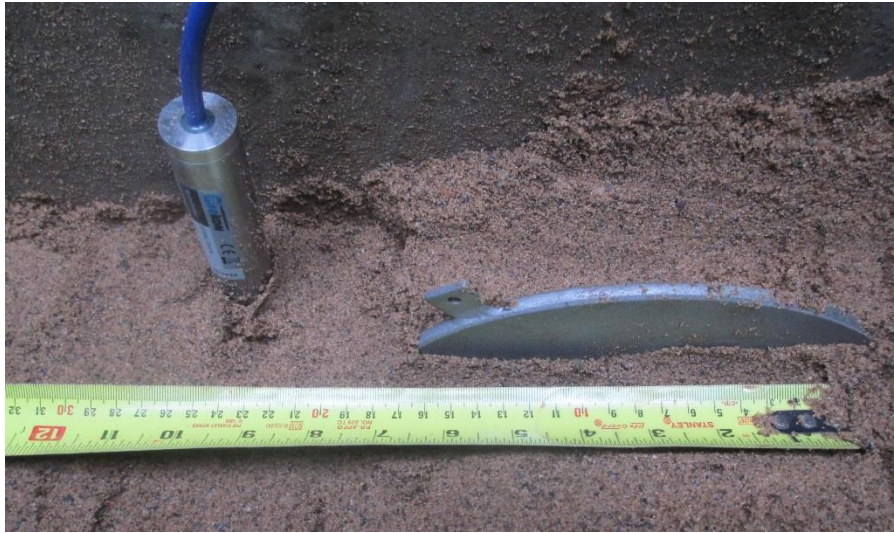
**Figure 87. Photograph of an installed PP (left) and EPC (right) sensors**
