A study of effects of a new agricultural-based deicer on the properties of pavement concrete

A thesis submitted to the graduate faculty
in partial fulfillment of the requirement for the degree of

Major: Civil Engineering (Civil Engineering Materials)

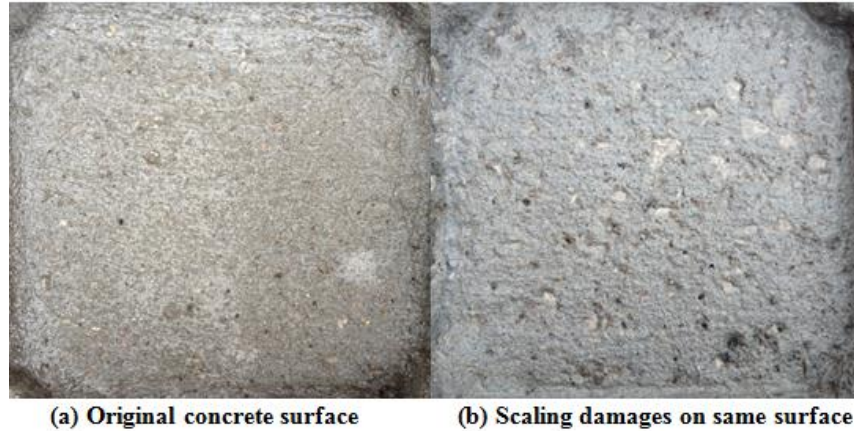
Scaling damage, as shown in Figure 2, is a superficial damage caused by freezing a saline solution and it is a progressive damage with esthetical hazard [14].

Figure 2. Typical Scaling Damage

It can be visually observed that thin pieces of surface cementitious materials are peeled off at random locations. The first theory of salt scaling mechanism was established in 1950s [15]. Being different from other frost damages, salt scaling does not harm the integrity of concrete body. However, scaling damage drastically increases the ingress of moisture offering a preferred environment for aforementioned chemical degradations including calcium leaching and C-S-H gel decomposition to occur. Moreover, the ingress of moisture due to scaling damage increases concrete's susceptibility to physical frost damage because of behavior of water with fluctuating temperature [16-17]. Another problem associated with the scaling damage is exposure of aggregates. Specific aggregates

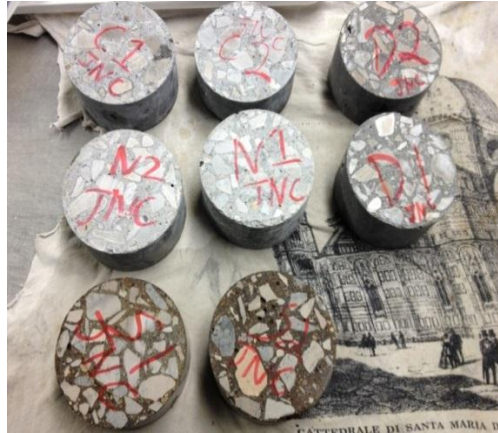
Twenty-four 4-in (diameter) by 8-in (height) cylinders (cylinder hereafter) were cast and cured following ASTM C192, “Standard Practice for Making and Curing Concrete Test Specimens in the Laboratory”. The w/c ratio of the concrete mixtures of cylinders was 0.45 and the slump measured was 1.5 inch. The mix design and fresh concrete properties can be found in Appendix A. All the cylinders were moist cured for 14 days, and then 6 cylinders were immersed in each of three deicers. The remaining 6 cylinders were cured in 100% moisture for 28 days. The cylinders were used in electrical resistivity test and compressive strength test.

Figure 9. 2-in circular disks for water absorption test

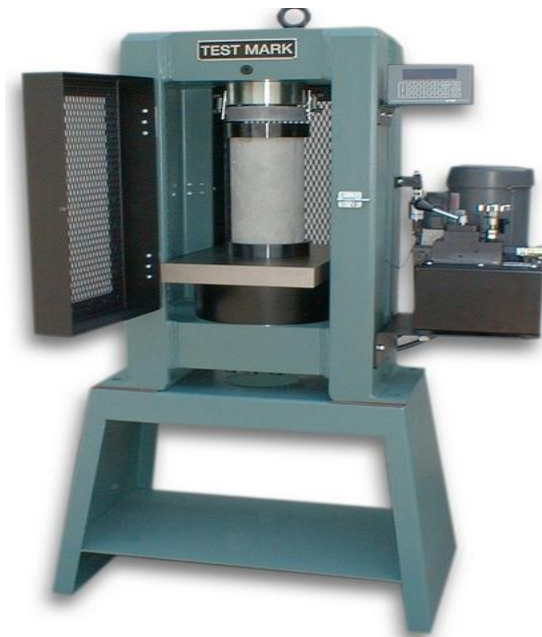
Figure 11. Compression tester

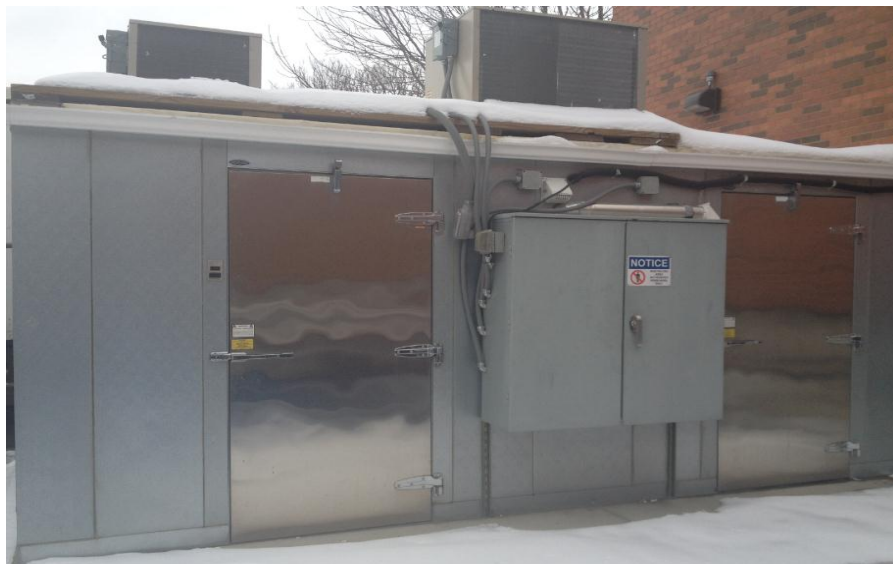
Figure 12. Freezing chamber

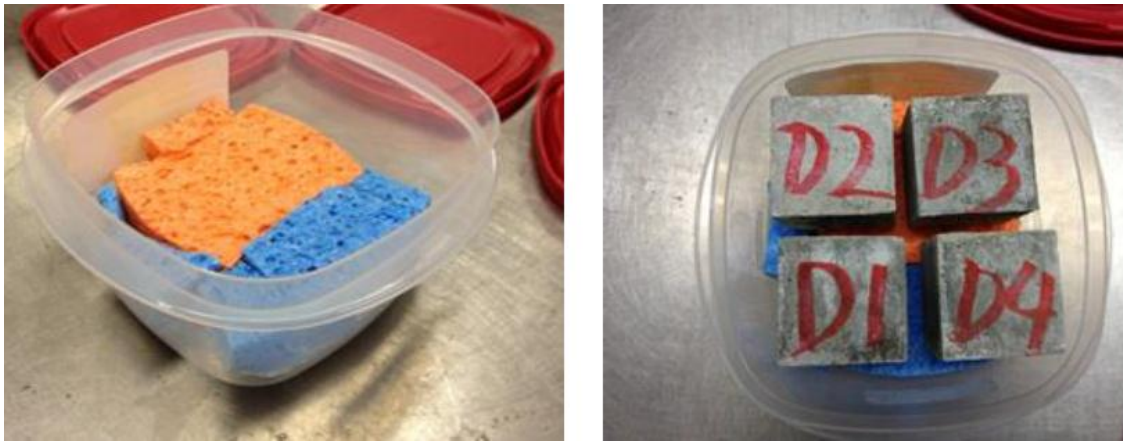
Each specimen was labeled and the initial weight was measured to calculate density. Cubes must be presoaked in deionized water for at least 24 hours before being placed in test cell. Test cell used in this study were prepared with a container and sponges at the bottom as shown in Figure 13.

Figure 13. Structural degradation test cell

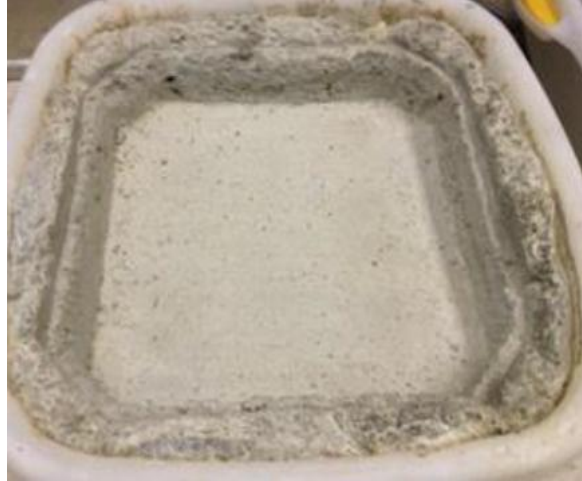
Slab with 9-in by 9-in ponding area was created by forming concrete dikes at the periphery as shown in Figure 14.

Figure 14. Concrete slab for salt scaling evaluation

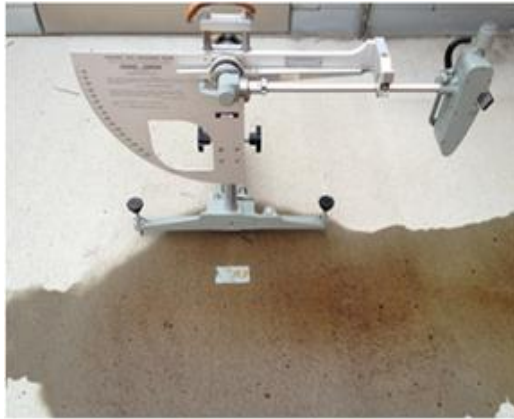
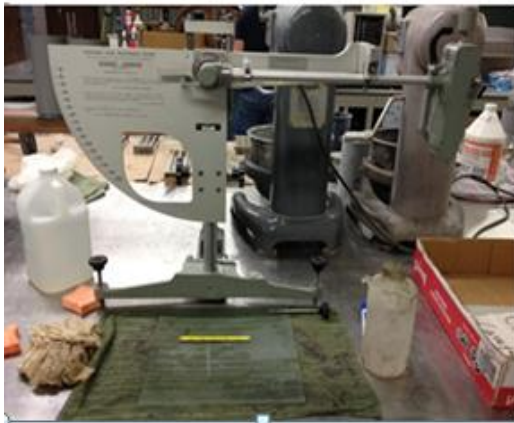
important adjustment is the slide length. Since the rubber slide is going to propel over the rough surface to reach its final position, the contacting length or area between the slider and the surface is critical. It is required to have a length of contact path between 4-7/8 and 5-inch (124 and 127 mm).

(a) Concrete slab

(b) Sand-blasted glass

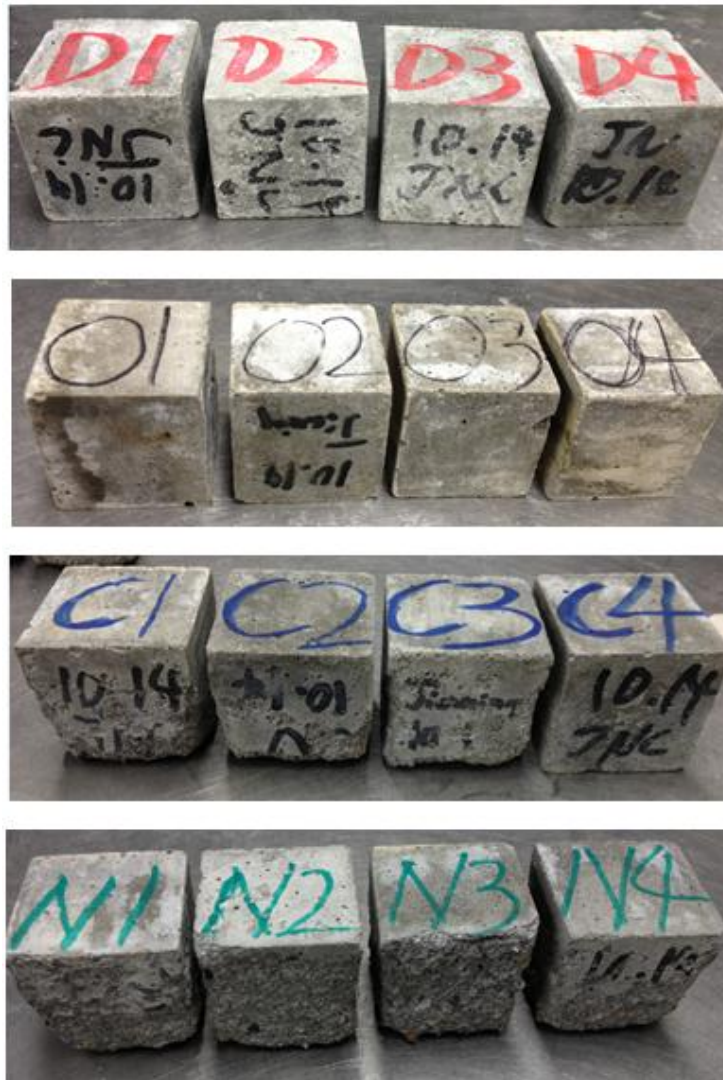
In spite of a direct relationship was established between average mass loss and average strength loss, there was an interesting finding that the structural integrity of cubes were harmed mainly due to the removal of surface paste materials instead of collapse of main concrete body as shown in Figure 25. No bulk piece of mortar was found loosen or disintegrated from of the most damaged cubes.

Figure 24. Cubes with surface materials removed after 10 cycles

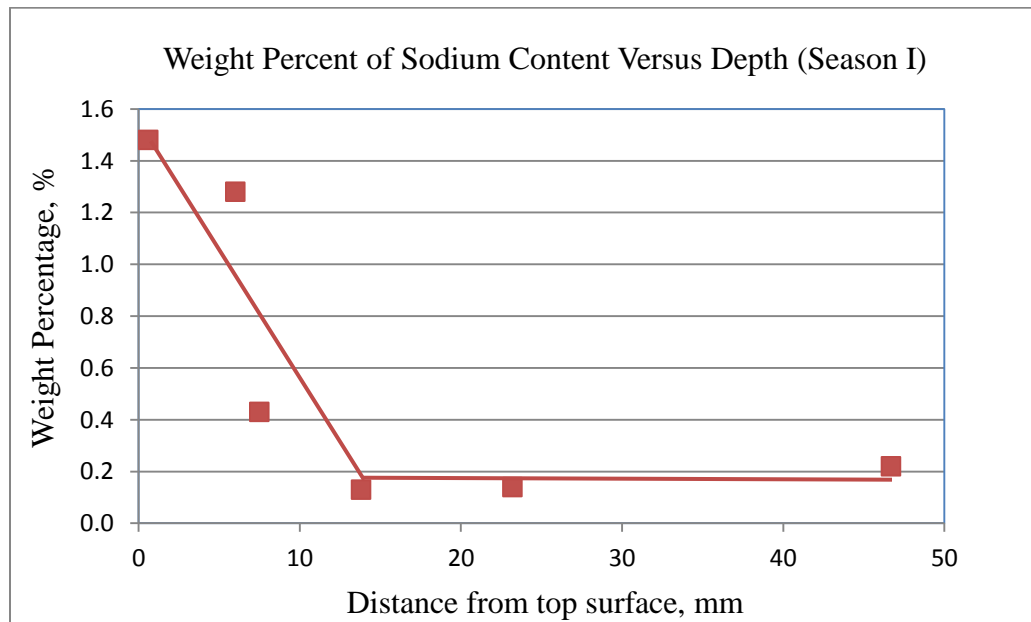
Results of the analysis are shown in Figure 35 and Figure 36 for NaCl solution penetrated sample and Season I penetrated sample. The NaCl solution penetrated about 19 mm where the weight percent of chloride drops drastically and Season I penetrated around 13 mm from the top surface of the cores. Table 14 and Table 15 are summarized results of chemical compositions versus the specimen depth. The exact relationship between scaling damage and deicer penetration depth is hard to interpret at this stage due to limited amount of samples in EDS analysis. However, the results suggest 3% NaCl solution penetrated 6 mm deeper than Season I deicer which might be resulted from more deicer ingress of slabs in scaling. Another contributing factor might be that, comparing with the NaCl solution, Season I is much more viscous due to the organic compounds it contained and it made Season I less flowable in pores. The particle size of these organic compounds might be too large to penetrate through capillary voids of concrete.

Figure 35. Sodium content versus depth for Season I specimen
