Evaluation of Iowa asphalt pavement joint cracking

A dissertation submitted to the graduate faculty
in partial fulfillment of the requirement for the degree of

Major: Civil Engineering (Civil Engineering Materials)

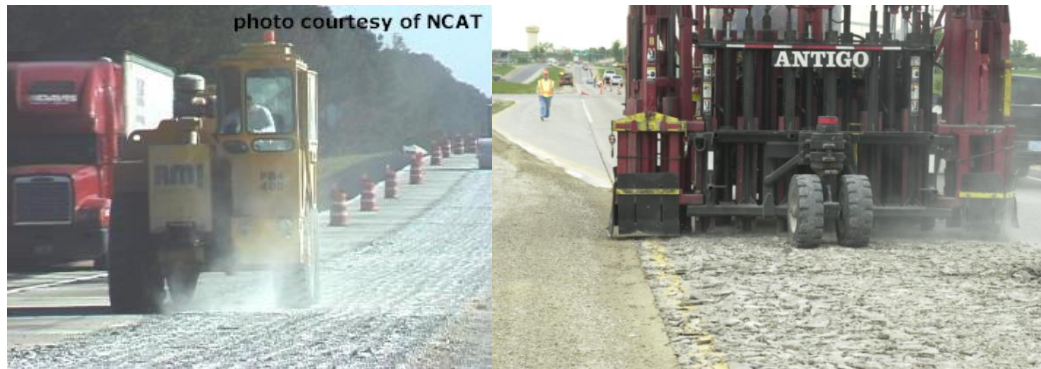
Figure 4 Rubblization: Resonant Pavement Breaker (left) and Multi-Head Breaker (right)

In general, two types of equipment are used in the rubblization process (see Figure 4): Resonant Pavement Breaker (RPB) and Multiple-Head Breaker (MHB). The RPB uses vibrating hammers to break the concrete slab and destroy the bond between the concrete and the steel. The other common rubblizing equipment is the self-contained and self-propelled MHB used by Antigo Construction which is capable of rubblizing the pavement over a minimum width of 13 ft. per pass.

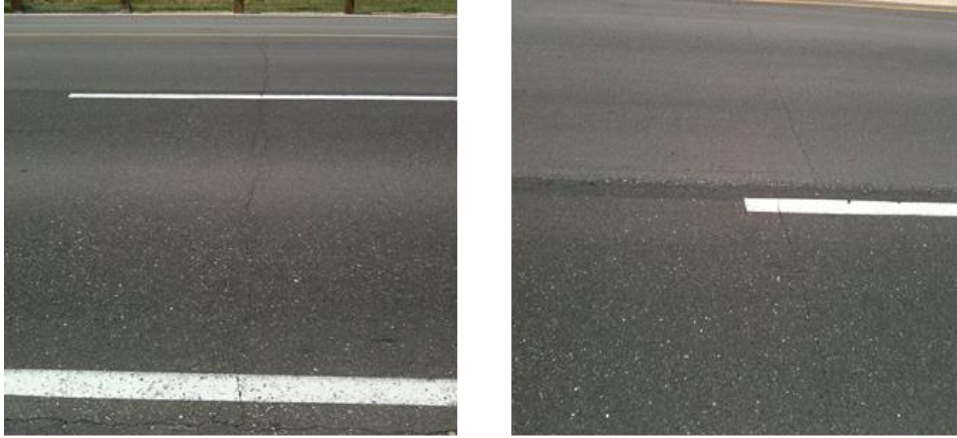
Figure 13 Survey on a project one year after construction (IA-13)

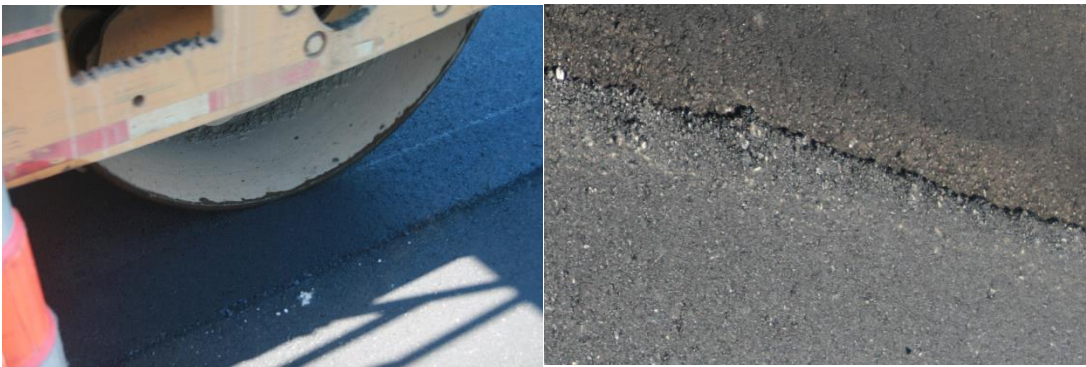
Figure 15 Butt joint construction with hot pinch (pictured on US-61)
