Validation of Ndesign in Iowa

Marie Grace Joson Mercado
Iowa State University

A thesis submitted to the graduate faculty
in partial fulfillment of the requirements for the degree of

Major: Civil Engineering (Civil Engineering Materials)

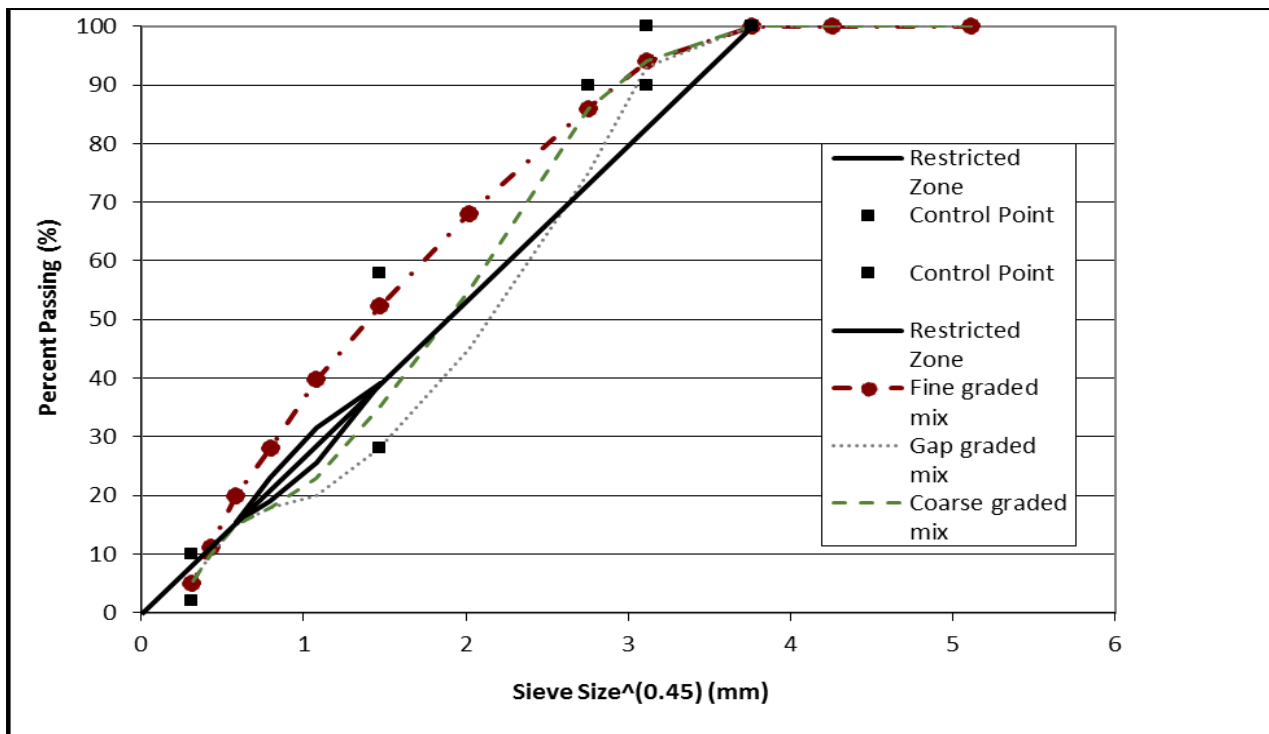
Figure 1: Typical Superpave mixes

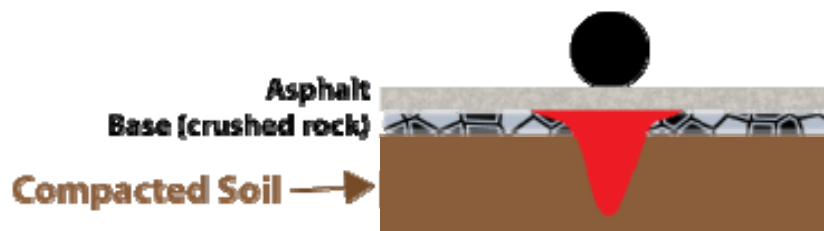
Figure 4: Stress distribution of flexible pavement [2]

design can lead to higher air voids in the field due to undercompaction during the compaction process, which consequently leads to durability issues in pavement [11]. Similarly, undercompaction in the field will cause higher ultimate pavement density which leads to bleeding or rutting [17]. A desirable, stiff asphalt mixture consists of a good aggregate skeleton and/or low asphalt content and generally compacts to 4% air voids after the pavement has been densified by traffic; whereas a weak asphalt mixture with the same compaction effort overcompacts to 2% air voids [12]. Note that the stress distribution of flexible pavements differ than concrete pavements, see Figure 4.

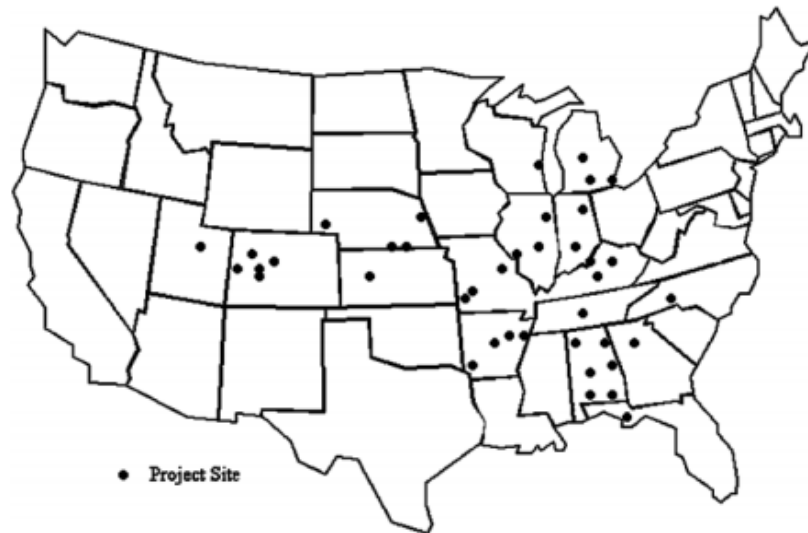
Figure 5: Location of NCHRP Project 9-9 field studies [4]

The National Center for Asphalt Technology at Auburn University was assigned NCHRP Project 9-9, “Verification of Gyration Levels in the N_{design} Table”; the final report is the NCHRP Report 573 published in 2007. The primary goal of the project was to validate the current design gyration levels in the AASHTO Standard Practice R 35 for four 20-year design traffic levels at traffic volumes including the following: less than 0.3 million, 0.30 million to 3 million, 3 million to 30 million, and greater than 30 million ESALs) while monitoring field performance [4]. The research team studied 40 field projects in 16 states with different traffic volume levels, aggregate and gradation types and asphalt binder performance grades, see Figure 5 for locations. One out of 40 projects used a compaction effort of 50 gyrations, 12 projects used 75 (68-86), 18 projects used 100 (90-109) and 9 projects used 125 gyrations. In addition, 11 projects, 26 projects and 3 projects used a NMAS of 9.5 mm, 12.5 mm and 19.0 mm respectively. For each project location,

prior to construction, loose mix samples were taken from the asphalt plant and three specimens were replicated and compacted to 100 and 160 gyrations; a total of about 26 to 36 specimens per project were compacted.

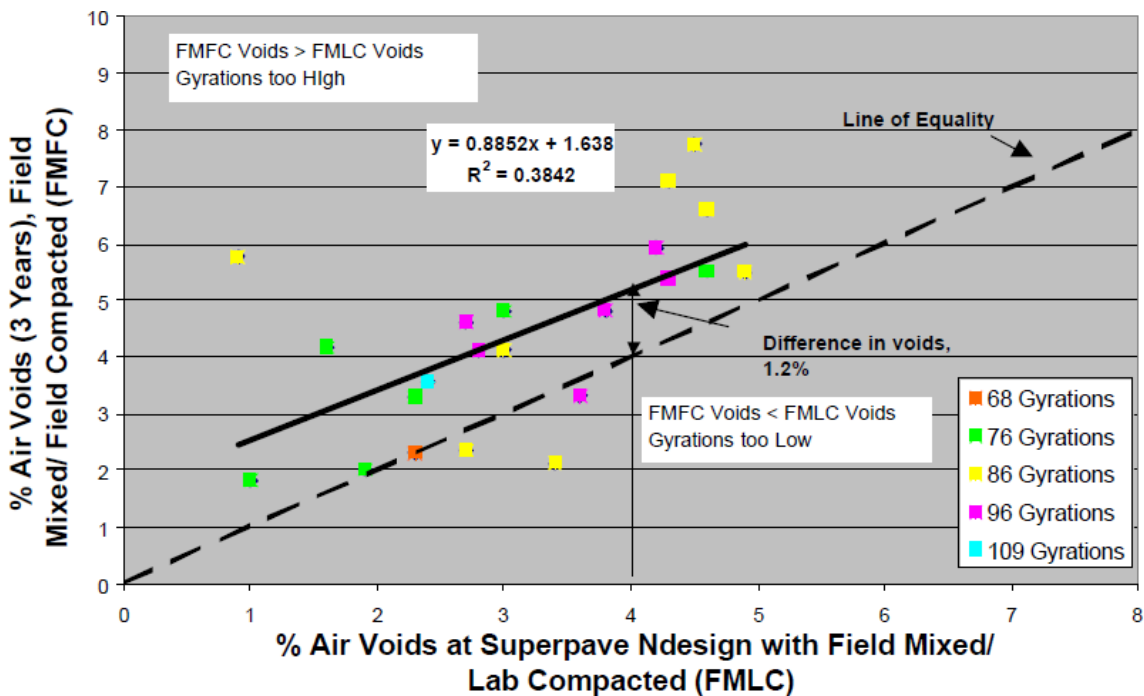
Figure 8: FMLC versus FMFC Air Voids after 3 Years [3]

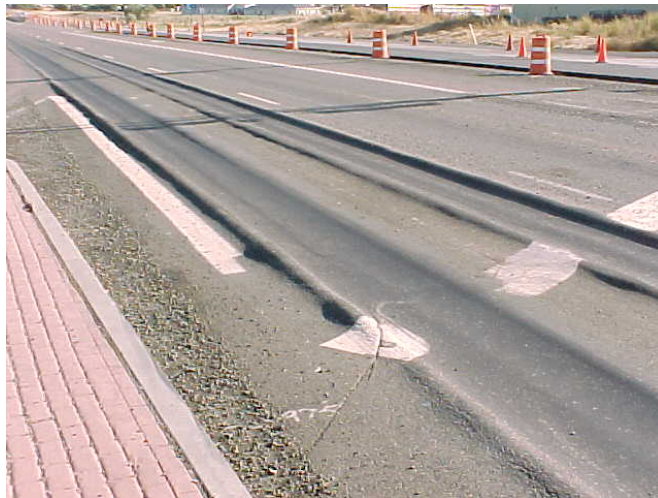
Figure 9: Severe rutting in flexible pavement [19]

Rutting occurs due to an accumulation of permanent deformation along the wheelpaths caused by excessive traffic loading (rut depth) and/or high temperature; and as a result causes compressive strain at the top of each layer, see Figure 9. Rutting can also occur due to inadequate compaction during construction [5]. The severity level can be detected by following the *Highway Pavement Distress Identification Manual for LTPP*. High severity rutting, if left untreated can lead to hydroplaning caused by the build-up of water and therefore may lead to structural failures [11]. Additionally, excessive rutting can cause serviceability issues because the ride quality becomes inadequate for travelers [5]. About 32% of rutting occurs in the surface layer and 14% and 45% in the base and subbase respectively [11]. Generally, with the existing N_{design} used in Superpave, rutting resistance has not been reported to cause major inadequacies to the pavement structure. Thus, reducing the N_{design} value can negatively affect the rutting resistance and consequently increase permanent deformation in the structure due to higher asphalt content [15].

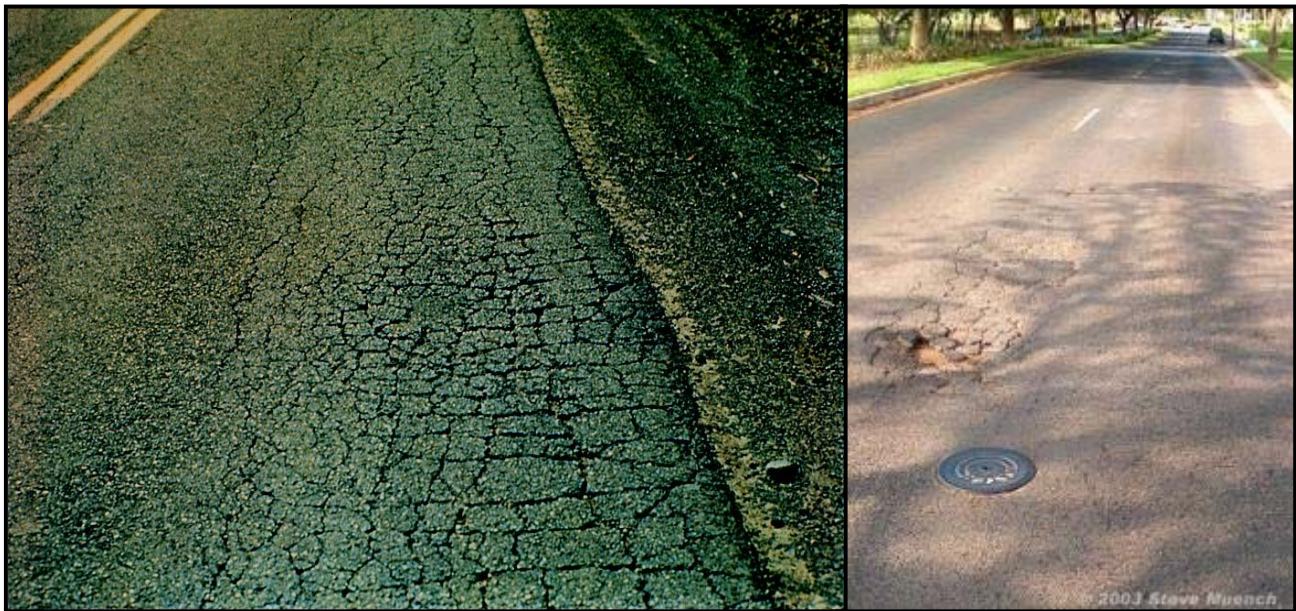
Figure 10: Fatigue cracking (left). Pothole caused by fatigue cracking (right) [20]

Fatigue cracking in flexible pavements causes horizontal tensile strain at the bottom of the asphalt or base layer under repeated traffic loading, see Figure 10(a). The small cracks start at the bottom of the asphalt or base layer and propagate to the surface layer resulting in a series of interconnecting cracks caused by fatigue failure [11]. There are many factors that contribute to fatigue cracking, such as improper design (QC/QA), pavement material characteristics, weak subgrade soil, traffic loading, moisture due to poor drainage and temperature. While too much

If left untreated excessive fatigue cracking will result in loose surface materials that will ultimately lead to potholes, as shown in Figure 10(b). Pavement rehabilitation is required in order to restore pavement conditions and increase serviceability. However, the underlying pavement layers in addition to the traffic loads must be evaluated and considered in design prior to the rehabilitation process because weak layers do not provide sufficient support to accommodate or withstand traffic loads [5]. Previous studies have shown that mix design using Superpave showed early signs of fatigue cracking. In order to reduce the fatigue cracking, different agencies suggested adding enough binder to reduce/delay cracking.

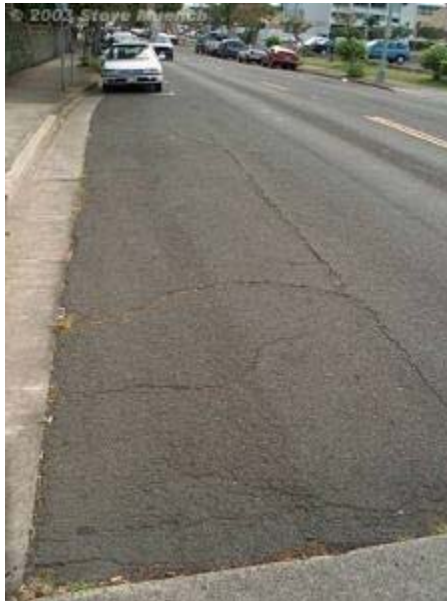
Figure 11: Block cracking, type of thermal cracking [21]

Thermal cracking is similar to fatigue cracking and is caused by repeated loads, in addition temperature changes [11]. There are two types of distresses under this category, low-temperature cracking and thermal fatigue cracking. Low-temperature cracking occurs primarily in the northern part of the United States where temperatures drop below -10°F , whereas thermal fatigue cracking occurs in locations with moderate temperature where the asphalt becomes too oxidized [11].

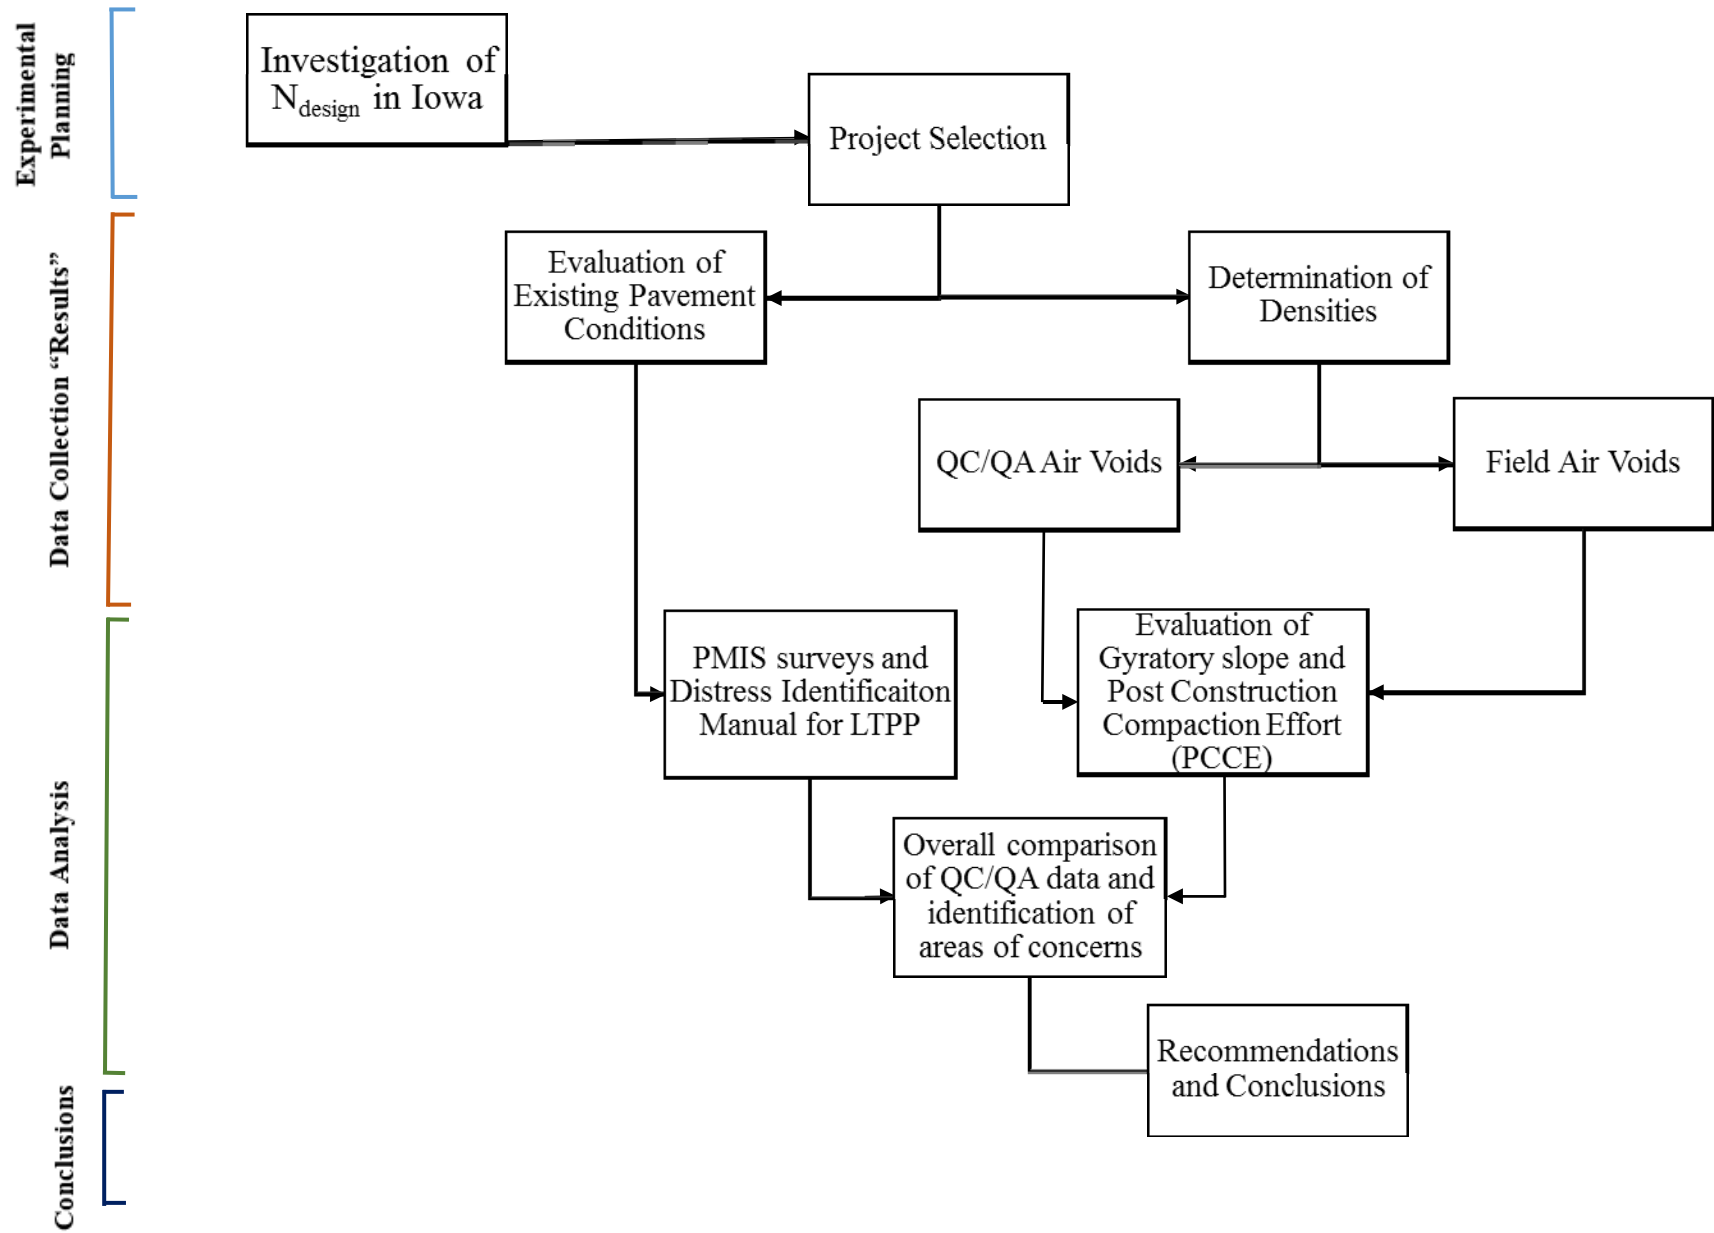
Figure 12: Flow chart of experimental plan for the study

This research will focus primarily on field sections; see Figure 12 for the flow chart visualization on the experimental plan. The evaluation of existing pavement conditions will be closely examined using the Pavement Management Information Systems (PMIS) surveys and the Highway Pavement Distress Identification Manual for the Long-Term Pavement Performance Program (LTPP). Identification of field pavements throughout Iowa was randomly selected with the assistance of Iowa Department of Transportation (DOT). Based on the availability of pavement condition data, eight projects were selected to evaluate existing pavement conditions. Field density measurements were collected and compared to QC/QA data to ensure quality in design and construction. Additionally, the gyratory slope and the post-construction compaction effort (PCCE) was calculated and evaluated in the study. The theory of overcompaction in the laboratory leading to undercompaction in the field will be validated. A he following diagram in Figure 12 summarizes the experimental plan for the study.

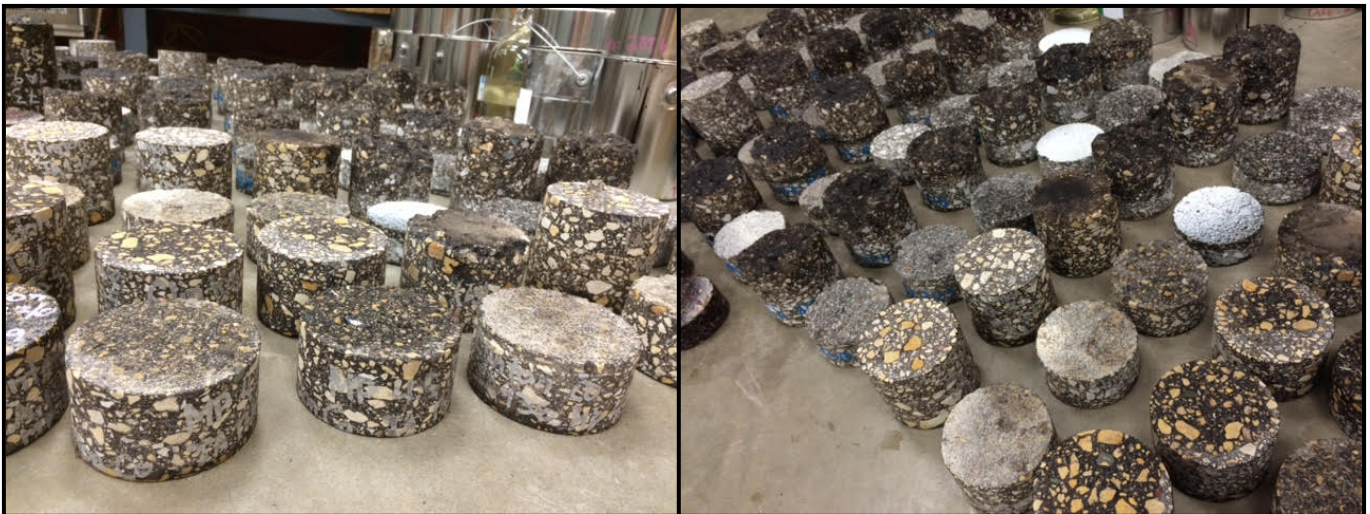
Figure 15: Actual field core samples

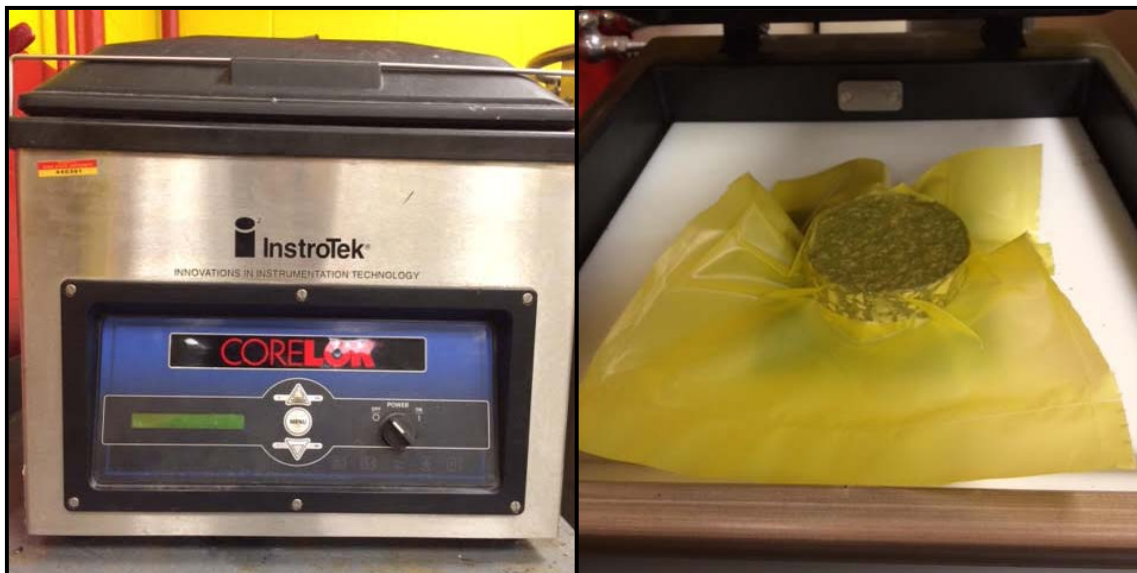
Figure 16: Corelock method

The corelock method is known to produce more accurate results for the specific gravity of the field and laboratory specimens. The concern of excess water absorption as well as water draining rapidly when samples are removed from the water tank cause problems with measurements and thus does not produce accurate results. Both methods were used in the determination of the bulk specific gravity of the field cores.

The first half of the samples was tested using the corelock method. The results of the corelock method did not have a significant difference in the bulk specific gravity in comparison to the conventional method. Thus, the remaining samples were tested using the conventional method. Using the conventional method, the dry, submerged and saturated surface dry (SSD) weights were obtained to calculate the bulk specific gravity. The SSD is defined as the condition when the external surface is “dry” but the internal part of the sample is saturated. The SSD weight obtained by patting the entire sample with a rag or towel [23].

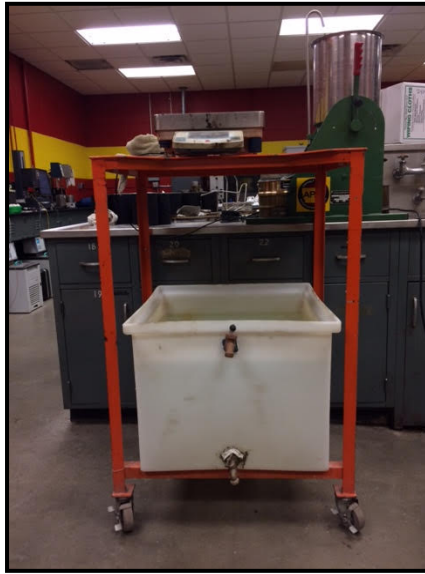
Figure 17: Water bath used for conventional method

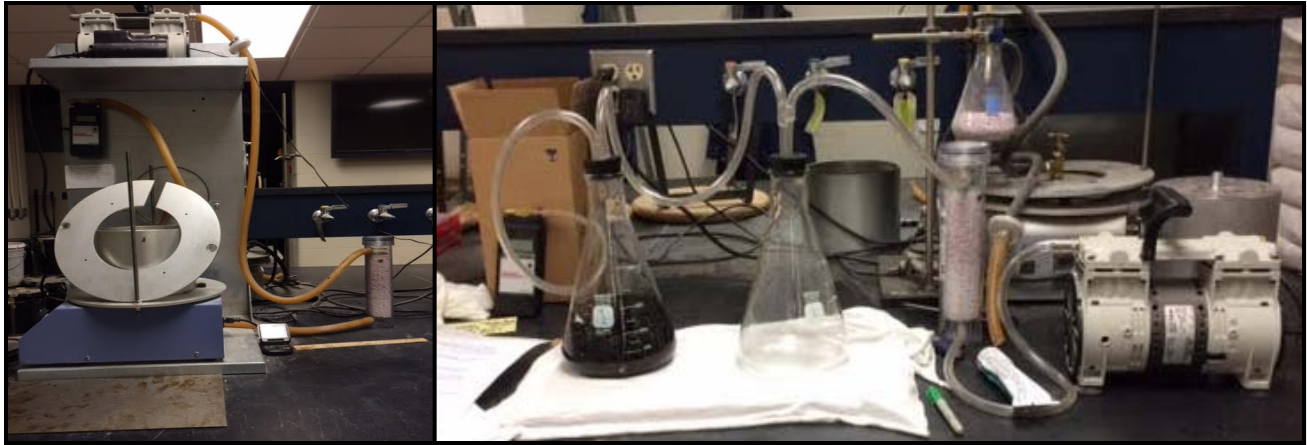
Figure 18: Metal bucket method (left) and flask method (right)

The theoretical maximum density (G_{mm}) was initially estimated per project milestone based on the closest stationing from the G_{mm} measured from the QC/QA hotbox of loose mix recorded by the Iowa DOT at construction. The actual G_{mm} for each core sample was then verified in accordance to AASHTO T 209. Two methods in AASHTO T 209 were used to determine the G_{mm} in the laboratory; the flask and metal bucket methods, as shown in Figure 18. The surface mix samples was heated in the oven at $105 \pm 5^{\circ}\text{C}$ for 30 minutes or until the core is tender enough to break apart. For the flask method, a total of 2000 grams of sample was tested [24]. Similar to the bulk specific gravity, the flask method is known to produce accurate values for G_{mm} . Both methods yielded the same results.

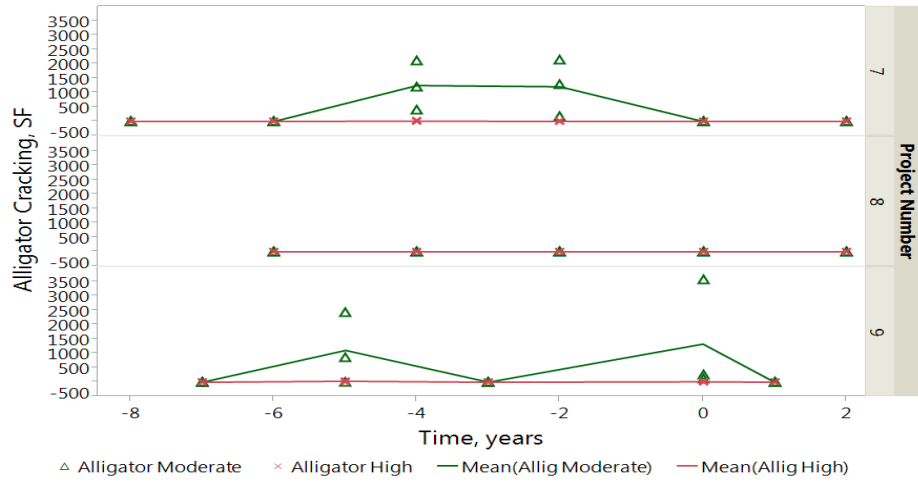
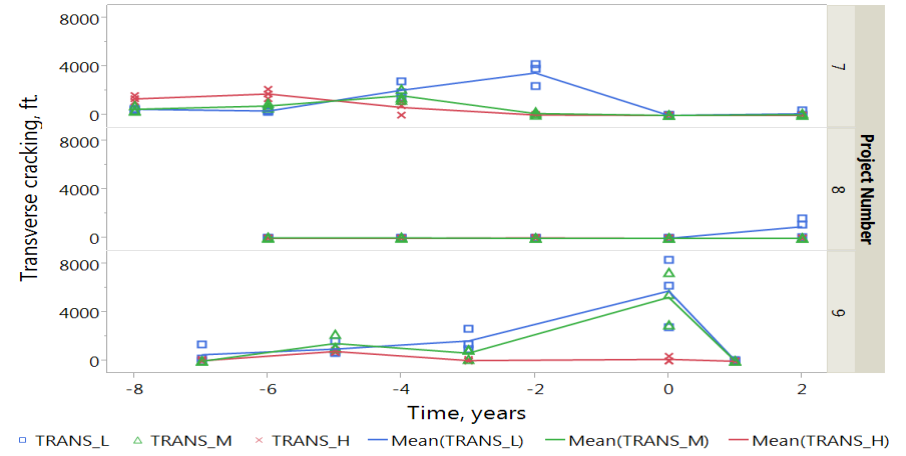
Figure 21: At 3M ESALs. (a) Alligator or Fatigue cracking, (b) transverse cracking, (c) longitudinal cracking, (d) rutting

The pavements showed post-rehabilitation improvement in majority of the pavement distresses except for low severity transverse cracking in project 8 and rutting in project 9. In Figure 21(b), the low severity transverse cracking for project 8 had a slight increase in distress, but the effect may be negligible. The average rutting depth for all three projects shown in Figure 21(d) did not exceed 0.26 inches. The average IRI values after rehabilitation indicated good pavement conditions in all three projects and similar to one million ESALs, low severity longitudinal and transverse cracking produced the greatest amount of distress in the pavements, as seen in Figure 21(b-c).

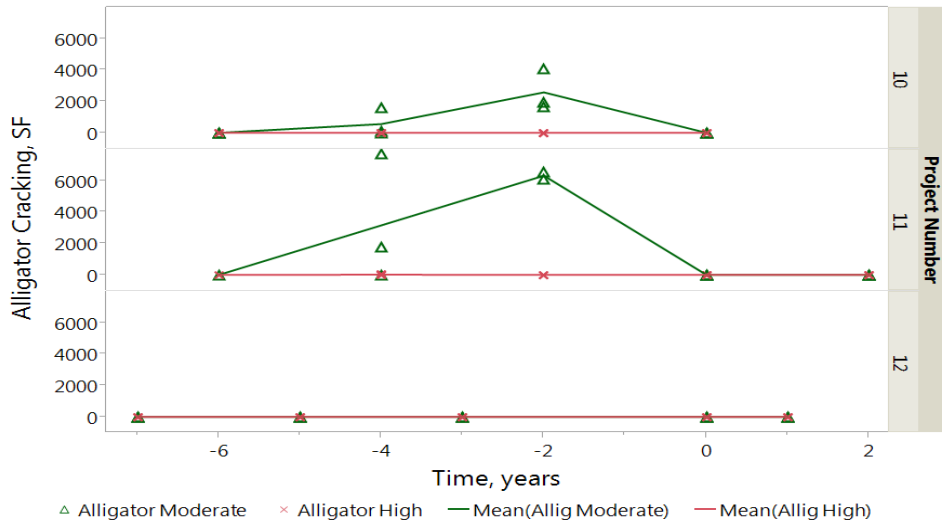
Figure 22: At 10M ESALs. (a) Alligator or Fatigue cracking, (b) transverse cracking, (c) longitudinal cracking, (d) rutting

In Figure 23, the average IRI for all three projects were below 200 and remained relatively constant overtime. Figure 22(c) displayed large amounts of low severity longitudinal and transverse cracking in the pavement structure. The maximum low severity transverse cracking in project 11 was approximately double the maximum low severity longitudinal two years prior to rehabilitation; a similar trend in project 4, as shown in Figure#. Additionally, the transverse and longitudinal cracking for project 10 displayed similar trends in the level of severities. Figure 22(d), showed a slight increase in the average rutting in project 11 after rehabilitation, but none of the projects exceeded an average rutting depth of 0.17 inches.

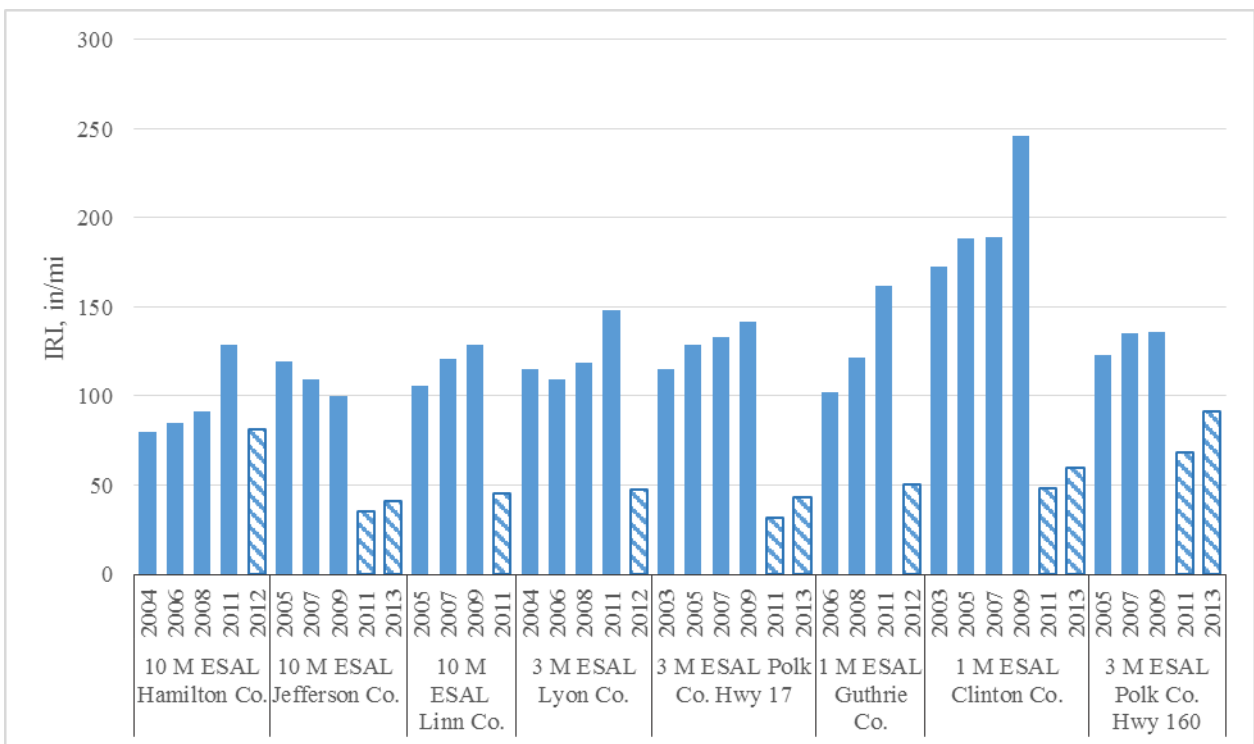
Figure 23: IRI indication at each ESAL levels

The international roughness index (IRI) was selected as an overall indicator of ride quality and is shown in Figure 23. According to Iowa Interstate Corridor Plan IDOT, the following IRI criteria was developed: $IRI < 95$ indicates good pavement condition, IRI between 95 and 170 suggest fair condition, and if IRI is greater than 170 the condition is poor [25]. For the selected projects, the pavement with the historically highest IRI was 1M ESAL located in Clinton County, but all pavements showed significant improvement after rehabilitation. In

For this research, IRI values were evaluated as shown in Figure 23. Pavement conditions post-rehabilitation for all projects showed significant improvement for all sections. PMIS data is collected on pavements in Iowa every two years and thus projects will continue to be evaluated under the State’s PMIS program. The highest IRI was from the 1M ESAL mix in Clinton County. The post-construction IRI was highest for the 10 M ESAL Hamilton Co. project followed by Polk Co. Hwy 160 3M ESAL.

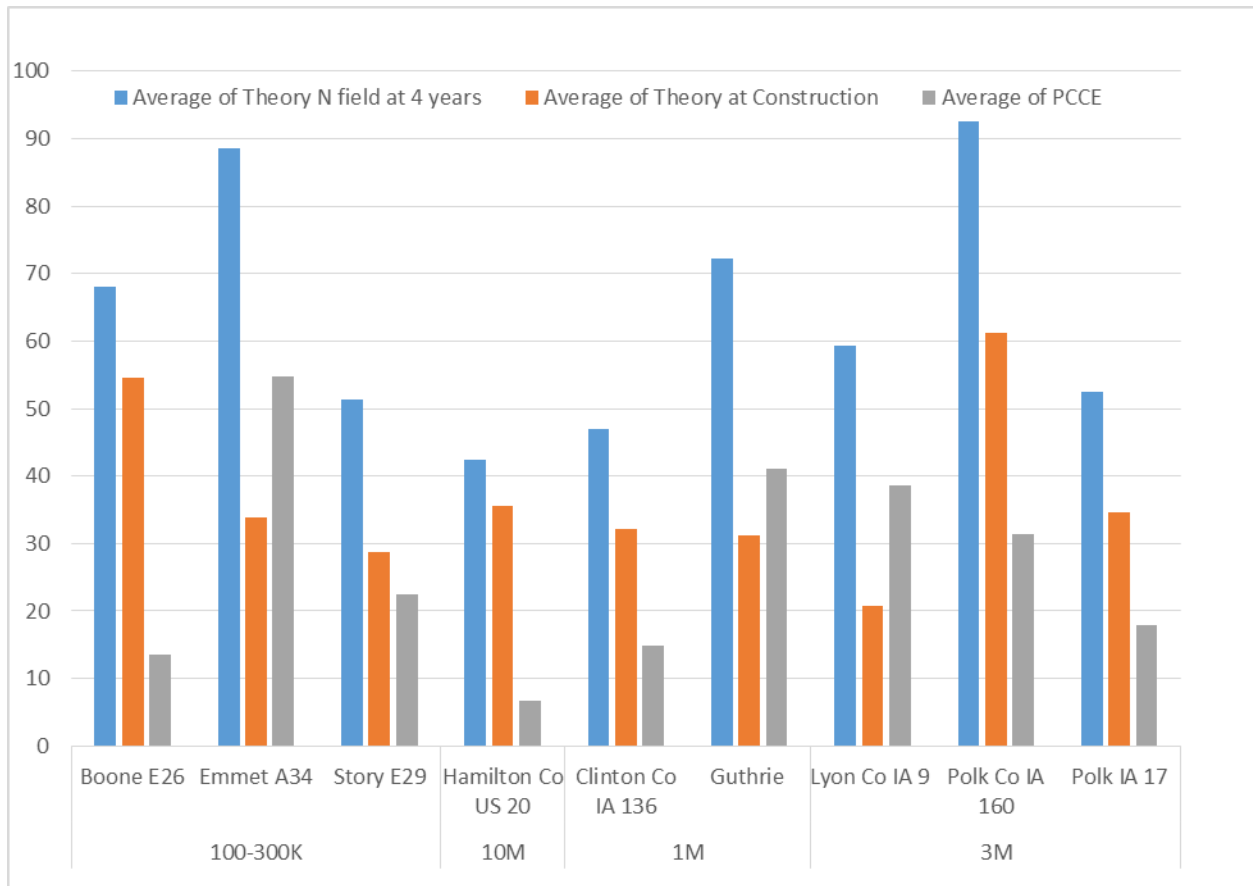
Figure 31: Average Theory N@4yrs, N@const., and PCCE for each ESAL level
