# Evaluation of de-icer deterioration of concrete

Xin Wang  
*Iowa State University*

MASTER OF SCIENCE

Major: Civil Engineering (Civil Engineering Materials)

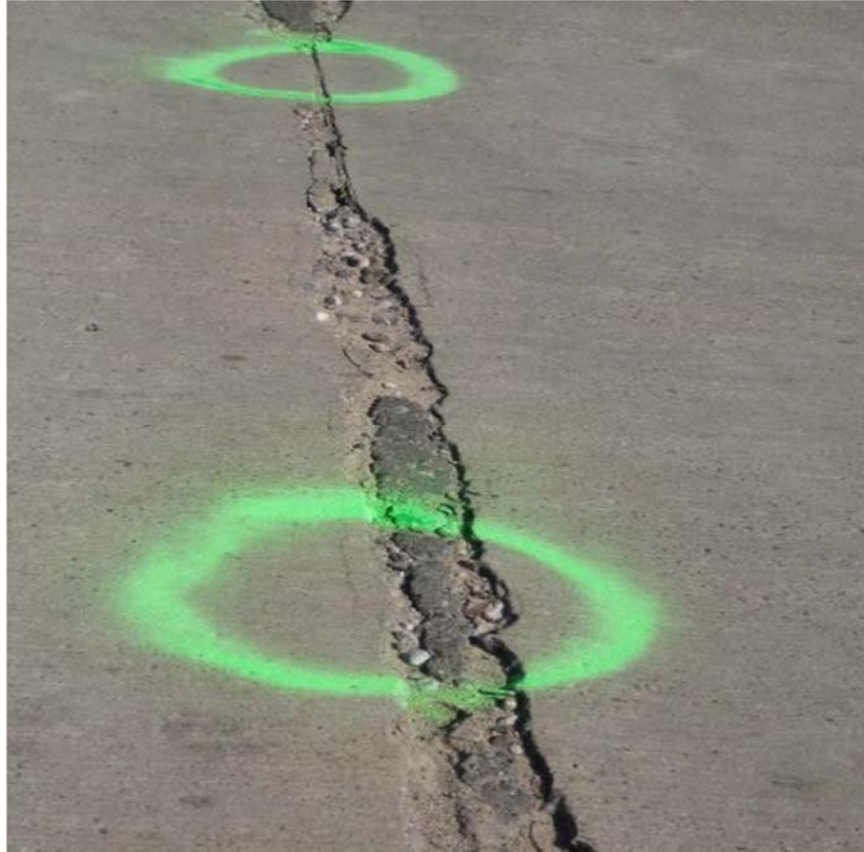
Figure 1. **Joint deterioration in Eau Claire, WI (Zhang and Taylor, 2013)**

However, it was observed in the field in a number of locations that the distress resulted in cracks forming in 1" steps rather than 1 mm steps (Figure 1). These cracks were observed to go around the coarse aggregate particles leaving little or no paste adhering to

could cause the dissolutions observed in Fig 1 and Fig 4. The mechanism behind this deterioration would be studied in this thesis.

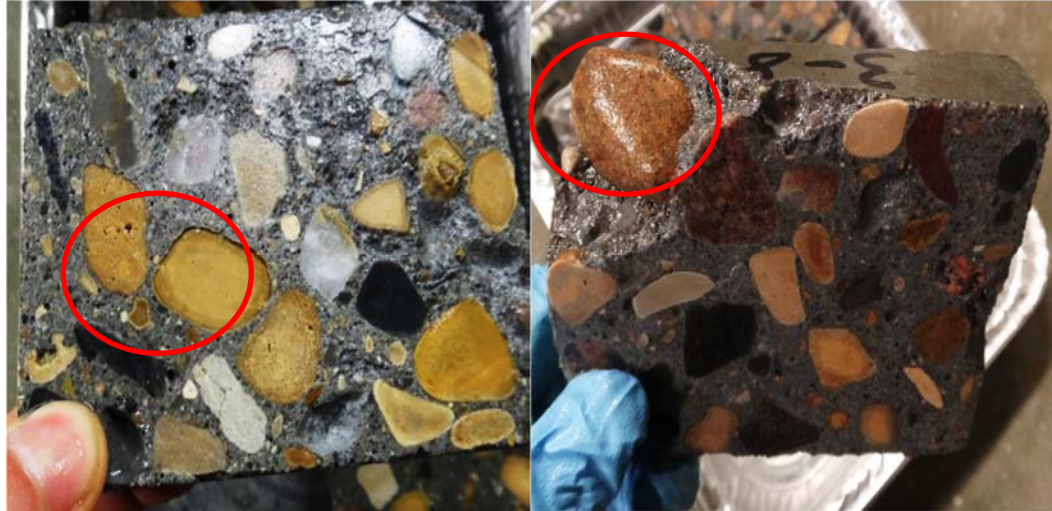
In 2013, Zhang and Taylor proposed that the ITZ around coarse aggregate particles exposed by saw-cutting may be damaged under the action of deicing salts in cold weather (Figure 19). This is notable because in general it is difficult to separate aggregate from paste in

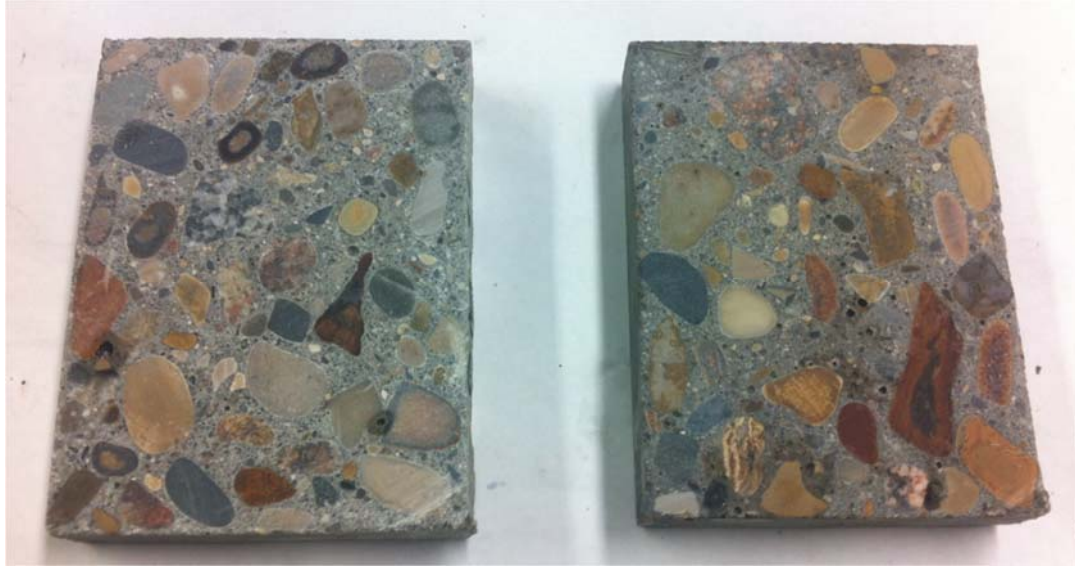
Figure 20. **Concrete slices before soaking**

Concrete was mixed in accordance with ASTM C192 and cast into 4 x 3 x 16" beams. The beams were cured in a fog-room for 28 days before they are cut by diamond saw into ½" thick slices (Figure 20). The slices were deliberately thin to ensure that some aggregate particles are exposed on both faces of the slice.

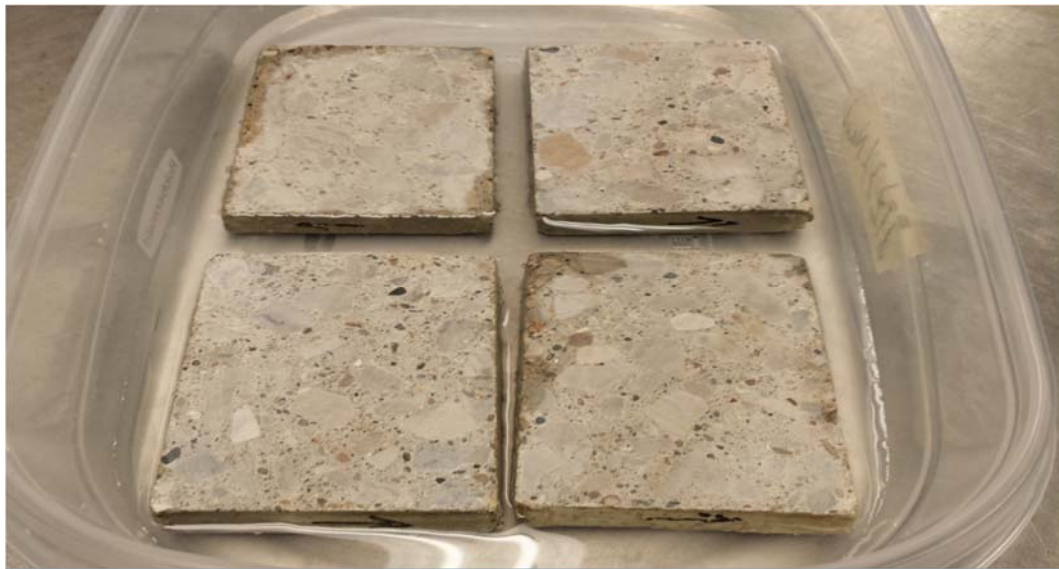
Figure 21. **Slices immersed in salt solution**

The slices were partially immersed, sawn face down, in a ¼" layer of test liquid comprising either water, 3% NaCl, or 3% MgCl<sub>2</sub>, at a constant 40°F (Figure 21). For each solution, four samples were tested. After 56 days, slices were cut into two halves to create vertical section so that the effects of the solutions could be observed through the thickness of the samples. Selected samples were examined in a Scanning Electron Microscope (SEM).

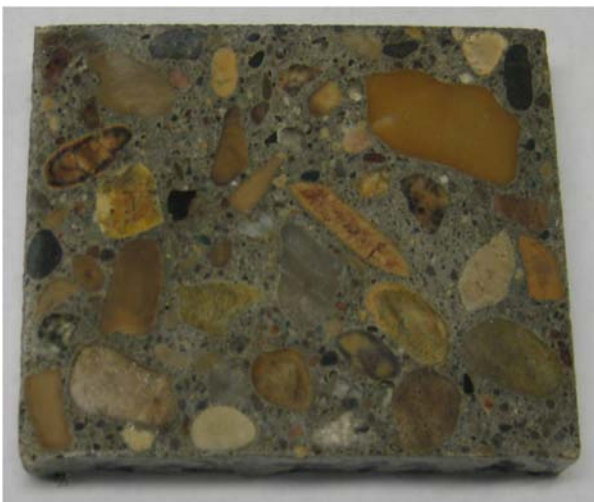
Figure 22. Typical sample tested in water after 56 days at 40°F  
A: Optical image. B: SEM image

No obvious deterioration is observed in either Figure 22A or 22B.

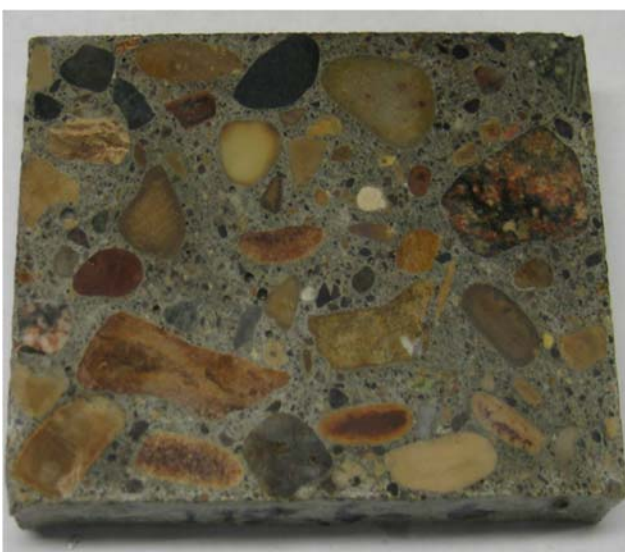
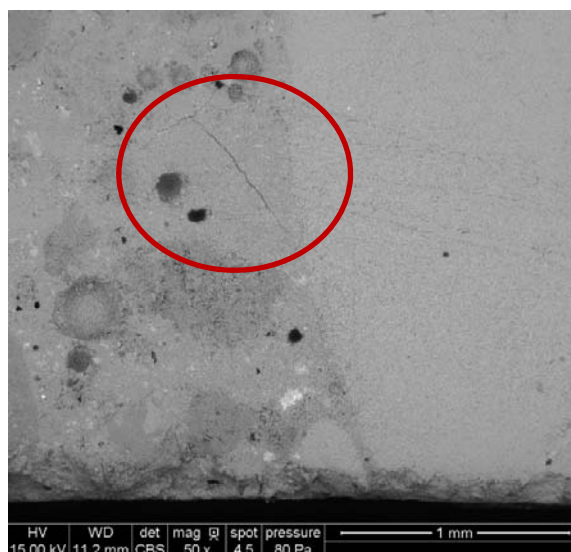
**Figure 23. Typical sample tested in NaCl after 56 days at 40°F**  
**A: Optical image. B: SEM image**

There were no signs of salt crystallization, nor of dissolution of the ITZ. Chemical mapping did not indicate concentrations of chlorides in any location, but rather a uniform spread through the paste.

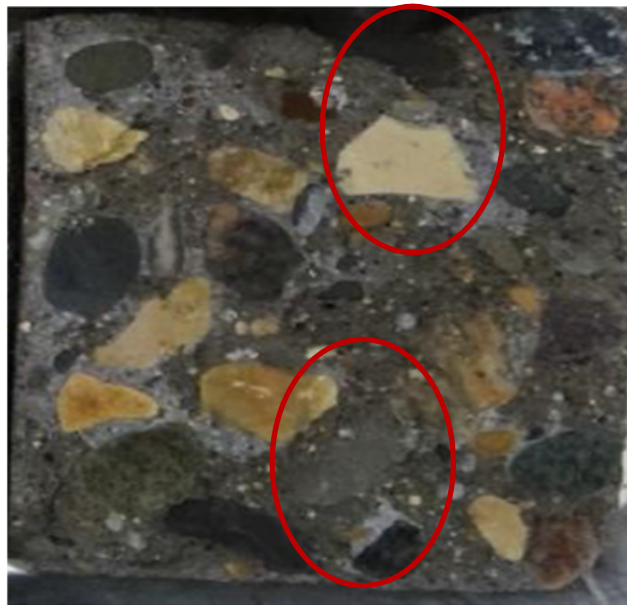
Figure 25. Sample in  $MgCl_2$  solution after freezing and thawing (Zhang and Taylor, 2013)

The materials used by Zhang and Taylor were similar to those used here but their samples were subjected to cyclic freezing and thawing for 600 cycles. Samples in this work were stored at a constant 40°F in order to remove the effects of freezing.
