# The effects of intersection collision warning systems on gap selection and stopping characteristics

**The effects of intersection collision warning systems on gap selection and stopping characteristics**

A thesis submitted to the graduate faculty  
in partial fulfillment of the requirements for the degree of

Major: Civil Engineering (Transportation Engineering)

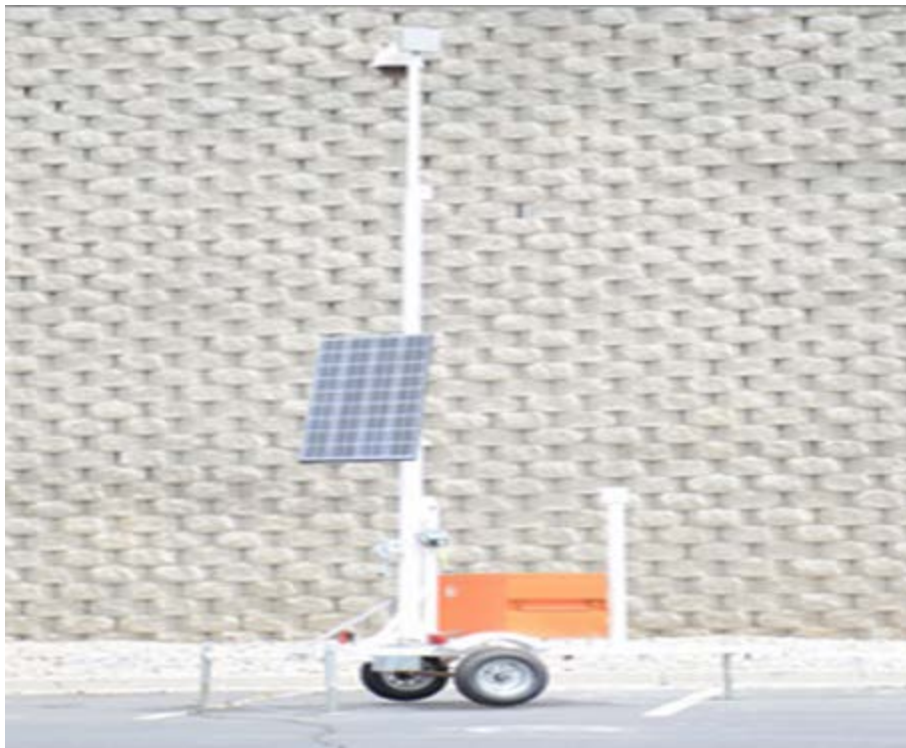
*Figure 5: Mobile camera trailer set up (Live View Technologies, 2014.)*

Video data were collected at each location before and after installation of the ICWS. An array of video trailers/cameras were used and video collected at each intersection for one week during the before period and one week during the after period. The cameras were recording the intersection continuously for the week period, which required an effective answer to video storage. With the video recording process lasting a week at a time, and multiple sites throughout the state of Minnesota, a decision was made to find a camera to be moved between locations. The solution to these problems came through Live View Technologies in supplying mobile cameras on trailers. Figure 5 displays the trailer with the camera set up and Figure 6 displays the trailer ready to be moved.

Live View Technologies mobile can be utilized in many situations. The wheels made the cameras portable and easily moved with a pickup and driven to their final location for viewing in most cases. Adjustable base legs allowed the trailer to be leveled on uneven ground, which was in a ditch most times for this project. Another useful feature is the ability to raise the camera up to 25 feet to gain better sight of an intersection. The trailer camera has pan, tilt, and zoom capabilities, which allow any area of the intersection to be seen. Most importantly, solar power can be captured and used to operate the camera and wireless internet connection. The camera mast also provides an ideal location to attach the solar panel. Immediately after a camera is turned on, a user can see and alter the camera view online in real time. With the use of removable memory, video was saved and downloaded after the week of data collection is finished.

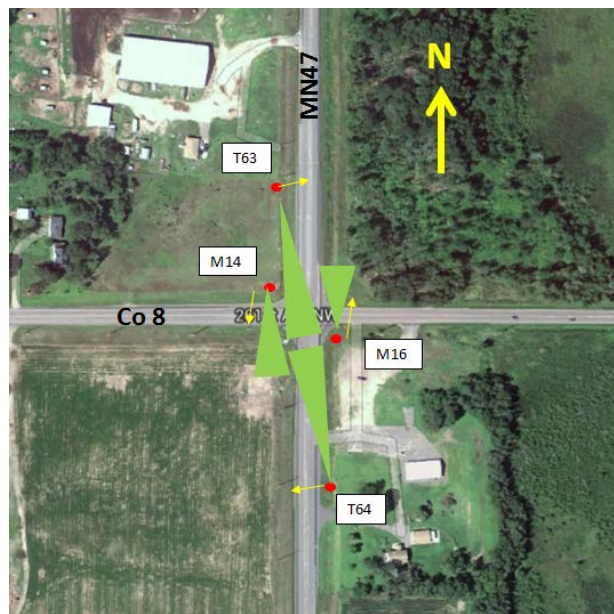
*Figure 7: Isanti treatment intersection camera layout*

Each intersection utilizes four cameras to make all approaches available for viewing. The camera setup at the intersection of MN47 and County Road 8 in Isanti County is displayed in Figure 7. The camera layout of the other 3 intersections are found

in Appendix A. Cameras T63 and T64 are mobile trailer cameras in the ditch of MN47. These cameras are used to view all aspects of the intersection. The vehicles approaching the stop signs are visible and the videos from these cameras are used to determine the stopping motions of the vehicles and the gaps between cars on MN47. In addition to the two mobile trailer cameras, each intersection utilizes two post-mounted cameras. These cameras are identical to the ones used on the trailer but are attached to a post in the ground at approximately the same height as vehicle windows. The cameras are facing the vehicles stopped at the stop sign in an attempt to see what the drivers are looking at while they are stopped.
